SHRP2 Nondestructive Testing for Concrete Bridge Decks (R06A) Round 7 NYSDOT Summary

October 31, 2018

BIN 1049529 I690 over CSX Town of Geddes Onondaga County, NY

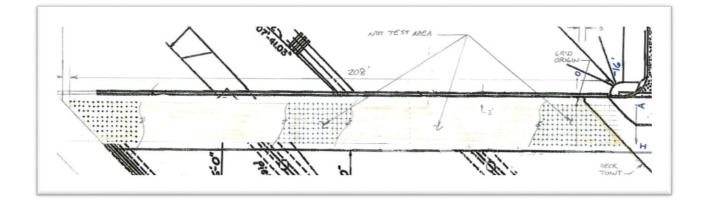
Test Grid Site:

Objective was to obtain top (and bottom) delamination location and quantities at the test site for the various rapid IE methods. This was a project-level experiment (versus a system-wide evaluation).
