Department of Transportation

SHRP2 – NDE Peer Exchange

Bridge Site Selection

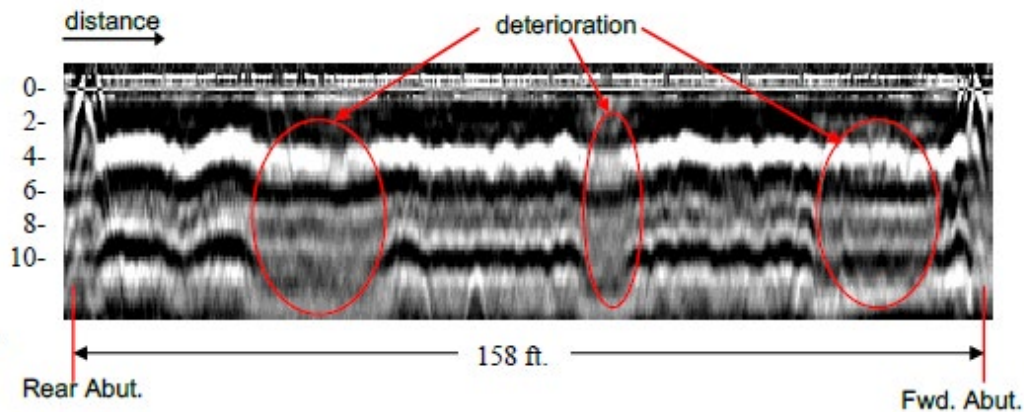
Figure 4 – Sample GPR Bridge Data with Probable Areas of Deterioration

- GPR - results indicate that 17.4%, 14.4%, and 3.6% of Structures 7, 14, and 18, respectively, have a high probability of deterioration at the rebar level.

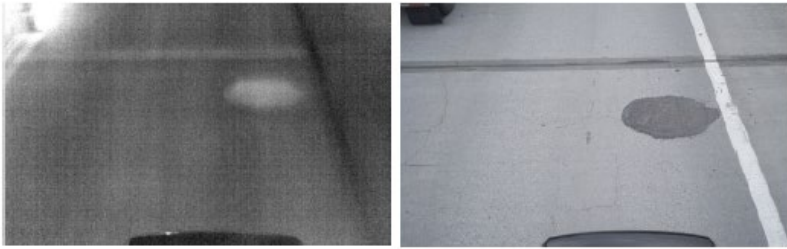
Figure 7 - Sample Infrared and Visual images

- IR and HRV - results indicate that 5.2%, 4.6%, and 2.0% of Structures 7, 14, and 18, respectively, are delaminated.

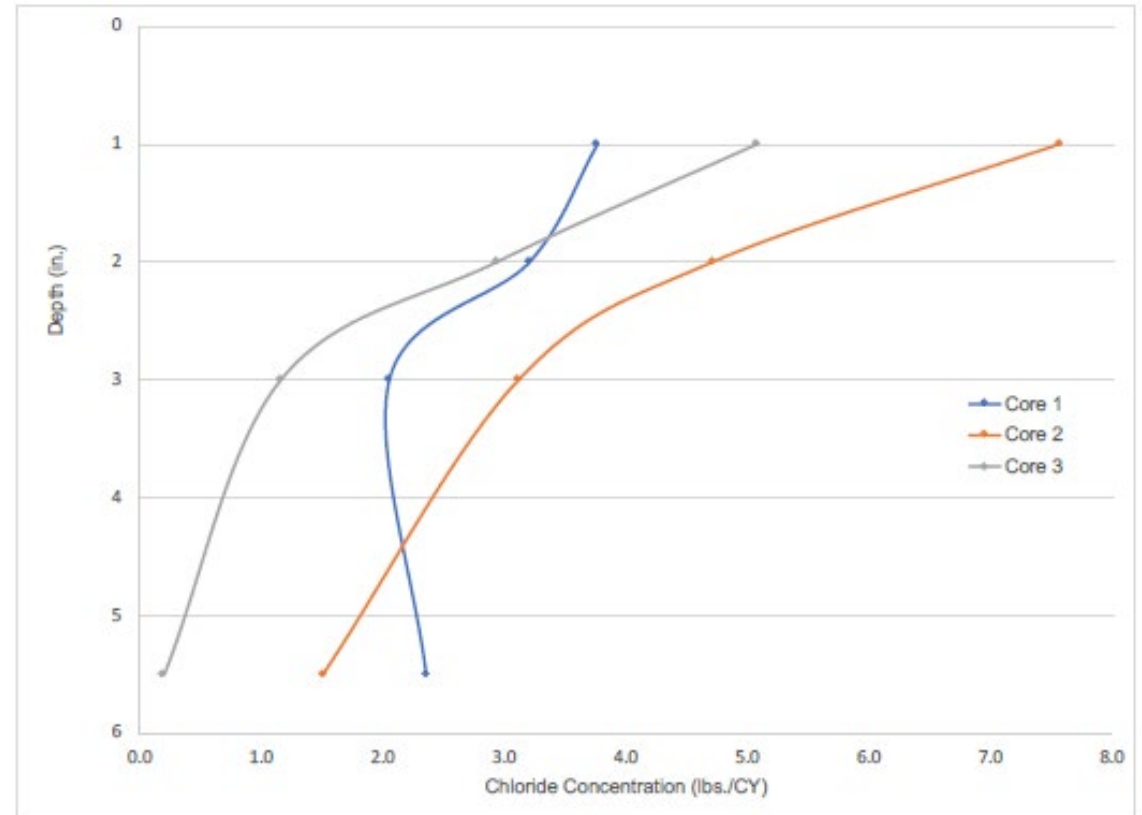
VALIDATION TESTS: Chloride Samples

Chloride Ion Penetration - results indicate that Structures 7, 14, and 18 had max chlorides of 4.01, 7.57, and 7.14 lbs./CY, with 33%, 75%, and 67%, having concentrations over 2.0 lbs./CY.

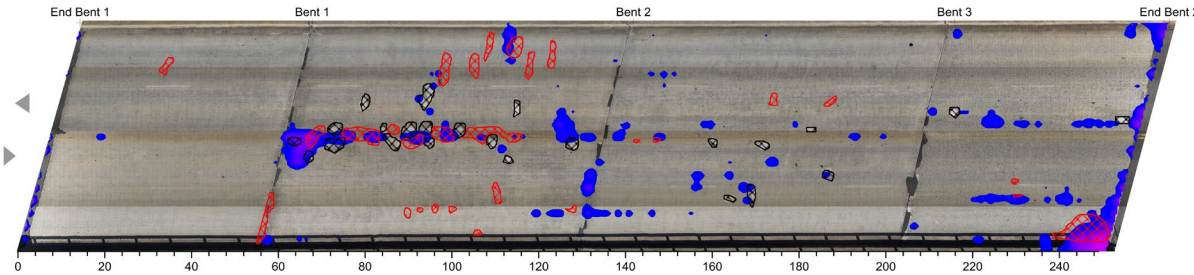
GPR and IR (Concr. Defects)

Concrete Condition Legend		Orientation	Quantity Summary			General Information	
Deterioration detected by GPR severity →	Delamination detected by IR		<p>Direction of traffic</p>	Condition	sq. ft.	%	Bridge ID: 290018 SUS 64 over I-40
	Patching	Delamination (IR)		269	2.0	Analyzed by: SB Reviewed by: AC Completed: 12/14/17	
	Spalling	Deterioration (GPR)		489	3.6	Sheet 1 of 1 	
	Thermal Obstruction	Patching		142	1.0		
*combined quantity accounting for overlap		Spalling		0	0.0		
			Combined Defects*	758	5.6

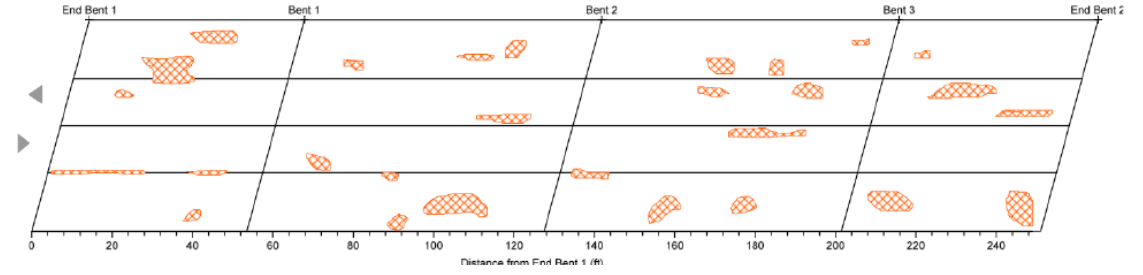
SoundAR (Delaminations)

Concrete Condition Legend		Orientation	Quantity Summary			General Information	
*Manual chain drag was not performed due to traffic control restraints.			<p>Direction of traffic</p>	Condition	sq. ft.	%	Bridge ID: 290018 SUS 64 over I-40
Delamination detected by SoundAR		Delamination (Chain)*		-	-	Analyzed by: SB Reviewed by: JC Completed: 1/26/18	
		Deterioration (SoundAR)		597.5	4.4	Sheet 1 of 1

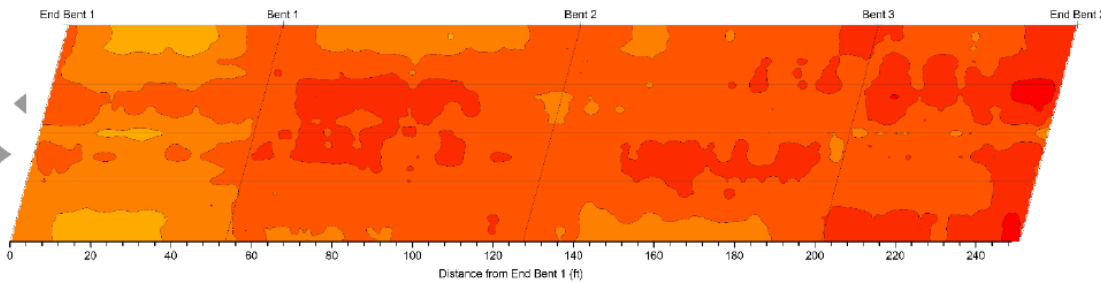
GPR (Concrete Cover)

Concrete Cover Legend		Orientation	Concrete Cover Statistics		General Information	
Concrete Cover (in)			<p>Direction of traffic</p>	Average	2.3 in	Bridge ID: 290018 SUS 64 at I-40
1 2 3 4					Analyzed by: SB Reviewed by: AC Completed: 12/14/17	
					Sheet 1 of 1

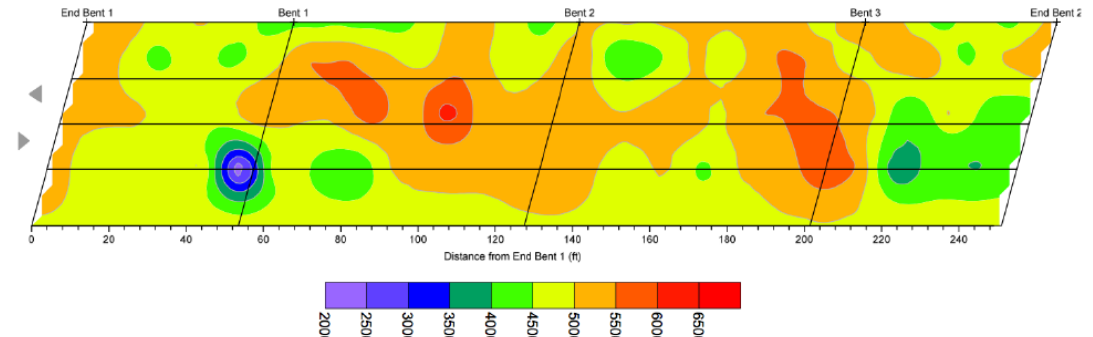
Impact Hammer (Conc Strength)

Concrete Condition Legend		Orientation	Quantity Summary		General Information	
The Lane was Closed During the Survey			<p>Direction of traffic</p>	Condition	%	Bridge ID: 290018 SUS 64 over I-40
Strength values are presented in lbs/sq. in. (psi)		<3000 psi		1	Analyzed by: SB Reviewed by: JC Completed: 1/26/18	
		<4000 psi		5	Sheet 1 of 1 	
		<5000 psi		35		
		>5000 psi		59
