Welcome to Oregon

And a Look at Our R06A Experience

Corey Withroe
Oregon DOT – 503 986 3339
corey.r.withroe@odot.state.or.us

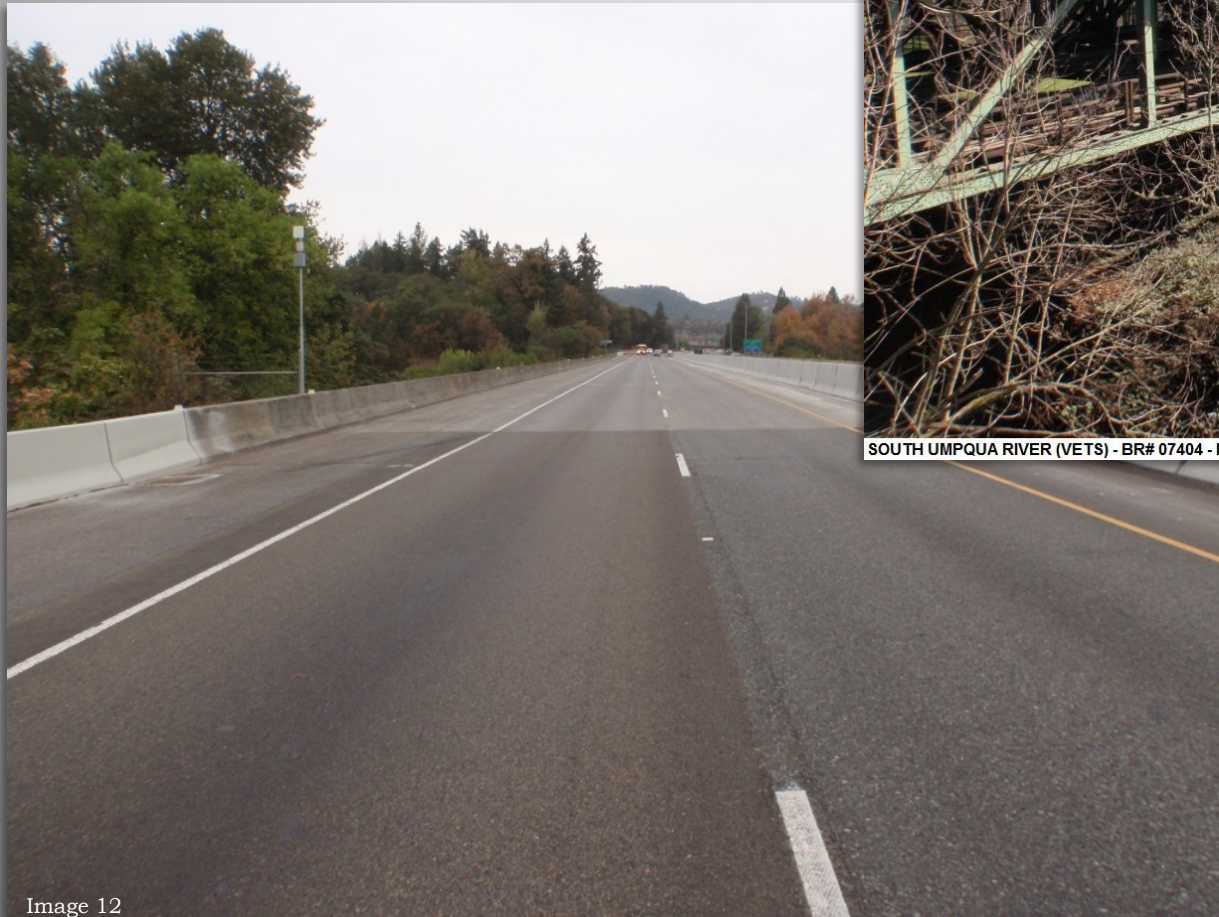
Image 12

**Routine Inspection:
Thin Overlay Recommended
(CS2 Efflorescence
Polished aggregates in wheel paths
Extensive CS1 Cracking)**

SOUTH UMPQUA RIVER (VETS) - BR# 07404 - HWY 1 SB - MP: 124.54

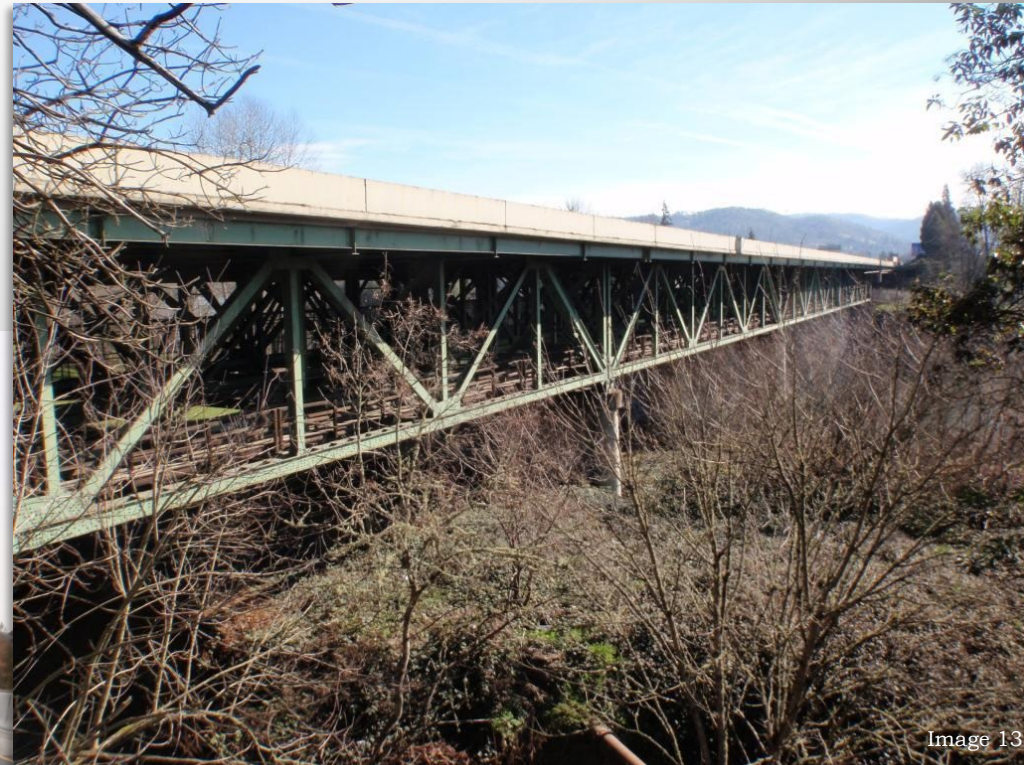
Image 13

SOUTH UMPQUA RIVER (VETS) - BR# 07404 - HWY 1 SB - MP: 124.54

**Deck sealed
previously**

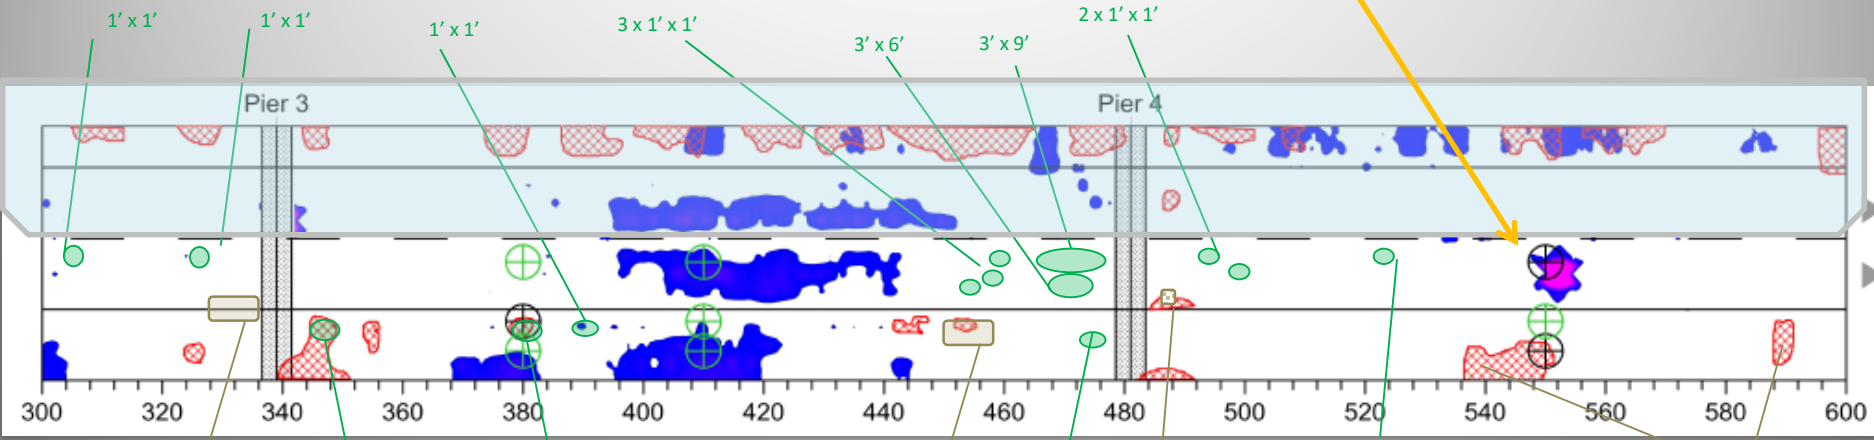
Figure 27 Exposed rebar 1' x 2' 1' x 2' Exposed rebar 1' x 1' 1' x 1' spall 1' x 1' No delaminations detected

Delamination detected by ODOT chain drag survey 12/1

I didn't see anything on the surface. I dragged my chain over it several times,

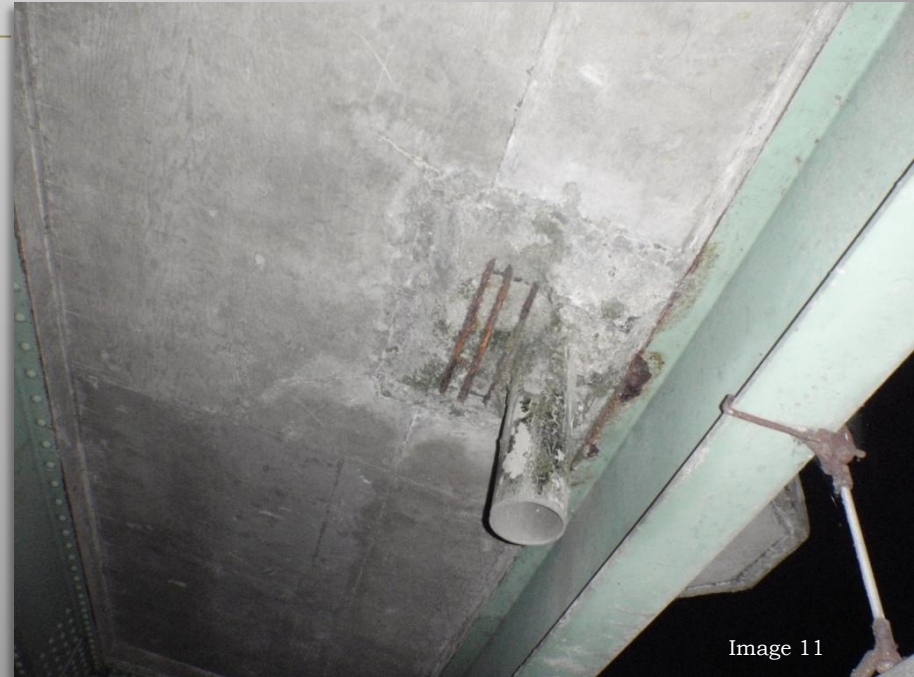
Image 11

Although this isn't the exact spot, this could be what's going on (report recommended patching several like it)

Conditions: 42°, foggy, moderate fast traffic

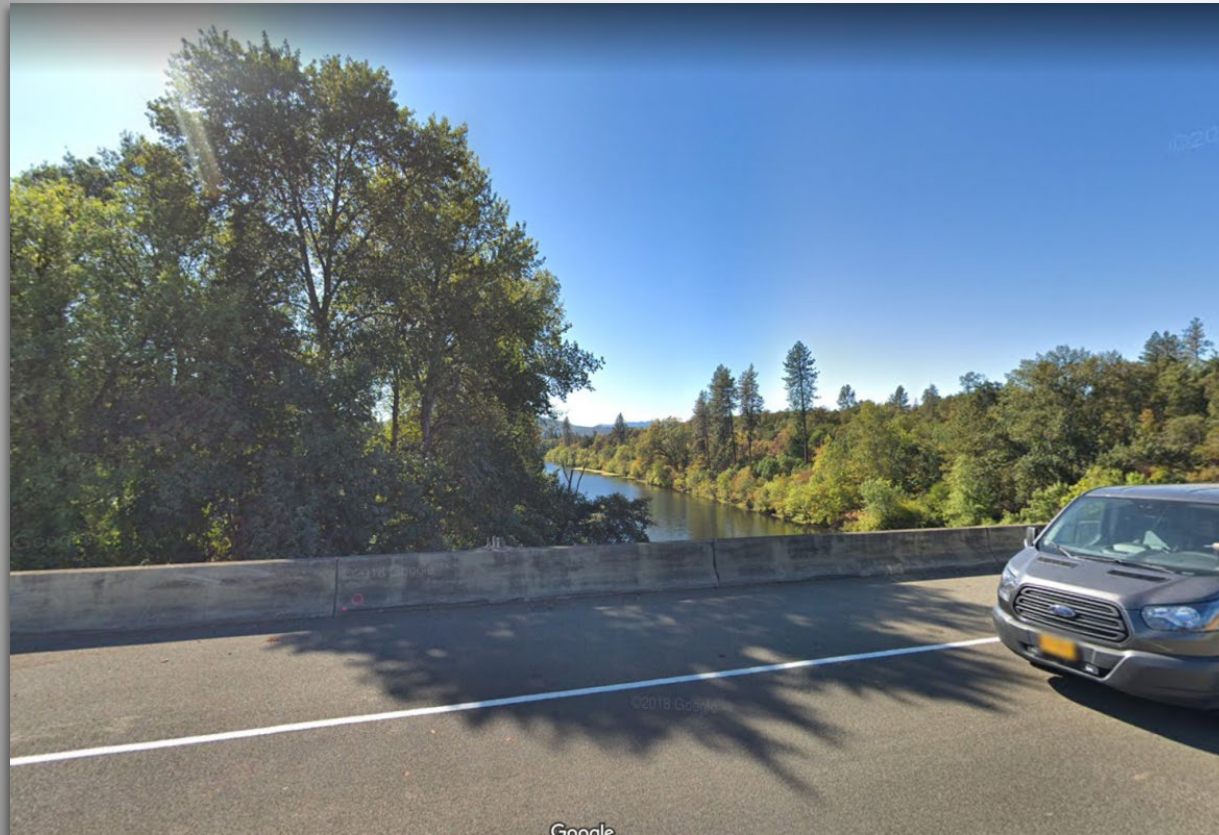
Image 12

**Shade from a
Cottonwood (?)
South end
~ 6pm summertime**

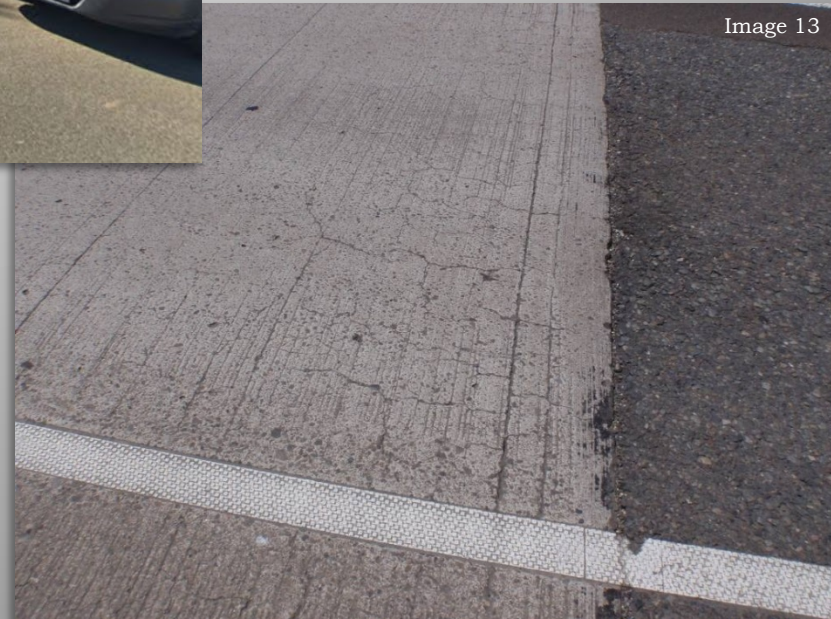
Image 13

Hairline map cracking prior to seal

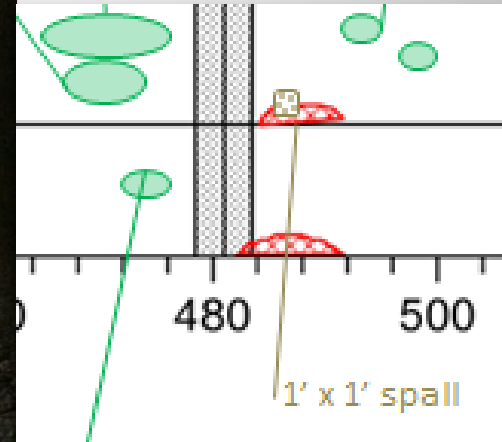
Figure 30

Spall with exposed rebar appears as Delam of different shape on map

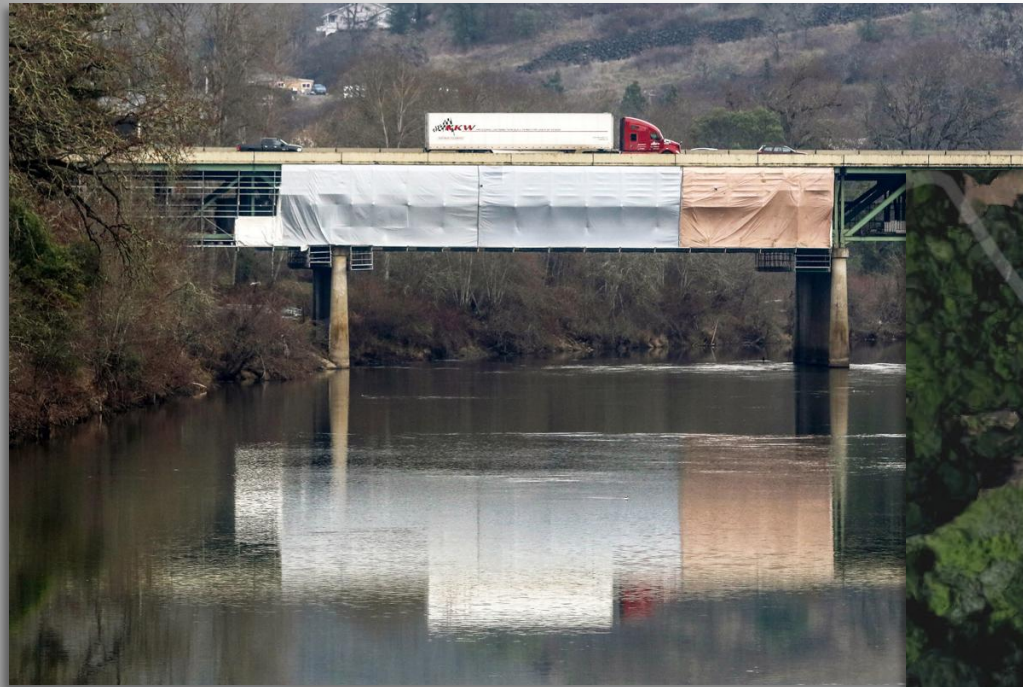
Image 16

Most repairs on south side of bridge, no class 3 prep

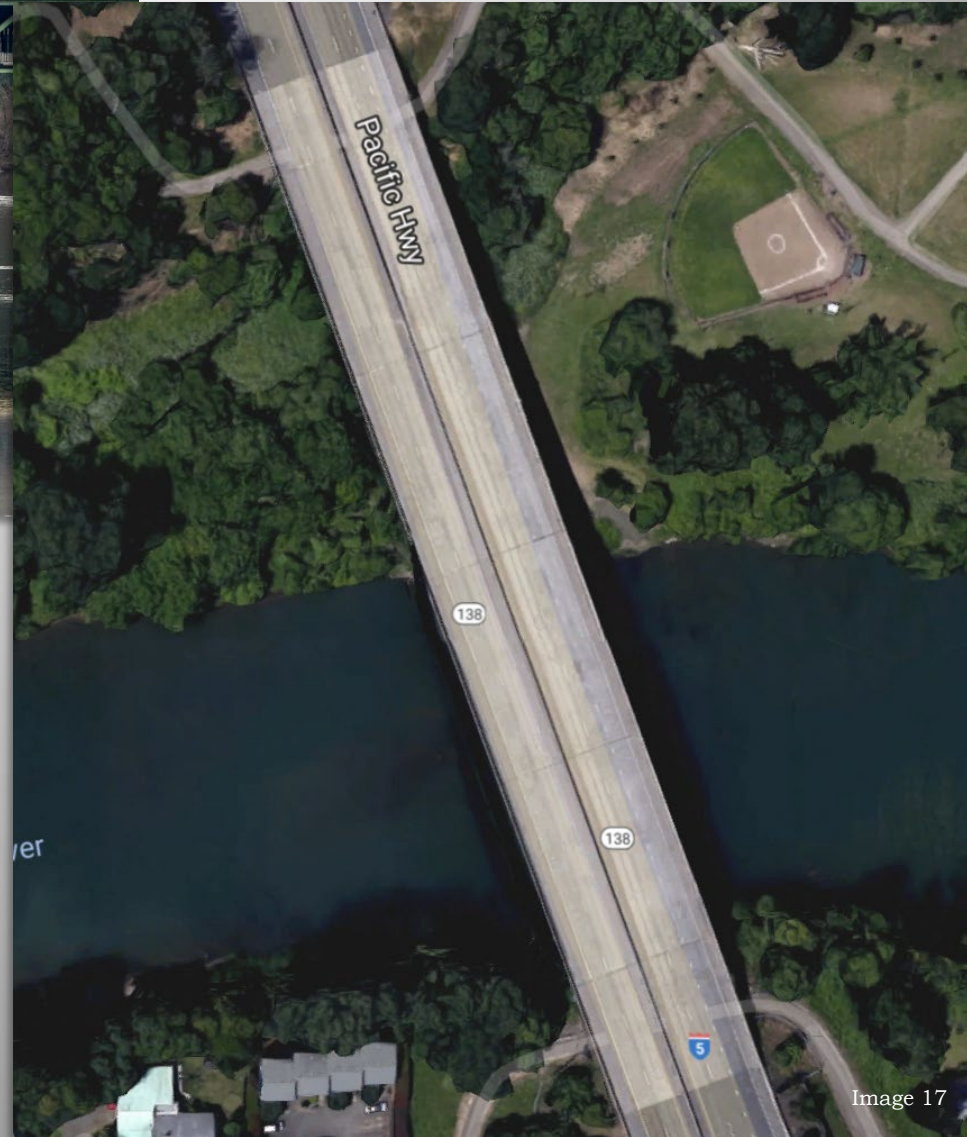
Image 17

**Thin wearing surface (25% CS3)
40 ft² of CS2 Spalls
1985 overlay
PPC overlay sometime since**

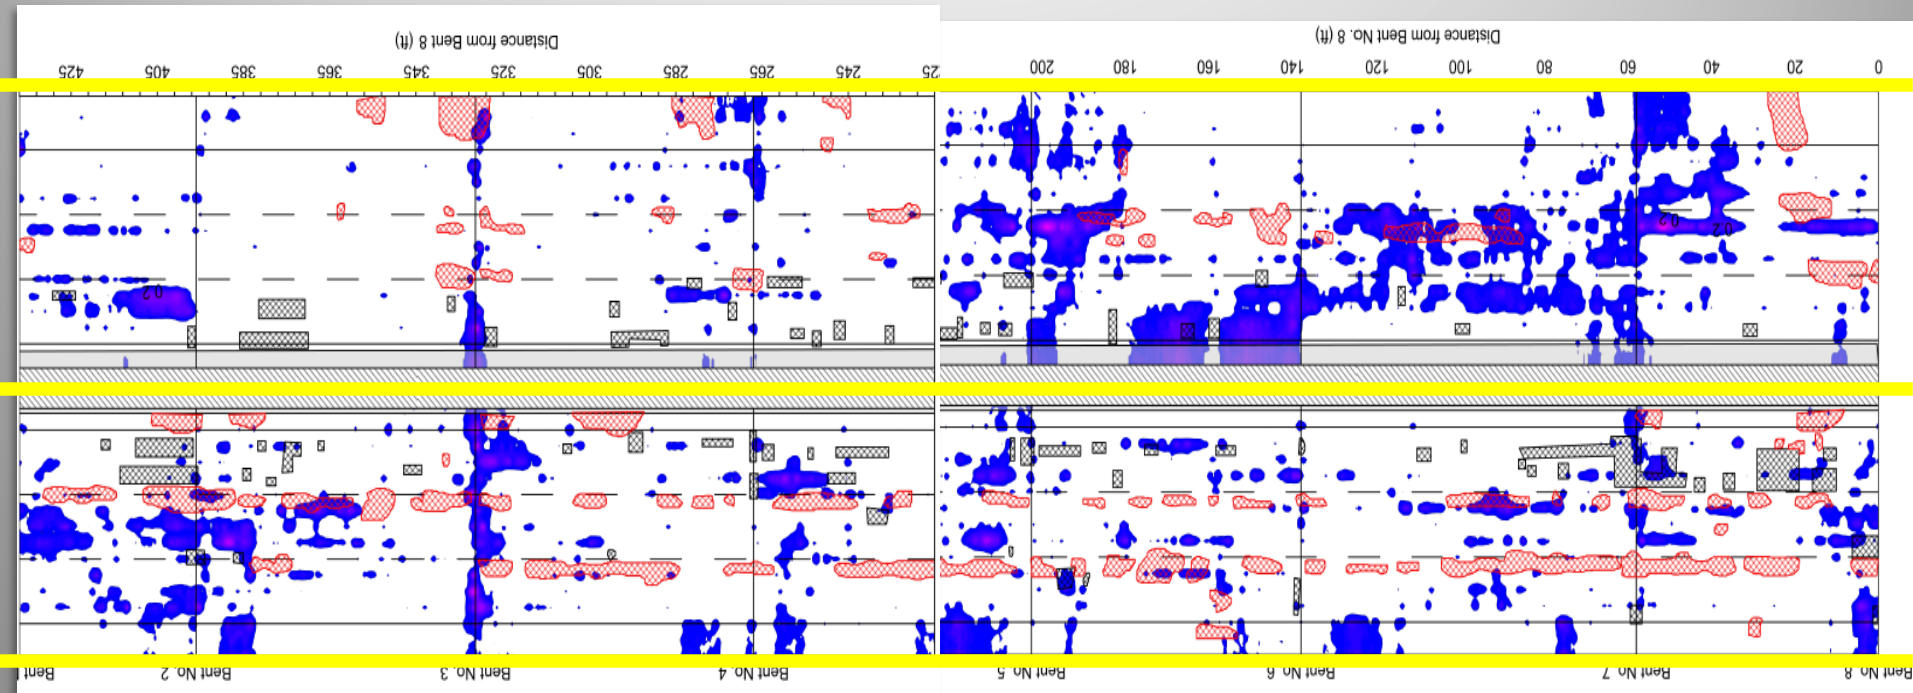
Figure 32

Better Delamination Correlation
14% Delamination

Note slight shifting of well-established patching locations

Conclusions: SB Deck to be replaced (2021)

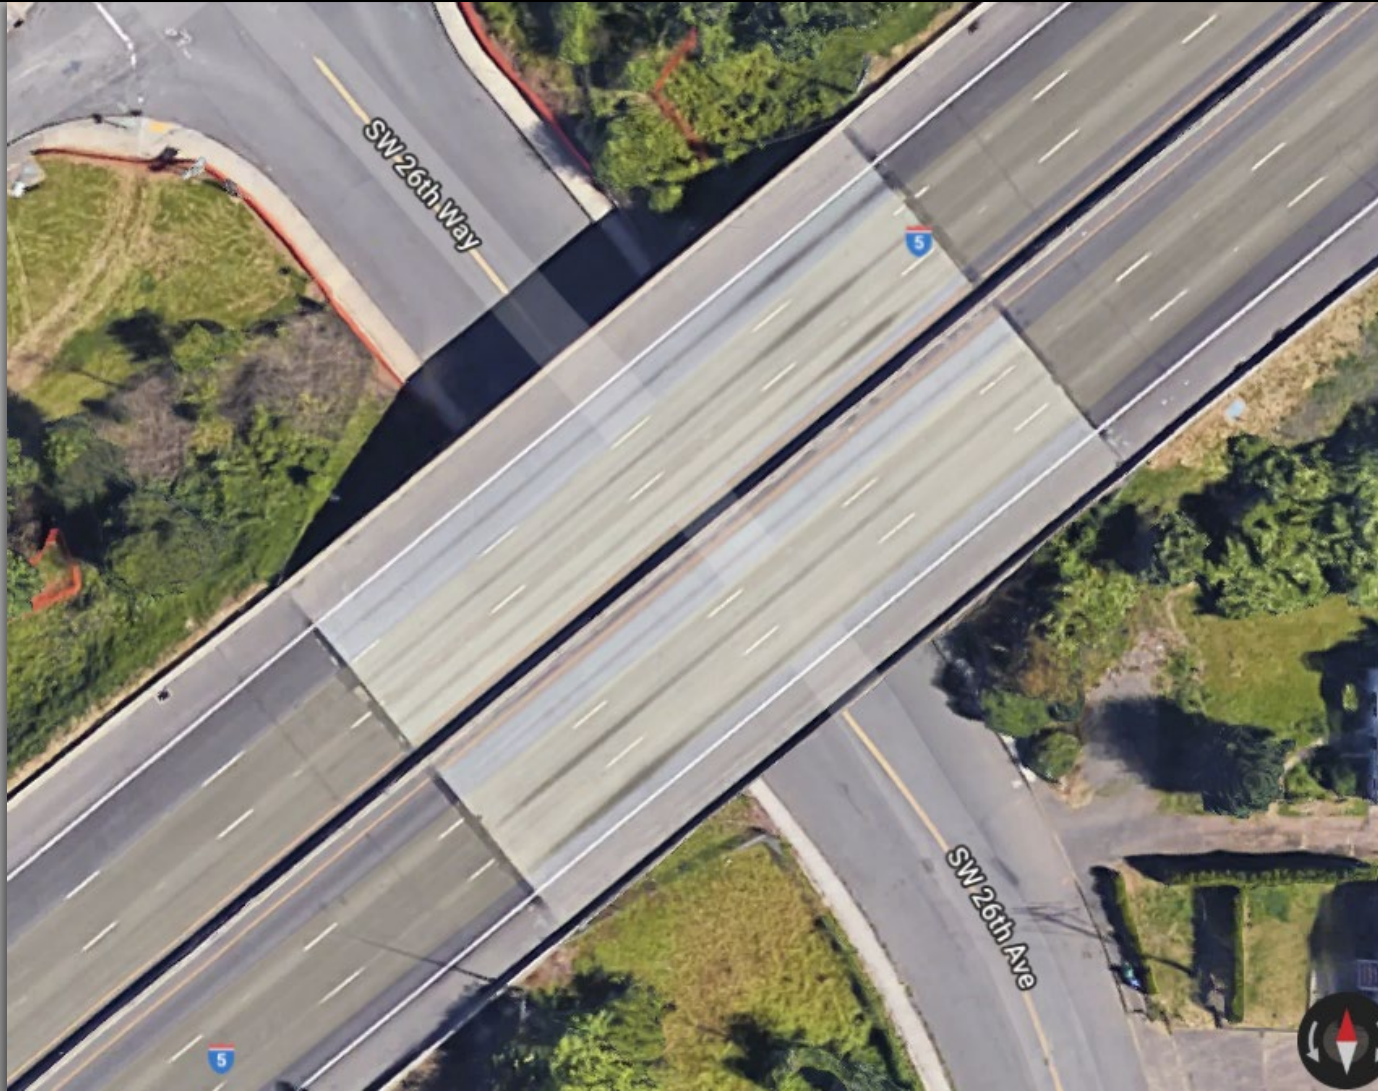
Image 20

**Routine
Inspection:
Top Flange**

- **3% CS3 (rust staining)**
- **12% CS2 (soffit cracking)**
- **Spalls, exposed rebar**
- **LMC overlay Sealed (2104)**
- **Column spalls & cracks**

Three options for bridge based (in part) on NDE results

- 1. Replace the overlay if deck is sound**
- 2. Apply PPC overlay to extend life 15-20 years**
- 3. Replace the entire bridge**

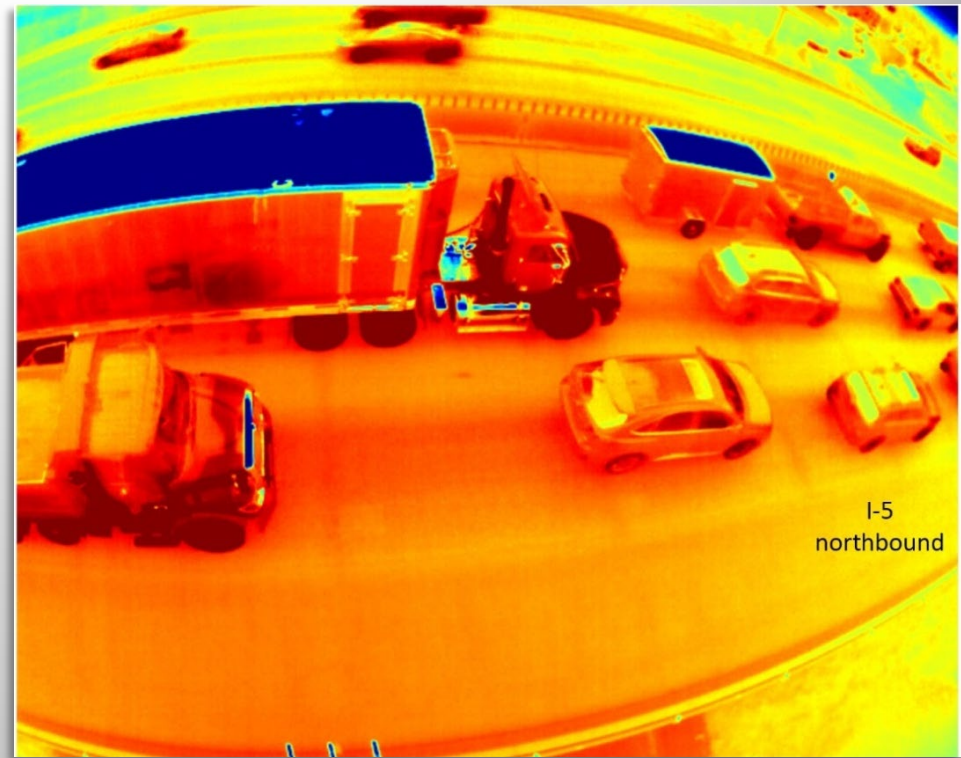
Image 29

Routine Inspection: RC Deck

- **30% CS2 (Delamination, cracking, rutting)**
- **1% CS3 (Exposed rebar, cracking)**

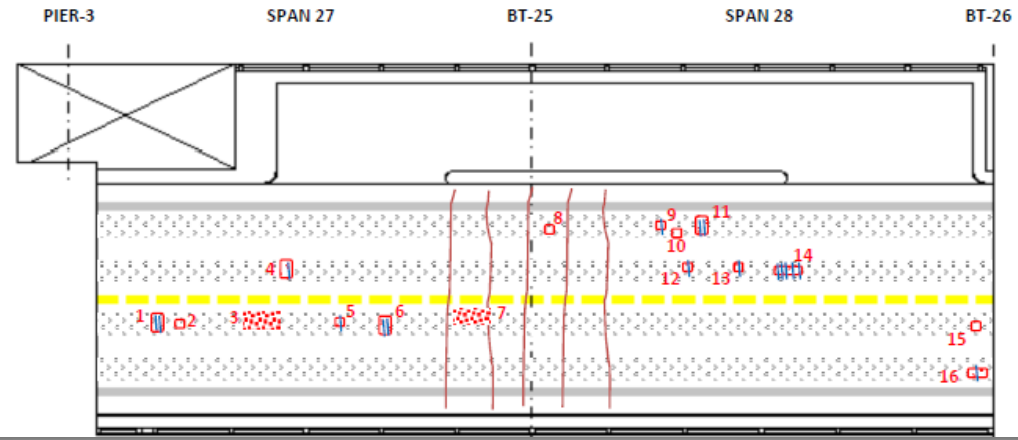
Figure 39

- 1. 2'X1' delamination with exposed rebar (2-SF)
- 2. 1' Ø delamination (1-SF)
- 3. 3'X1' hollow sounding concrete (3-SF)
- 4. 2'X1' shallow spall with exposed rebar (2-SF)
- 5. 1'X1' shallow spall with exposed rebar (1-SF)
- 6. 2'X1' shallow spall with exposed rebar (2-SF)
- 7. 3'X1' hollow sounding concrete (3-SF)

- 8. 1'X1' delamination (1-SF)
- 9. 1'X1' delamination with exposed rebar (1-SF)
- 10. 1'X1' delamination (1-SF)
- 11. 3'X1' delamination with exposed rebar (3-SF)
- 12. 1'X1' shallow spall with exposed rebar (1-SF)
- 13. 1'X1' shallow spall with exposed rebar (1-SF)
- 14. 3'X1' shallow spall with exposed rebar (3-SF)
- 15. 1'X1' delamination (1-SF)
- 16. 2'X1' delamination with exposed rebar (2-SF)
