# Testing and Evaluation of Existing Bridge Decks for Chloride Concentration

SHRP2 Service Life Design Workshop (R19A)

Andrew S. Blower, P.E.

ODOT

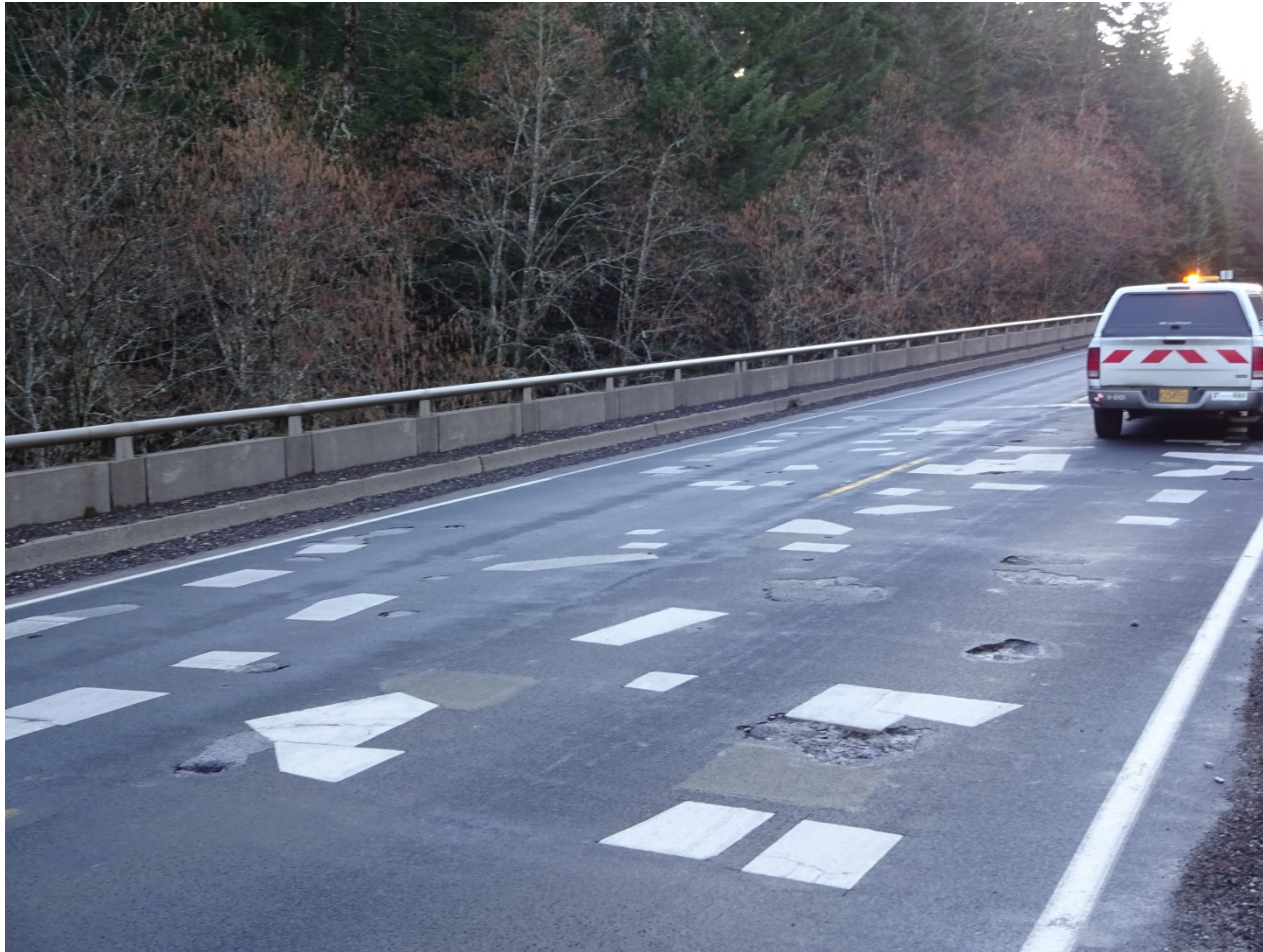
# Case Study: Salt Creek Bridge #02071A

- Structure had “dense cracking” and approx. 20 sq. ft. of delaminations in span 1 prior to thin overlay installation in 2011.
- Since overlay installation, approximately 20% of the surface of the deck exhibits extensive spalling and/or cracking of the concrete and epoxy based wearing surface.
- Cores taken from this deck show that the concrete is near or has exceeded the corrosion threshold at the level of reinforcement.
- Corrosion will continue to occur unless significant concrete removal takes place.\*\*

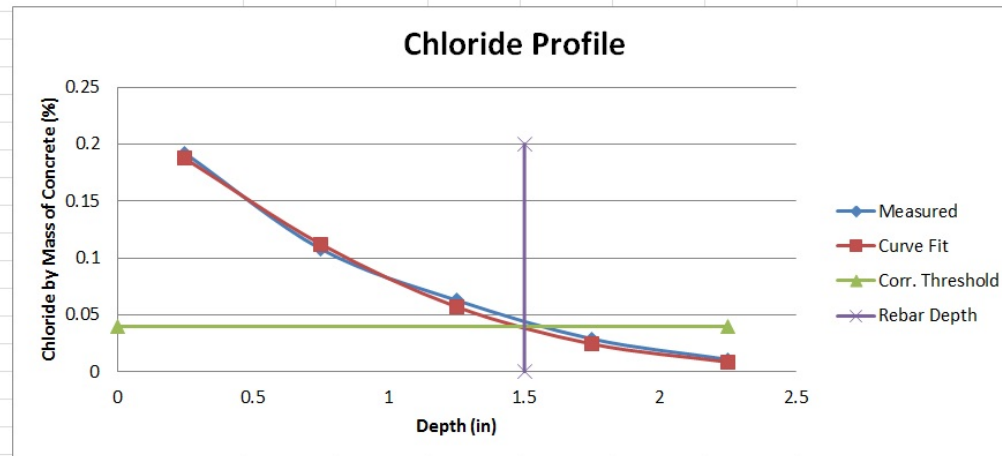
## Chloride Testing Results

Field Test Data						User Input Data	
X[Depth, in]	0.25	0.75	1.25	1.75	2.25	t[time, yr]	48
Cf [Chloride Concentration, %]	0.192	0.108	0.063	0.029	0.011	Diffusion Coefficient [Dc, in <sup>2</sup> /yr]	0.0123
Calculated Values							
C(x,t) [Chloride Concentration, %]	0.187331	0.112226	0.057252	0.024571	0.008793	Surface Concentration [Cmax, %]	0.229
Sum of Least Squares							
(Cf-C(x,t))^2		1.79E-05	3.3E-05	1.96E-05	4.87E-06		
Sum[(Cf-C(x,t))^2]							7.54E-05

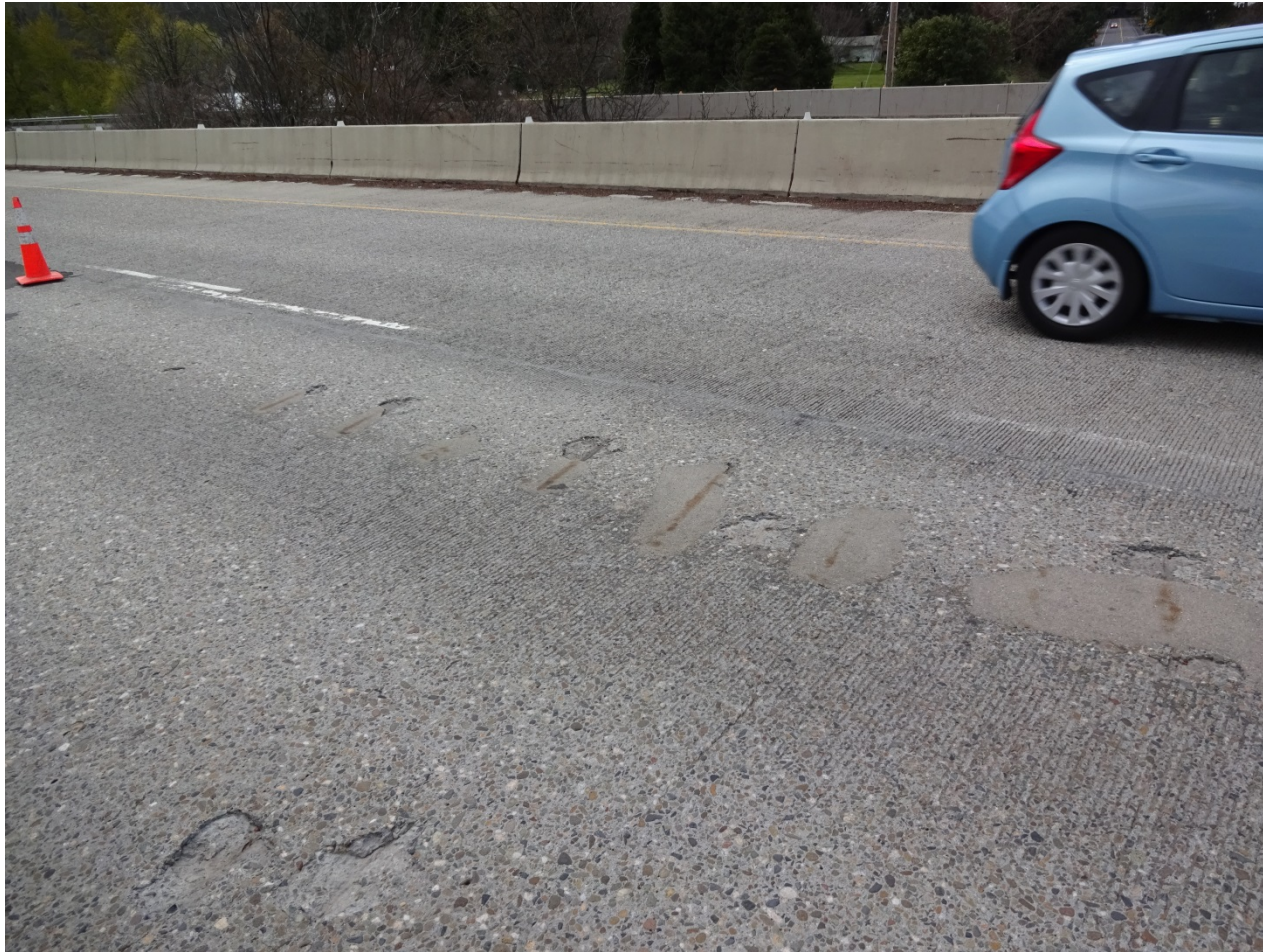
# Case Study: I5 Over Crowson Rd. BR #08746N

- This deck was replaced during a widening project that completed in 2001.
- At only 15 years old, this bridge deck is already showing signs of severe corrosion activity and damage.
- This damage is caused by a combination of heavy deicer usage and shallow reinforcement where the transverse bars are tied together which also corresponds to a wheel track.

- Additional third party QA testing of reinforcement clearances via GPR prior to acceptance.
- Application of a water impenetrable wearing surface after 3 months of aging.

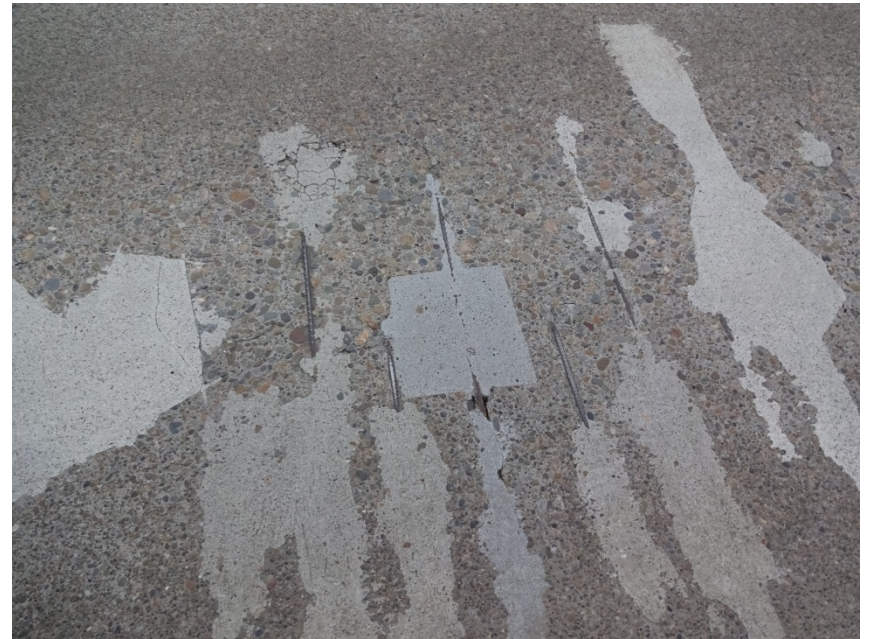
- Programmed to receive a PPC overlay.
- Visual examination reveals there are issues with the deck that will likely not be resolved by a wearing surface.
- 43% of the surface is in CS3.

- A PPC wearing surface is not recommended. Even with Class 2 prep removing a portion of contaminated material, the remaining area has likely or is about to initiate corrosion.
- A structural overlay is recommended with at least 0.5" of contaminated concrete removal via hydro-demolition due to shallow reinforcement.
- Class 2 prep should be performed on all spalled or patched areas and where hydro-demo reveals cracking over rebar.

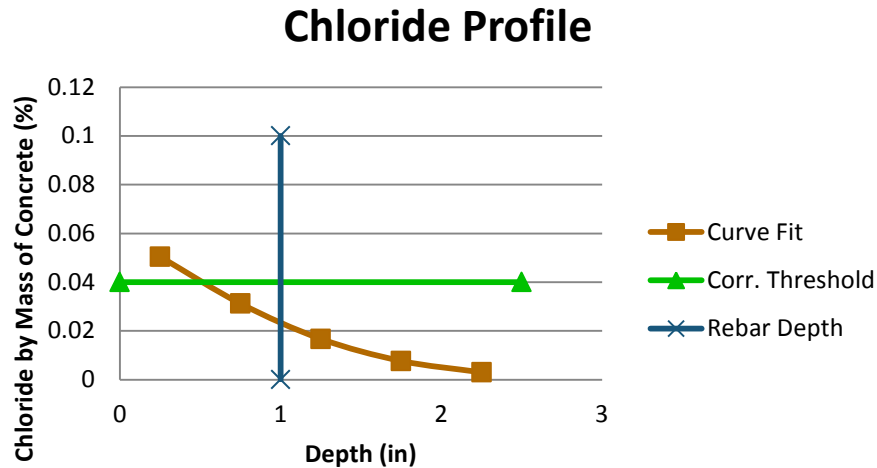
## Chloride Tests

- Bridge has fairly low chloride content.
- However, the rebar was not placed with 1" of cover in many locations and rutting has further reduced cover.
- Any rebar within 0.5" of the surface likely has corrosion initiated.

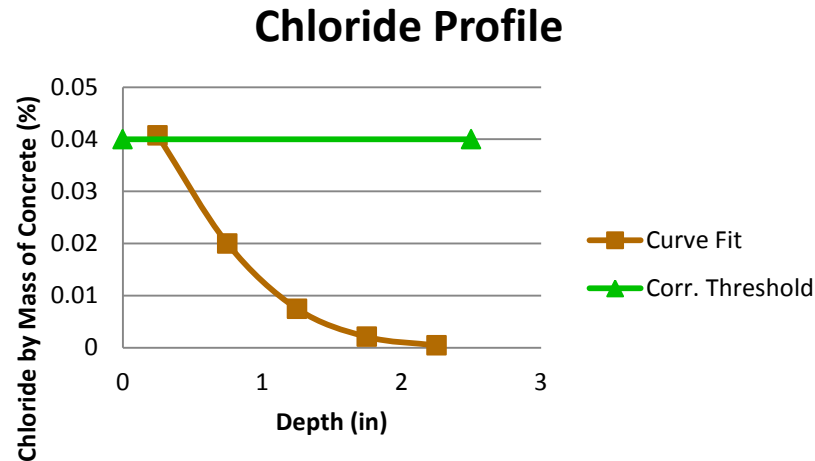
Predicted Chloride Concentration of LMC or SFC overlay after 30 years service life

- This curve was generated using a population of chloride samples from existing in-service overlays and the chloride loading derived from the sampling at BR08492.
- 0.5" additional cover will provide a 30 year service life for the overlay, but 1.5" is recommended to account for rutting, and construction tolerances.

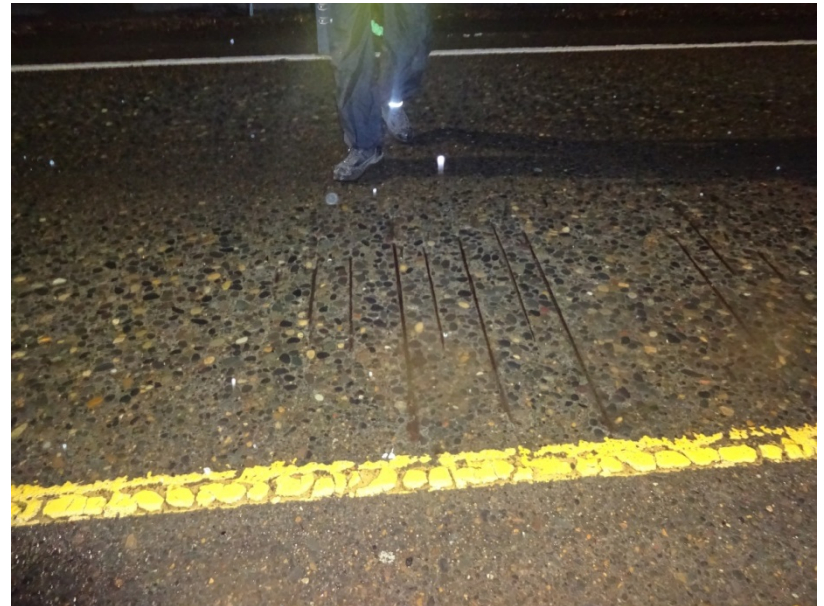
- Programmed to receive a PPC overlay.
- Visual examination reveals multiple bars exposed at the wearing surface.
- However, there are few spalls and spalls are shallow.

- A PPC wearing surface is not recommended. It is unclear how much cover exists and corrosion has likely initiated on rebar that are within 0.75" of the surface. PPC will not have an opportunity to reach its intended service life of 25 years.
- A structural overlay is recommended with at least 1" of contaminated concrete removal via hydro-demolition due to shallow reinforcement.
- Class 2 prep should be performed on all spalled or patched areas and where hydro-demo reveals cracking over rebar.

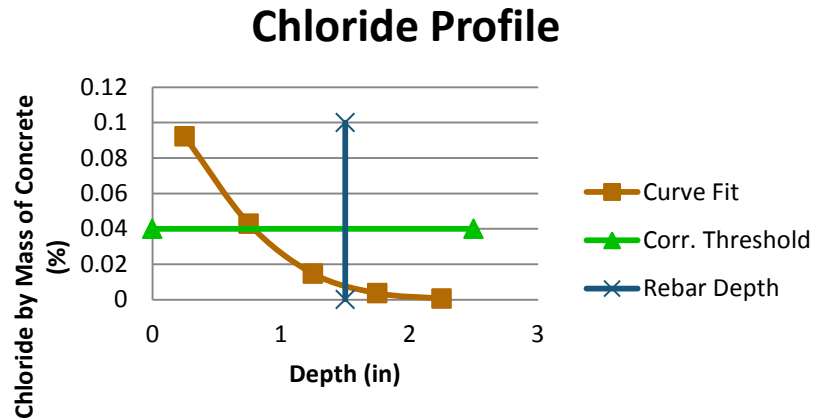
## Chloride Tests

- Deck is above chloride threshold to about 0.75" below the surface.
- The rebar was not placed with 1.5" of cover in many locations and rutting has further reduced cover.
- Any rebar within 0.75" of the surface likely has corrosion initiated.

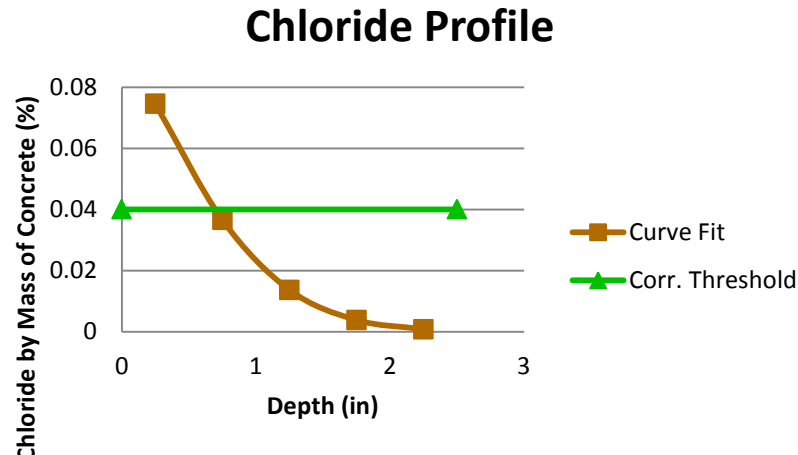
Predicted Chloride Concentration of  
LMC or SFC overlay after 30 years  
service life

- 0.75" additional cover will provide a 30 year service life for the overlay, but 1.5" is recommended to account for rutting, and construction tolerances.

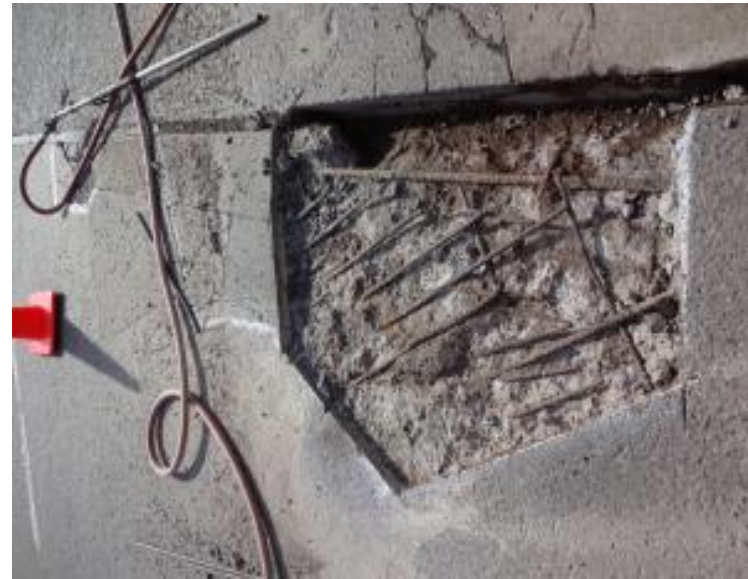
- Programmed for a PPC Overlay
- Visual examination reveals there are numerous spall repairs with a high concentration at the impact panel joints due to steel dowels used to hold grade.
- Cores reveal that the overlay has a thickness variation from 2" to 4".

- A PPC wearing surface is not recommended. The overlay shows chloride contamination approaching the chloride threshold at the depth of reinforcement.
- There is significant chloride contamination in the original construction material and hydro-demolition would need to remove material to a depth of 4" to ensure further delamination does not occur and chlorides don't migrate toward the bottom mat.
- The Iowa method utilized an extremely dense, low slump mix. The dense material in conjunction with variable thickness makes partial hydro demolition difficult and likely much of the deck will be removed to full depth with this quantity being unknown.

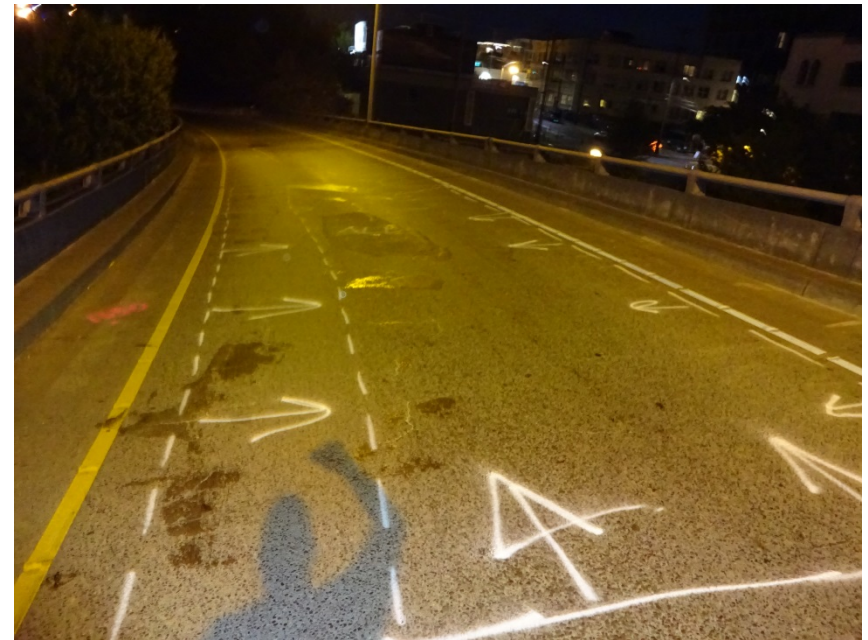
- Programmed to receive a PPC overlay.
- Visual examination and chain drag reveals numerous delaminations and cracks throughout the overlay.
- Some joints have severe impact damage at header details with numerous patch materials.

- The overlay has reached the end of it's service life due to normal wear from impact. There may be small amounts of freeze/thaw forces at work, but degradation is not caused by widespread chloride induced corrosion.
- Due to the amount of delamination, the overlay should be removed and replaced by a new wearing surface.
- Soffit cracking and efflorescence indicate that the thin deck is flexing and may benefit from a structural concrete overlay. Care should be taken when deciding on a wearing surface material.
