# **SHRP2 R06A NDT Bridge Decks = primarily GRP**

Kathy Crowell, NMDOT  
Dr. Brad Weldon, NMSU  
Daniel Diaz, NMSU

# Nine Bridges

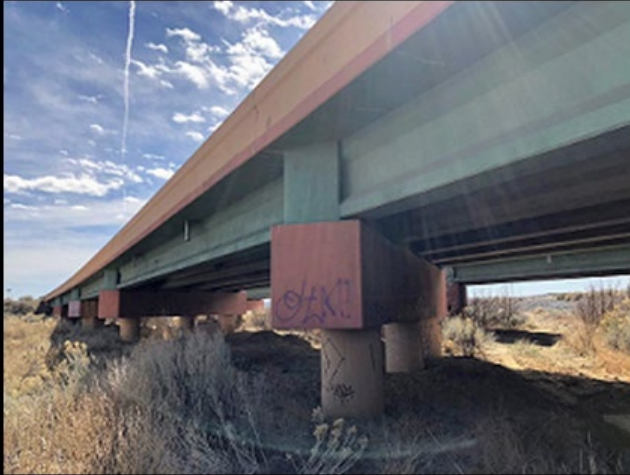
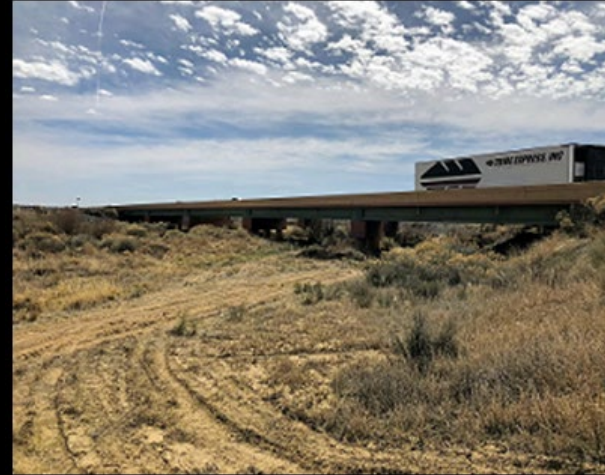
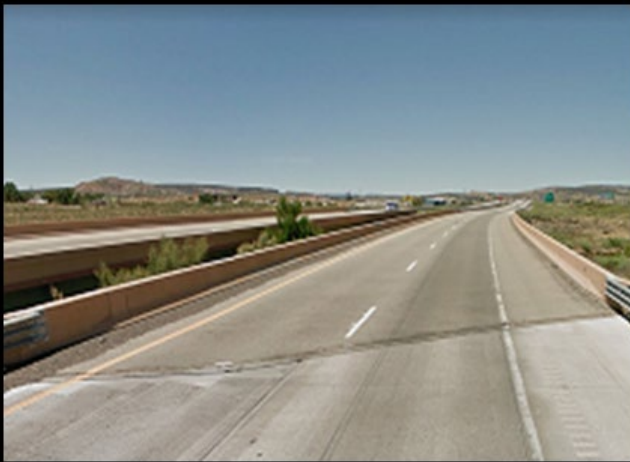
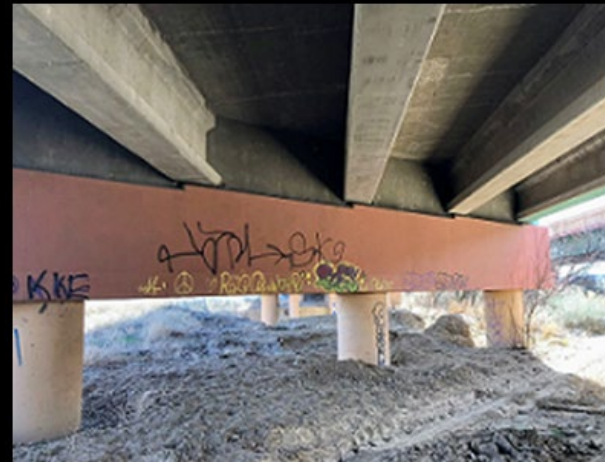
# GPR Evaluation Results: Bridge 8845

- AASHTO Girder
- From most current inspection report:
  - Deck: 7
  - Superstructure: 7
  - Substructure: 7
- Deck inspection reports:
  - Isolated transverse and longitudinal cracks up to 1/32" with light leaching (Underside)
  - Transverse and vertical cracks up to 1/16" with light leaching (Deck edges)

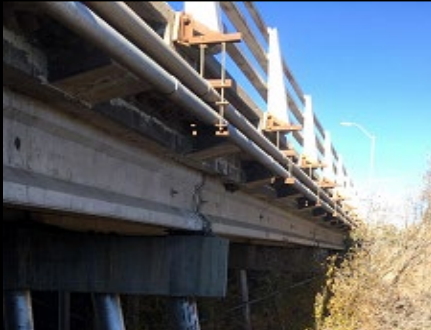
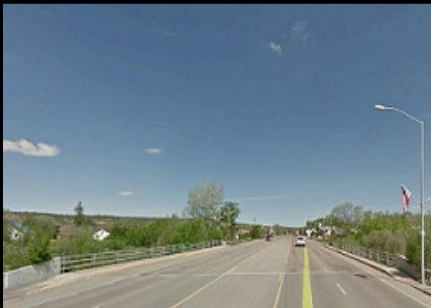
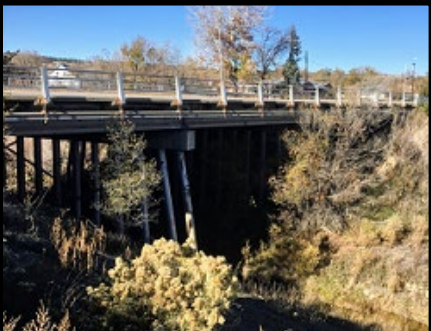
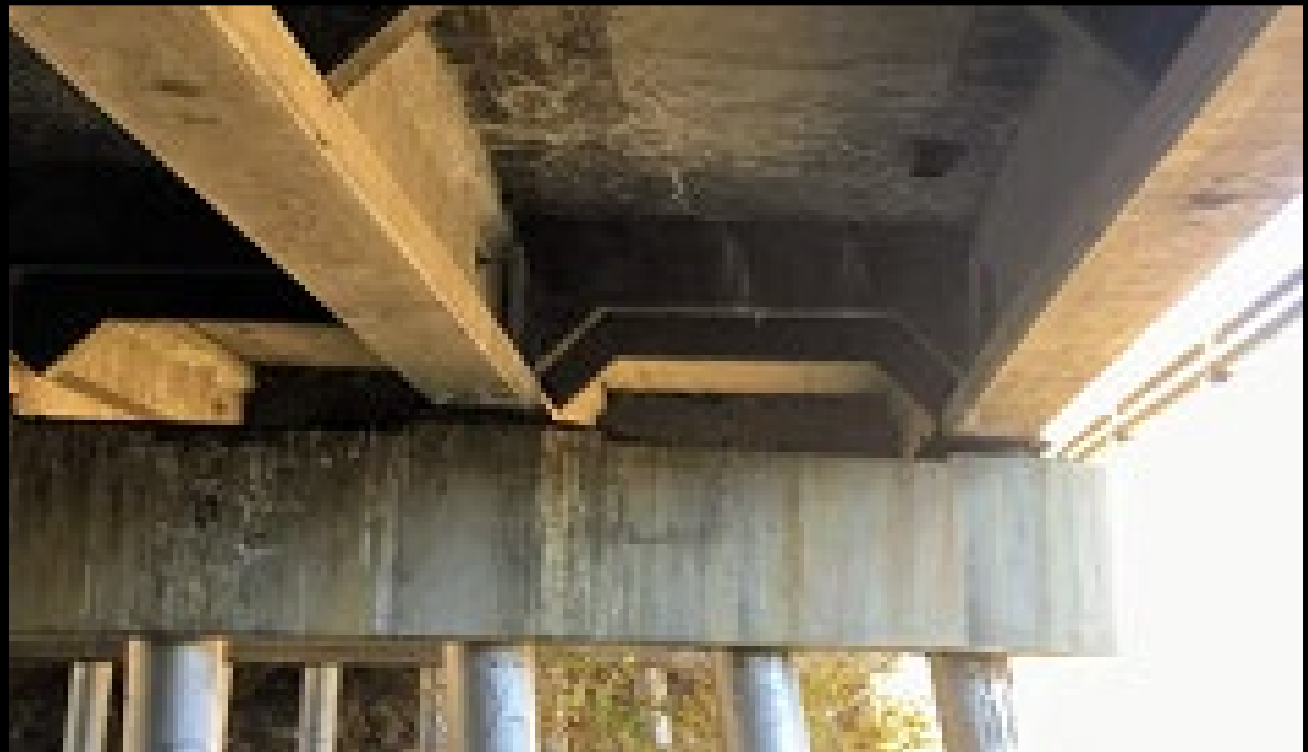
# GPR Evaluation Results: Bridge 6840

- AASHTO Prestressed Girder
- From most current inspection report:
  - Deck: 4
  - Superstructure: 5
  - Substructure: 6
- Deck inspection reports:
  - Transverse and longitudinal cracks up to 1/8" with heavy leaching (deck edges); transverse and longitudinal cracks up to 1/16" with heavy leaching and rust stains near joints

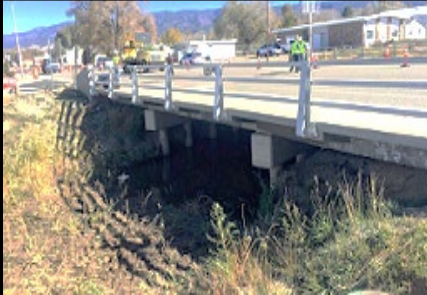
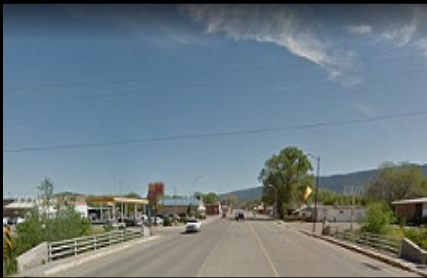
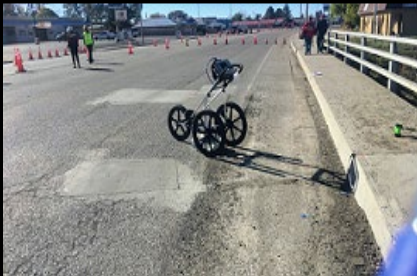
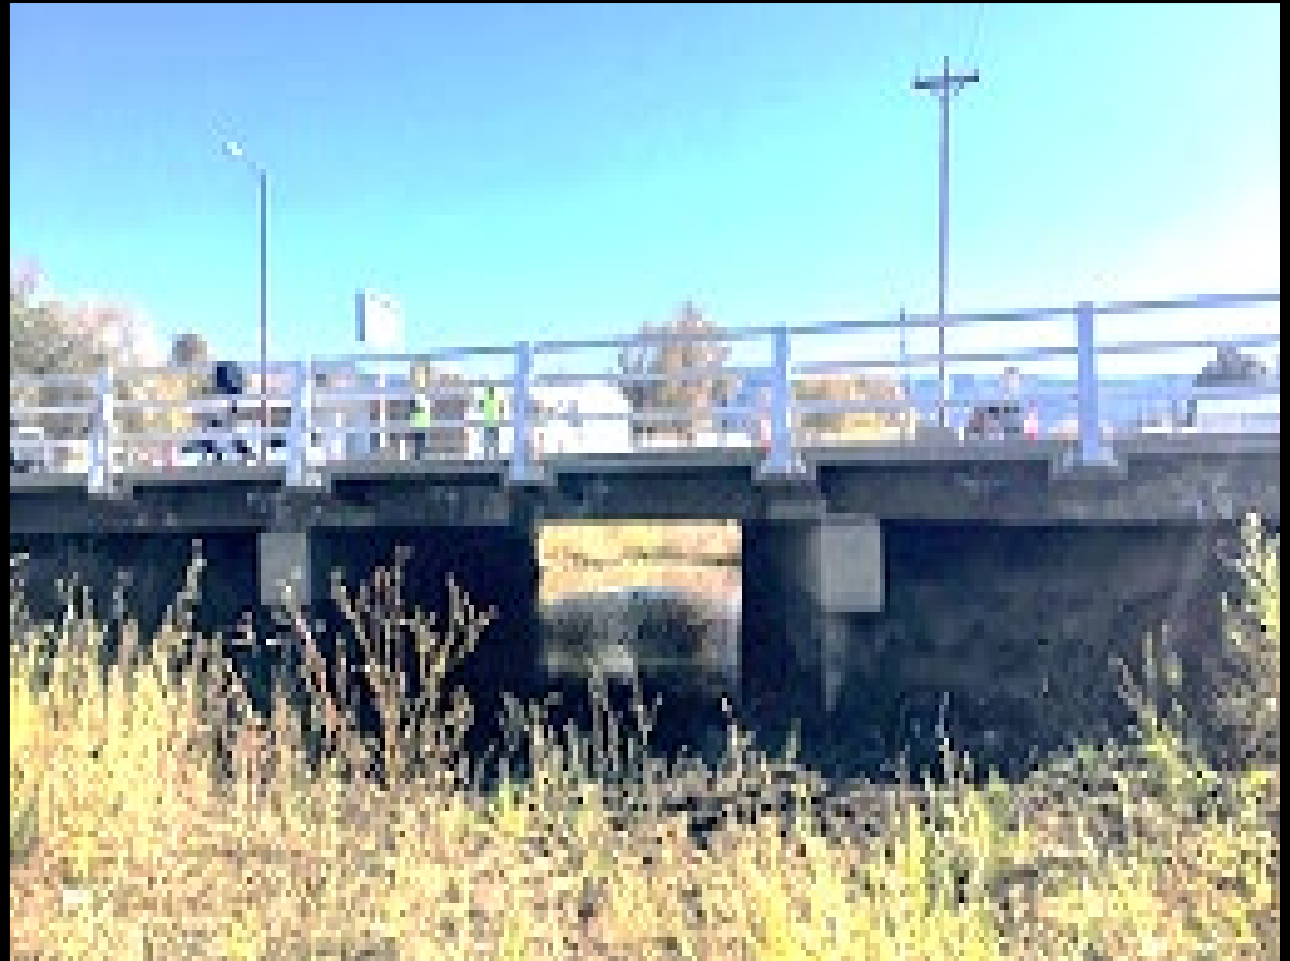
# GPR Evaluation Results: Bridge 6932

- Concrete Slab Bridge – Asphalt Overlay
- From most current inspection report:
  - Deck: 5
  - Superstructure: 5
  - Substructure: 6
- Deck inspection reports:
  - Vertical, horizontal, transverse and map cracks up to 1/4" (deck edges); transverse and map cracks up to 1/16", areas of moderate leaching, and spalls up to 6" by 5" (Underside)

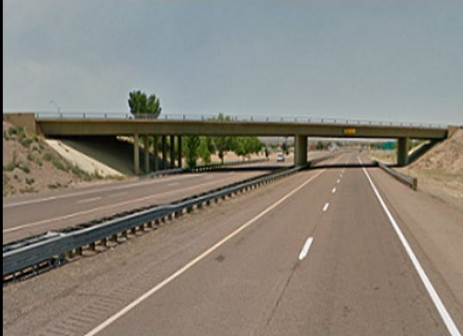
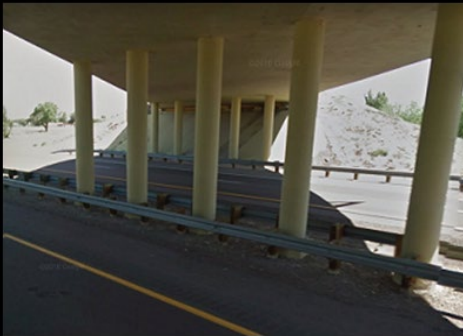
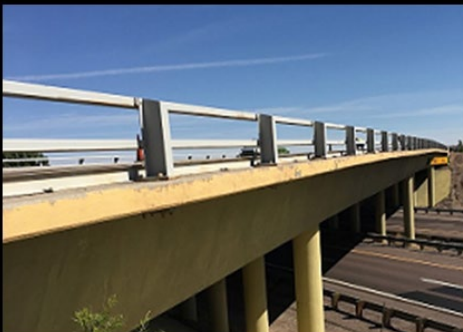
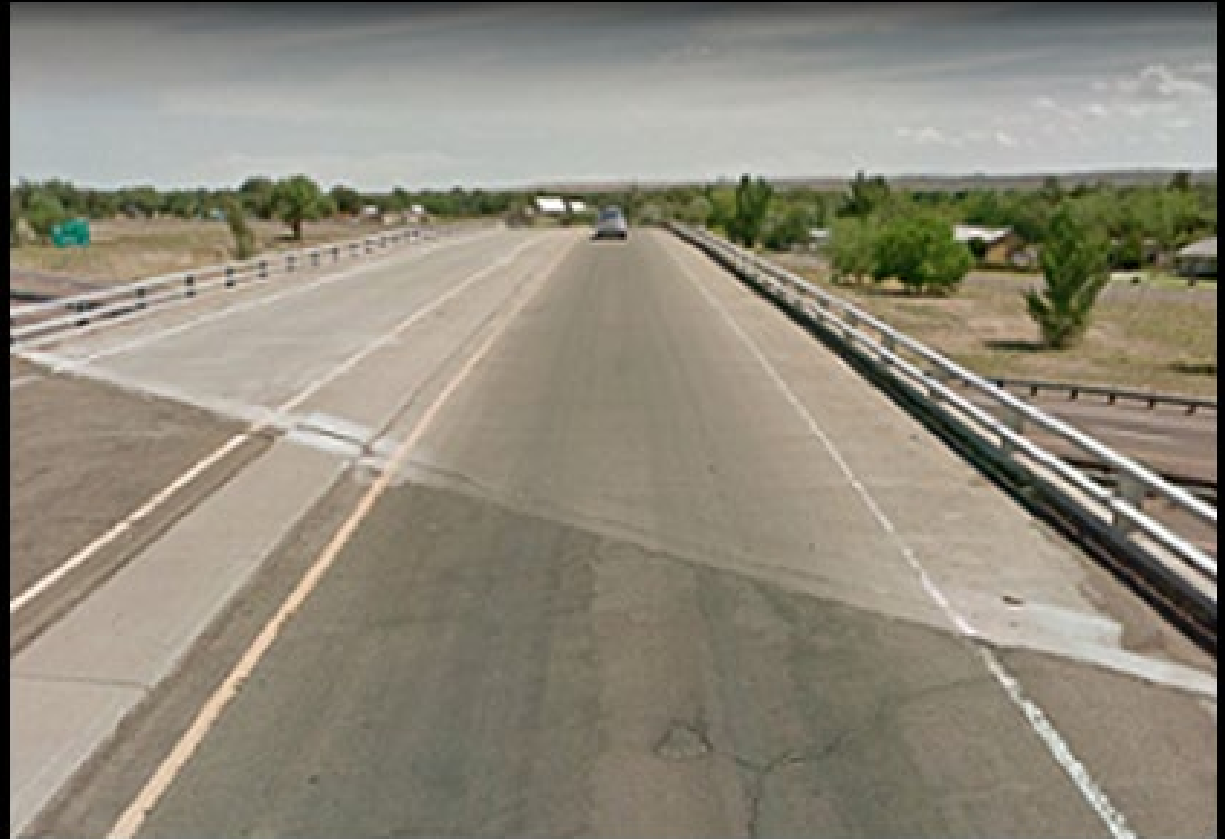
# GPR Evaluation Results: Bridge 7032

- **THIS BRIDGE HAS A COMPLETELY DELAMINATE LATEX MODIFIED CONCRETE DECK OVERLAY**
- From most current inspection report:
  - Deck: 5
  - Superstructure: 5
  - Substructure: 5
- Deck inspection reports:
  - Vertical, transverse, longitudinal cracks up to 1/4"; exposed rebar up to 22', spalls up to 8'x6", apparent delaminations up to 28', and minor leaching and water stains (Deck edges)

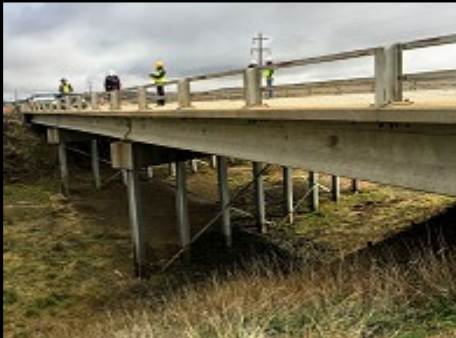
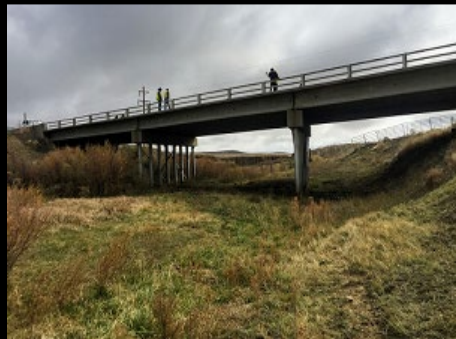
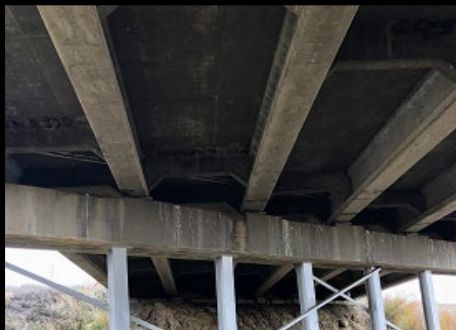
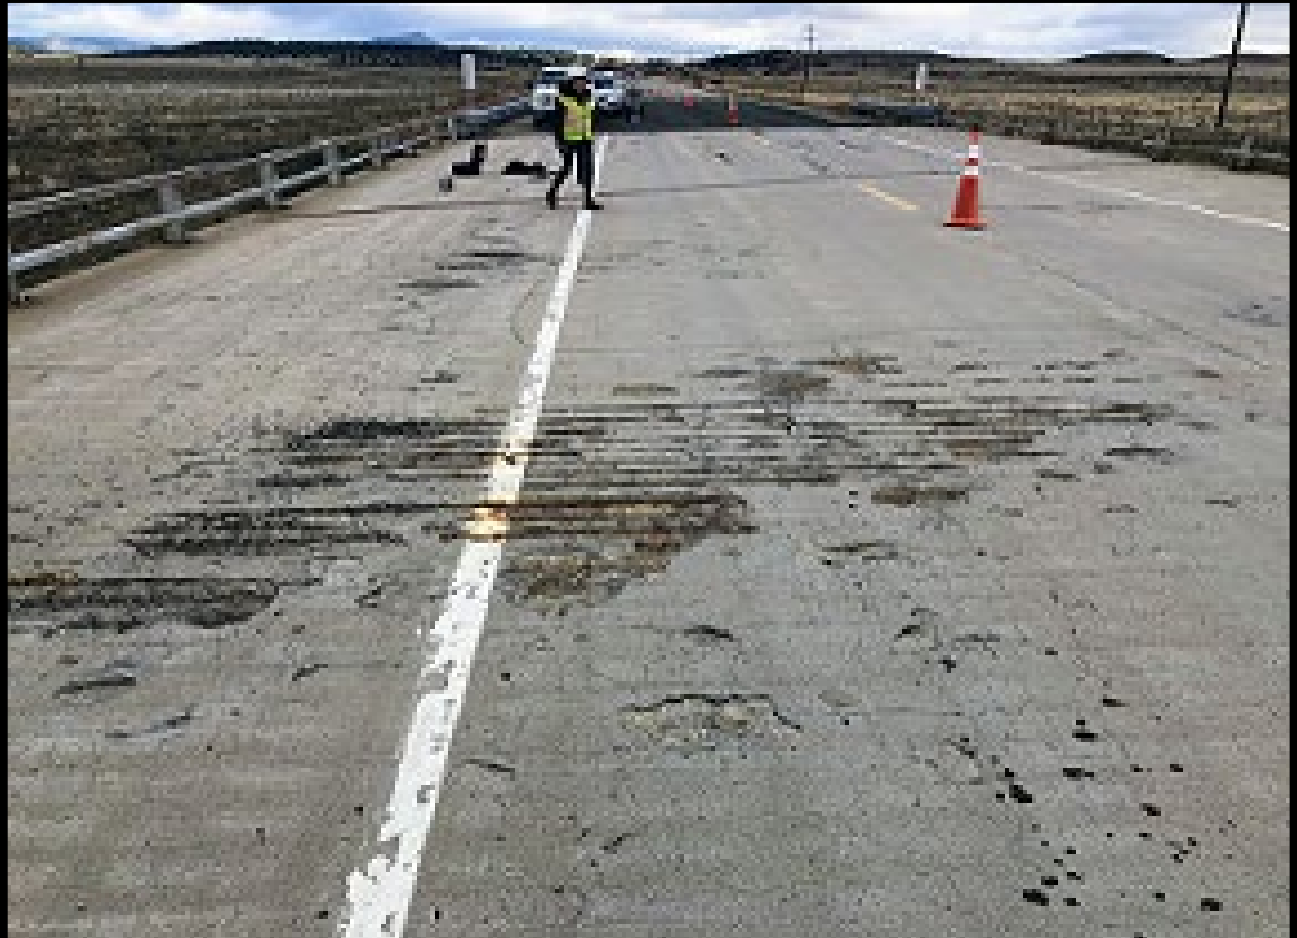
# GPR Evaluation Results: Bridge 7113

- AASHTO Girder – construction defect (cover)
- From most current inspection report:
  - Deck: 5
  - Superstructure: 7
  - Substructure: 7
- Deck inspection reports:
  - Transverse cracks up to 1/16" and minor leaching (Deck edges); transverse and map cracks up to 1/16", exposed rebar, and spalls (Top of Deck); Rust stains at the joint locations (Underside)

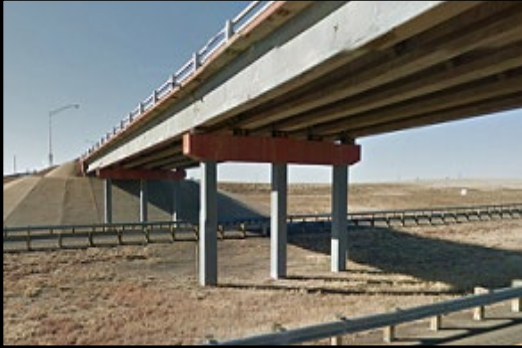
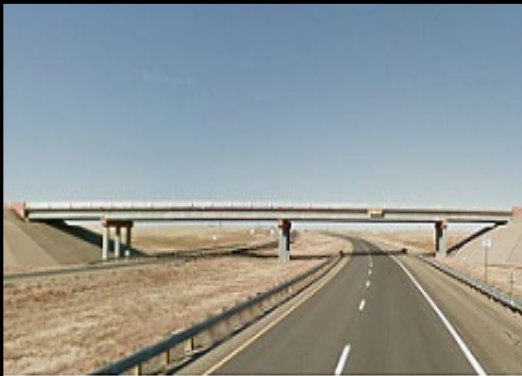
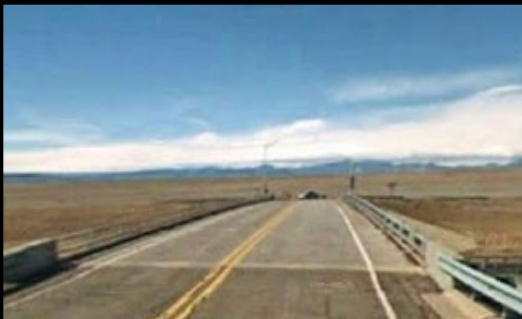
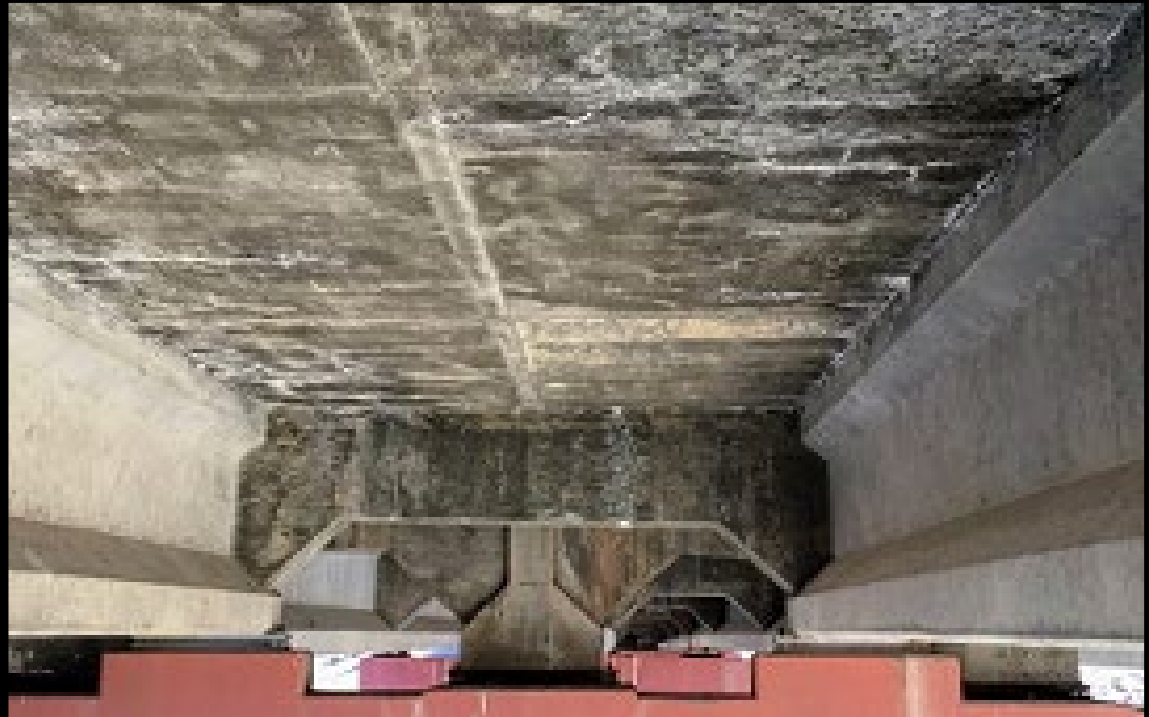
# GPR Evaluation Results: Bridge 7299

- Grant Application
- From most current inspection report:
  - Deck: 5
  - Superstructure: 5
  - Substructure: 5
- Deck inspection reports:
  - Transverse and vertical cracks up to 1/8" with heavy leaching (Deck edges); transverse and longitudinal cracks up to 1/8" with heavy leaching (Underside)
