SHRP2 R06A - Nebraska Experience

Jason Volz

Assistant Construction Engineer
Nebraska Department of Transportation

STRUCTURE 006 30574

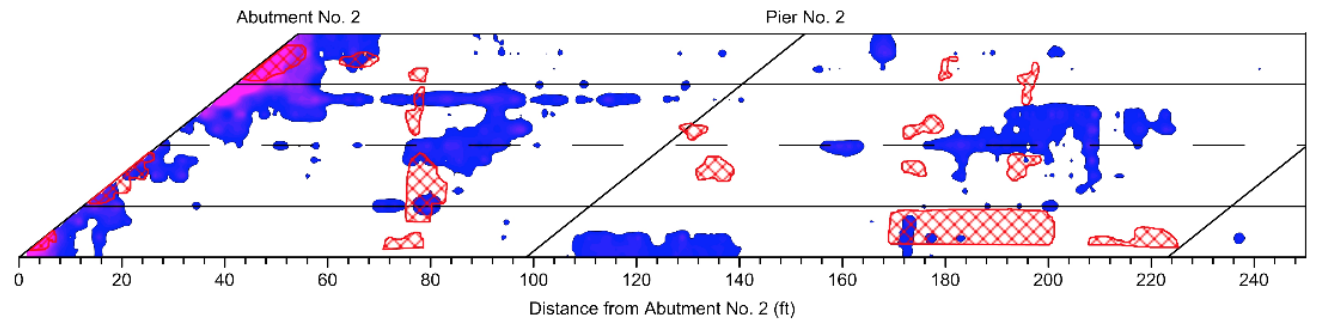
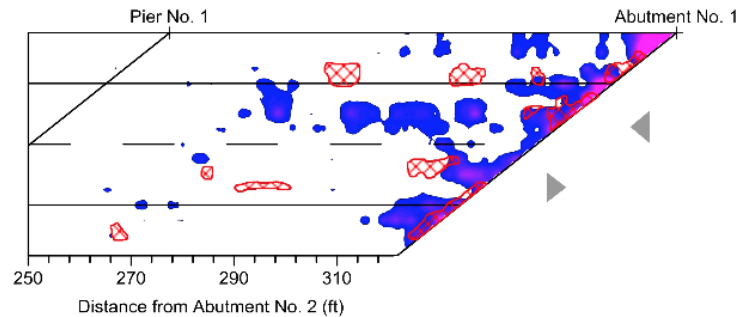
PHASE I RESULTS S006 30574

Patching		Delamination (IR)	758.1	5.7	Analyzed by: SB, RG Reviewed by: AC Completed: 11/20/17
*combined quantity accounting for overlap

Spalling		Deterioration (GPR)	2059.5	14.6	Sheet 1 of 1

Not Surveyed		Patching	0.0	0.0	
			Spalling	0.0	0.0	
			Combined Defects*	2586.6	18.3

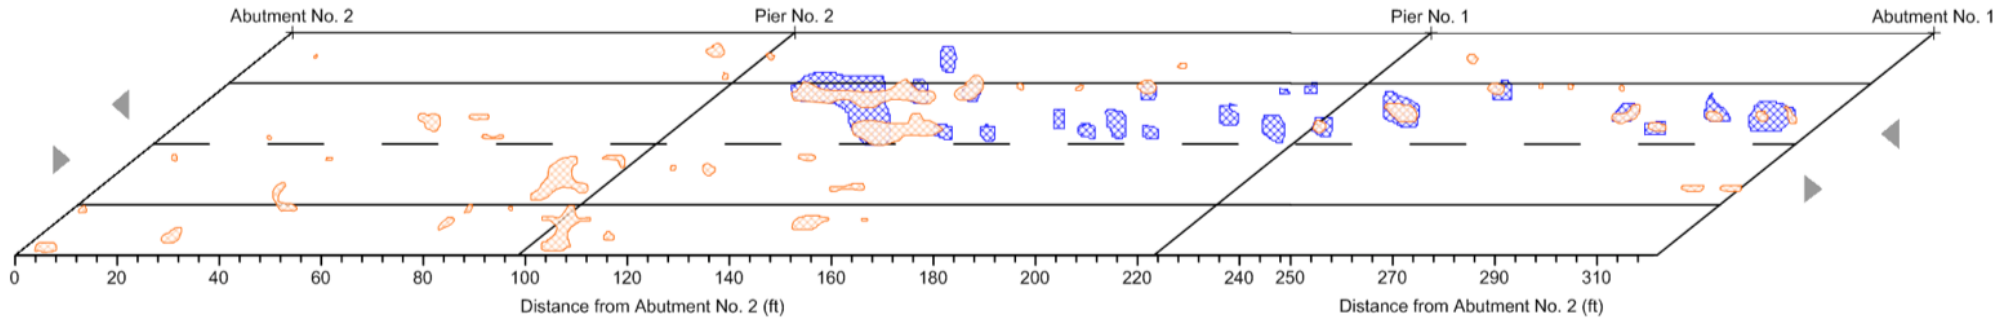
PHASE II RESULTS S006 30574

Concrete Condition Legend	Orientation	Quantity Summary			General Information
<p>Only the east bound lane and shoulder between were surveyed via manual chain drag. The entire roadway was surveyed with SounDAR. The lanes were closed during the survey.</p>

Delamination detected by Chain		Delamination (Chain)	436.6	3.1	Analyzed by: JC Reviewed by: SB Completed: 3/2/18

Delamination detected by SounDAR.		Deterioration (SounDAR)	402.8	2.9	Sheet 1 of 1
Defects have overlapping areas		Combined Defects*	839.5*	6.0

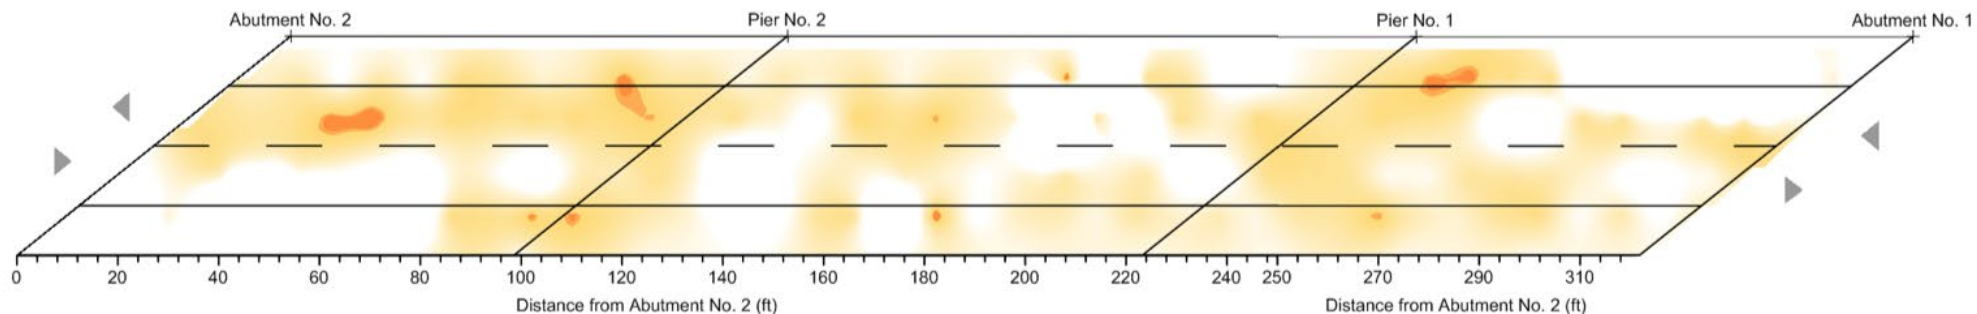
PHASE II RESULTS S006 30574

Electrical Resistivity (R) Color Scale	Orientation	Quantity Summary		General Information
<p>R > 20</p> <p>10 < R < 20</p> <p>5 < R < 10</p> <p>R < 5</p>	<p>Direction of traffic</p>	Corrosion Likelihood	%	Bridge ID: S006 30574 US 6 Over BNSF RR
		Very High (R < 5)	0	Analyzed by: LM
		High (5 < R < 10)	0	Reviewed by: SB
		Moderate Low (10 < R < 20)	2	Completed: 3/2/18
		Low (R > 20)	98	Sheet 1 of 1

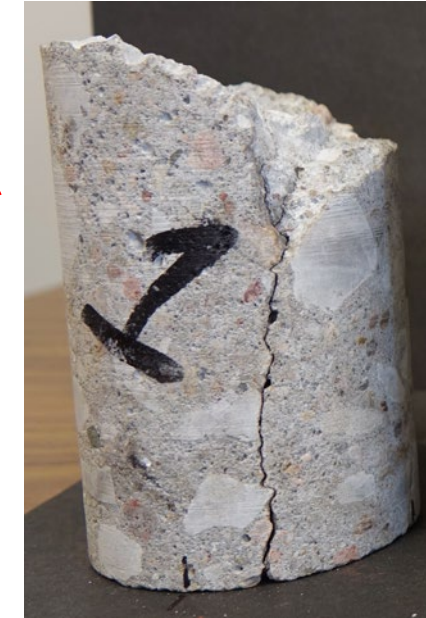
Chlorides:
3.11 lb/cuyd

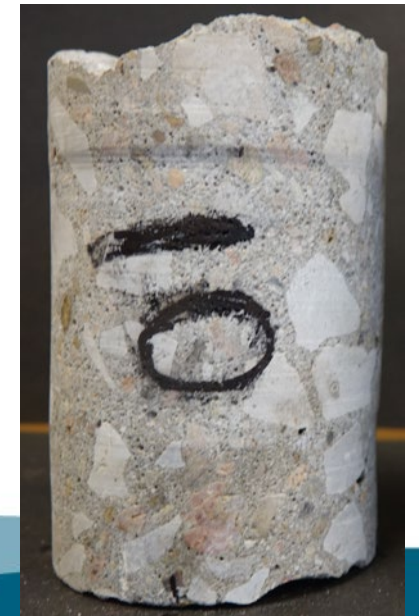
Chlorides:
4.12 lb/cuyd

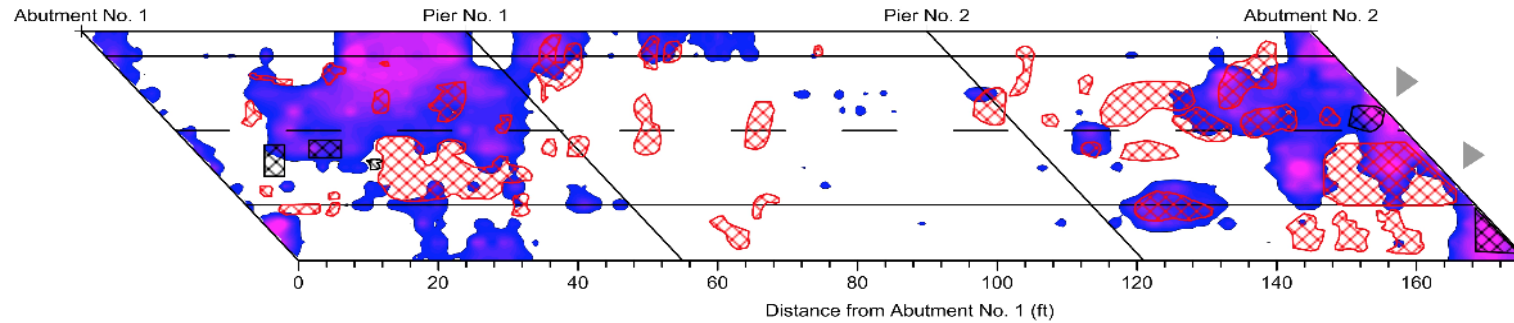
PHASE I RESULTS S077 05693R

Concrete Condition Legend		Orientation	Quantity Summary			General Information	
Deterioration detected by GPR severity → 	Delamination detected by IR		 Direction of traffic	Condition	sq. ft.	%	Bridge ID: S077 05693R US 77 NB over RI & P RR
Patching	Spalling	Delamination (IR)		870.4	20.1	Analyzed by: SB, RG Reviewed by: AC Completed: 11/20/17	
Spalling	Not Surveyed	Deterioration (GPR)		1789.3	27.6	Sheet 1 of 1	
Not Surveyed		Patching		68.4	1.5		
		Spalling		0.0	0.0		
		Combined Defects*		2247.6	34.6

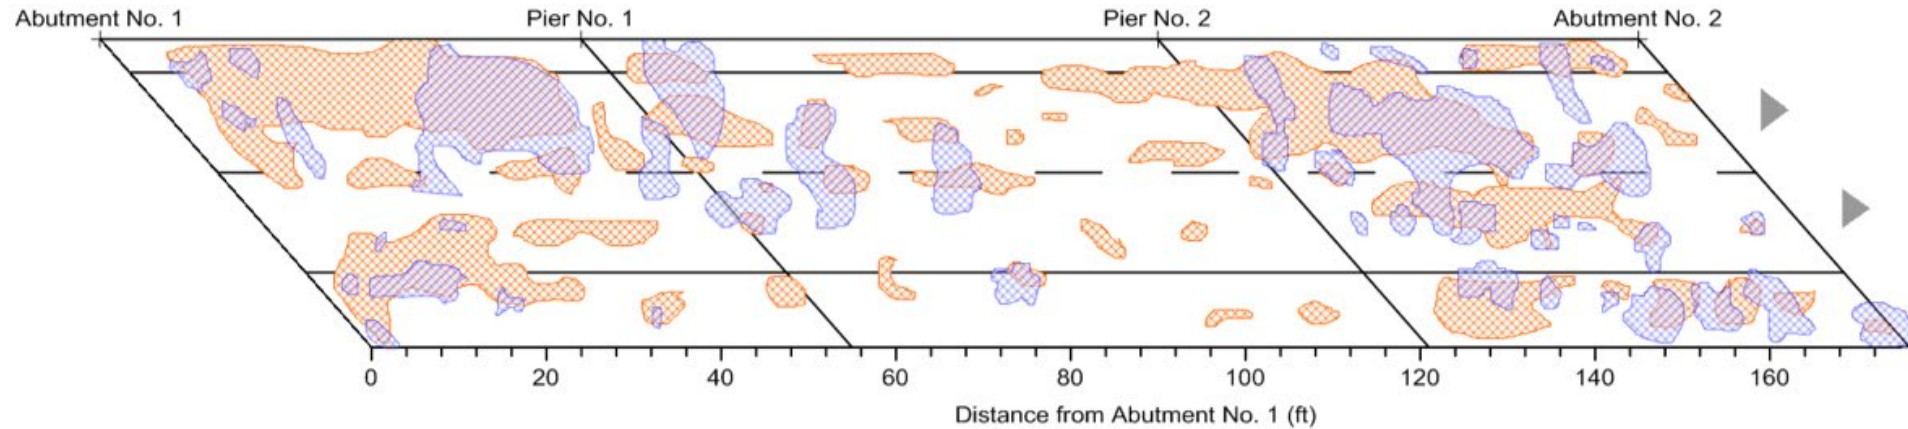
PHASE II RESULTS S077 05693R

Concrete Condition Legend	Orientation	Quantity Summary		General Information	
<p>The entire roadway were surveyed with manual chain drag and SoundAR. The lanes were closed during the survey.</p> <p>

Direction of traffic	Condition	sq. ft.	%	Bridge ID: S077 05693R US 77 NB over RI & P RR
		Delamination (Chain)	1173.9	18.2	
		Deterioration (SoundAR)	1800.0	27.6	Sheet 1 of 1
		Combined Defects*	2973.9*	45.7

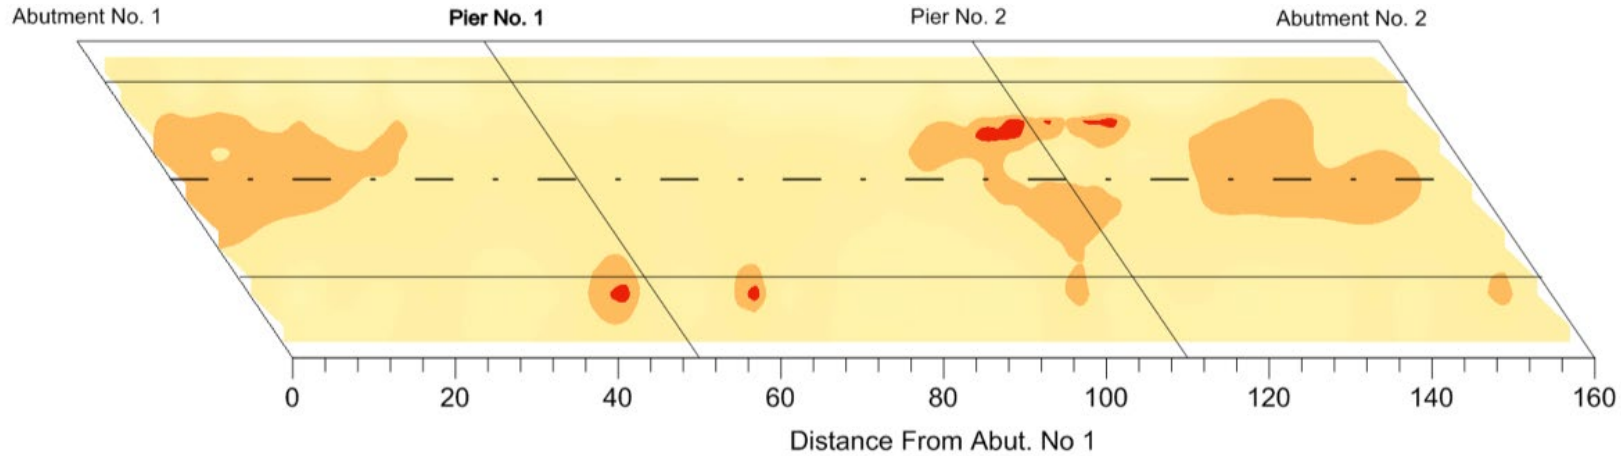
Electrical Resistivity (R) Color Scale	Orientation	Quantity Summary		General Information
 R > 20 10 < R < 20 5 < R < 10 R < 5	 Direction of traffic	Corrosion Likelihood	%	Bridge ID: S077 05693R US 77 NB over RI & P RR
		Very High (R < 5)	0	Analyzed by: LM Reviewed by: SB Completed: 02/07/18
		High (5 < R < 10)	2.5	Sheet 1 of 1
		Moderate Low (10 < R < 20)	4.6	
		Low (R > 20)	92.9

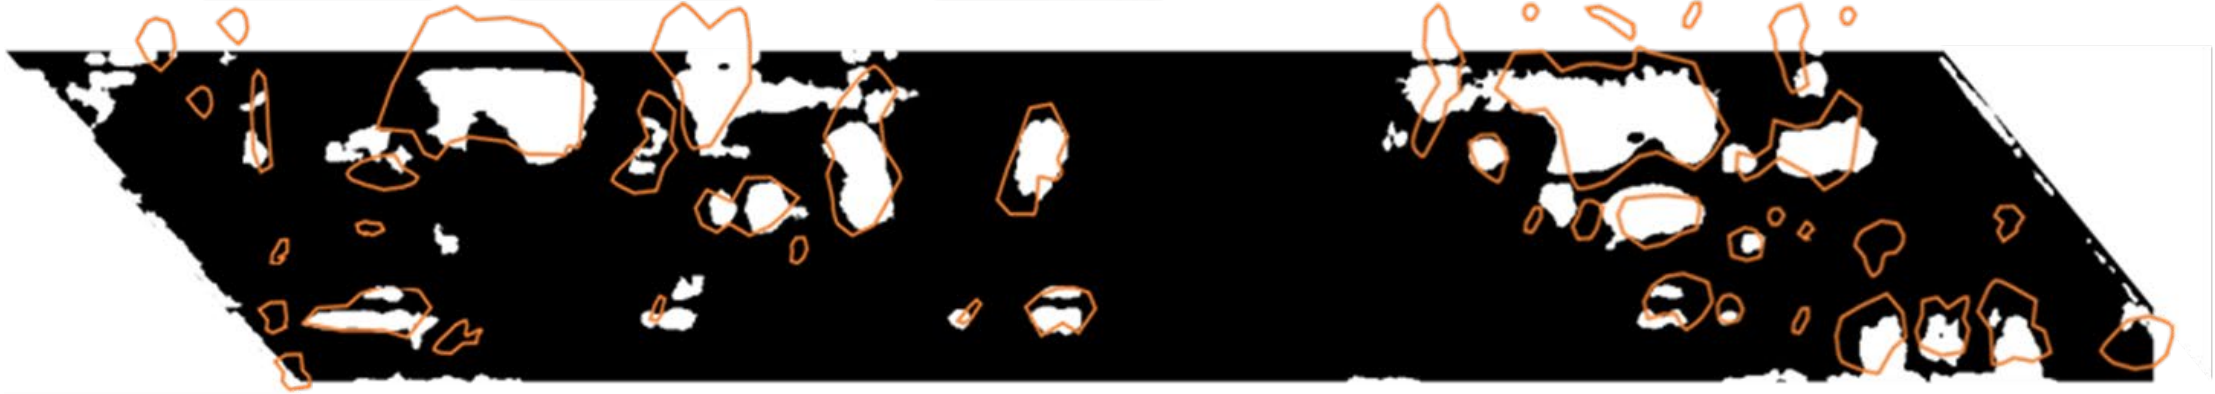
Total deboned/delaminated: 26.7%

Fig. 3. The preliminary result of Bridge-S0770 5693R: 3" concrete overlay debonding

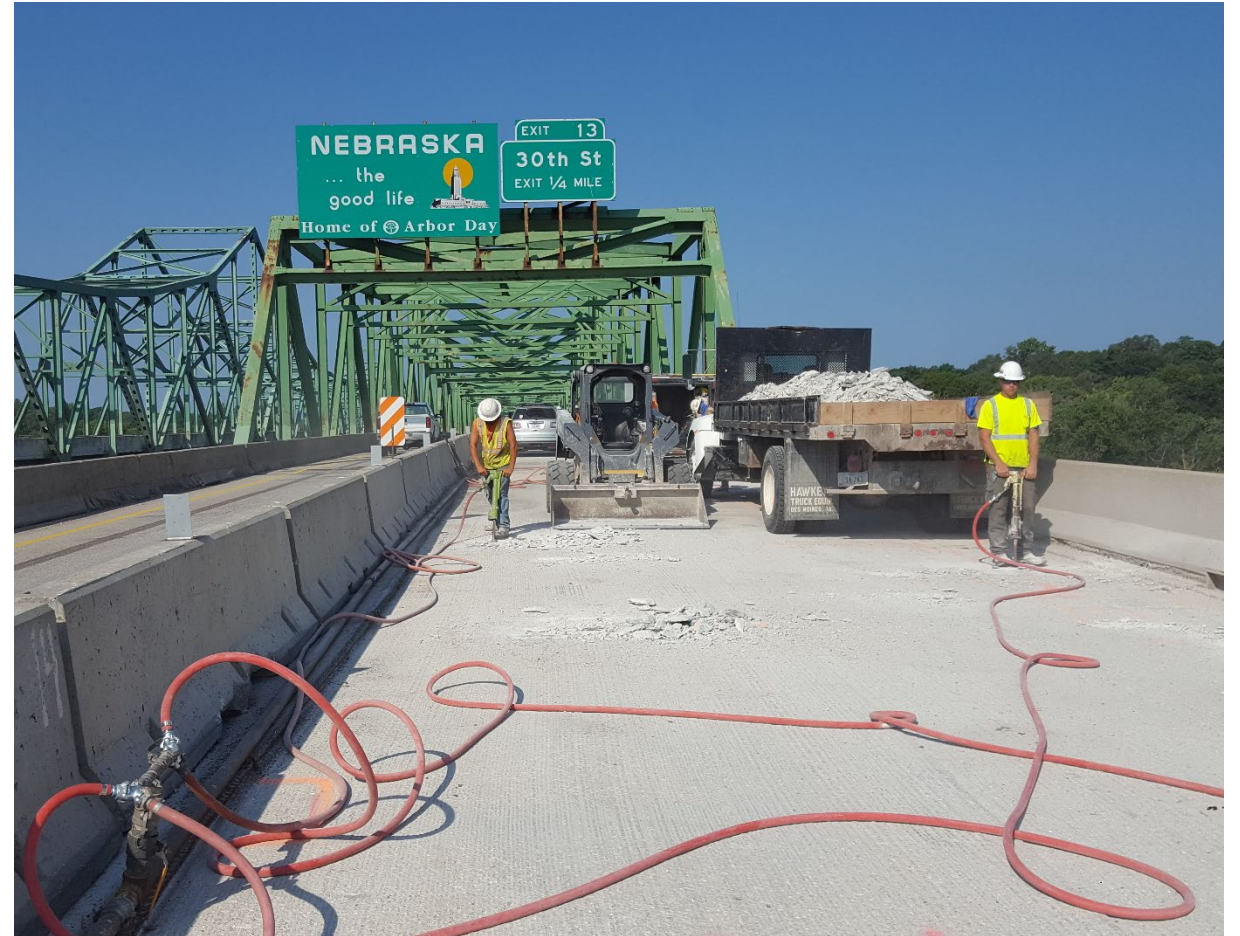
- I-680 Mormon Bridge:
 - Asphalt over existing deck
 - Plan quantity over ran on first half of first bridge
 - GPR scan prior to membrane being removed predicted high potential for deterioration.

Quantity Summary		General Information	
Cover Condition	Conc. Deterioration (%)	29.5	Bridge ID: S680 01343R I-680 WB over Missouri River
	Conc. Deterioration (s.f)	17120	
	Concrete Cover (in)	1.8	Analyzed by: EG Reviewed by: AC Completed: 1/10/19
	Asphalt Cover (in)	2.7	
		Sheet 1 of 4
