Nondestructive Condition Evaluation of 14 Bridge Decks – Florida DOT, District 2

FINAL REPORT

RS&H
10748 Deerwood Park Blvd South
Jacksonville, FL 32256

Infrasense, Inc
21-G Olympia Avenue, Suite 45
Woburn, MA 01801

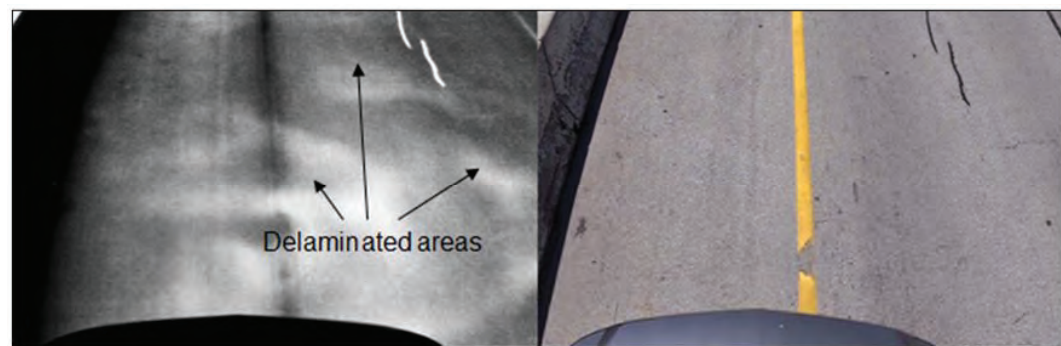
Figure 1. Sample Infrared and Visual images

The infrared data is reviewed simultaneously with the video data to differentiate delaminated areas from surface features (discoloration, oil stains, sand and rust deposits, etc.) that appear in the infrared, but are unrelated to subsurface conditions. Figure 1 shows an example of delaminated areas as they appear in a single image of infrared data and in the corresponding visual data. For analyzing this data, a horizontal slice is taken from each image, calibrated so that it captures an area that is 1 foot in the direction of travel. Sequential slices are then stitched together to create a single strip image for each pass. The strip image for each pass is placed next to those of adjacent passes to produce a composite thermal image of the entire deck as shown in Figure 2 (bridge 720079).

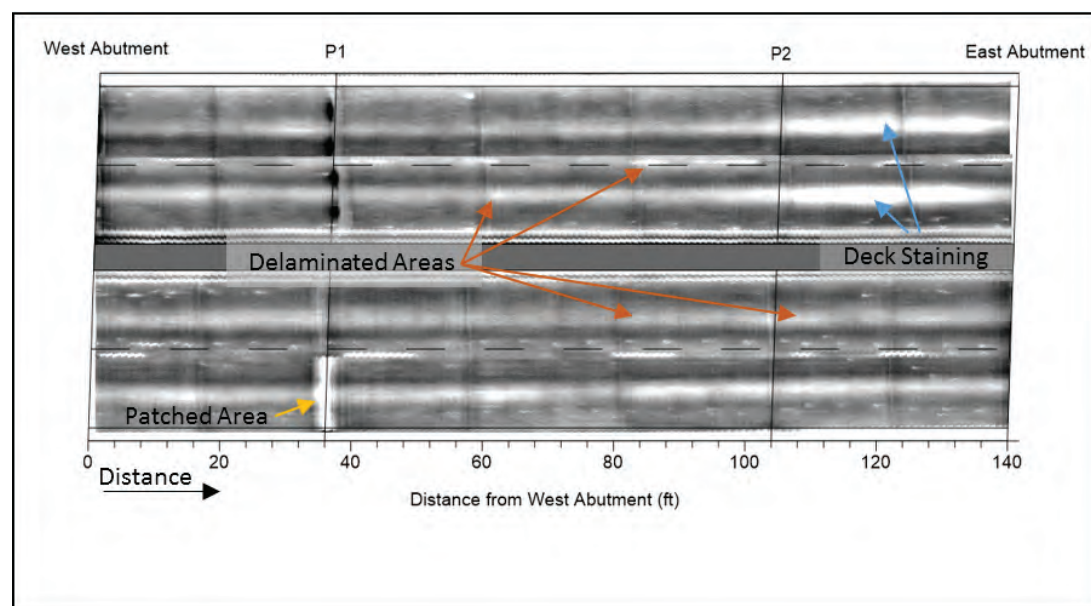
Figure 2. Sample IR image from bridge 720079 showing delaminations, deck staining and patching.

The white blotchy areas on the IR image of Figure 2 indicate delaminations. These are "hot spots" where the surface temperatures are higher due to the thermal barrier produced by the delaminations. Surface staining/discoloration can also produce "hotspots" unrelated to subsurface conditions. The darker the color of the deck surface, the higher the emissivity and corresponding surface temperature. Figure 3 shows the stained areas highlighted in Figure 2 as they appear in the visual data.

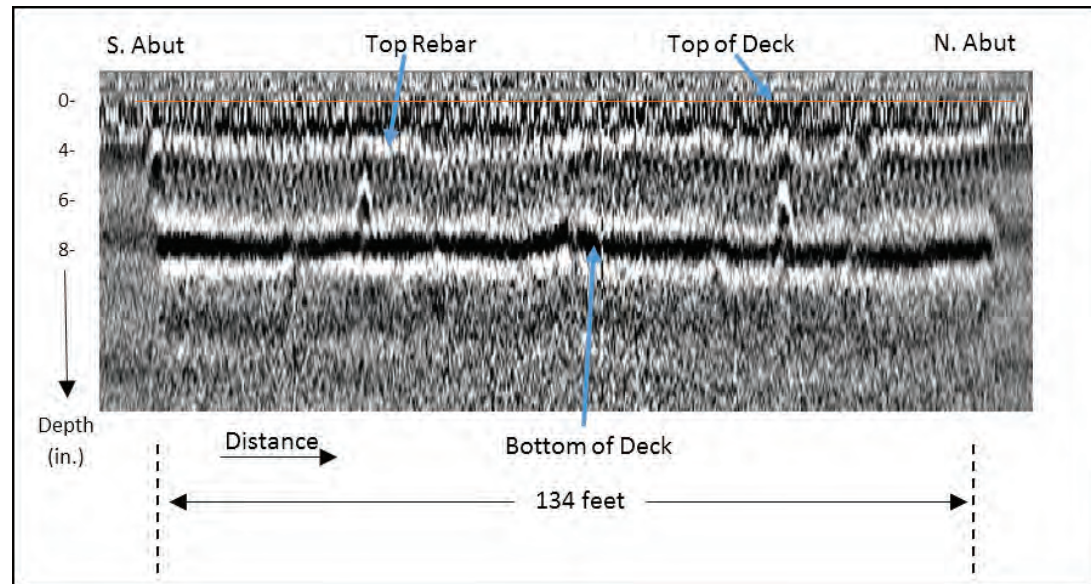
Figure 4. Sample GPR data from bridge 720174 (left lane).

data. Figures 4 and 5 show samples of GPR data used for the condition assessment. Figure 4 is a sample of GPR data recorded along the left wheel-path of the inside lane of bridge 720174. Note that the reflections from the rebar and deck bottom are both strong (relatively high amplitude) and uniform throughout the length of the pass.

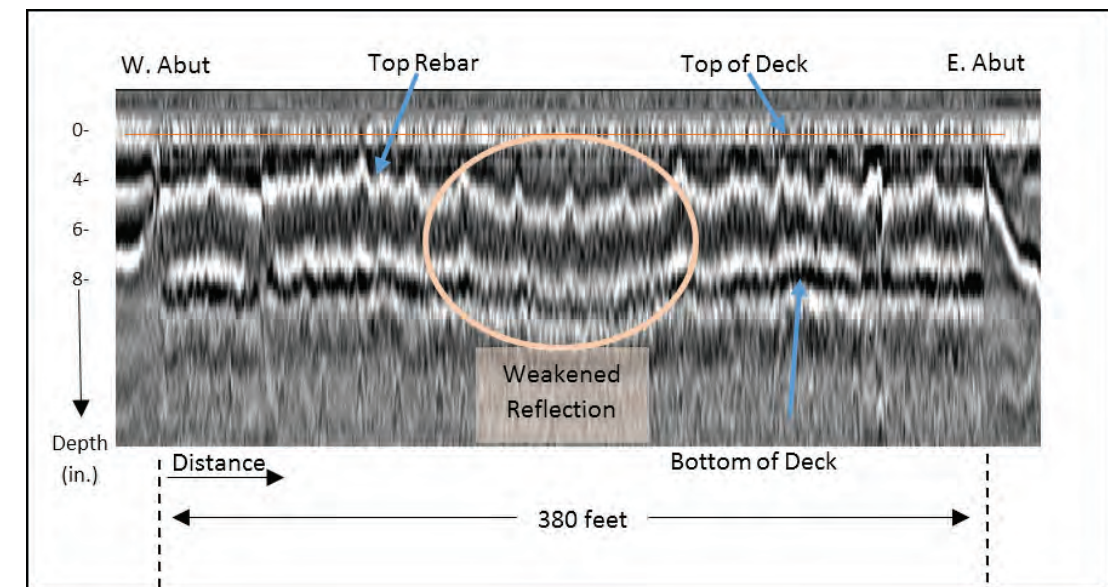
Figure 5. GPR data from Bridge 720323 showing typical signs of deterioration.

Figure 5 provides a sample of GPR data recorded in the shoulder of the southbound direction of bridge 720323, showing typical signs of deterioration. The weakening of the reflection (attenuation) from the top rebar layer and the bottom of the deck is an indication of corrosion, chloride contamination, and possible delamination.

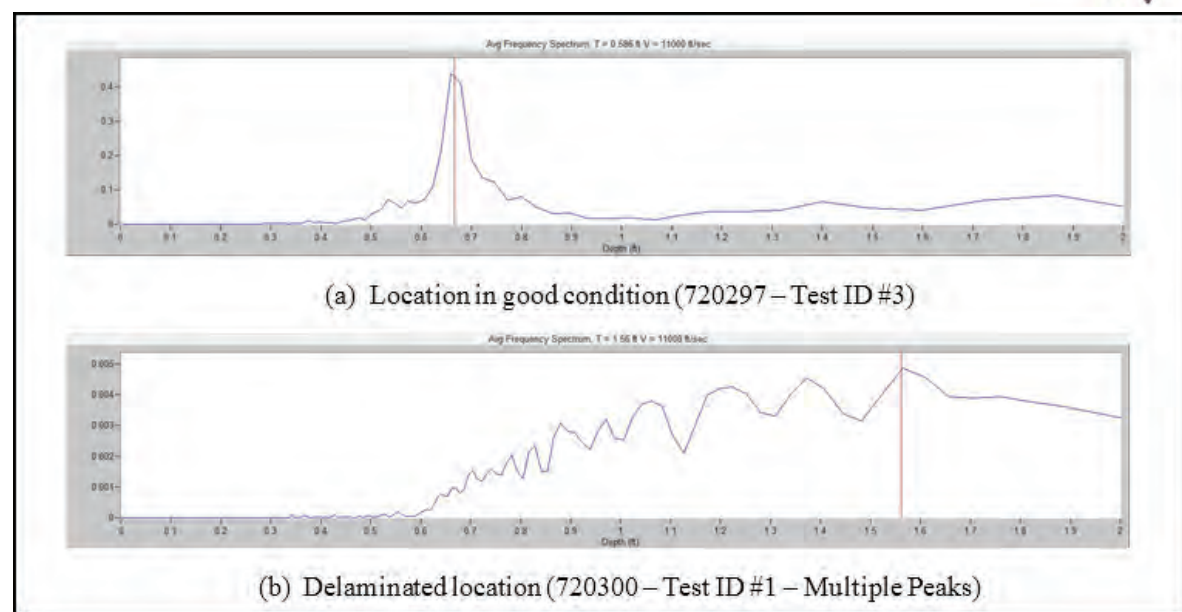
Figure 6. Impact-Echo data samples showing a non-delaminated (a) and delaminated location (b)

Impact-echo testing was carried out at 114 locations to validate the IR and GPR results. Test locations were selected using the preliminary condition maps. The impact-echo test provides a resonant frequency associated with the thickness of the deck slab. If the slab is intact, the thickness data is clear, and should correspond with the expected slab thickness. If the slab is delaminated, the thickness data is unclear and generally does not correspond to the thickness of the slab. Figure 6 provides example data from both a sound and delaminated location. Note that the thickness scale on these plots is in feet. The thickness in plot (a) corresponds to the expected thickness (sound), where the thickness in plot (b) is very different (delaminated). The impact-echo results were subsequently used to calibrate the preliminary IR and GPR results and produce the final version of the condition maps presented in Attachment C.
