*Ground Penetrating Radar
Condition Survey of 7 Bridge Decks in Iowa*

FINAL REPORT

Iowa Department of Transportation
800 Lincoln Way
Ames, IA 50010

Infrasense
21G Olympia Avenue, Suite 45
Woburn, MA 01801

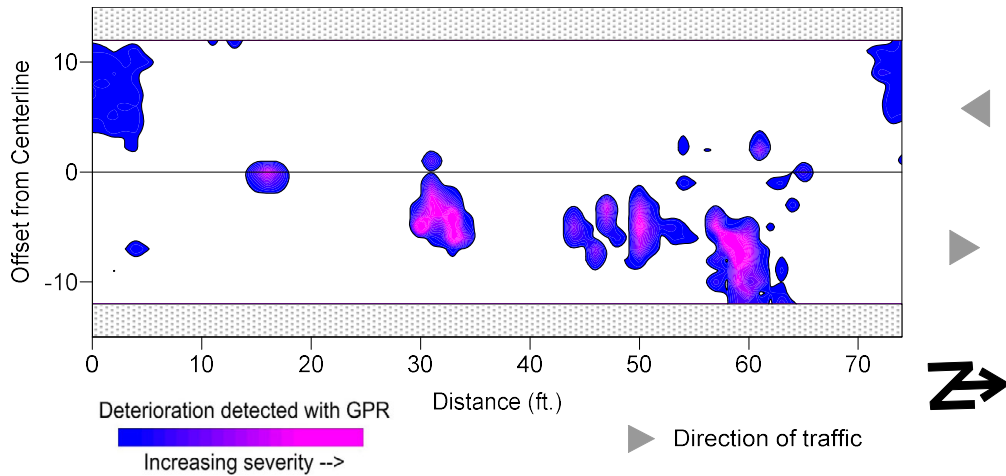
(a) Concrete deterioration map

Representative results for bridge 5341.2S038 are shown in Figure 3a and 3b below. Areas shown in Figure 3a are those where the attenuation levels exceed a threshold value, indicating chloride contamination and corrosion. The color scale indicates the degree to which the threshold is exceeded, which represents the severity. Figure 3b shows a contour map of the rebar depth. The blue areas represent rebar cover from 2.5 to 3.25 inches, and the green areas represent rebar cover from 3.5 to 4.25 inches. A summary of deterioration and rebar depth quantities is presented in Table 1 below:

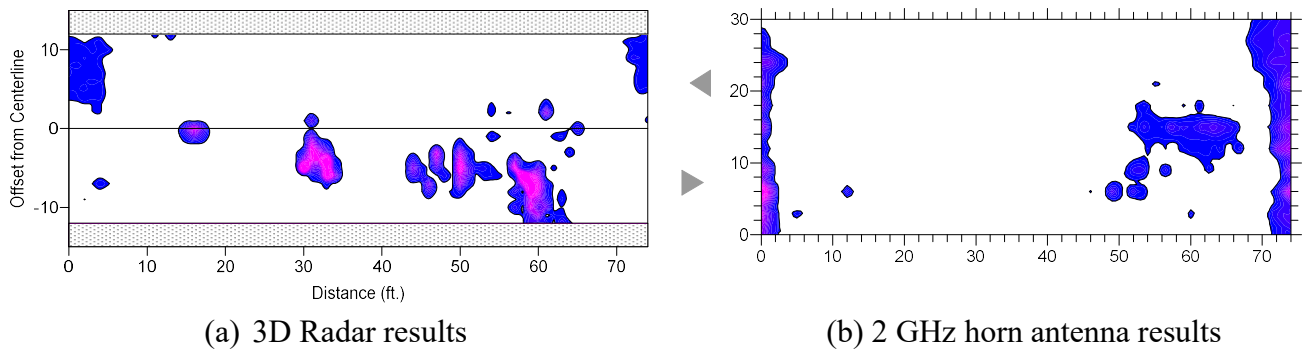
Figure 5 - Bridge 5341.2S038: Comparison of 3D Radar results with conventional system

The results show some differences and some similarities. While the locations of the deterioration in the north (right) span are different, the results do agree that most of the deterioration is in that span. Also, the total quantity of deteriorated concrete is approximately the same. The 3D Radar data appears to show more detail, and does indicate areas of deterioration in the south span that are not identified by the 2 GHz horn system. Also, the mapped 2 GHz horn antenna data is extrapolated out to the curb, even though the antenna offset from the curb was not less than 3 feet. The 3D Radar map, on the other hand, only shows data where the antennas were located.

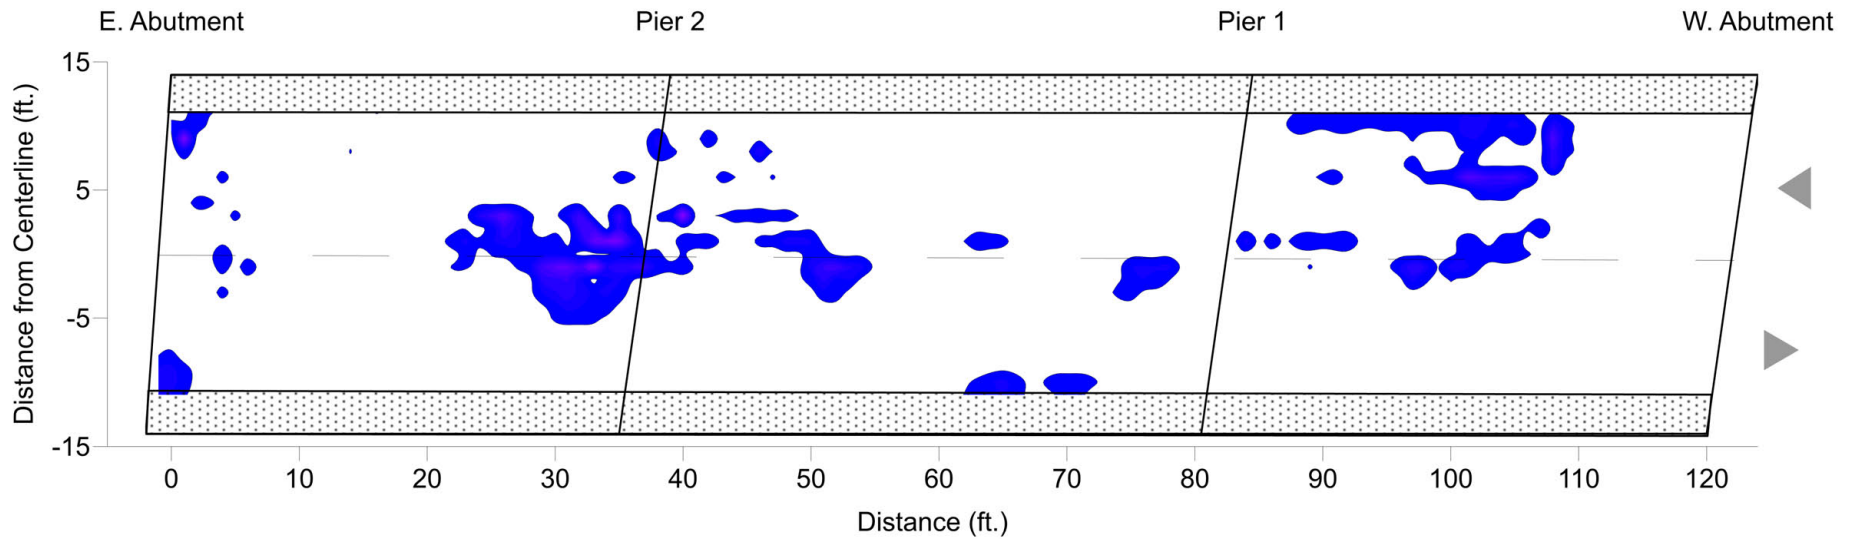
<table><tr> <td rowspan="2" style="writing-mode: vertical-rl; transform: rotate(180deg);">Deck</td> <td>Conc. Deterioration (%)</td> <td>11</td> </tr><tr> <td>Conc. Deterioration (s.f)</td> <td>291</td> </tr></table>

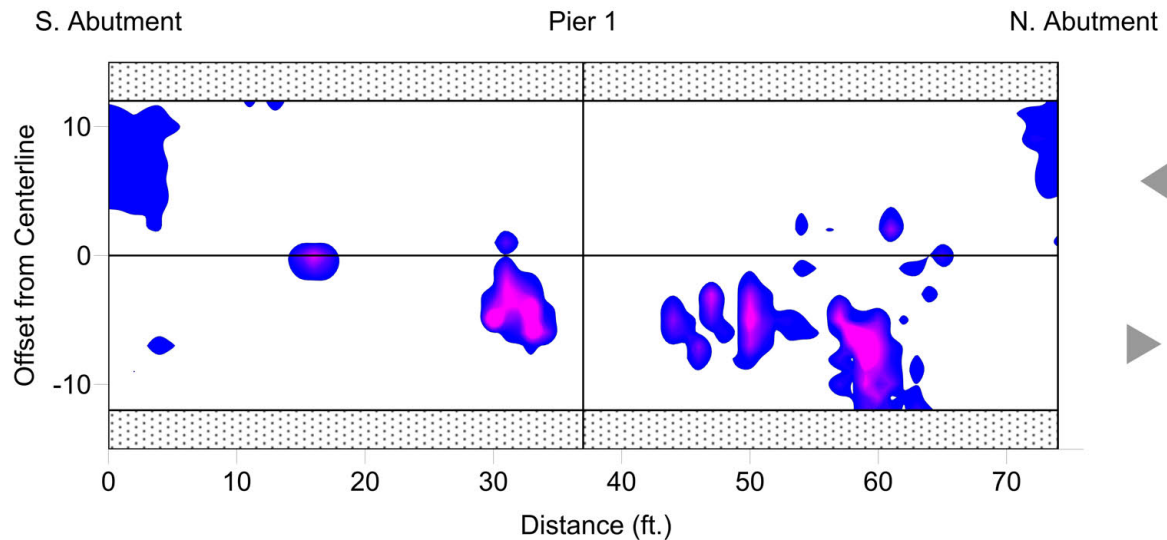
<table><tr> <td rowspan="2" style="writing-mode: vertical-rl; transform: rotate(180deg);">Deck</td> <td>Conc. Deterioration (%)</td> <td>8.7</td> </tr><tr> <td>Conc. Deterioration (s.f)</td> <td>155</td> </tr></table>

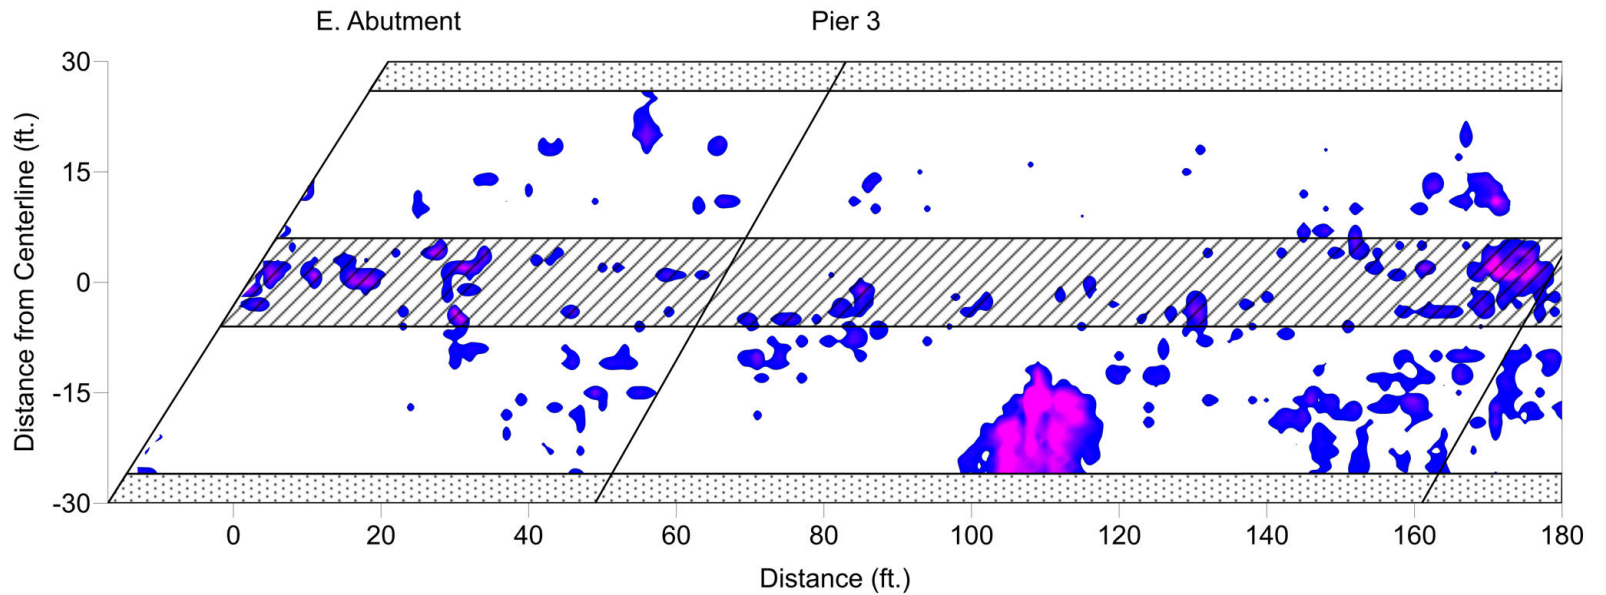
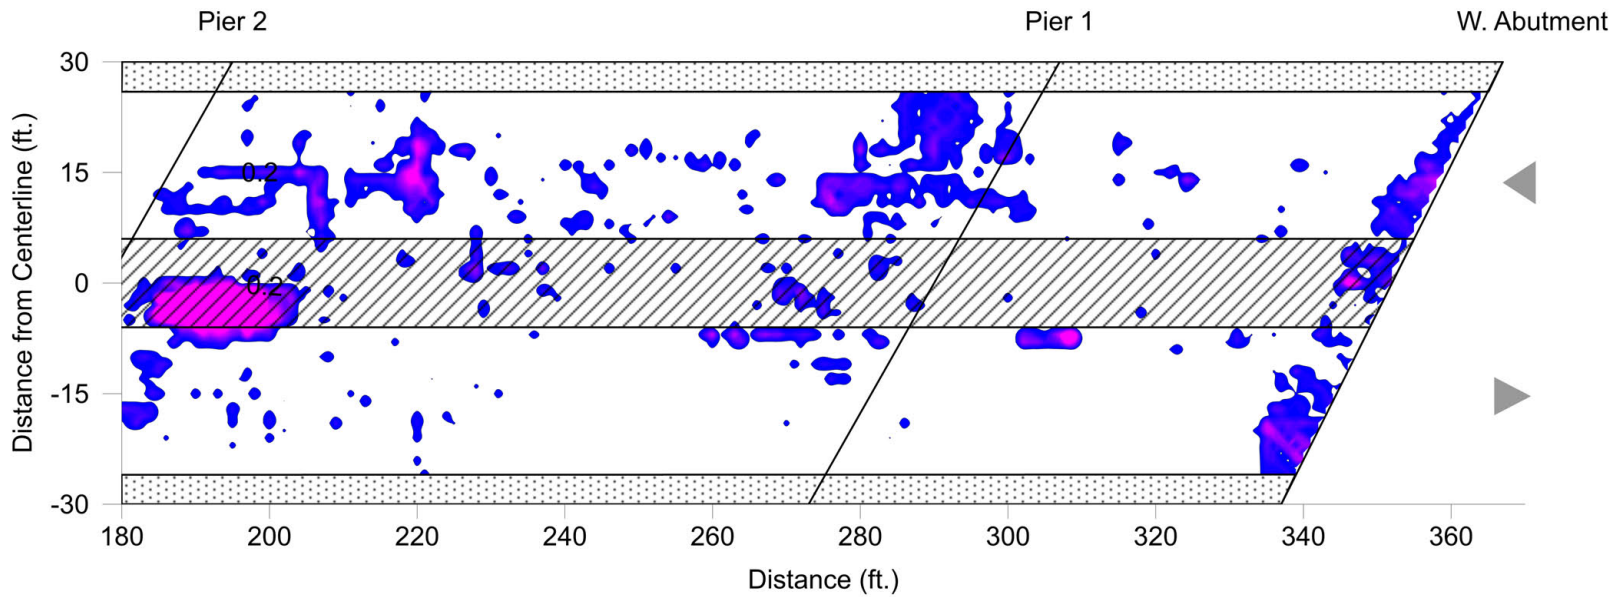
Concrete Condition Legend	Orientation	Quantity Summary	General Information				
<p>Deterioration</p> <p>Increasing severity --></p> <p> Median Gore Strip</p> <p> Area not covered by GPR antenna</p>	<p></p> <p> Direction of traffic</p>	<p>Deck</p> <table border="1"> <tr> <td>Conc. Deterioration (%)</td> <td>9</td> </tr> <tr> <td>Conc. Deterioration (s.f)</td> <td>1475</td> </tr> </table>	Conc. Deterioration (%)	9	Conc. Deterioration (s.f)	1475	<p>Bridge ID: 3572.3S003 Iowa 3 over I-35</p>
		Conc. Deterioration (%)	9				
Conc. Deterioration (s.f)	1475						
		<p>Rebar</p> <table border="1"> <tr> <td>Avg.Rebar Depth (in.)</td> <td>4.4</td> </tr> </table>	Avg.Rebar Depth (in.)	4.4	<p>Analyzed by: KS Reviewed by: KM Completed: 6/7/2017</p>		
Avg.Rebar Depth (in.)	4.4						
			Sheet 1 of 1

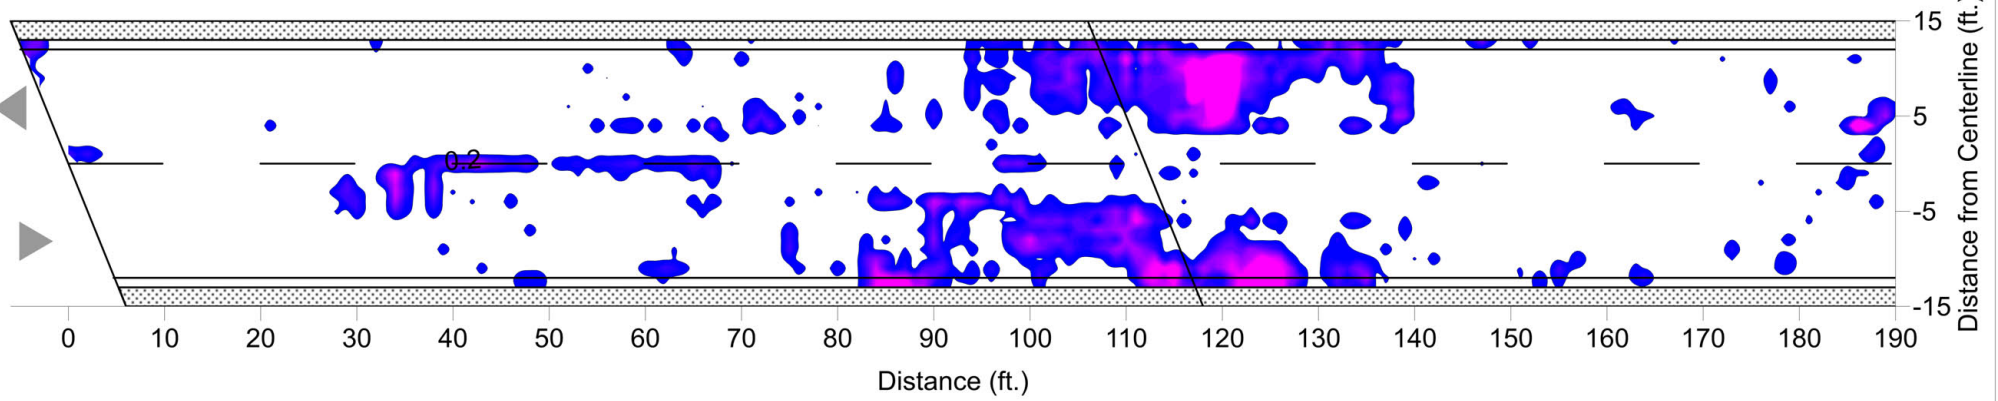
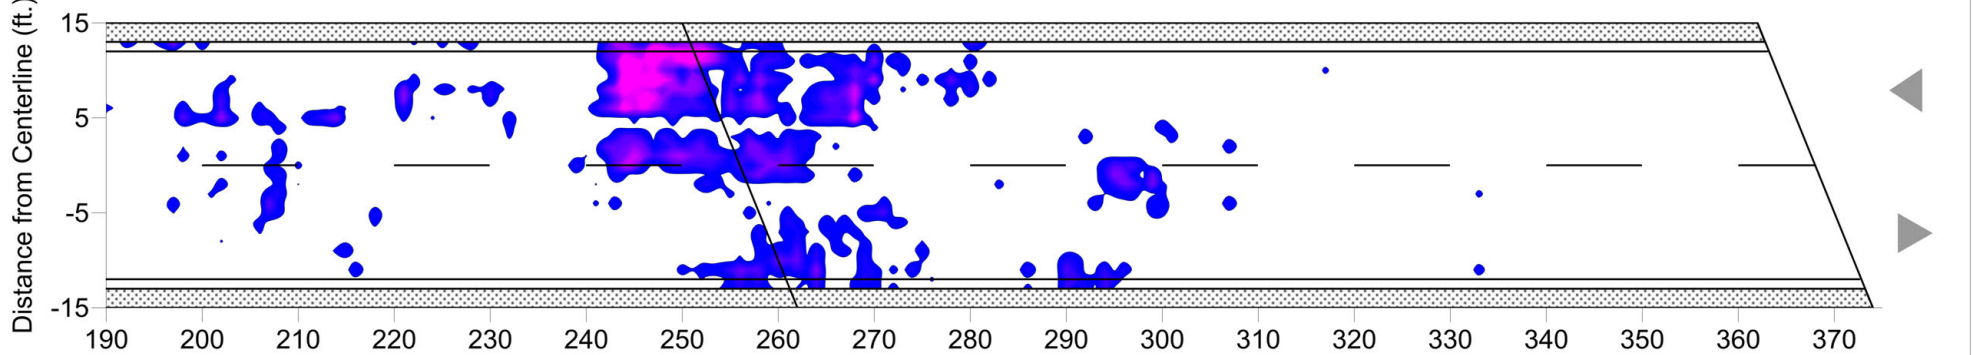
<table><tr> <td rowspan="2" style="writing-mode: vertical-rl; transform: rotate(180deg);">Deck</td> <td>Conc. Deterioration (%)</td> <td>14.8</td> </tr><tr> <td>Conc. Deterioration (s.f)</td> <td>1412</td> </tr></table>

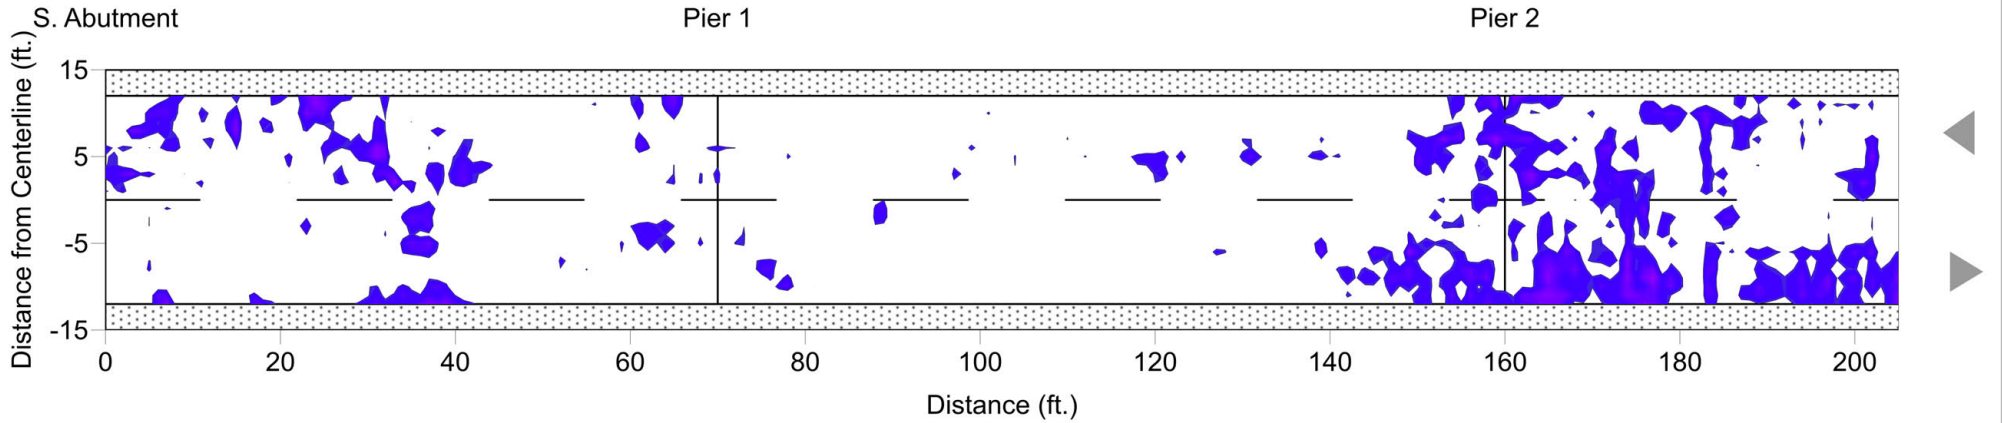
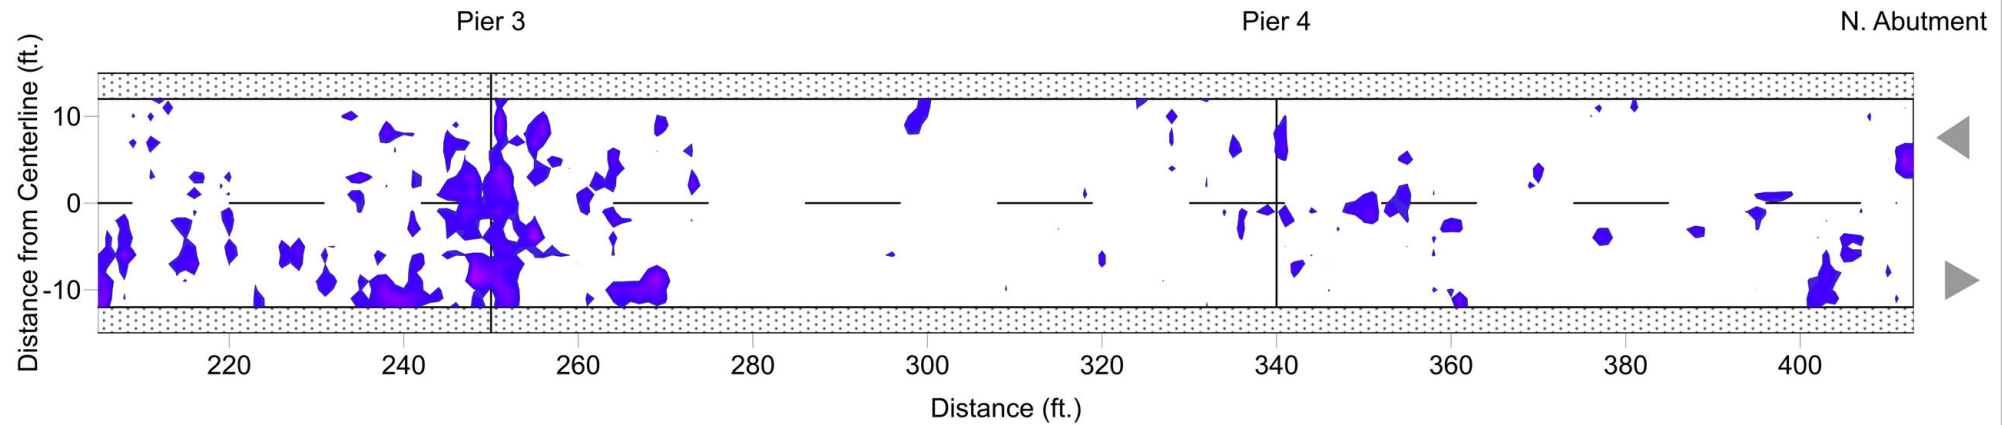
<table><tr> <td rowspan="2" style="writing-mode: vertical-rl; transform: rotate(180deg);">Deck</td> <td>Conc. Deterioration (%)</td> <td>13</td> </tr><tr> <td>Conc. Deterioration (s.f)</td> <td>1331</td> </tr></table>

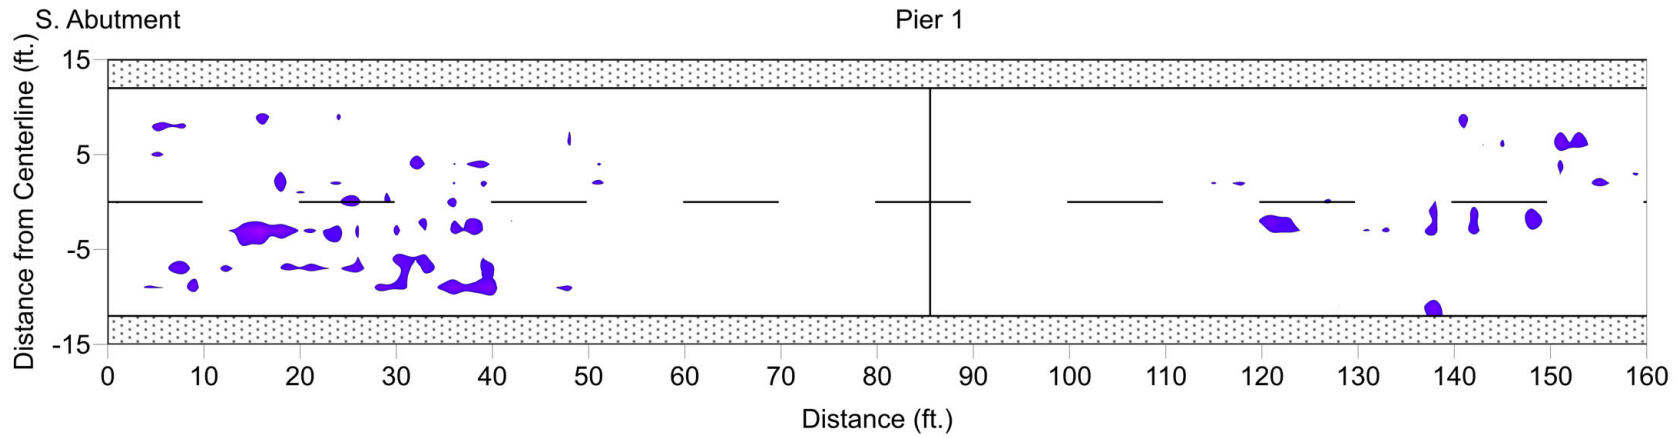
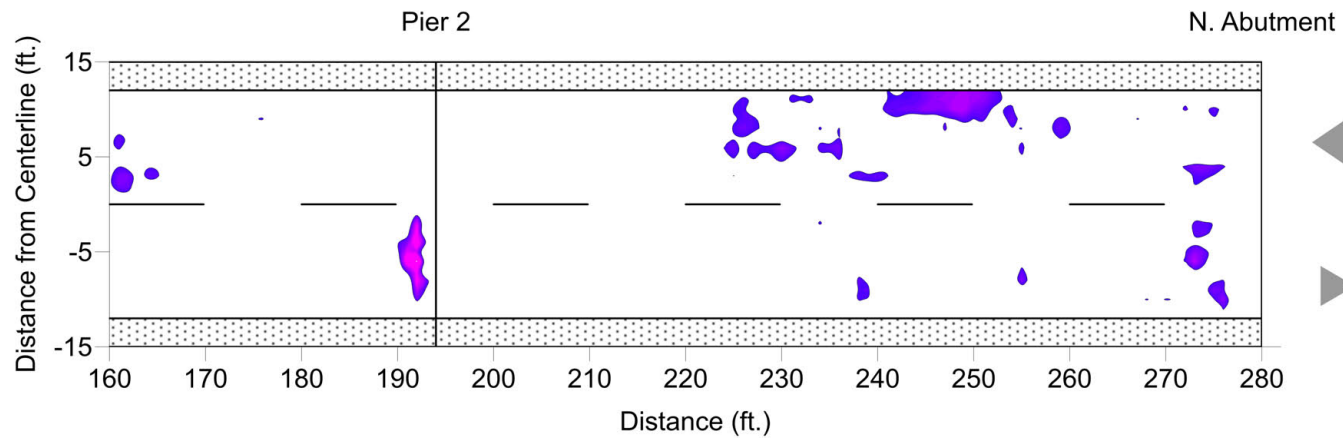
<table><tr> <td rowspan="2" style="writing-mode: vertical-rl; transform: rotate(180deg);">Deck</td> <td>Conc. Deterioration (%)</td> <td>3.7</td> </tr><tr> <td>Conc. Deterioration (s.f)</td> <td>250</td> </tr></table>

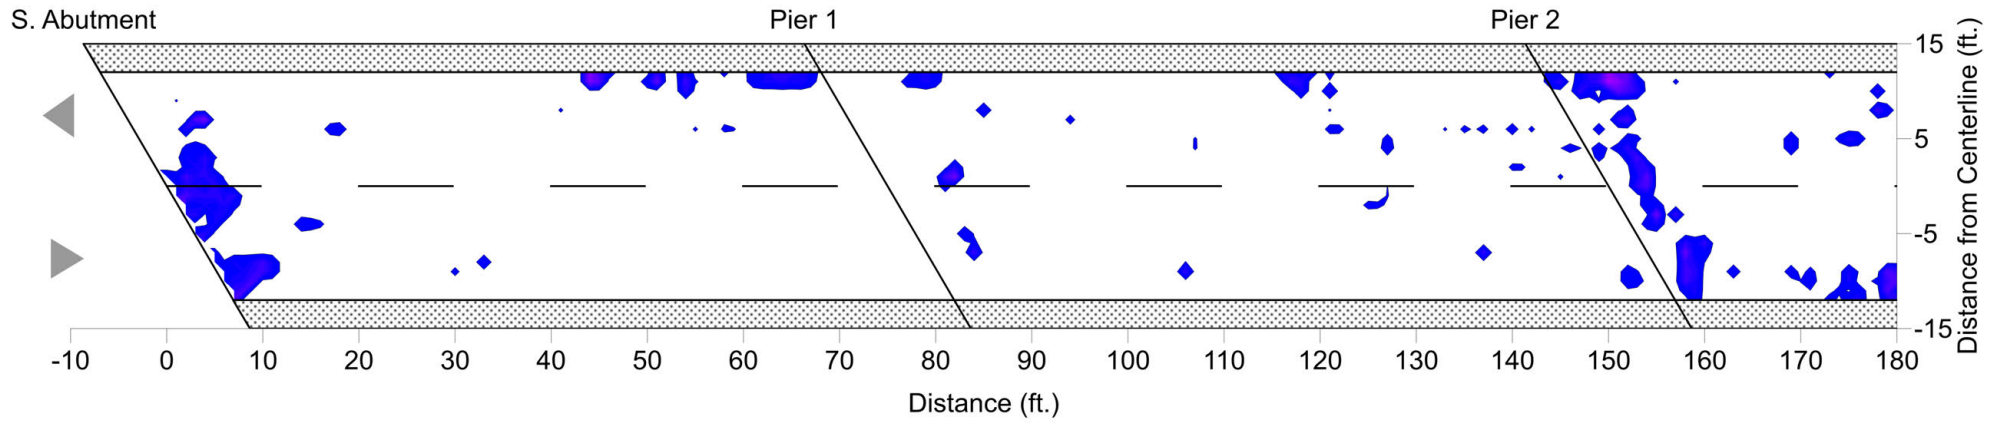
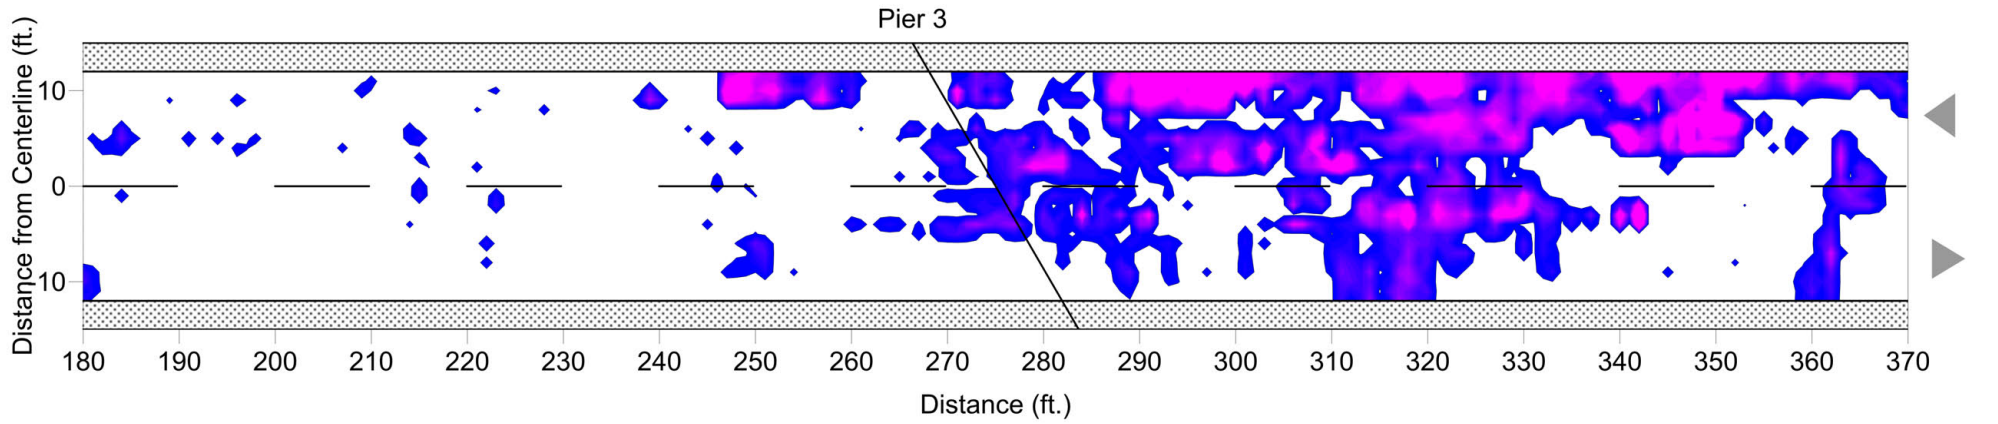
<table><tr> <td rowspan="2" style="writing-mode: vertical-rl; transform: rotate(180deg);">Deck</td> <td>Conc. Deterioration (%)</td> <td>11.2</td> </tr><tr> <td>Conc. Deterioration (s.f)</td> <td>1924</td> </tr></table>

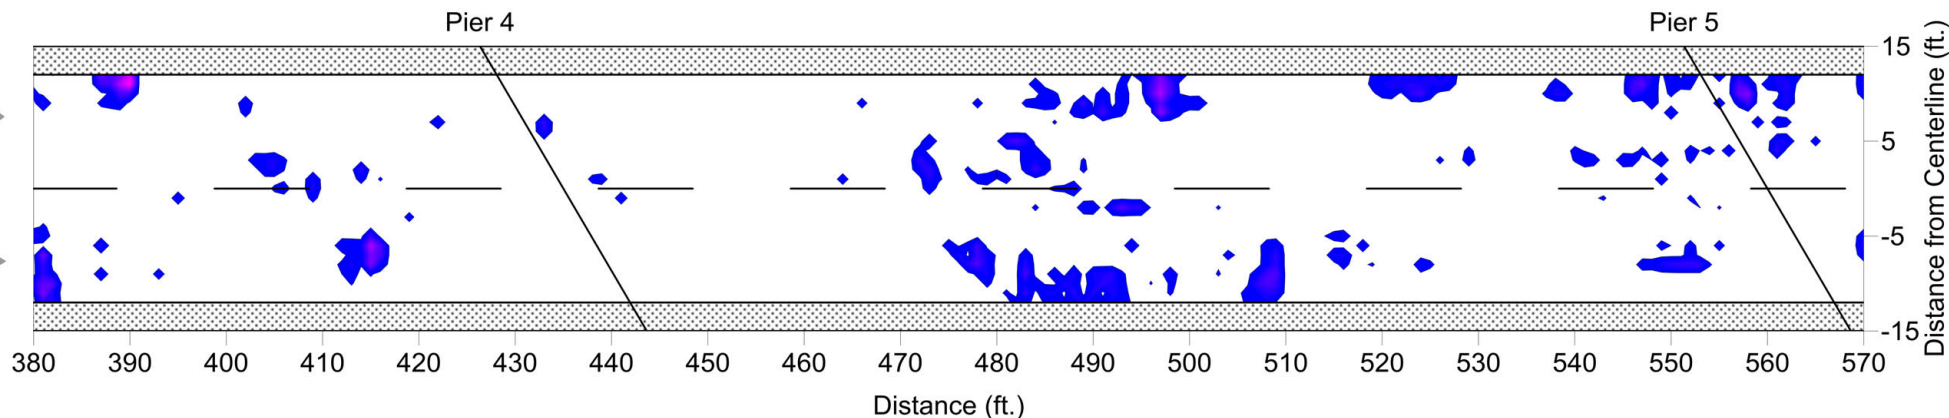
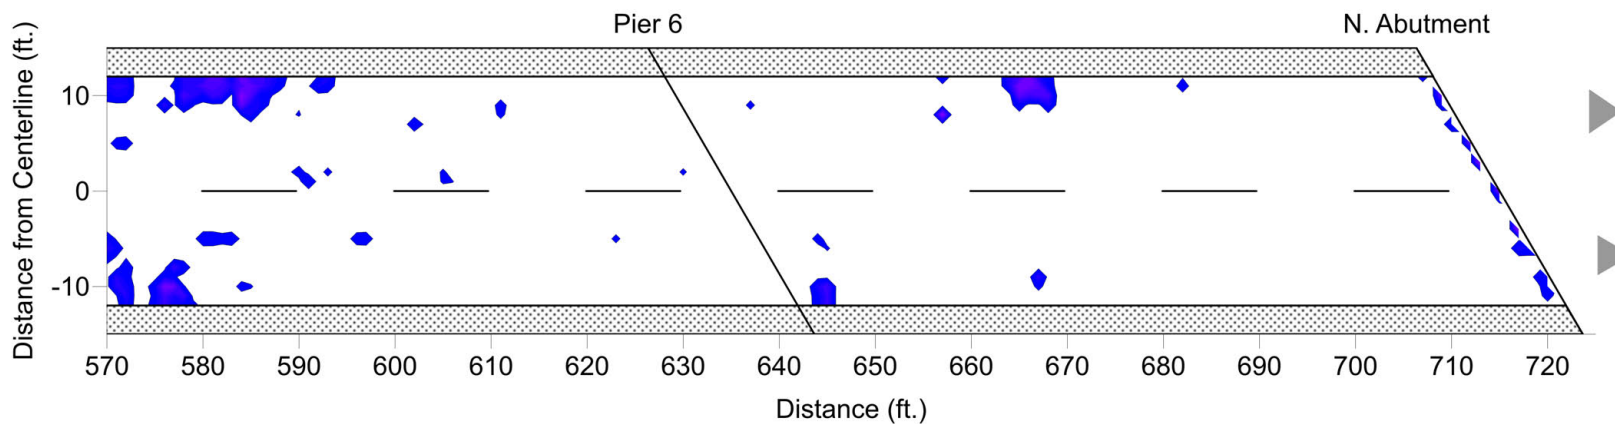
<table><tr> <td rowspan="2" style="writing-mode: vertical-rl; transform: rotate(180deg);">Deck</td> <td>Conc. Deterioration (%)</td> <td>11.2</td> </tr><tr> <td>Conc. Deterioration (s.f)</td> <td>1924</td> </tr></table>

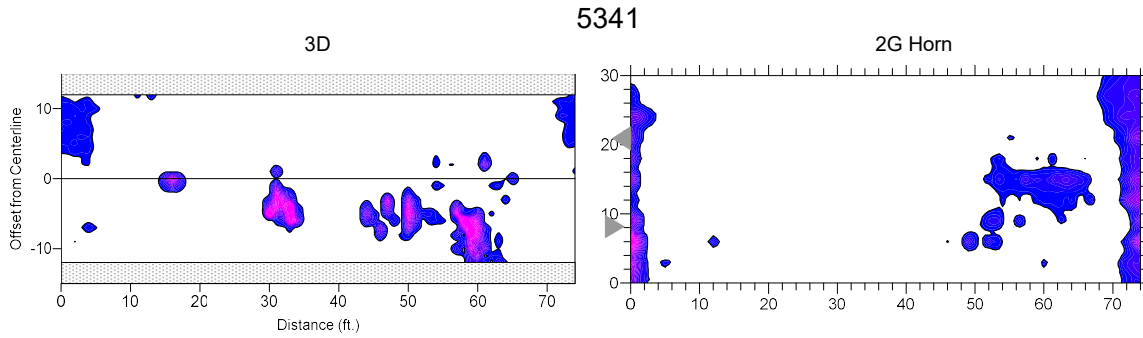
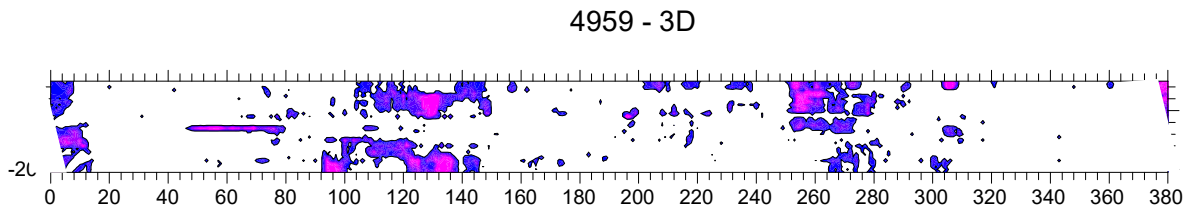
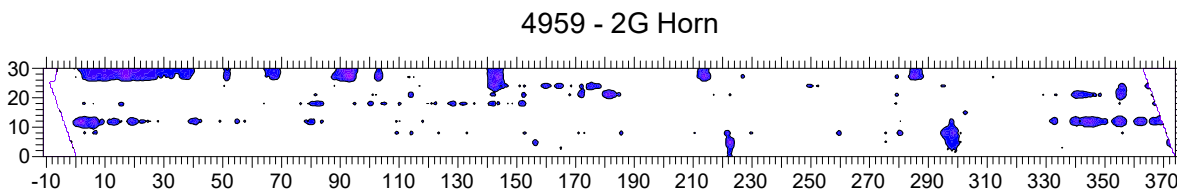
Comparison of 3D Radar Results to 2 GHz Horn Antenna Result

Attachment B shows the complete set of comparisons for each of the three decks. The results for bridge 4915.2S052 showed similar results to that in Figure 5 – i.e., some differences in detailed

locations but some similarities in general areas of deterioration. The results for bridge 4959.4R061 show very little similarity between the two methods. At this point the only way to explain these differences is that the 3D Radar system detects much higher levels of detail and therefore is showing more potential areas of deterioration.
