NCDOT SHRP2 R06A Feasibility Study for Nondestructive Evaluation of Bridge Decks

FINAL REPORT

FEBRUARY 5, 2018

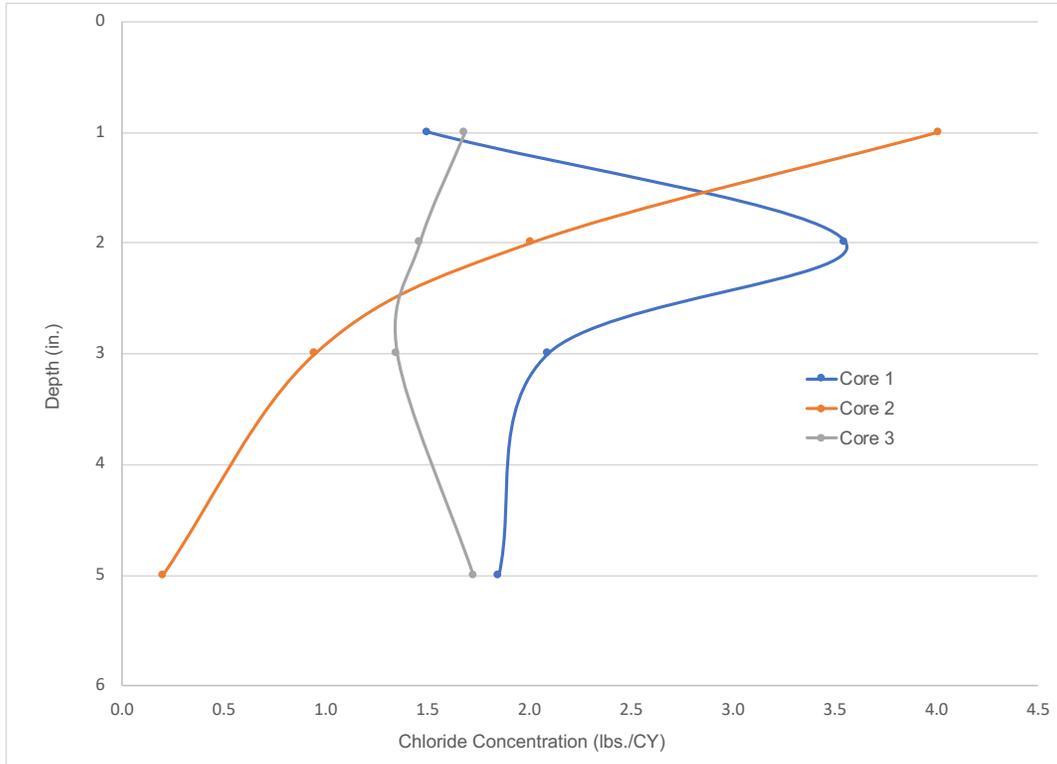
Sample 2 of bridge 290007 indicates typical behavior for chloride ingress and chloride concentration decreases as a function of depth. However, samples 1 and 3 of bridge 290007 exhibit odd behavior. This contamination correlates with locations where GPR identified high corrosion probability. 33% of the samples taken exceeded 2.0 lbs./CY.

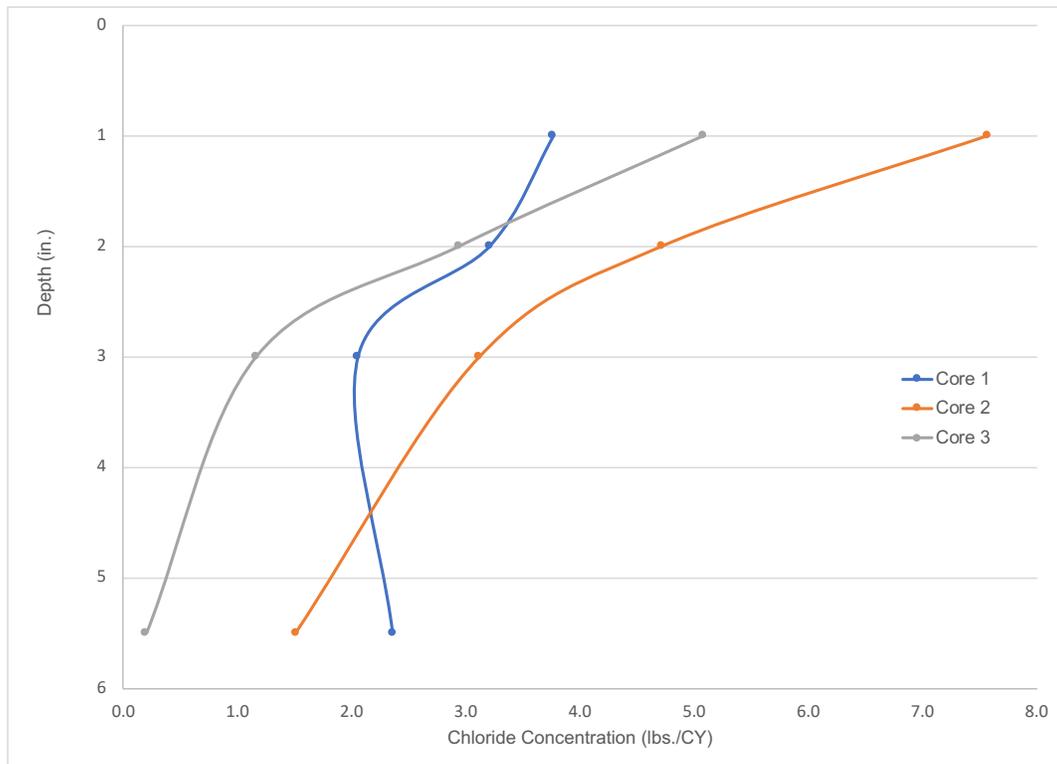
All samples taken from bridge 290014 indicate typical behavior for chloride ingress through concrete. However, 75% of the measurements taken exceed the threshold of 2.0 lbs./CY and correlate with areas identified for probable corrosion.

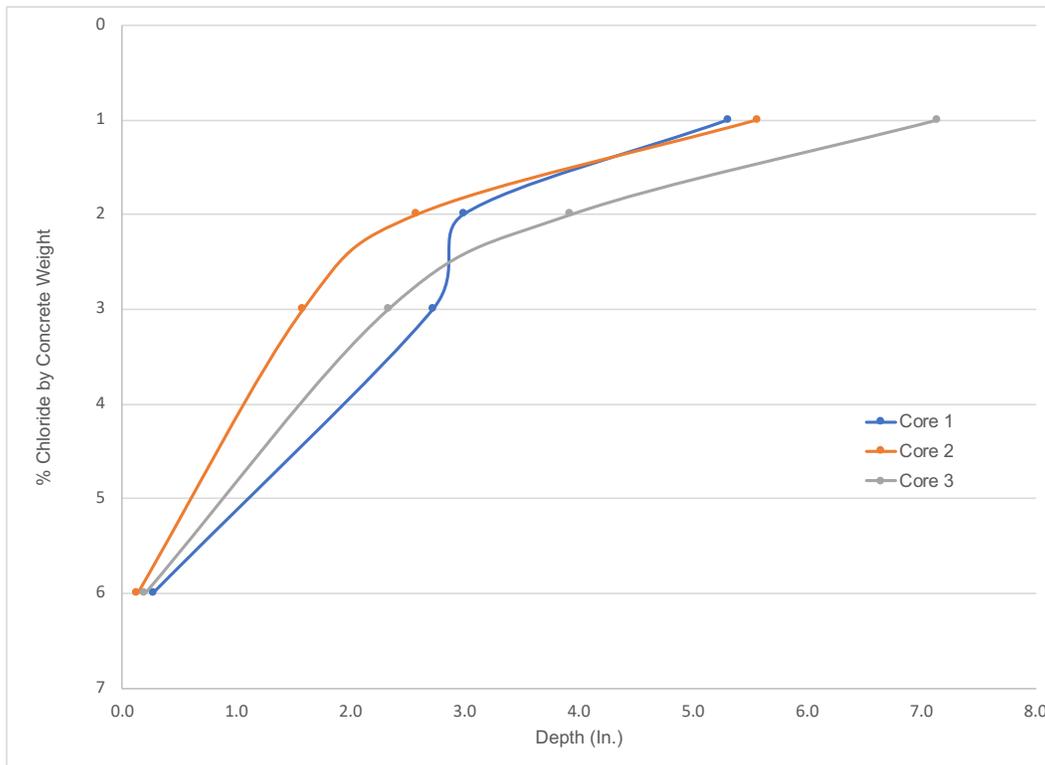
Samples taken from bridge 290018 mostly indicate typical behavior for chloride ingress through concrete. However, sample 1, taken in an area of high GPR corrosion probability, maintains a higher chloride concentration from 2" – 3". Additionally, 67% of the measurements taken exceed the threshold of 2.0 lbs./CY and correlate with areas identified for probable corrosion.

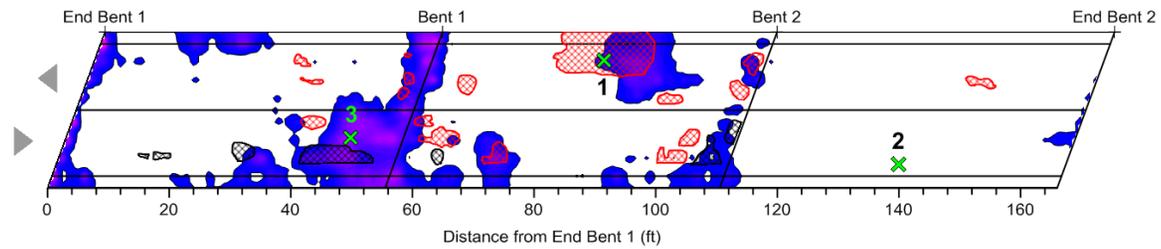
1. GPR results indicate that 17.4%, 14.4%, and 3.6% of Structures 290007, 290014, and 290018, respectively, have a high probability of deterioration at the rebar level.

► Direction of traffic	Condition	sq. ft.	%	Bridge ID: 290007 SR 1147 over Hunting Creek
*combined quantity accounting for overlap				Delamination (IR)	225	5.2	Analyzed by: SB Reviewed by: AC Completed: 12/14/17
			Deterioration (GPR)	749	17.4	Sheet 1 of 1	
			Patching	134	3.1		
			Spalling	0	0.0		
			Combined Defects*	947	22.0

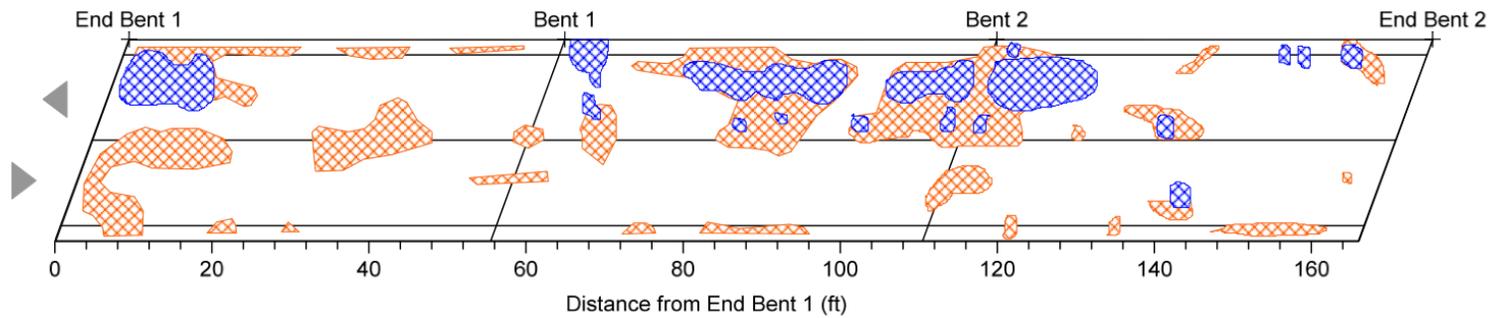
Delamination detected by Chain		Delamination (Chain)*	331.7	7.8	Analyzed by: JC Reviewed by: SB Completed: 1/22/18

Delamination detected by SoundAR		(Quantity Summary for SoundAR is not explicitly listed in the table)	Deterioration (SoundAR)	892.4	21.1

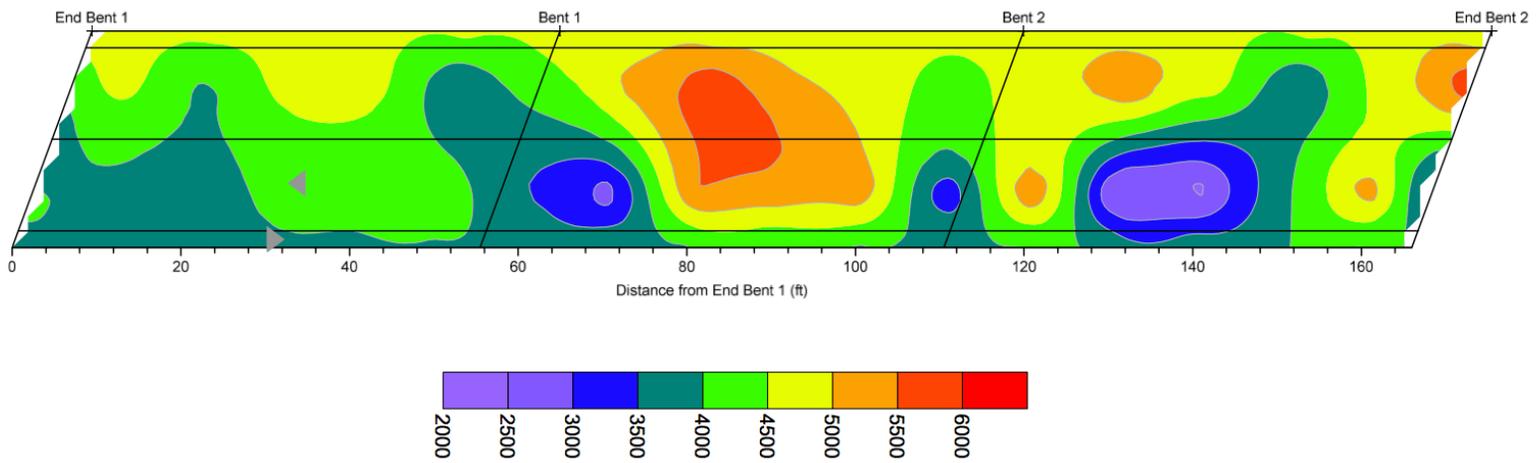
Direction of traffic	Condition	%	Bridge ID: 290007 SR 1147 over Hunting Creek
		<3000 psi	13	Analyzed by: SB Reviewed by: JC Completed: 1/26/18
		<4000 psi	22	
		<5000 psi	34	
		>5000 psi	31	Sheet 1 of 1

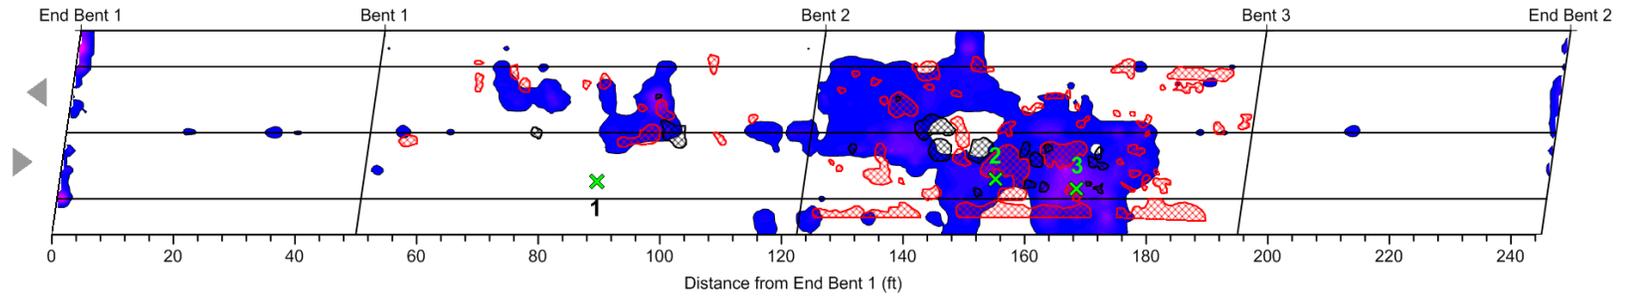
Direction of traffic	Condition	sq. ft.	%	Bridge ID: 290014
*combined quantity accounting for overlap				Delamination (IR)	396	4.8	SR 1147 over I-40
			Deterioration (GPR)	1196	14.4	Analyzed by: SB	
			Patching	87	1.0	Reviewed by: AC	
			Spalling	0	0.0	Completed: 12/14/17	
			Combined Defects*	1371	16.5	Sheet 1 of 1

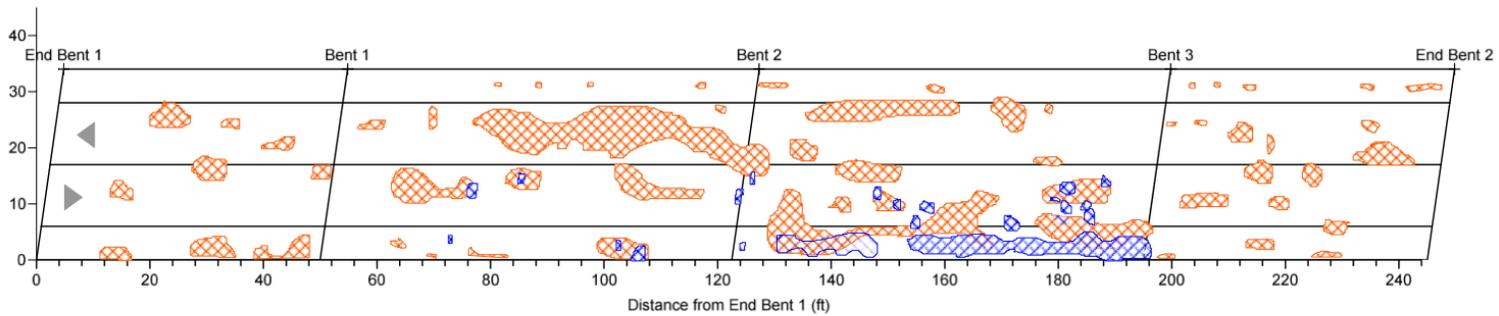
Direction of traffic	Condition	sq. ft.	%	Bridge ID: 290014 SR 1147 over I-40
		Delamination (Chain)*	237	2.9	Analyzed by: JC Reviewed by: SB Completed: 1/22/18
		Deterioration (SounDAR)	1197	14.4	Sheet 1 of 1

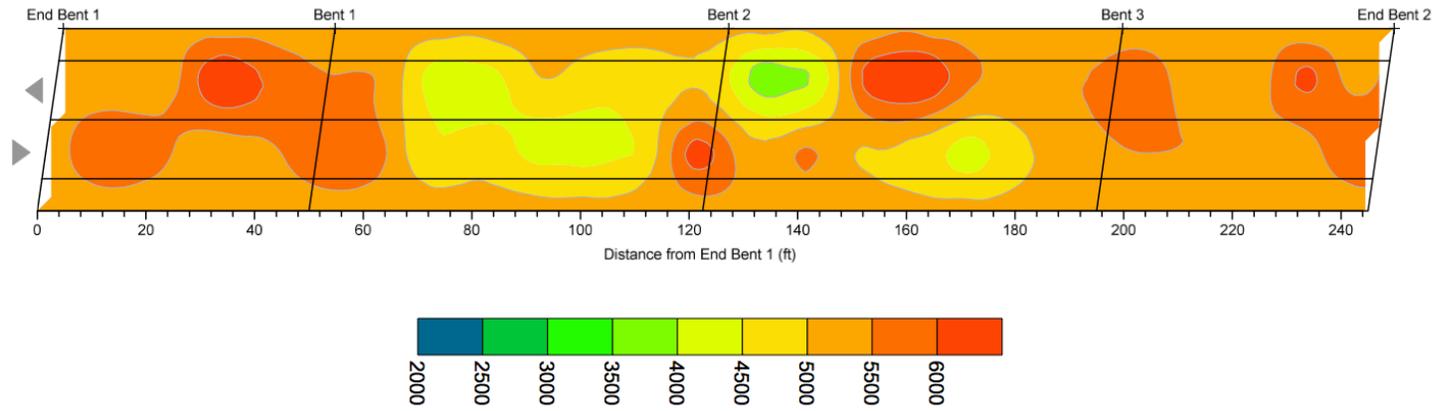
Direction of traffic	Condition	%	Bridge ID: 290014 SR 1147 over I-40
		<3000 psi	0	Analyzed by: SB Reviewed by: JC Completed: 1/26/18
		<4000 psi	6	
		<5000 psi	27	
		>5000 psi	67	Sheet 1 of 1

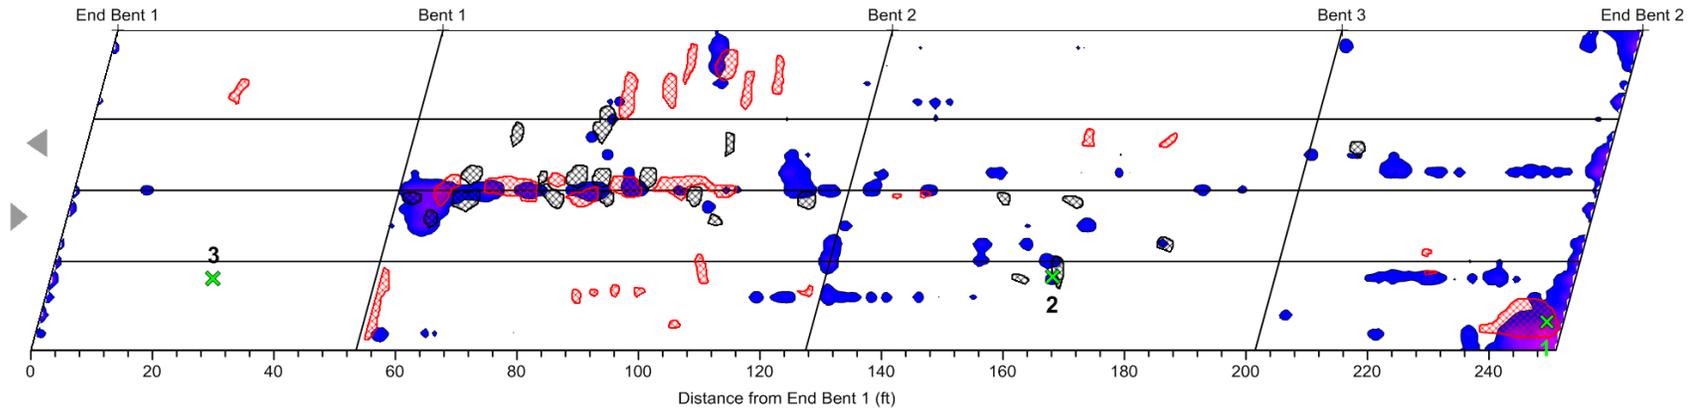
Concrete Condition Legend		Orientation	Quantity Summary		General Information	
Deterioration detected by GPR severity → *combined quantity accounting for overlap	Delamination detected by IR Patching Spalling Thermal Obstruction	 Direction of traffic	Condition	sq. ft.	%	Bridge ID: 290018 SUS 64 over I-40 Analyzed by: SB Reviewed by: AC Completed: 12/14/17
	Delamination (IR) 269 2.0		Deterioration (GPR) 489 3.6	Patching 142 1.0	Spalling 0 0.0	
			Combined Defects*	758	5.6

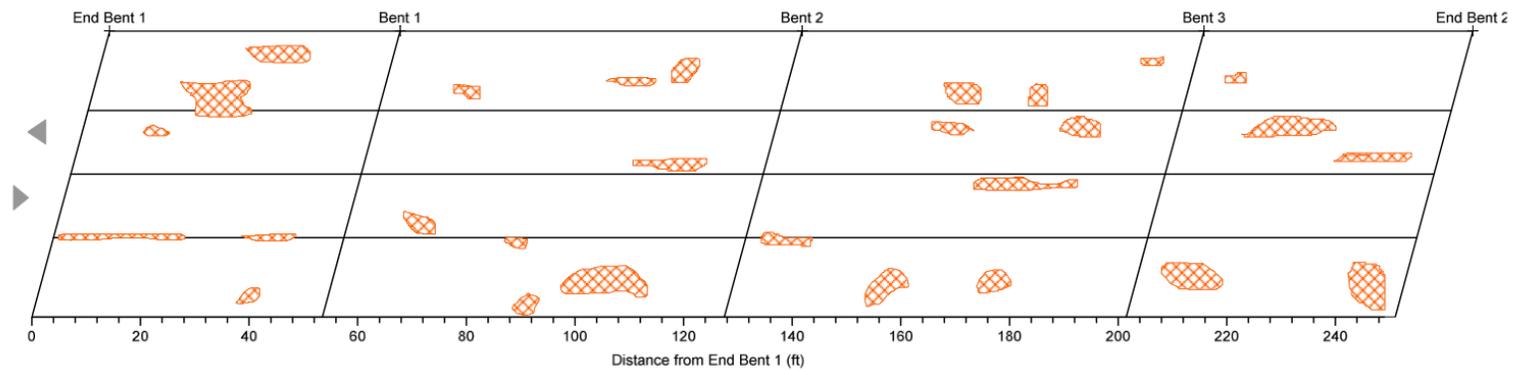
Direction of traffic	Condition	sq. ft.	%	Bridge ID: 290018 SUS 64 over I-40		
		Delamination (Chain)*	*	*	Analyzed by: SB Reviewed by: JC Completed: 1/26/18		
		Deterioration (SounDAR)	597.5	4.4	Sheet 1 of 1

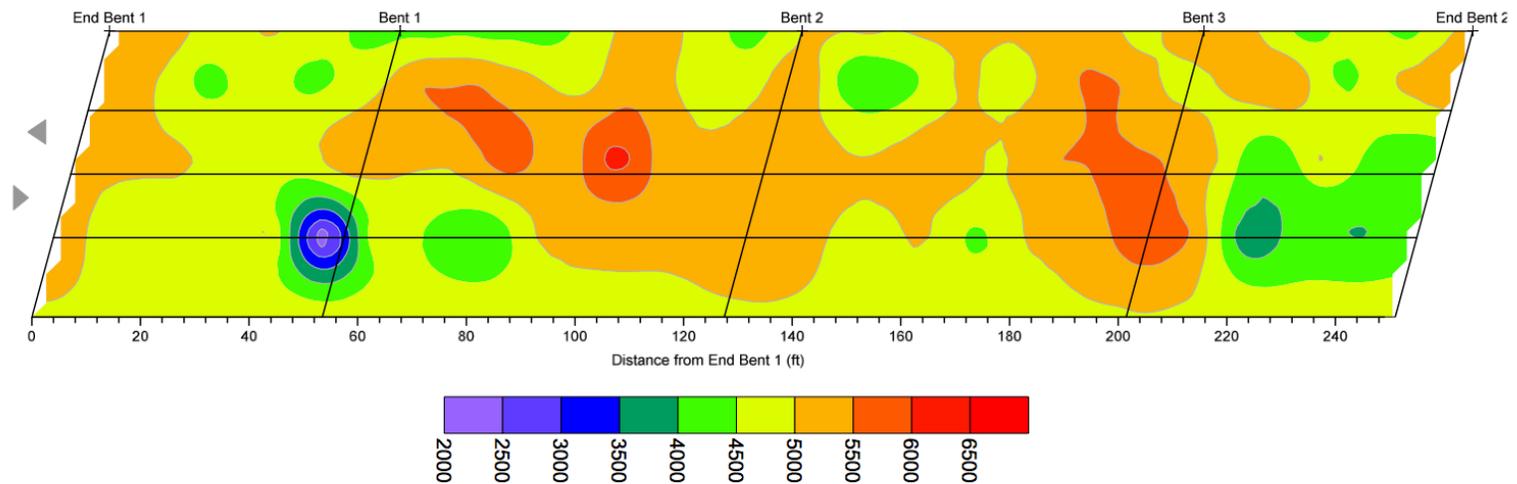
Direction of traffic	Condition	%	Bridge ID: 290018 SUS 64 over I-40
		<3000 psi	1	Analyzed by: SB Reviewed by: JC Completed: 1/26/18
<4000 psi	5			
<5000 psi	35			
		>5000 psi	59	Sheet 1 of 1
