Advanced Methods to Identify Asphalt Pavement Delamination--R06D New Mexico Department of Transportation

IE/SASW

Pavement Management and Design

August 2, 2018

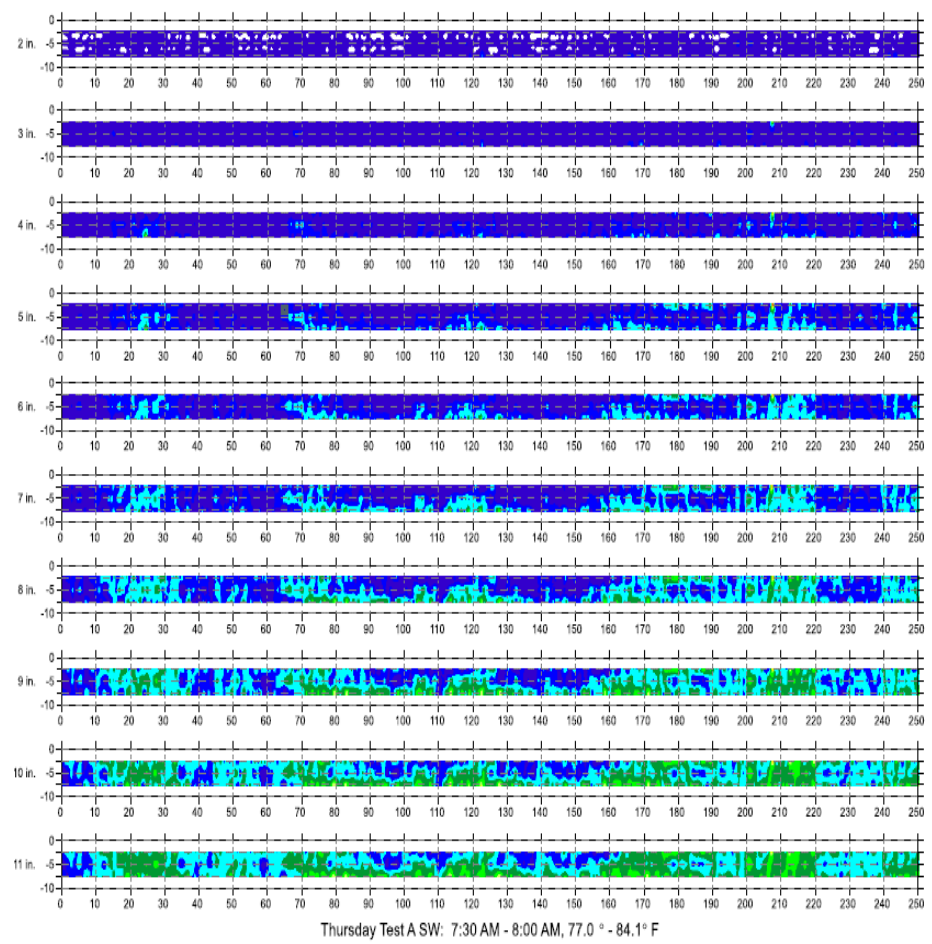
Thursday Test A SW: 7:30 AM - 8:00 AM, 77.0 ° - 84.1° F

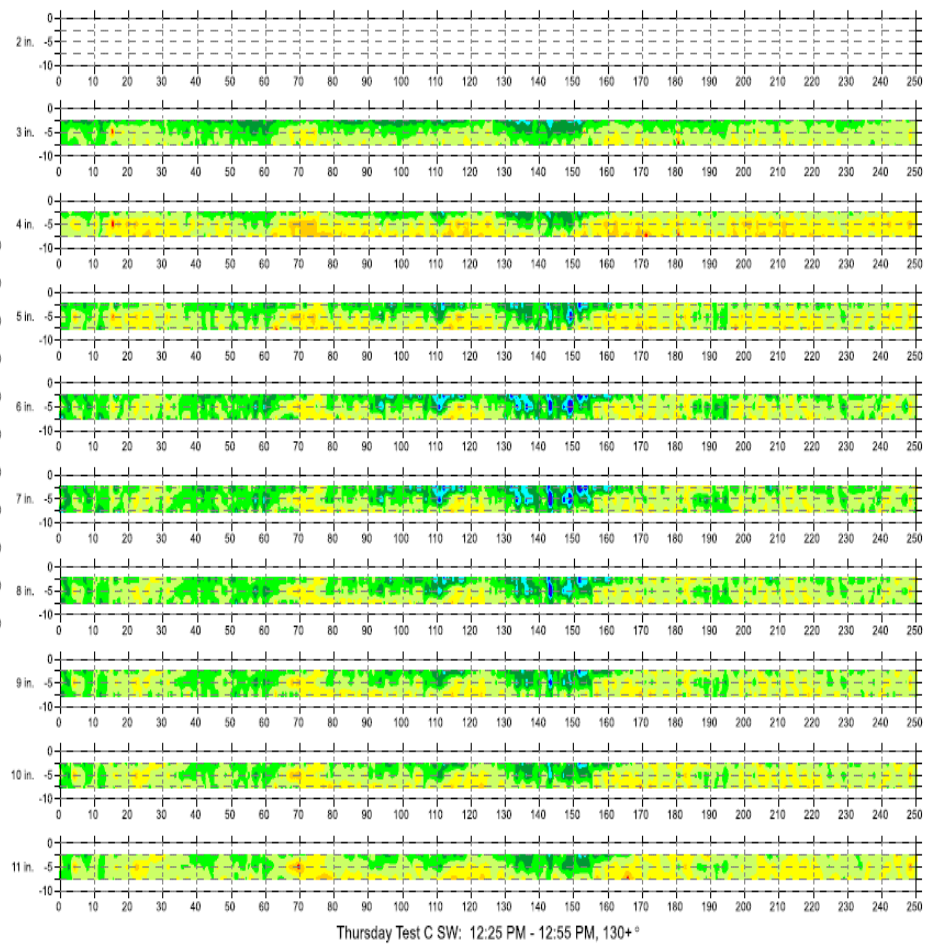
Thursday Test C SW: 12:25 PM - 12:55 PM, 130+ °

As temperature increases velocity decreases

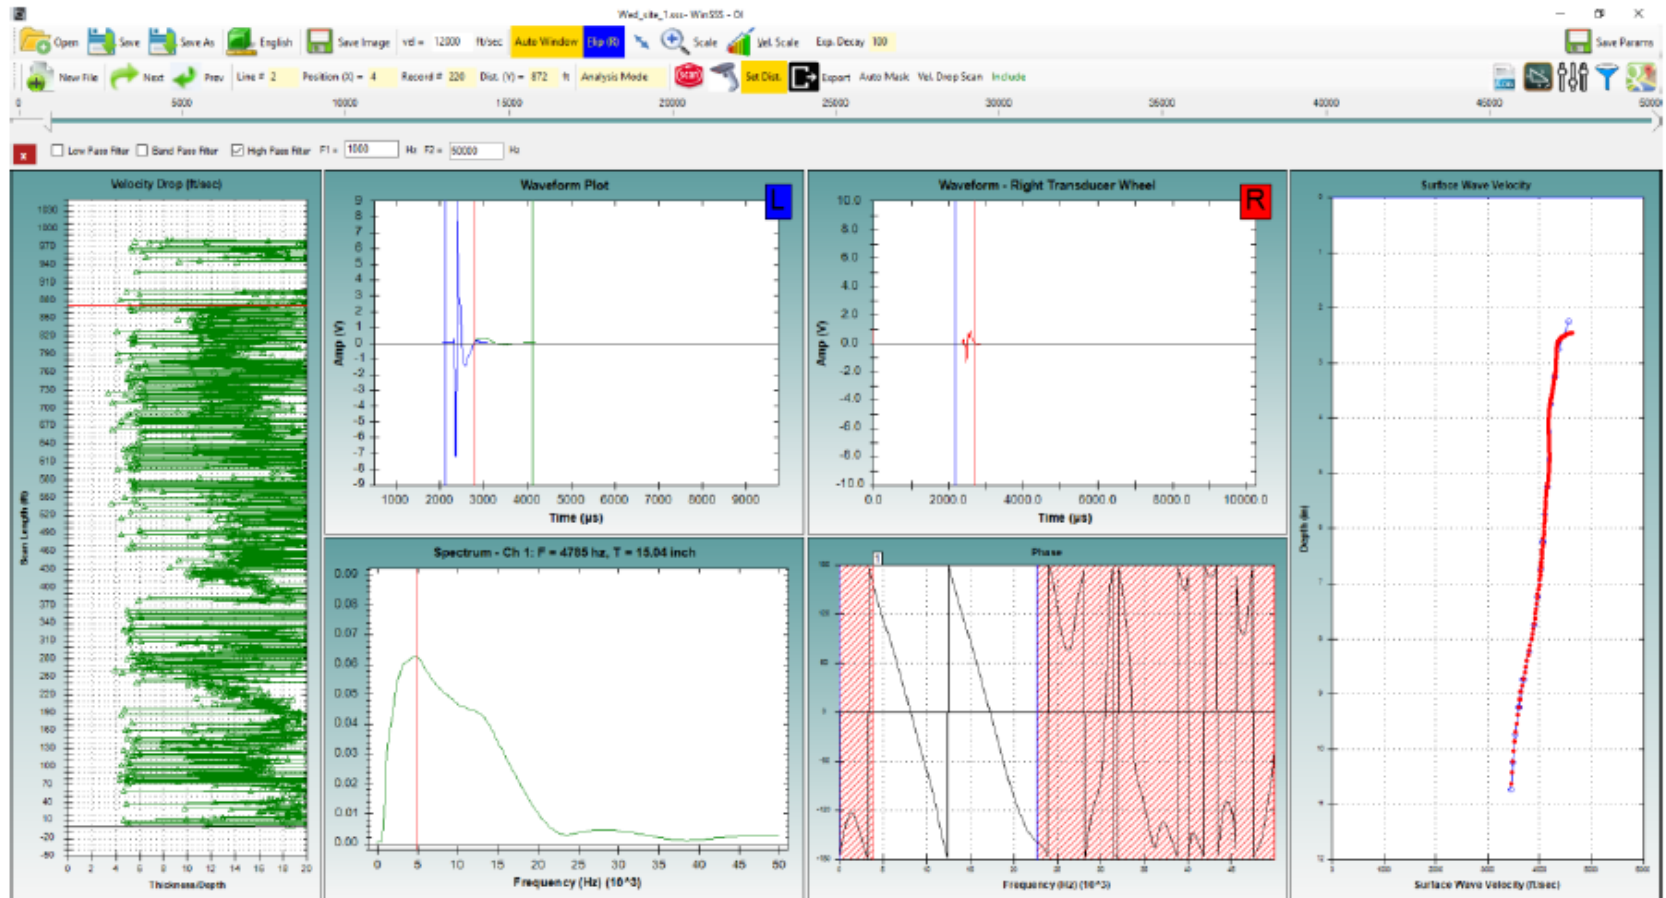
Figure 4: Good SASW conditions from 7/19 Site #1 at X = 872', Y = 3', consistent velocity gradually decreasing throughout full tested depth (2 – 11 inches).

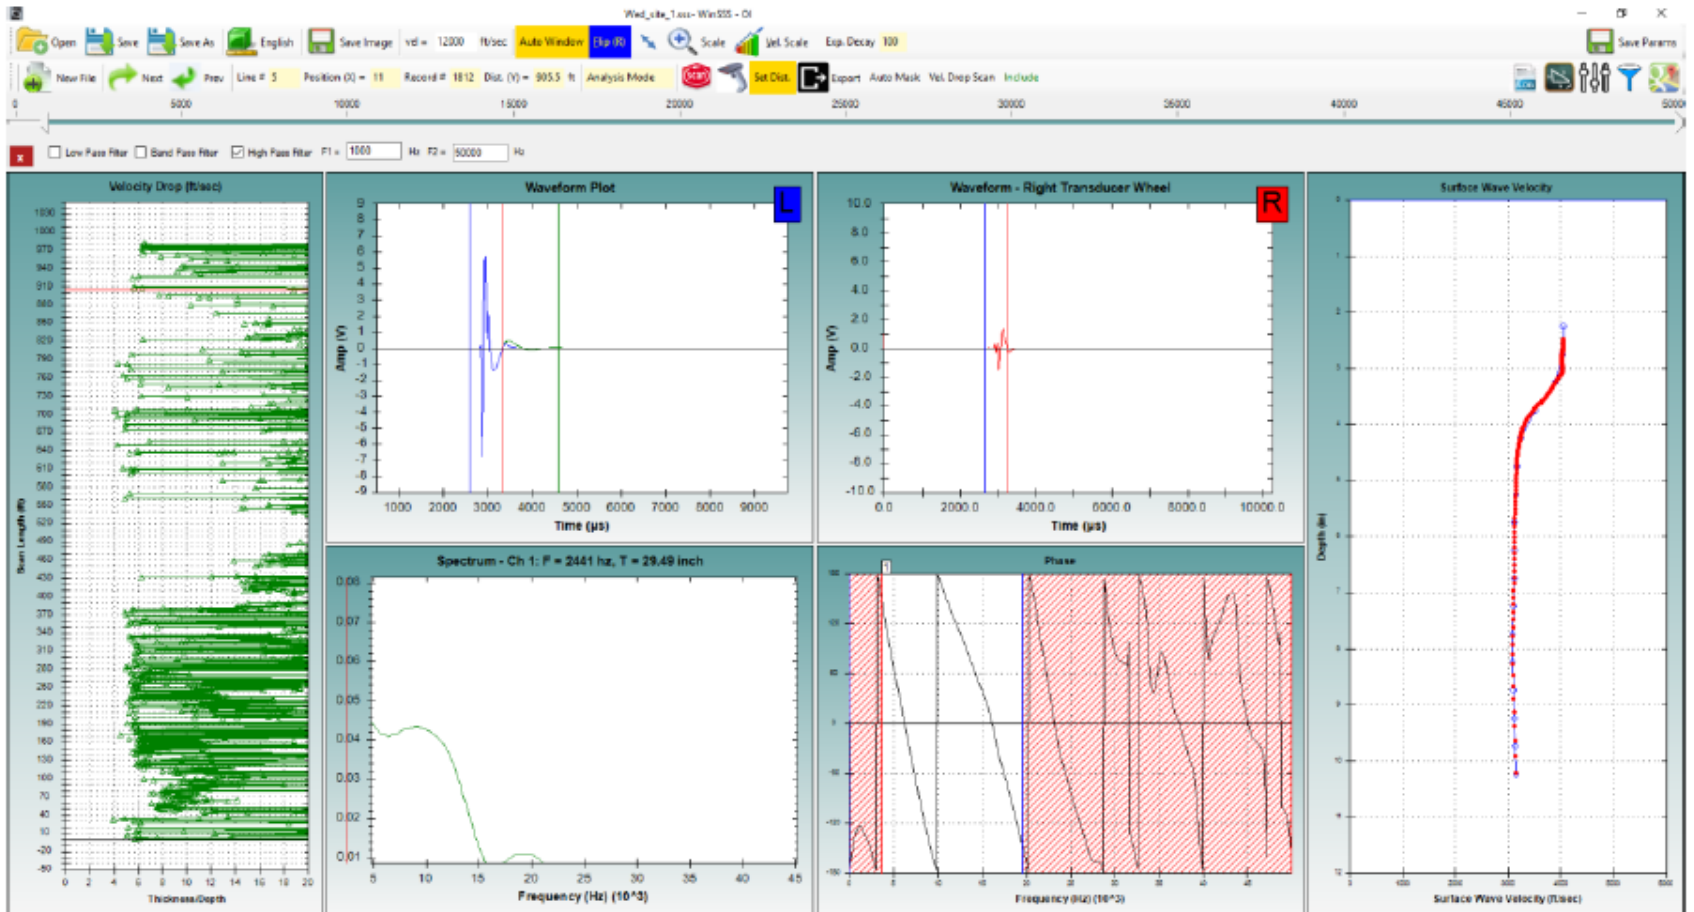
Figure 5: Poor SASW conditions from 7/19 Site #1 at X = 905.5', Y = -9', significant velocity drop of ~1,000 ft/sec between 3 and 4.5 inches deep indicating degradation.

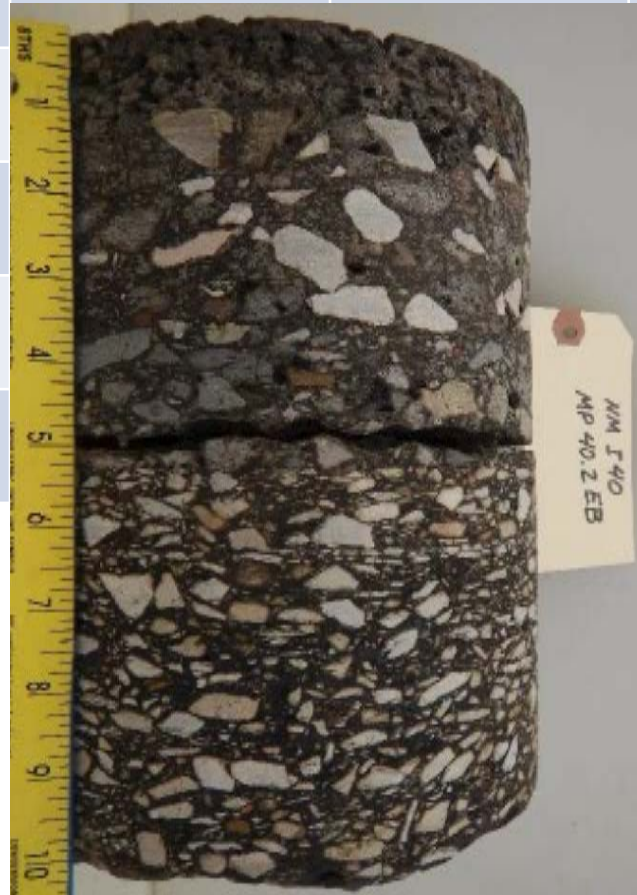
Core #	IE/SASW condition	Depth to Delamination	Core Condition	Depth to Delamination	Accuracy
4	Fair to Poor	4	Debonding	5	Correct, close

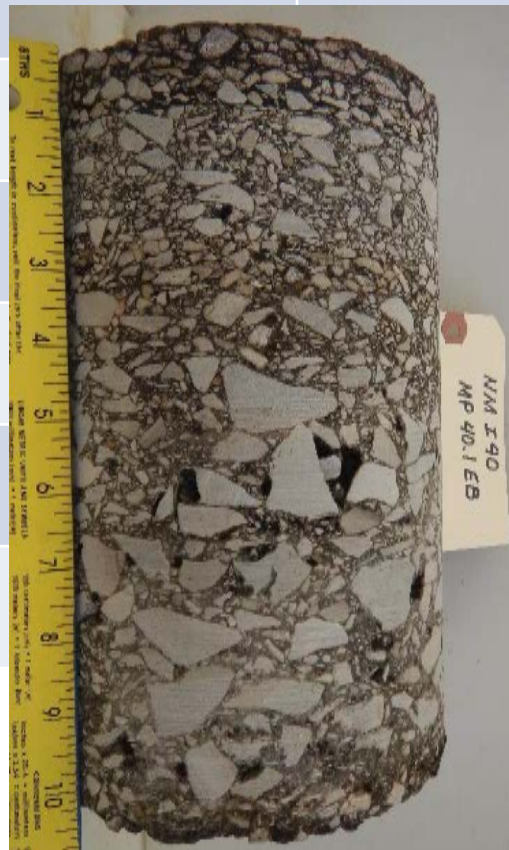
Core #	IE/SASW condition	Depth to Delamination	Core Condition	Depth to Delamination	Accuracy
3	Good, full depth	NA	Visible strip	6	Incorrect

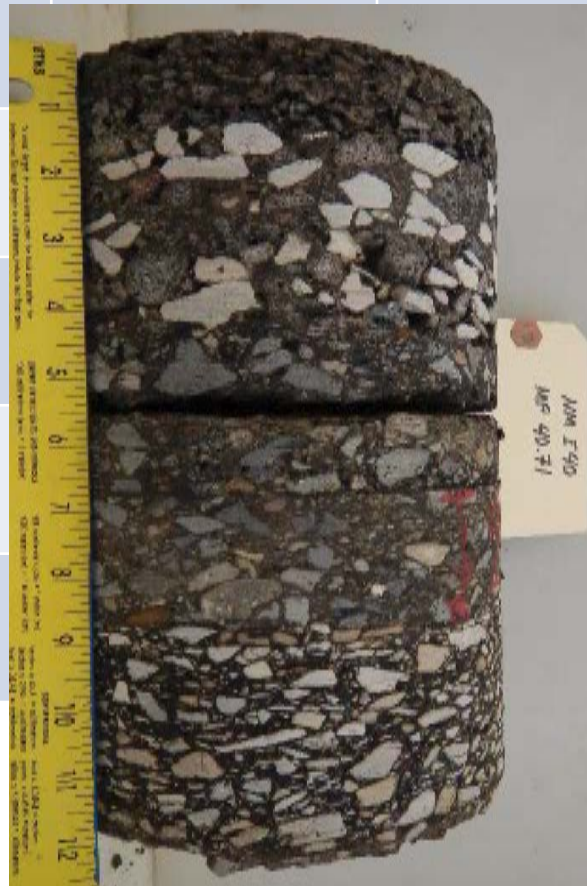
Core #	IE/SASW condition	Depth to Delamination	Core Condition	Depth to Delamination	Accuracy
6	Good to fair	4	Debonding	5.5	Correct, close

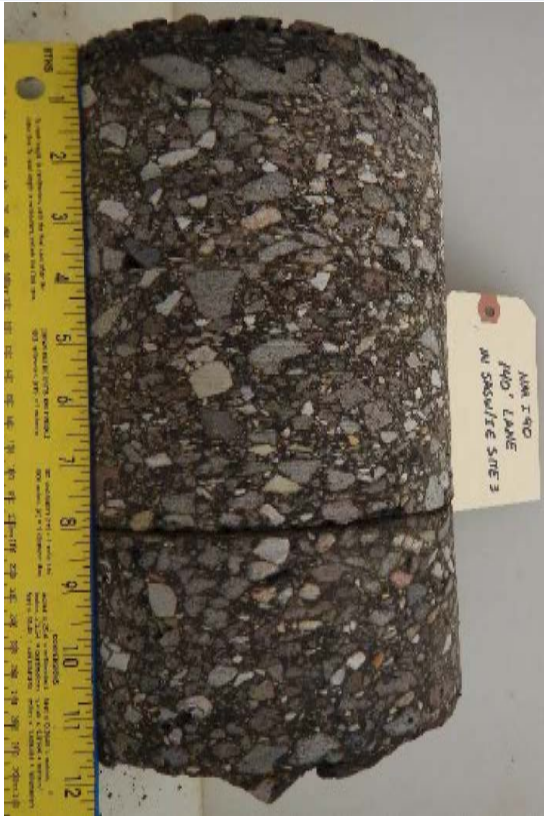
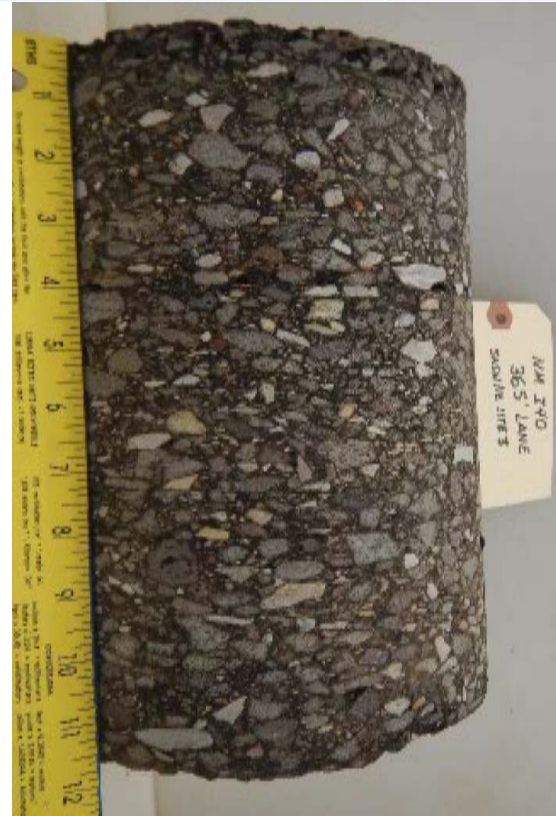
Core #	IE/SASW condition	Depth to Delamination	Core Condition	Depth to Delamination	Accuracy
15	Good, full depth	NA	Debonding	8	Incorrect
16	Good, full depth	NA	Visible strip	4	Incorrect
