Advanced Methods to Identify Asphalt Pavement Delamination (R06D) Spectral Analysis of Surface Waves (SASW) and Impact Echo (IE)

Texas Department of Transportation

Darlene Goehl, P.E.
Research Specialist, TTI
Webinar
August 1-3, 2018

US 59
From Marion/Harrison County line
to FM 1997

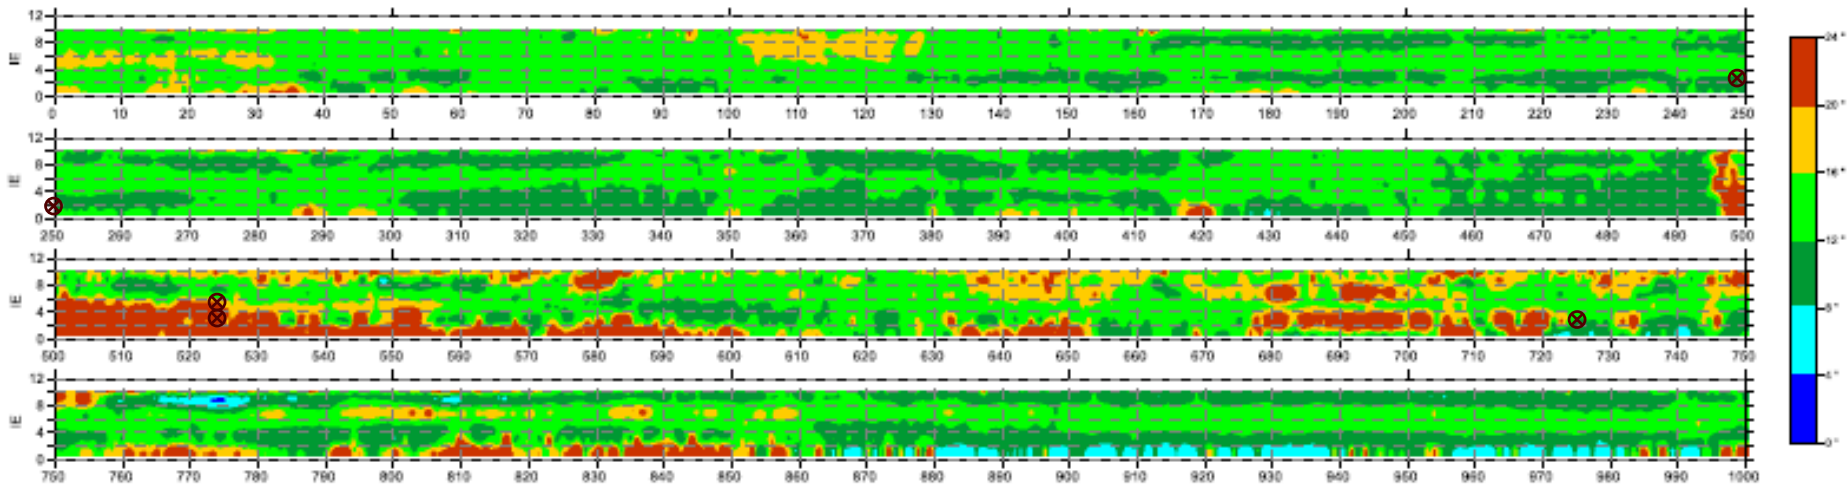
- Impact Echo (IE) Test Results
 - Test every 6 inches resulting in ~12,000 tests for the 6000 LF tested (1000' test section with 6 locations)
 - IE velocity of 8,000 ft/sec used for thickness values
 - Yellow and Red areas are potential deteriorated areas

Figure A1: IE Results, Highway 59 SB Right Lane. X = 0 @ start of section, Y = 0 at right shoulder.

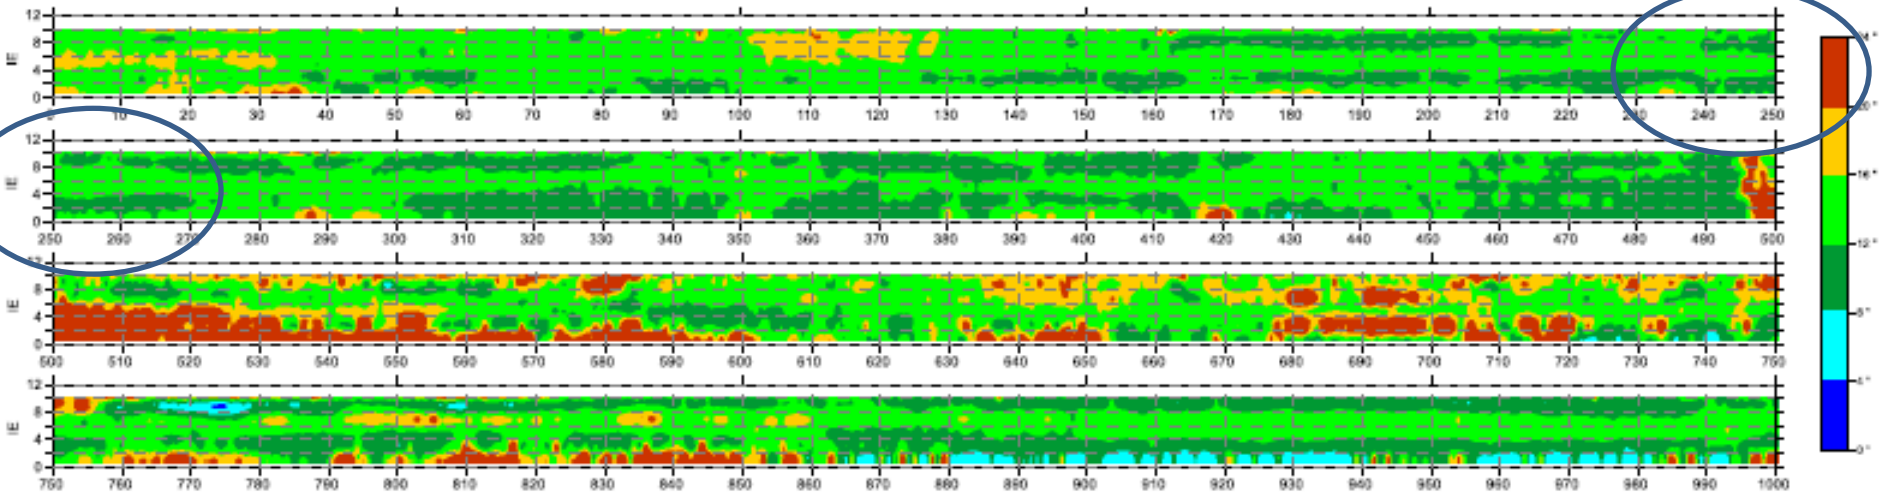
IE Test Results – 250'

Figure A1: IE Results, Highway 59 SB Right Lane. X = 0 @ start of section, Y = 0 at right shoulder.

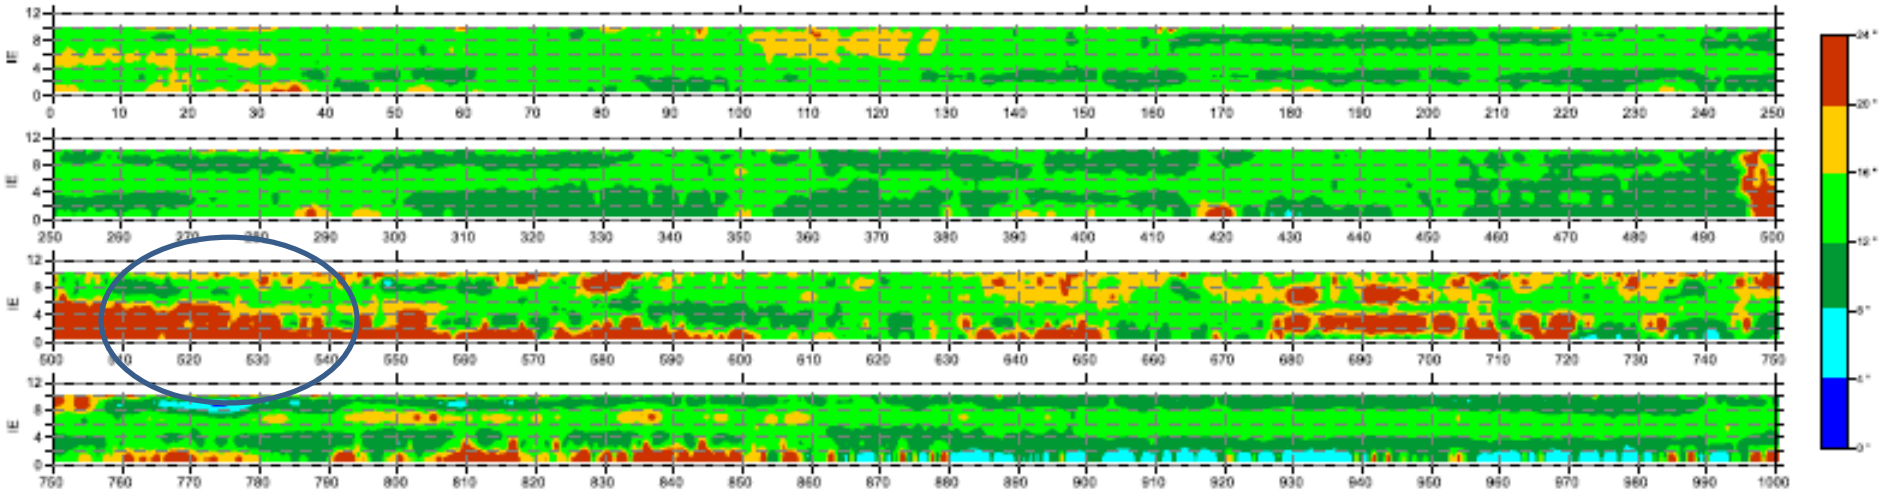
IE Test Results – 525'

Figure A1: IE Results, Highway 59 SB Right Lane. X =

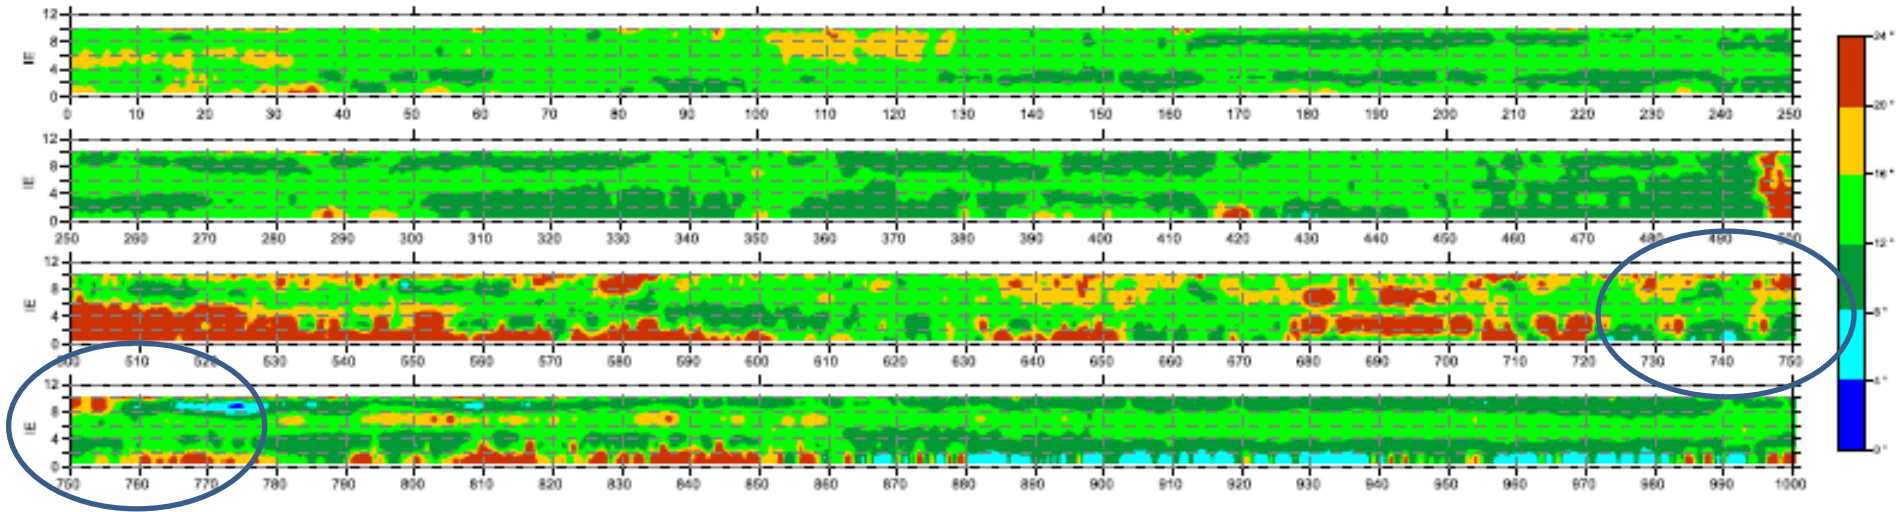
IE Test Results – 750'

Figure A1: IE Results, Highway 59 SB Right Lane. X = 0 @ start of section, Y = 0 at right shoulder.

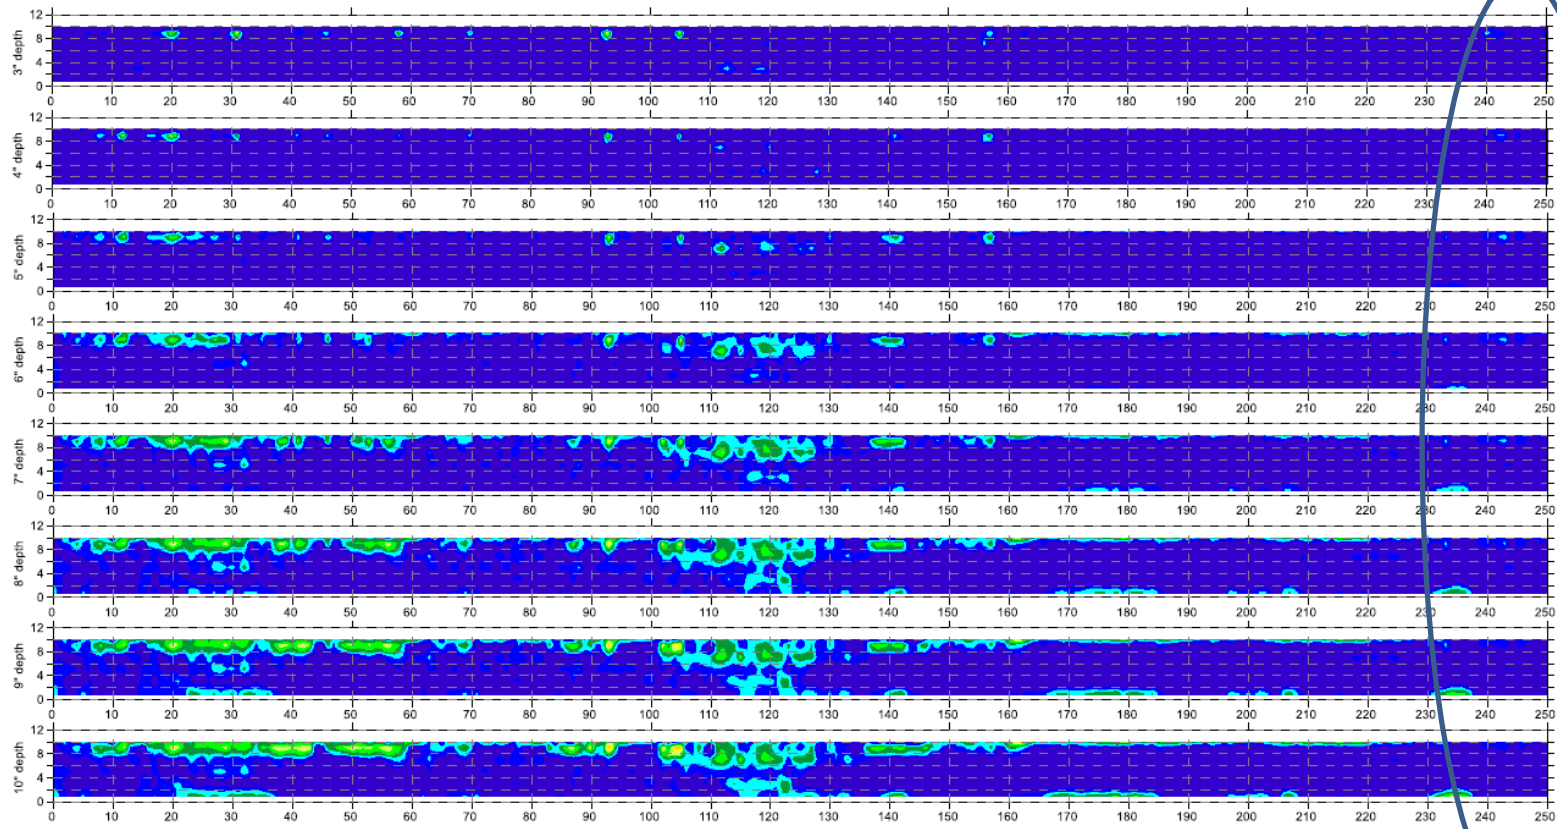
Figure B1: SASW Results, Absolute Velocity, Highway 59 SB, Right Lane. X = 0 @ start of section, Y = 0 at right shoulder. Distance 0 – 250 feet.

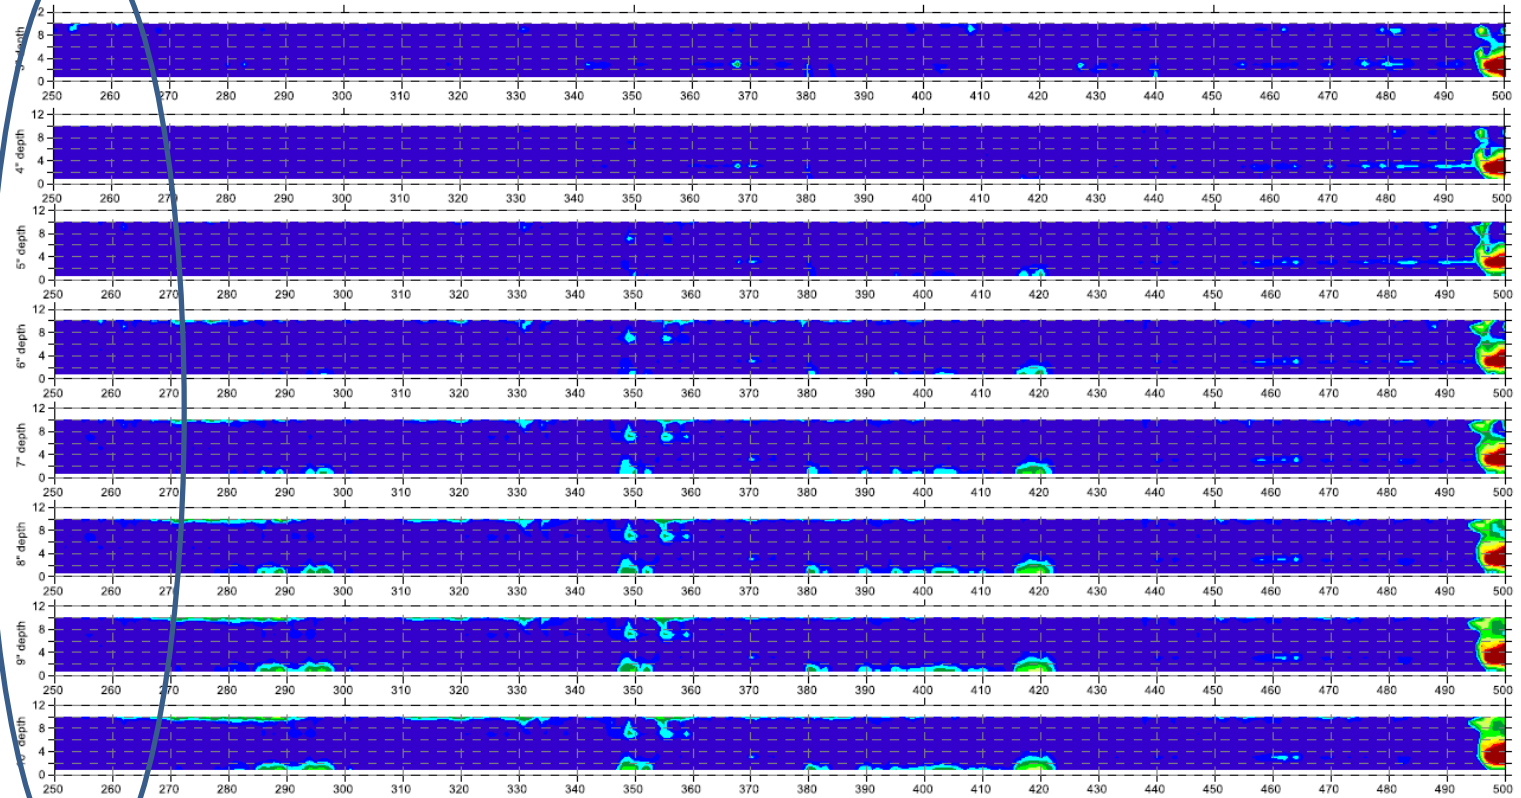
Figure B2: SASW Results, Absolute Velocity, Highway 59 SB, Right Lane. X = 0 @ start of section, Y = 0 at right shoulder. Distance 250 – 500 feet.

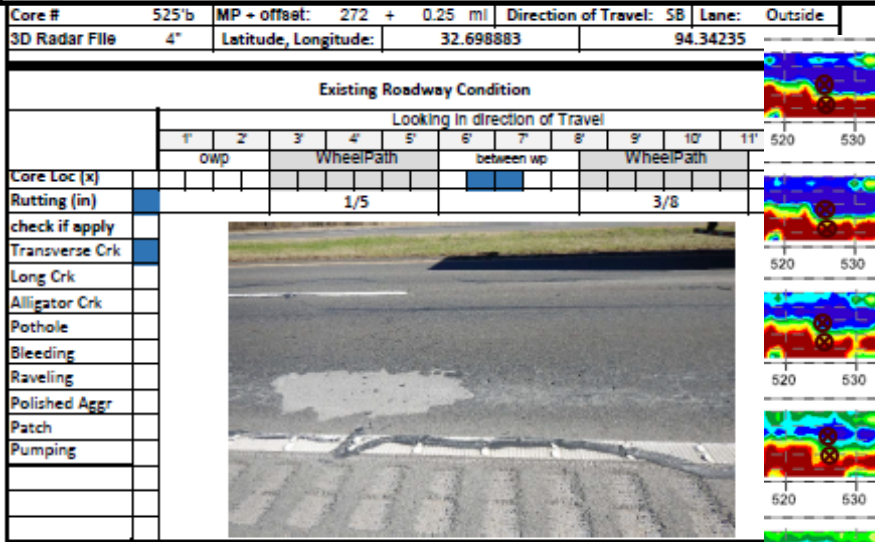
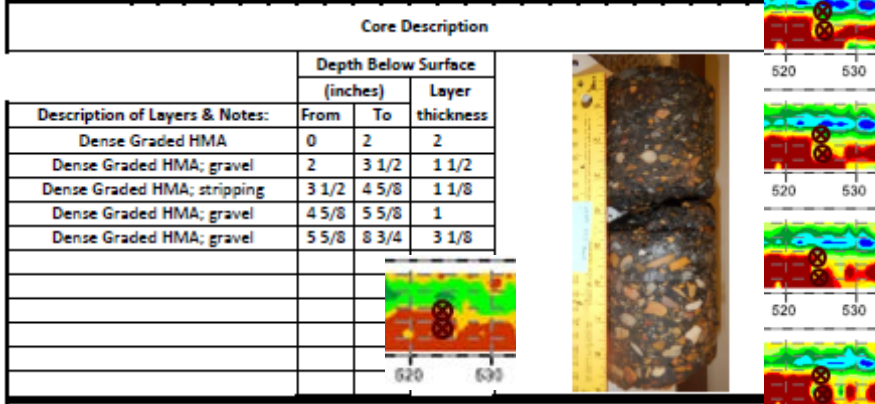
2nd Core – POOR CONDITION

Description of Layers & Notes:	Depth Below Surface (inches)		Layer thickness
	From	To	
Dense Graded HMA; cracked	0	2	2
Dense Graded HMA; stripping	2	3 1/2	1 1/2
Dense graded HMA; gravel	3 1/2	7	3 1/2

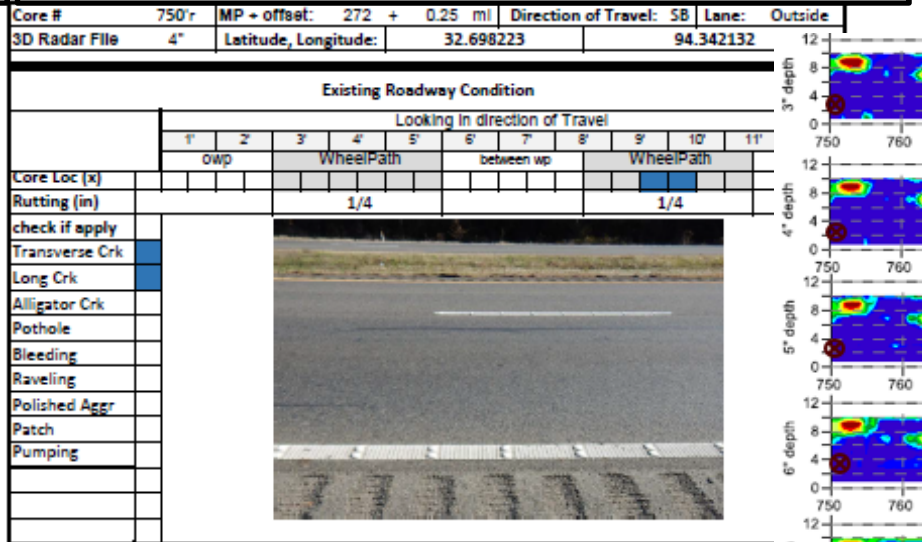
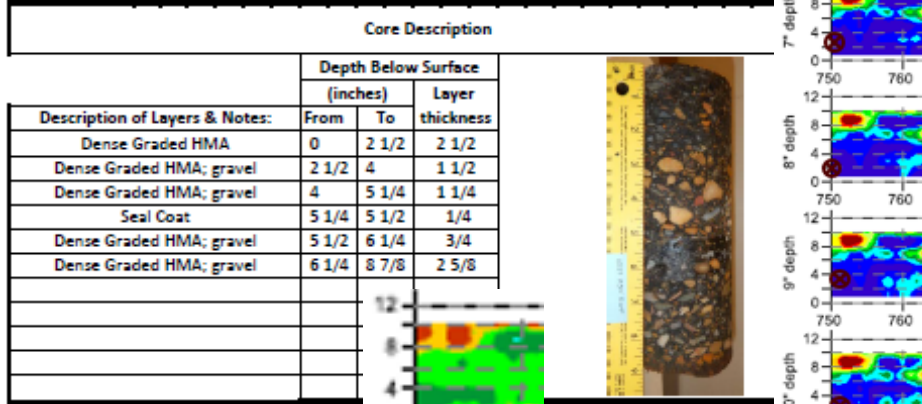
2nd Core – FAIR CONDITION

Core #	Distance from Start (ft)	Expected Condition	Depth of Deterioration (inches)	Notes
1	250	Good Condition, Full Depth	NA	
2	525	Poor Condition	<3 to 7"	Core on borderline regarding depth to degradation, possibly near surface, possibly 6-7" deep
3	750	Fair Condition	7"	Core on borderline of Poor Condition near surface and Fair condition at 7" deep
