### Final Report on the Non-Destructive Inspection of the Tooth Rock & Vista Ridge Tunnels

Oregon Department of Transportation Contract B35752 R06G Tunnel Liner Investigation Project

October 16, 2018

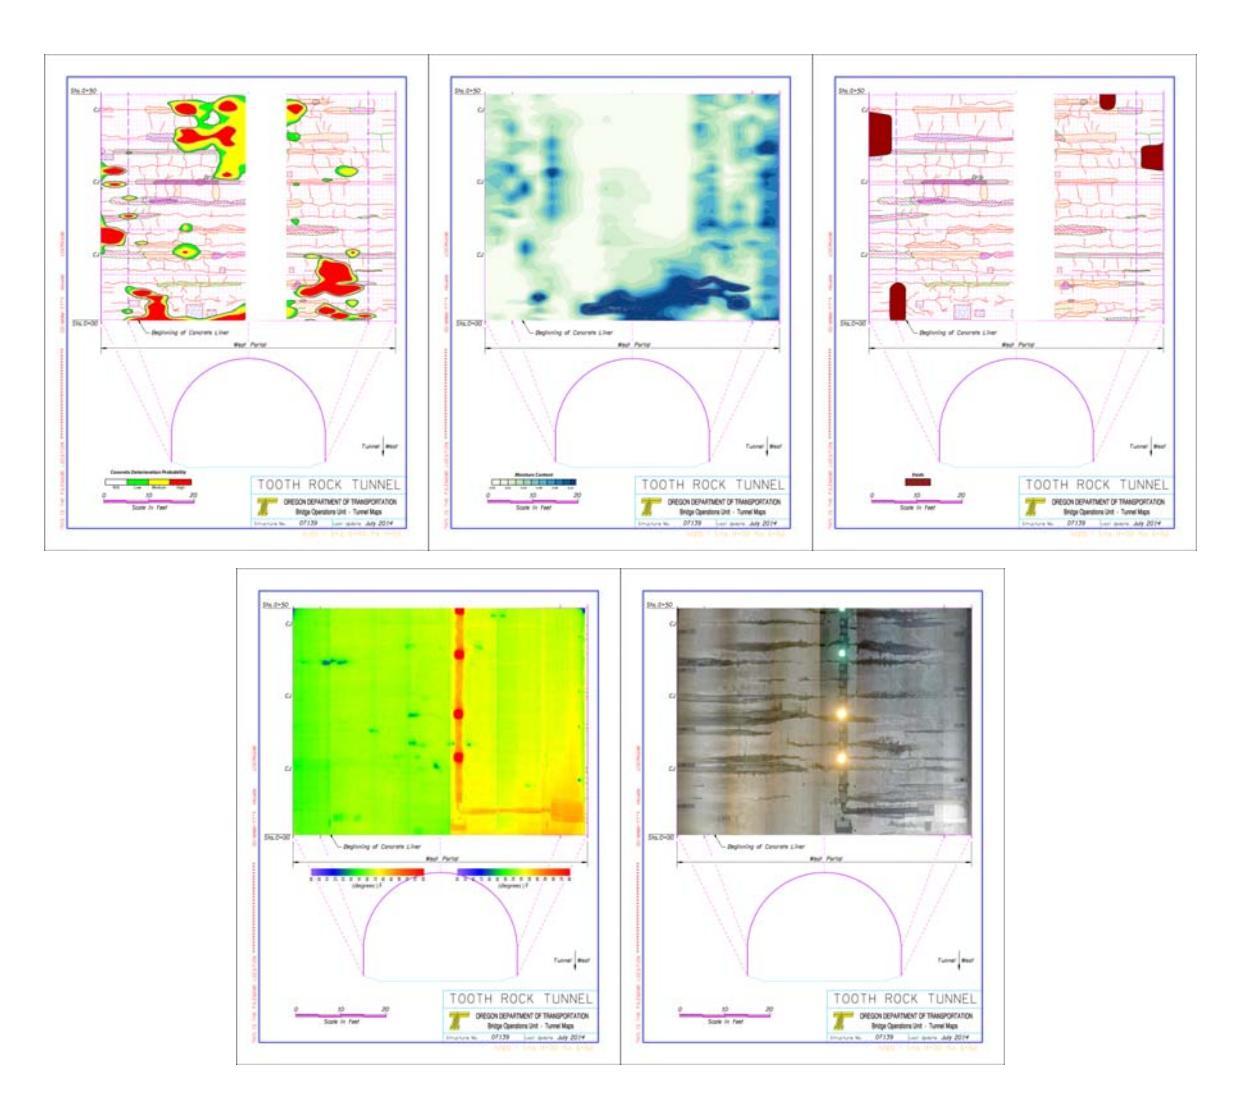
*Figure 5.* Unfolded Plan-view maps show GPR Attenuation (top left); Moisture Content (top middle); Air-Filled Voids (Top Right); Infrared Thermography Temperature Measurements (Bottom Left); and High Resolution Imaging (Bottom Left). These maps are shown in 50-foot sections near the West Portal of the Tooth Rock Tunnel.

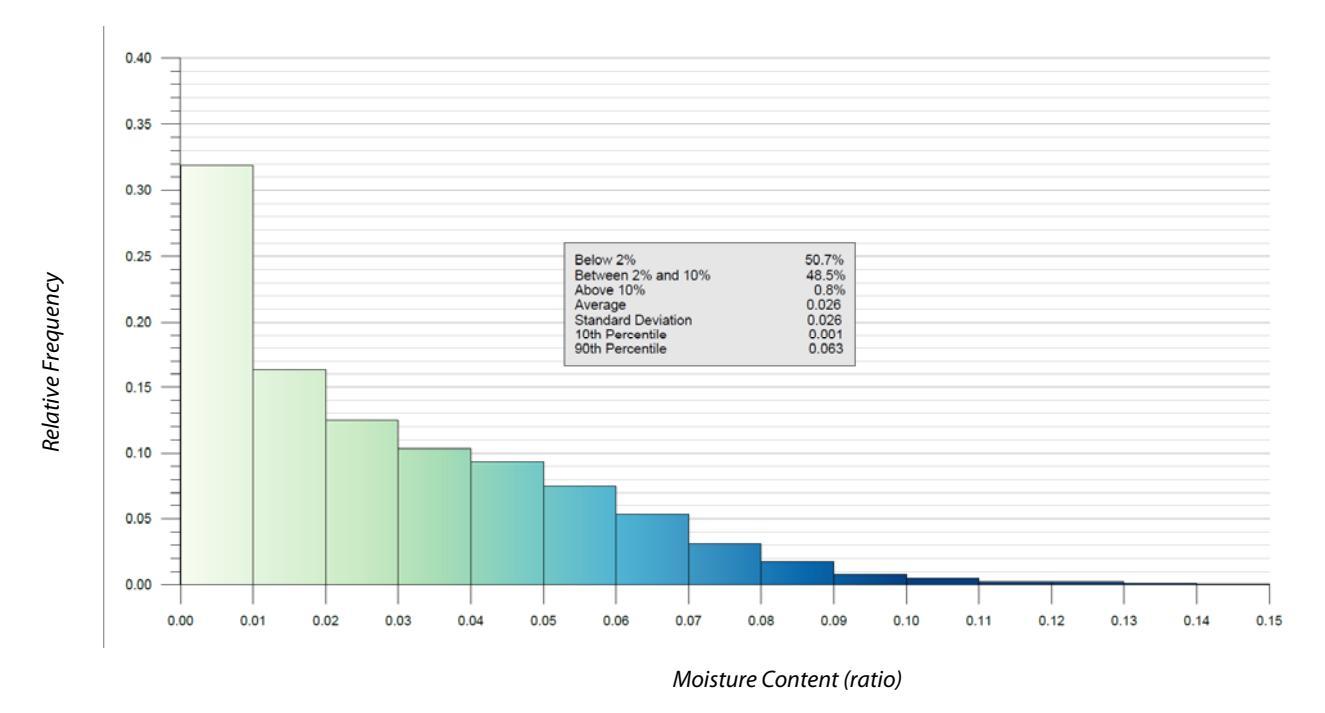
**Moisture Content Distribution of Tooth Rock Tunnel**

The average dielectric constant of the west wall was determined to be 8.2. This value corresponds to 2.6% moisture by volume. Figure (14) shows the distribution plot of calculated moisture content of the concrete of the Tooth Rock Tunnel. (The colors of the graph for the moisture connect values match the corresponding moisture maps shown later in this report.) Just as in the GPR attenuation distribution charts, the moisture content values are shown in relation to frequency of occurrence. There are three percentages given for ranges of dielectric constants for concrete that relate to low (less than 2%), moderate (2%-10%) and high (10% or greater) amounts of moisture content in the concrete. For the Tooth Rock Tunnel, 50.7% (26,778 ft<sup>2</sup>) of the concrete liner was found to have low moisture content, 48.5% (25,578 ft<sup>2</sup>) with moderate moisture content and 0.8% (404 ft<sup>2</sup>) of the concrete to have a high moisture content.

**Figure 14.** Histogram showing the distribution of calculated moisture content based on relative dielectric content of concrete in the Tooth Rock Tunnel. The dielectric constant is calculated based on measurement of the surface reflection coefficient of the liner, which is related to moisture content in the liner. The relative frequency shows the percentage of moisture content ratio values falling within a specific range. Higher calculated moisture content generally derives from higher dielectric constants.

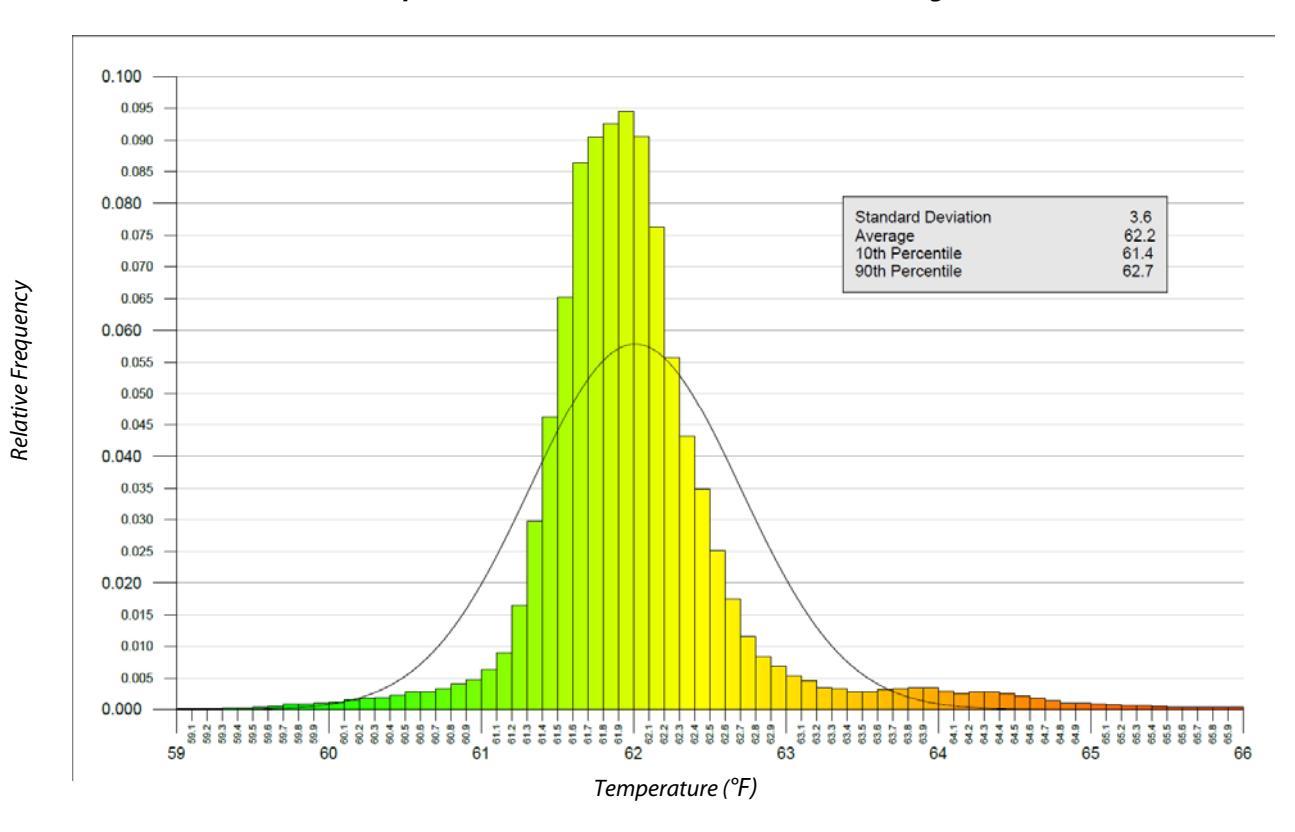
Infrared Temperature Distribution of Tooth Rock Tunnel (Right Lane Wall)

Although temperature measurements were tightly distributed, the infrared inspection identified warmer areas, possibly the result of debonded or delaminated concrete, and cooler areas throughout the tunnel which were caused by water flow. A large area of these cooler sections can be found from Sta 1+50 to Sta 2+00.

**Figure 15.** The histogram showing the distribution of temperature values recorded during the Infrared Thermography scan of the Tooth Rock Tunnel – Right Lane Wall.

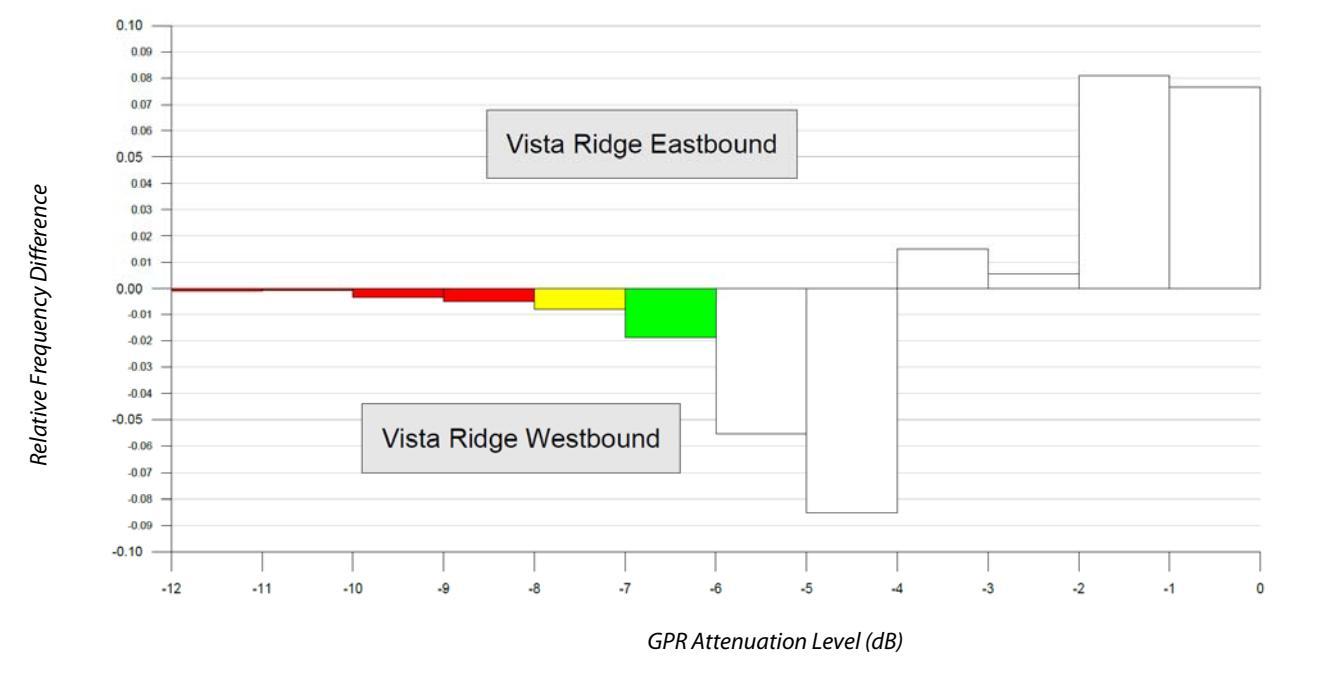
#### GPR Attenuation Distribution Comparison of Vista Ridge Tunnels

In comparing the attenuation distribution for the eastbound and westbound Vista Ridge tunnels; it is evident that the Westbound tunnel exhibited higher amounts of attenuation for all values exceeding the GPR attenuation threshold of -6db. With roughly twice the attenuation found in the westbound than the eastbound tunnel, a comparison would suggest the westbound tunnel to be in generally worse physical condition than the eastbound tunnel. The comparison of the two sides is shown in Figure (23) below.

**Figure 23.** The comparison shows the difference in the relative frequencies of each GPR attenuation level for the Vista Ridge Eastbound and Westbound Tunnels. This shows that high attenuation levels were found in a greater percentage of the westbound tunnel eastbound tunnel, suggesting that the westbound tunnel is in worse condition.

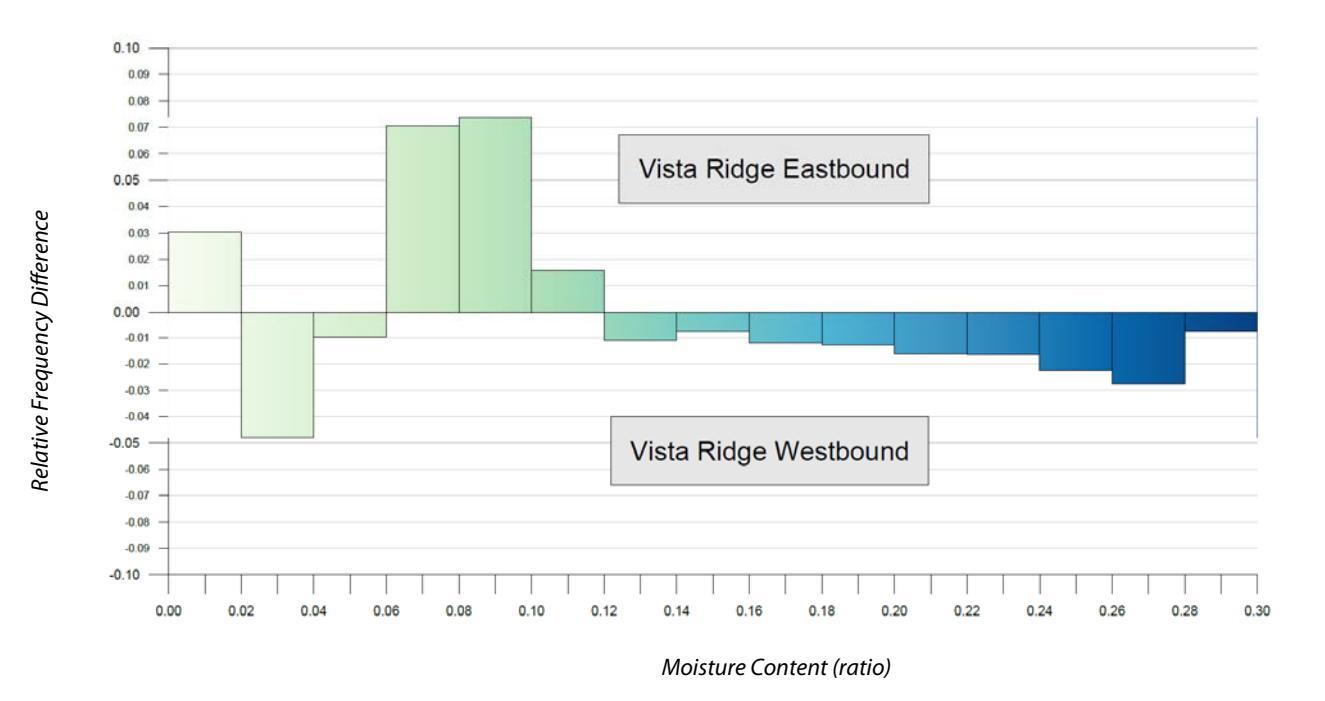
Moisture Content Distribution Comparison of Vista Ridge Tunnels

**Figure 30.** The comparison shows the difference in the relative frequencies of the calculated moisture content values for the westbound and eastbound Vista Ridge Tunnels. A greater number of measurements below a moisture percentage of 12 (measured dielectric constant of 15.2) were found in the eastbound tunnel while a greater number of moisture percentage above 12 were found in the westbound tunnel which implies a greater overall presence of moisture content in the westbound tunnel. This difference equates to the westbound tunnel containing 2% more moisture than the eastbound tunnel, overall.

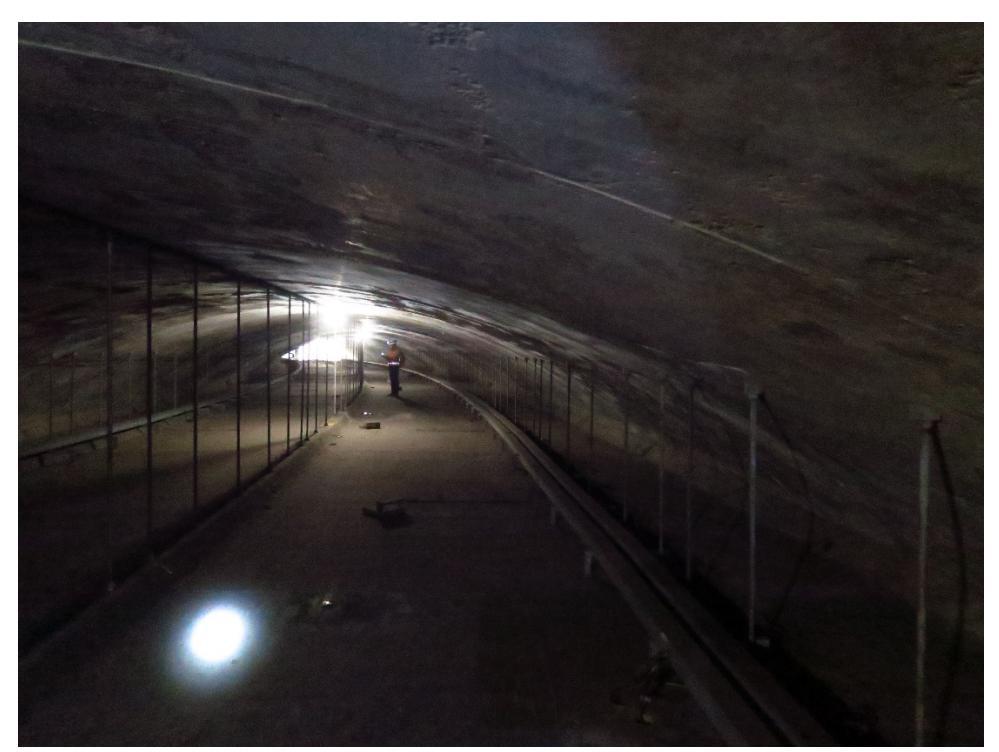
The entire EB Adit is lined with CIP concrete. Overall the concrete liner was observed to be in good condition (CS1). The concrete was sound based on regular concrete sounding with a hammer. Figure 3 shows the typical conditions of the EB Adit.

Figure 3. Typical adit conditions. Photo taken in EB Adit at approximate Station 3+00, looking west.

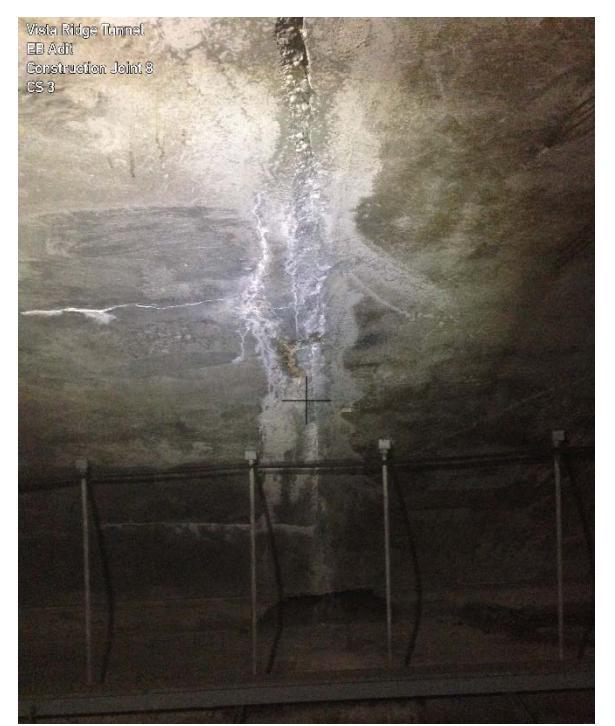
The concrete lining was generally dry. Thirteen actively dripping areas were observed, each located along construction joints. In each area, seepage was measured at less than 5 drips per minute.

Figure 4. Typical construction joint. Photo taken in EB Adit at approximate Station 1+70, looking south.

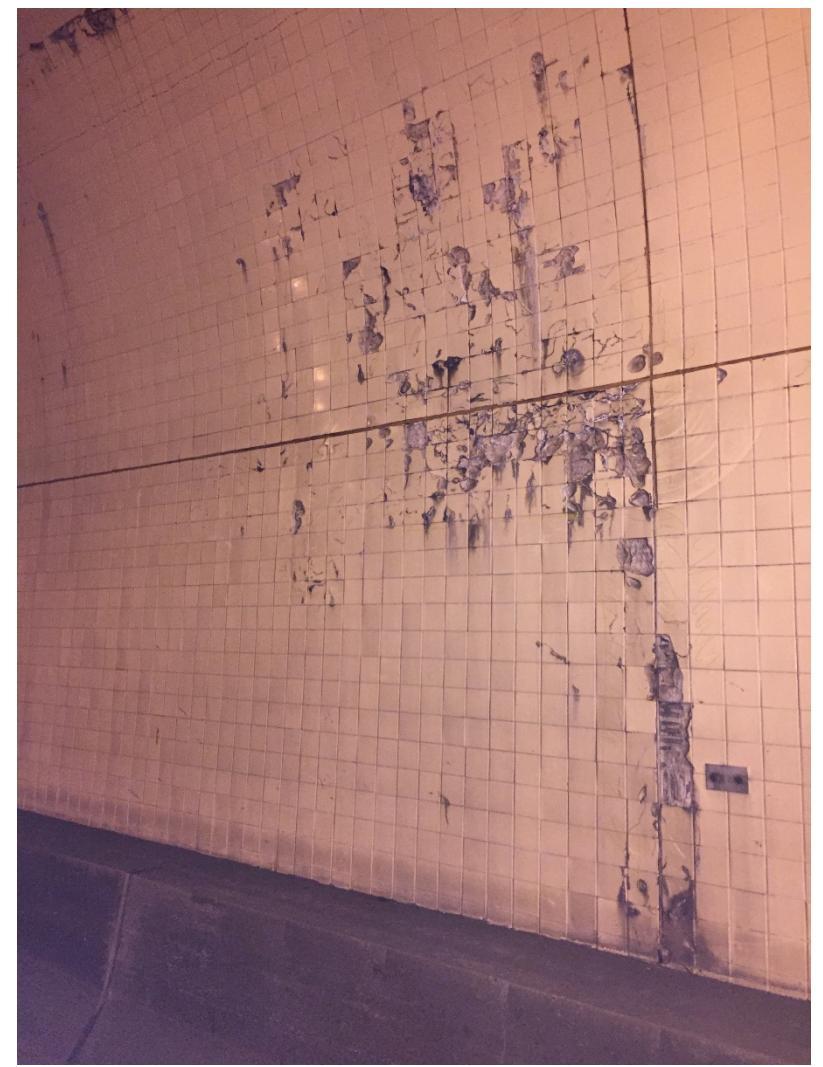
Numerous spalls were historically mapped in this tunnel, primarily above springline (about 7 ft above roadway). The majority of these appeared to be relatively small (less than 6-12 inches in diameter). In some cases, minor spalls (less than 3 inches) and short cracks were concentrated in small (less than 100 square feet) areas (Figure 5). Several transverse spalls were along cracks near the 2 to 3 o'clock and 9 to 10 o'clock position. These are near the transition to the adit slab. Due to access these were not quantified but they appeared to be primarily CS2 and CS3 defects.

Figure 5. Concentrated area of small spalls and cracks. Photo taken in EB Tunnel at approximate Station 9+50, looking southeast.

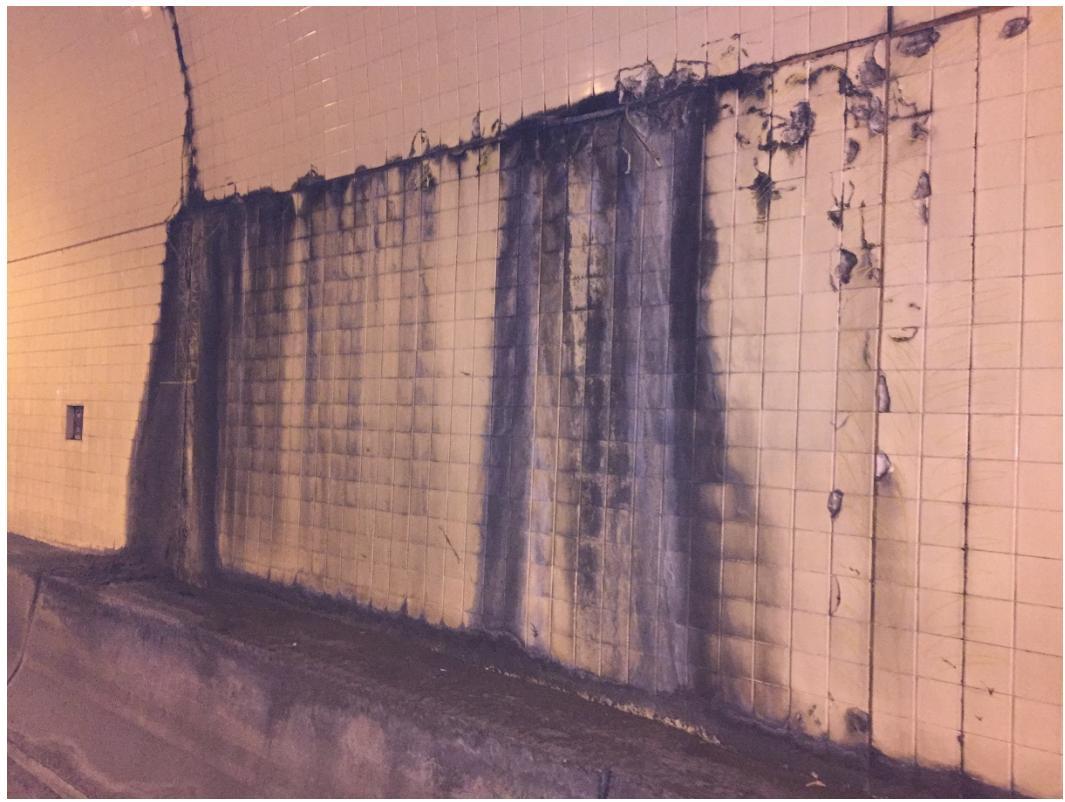
The tunnel lining was generally dry. Minor seepage staining was present on both transverse and longitudinal cracks (Figure 6). One moist area was observed near Station 4+06 at the foot of the north tunnel wall. Active seepage was not measurable. Minor efflorescence was observed in several locations however this is likely removed with the regular wall washing completed by ODOT maintenance forces.

Figure 6. Water staining along transverse and longitudinal construction joints. Photo taken in EB Tunnel at approximate Station 9+75, looking southeast.

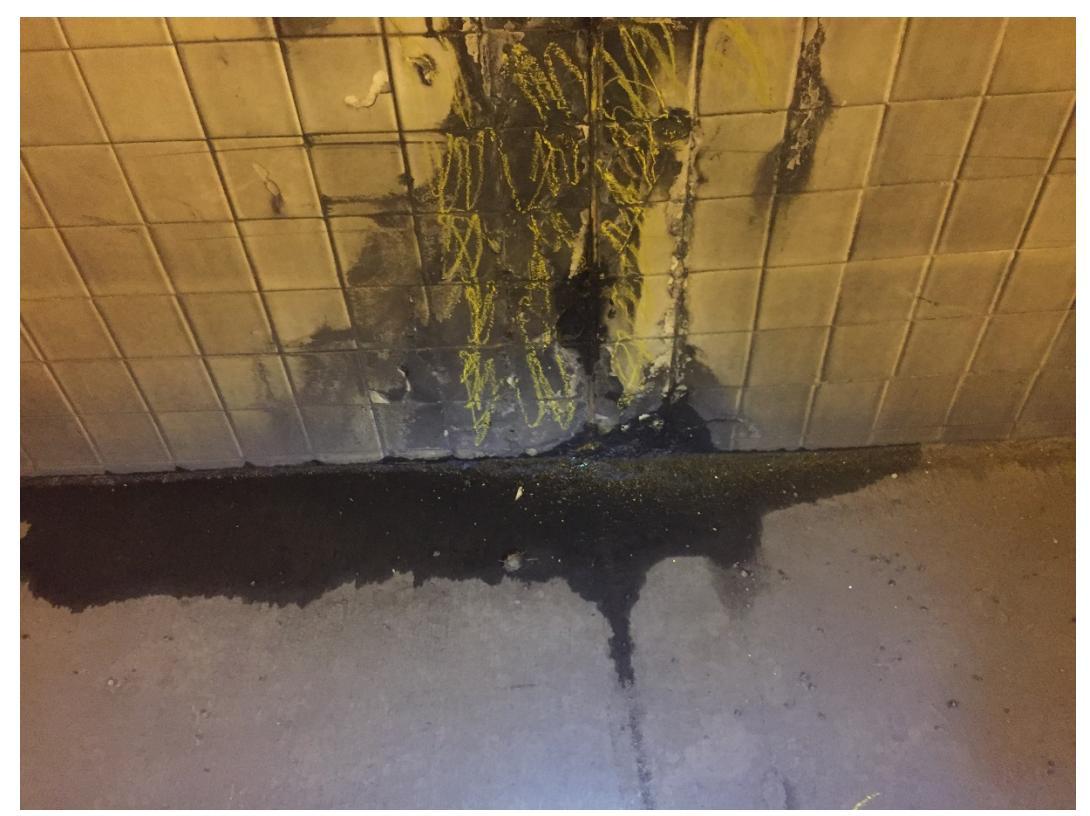
The tunnel lining was generally dry. Seepage staining was limited and significantly less than what was observed in the east-bound tunnel. Observed staining occurred on both transverse and longitudinal cracks. Two moist areas were observed near Stations 2+90 and 3+18, both at the foot of the right (south) tunnel wall (Figure 7). Active seepage was not measurable. Efflorescence was not observed in this tunnel however this is likely removed with the regular wall washing completed by ODOT maintenance forces.

Figure 7. Wet area and staining at the base of the tunnel wall. Yellow grease pencil identified debonded tile. Photo taken in WB Tunnel at approximate Station 2+90, looking south.
