# FDOT'S Experience with 3D RADAR

**Bouzid Choubane**, Florida Department of Transportation  
**Charles Holzschuher**, Florida Department of Transportation  
**Guangming Wang**, Florida Department of Transportation  
**Ken Maser**, Infrasense, Inc.  
**Edward Offei**, Applied Research Associates

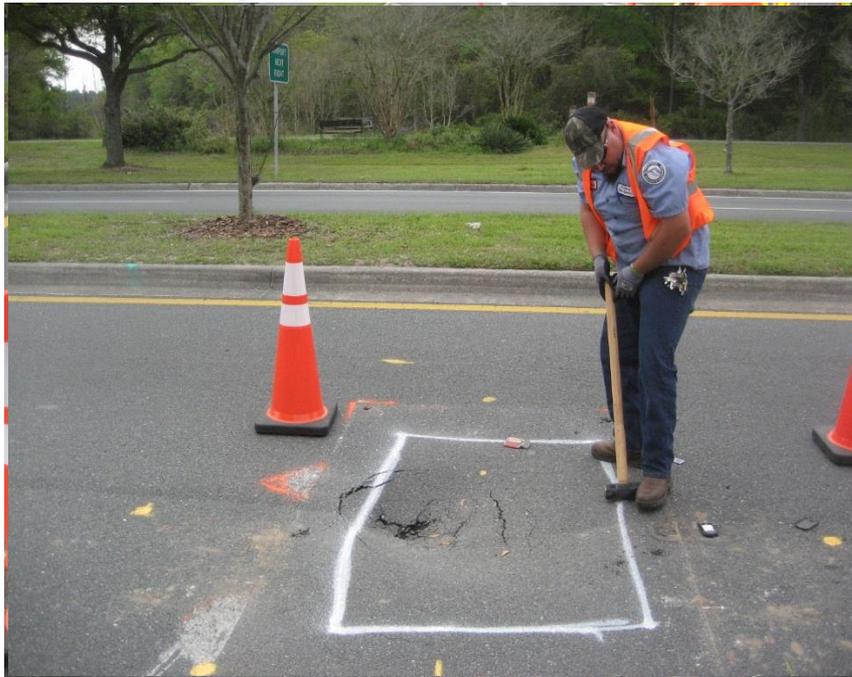
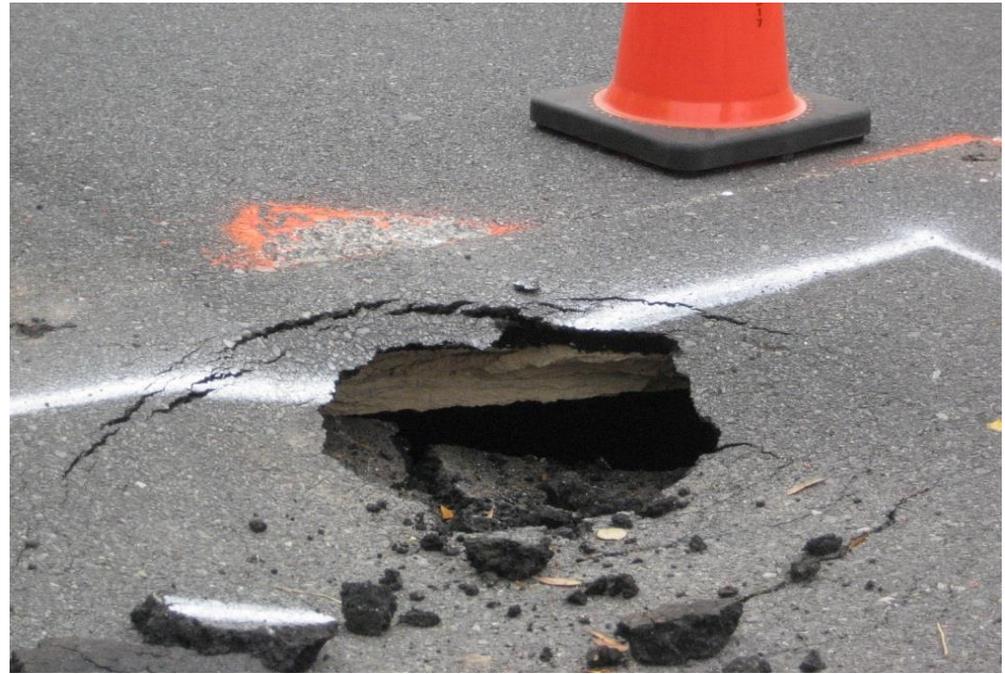
# Sinkhole Investigation

- Pavement depression on SR 24 in Gainesville, FL
- Southbound Lanes
- Steel plate used to temporarily cover pavement depression

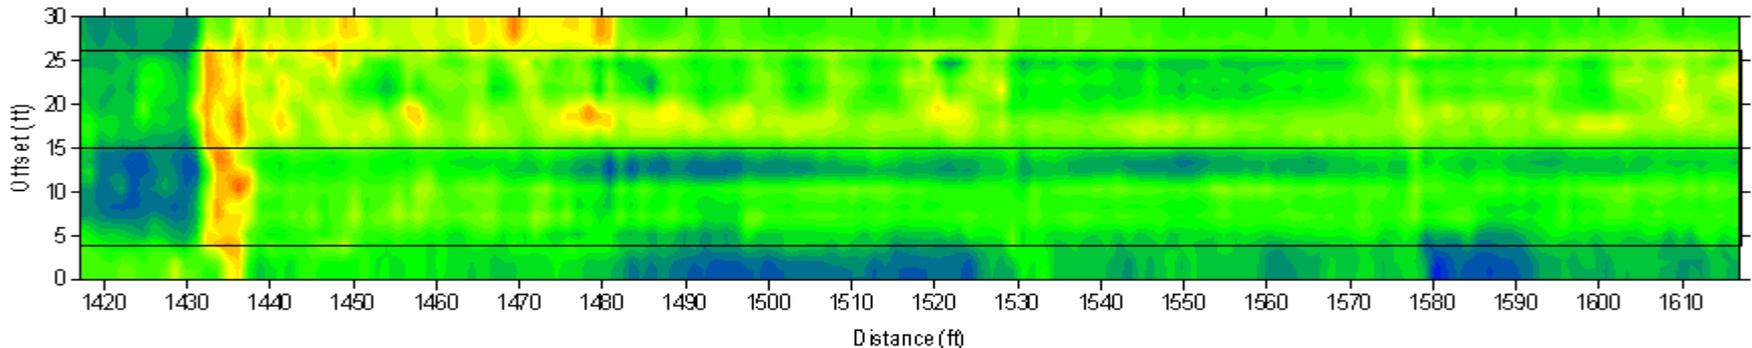
# Bridge Deck Survey

- Bridge Number 940045
- SR A1A, Roadway Section 94060 (MP 0.330 to 0.719)
- Bridge Length = 2,054 ft.
- Bridge Width = 30 ft.
- Steel Grate from 1,314 ft. to 1,417 ft. from South End of Bridge (Excluded from Contour)

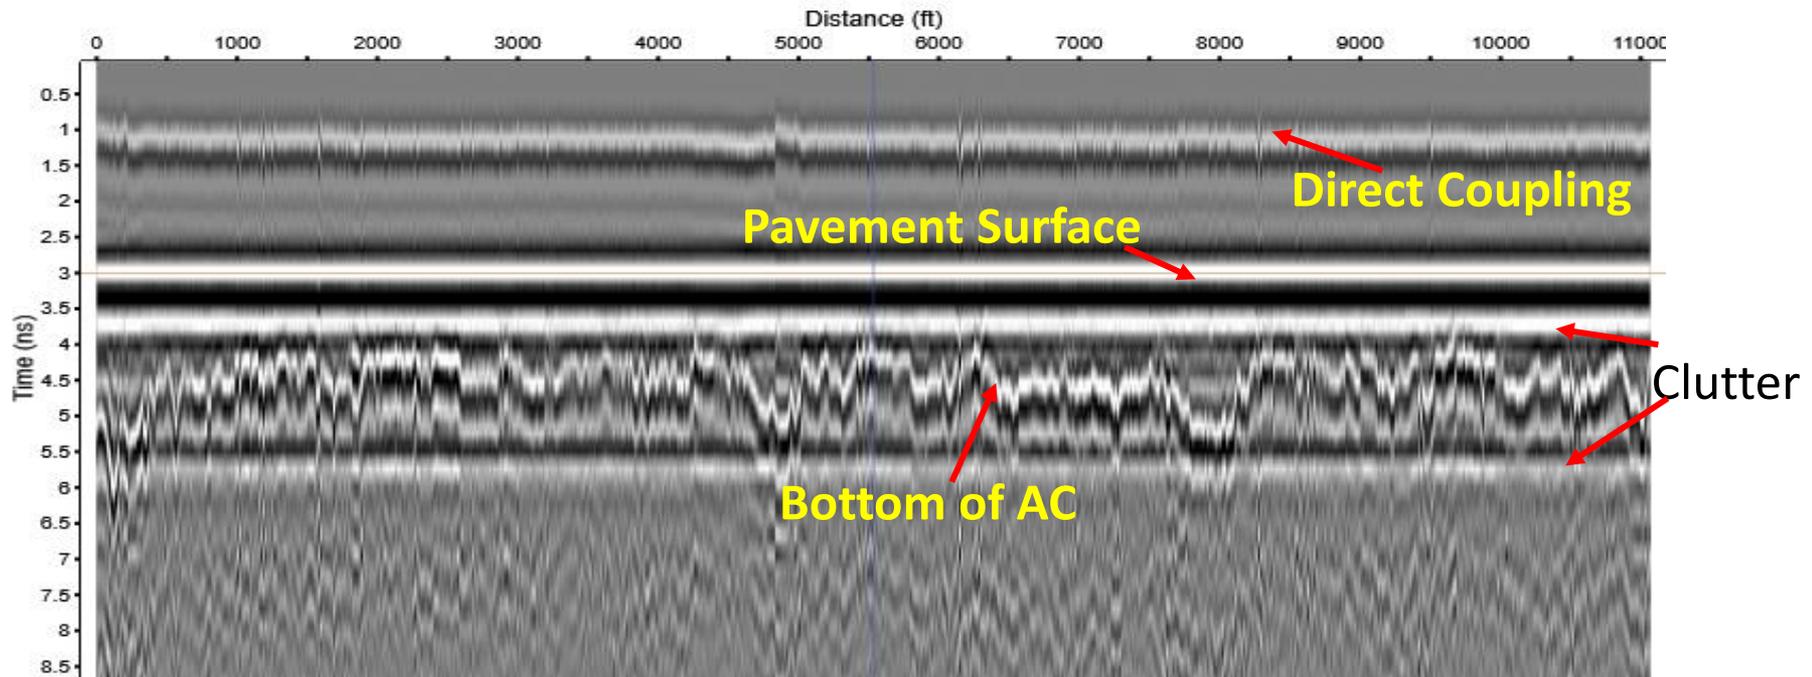
- Mounting Systems:
  - Issues with existing mounting
  - Clutter problem not solved

GPR reflection interference (“clutter”) caused by vehicle proximity and mounting

- “Clutter” is caused by reverberations from the pavement and nearby objects
- Some clutter is intrinsic to the antenna, and some is related to the mounting system and proximity to the vehicle.
- For most analyses, it will be necessary to do background removal starting just below the pavement surface, in order to effectively remove the clutter.
- Sometimes background removal takes away some of the real data
- Best approach is to mount the antenna in a way to minimize clutter

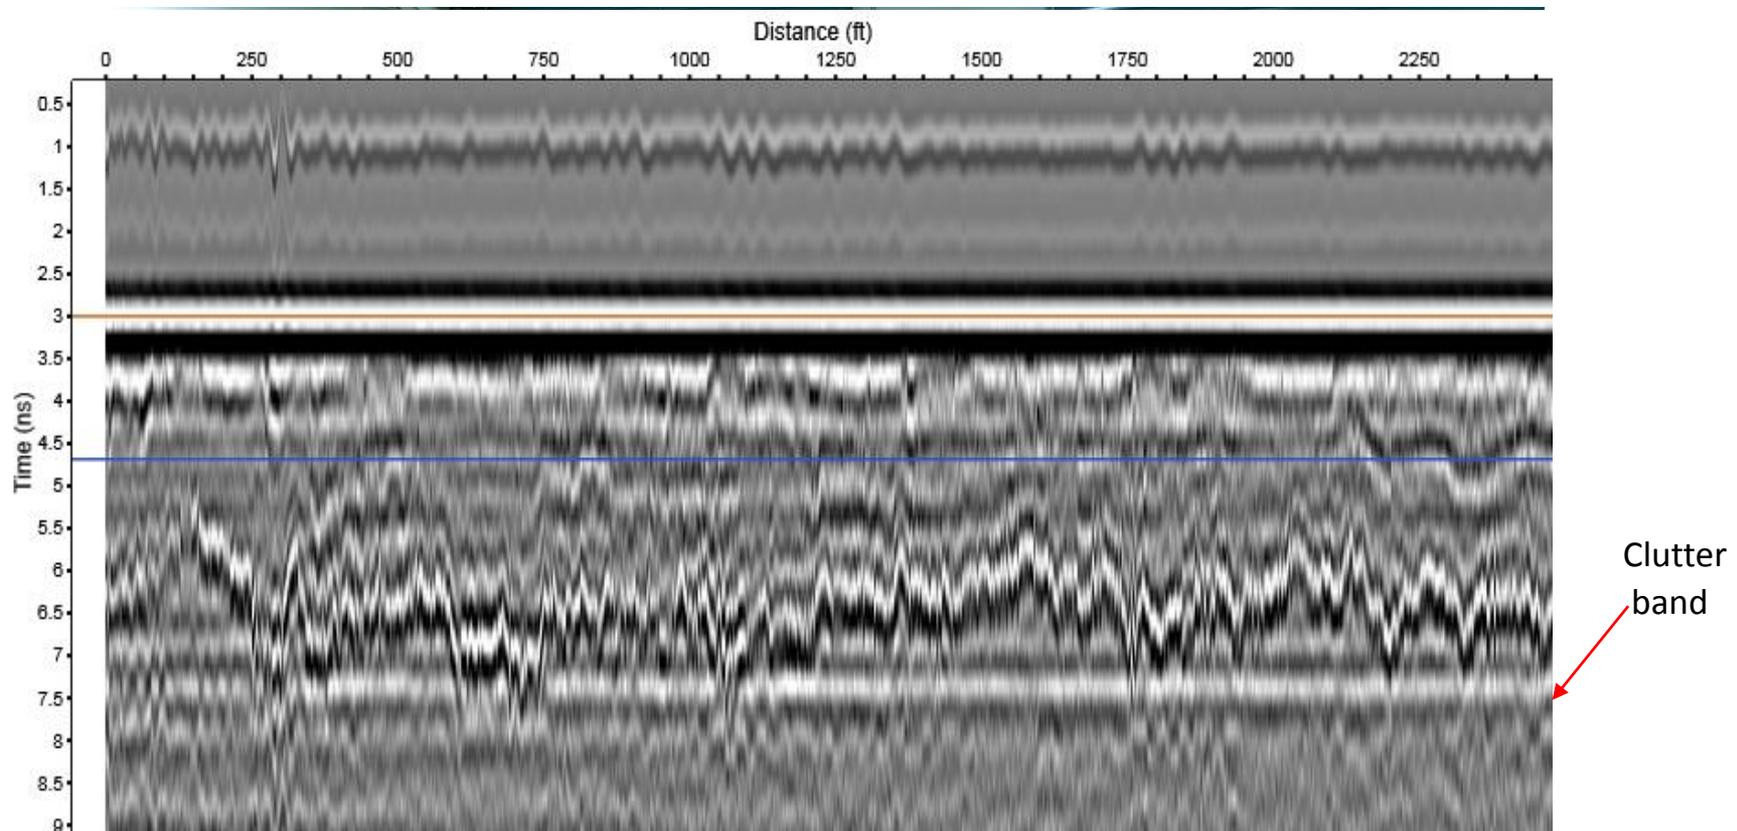
- Development of improved mounting
- FDOT: 4ft offset and 15in height

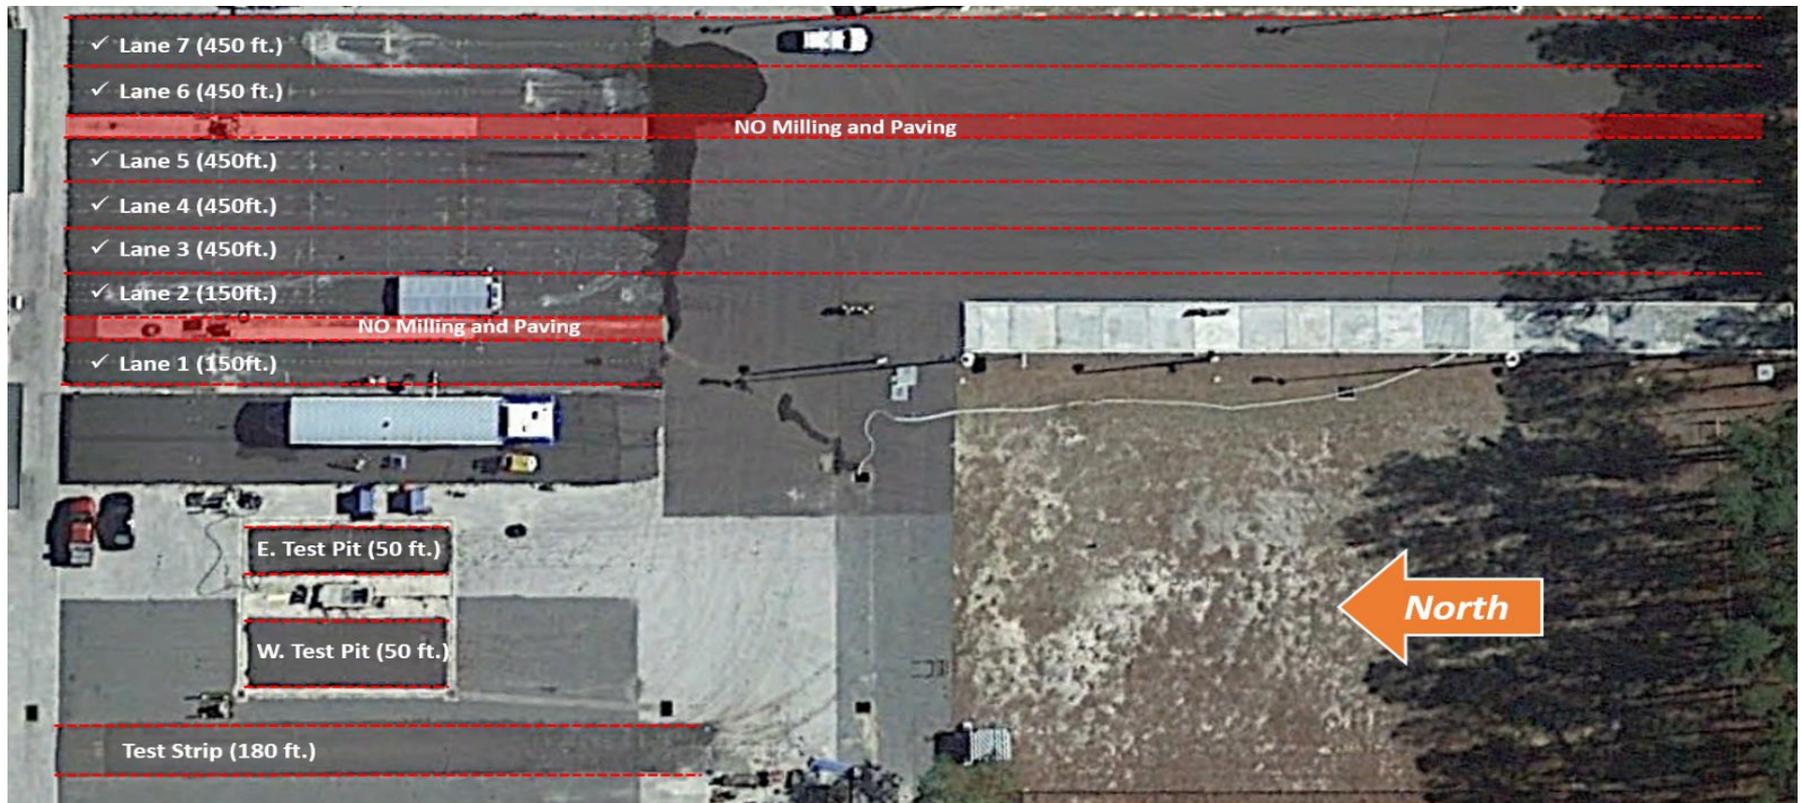
- Testing at SMO Test Lanes:
  - Evaluation of first 150 feet of Lanes 3, 4, 5

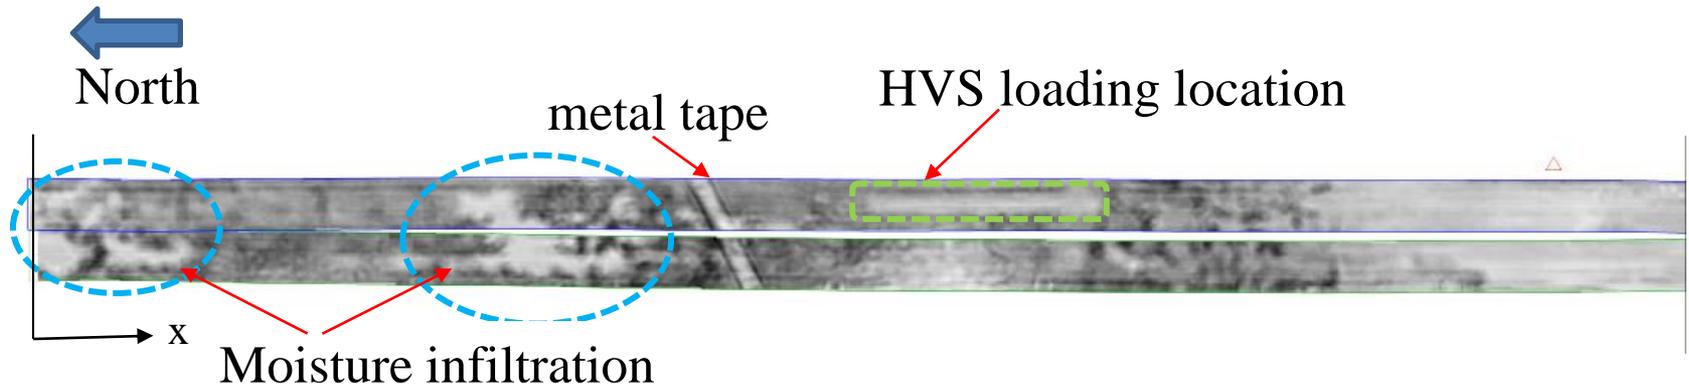
- SMO Test Lane 3 – Debonding - Delamination

Lane 3 -3D Radar depth slice at 2”

This section - Sand interface area (unbonded) – 1.4”

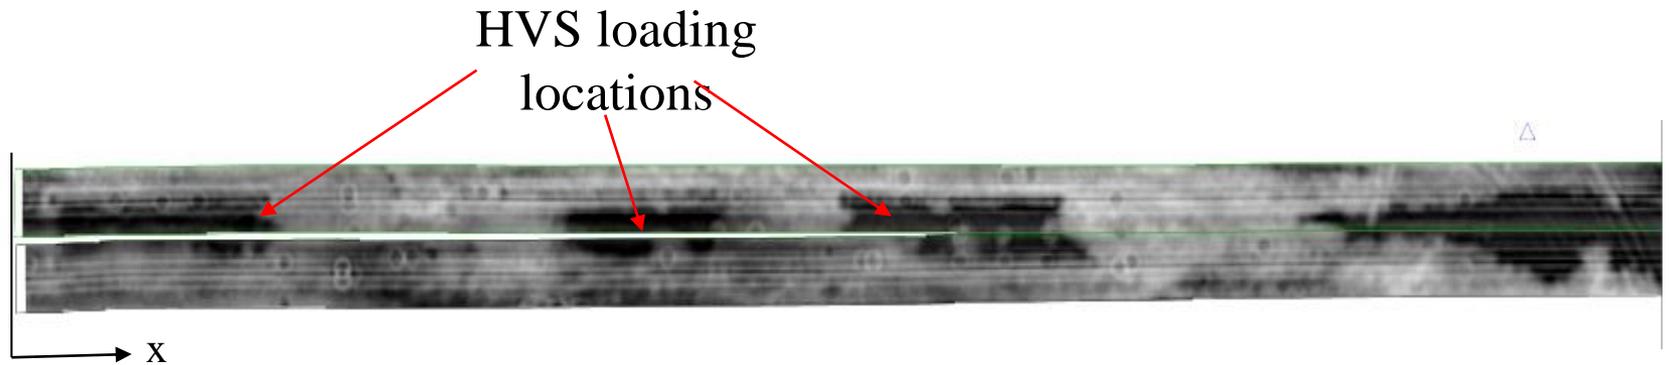
- SMO Test Lane 4 – Density

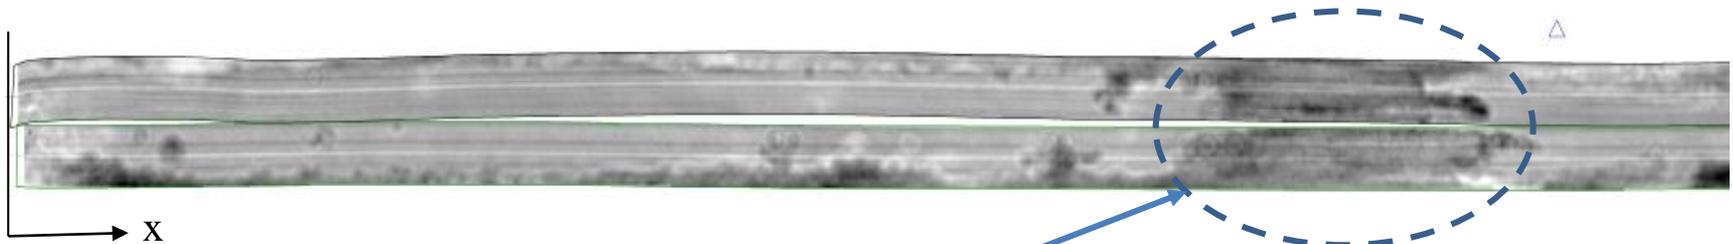
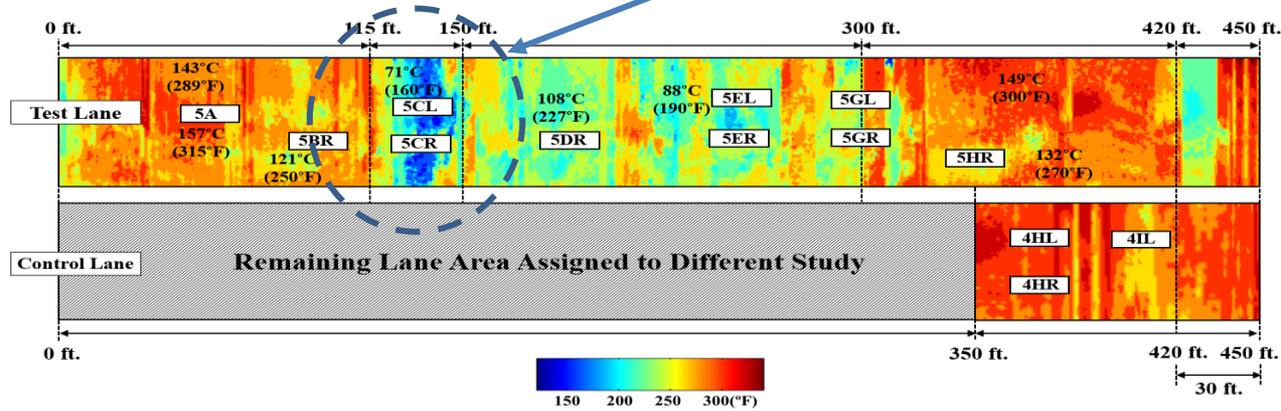
- SMO Test Lane 5 – Segregation

Lane 5 - depth slice at 1.5"

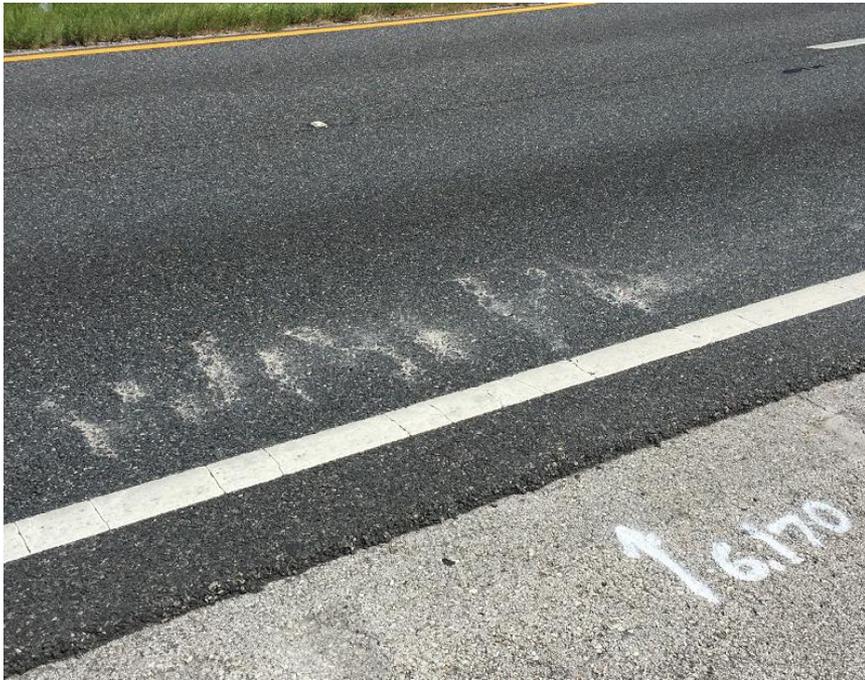
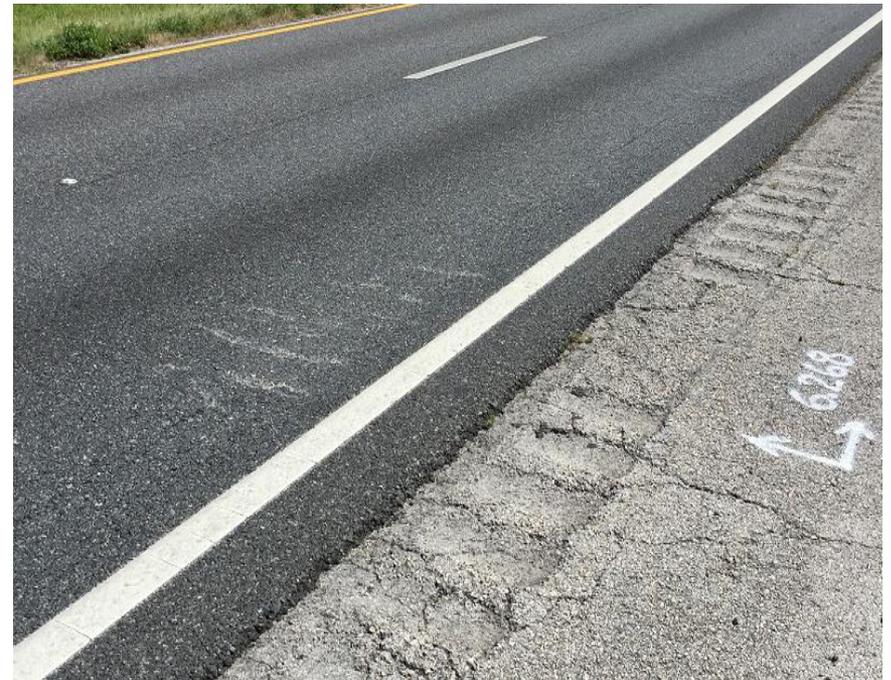
Observed Distresses on I-10

- Stripping and Moisture Damage
  - Interstate 10, Duval County, MP 0 – 8.989

- Pavement consists of multiple layers
  - Friction course, 2 structural courses, ARMI layer
- Total thickness = 7 inches
- Seven cores taken at different areas
  - Four showed internal damage to the pavement structure
- Four lines of 3D Radar data were collected
  - Two in the travel lane in each direction

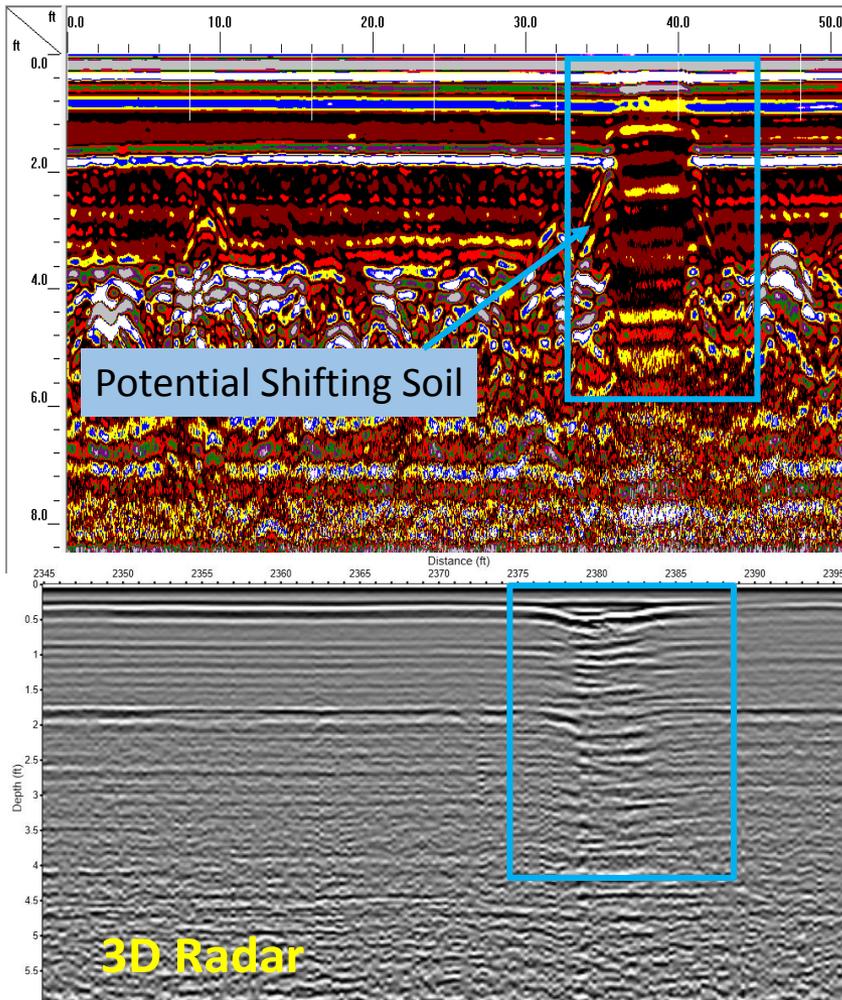
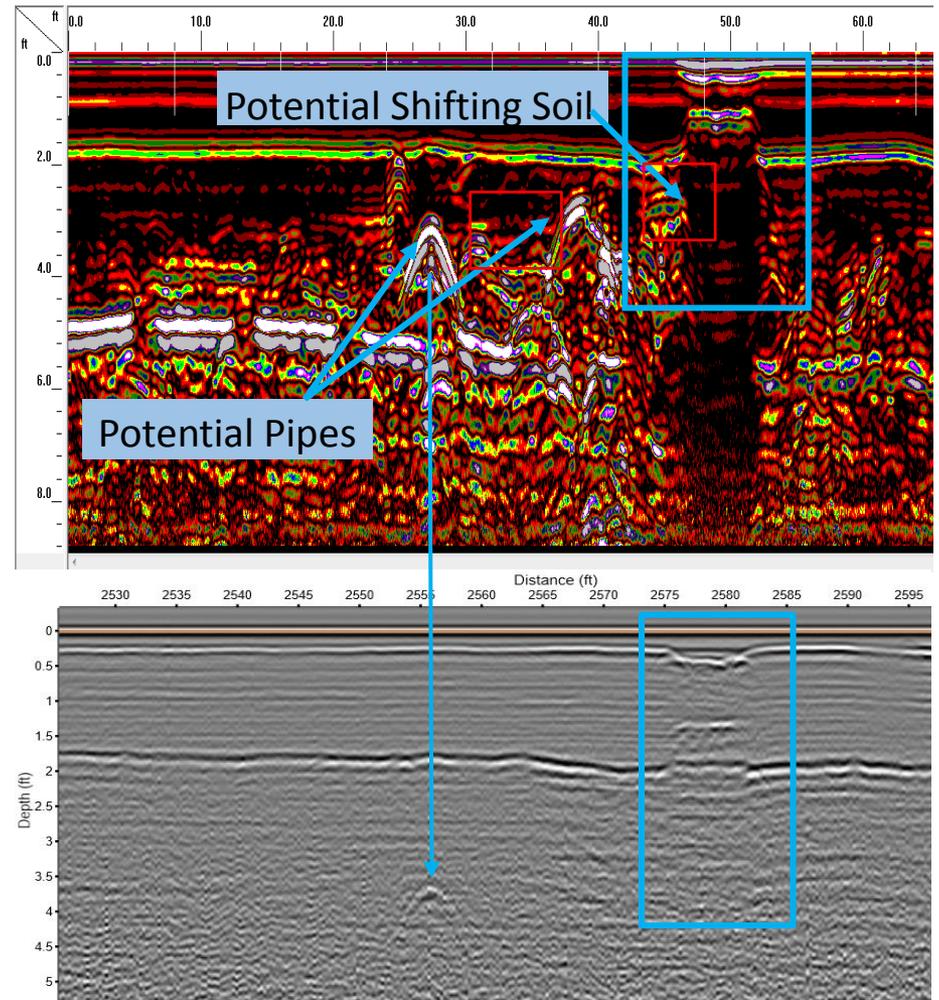
- State 24 (Waldo Road) near Gainesville, FL
- Pavement depression experienced over the years near drainage inlet location
- FDOT 400 MHz GSSI system used initially
- Results compared to 3D Radar
- Similar comparison done for I-75 subsidence study

- 400 MHz GSSI System vs. 3D RADAR Results

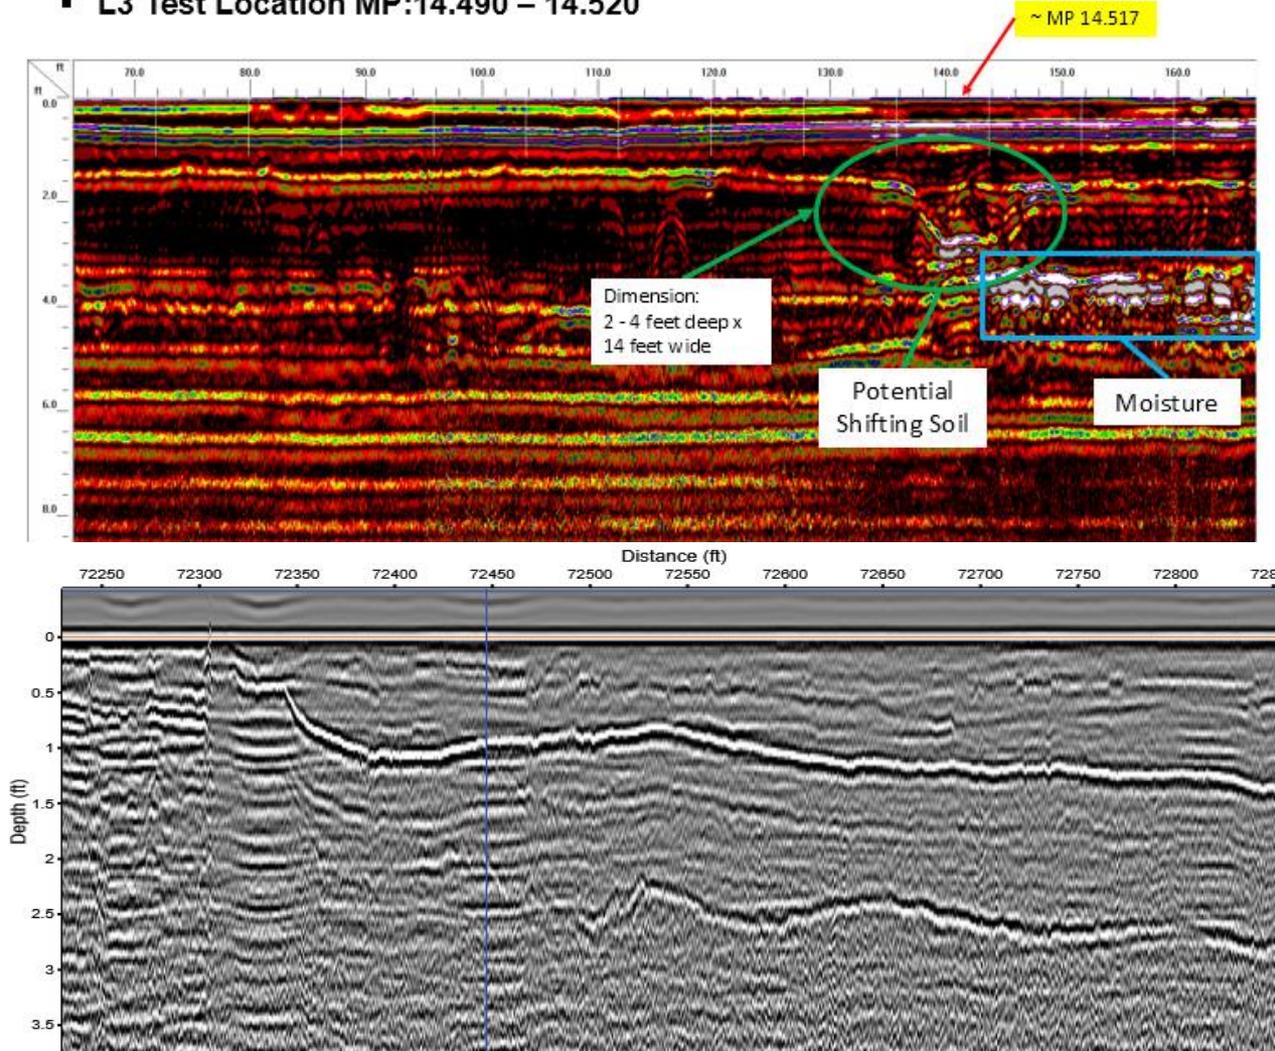
- L3 Test Location MP:14.490 – 14.520

400 MHz

3D Radar

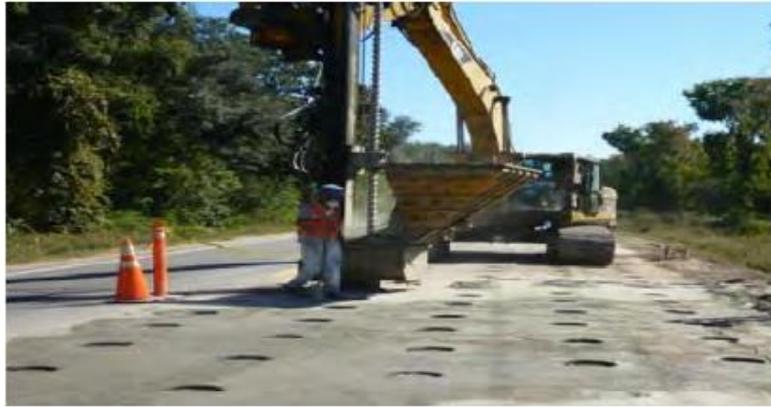
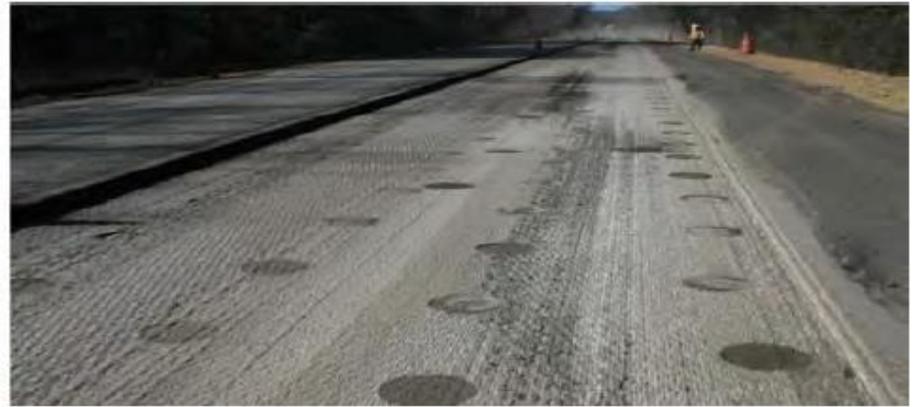
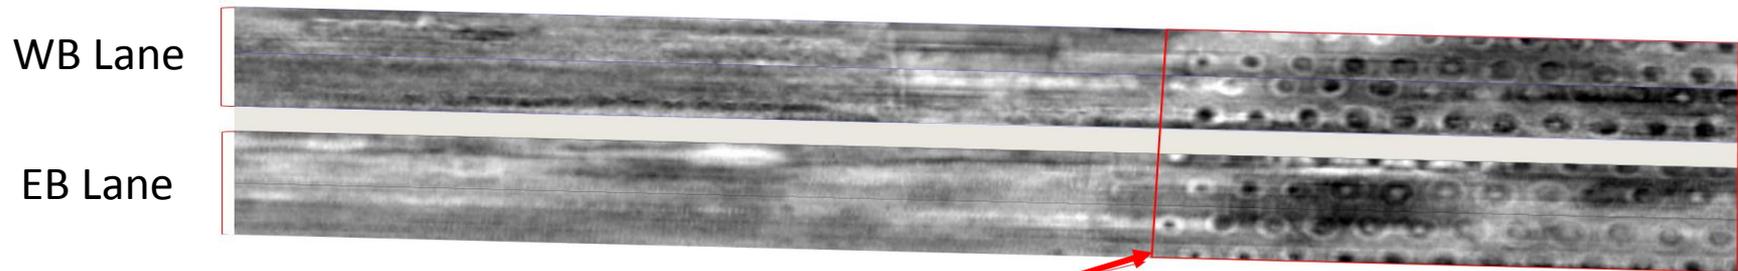
- Subsurface Soil Stabilized Columns (SCC)
  - SR 100, Putnam County, MP 7.000 – 8.000
  - Columns installed to mitigate roadway settlement

Area with installed Soil Stabilized Columns (SCC)

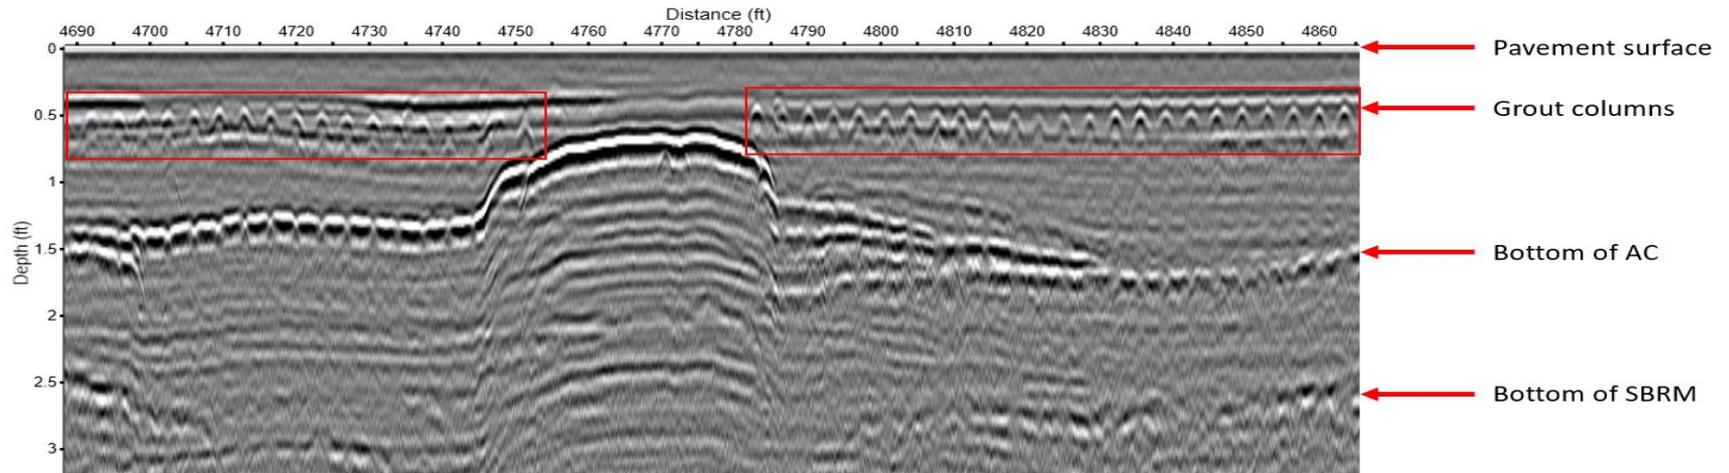
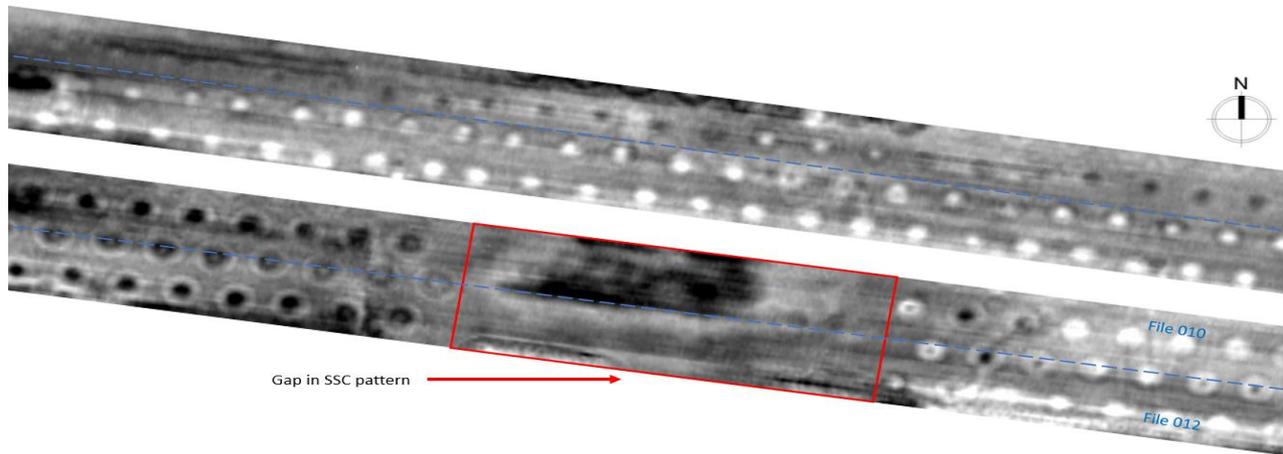
- Area with no SCC

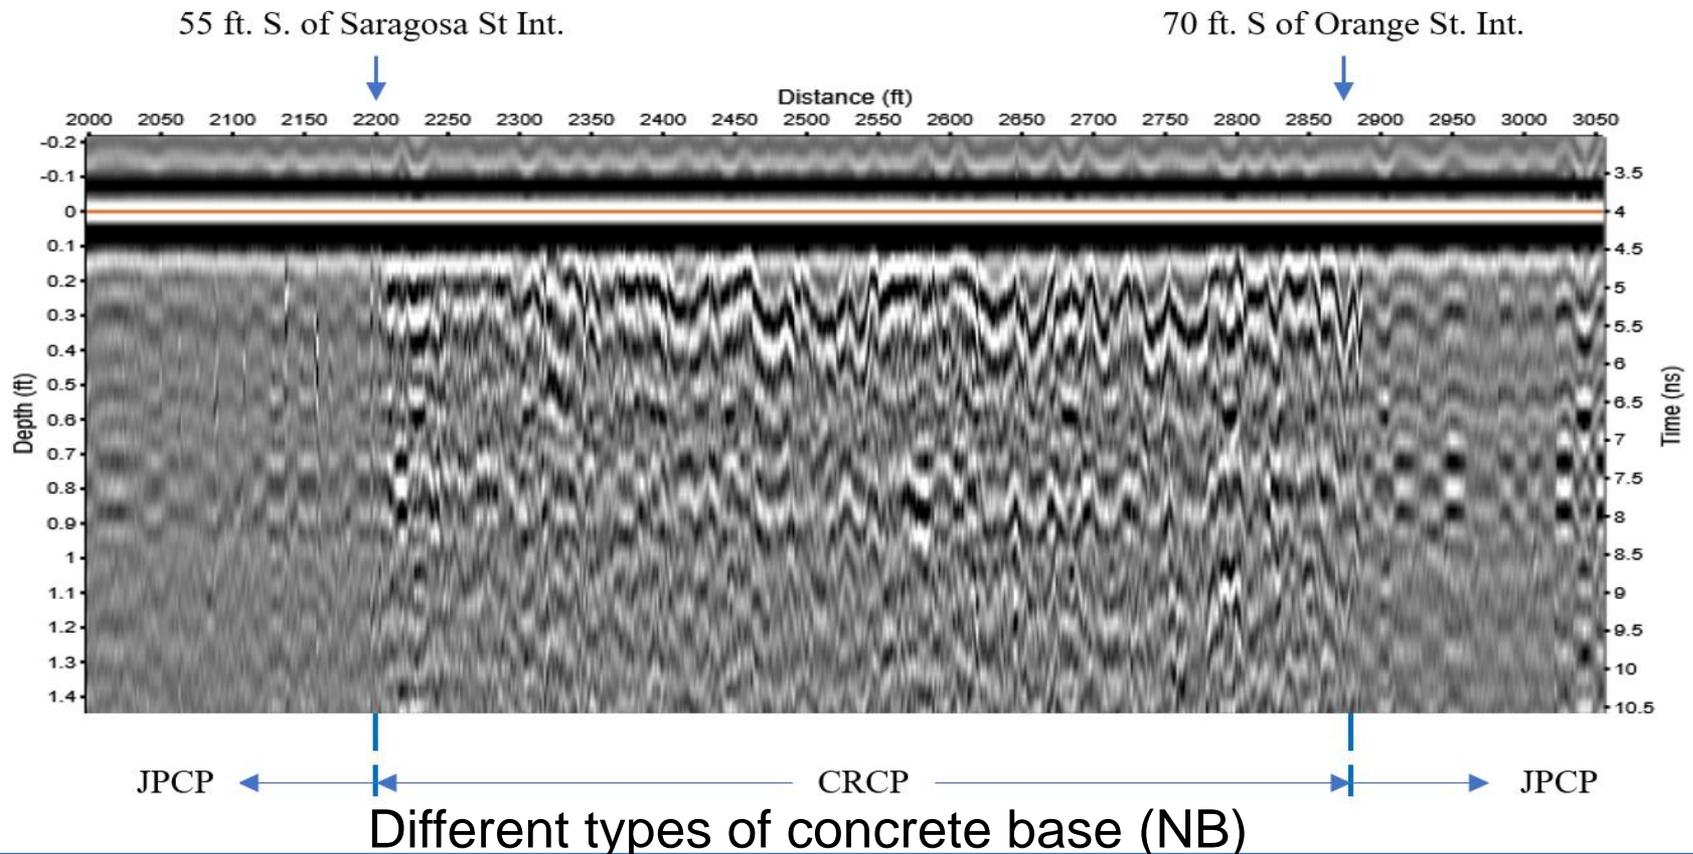
- SR 5 (US 1), St. Johns County, 2-mile section, NB & SB
  - Detected location and type of concrete base

- Different types of concrete base (NB)
  - SR 5 (US 1) St. Johns County, 2-mile section, NB & SB
  - Detected location and type of concrete base
  - Identified area of extensive settlement

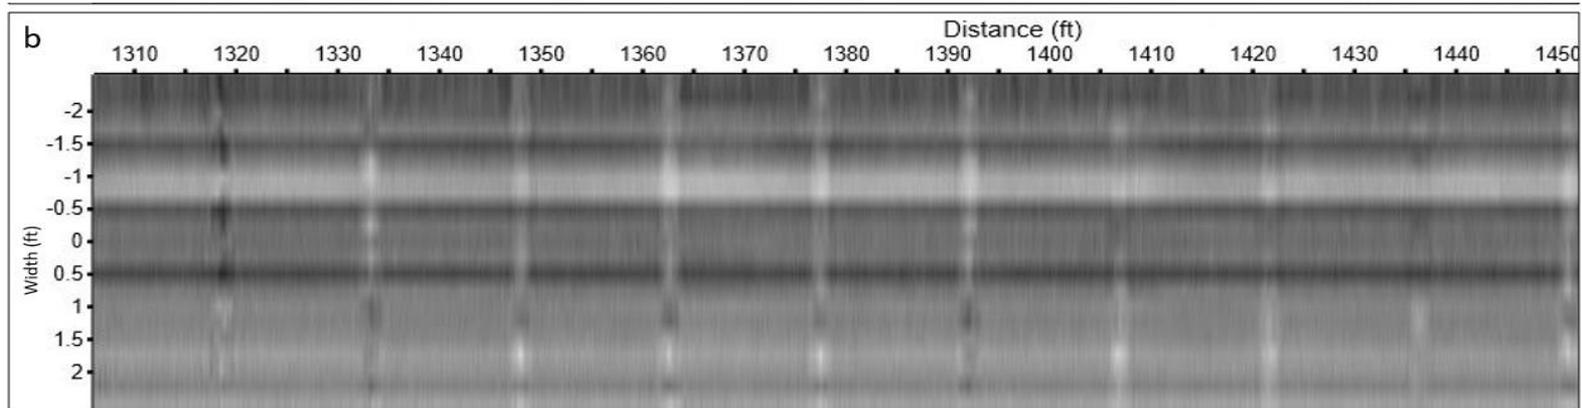
## JCPC Joints at 15 feet

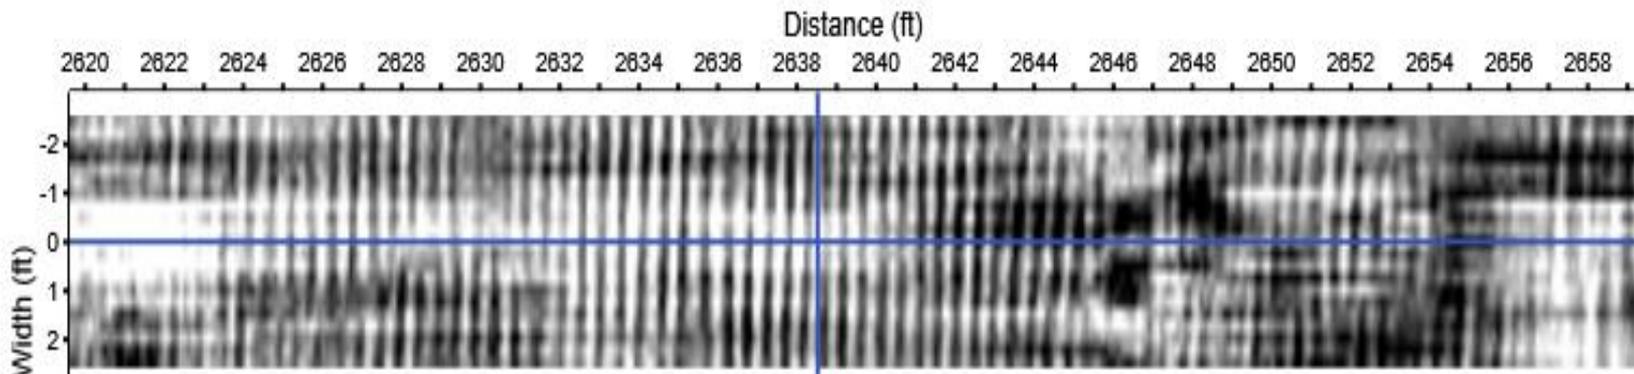
## CRCP Transverse Rebar at 6 inches

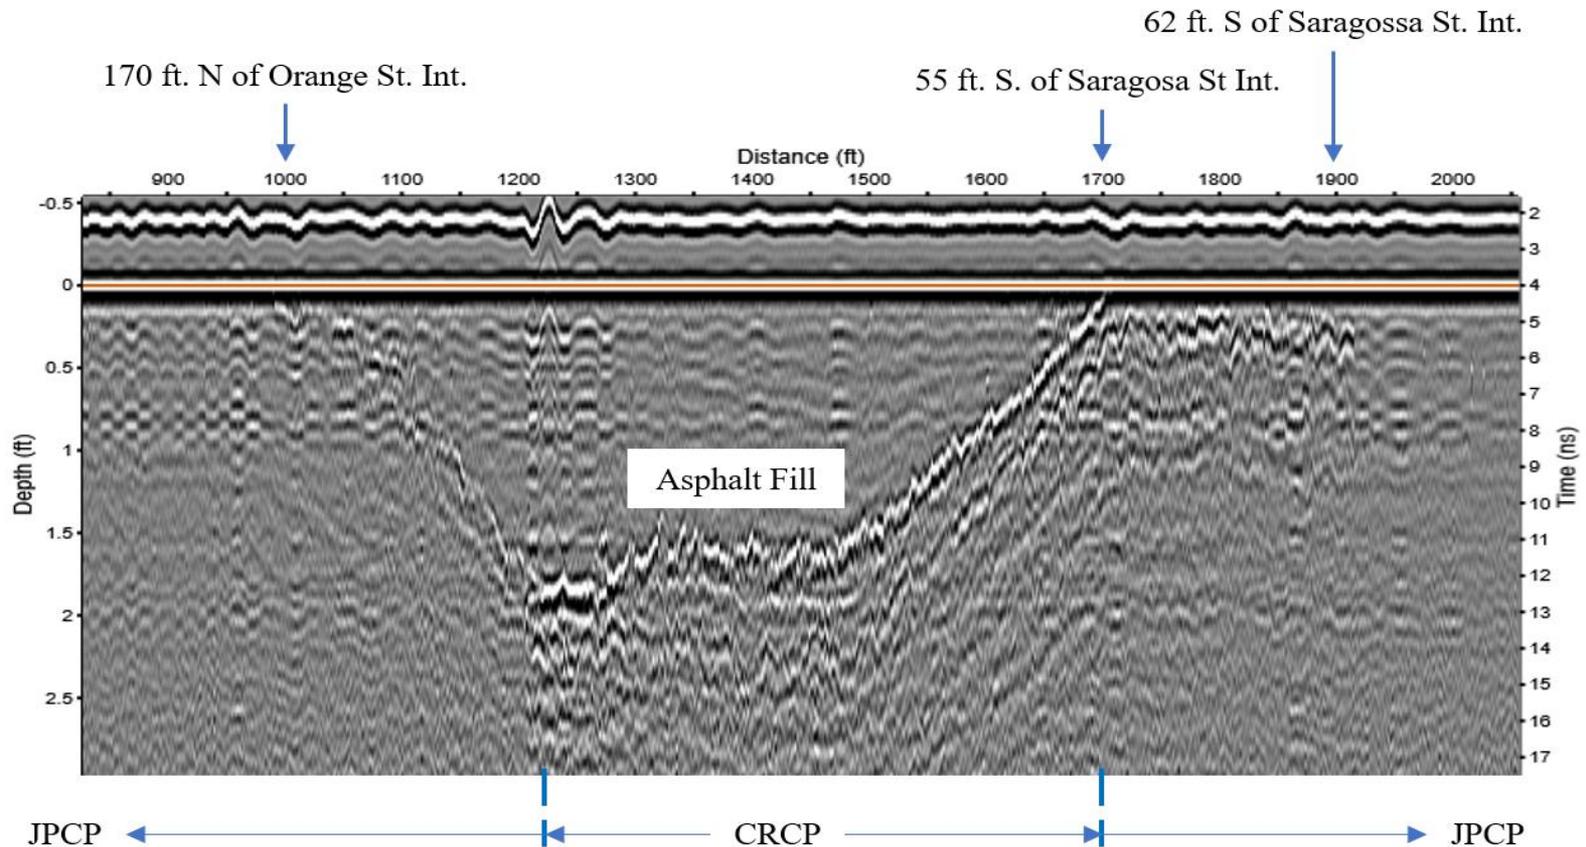
- Area of pavement settlement (SB)

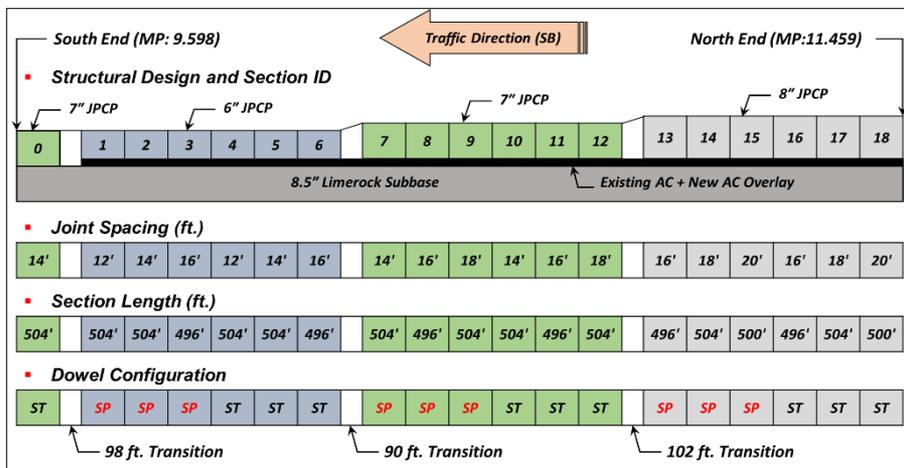
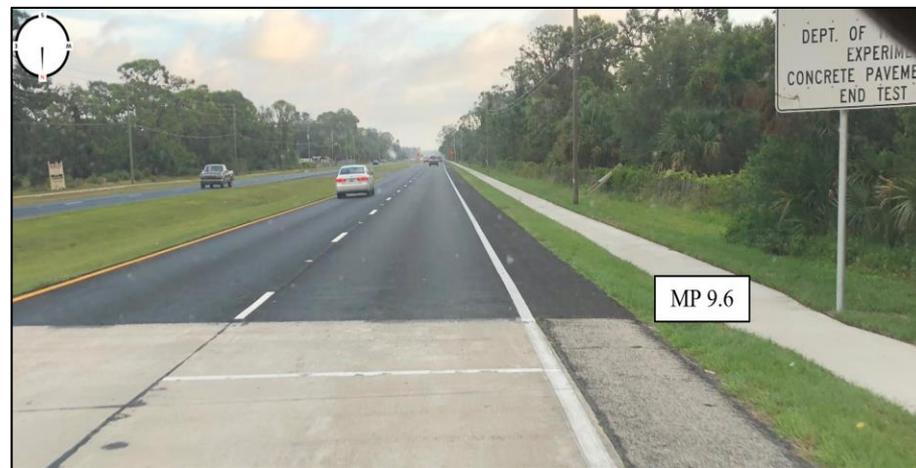
- SR 5 (US 1) Volusia County, MP 9.600 – 11.500 (SB)
- White-topping thicknesses – 6”, 7” and 8”
- Specially designed with different dowel patterns:
  - 12 dowels spaced at 12” centers starting at 6” from pavement edge
  - 3 dowels in each wheelpath spaced at 12” centers beginning at 12” from each edge
  - No dowels

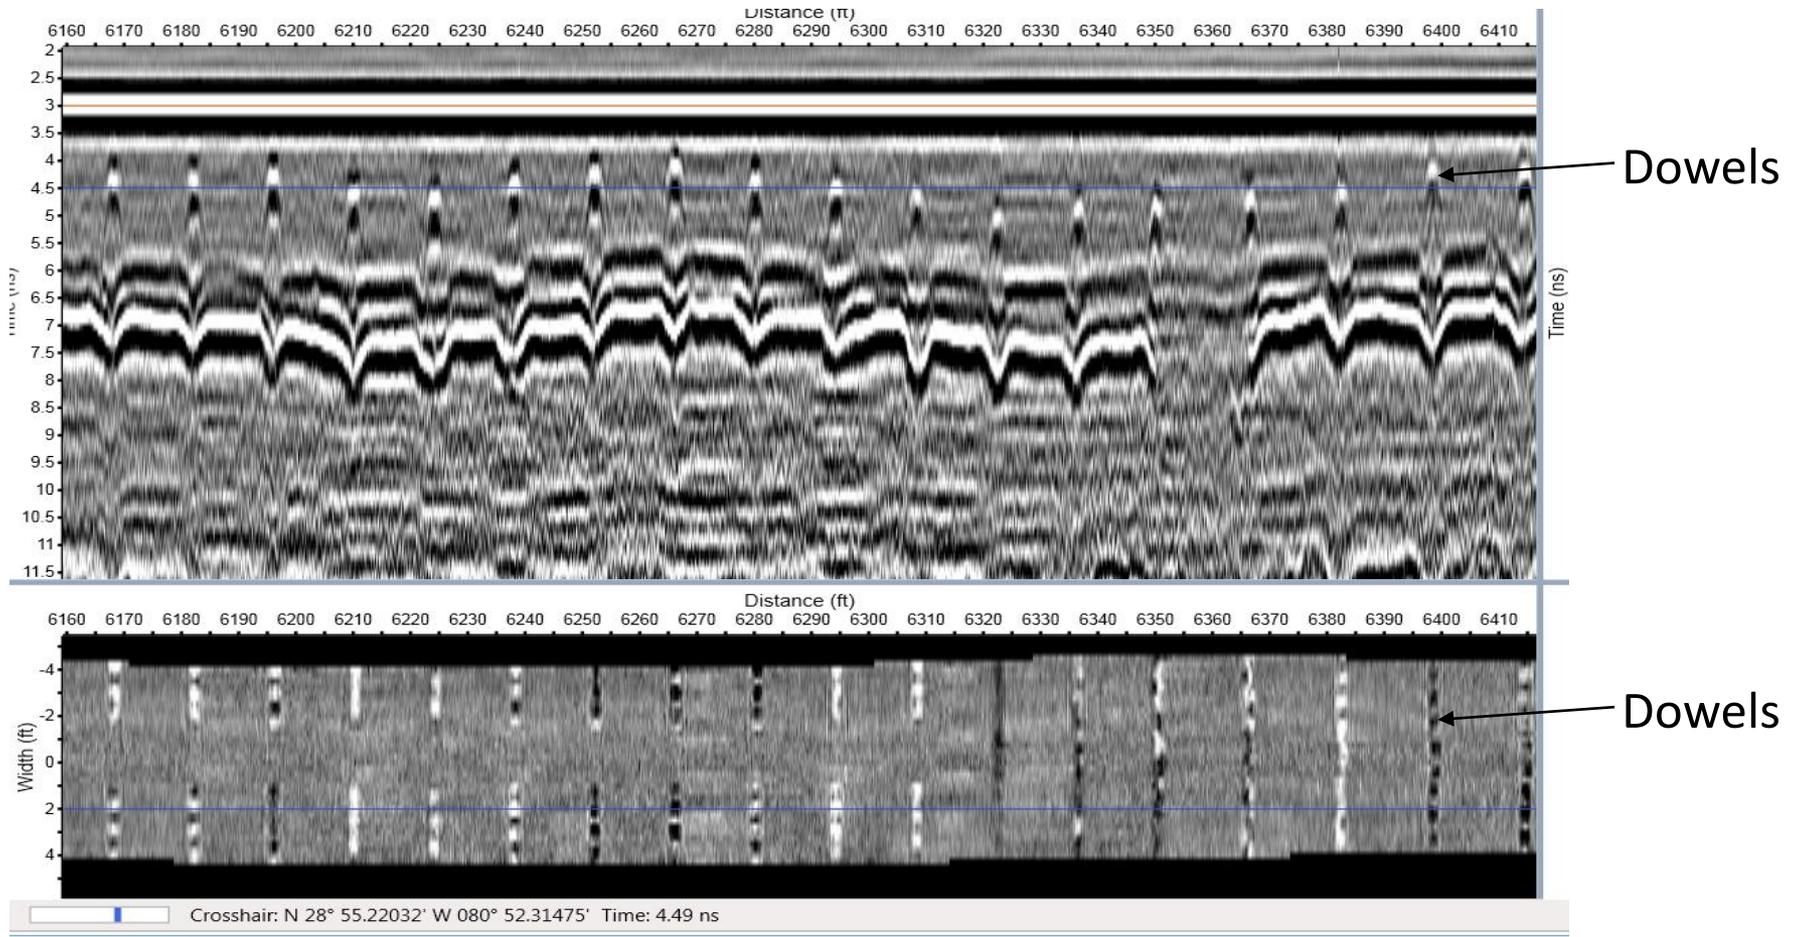
- 3D RADAR Results
