# FDOT'S Experience with 3D RADAR

**Bouzid Choubane**, Florida Department of Transportation  
**Charles Holzschuher**, Florida Department of Transportation  
**Guangming Wang**, Florida Department of Transportation  
**Ken Maser**, Infrasense, Inc.  
**Edward Offei**, Applied Research Associates

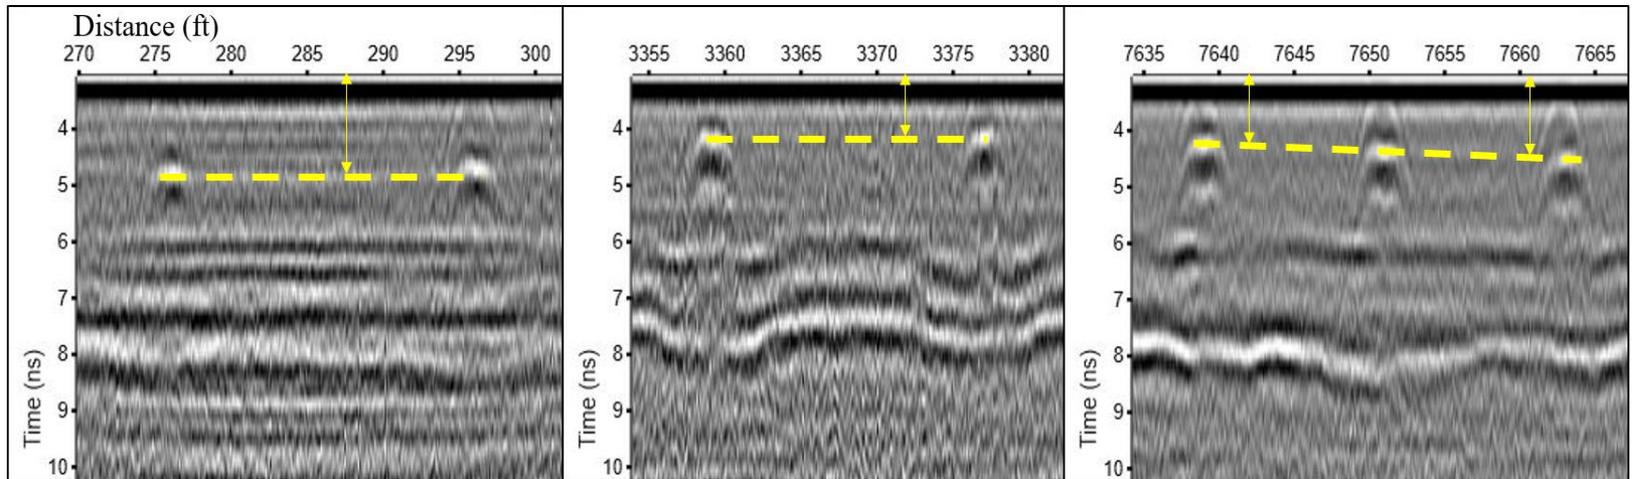
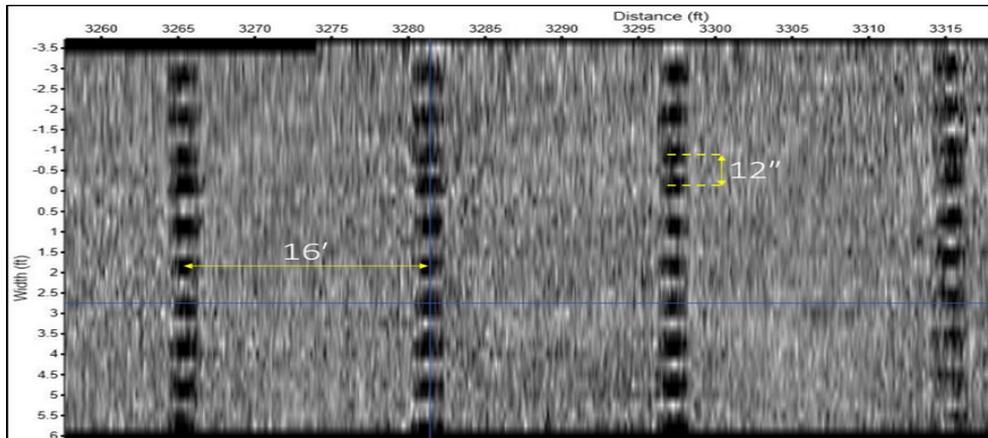
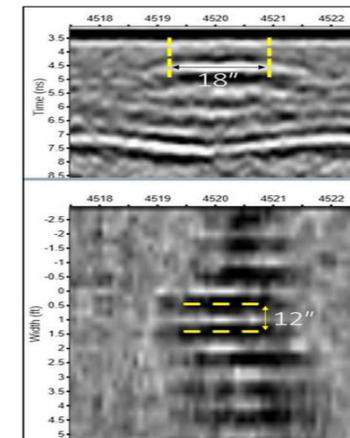
- Dowel Bars – Position, Dimensions and Alignment

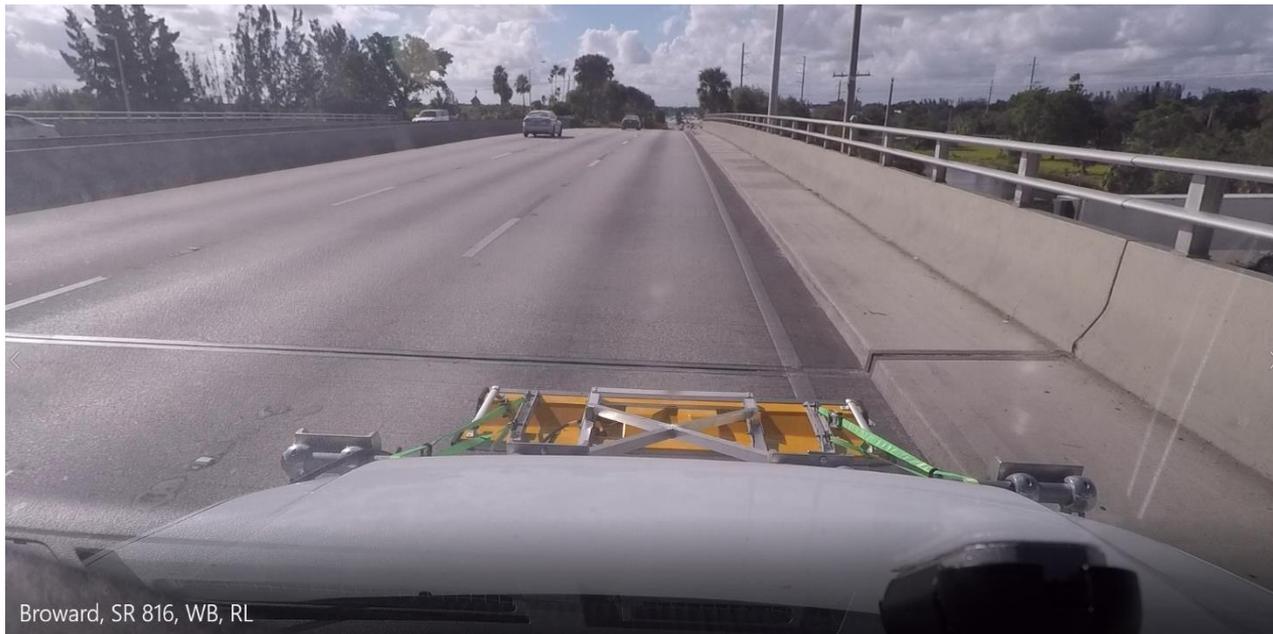
- SR 816 Bridge, Broward County, 3 passes per lane
- Identify spans and structural changes between spans
- Locate rebar schedules in both directions
- Calculate rebar depth and areas of deck deterioration

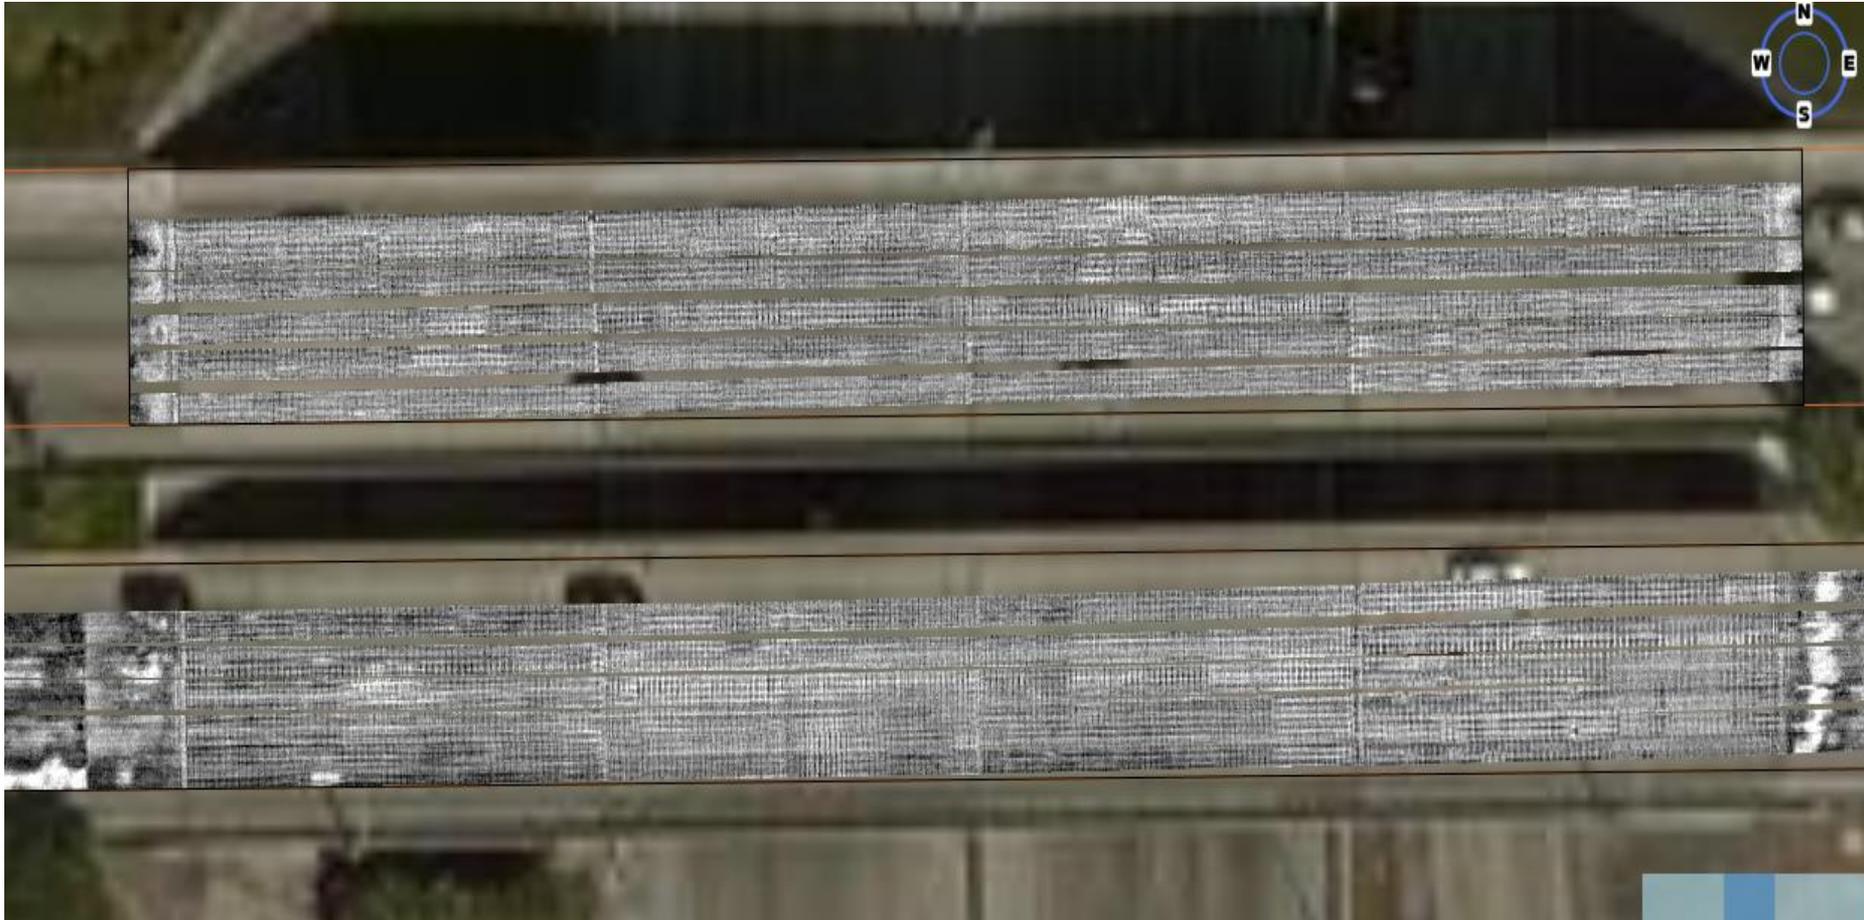
- Bridge Deck – Overview Slice

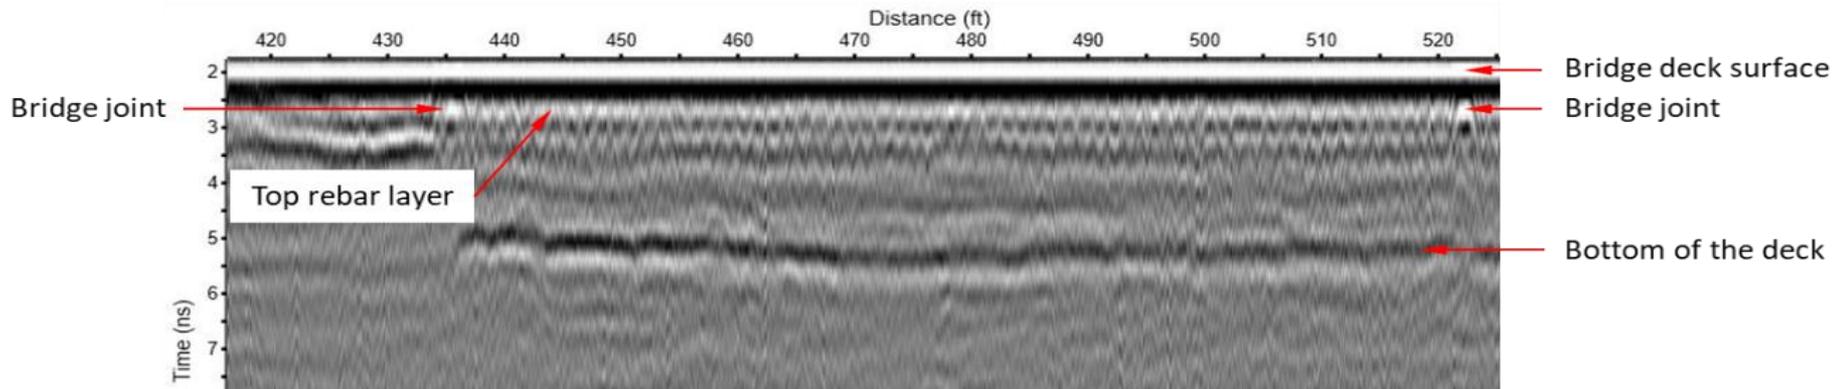
## Bridge Deck – B Scan

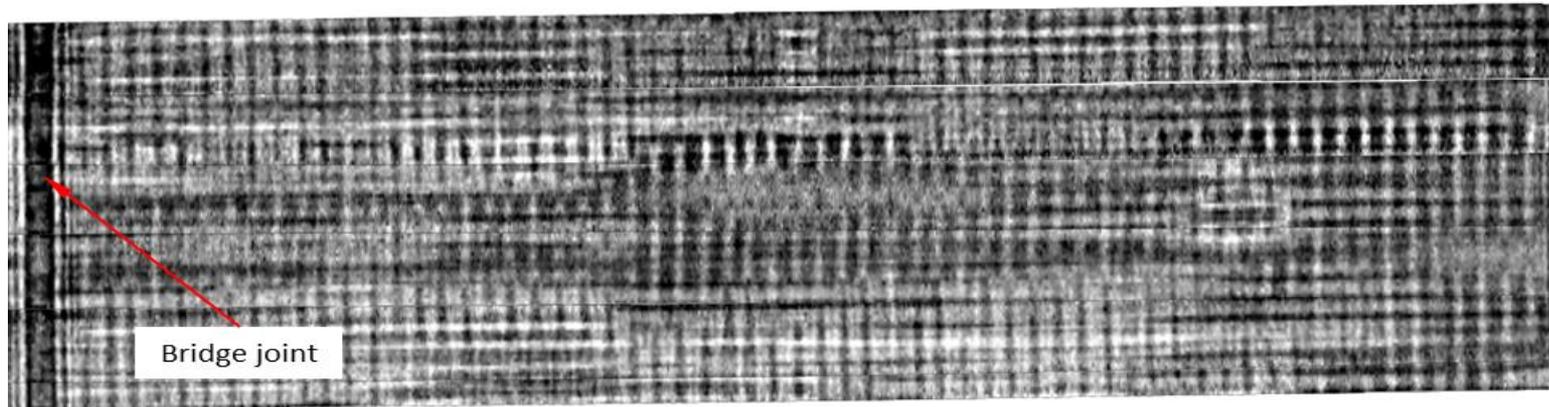
## Bridge Deck – Depth Slice, Rebar Pattern

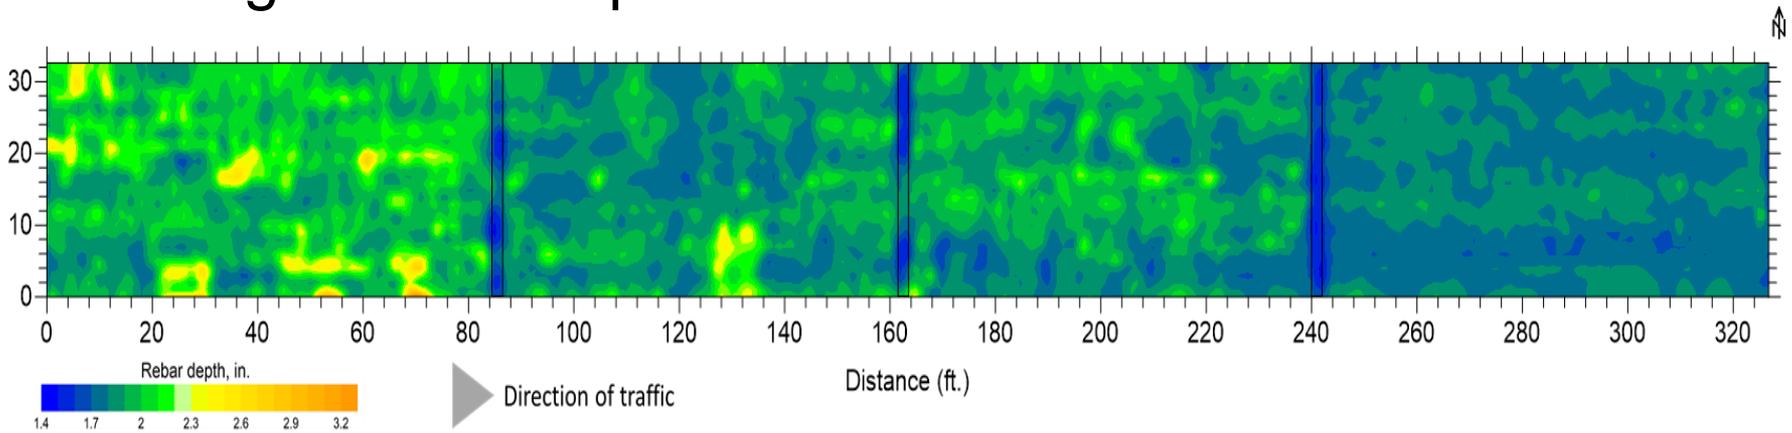
- Bridge Rebar Depth

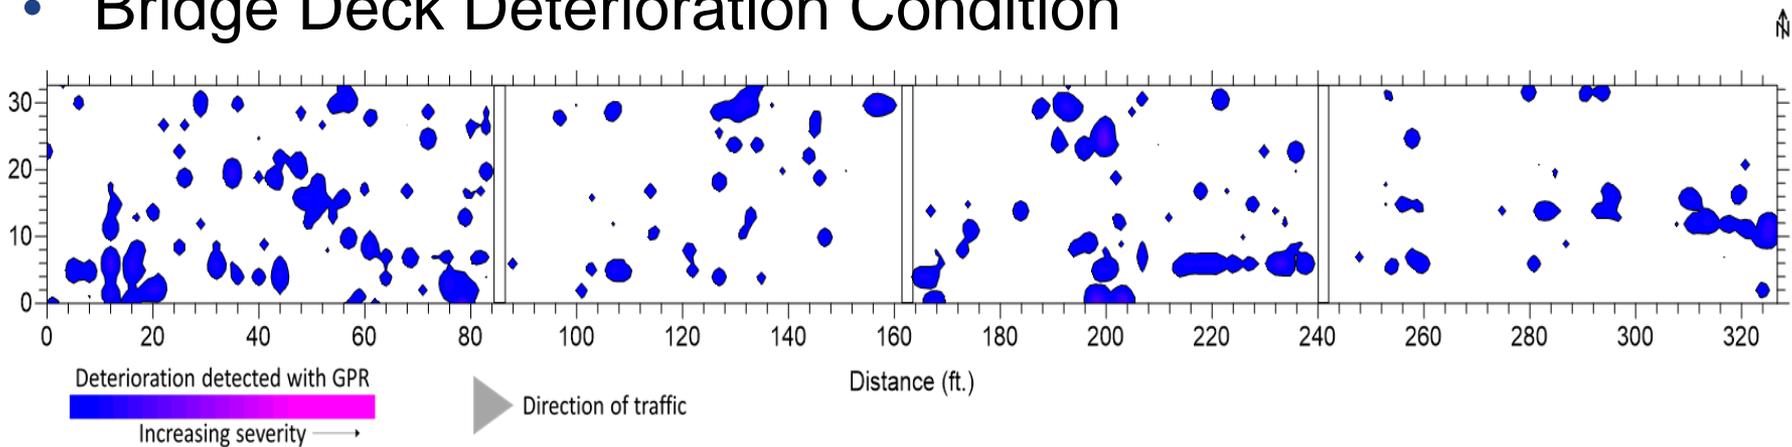
- Bridge Deck Deterioration Condition

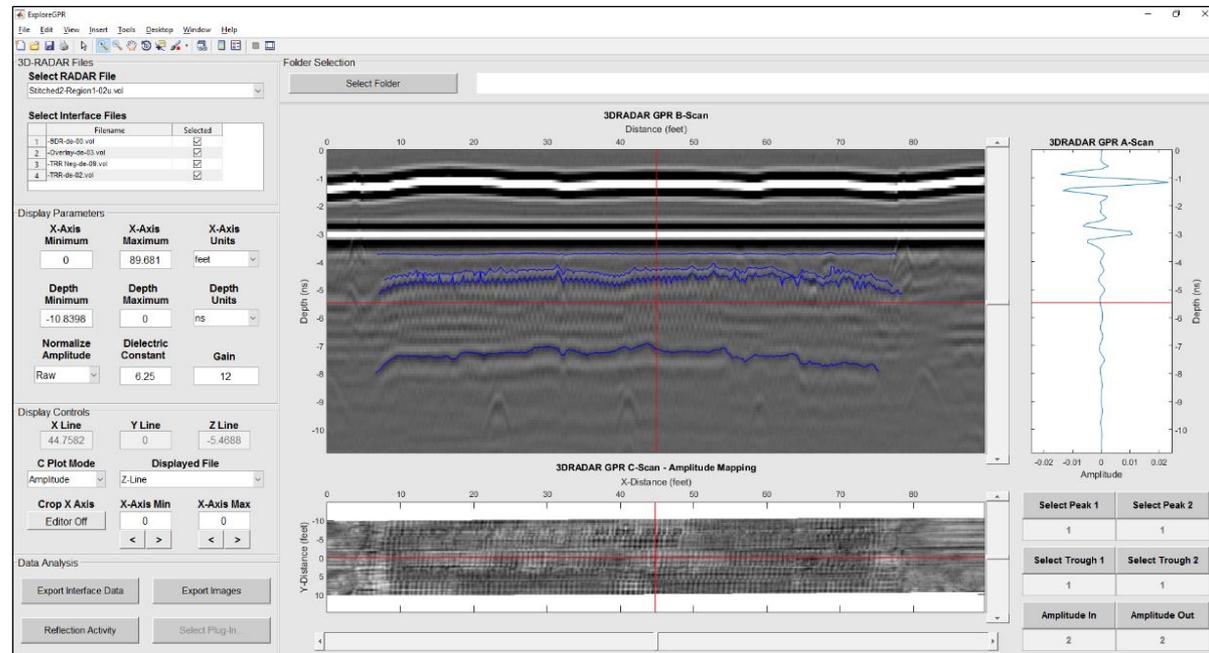
- ExploreGPR Software processes output of Examiner
- Provides data visualization, analysis, and reporting
