Oregon Department of Transportation

Implementation of SHRP2 R19A:

- 1. Trial Use for Routine Bridge Design,**
- 2. Evaluation of In-service Bridges to develop Design Standard Practice for Service Life Design, and**
- 3. Service Life Design Specification Template for Major Bridges**

October 2017

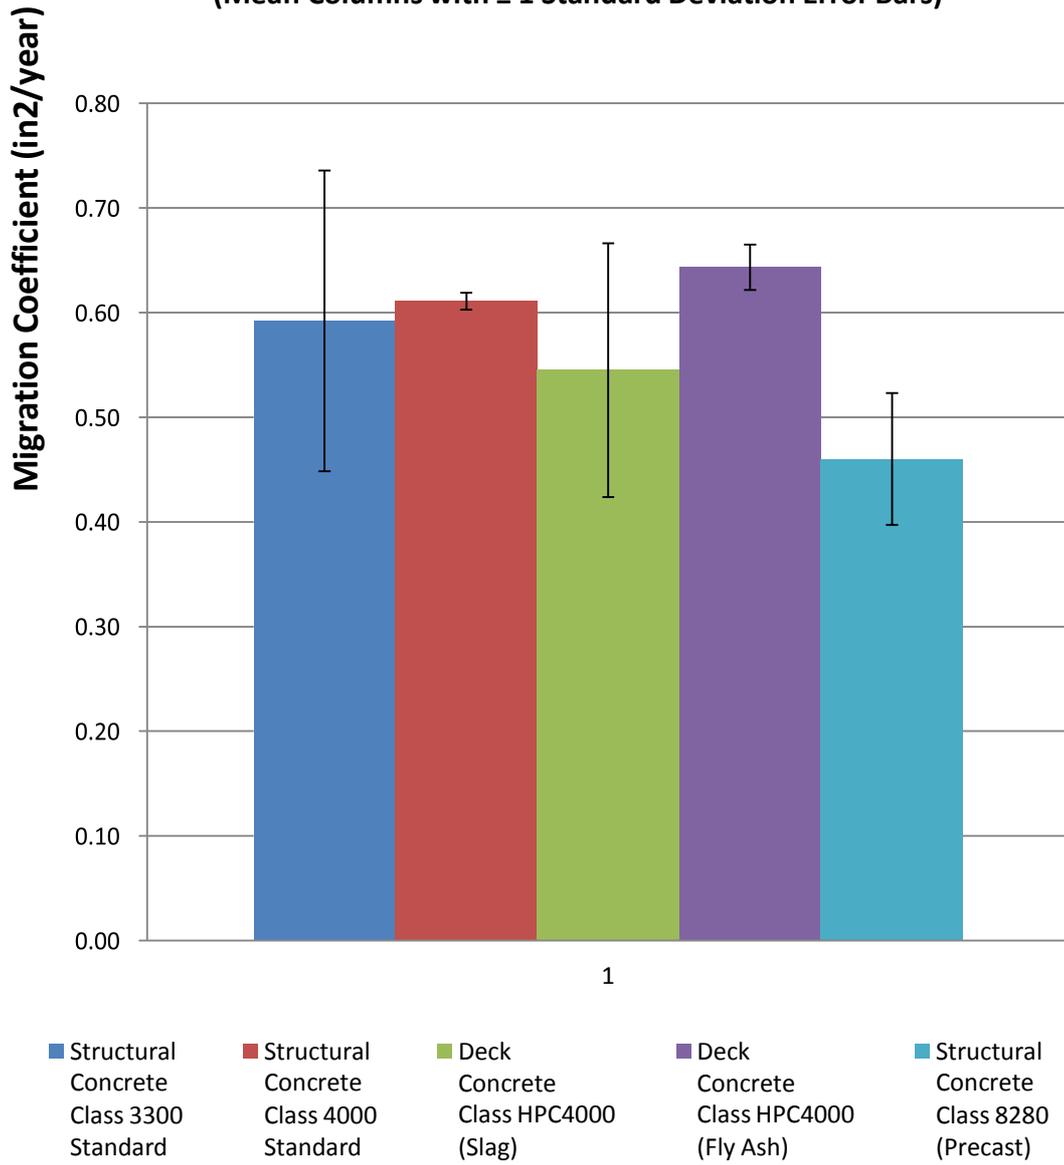
Figure 3.1 – NT Build 492 Test Results by Concrete Product

(Mean Columns with ± 1 Standard Deviation Error Bars)

Test result comparison is subject to the accuracy and repeatability of the test itself. The NT Build 492 states that a coefficient of variation of repeatability of 9% was observed based on a limited test pool. Fib bulletin 34 recommends using a coefficient of variation of repeatability of 20% based on an expanded pool.

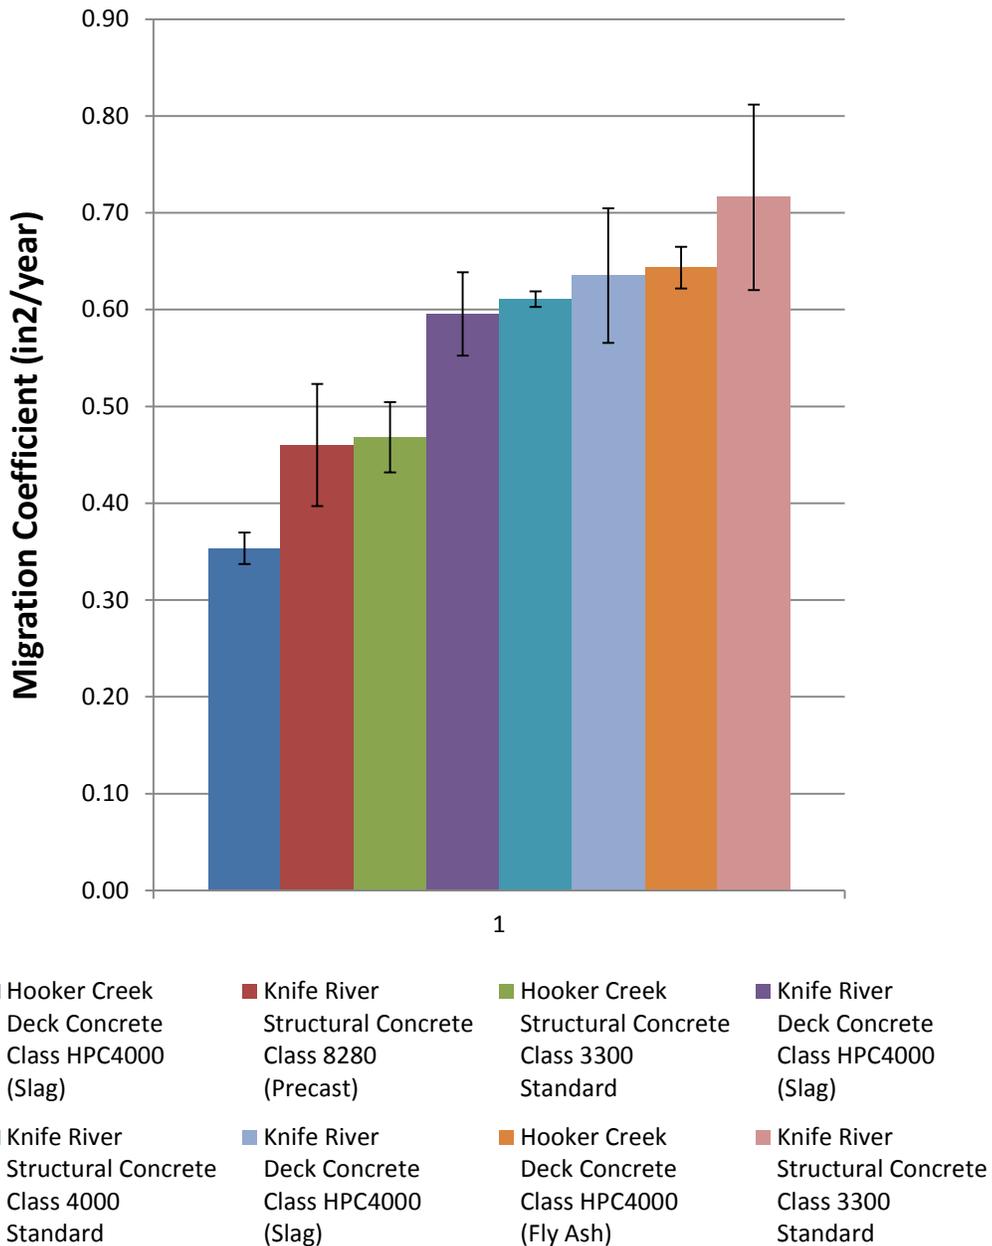
Figure 3.2 – NT Build 492 Test Results by Mix Design

(Mean Columns with \pm Standard Deviation Error Bars)

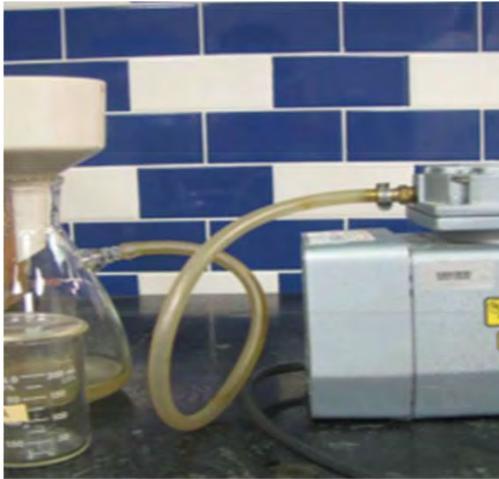
All of these test methods digest a powder sample in nitric acid (HNO_3). Electrodes are immersed into the HNO_3 solution and connected to a volt meter. A Silver nitrate (AgNO_3) solution is slowly added to the solution until an equivalence point is reached (titration) as the chloride ions freed in the acid digestion precipitate as silver chloride (AgCl). The weight of silver nitrate needed to reach the equivalence point is recorded and used in conjunction with the weight of the powder sample to determine the percentage of chloride by weight of sample.

Vacuum Filtering after Acid Digestion
Photos Courtesy Siva Corrosion Services, Inc.

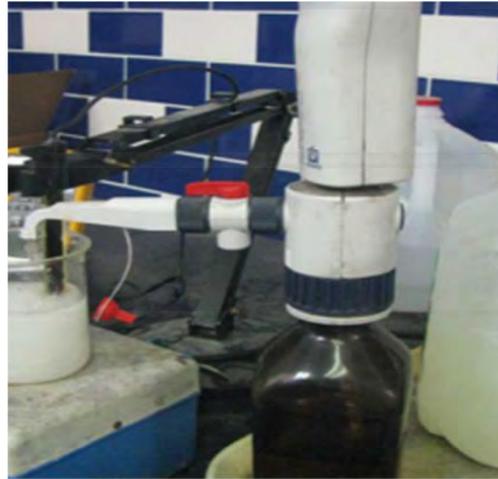
Titration with Silver Nitrate

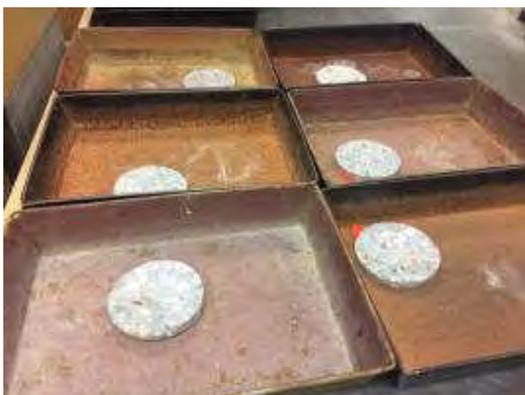
Core Sliced into 1/2" Increments

A large portion of the initial cores were sent off to a third party lab awarded the work based on price; Siva Corrosion Services, Inc. They were responsible for slicing and pulverizing the cores before performing the acid soluble chloride tests.

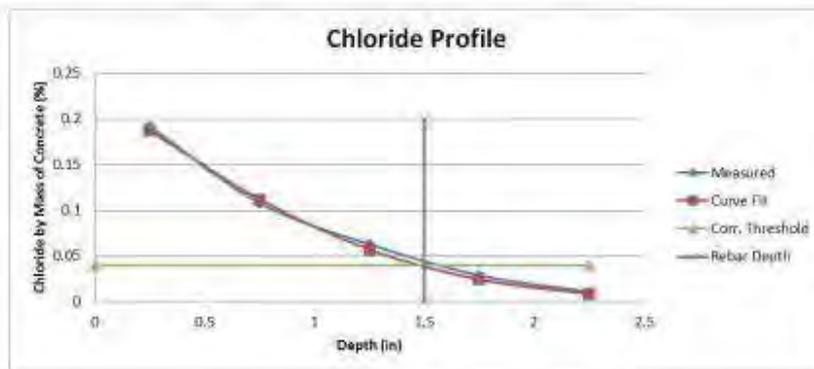
Figure 2 – Typical Curve fit of Measured Data

Field Test Data						User Input Data	
X[Depth, in]	0.25	0.75	1.25	1.75	2.25	t[time, yr]	48
CF [Chloride Concentration, %]	0.192	0.108	0.063	0.029	0.011	Diffusion Coefficient [Dc, in ² /yr]	0.0123
						Surface Concentration [Cmax, %]	0.229
Calculated Values							
C(x,t) [Chloride Concentration, %]	0.187333	0.112226	0.057252	0.024571	0.008793		
Sum of Least Squares							
(CF-C(x,t)) ²		1.79E-05	3.3E-05	1.96E-05	6.87E-06		
Sum[(CF-C(x,t)) ²]							7.54E-05

The datapoint closest to the concrete surface is not used in correlation of the curve fit because a large portion of samples collected showed poor correlation of this datapoint to Fick's 2nd law. The theory is the surface of bridge decks in particular are subject to large seasonal variations. Precipitation can wash chlorides away from the surface and lack of precipitation and humidity can cause chlorides to remain on the surface but never absorb into the concrete.

The accuracy of this analysis is subject to a lot of assumptions. First, the rate at which chloride is absorbed into the concrete is not a constant value, but both the diffusion coefficient and effective surface concentrations are considered constant due to the lack of reliable data to appropriately model dynamic conditions.

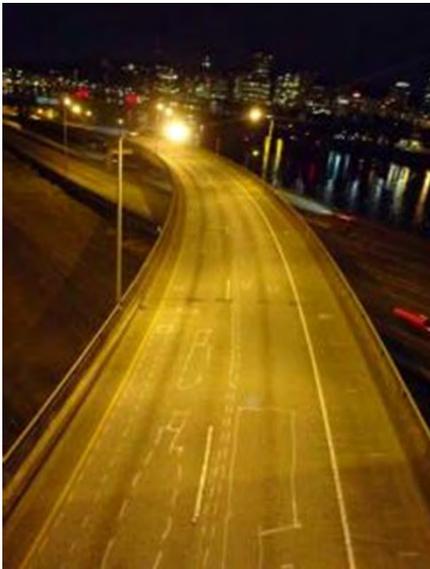
BR08588A at M.P. 0.24 on Hwy 2 (Route IS84N), BR08588B at M.P. 0.52 on Hwy 2 (Route IS84N), and BR08588C at M.P. 0.23 on Hwy 2 (Route IS84N) are a mixed plate girder and RCDG design constructed in 1963. The decks are 6" thick with a 1.5" structural wearing surface that was planned for when the bridges were designed. I was not able to find record of when these overlays were installed. The decks have extensive delamination and cracks throughout with a concentration of spalling at the joints (expansion and overlay construction) due to impact with secondary corrosion occurring from the loss of cover. All 3 structures are in similar condition.

BR08588B as Seen From BR08588C
After Delamination Survey

Whatever the case may be, the chloride levels measured were all below the corrosion threshold of steel reinforcement in concrete. The damage observed on these structures are predominantly from impact, flexure, thermal cycling/shrinkage, and freeze/thaw, with a strong probability of some localized secondary corrosion from chlorides penetrating these cracks.

It is recommended that the current 1.5” overlay be ground completely off and a new overlay be placed with class 2 preparation as needed. From a corrosion standpoint, a waterproof material such as polyester polymer concrete (PPC) would be preferable, but a structural design engineer should analyze how this would affect deck stiffness as the current 6” deck with the 1.5” rigid overlay is showing signs of flexural cracks and efflorescence in the soffit according to inspection reports. It would be better to have a latex modified concrete (LMC) or silica fume concrete (SFC) with some cracks than a PPC with extensive flexural cracking. Fibers may be appropriate in the overlay material to reduce cracking.

In addition, special attention should be paid toward joint and joint header design due to the traffic volume and speed on these structures. The B and C structures have especially bad spalling at the joints due to impact damage leading to corrosion damage. There also appears to be extensive corrosion damage to soffits and cross beams on RCDG spans according to inspection reports. This is consistent with deicing chemicals leaking through failed joints and should be addressed sometime in the near future if it is not included with a joint and overlay replacement.

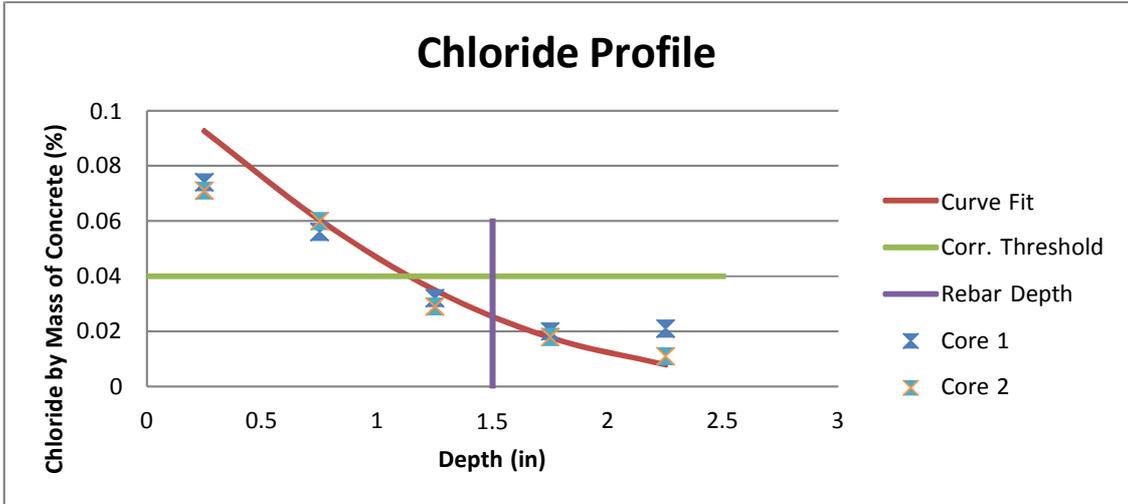
Figure 9: BR08003 Chloride Concentrations (Curve Fit, 2 Samples)

The 2 deck cores were tested for chlorides according to ASTM C1152/C1152M at ½” depth increments to a depth of 2.5”.

A PPC wearing surface programmed to be installed will slow chloride ingress and extend the life of this deck.

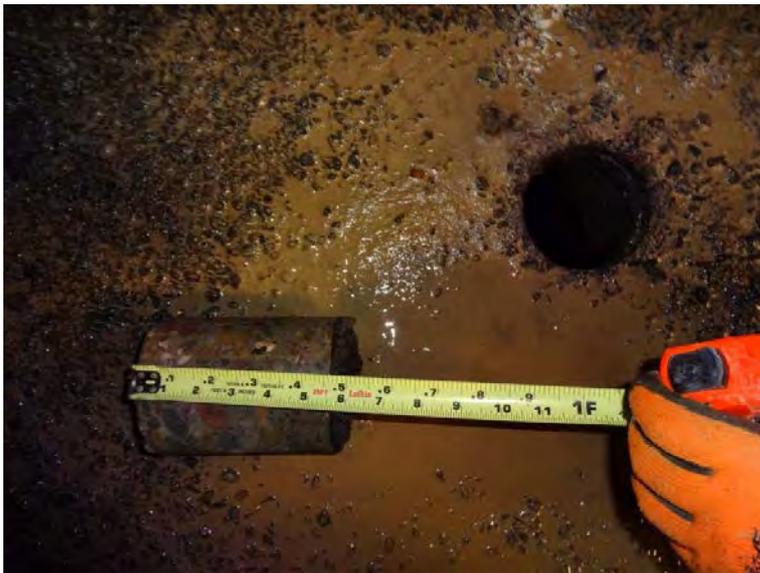
The 4 deck cores were tested for chlorides according to AASHTO T-260 at ½” depth increments to a depth of 2.5” after removing the ACWS.

Core Sample Demonstrating 5.5” Deck With Compromised ACWS

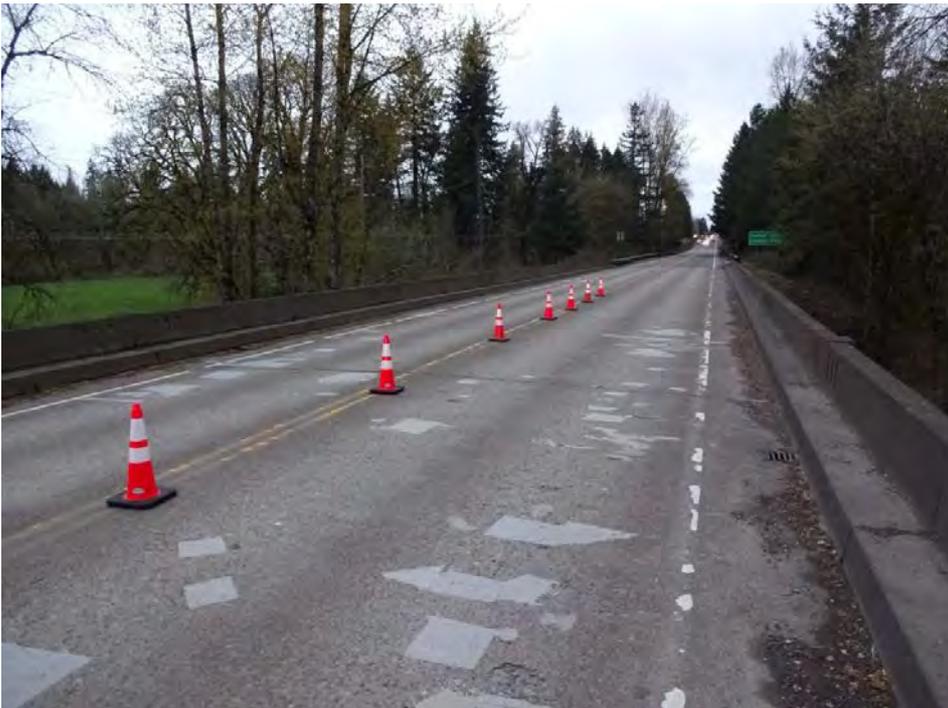
BR08492 at M.P. 45.76 on Hwy 39 (Route OR18N) was constructed in 1963 and is a RCDG design with precast beams on timber bents. The design calls out a cover detail of 1" over the top mat of the deck and a "2" AC wearing surface by others". The AC wearing surface was never placed on the bridge as recommended by structural design engineers in 1979. The oldest digitally recorded inspection report from 1992 reports transverse cracks in the wearing surface and soffit with a half dozen exposed rebar. The condition has deteriorated ever since to the condition shown.

BR08492 Damage on Deck

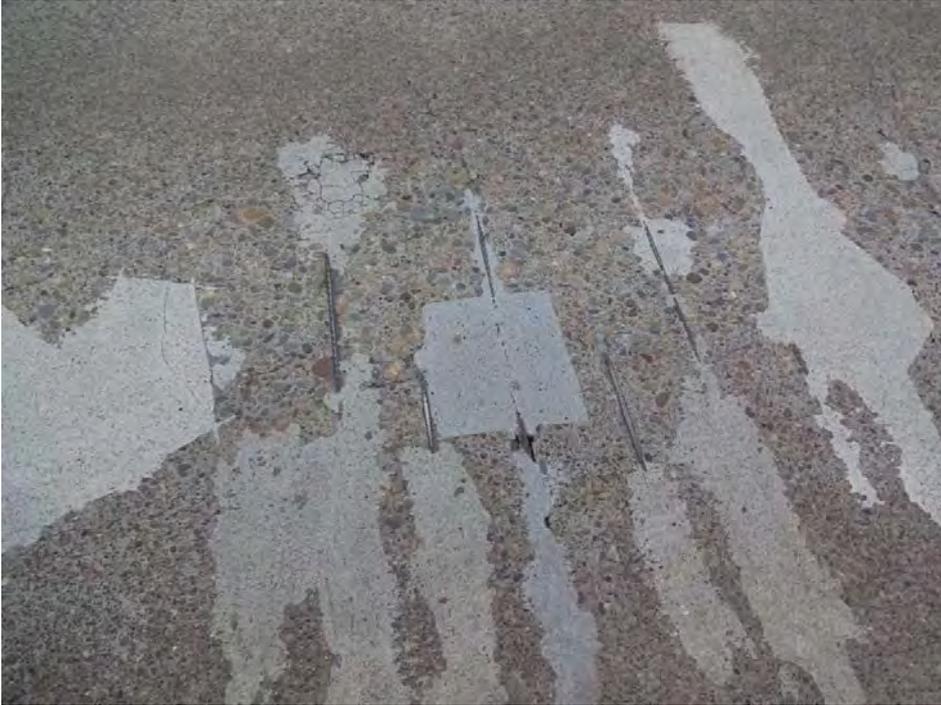
BR08492 Exposed Rebar on Deck

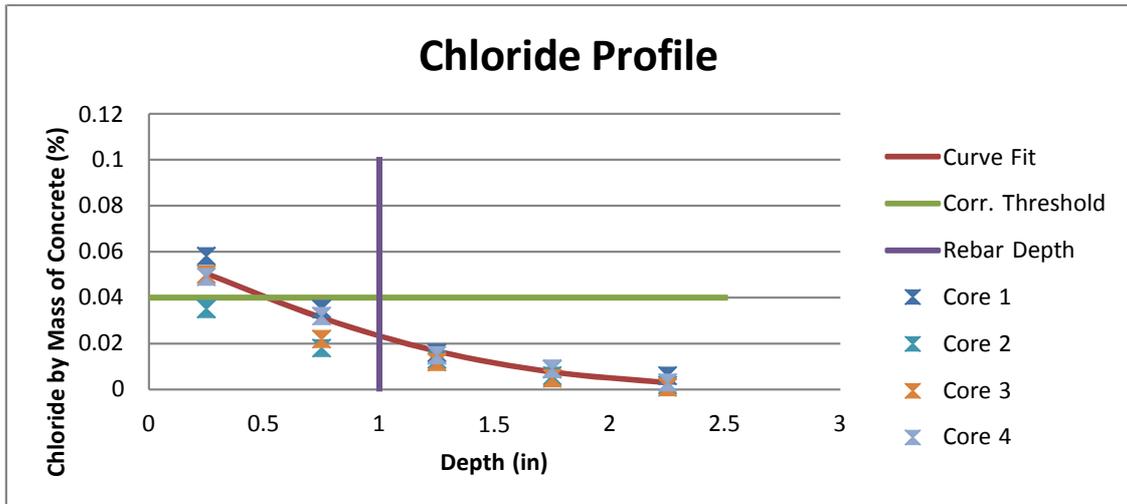
Figure 11: BR08492 Chloride Concentrations (Curve Fit, 4 Cores)

Deck cores were tested for chlorides according to AASHTO T-260 at ½” depth increments starting at the deck surface down to 2.5”.

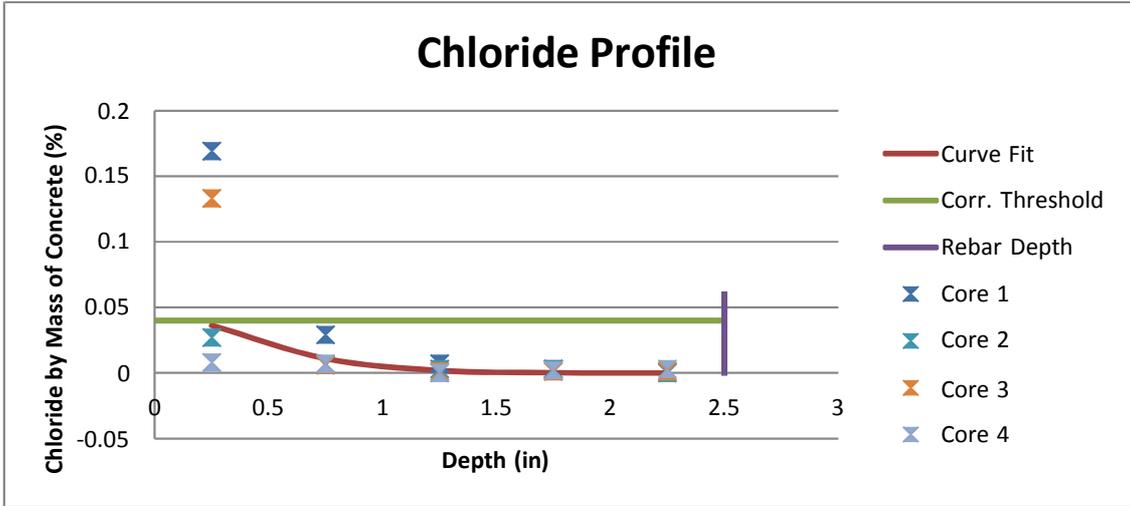
Figure 12: BR18675 Chloride Concentrations (Curve Fit, 4 Samples)

The 4 deck cores were tested for chlorides according to ASTM C1152/C1152M at ½" depth increments to a depth of 2.5".

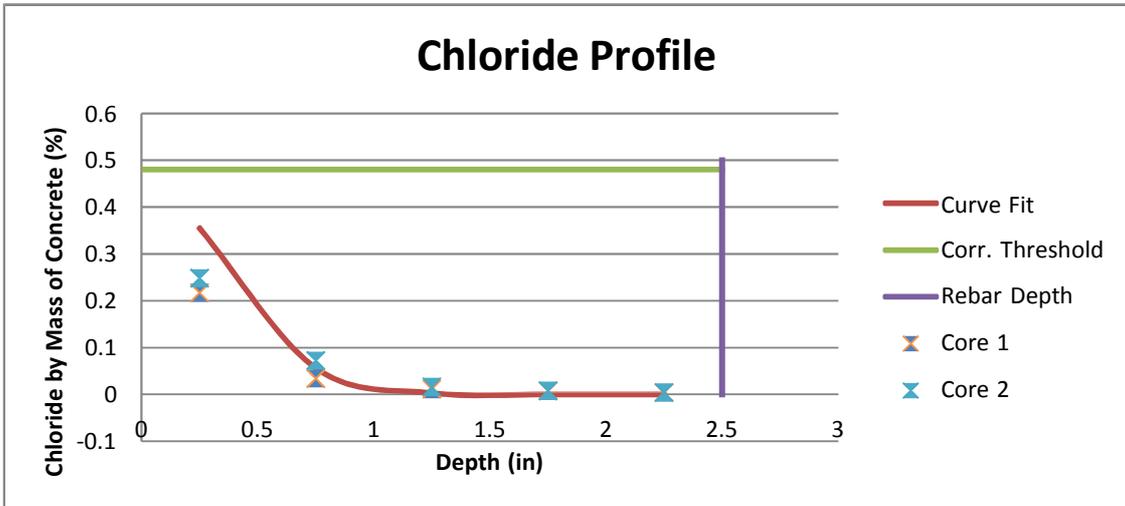
Figure 14: BR20198 Chloride Concentrations (Curve Fit, 2 Samples)

The 2 deck cores were tested for chlorides according to ASTM C1152/C1152M at ½" depth increments to a depth of 2.5".

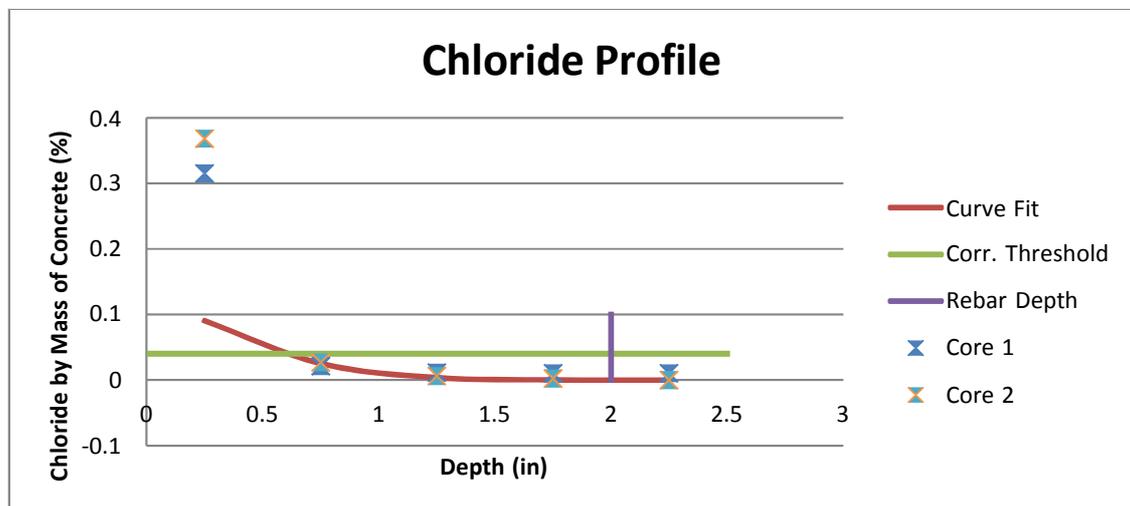
Figure 16: BR19086 Chloride Concentrations (Curve Fit, 2 Samples)

The 2 deck cores were tested for chlorides according to ASTM C1152/C1152M at ½” depth increments to a depth of 2.5”.

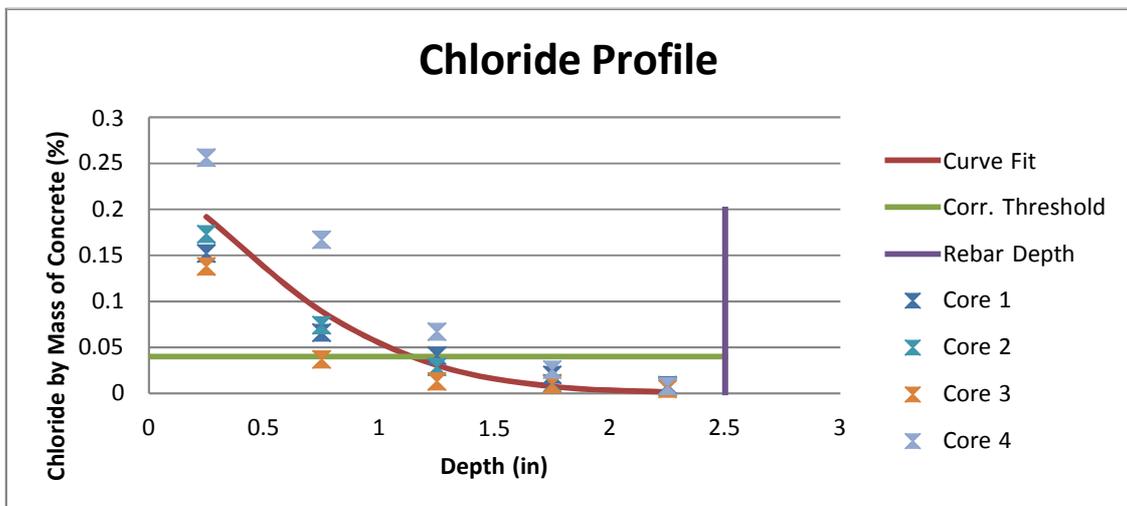
Figure 20: BR07894 Chloride Concentrations (Curve Fit, 4 Samples)

The 4 deck cores were tested for chlorides according to ASTM C1152/C1152M depth increments starting at the deck surface

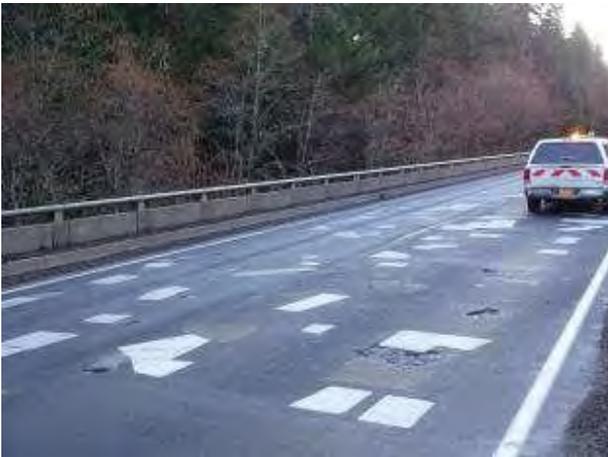
The deck has been having spalling issues for several years that the bridge crew has been chasing with patching efforts and a thin epoxy overlay that has continued to crack and spall as corrosion of the reinforcement continues. Chloride tests were conducted in September of 2015, but the results were inconclusive as not enough depths were tested to obtain a proper chloride profile and the sampling method is subject to inaccuracies.

BR2071A: Damage on Deck of Span 1

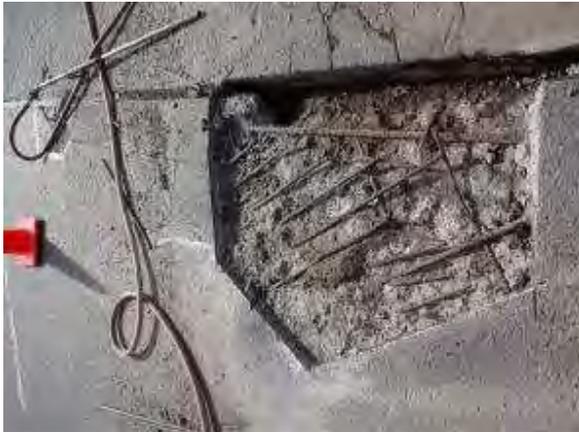
BR09259 Repair Area at Deck-Impact Panel Joint

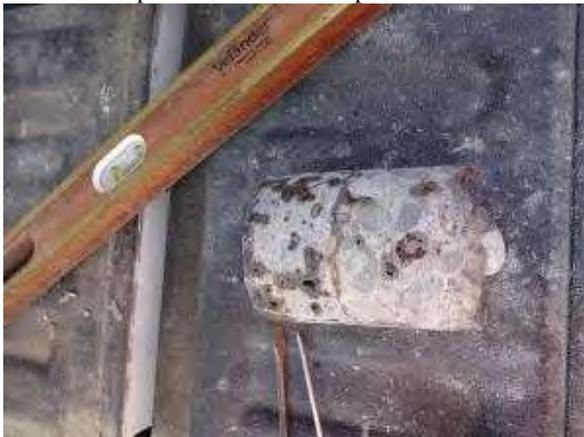
BR09259: Core Showing Overlay (left), Parent Material with Large River Rock (Right)

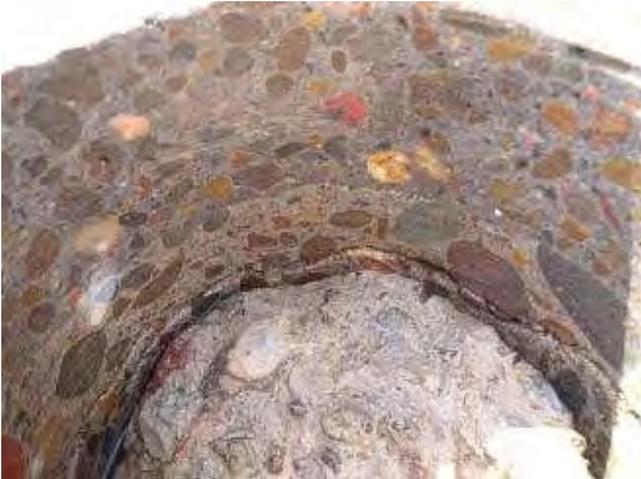
BR09259A: Core Hole Showing Relatively Shallow Portion of Overlay With Corrosion Induced Fracture at Top Mat Plane

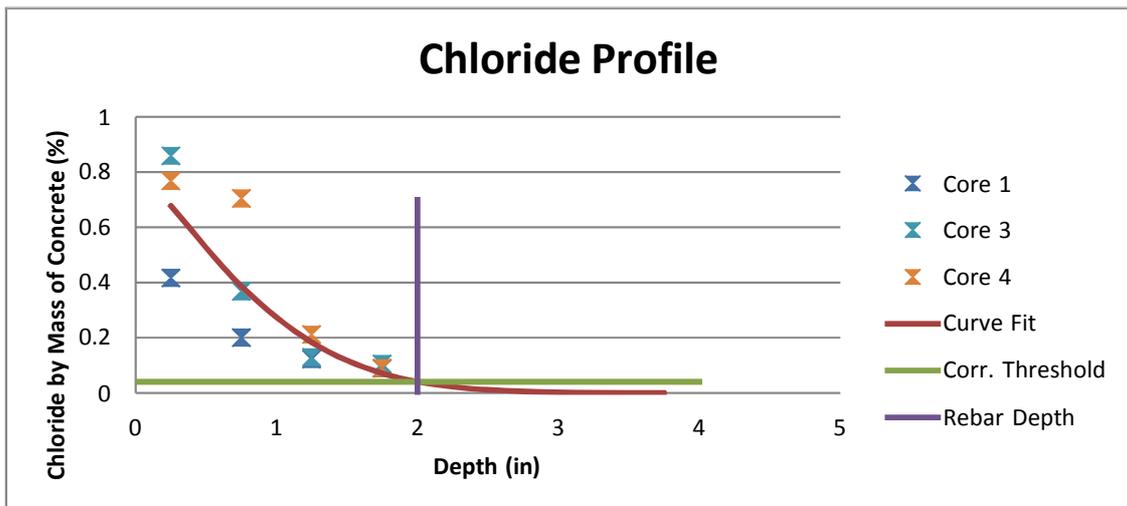
Figure 22: BR09259 Chloride Concentrations of Rigid Overlay (Curve Fit, 3 Samples)

The 6 deck cores were tested for chlorides according to ASTM C1152/C1152M at ½” depth increments starting at the deck surface.

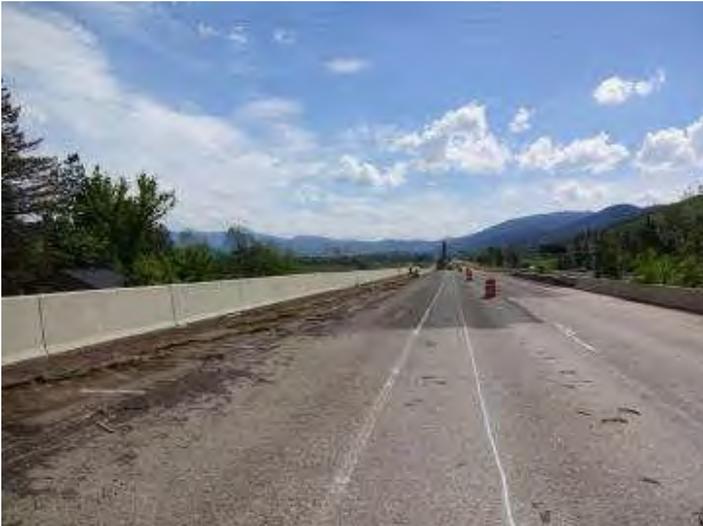
BR08746N at M.P. 13.29 on Hwy 1 (Route IS5N) is a pre-stressed concrete girder design constructed in 1963. The deck was replaced when the bridge was widened in 2001. The deck has spalling mostly concentrated in the left rut of the right travel lane which prompted this investigation.

BR08746N: Overview of Right Travel Lane with Spalled/Patched Areas

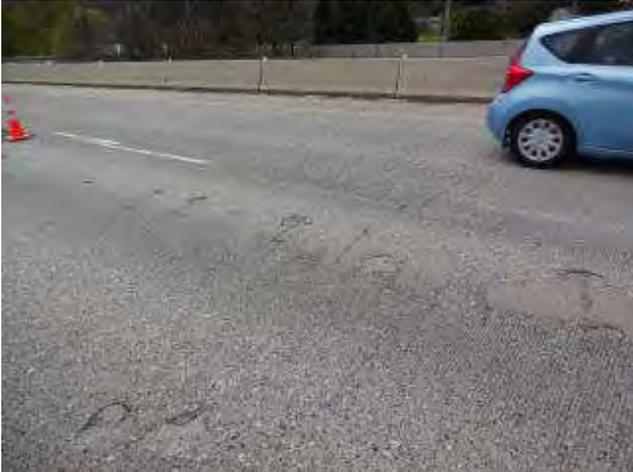
BR08746N: Spalling and Patch Repair

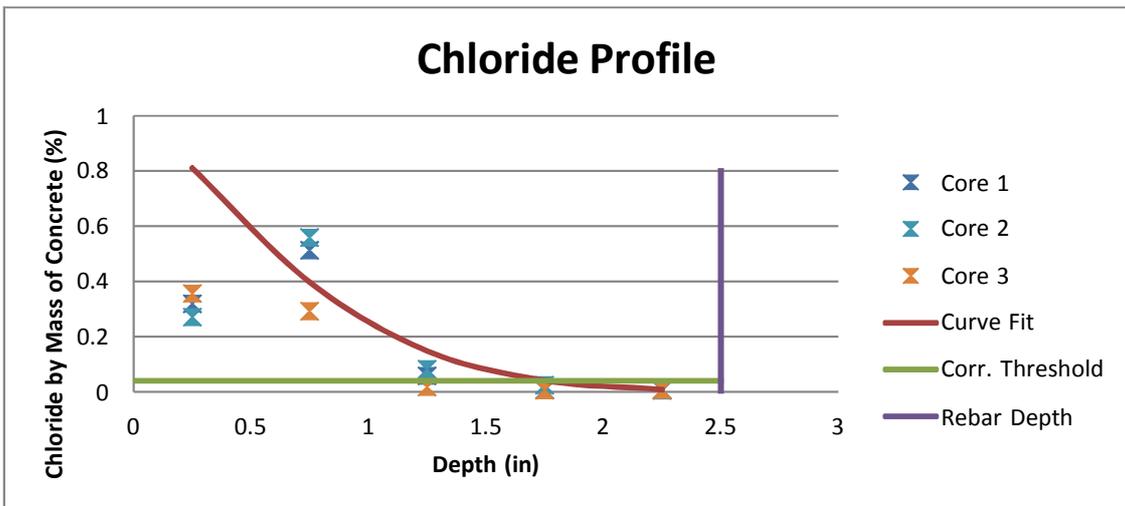
Figure 26: BR08746N Chloride Concentrations (Curve Fit, 3 Cores)

The 4 deck cores were tested for chlorides according to ASTM C1152/C1152M at 1/2” depth increments starting at the deck surface.

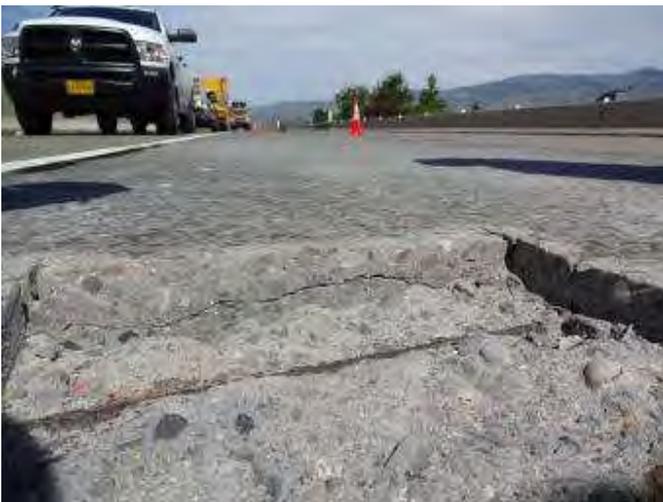
BR08746S at M.P. 13.29 on Hwy 1 (Route IS5S) is a pre-stressed RCDG design constructed in 1963. A microsilica overlay was placed on the deck in 2001. The deck has widespread cracking and sporadic spalling.

BR08746S: Repair Area Showing Surface Cracking, Corrosion, and Fracture Plane at Rebar Depth

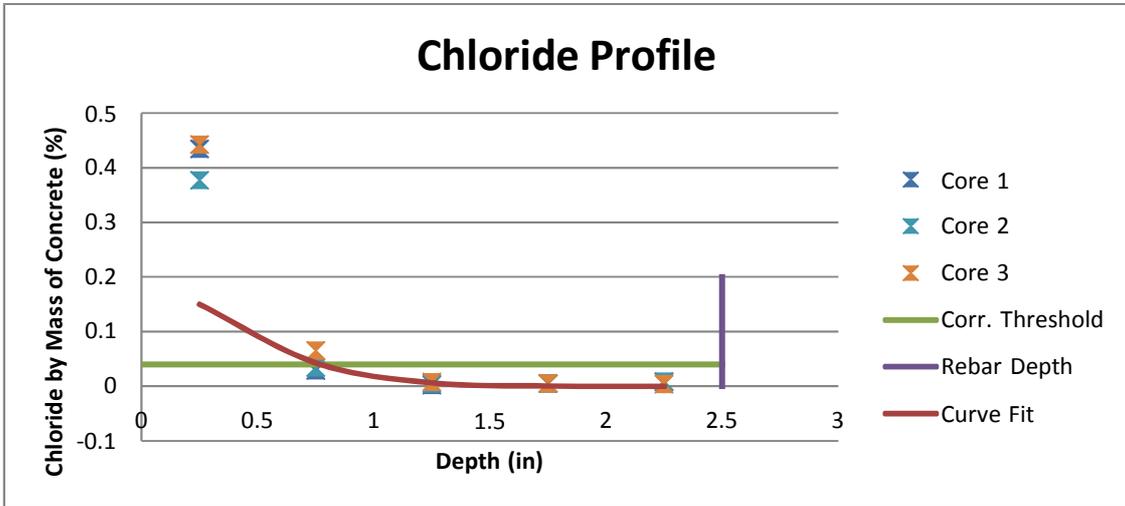
Figure 27: BR08746S Chloride Concentrations of Rigid Overlay (Curve Fit, 3 Cores)

The 4 deck cores were tested for chlorides according to ASTM C1152/C1152M at ½" depth increments starting at the deck surface.

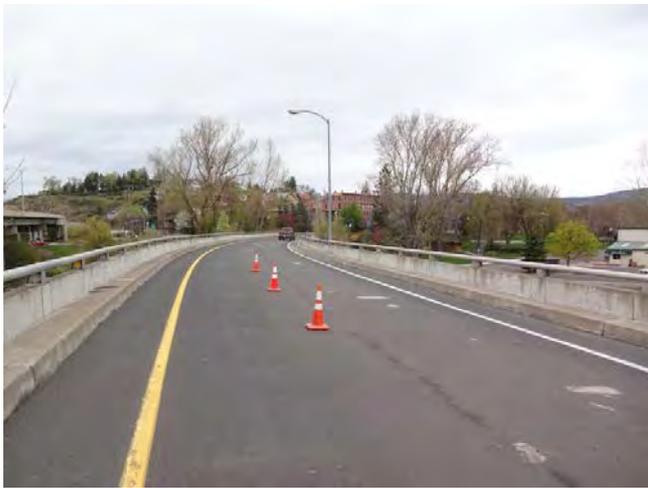
BR08347A at M.P. 275.38 on Hwy 4 (Route US97N) is a RCBG design constructed in 1968. The deck has been having spalling issues for several years that the bridge crew has been chasing with patching efforts and a thin epoxy overlay installed in 2008 that has continued to crack and spall as corrosion of the reinforcement continues. Chloride tests were conducted in late 2012 and correctly identified that the bridge had corrosion issues due to chloride contamination but the sampling method is subject to inaccuracies and could not be used to offer proper advice on repair measures.

BR08347: Overview of Deck with Repair Areas

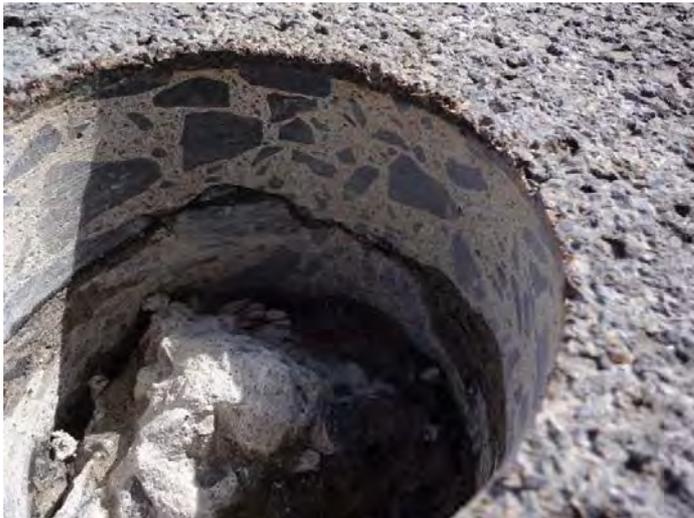
BR08347A: Corrosion Induced Delamination Fracture within Core

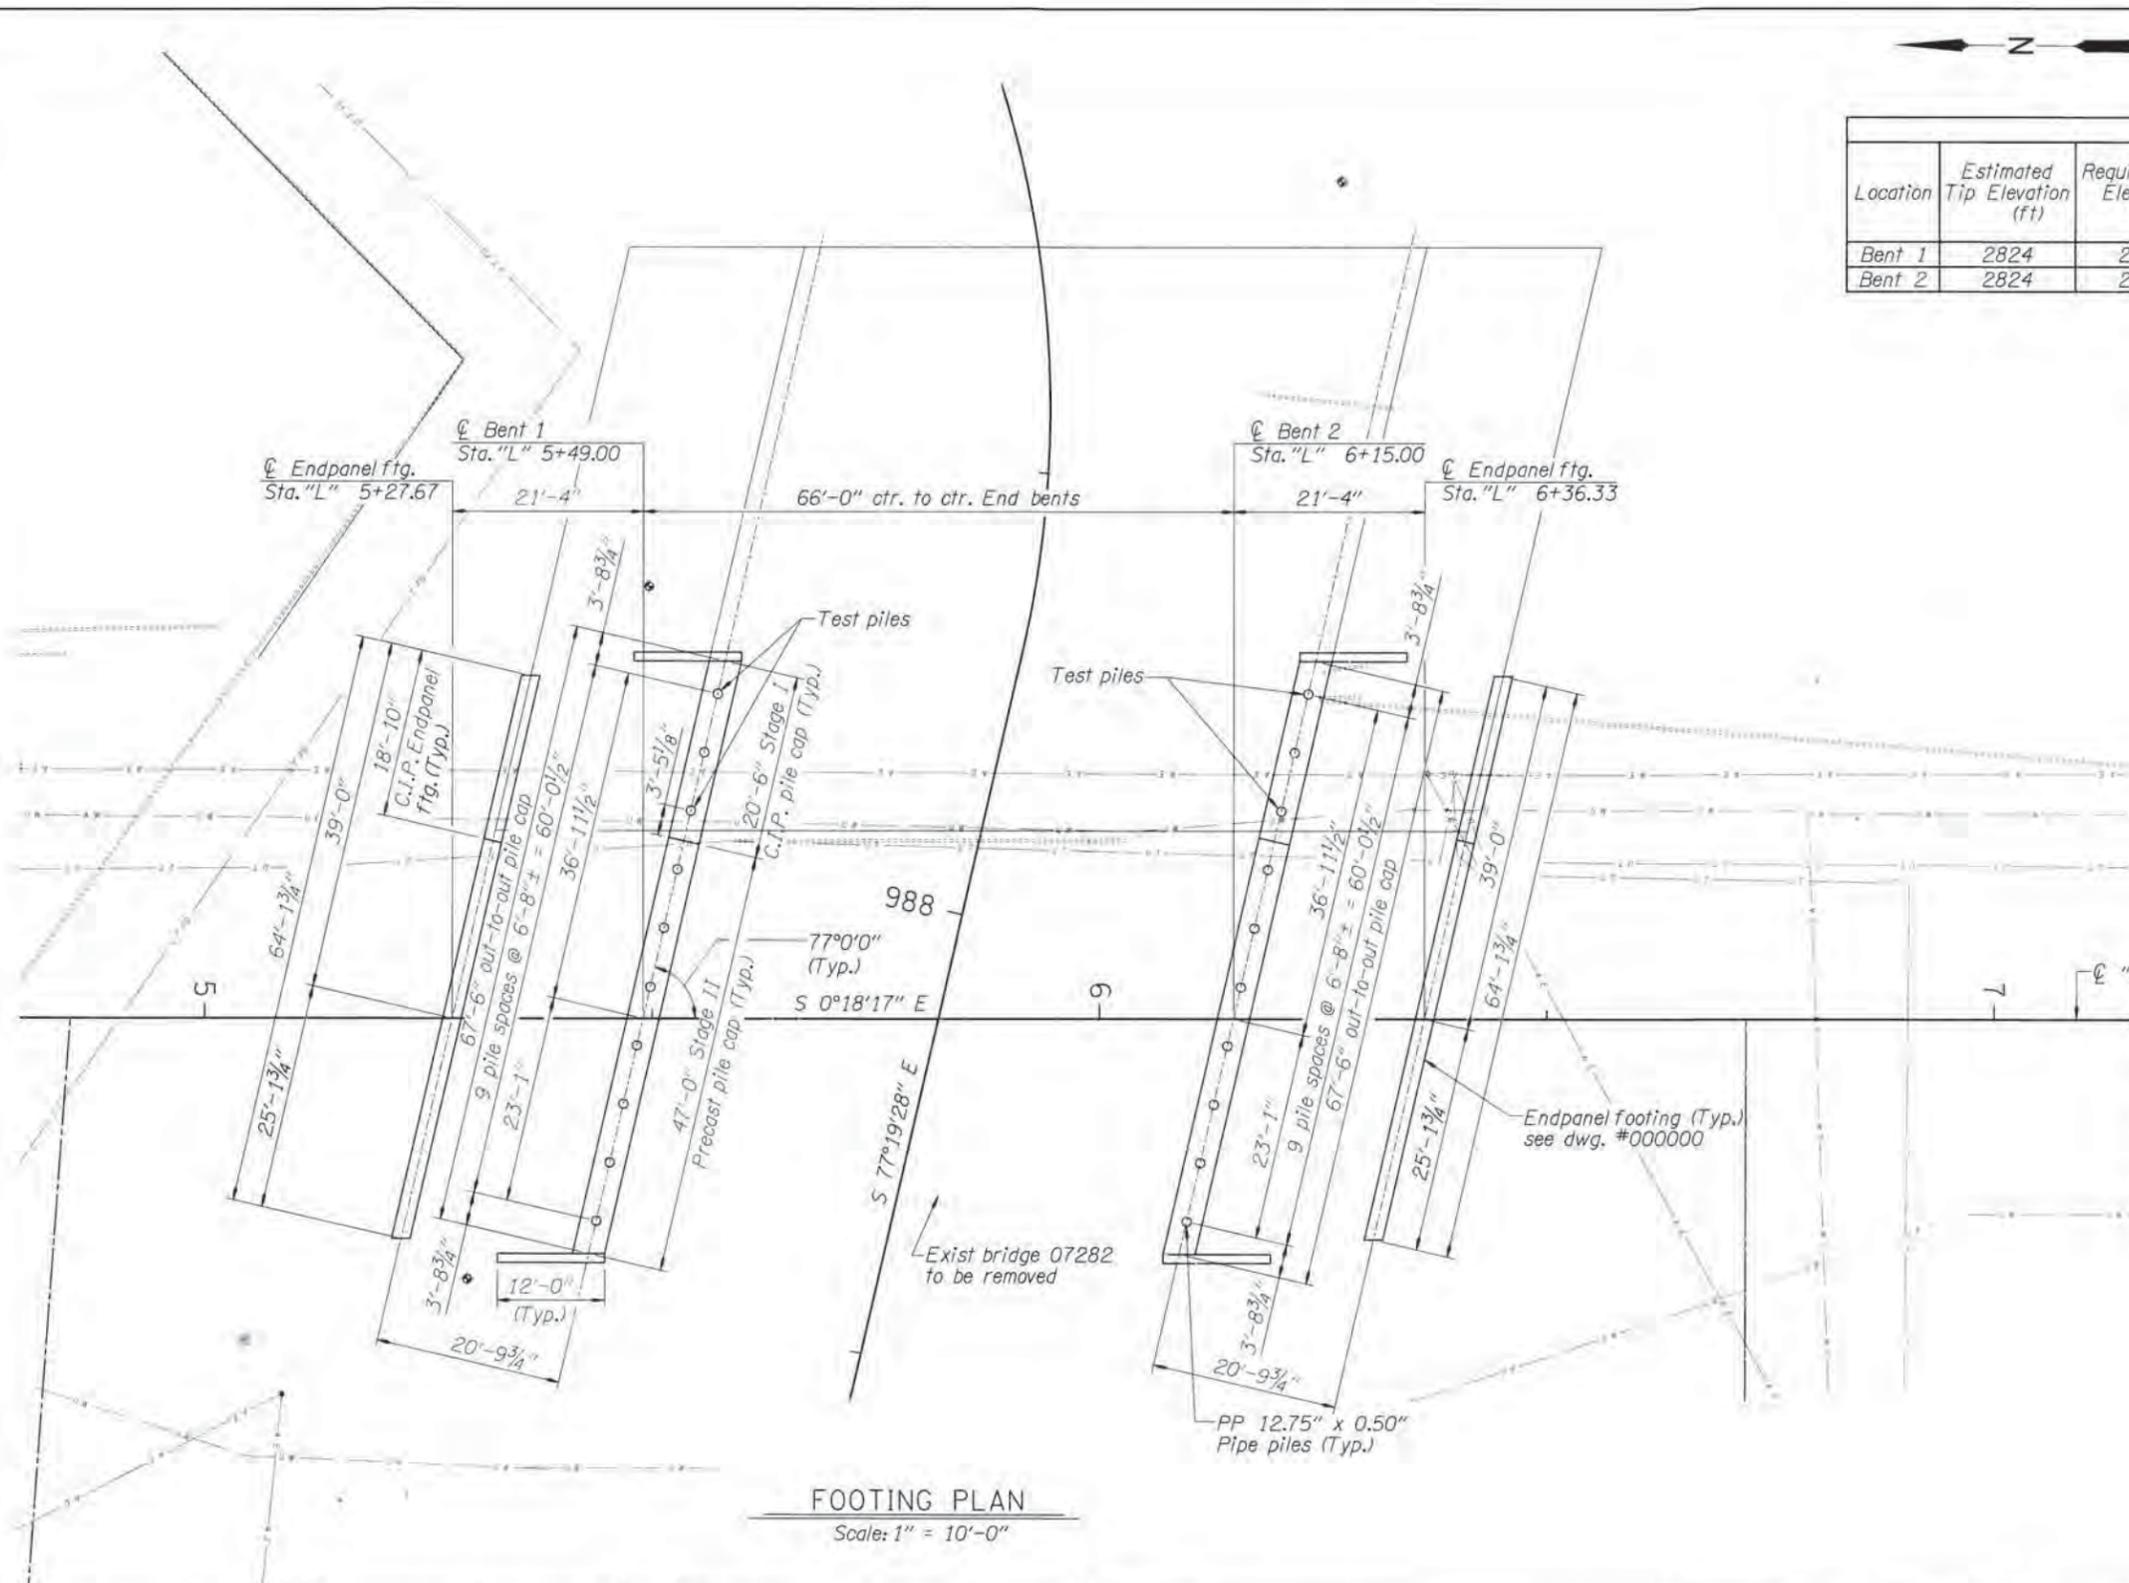
PIPE PILE (COVER PLATE)
No Scale

Pile Data (PP 12.75 x 0.500)						
Location	Estimated Tip Elevation (ft)	Required Tip Elevation (ft)	Cutoff Elevation (ft)	Engineer's Estimated Length (ft)	Nominal Bearing Resistance Rn (kips)	Factored Bearing Resistance (kips)
Bent 1	2824	2860	2888.39	65	340	220
Bent 2	2824	2860	2888.08	65	340	220

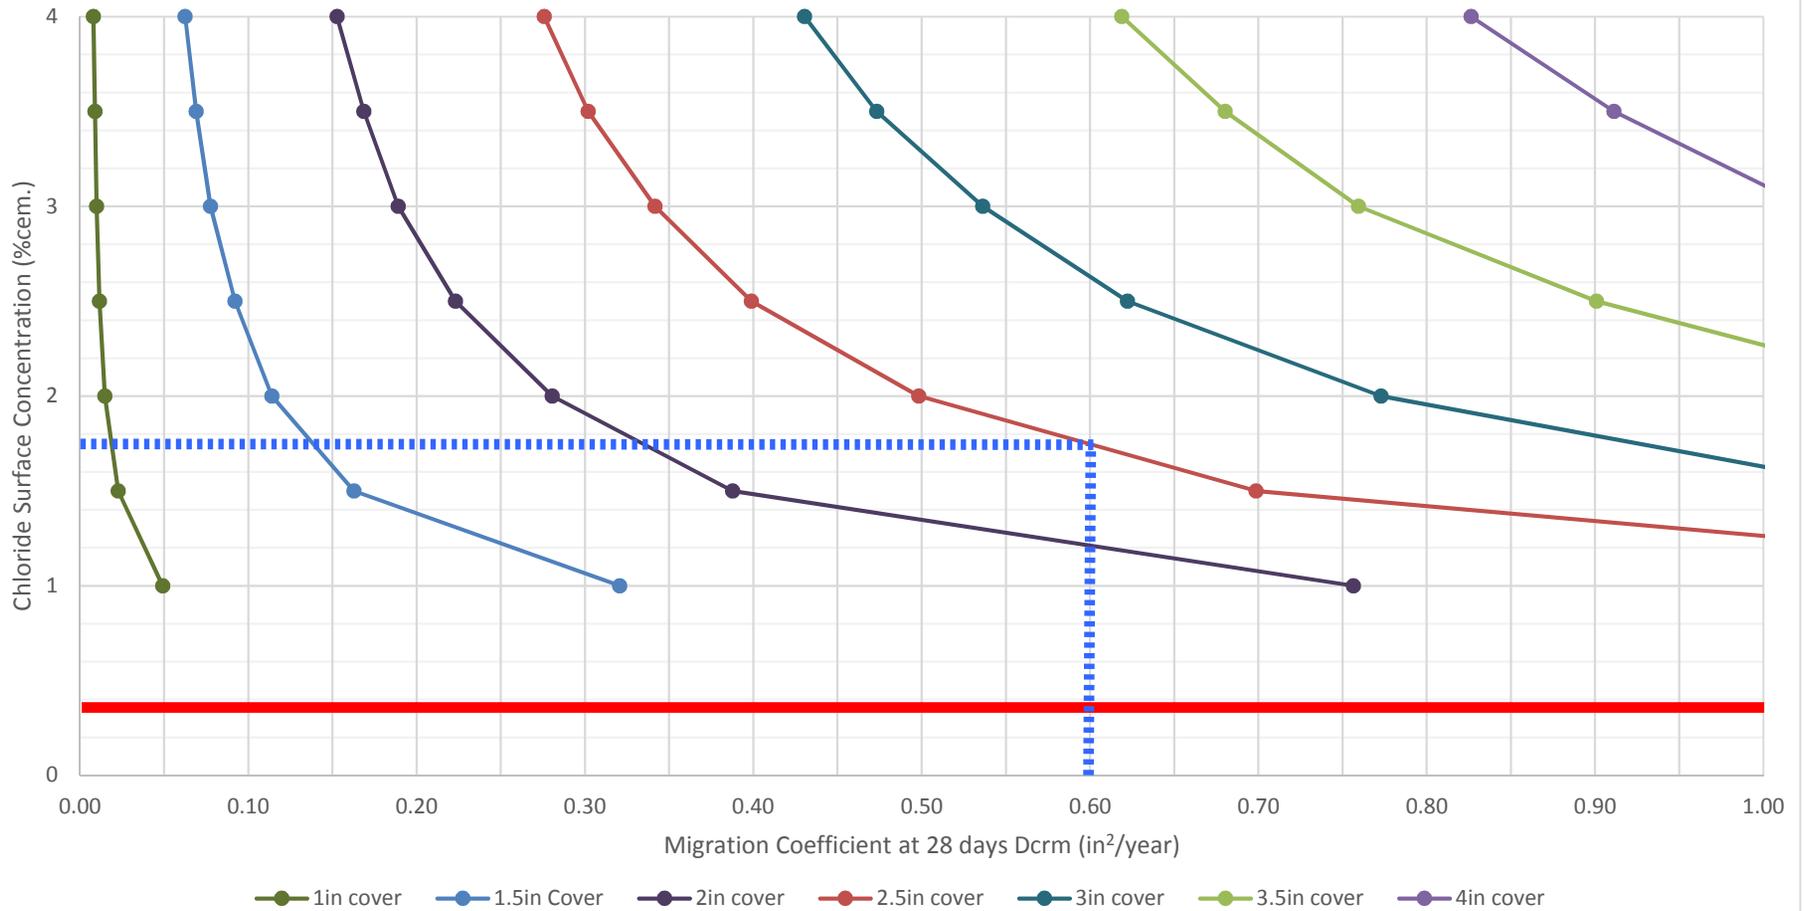
Age factor 0.6 = mean, std = 0.25

Capacity - QA Deck Concrete, Class HPC4000 (Slag) - $D_{RCM} = 0.60 \text{ in}^2/\text{year}$ - 2.5" Clear -----> 1.75%cm

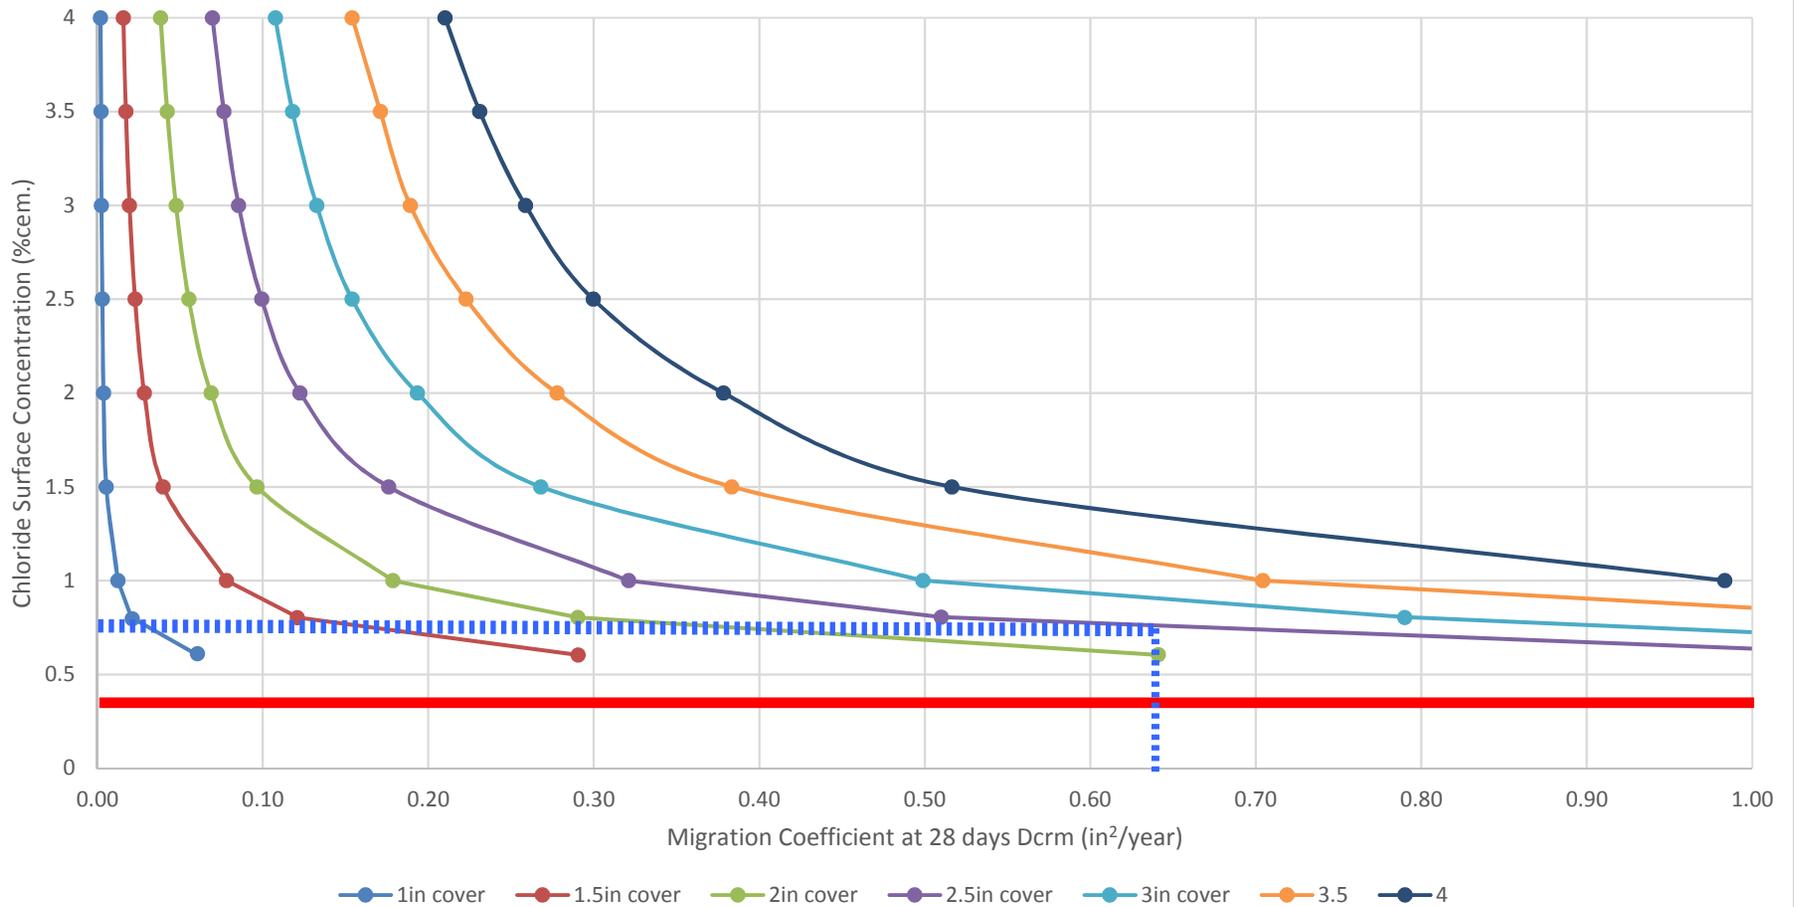
Capacity - Deck Concrete, Class HPC4000 (Fly Ash) - $D_{RCM} = 0.60 in^2/year$ - 2.5" Clear -----> 0.75%cem
