# ***Alaska Department of Transportation & Public Facilities***

***No Pothole Left Behind***

Rich Giessel

July 26, 2018

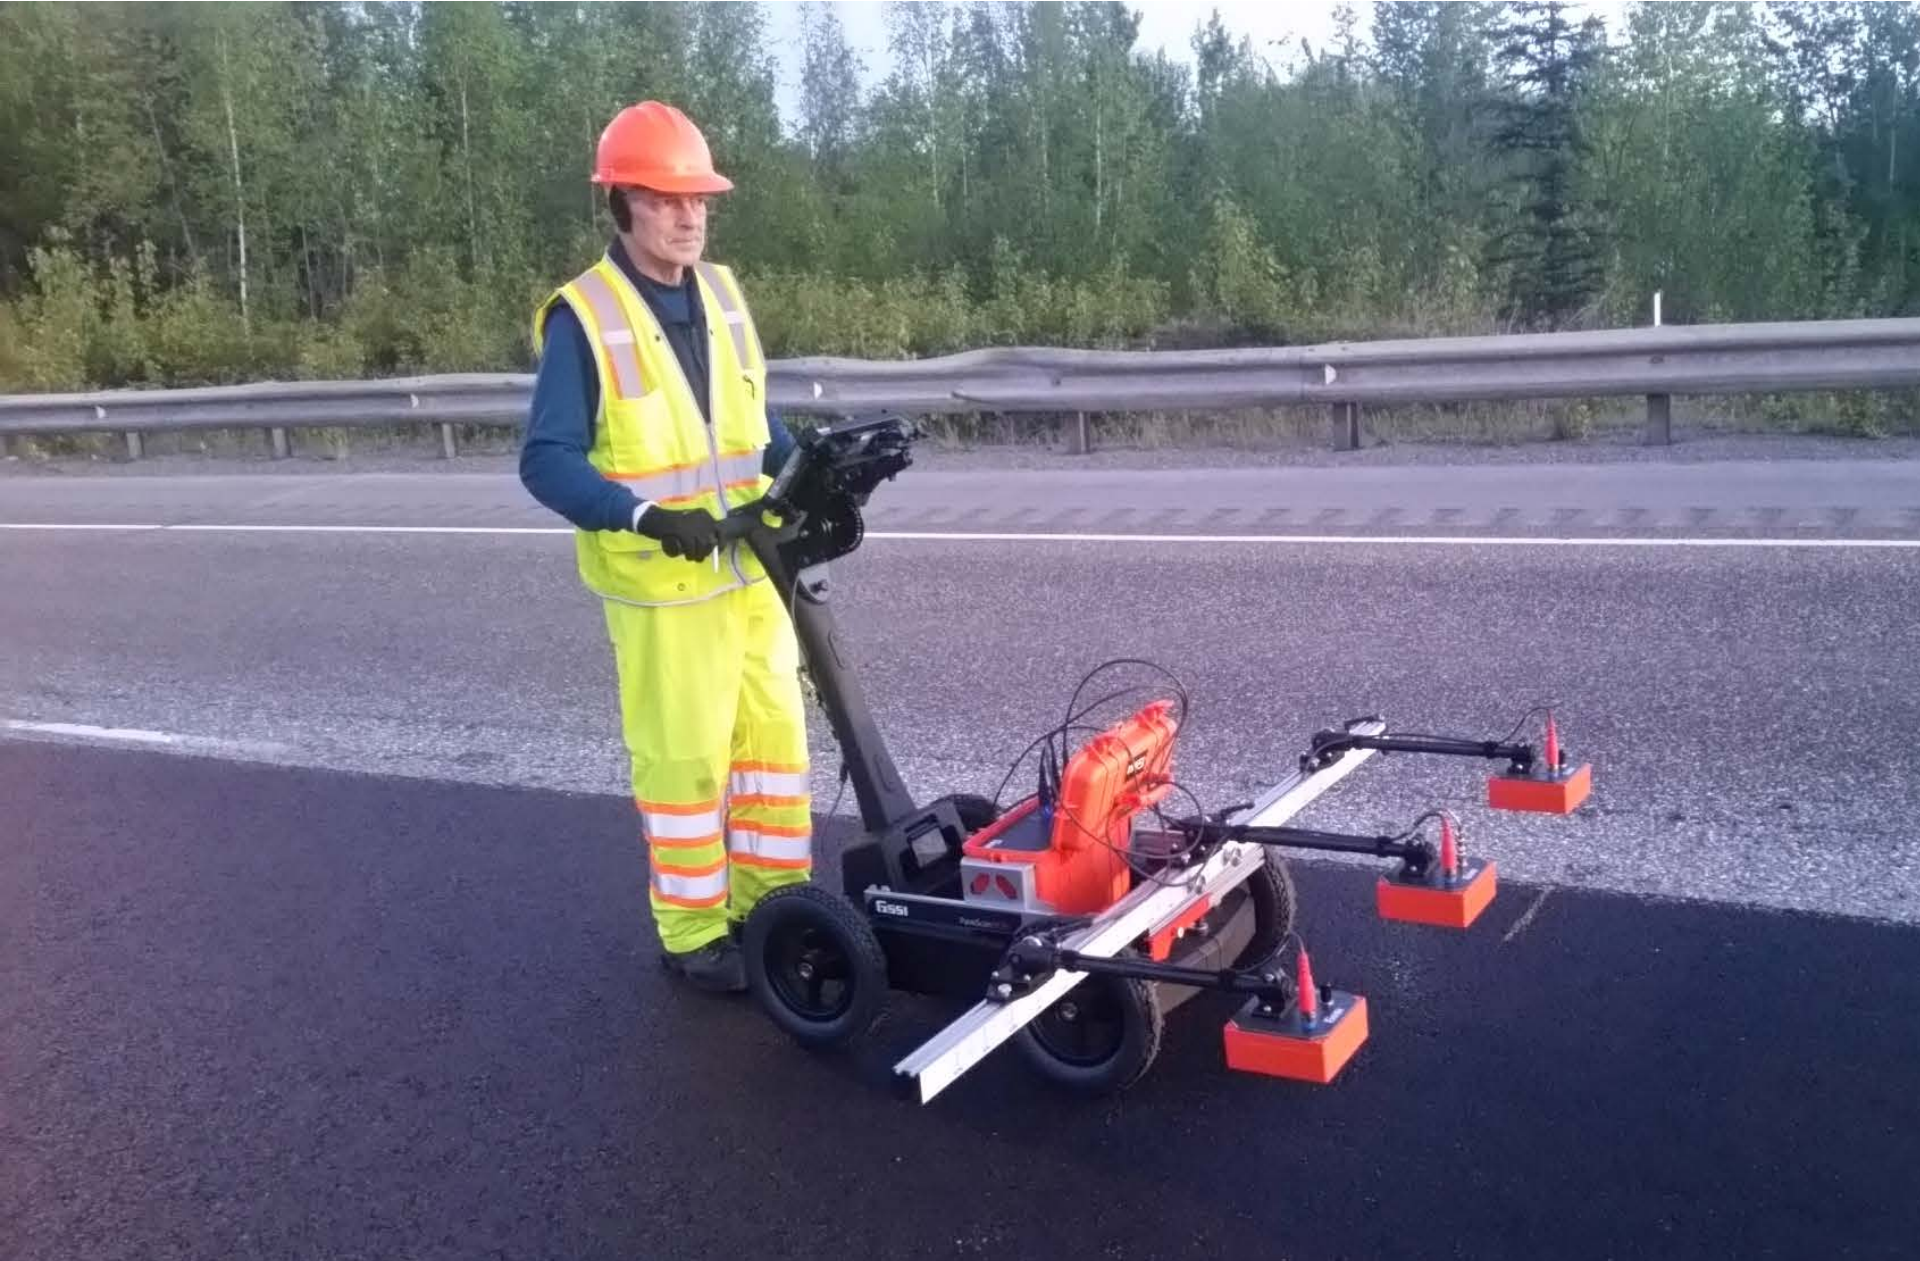
# PaveScan RDM (2017)

- PaveScan Rolling Density Meter Provides:
  - Geo-located Data
  - 400,000 pulses per second processed with equivalent time sampling to produce 60 scans/sec
  - 60 scans (dielectric readings) per second recorded to Raw Data File
  - =10 Dielectric readings per foot of travel at 6 ft/sec (~ 4 mph walking speed) per antenna

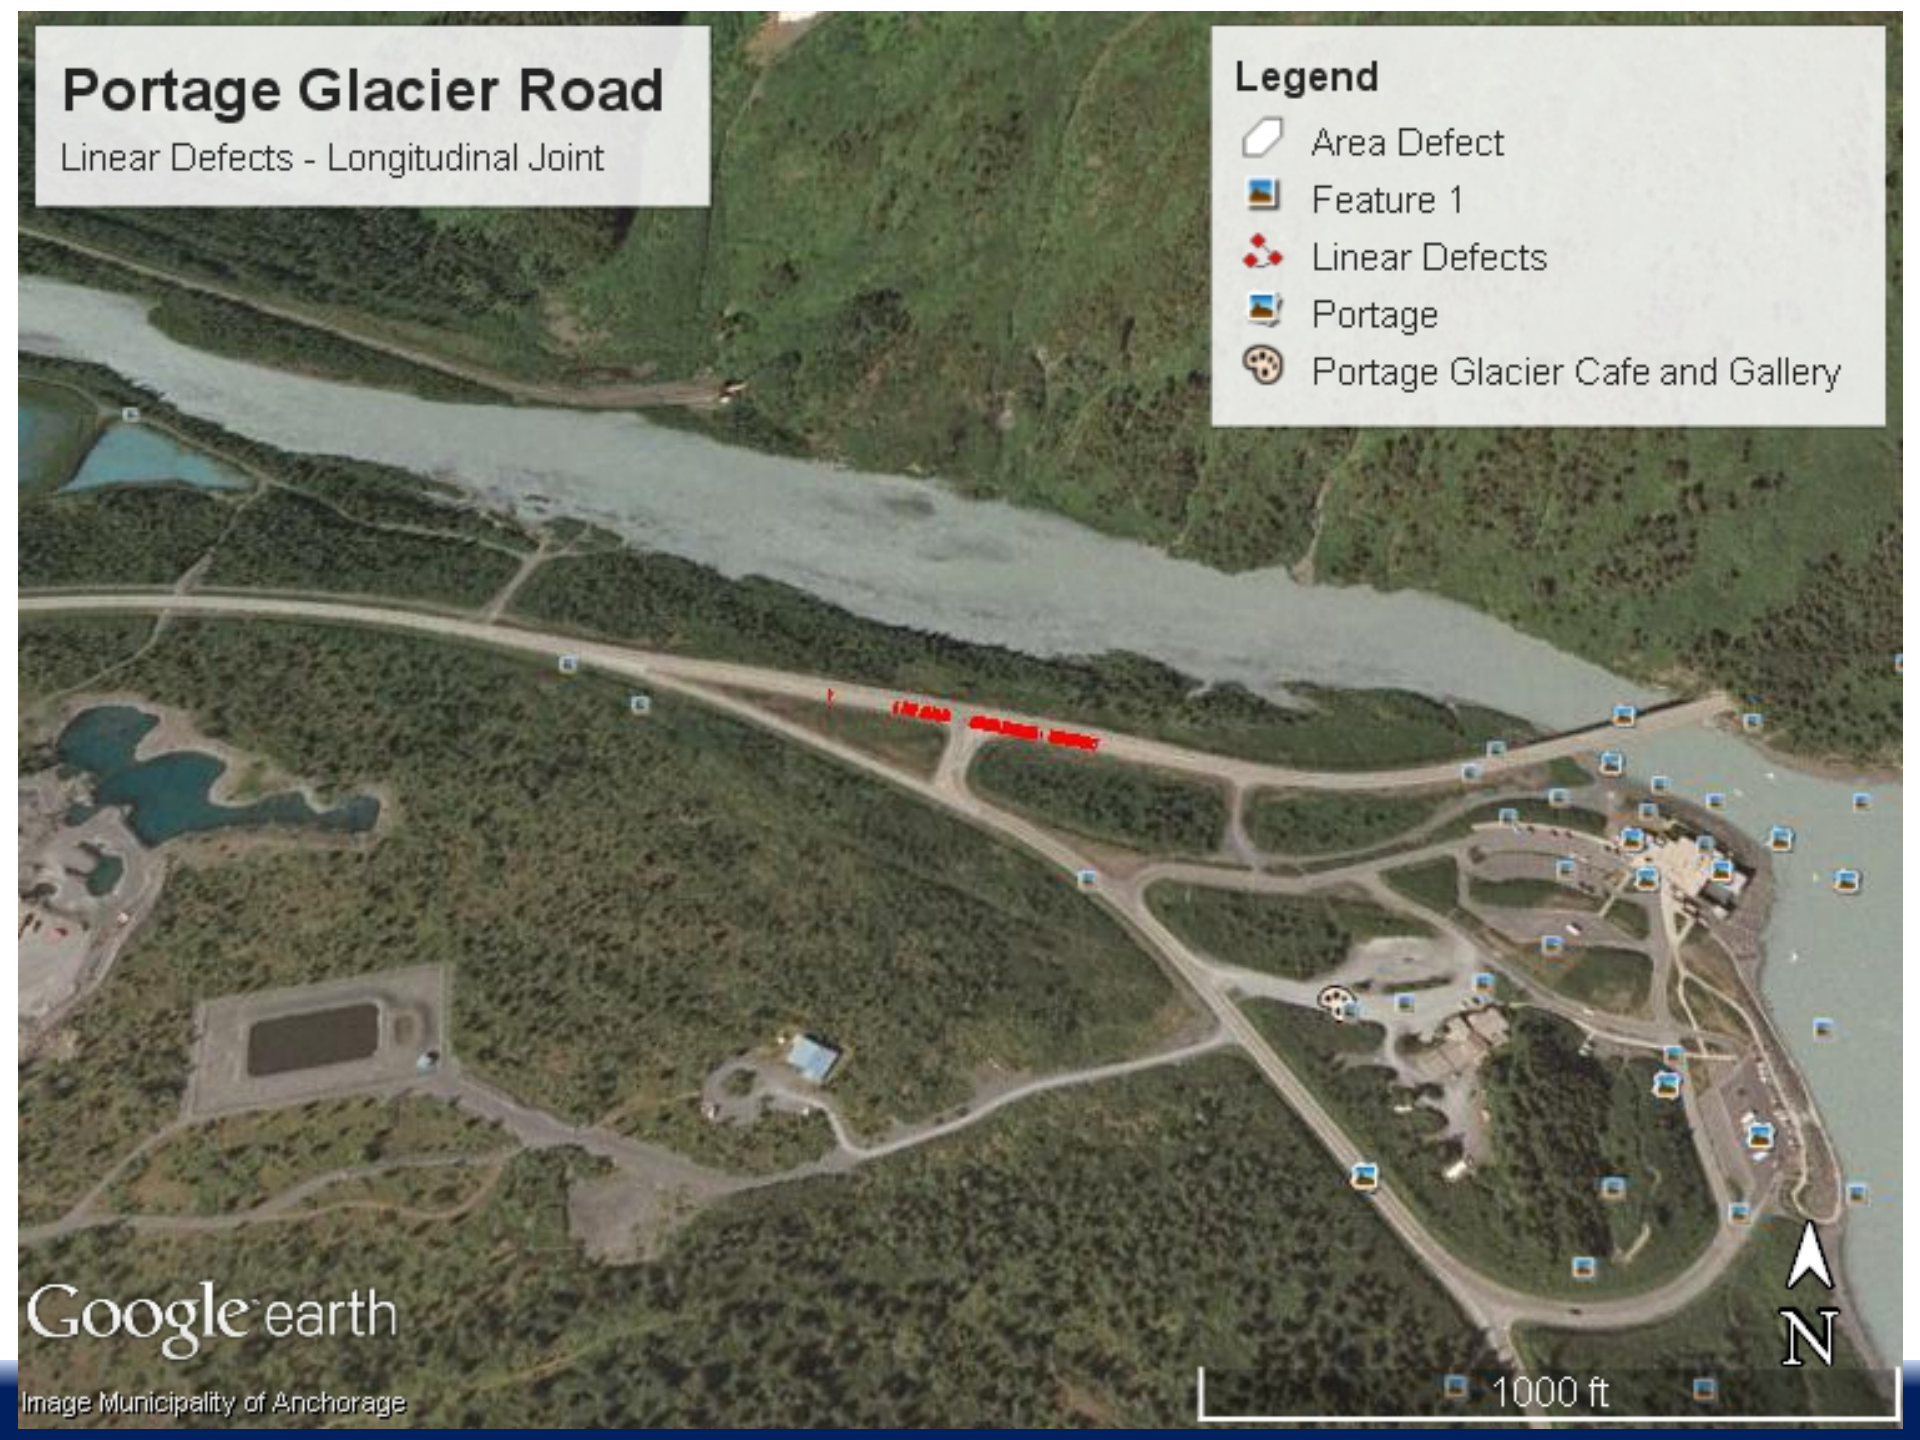
# Portage Glacier Road

Linear Defects - Longitudinal Joint

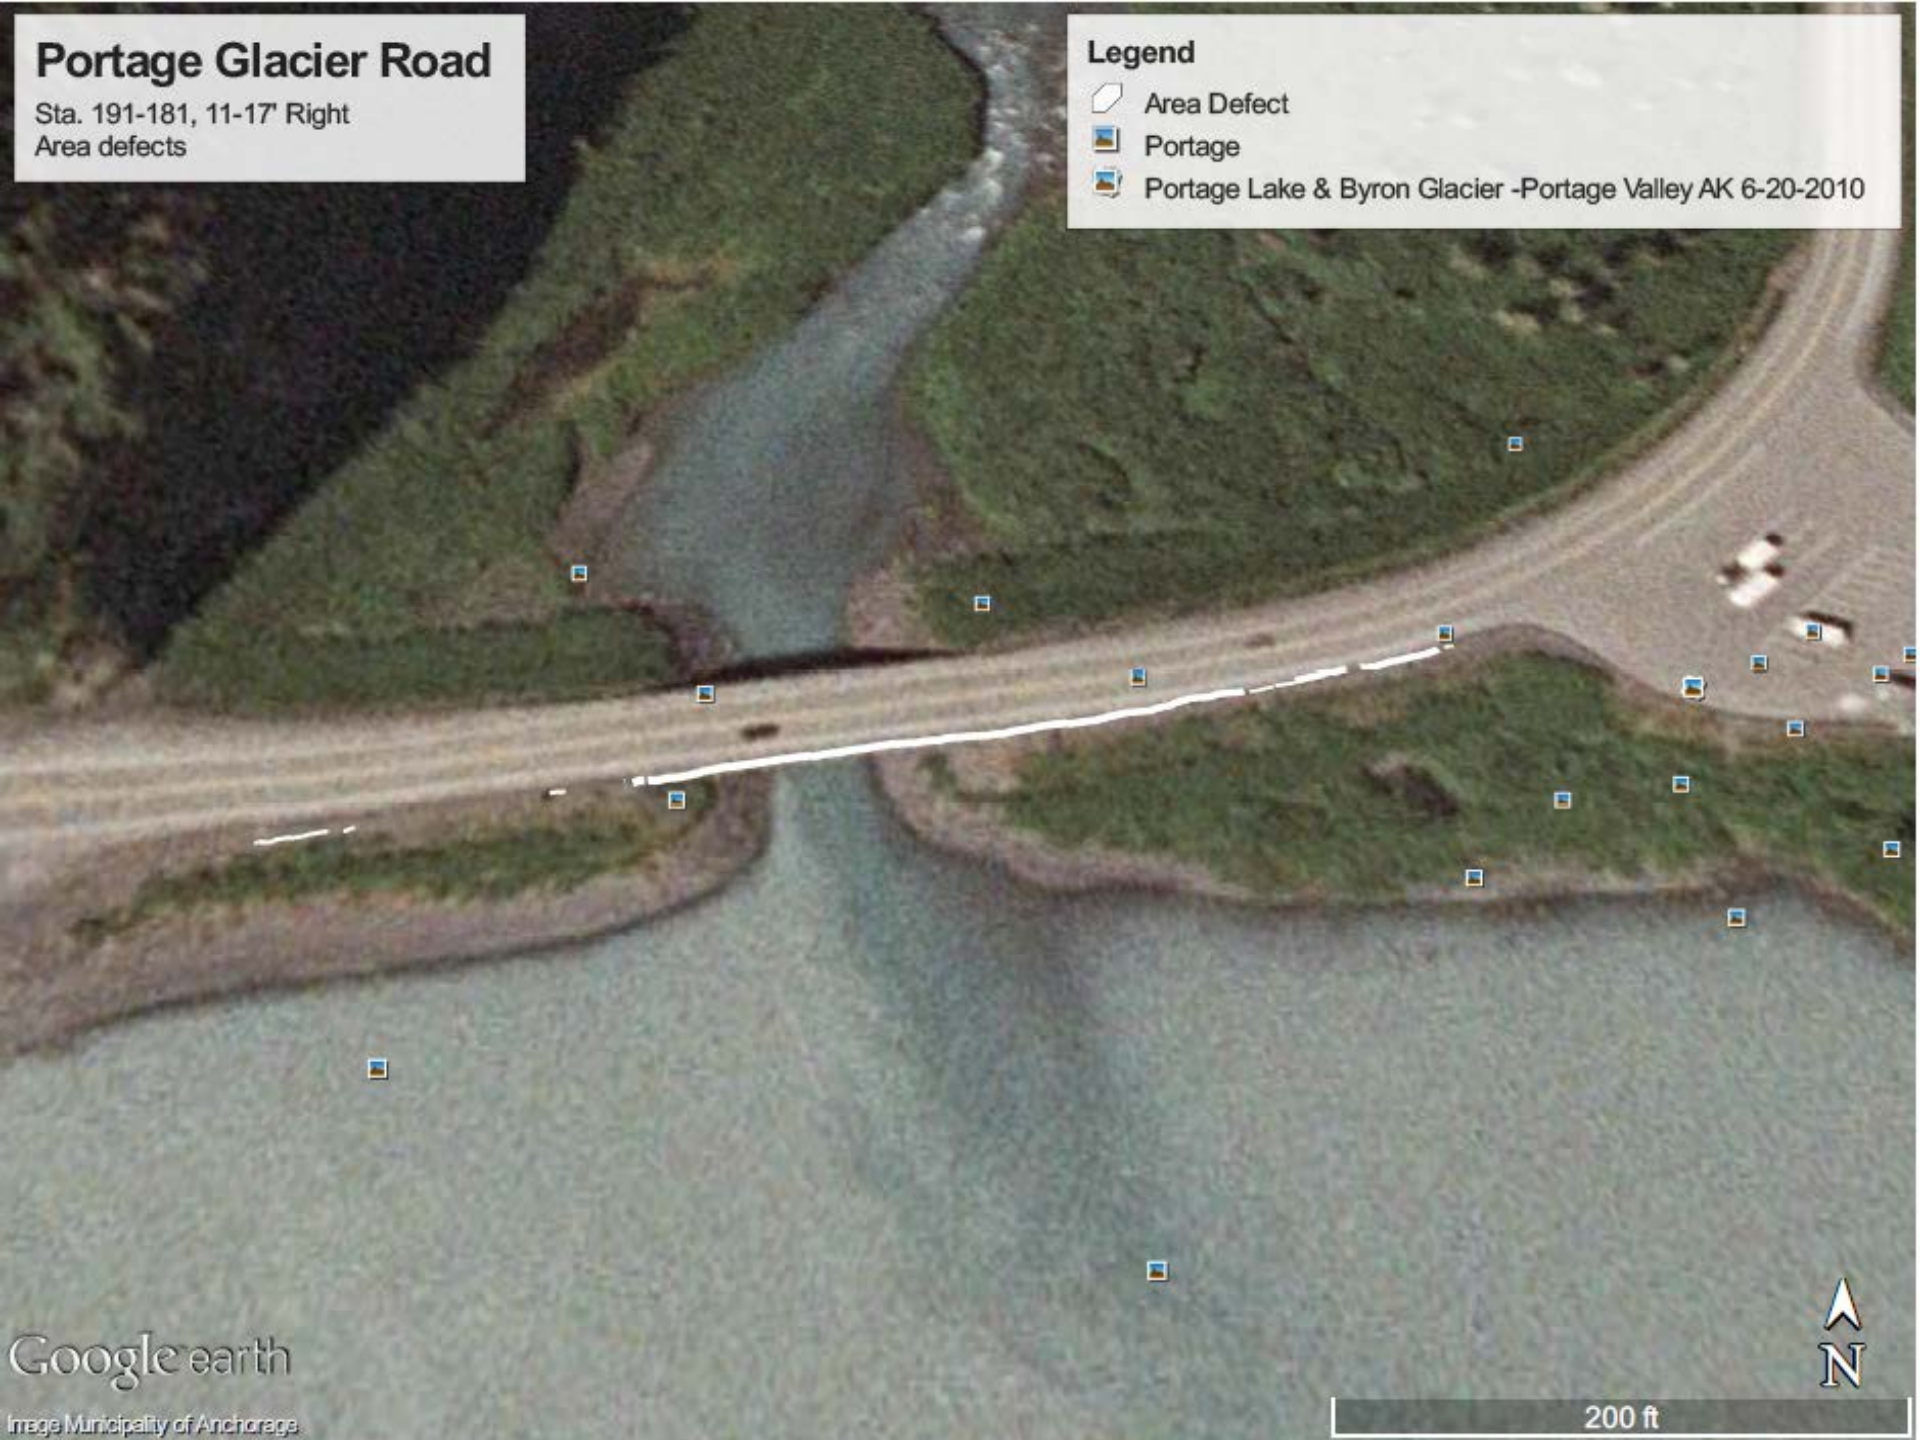
# Portage Glacier Road

Sta. 191-181, 11-17' Right  
Area defects

# REPAIRING DEFECTIVE AREAS

1. Apply Sand Seal to the mat of an entire lane station that contains low density (Bulk density less than 92.0% of MSG) areas that are small (less than 8 ft<sup>2</sup>), discontinuous, and total more than 2% of a lane station area [(2%)(12'x100') = 24 ft<sup>2</sup>]

2. Apply Sand Seal to the mat of an entire lane station that contains a large (equal to or greater than 8 ft<sup>2</sup>) contiguous low density area

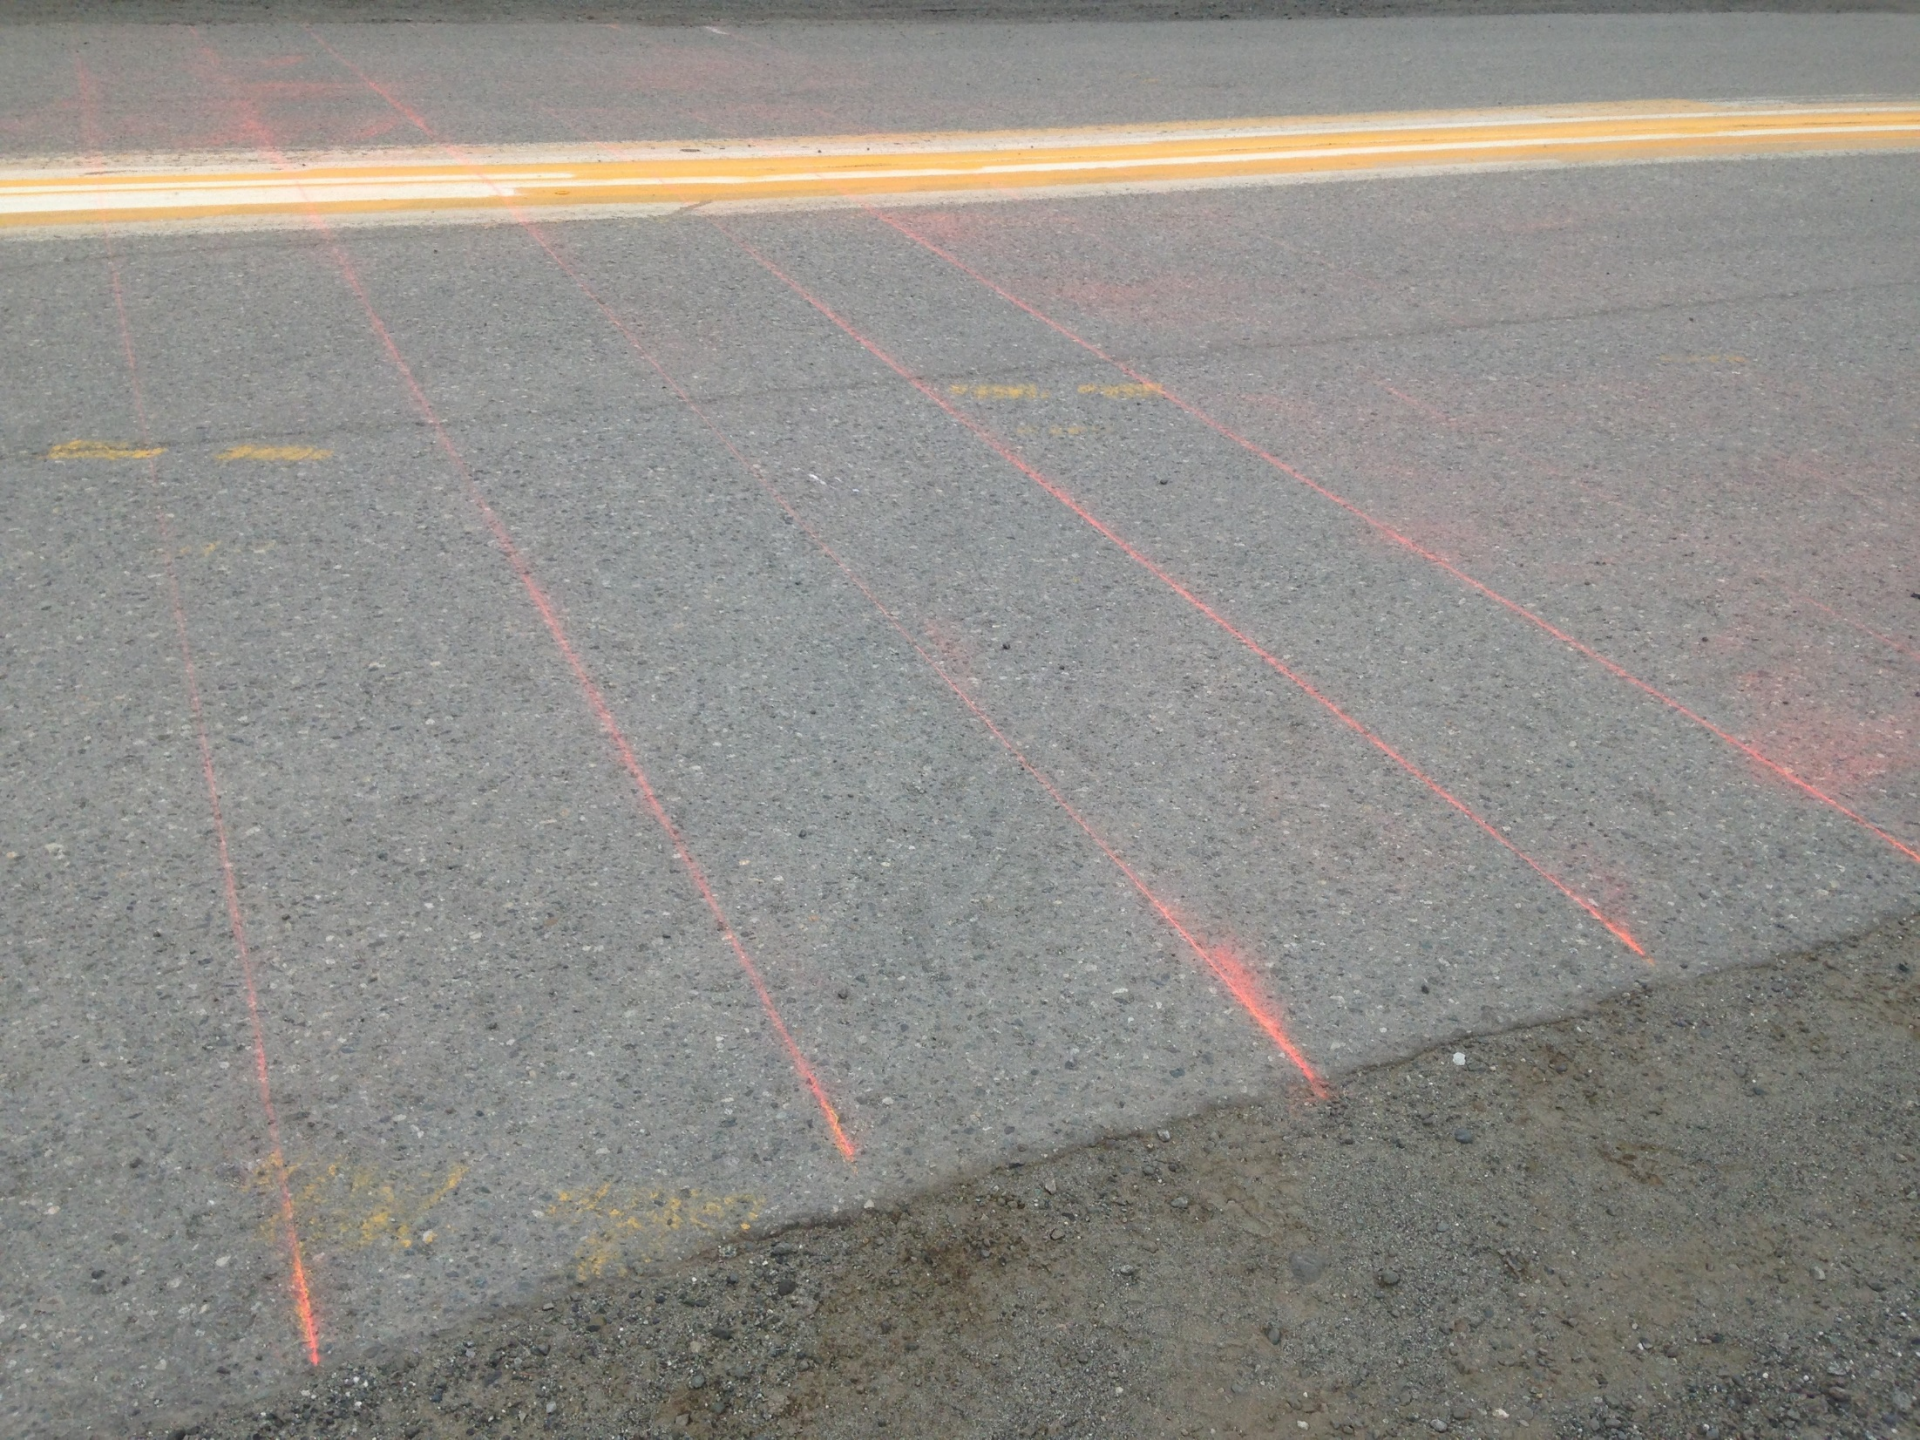
Plan for collecting Antenna Verification Data  
Center Antenna on Lines 1-5

1. Before beginning data collection, set the antennas at the spacing to be used for that day.
2. Make certain that antenna check area is protected by traffic control.

3. Make 5 marks at the antenna spacing (2' is typical) along the antenna check area.
4. Layout 5 equal length parallel lines transverse to the paving direction across one or more newly paved lanes.

5. Snap a chalk line, or otherwise mark, the 5 parallel lines so they are easy to see. Also mark both ends.
6. Name a file "Antenna Check" and set offset equal to "0".

7. Position PaveScan with center antenna right at the marked starting point of Line 1.  
Note: Left antenna will be on Line 0, right antenna will be on Line 2 (see graphic).

8. Collect distance file across lane. Stop right at the marked end point and save data.
9. Increase file offset setting by 2 feet or the antenna spacing selected for that day.

10. Back up and index over to the right one Line such that the center antenna is now on Line 2, (right antenna will be on Line 3).
11. Repeat this procedure until center antenna has travelled on Lines 1-5.

12. In walk mode dielectric reading variations among the three antennas should be within  $\pm 0.08$  (If variation is greater than  $\pm 0.08$  then recalibrate the PaveScan RDM with new Air and Metal plate readings.)
