# Evaluation of 3D Radar and Sonic Surface Scanner (SSS) Technology for Pavement Forensics (a.k.a. pavement delamination RO6D)

## KENTUCKY

Brad Rister P.E.  
Brad Frazier P.E.  
Jamie Creech Eng. Tech.  
Joe Tucker P.E.  
Kate Kurgan  
Michael Heitzam P.E.

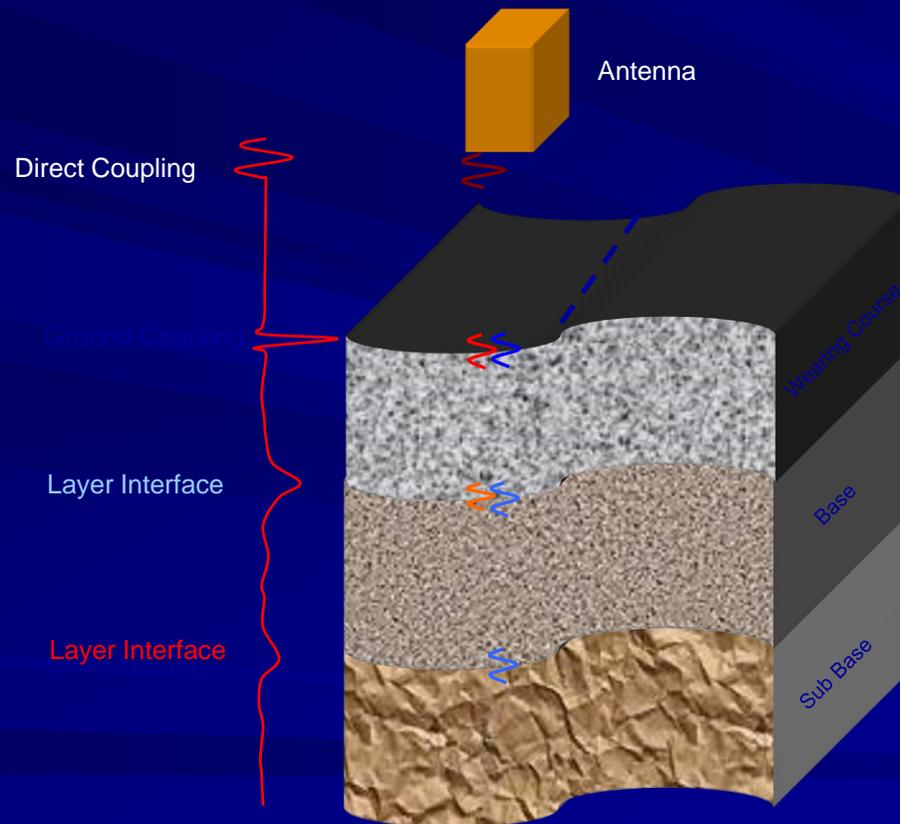
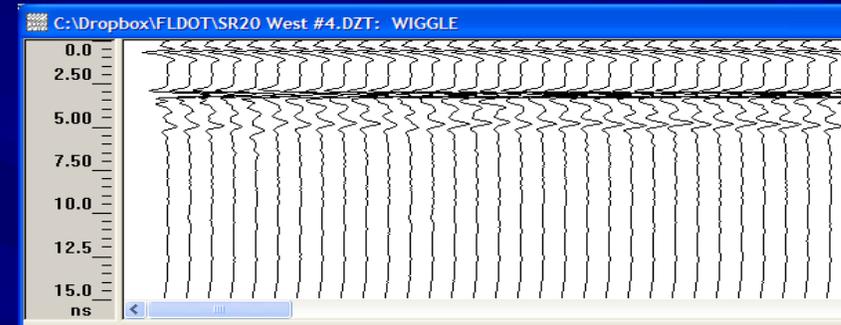
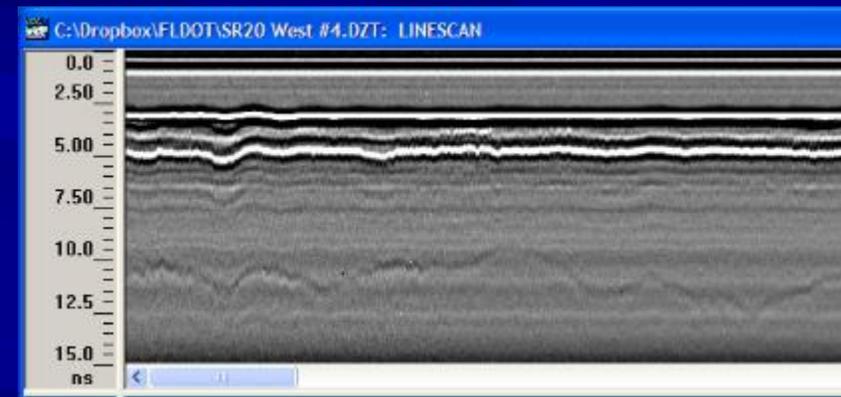
## GPR: Theory of Operation

Reflections are produced when the pulse encounters a material with different dielectric constant  
Dielectric Constant: Air = 1 Asphalt = 3-5 Concrete = 6-8

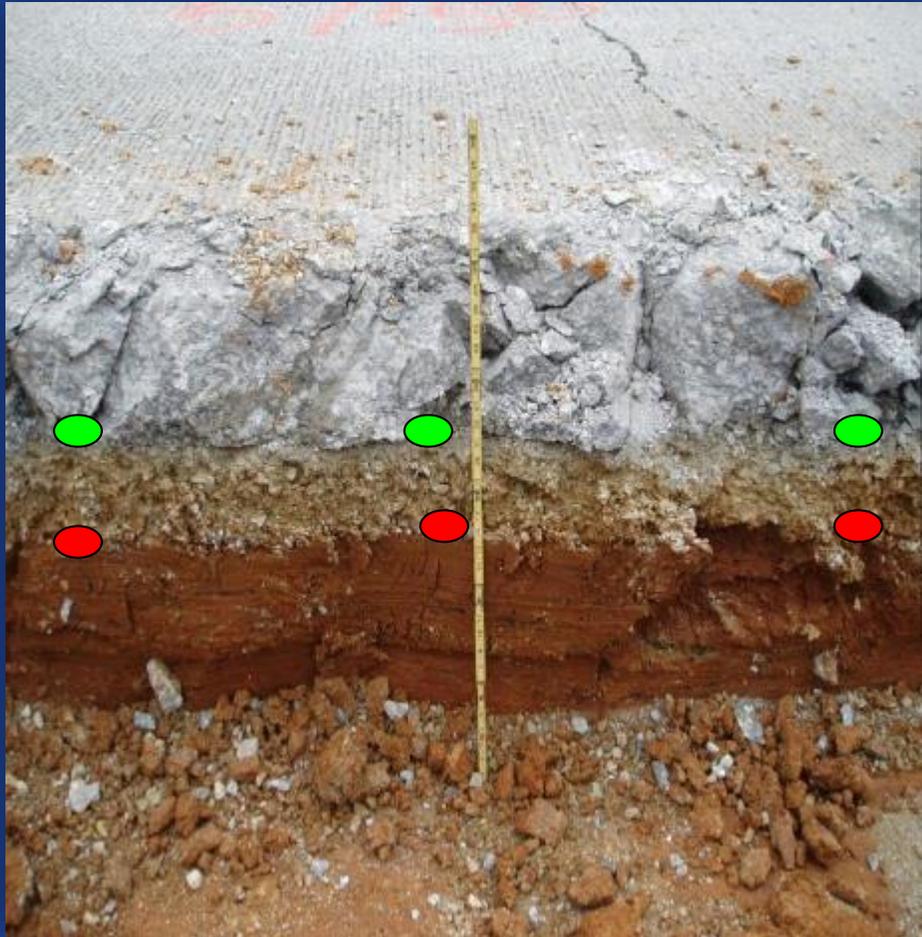
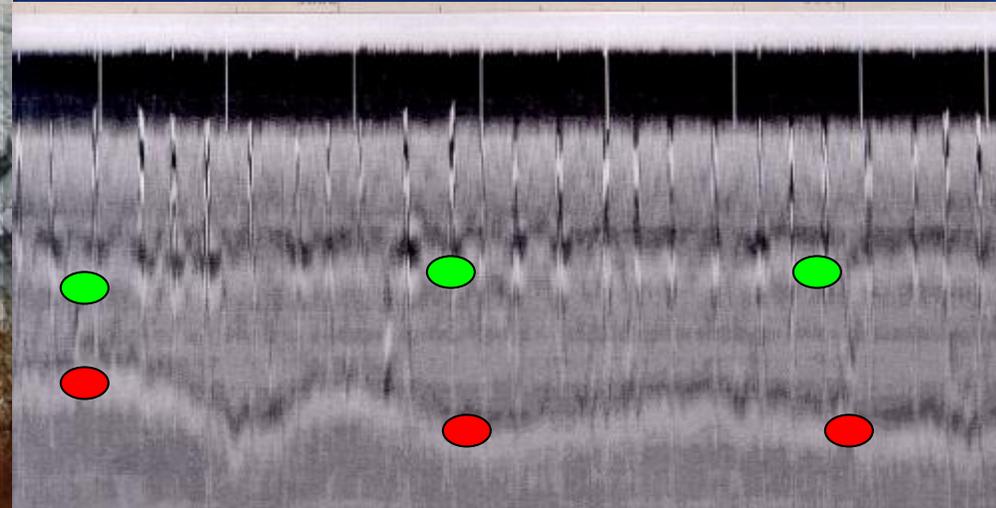
# Comparison of GPR data to field conditions

Conventional coring is one core per 1,000 ft. alternating lanes

GPR is scanning every six inches at 20 mph.

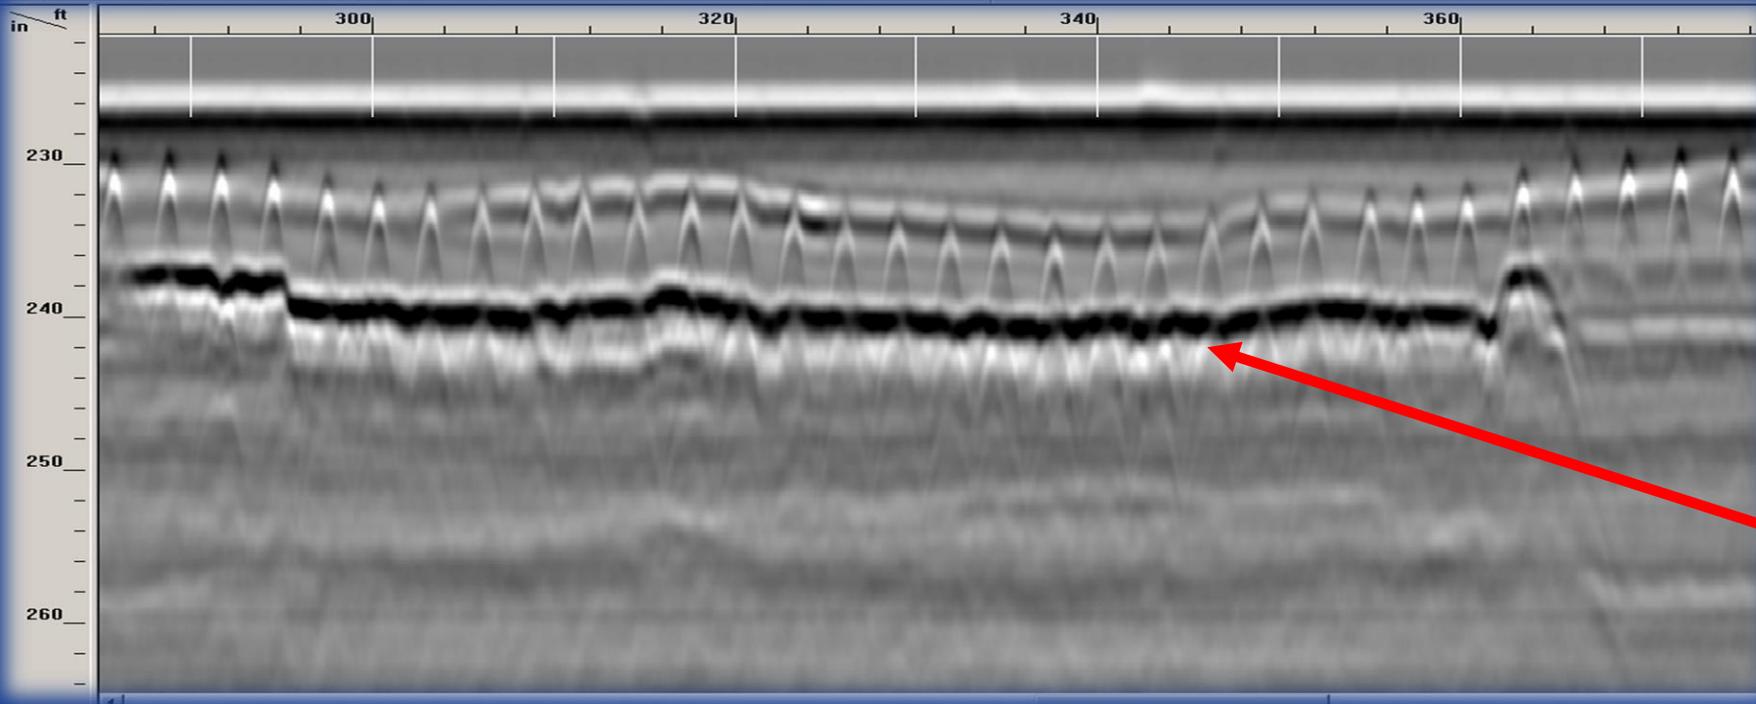
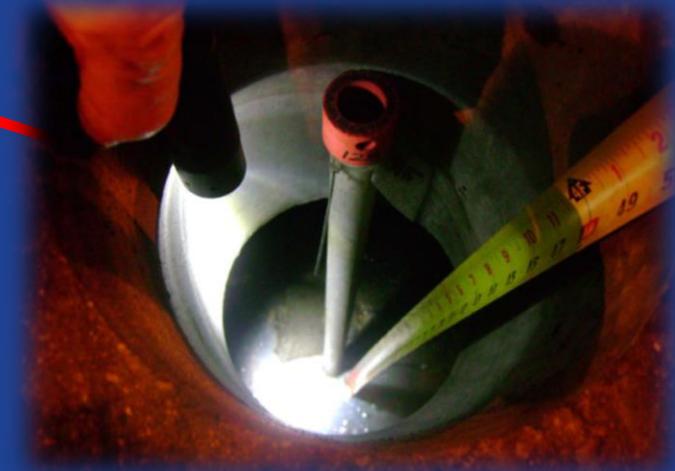
# Void area beneath concrete pavement southbound tunnel

GPR signal has negative amplitude (noted as black space) because it doesn't have anything to bounce off of (namely air).

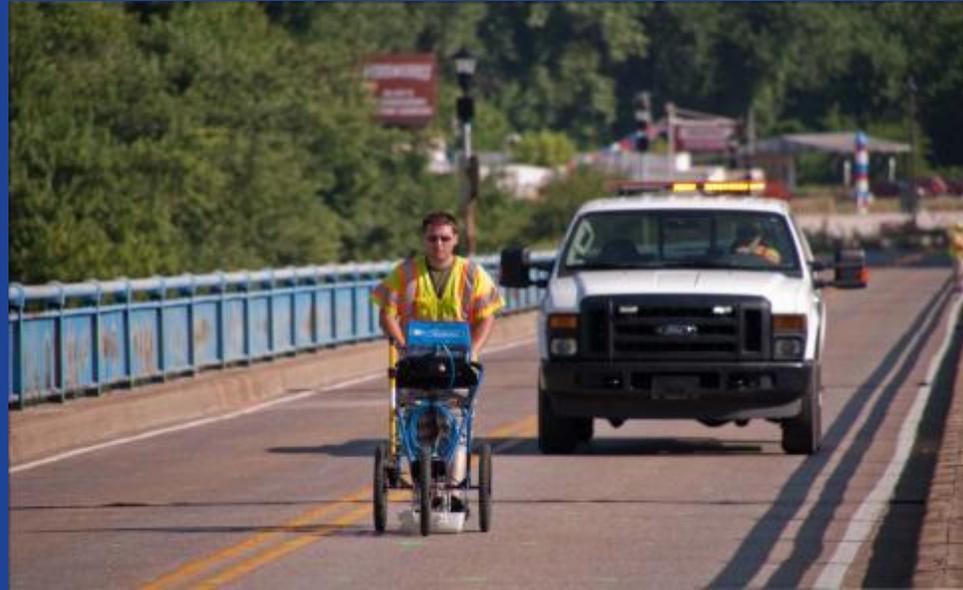
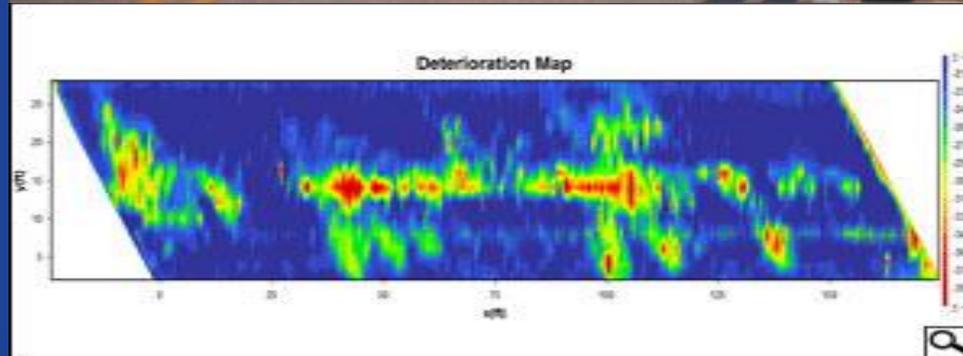
# Similar to Bridge Deck Deterioration

Use amplitudes of return signals at interface to determine if voided or not

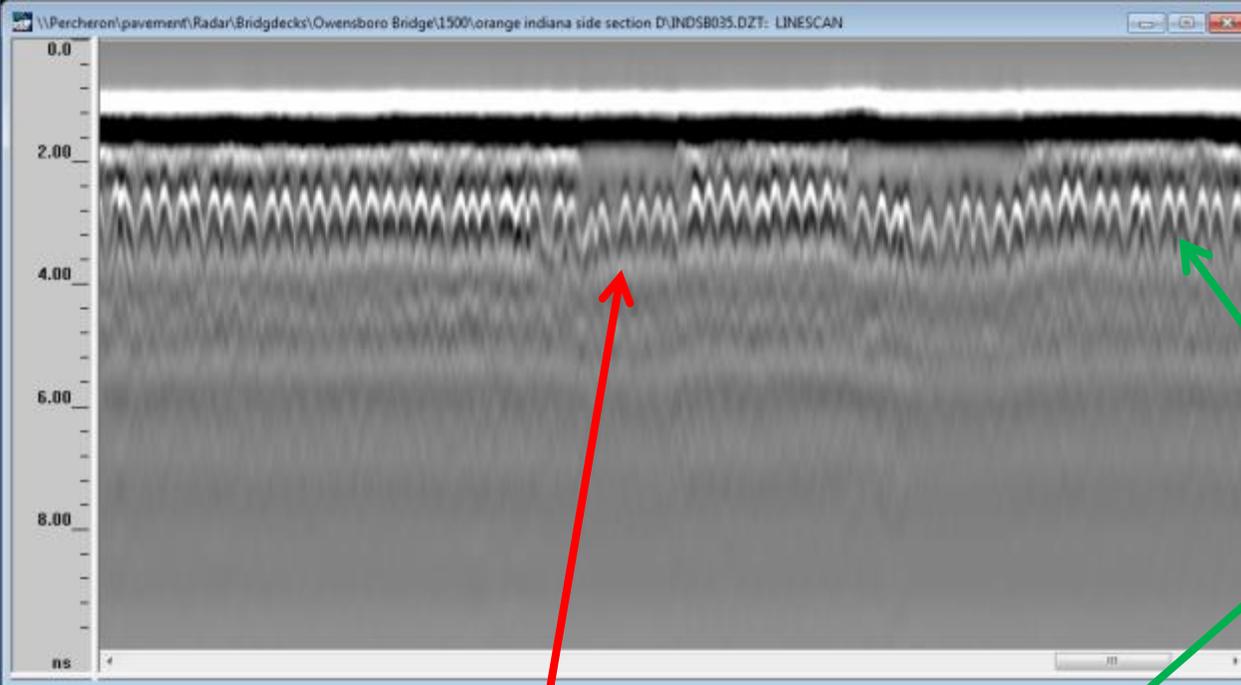
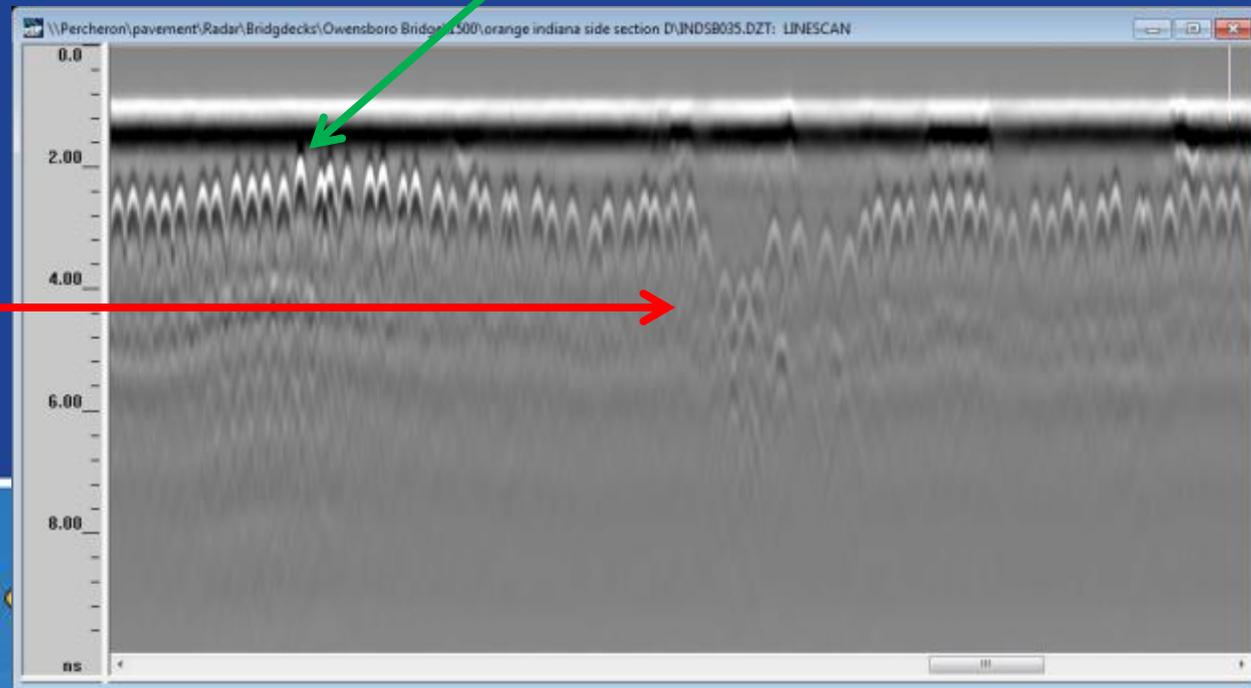
Change in reinforcement corrosion and delaminated concrete affects amplitude of radar signal

Good reflections high amplitudes

Weak reflections low amplitudes

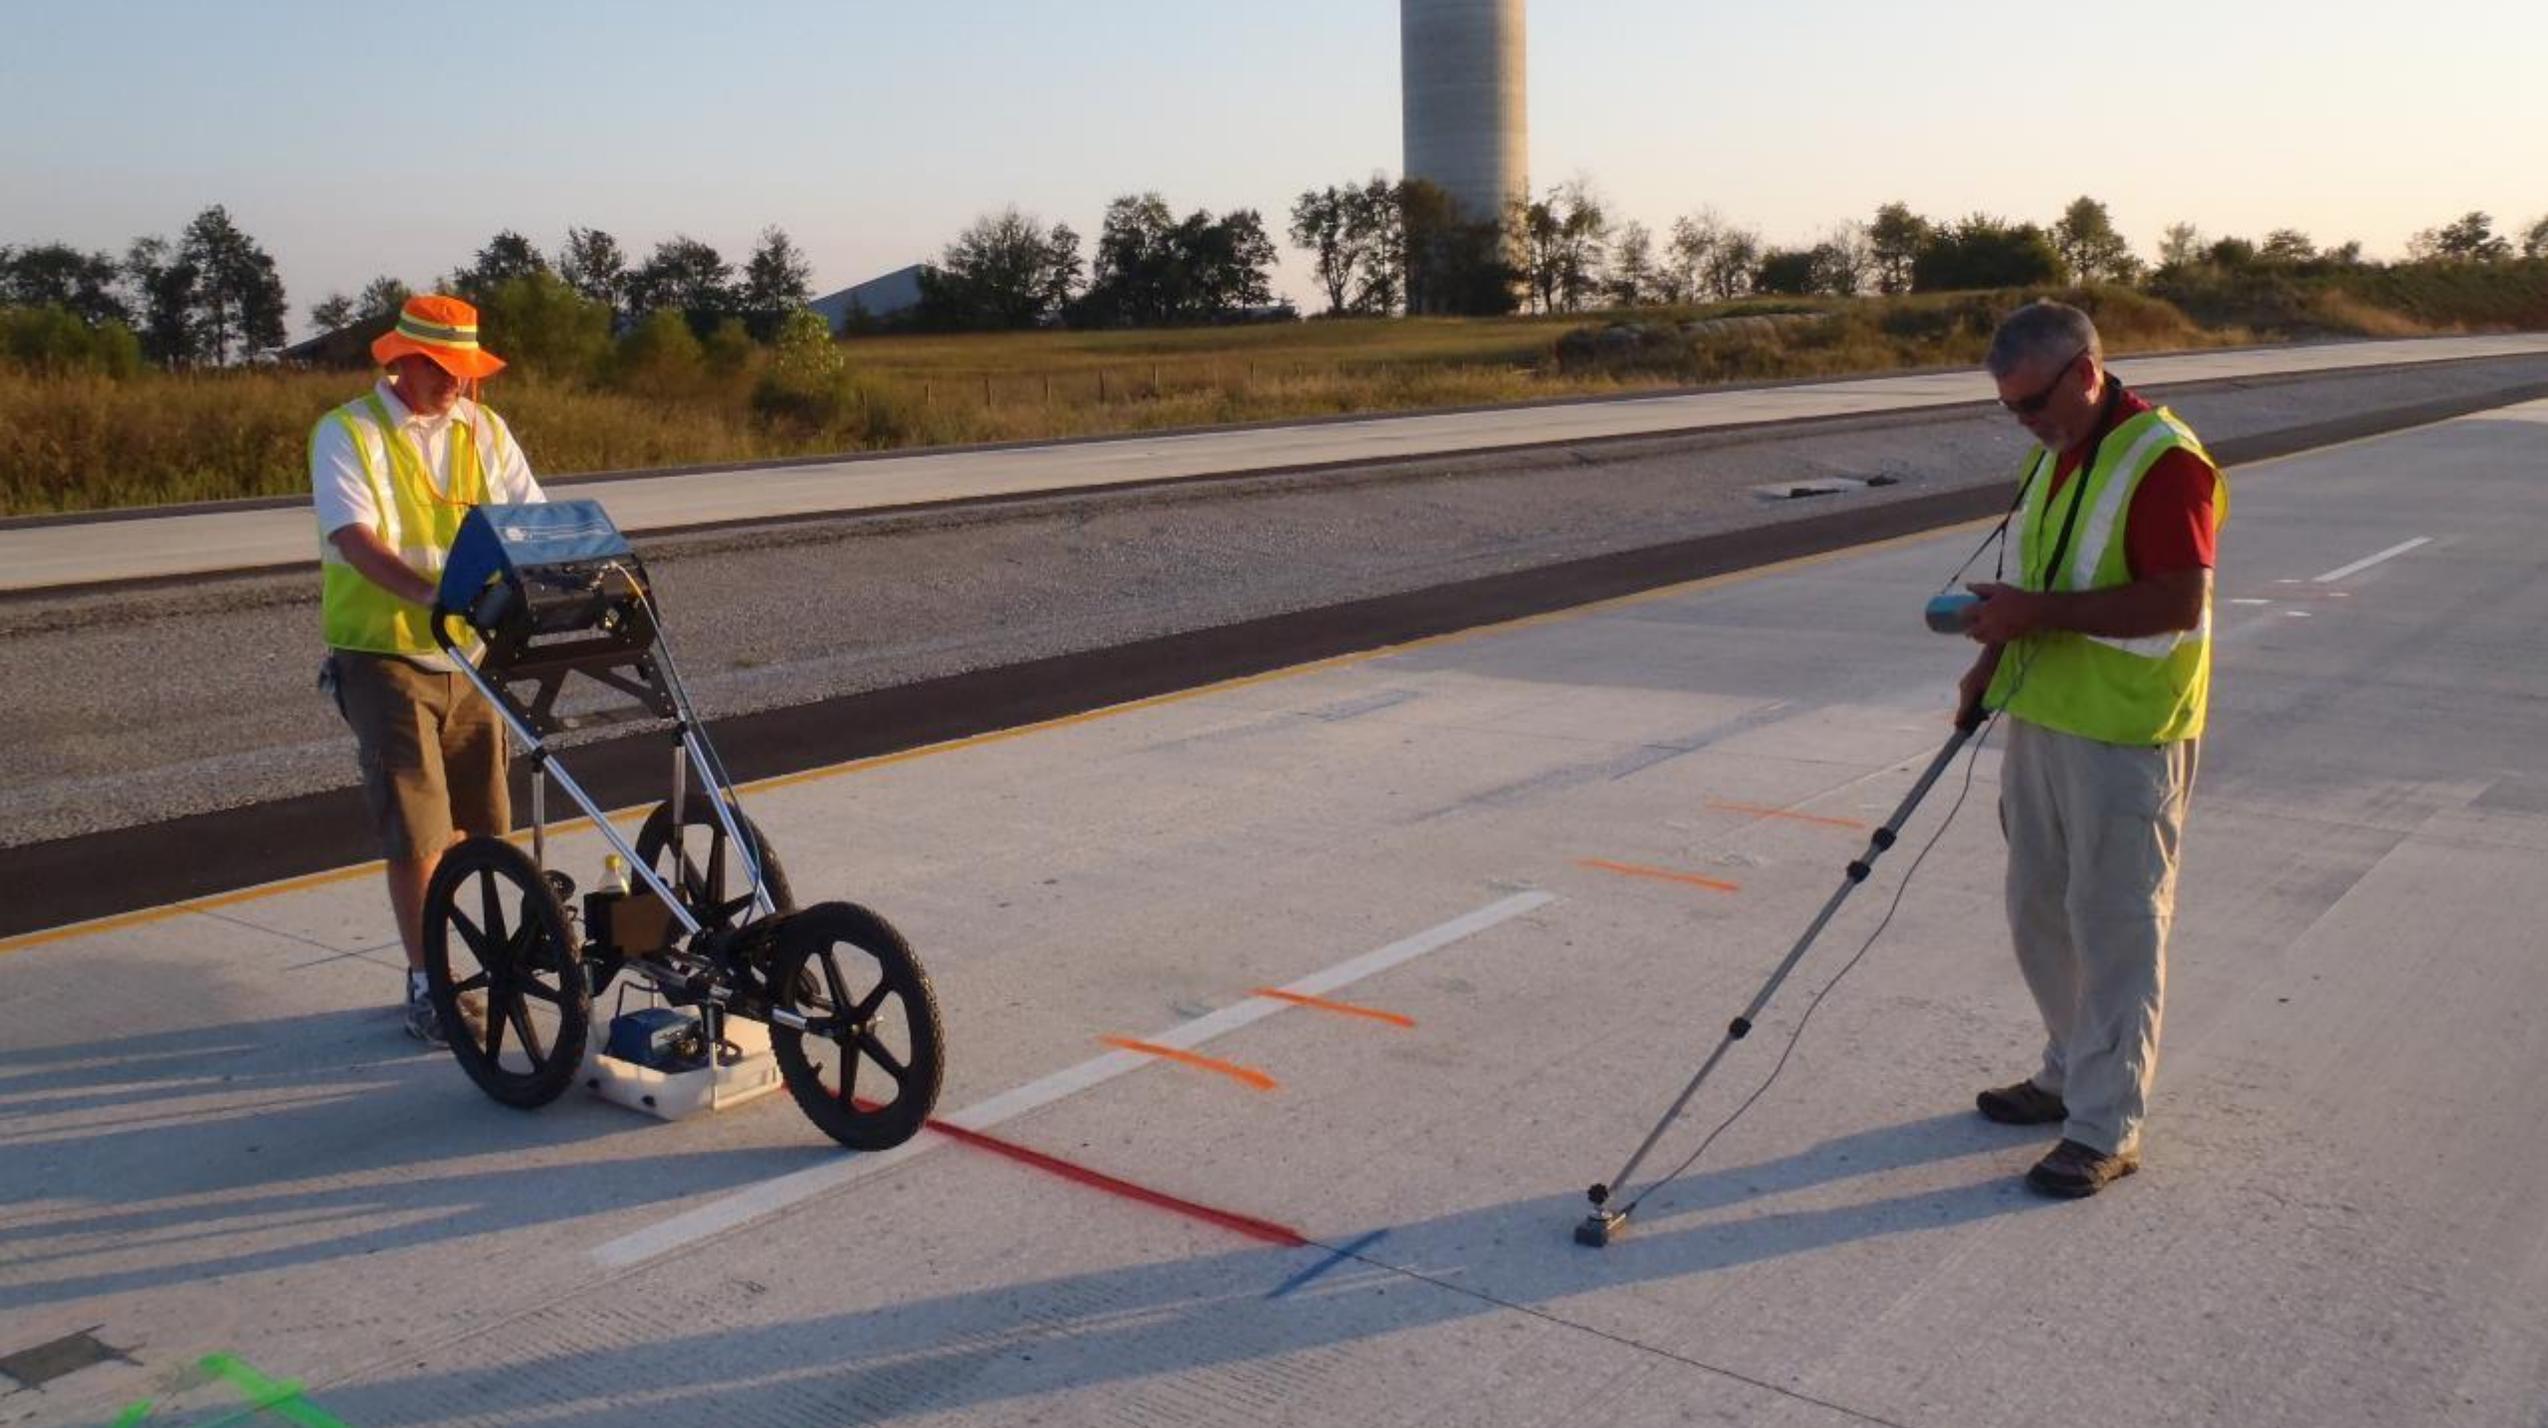
Shelbyville Bypass: after diamond grinding to achieve ride acceptance—Longitudinal Tie Bars were exposed

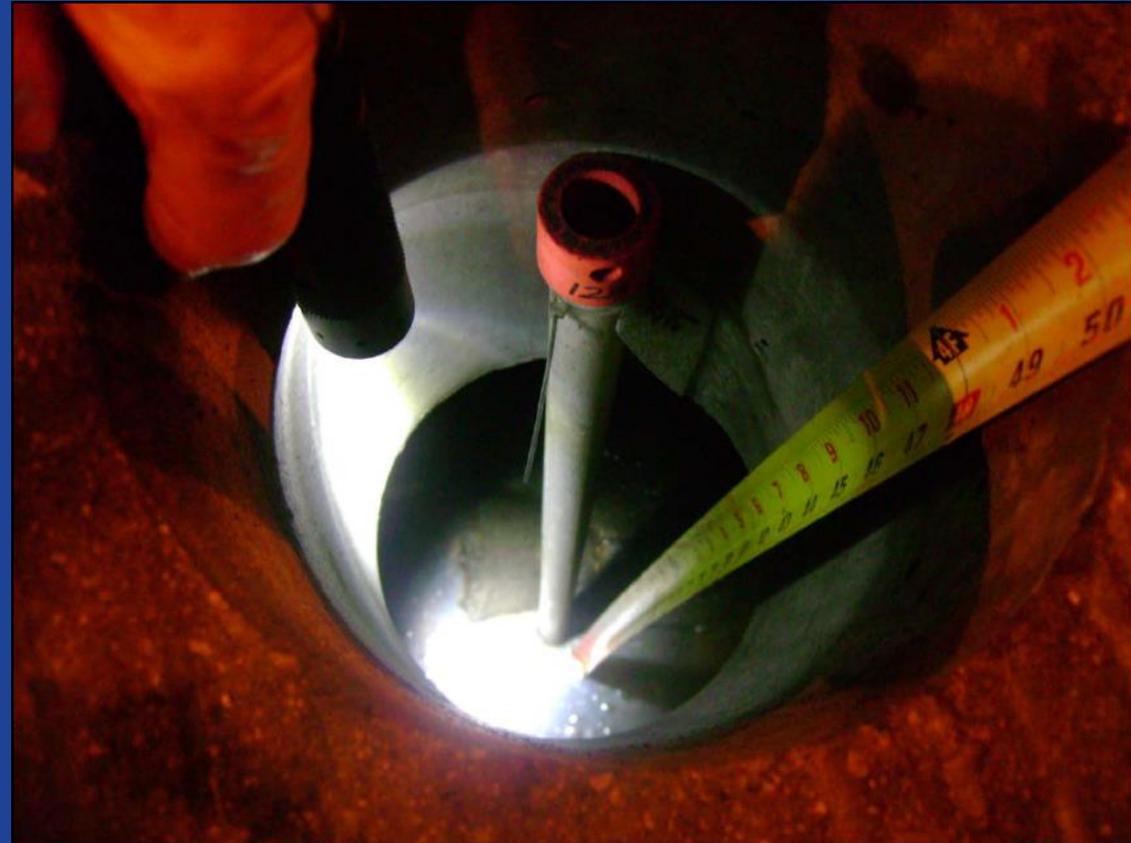
# Void depth beneath 10 inch concrete pavement

40 inch deep void

10,000 s.f. of voided  
areas found

Rate of void growth:  
75-100 S.F. per month

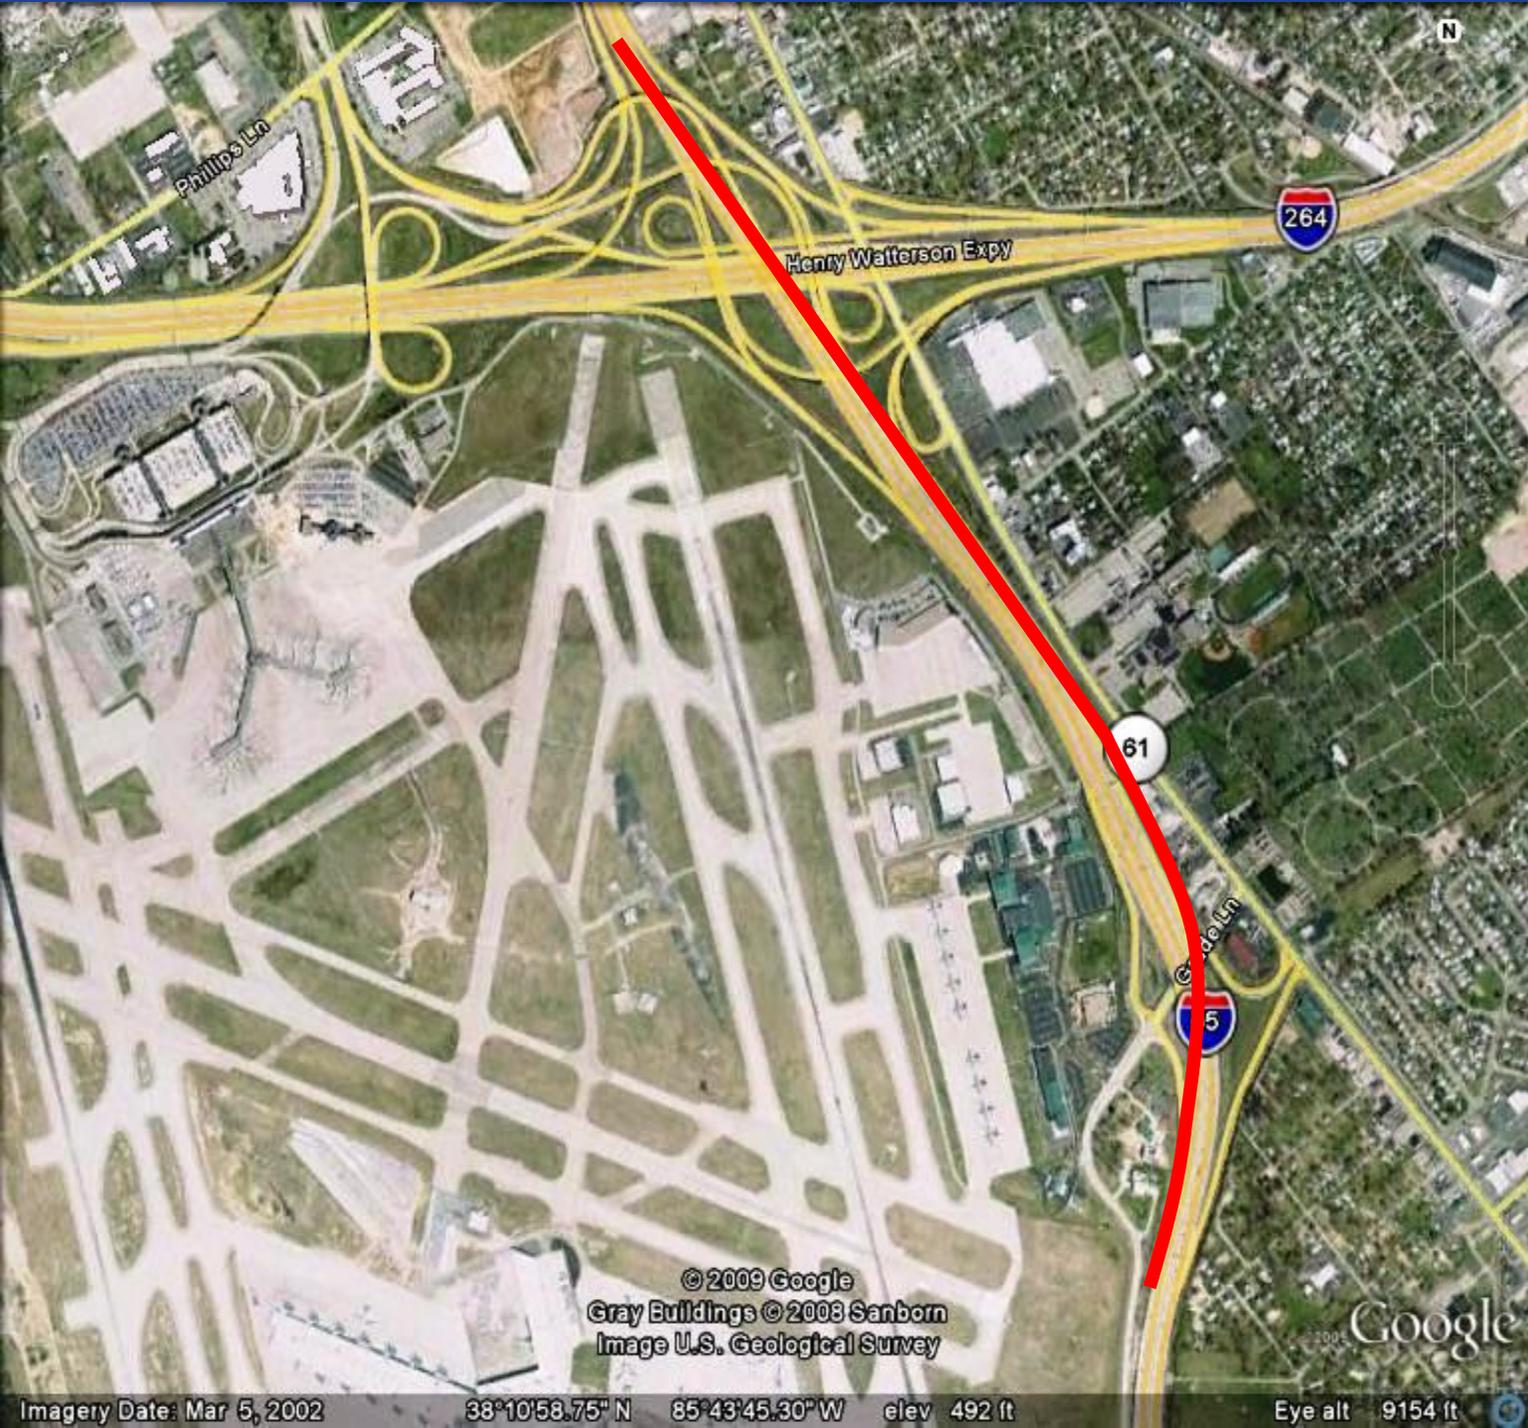
I-65  
differential settlement in the  
longitudinal joint

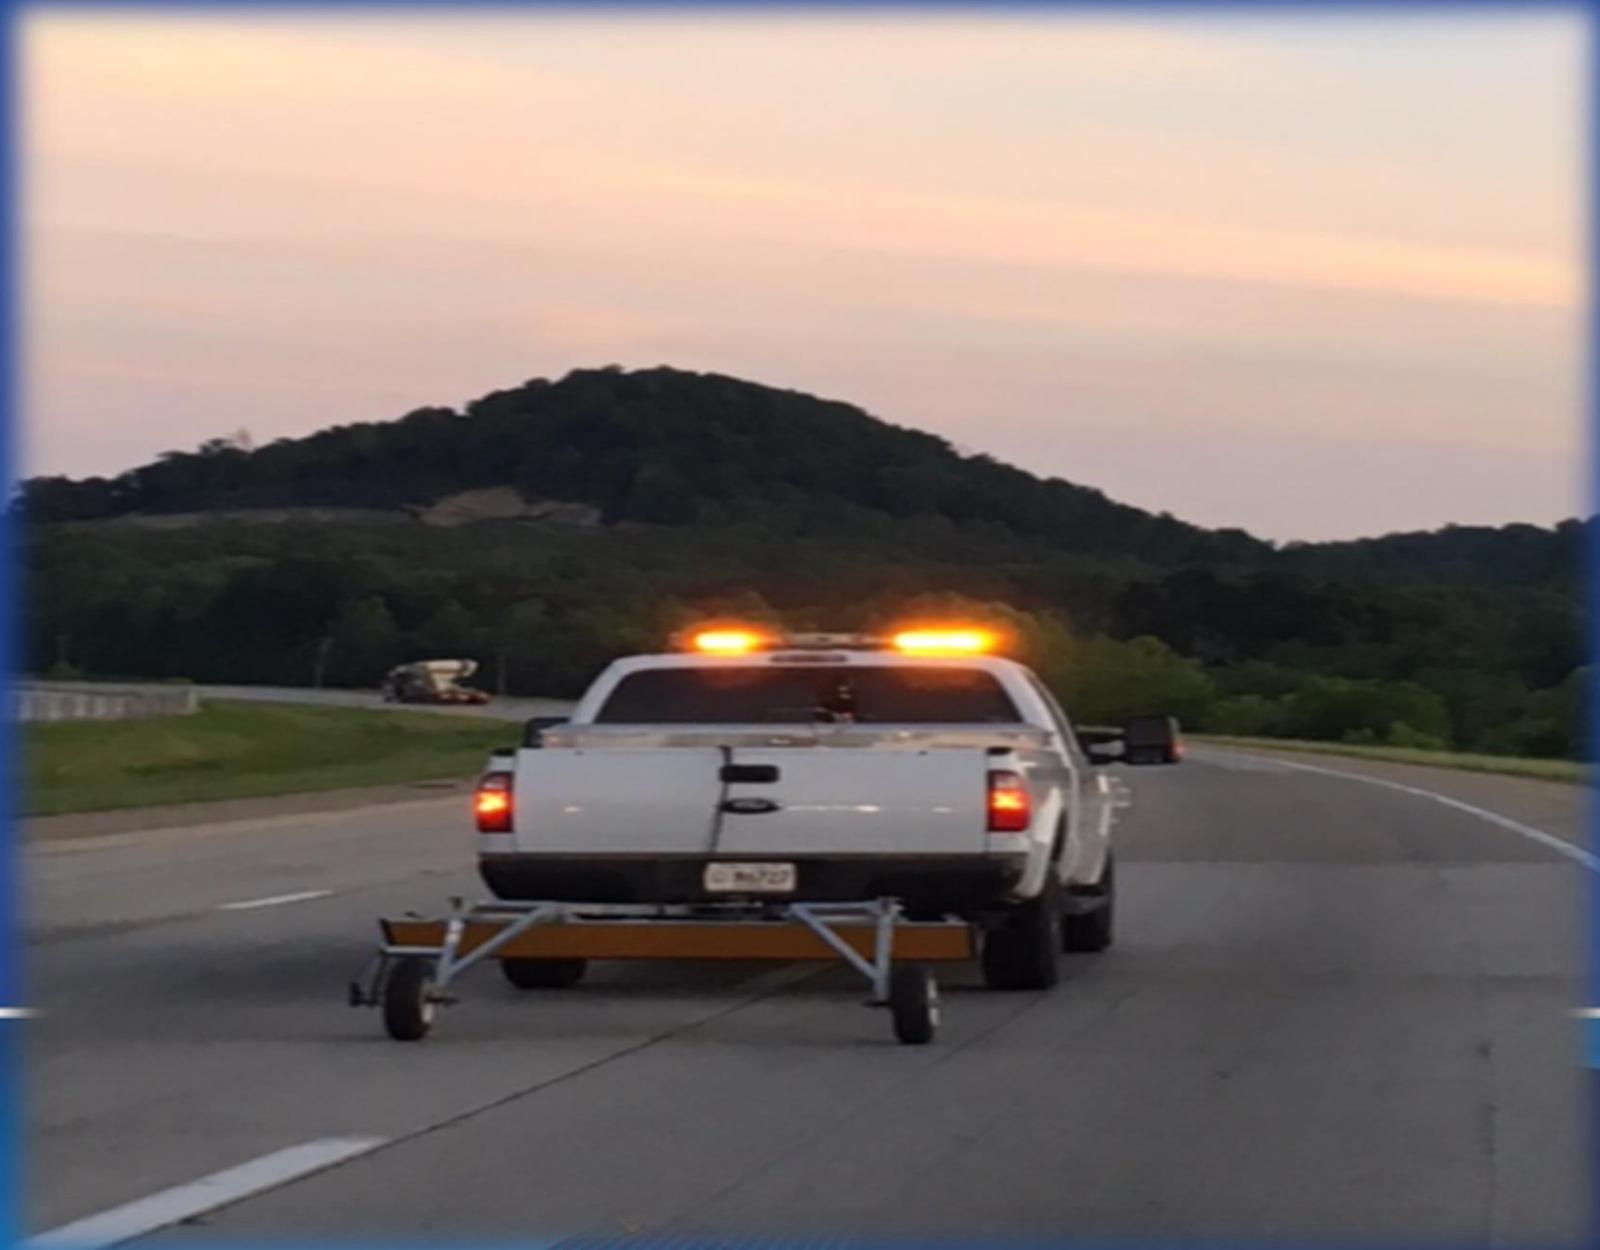
# 165 Longitudinal Joint Settlement with 3D Radar

- Crossline slice (X)
- Inline slice (Y)
- Horizontal slice (Z)

Crosshair: N 371.4063603° W 085° 43' 30.455" Depth: 0.6

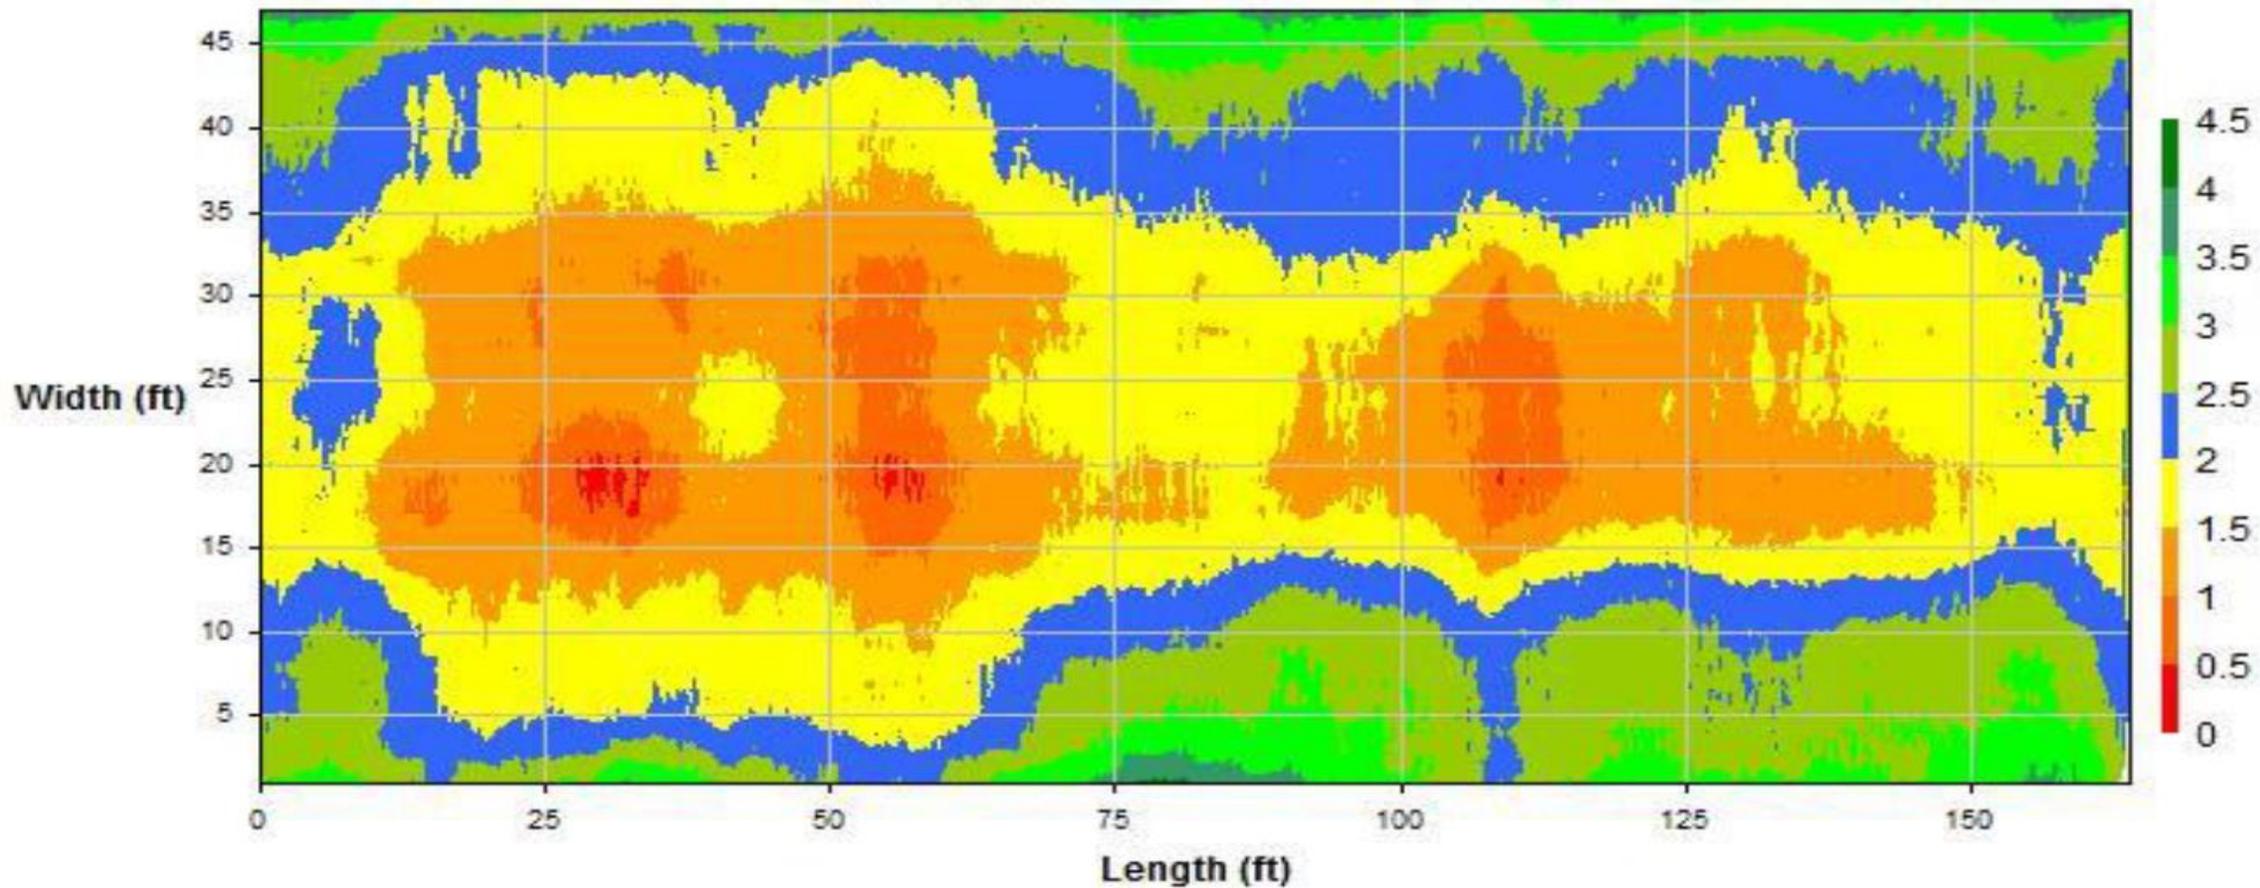
## Southbound Approach Unit 2 Pour 2

# Process GPR data using a known dielectric value

0/0 point is Southwest Corner

Depth (in) approximate  $\pm 1/2$ " variability
