Detecting Delamination with New NDT Systems

The project, *Advanced Methods to Identify Pavement Delamination* (or R06D), field tested ground penetrating radar (GPR) equipped with stepped frequency antenna array (3D-GPR) and a scanning system employing Spectra Analysis of Surface Waves (SASW) and Impact Echo (IE). These nondestructive technologies may enable DOTs to obtain reliable results for project-level planning and forensics in a safer, faster, and less expensive way.

Six States Evaluated 3D-GPR and Scanning IE/SASW in SHRP2 Proof-of-Concept Effort

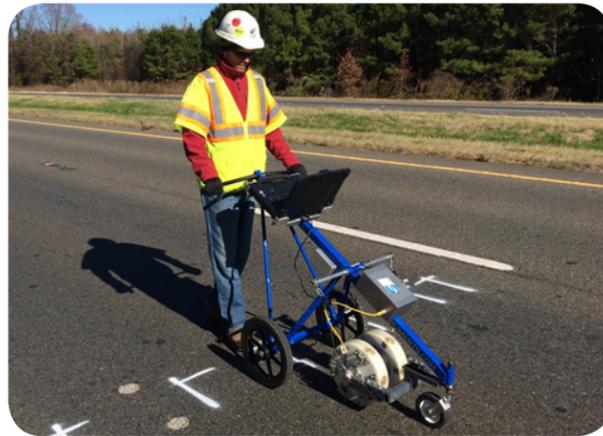
A Scanning IE/SASW Unit. Photo courtesy of Texas DOT.

Caltrans evaluated scanning IE/SASW on one pavement project on State Route 247, Lucerne Valley, with known areas of distress identified through previous GPR results.

The scanning IE/SASW was partially successful for detecting pavement delamination and provided a good indication of general pavement conditions; subsequent milling of the pavement surface ahead of overlay placement showed good agreement between areas of poor condition as identified with the IE/SASW and stripping observed during milling. The results did not, however, appear to detect some delamination identified in the GPR data (and confirmed by coring).

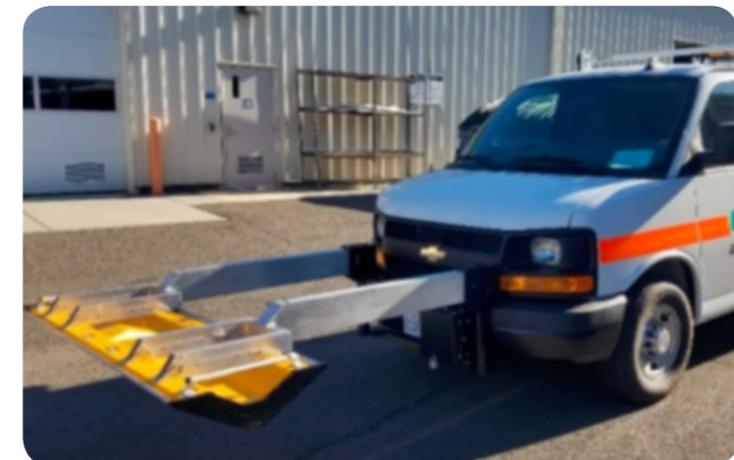
A 3D-GPR System. This is a Caltrans unit which shows the most current permanent mounted antenna design. Photo courtesy of Caltrans.

Caltrans acquired the 3D-GPR system for use on pavement and bridge deck investigations, as well as for subsurface utility investigations over pavement. Caltrans collected mea-
