Virginia's SHRP2 R06A Project

Jeff Milton - Bridge Preservation Specialist
Virginia Department of Transportation
Structure and Bridge Division
January 2019

What is R06A? (Nondestructive Testing to Identify Concrete Bridge Deck Deterioration)

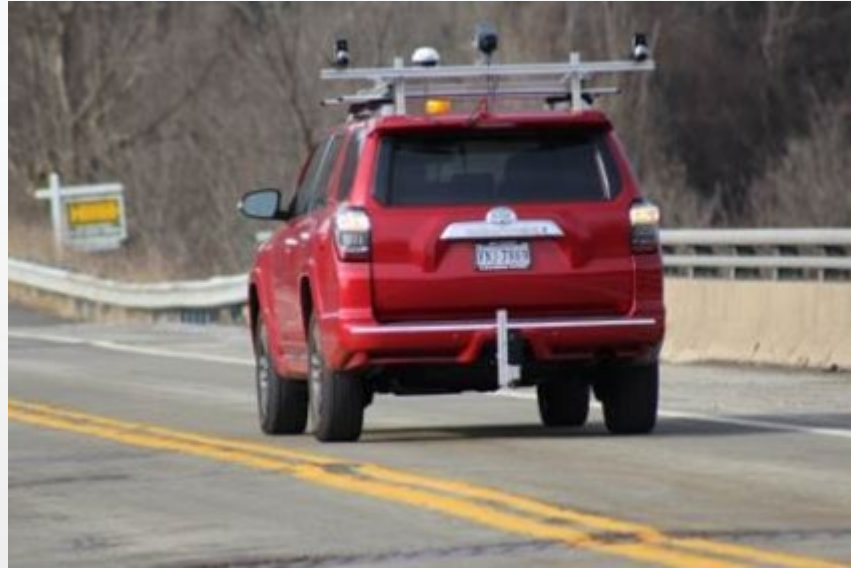
- The technology used was the Deck Top Scanning System (DTSS) which is a mobile platform that can be loaded/mounted onto a vehicle. It consists of an infrared thermography (IR) camera, two line-scanning cameras, a GPS unit, and a speedometer unit that, combined, locate surface and sub-surface defects in bridge decks or roadways.

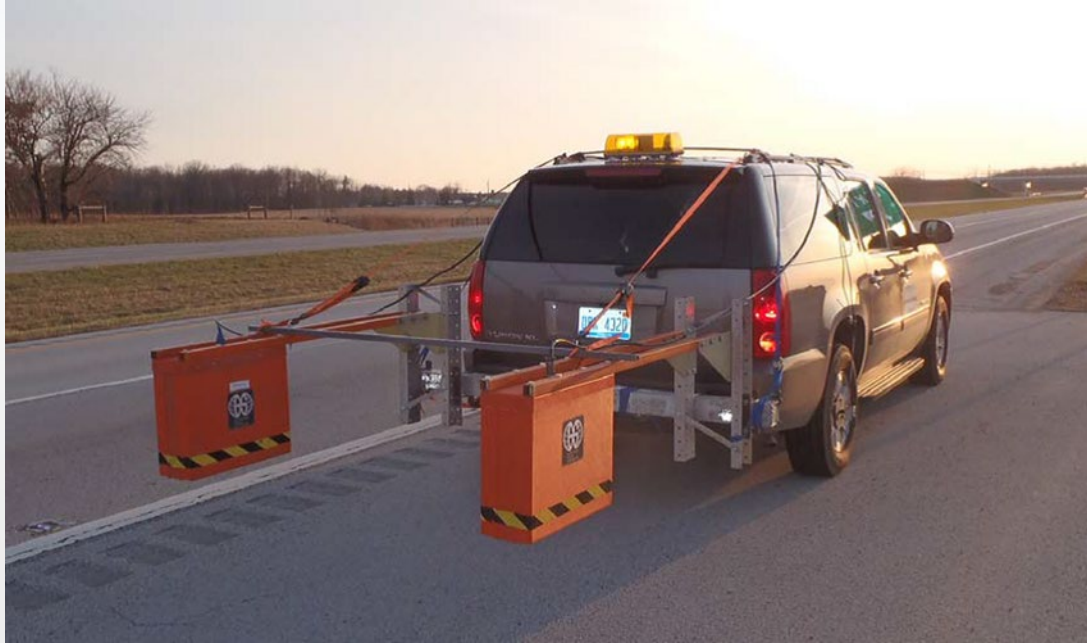
The technology used was a dual 2 GHz horn antenna system manufactured by GSSI, Inc. of Nashua, NH. The survey vehicle was equipped with an electronic distance-measuring instrument (DMI) mounted to the rear wheel of the survey van, providing continuous distance data as the GPR data was collected. The data collection and recording was controlled by the SIR-30 GPR system operated from within the survey vehicle.
