SHRP2 R06A IAP Round 7 Concrete Bridge Deck NDT New York State DOT Participation Summary

Bridge Test Site
BIN 1049529
I690 over CSX RR

SHRP 2 R06A Round 7 – New York State DOT Peer Exchange Presentation – January 2019

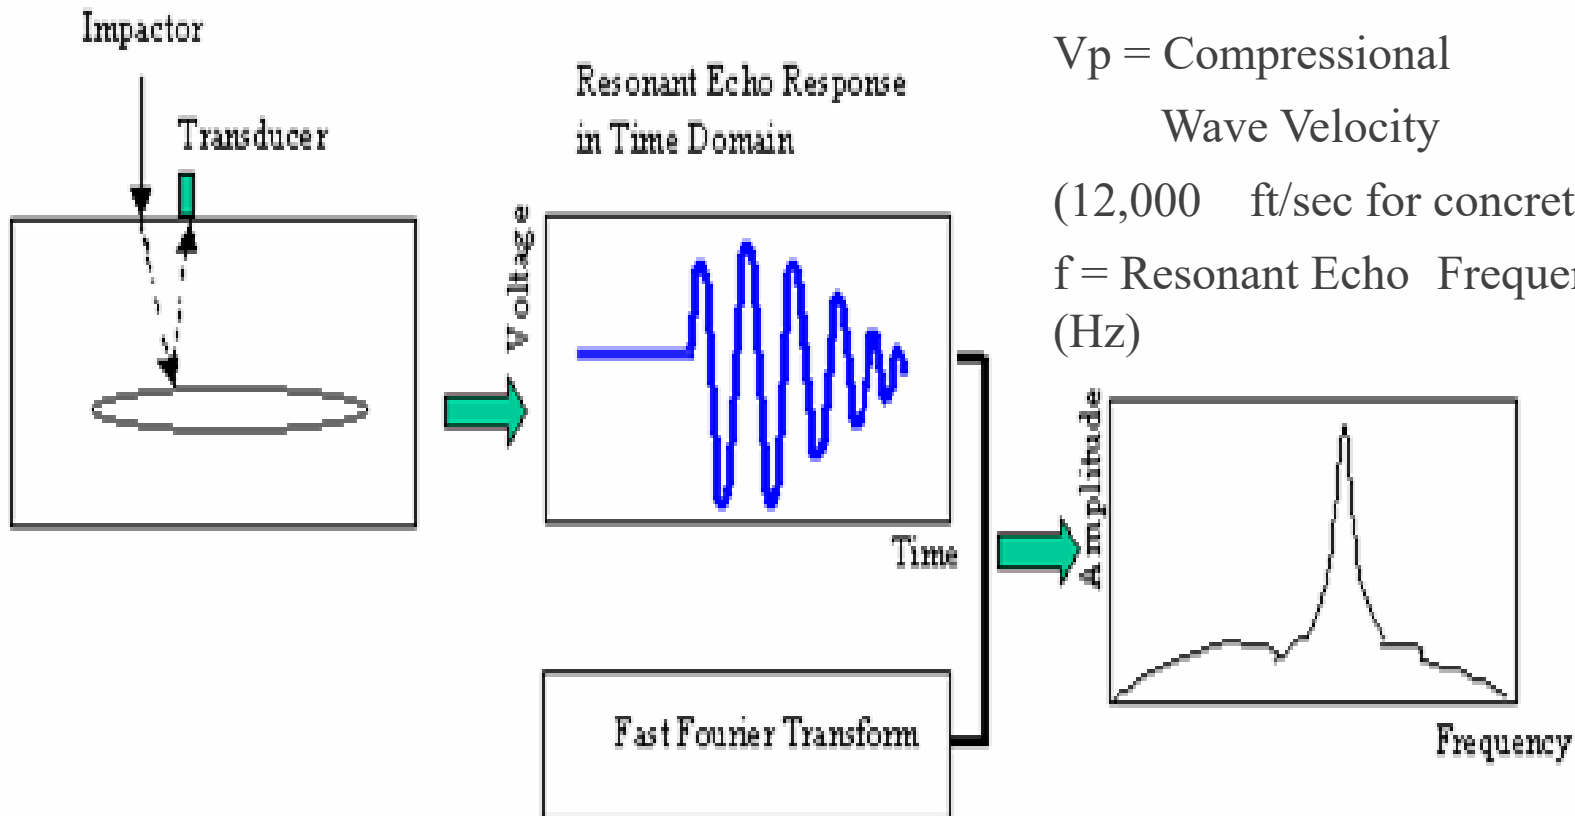
Physical Principle

$$D = \beta V_p / (2 * f)$$

β = Shape Factor (0.96 for slab/wall shape)

D = Thickness

V_p = Compressional
Wave Velocity

(12,000 ft/sec for concrete)

f = Resonant Echo Frequency
(Hz)

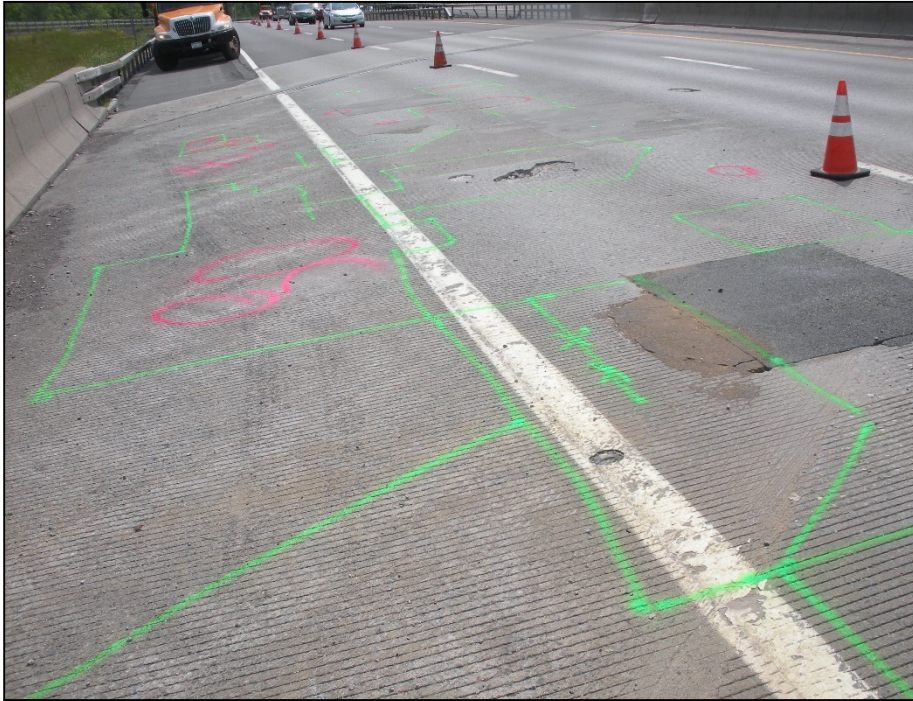
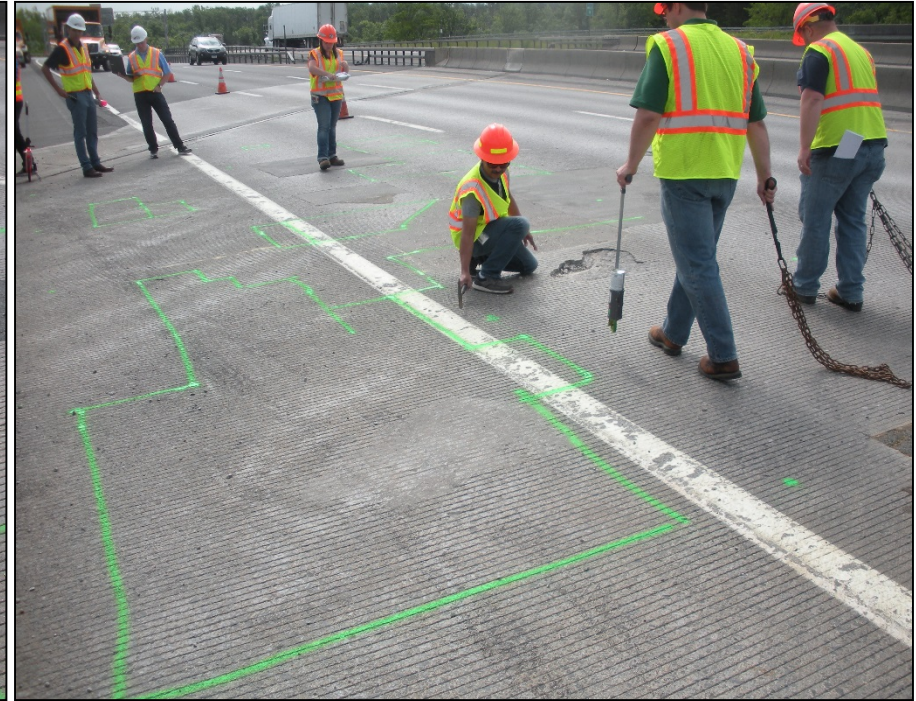
I-690 over CSX RR; BIN 1049529 BRIDGE DECK NDT GRID

- Mark out test grid.
- Chain drag/hammer sound test grid.
- Mark out delaminations.
- Mapping and Quantity work-ups.

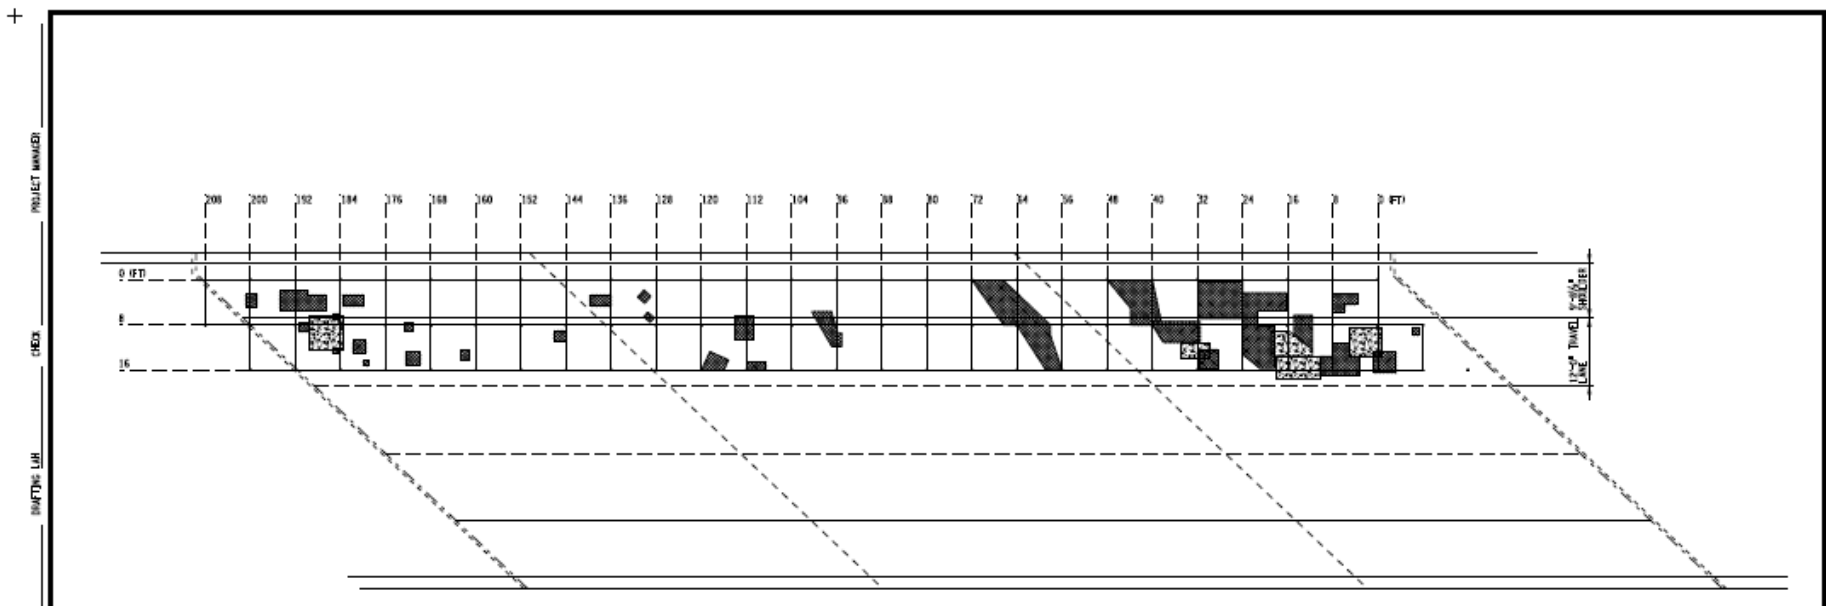
New York State DOT BIN 1049529
 WESTBOUND LANE

TOTAL AREA DISPECTED: 3328.00 SF
 TOTAL DELAMINATION AREA: 491.41 SF
 PERCENT OF DECK DELAMINATED: 14.77%
 TOTAL PATCH AREA: 134.00 SF
 PERCENT OF DECK PATCHED: 4.03%
 PERCENT OF DECK DETERMINATED: 18.79%

Chain Drag Sounding & Inspection Results:

- 15% Test Grid Delaminations
- 4% Test Grid Patched Areas

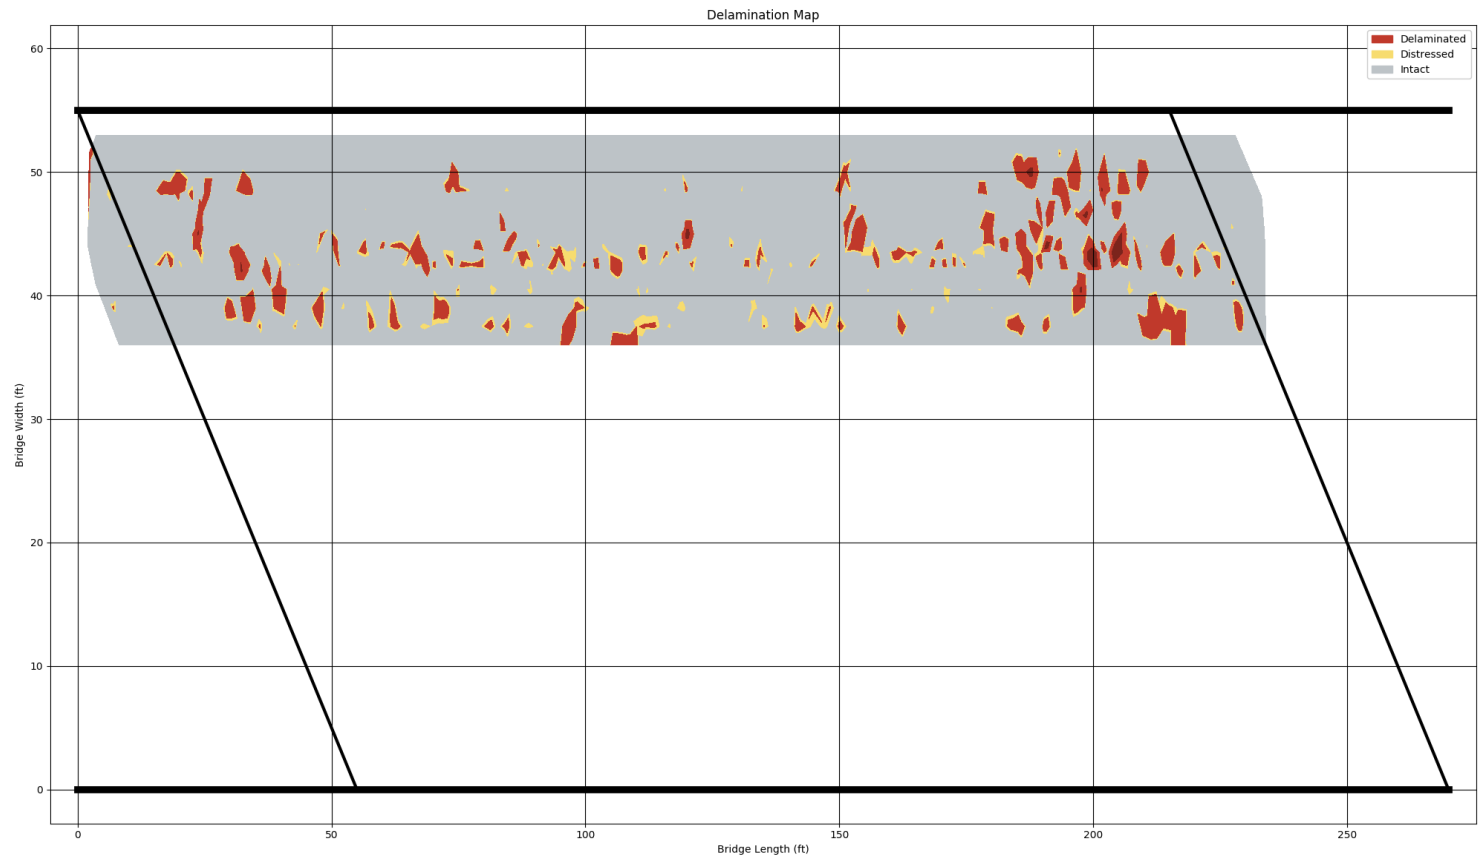
Advanced Bridge Inspections LLC

Right lane and shoulder (test grid) results:

- 10% Top Mat Delaminated/Distressed

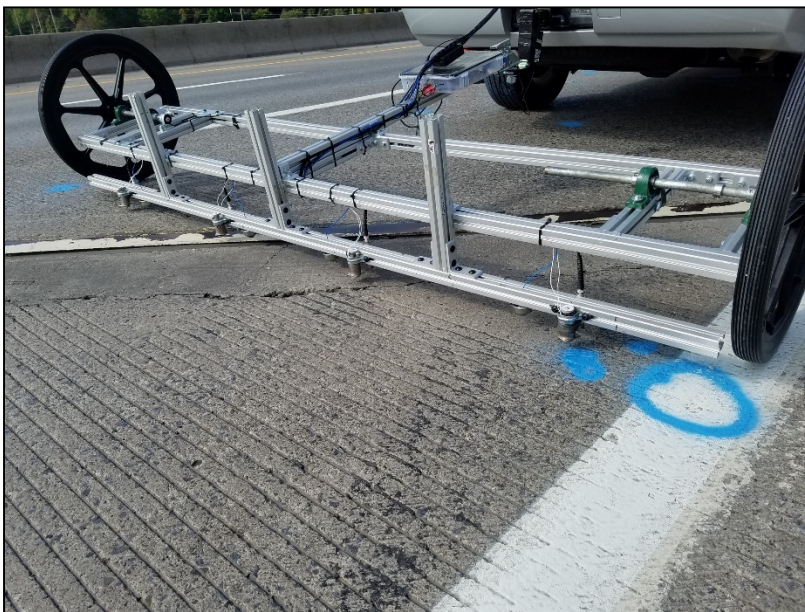
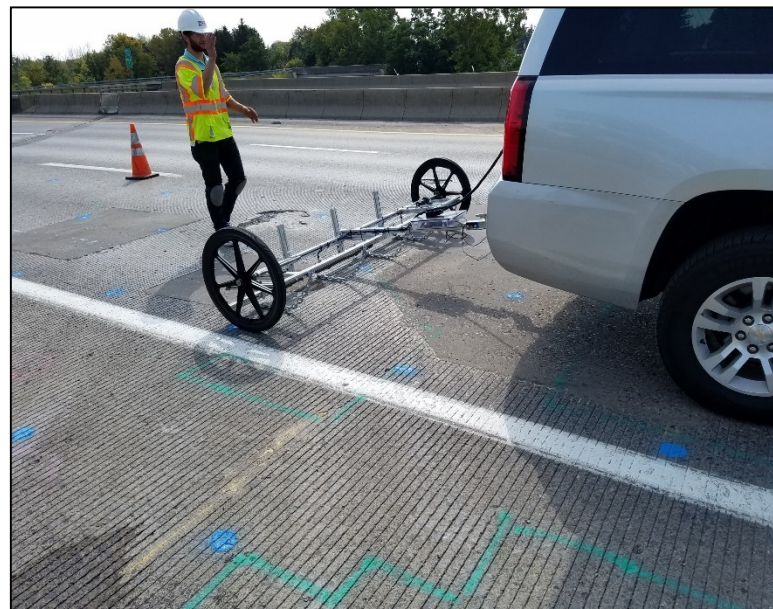
“Rapid Automated Sounding (RAS) Device”:

- Mobile trailer with 9 automated mallets with onboard microphones. Resonant frequency sounding/scanning.
- Top mat (shallow) delamination detection only.
- Thousands of impacts are generated.
- Mapped to specific positions using GPS and LIDAR.
- Entire 12' lane scanning capability.
- 2 MPH acquisition speed.
- Rapid deployment once on site.

- Solid looking deck areas within the test grid did have delaminations (picked up by RAS).
- Does provide quick sounding to differentiate between highly delaminated versus good condition decks.

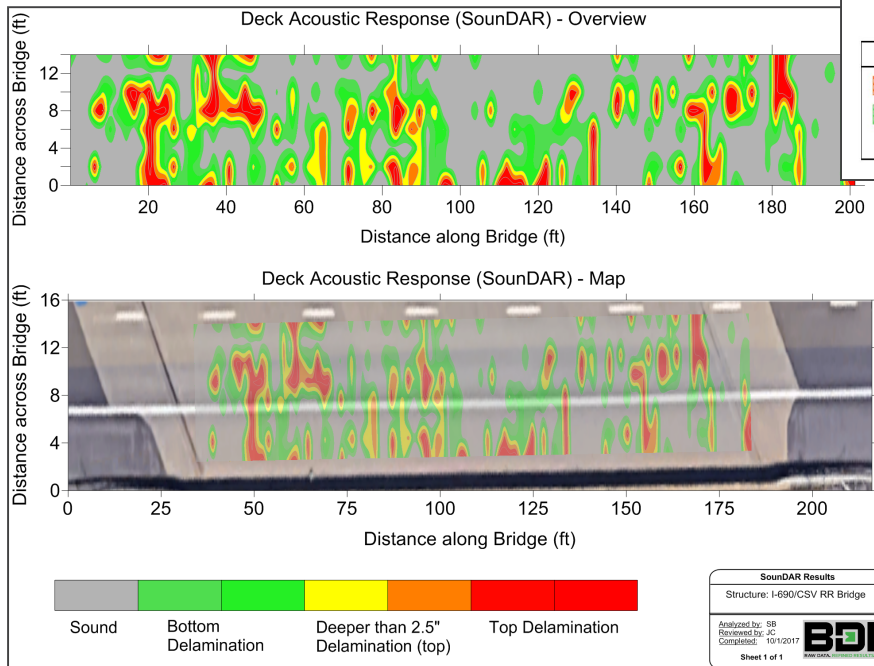
SoundAR Results
 Structure: I-690/CSV RR Bridge

Right lane (test grid) results:

- Probable Top Delamination = 13%
- Probable incipient (deeper) top delamination = 3%
- Probable Bottom Delamination = 9%
- Sound = 74%

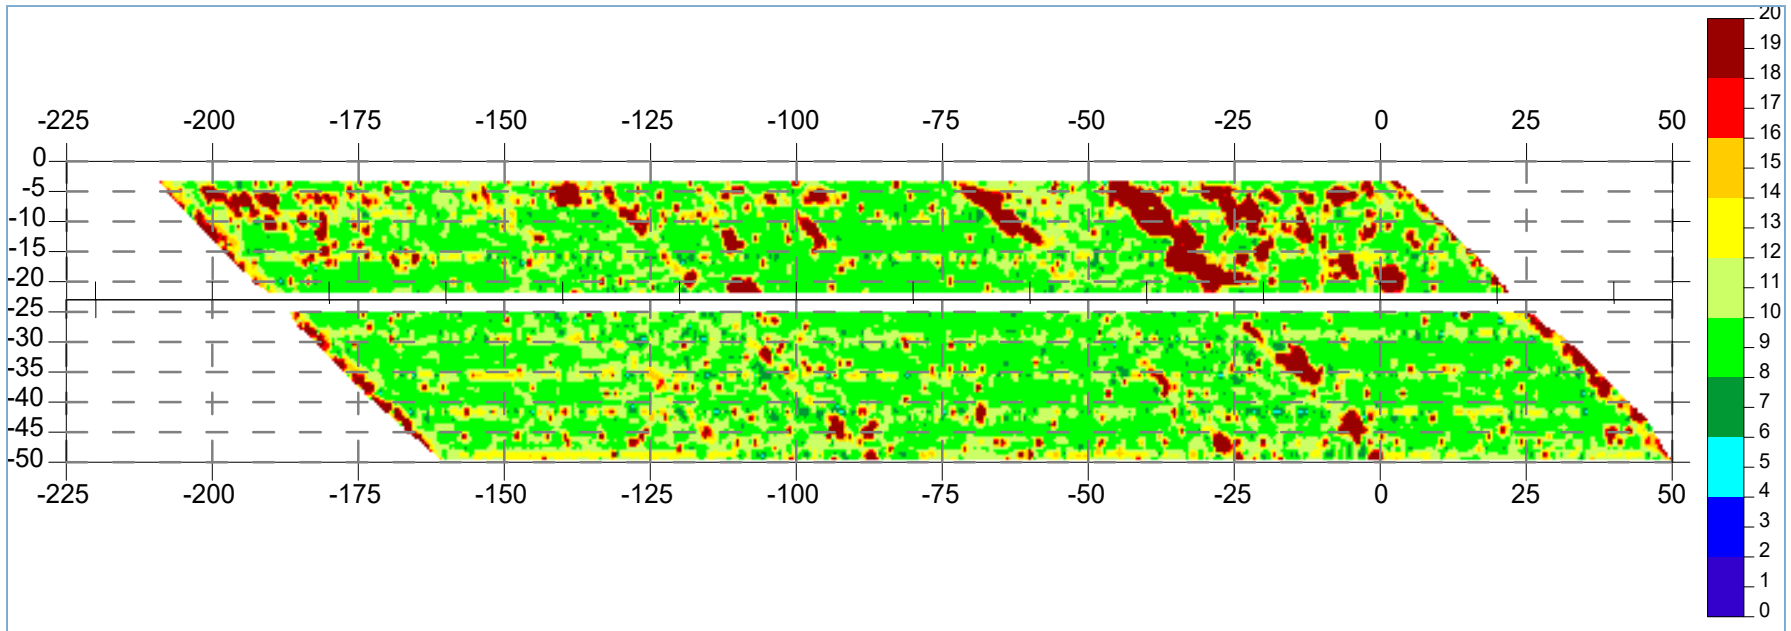
Areas (ft ²)			Notes
WB1	3379.6	<16"		Right Shoulder / Right Lane
	562.9	>16"	14.28%	
Total	3942.5			
WB2	4981.8	<16"		Middle Lane / Left Lane / Left Shoulder
	260.2	>16"	4.96%	
Total	5242			
Combined	8361.4	<16"		All West Bound
	823.1	>16"	8.96%	
Total	9184.5
