USING INFRARED THERMOGRAPHY FOR NON- DESTRUCTIVE EVALUATION OF BRIDGES

SHRP2 R06A Peer Exchange

Nancy Huether, P.E.

NDDOT Bridge Division

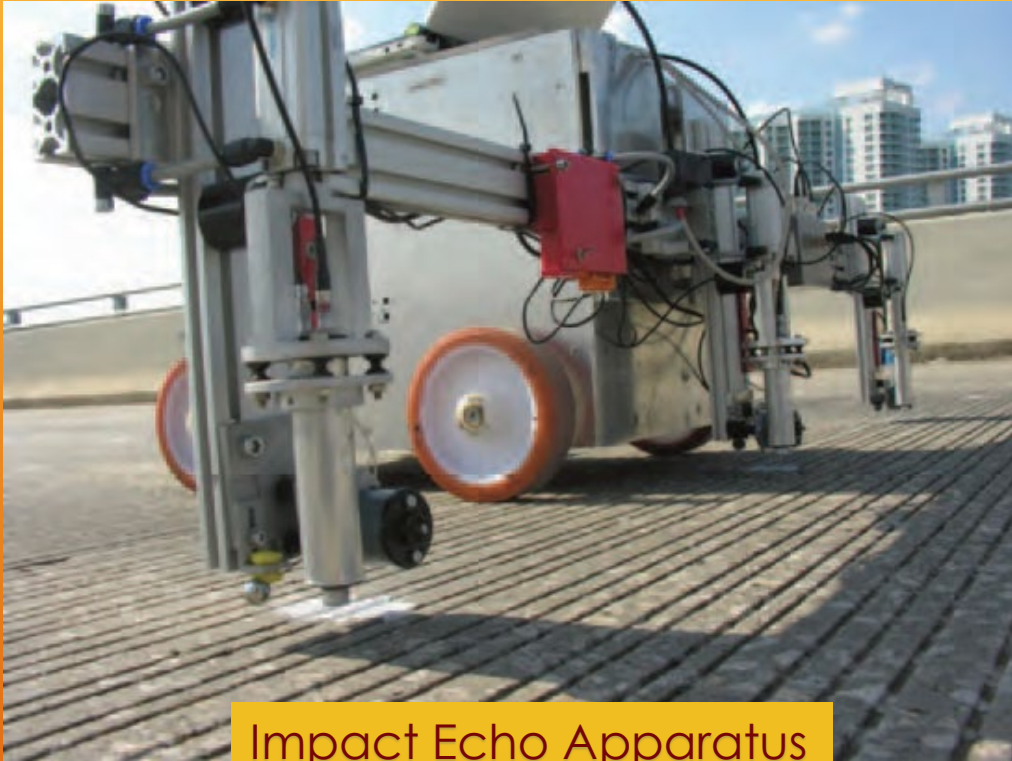
Impact Echo Apparatus

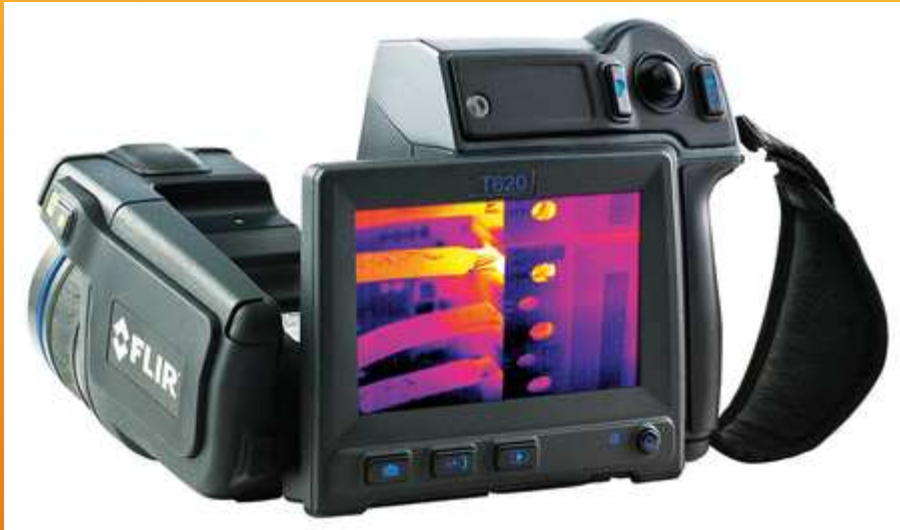
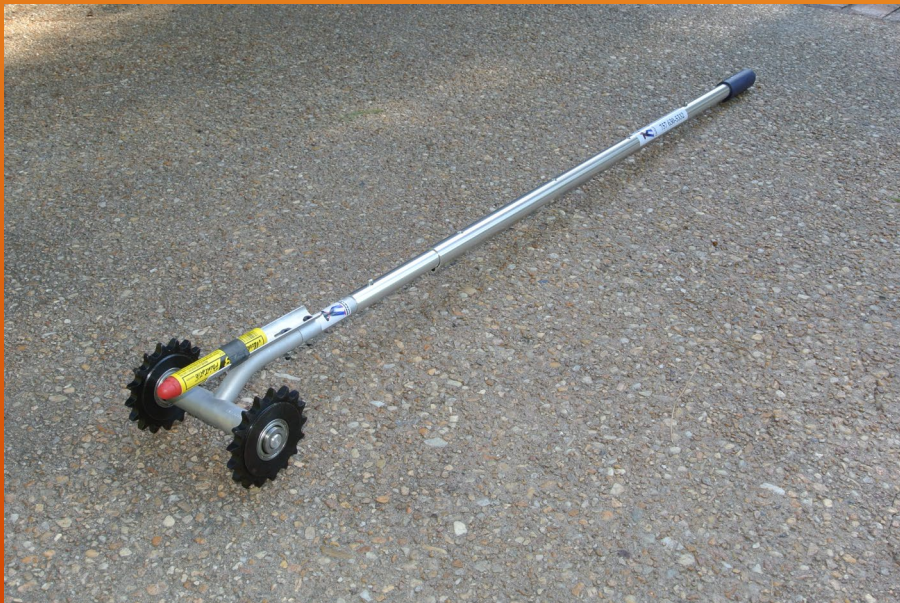
- **Purchase of Infrared camera**
 - Researched and tested several
 - Purchased FLIR T620 – March 2017
- **SME Training**
 - Provided training in Bismarck – May 2017
- **Additional training and NDE tools**
 - ITC (Infrared Training Center) Level I Certification
 - Delam Tool

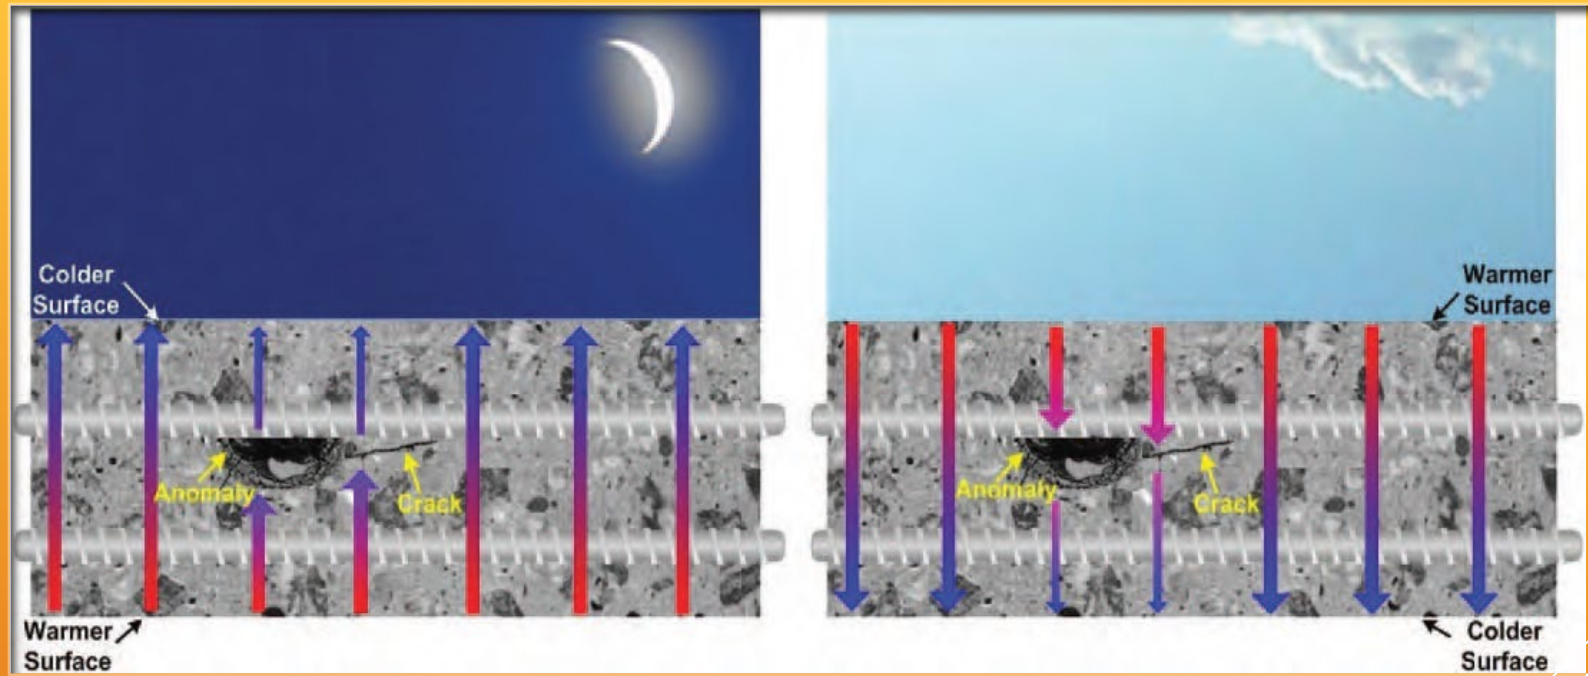
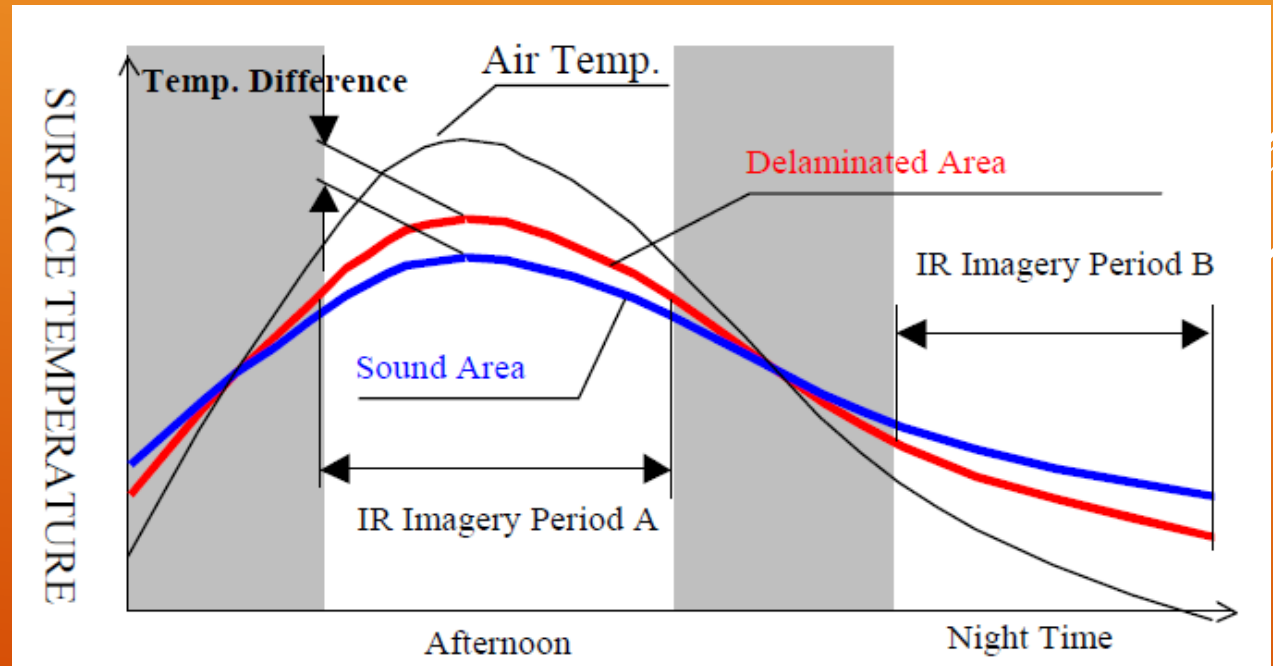
- Variations in the surface temperature of the bridge deck indicate areas of discontinuity
- Uniform material of uniform depth (sound concrete) heats and cools relatively uniformly
- Uniform material of differing depths heats and cools non-uniformly

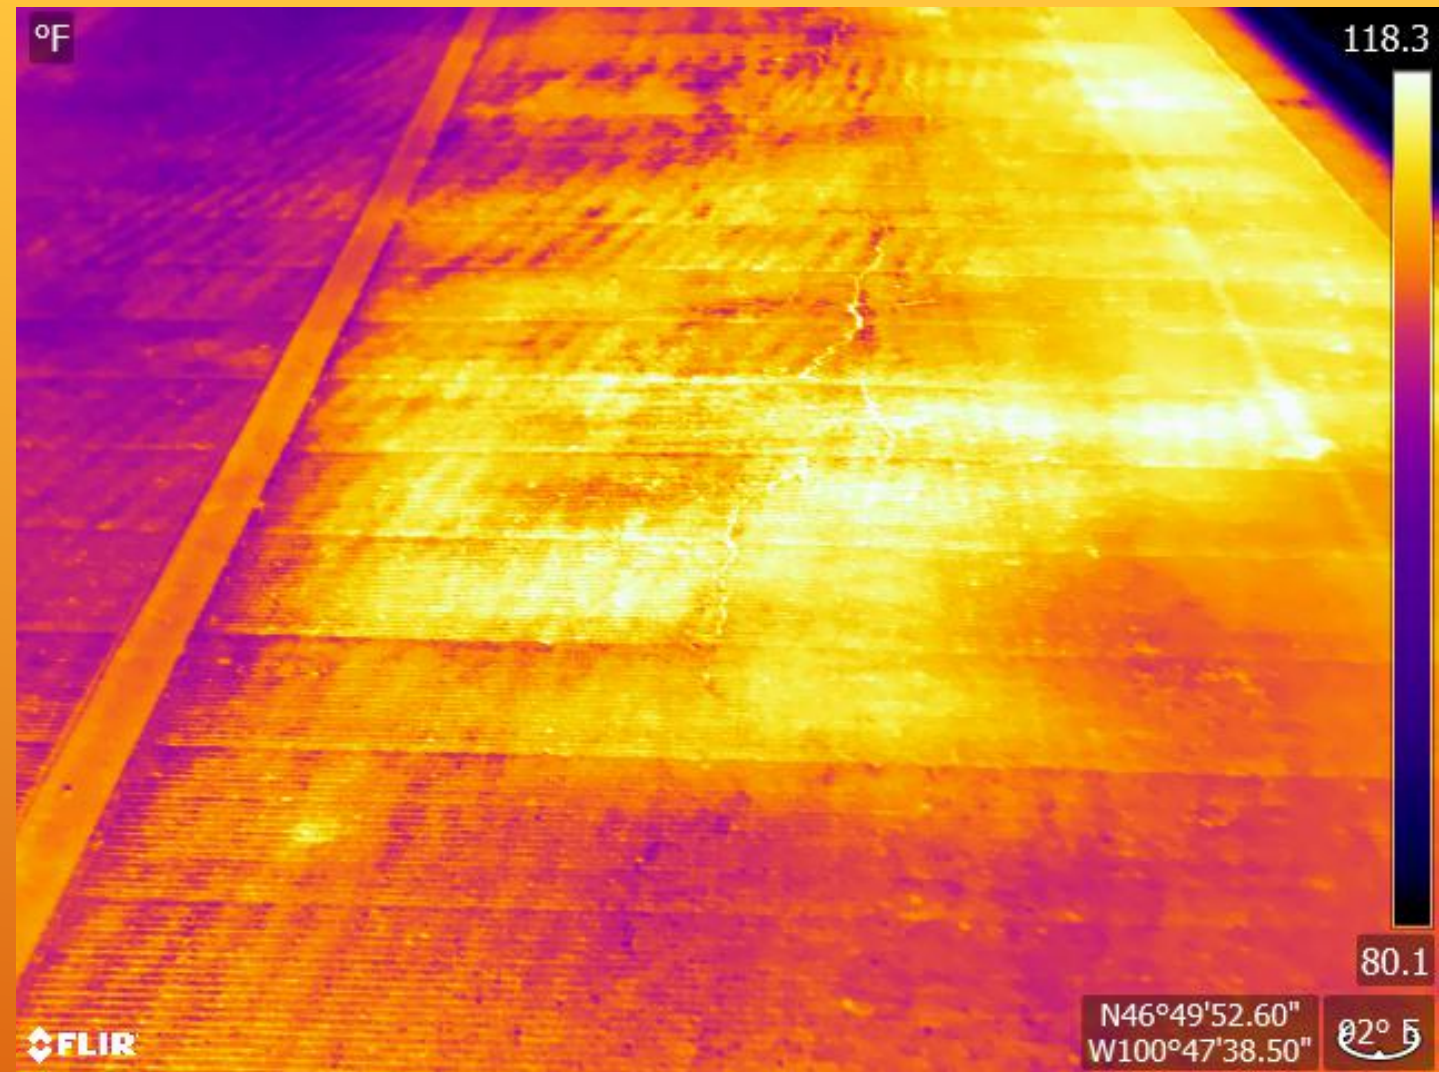
- ▶ Areas of a bridge deck with discontinuities will warm and cool more rapidly than the surrounding sound concrete.
- ▶ Using an infrared camera to observe these areas will help identify the presence of:
 - ▶ Delamination
 - ▶ Cracking
 - ▶ Voids/Anomalies

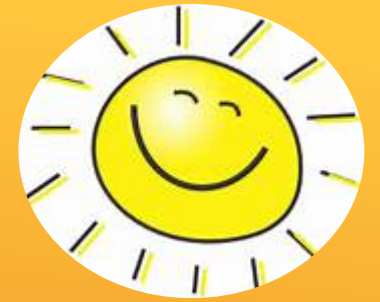
• Weather

- Optimal weather – Sunshine, low humidity, calm winds, fairly large temperature changes (10° F minimum; 20° F or more is best)
- Due to thermal sensitivity of T620 can operate in less than optimal conditions

• Timing

- Typically the daytime “window of opportunity” begins about 4-6 hours after sunrise and continues for about 4-6 hours

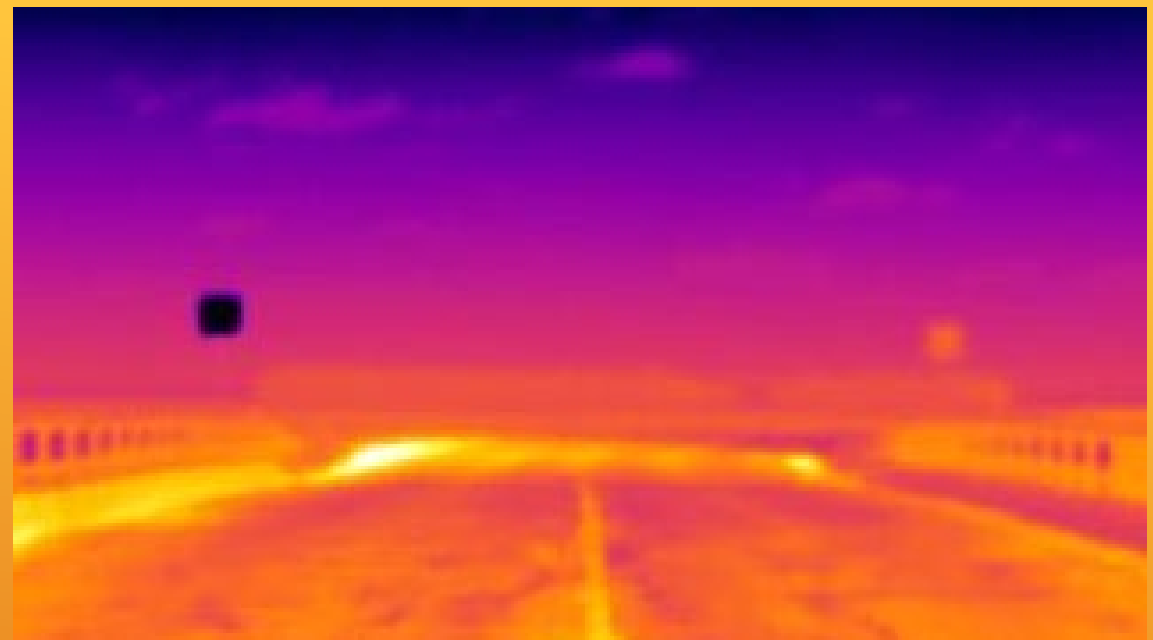
- Potential misinterpretation of image
- Different materials have different emissivities
 - Emit differing amounts of “heat”
 - Concrete has a high emissivity – typically appears close to actual temperature
 - Asphalt has a very high emissivity
 - Shiny metals typically have low emissivities – can’t trust apparent temperature
- Need to understand *what* you are seeing and *why* it appears as it does

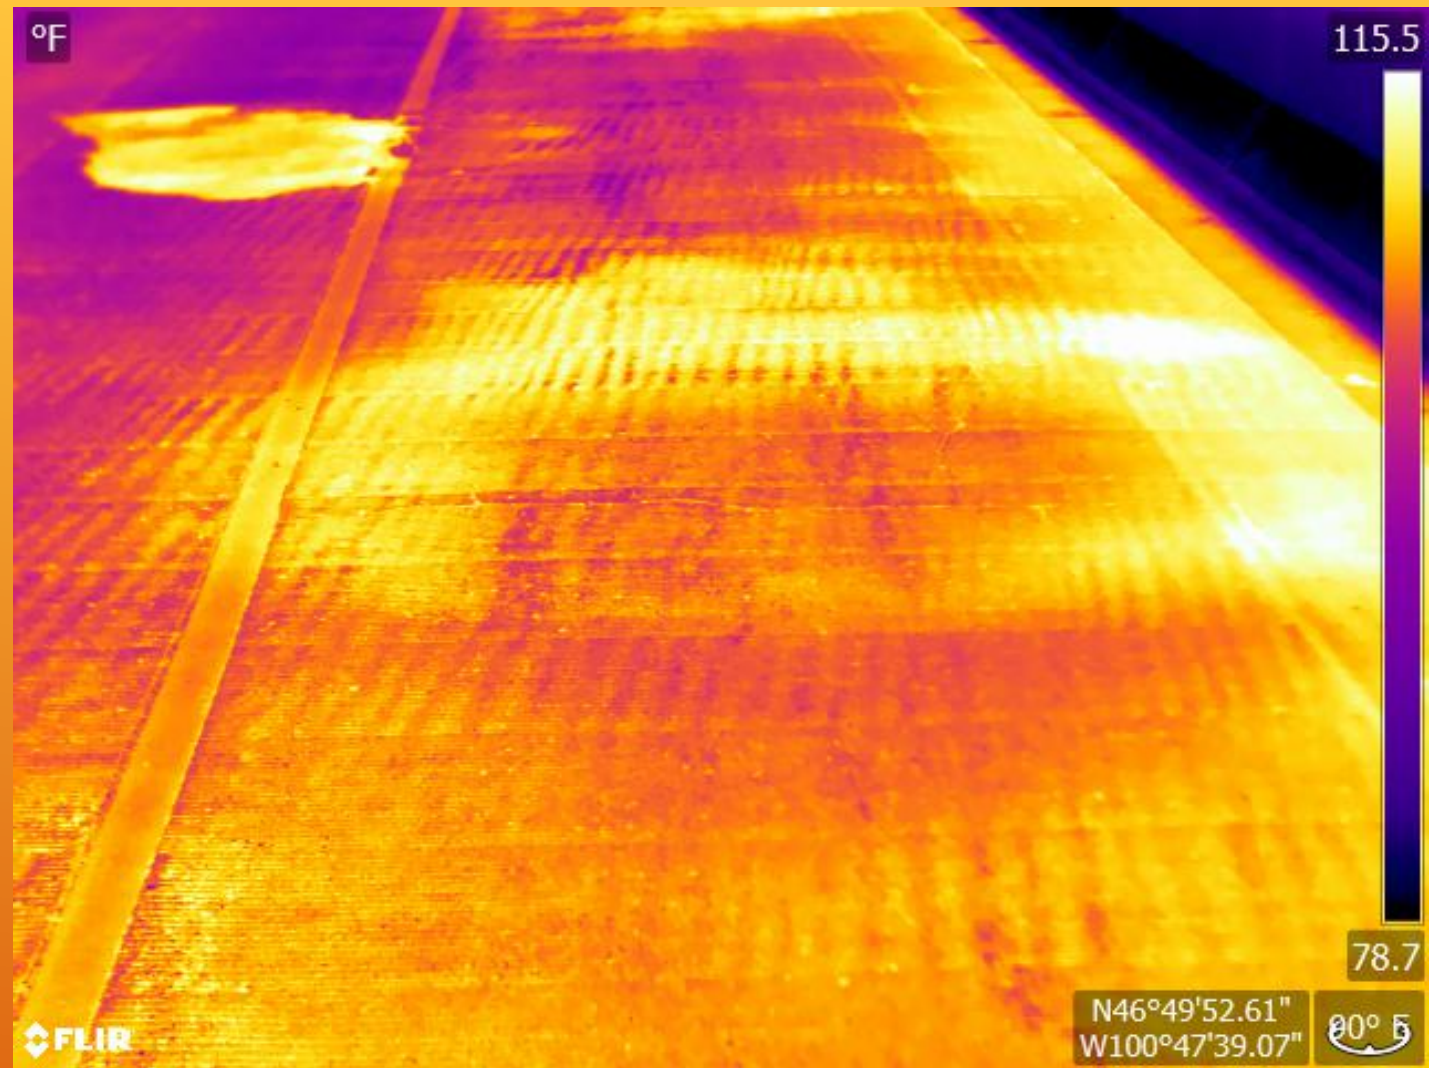
- Potential misinterpretation of image
- Other
 - Shade or shadows
 - Reflected IR radiation
 - Moisture
- Need to understand what you are seeing and why it appears as it does

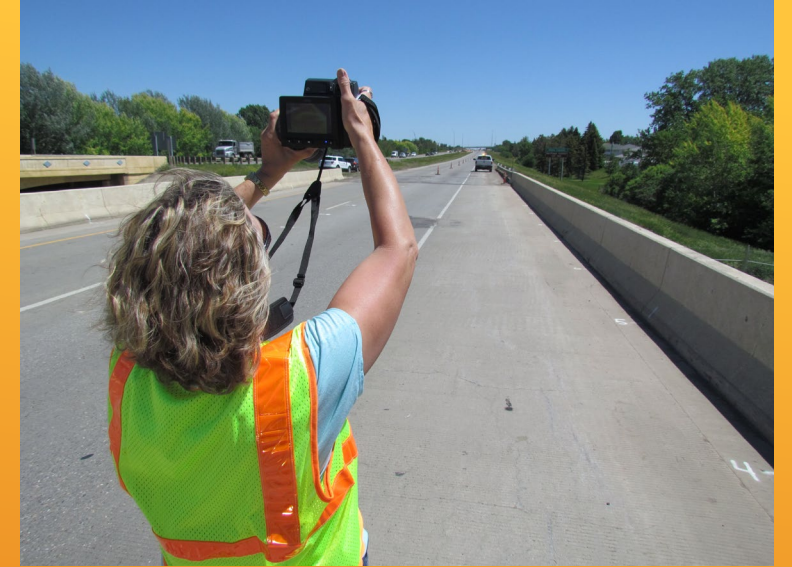
- ▶ Coordinated with Materials and Research Division and Bismarck District Construction
- ▶ Measured and marked 10' grid on deck
- ▶ Used IR camera to systematically image deck
- ▶ Bismarck District chained and marked areas of delamination
- ▶ Reimaged deck with IR camera for comparison

- ▶ Marking and labeling at 10' intervals along right, left, and center of bridge took about 10 minutes
- ▶ Thermal imaging of the deck took about 8 minutes (about 36 images)
 - ▶ 3 passes; 12 images per pass
- ▶ Chaining took about 45 minutes with 3 people working (2 hrs 15 minutes work time)
 - ▶ Included marking delaminated areas
