Background on the TRB-SHRP2 Research and Current Deployment Overview for Nondestructive Testing for Tunnel Linings (R06G) Implementation

Dennis Sack P.E.
Sr. Vice President
Olson Engineering

High-Speed Mapping of Defects In or Behind Tunnel Linings (R06G)

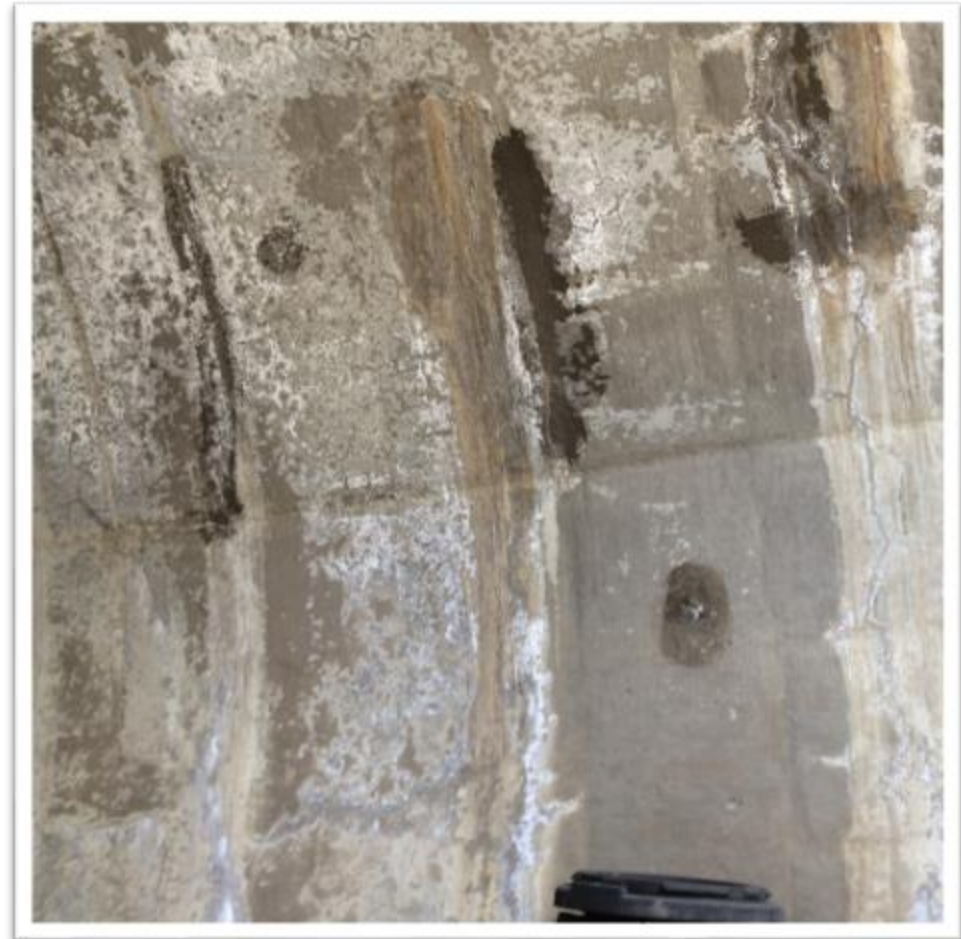
Efflorescence, Water Leakage (Mineral Deposits from Water Flow)

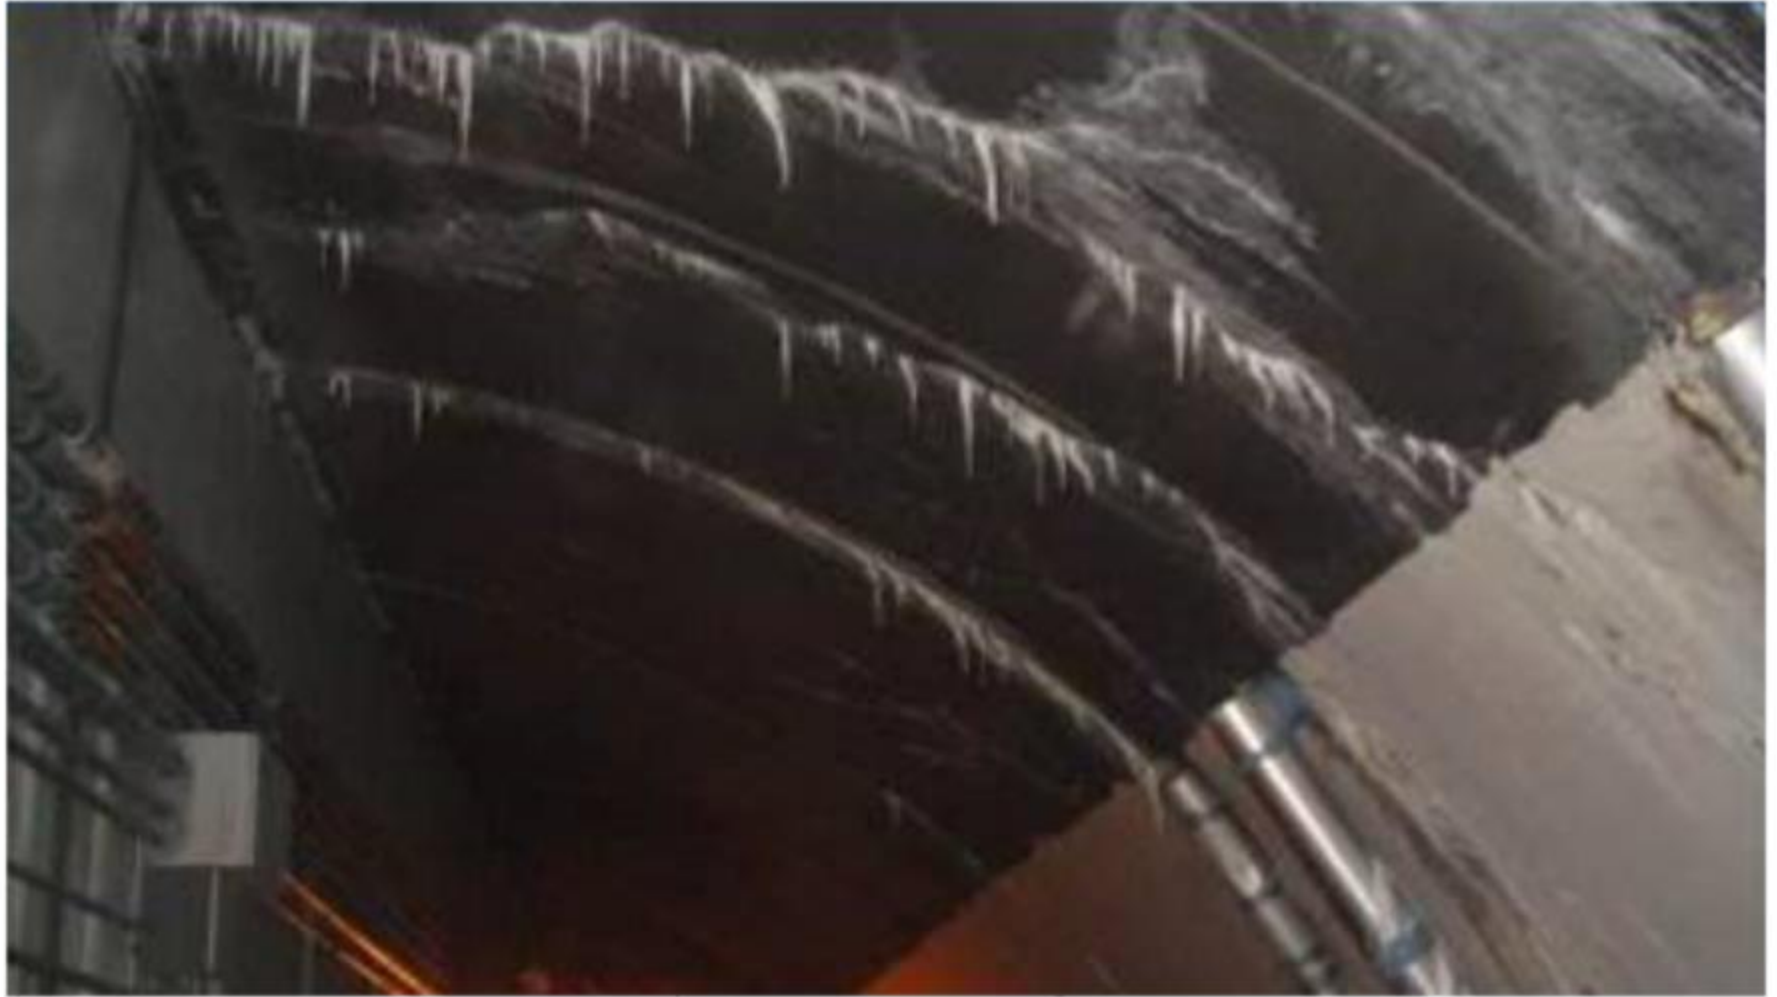
Efflorescence, Water Leakage with Cracking and Rust Staining (Rebar Corrosion)

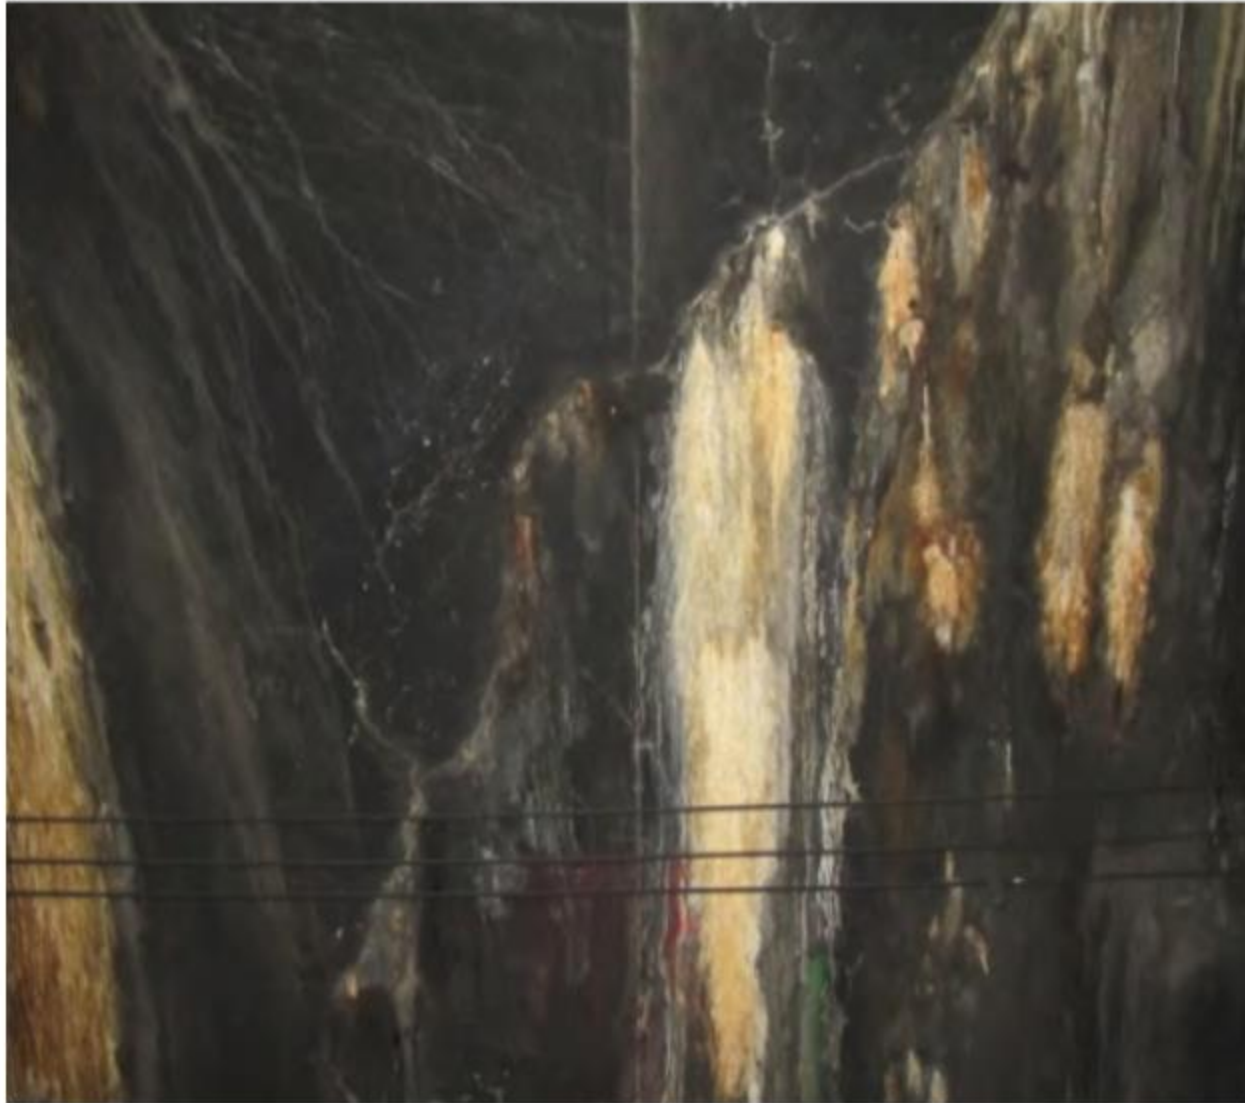
Cracking in Liner Concrete with Covered Void/Spall

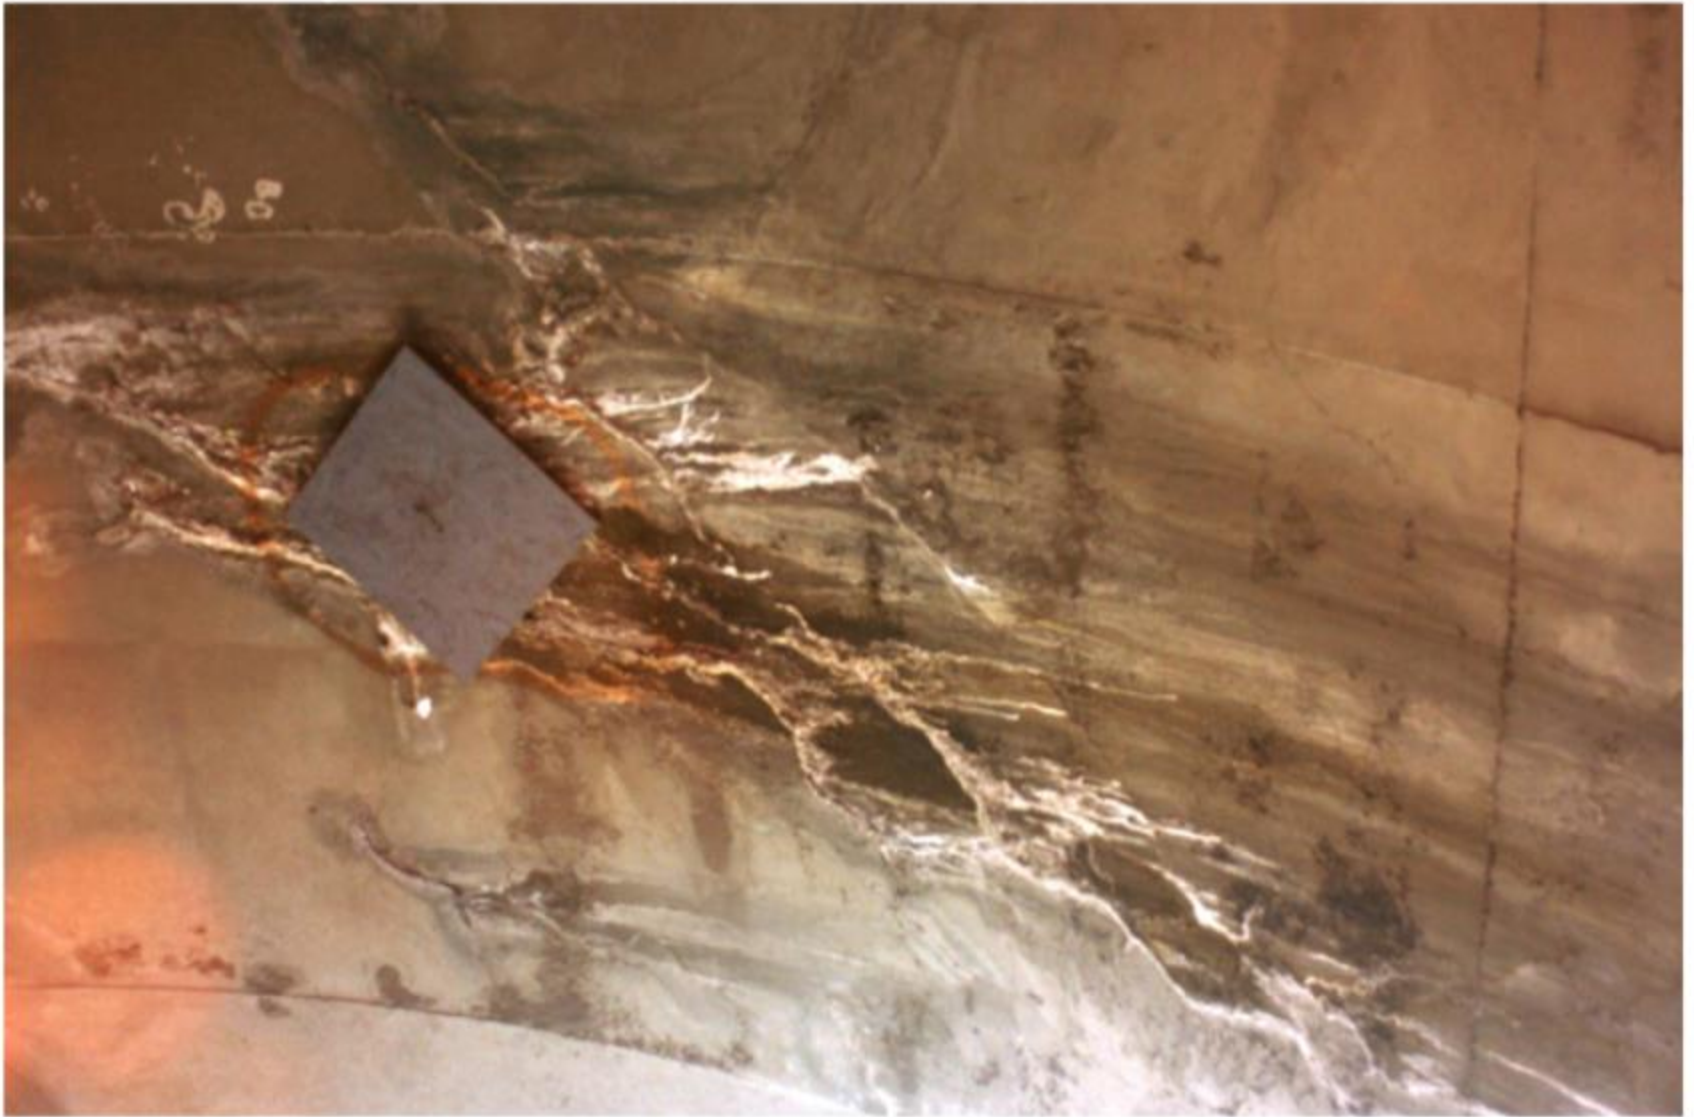
Concrete Liner Cracking

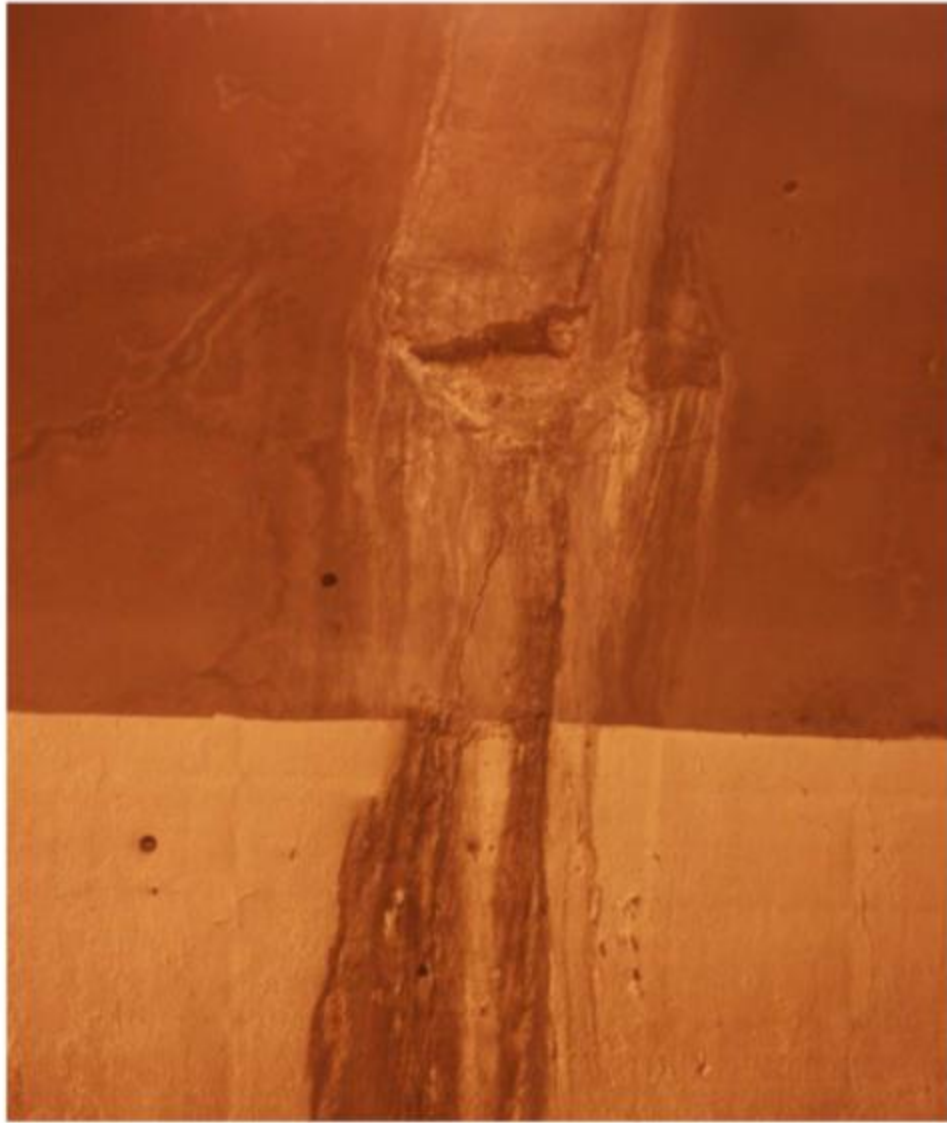
Delamination of Shotcrete Coating

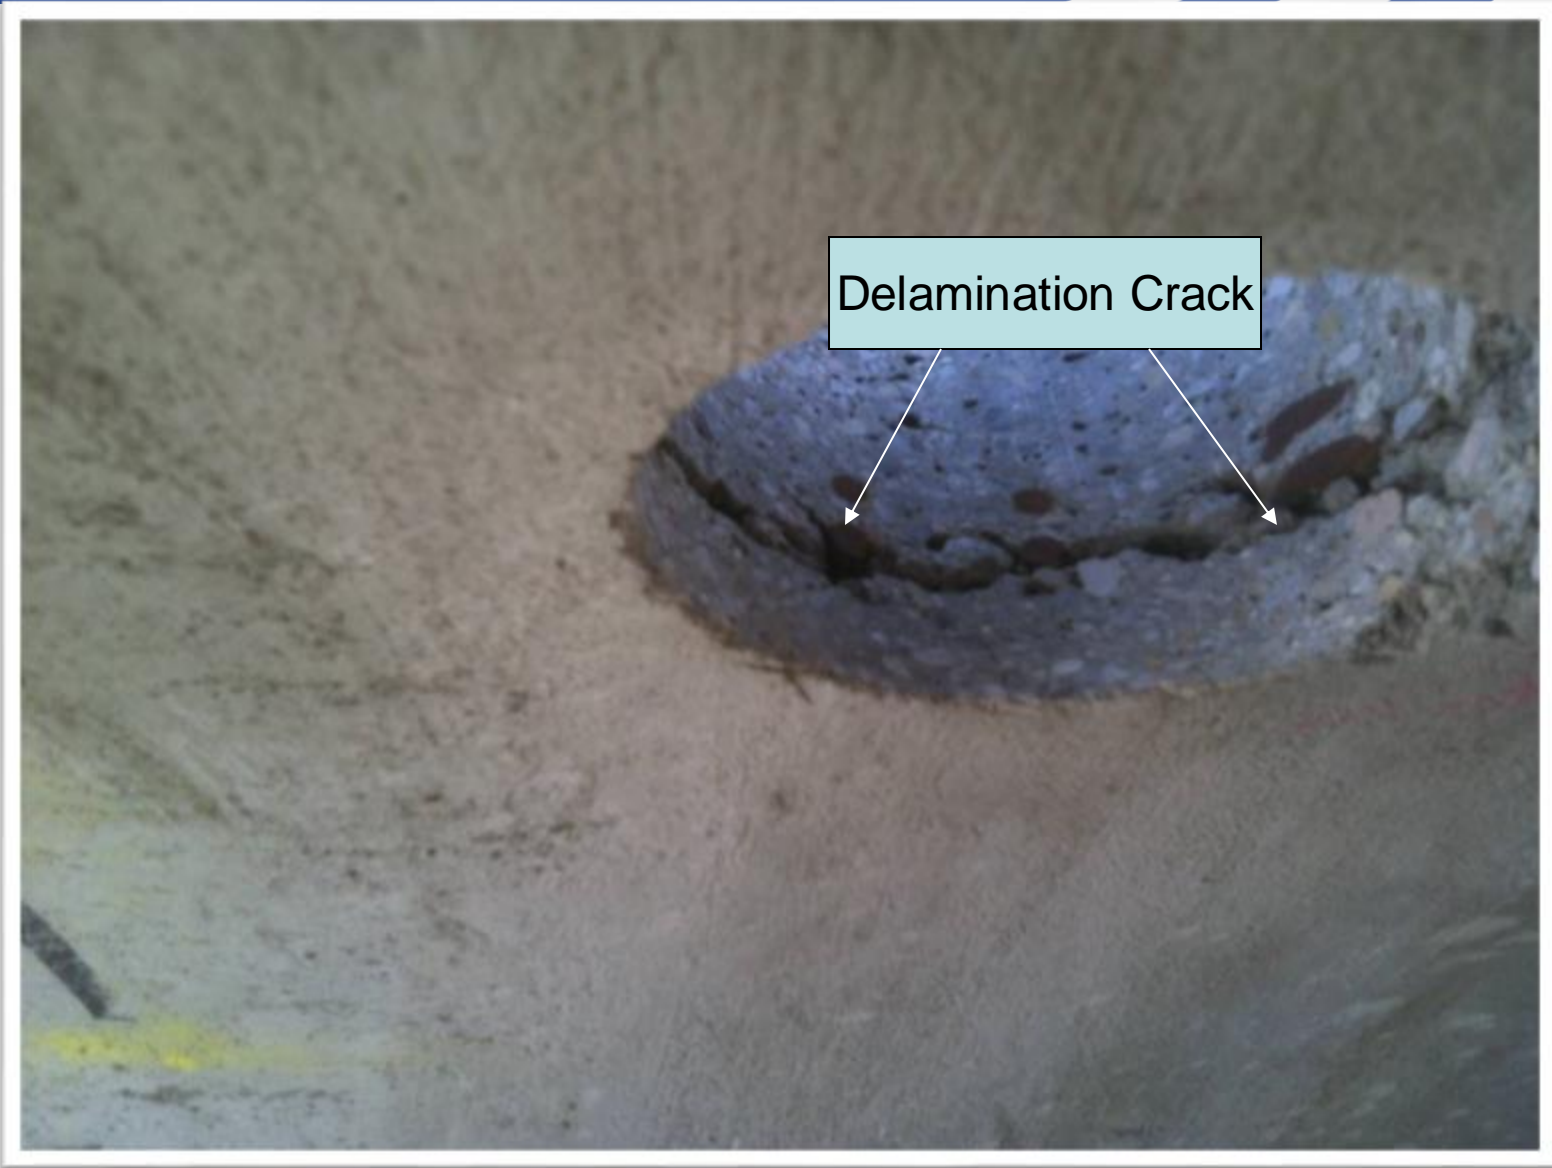
Photogrammetry Image of Severe Liner Rebar Corrosion and Spalling

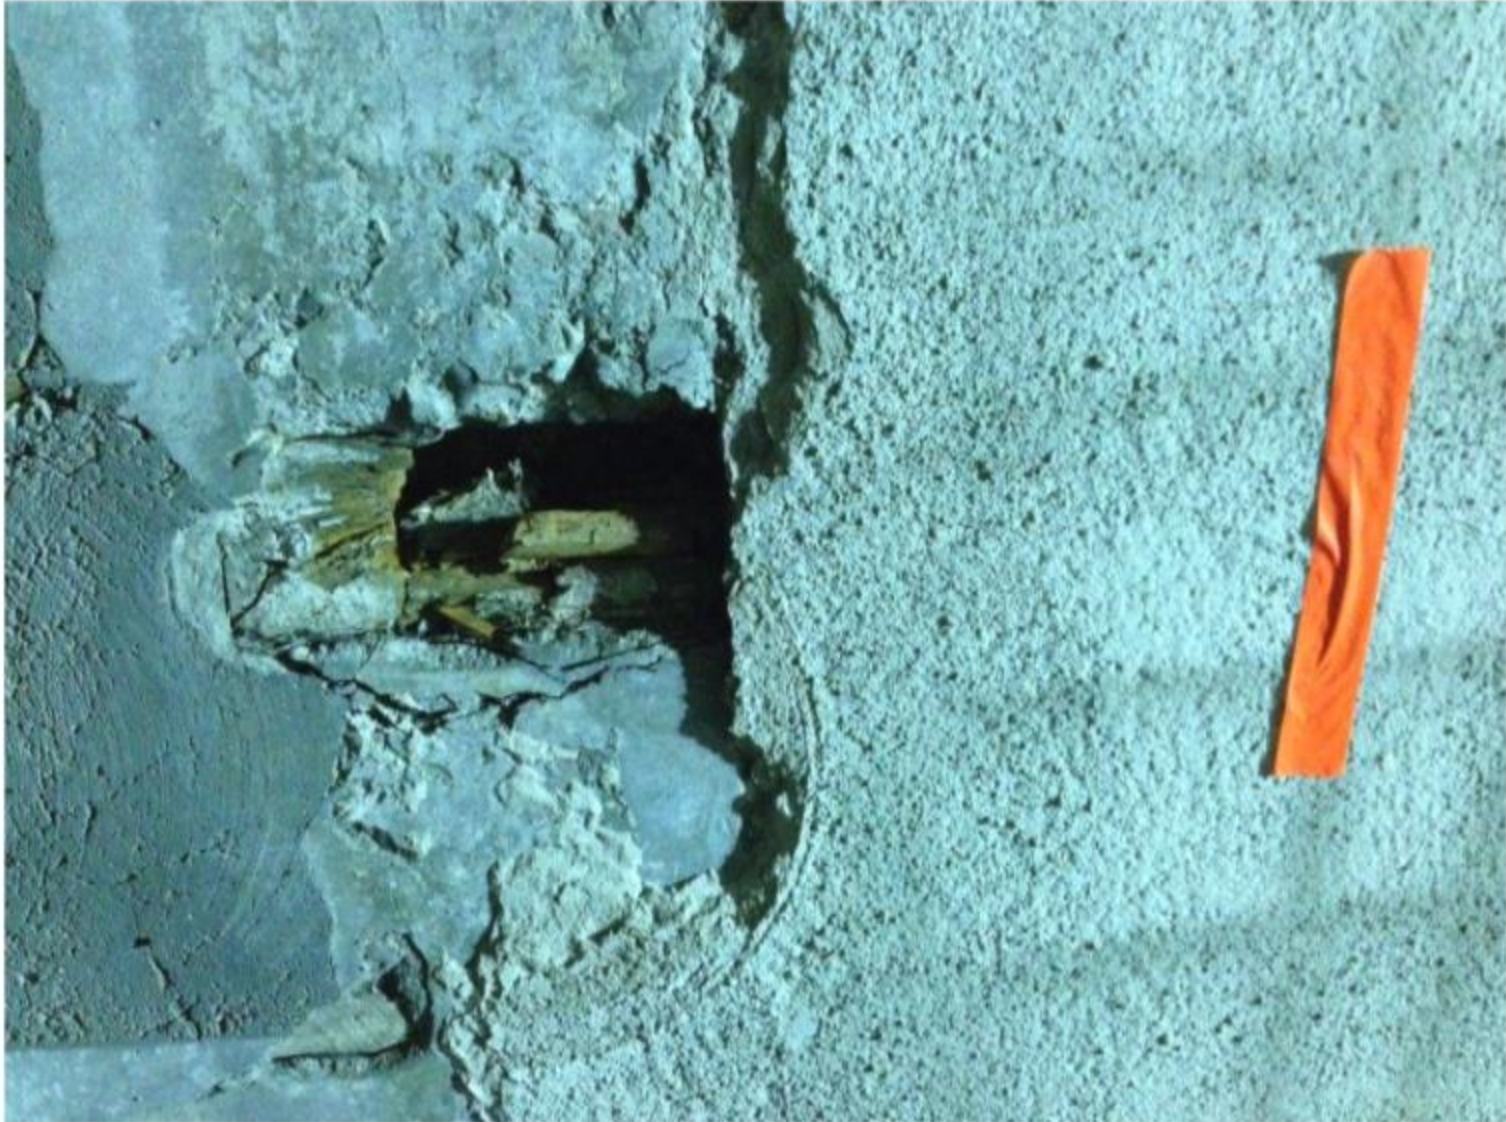
Geophones on Tunnel Crown for Void Detection Survey

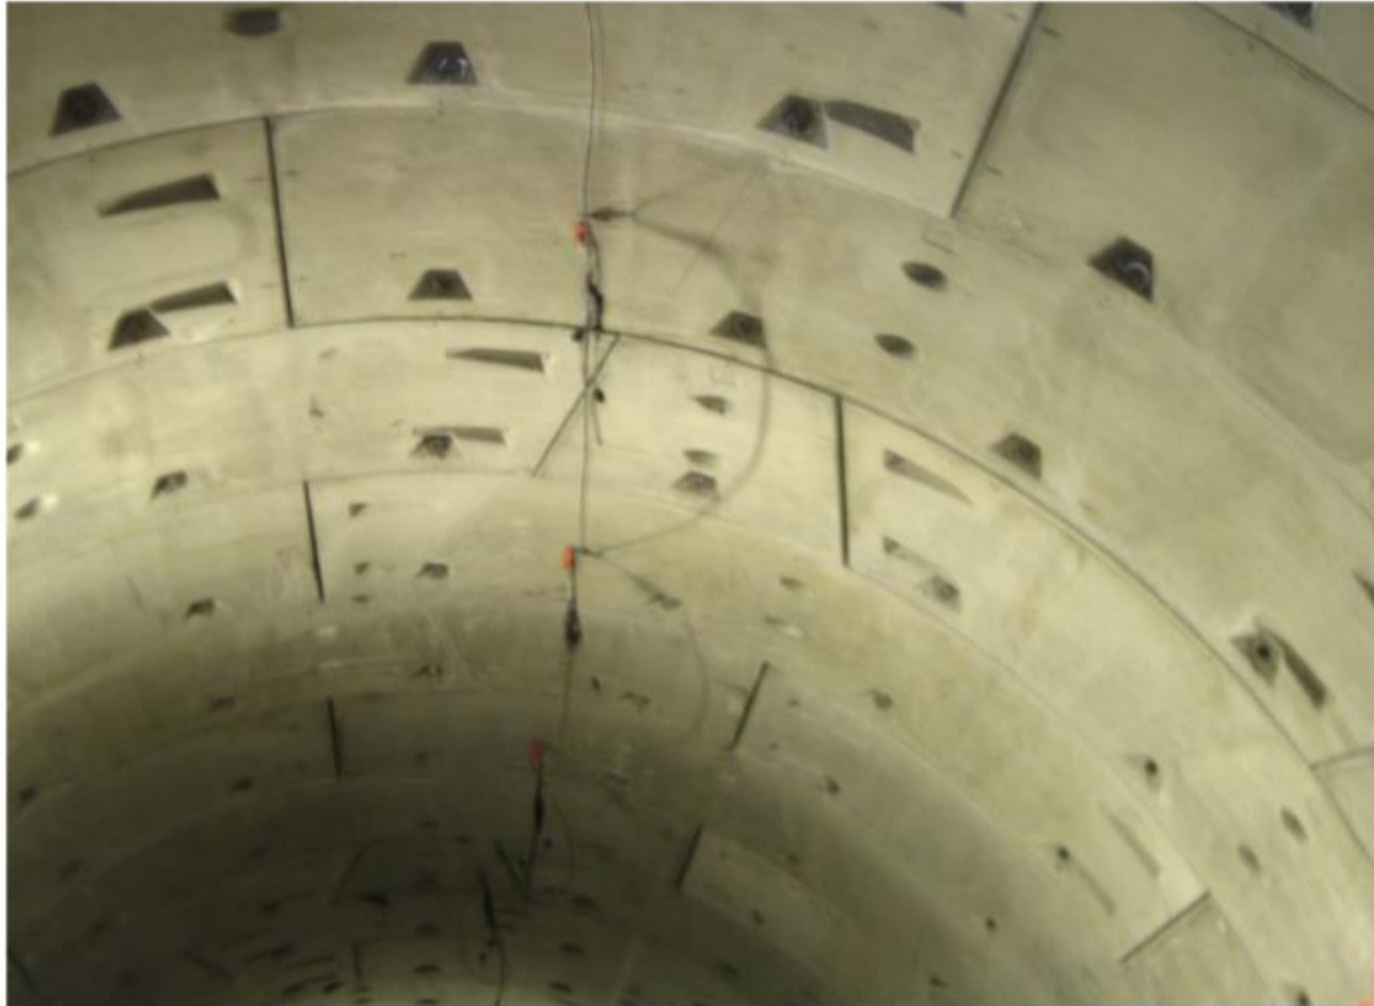
Geophones
Used for Shear
Wave Velocity
Survey to
Locate Voids
Above Liner

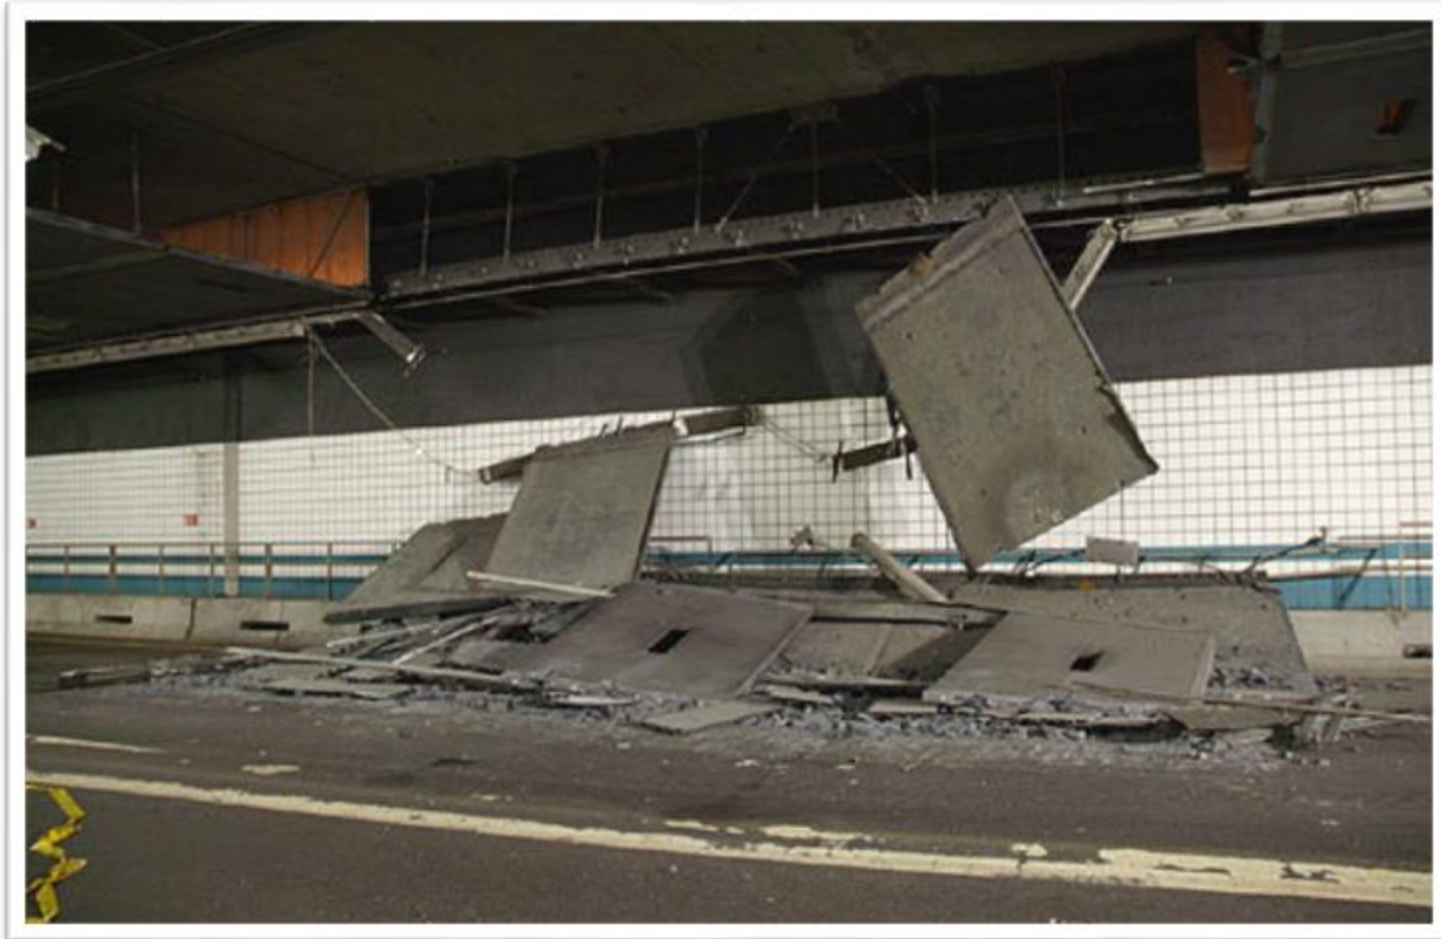
Panel Anchorage Failure

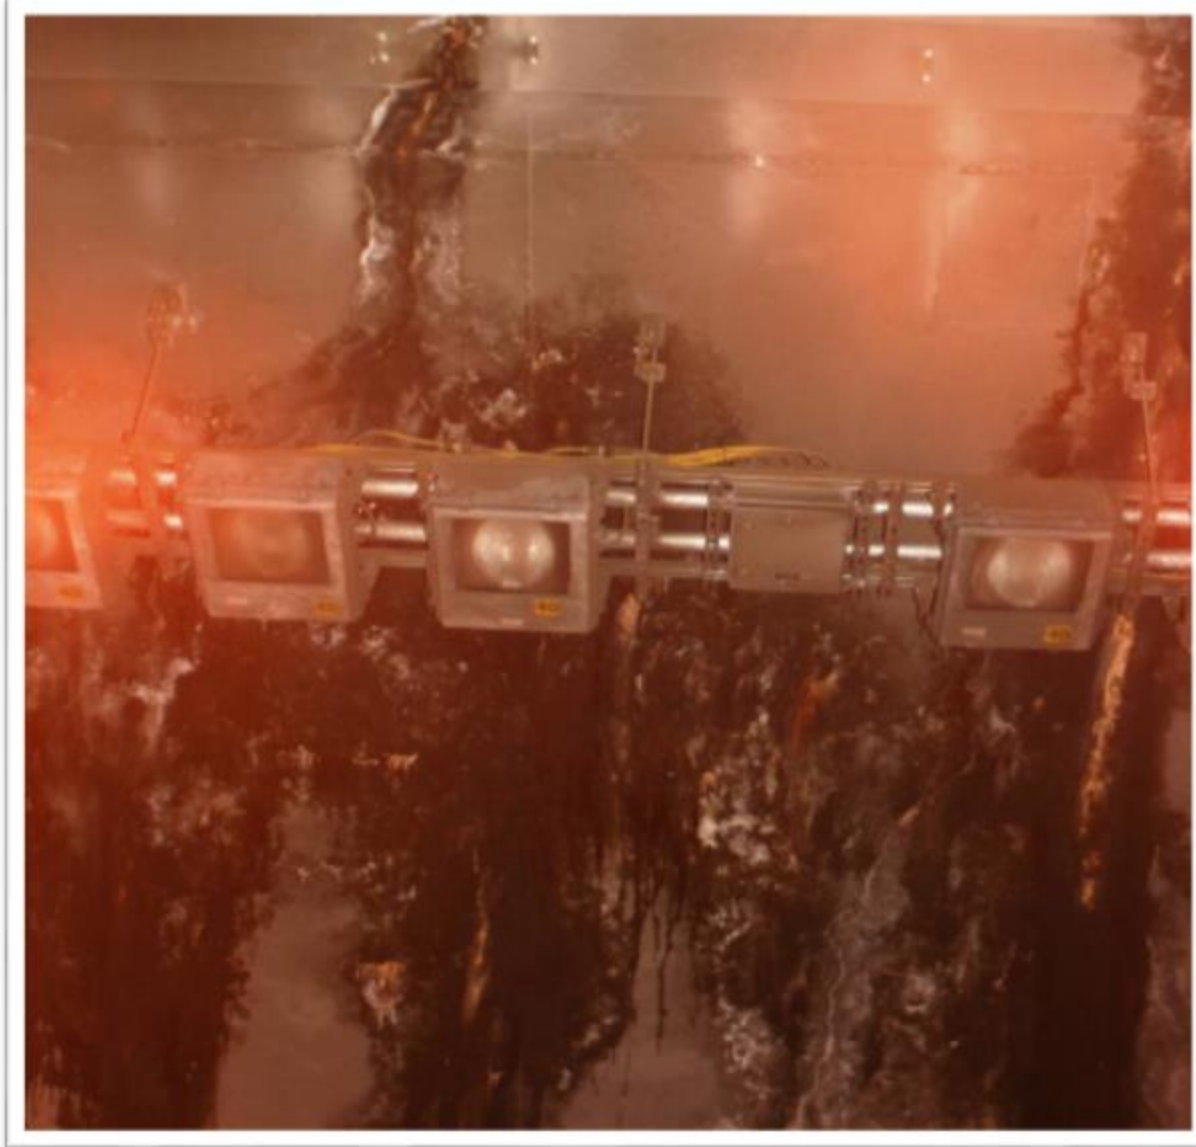
Cracking, Moisture Intrusion with Rust Staining – Possible Fixture Asset Threat As Well

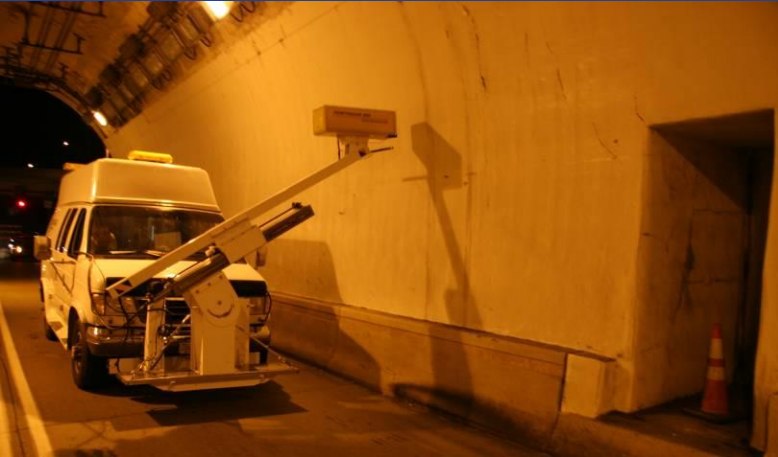
Penetradar GPR of PennDOT Tunnel

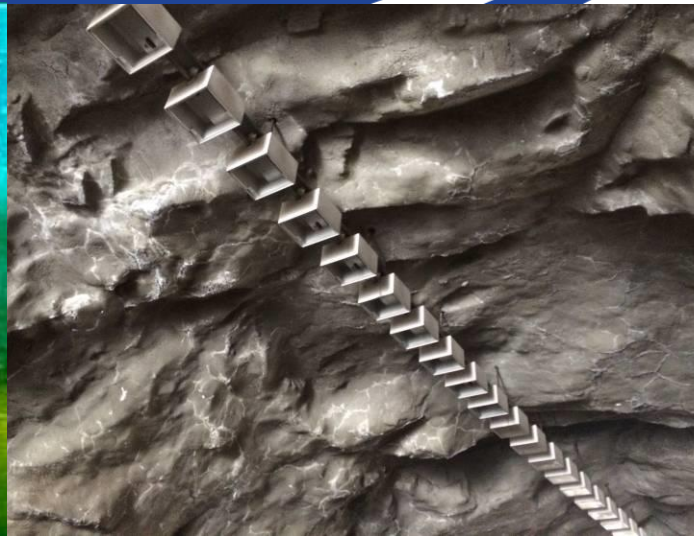
Shotcrete Lined Tunnel

IR Image of Debonded Shotcrete (debonds in red)

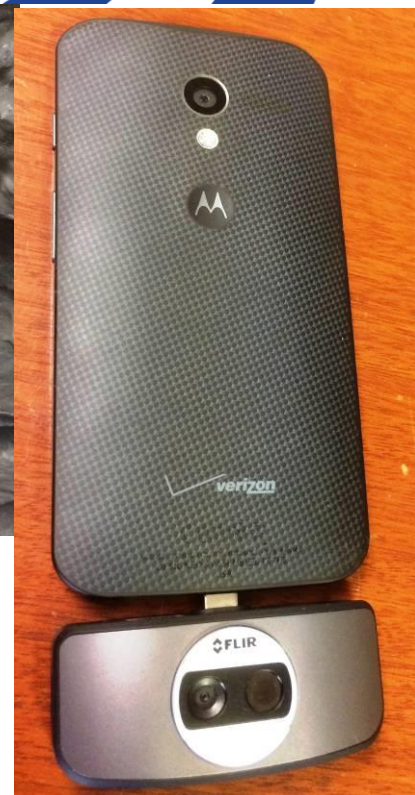
FLIR 1 IR
Camera
