Nondestructive Testing for Concrete Bridge Decks (RO6A)

KENTUCKY

Brad Rister P.E.
Kean Ashurst P.E.
Josh Rogers P.E.
Jamie Creech Eng. Tech.

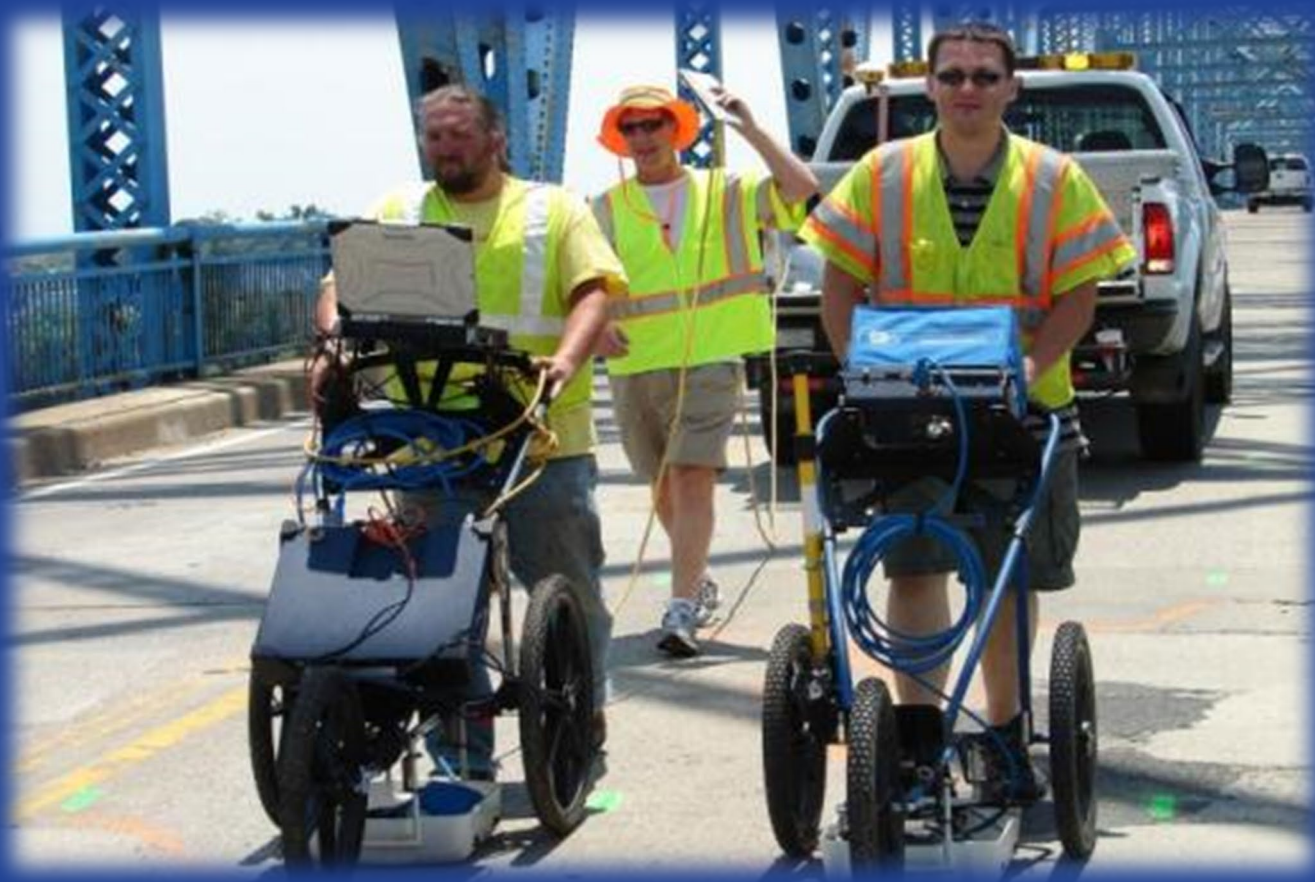
Ground Penetrating Radar Survey

Survey lines 2' o.c.

6 lines per lane

24 scans per foot

4007 ft. per line

96,168 data points

Collection time 2 days

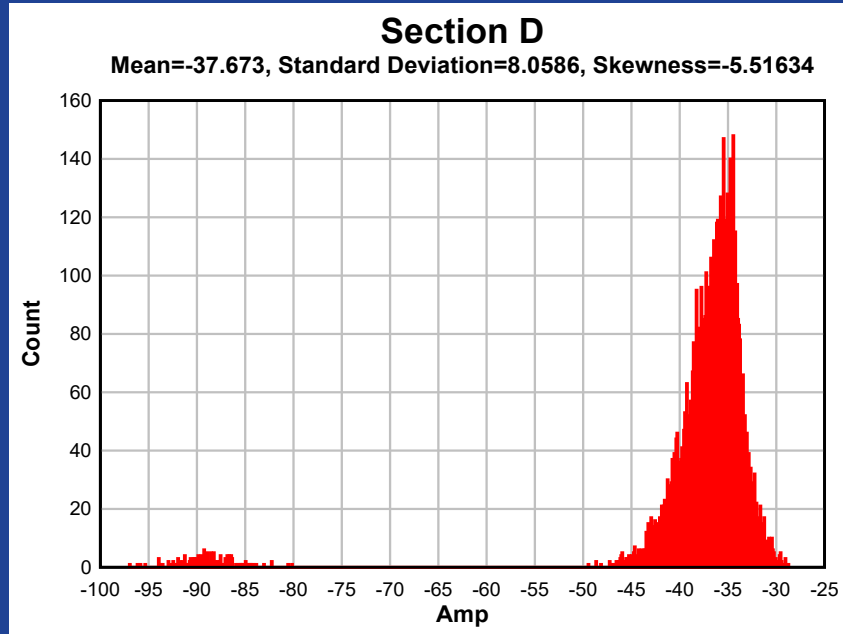
Section D: 25% +/- 5% deteriorated

Section	% deterioration Visual	% deterioration GPR +/- 5%
D	19.4	25
E, F	1	3.5
G	15.6	36

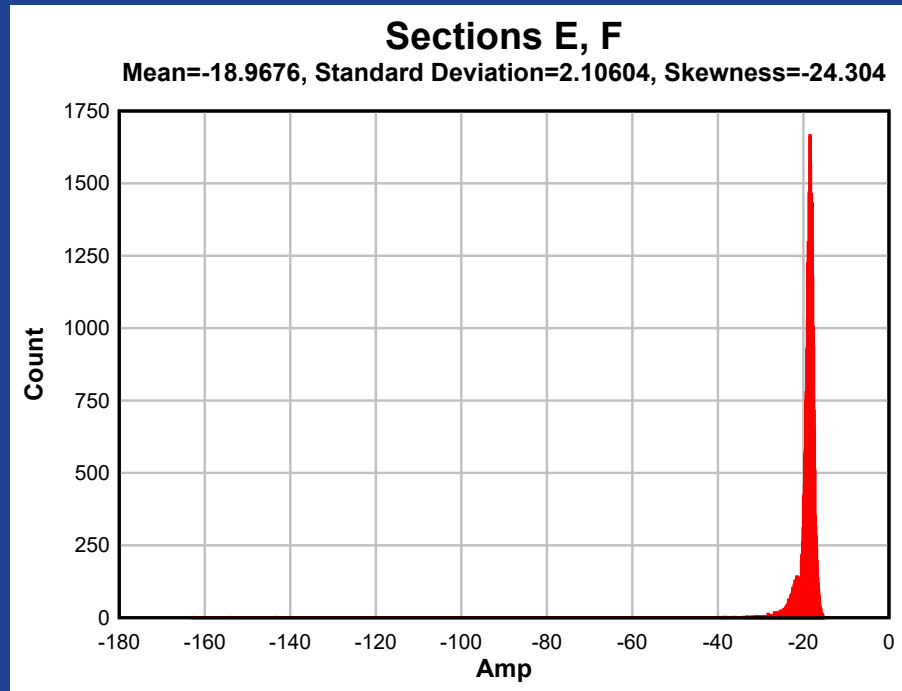
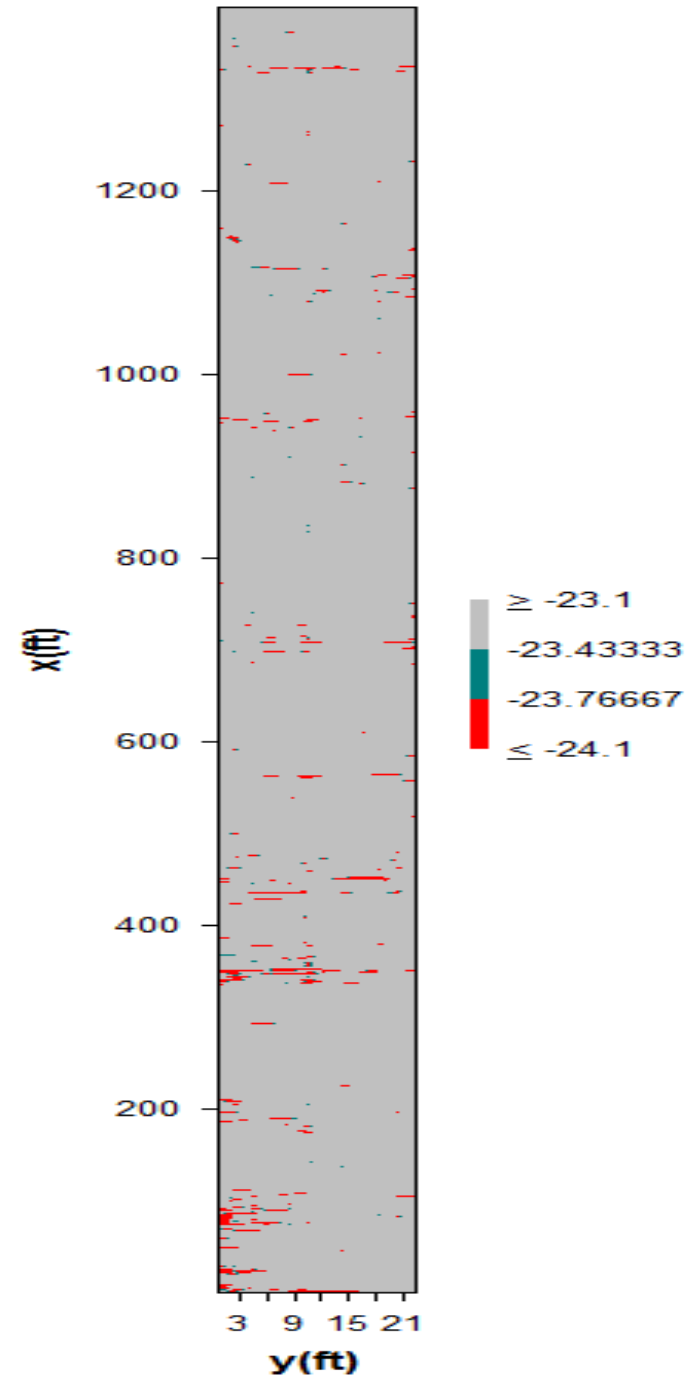
Section E, F: 3.5% +/- 5% deteriorated

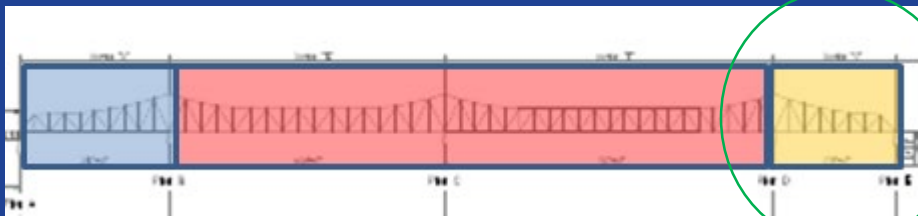
Section G: 36% +/- 5% deteriorated

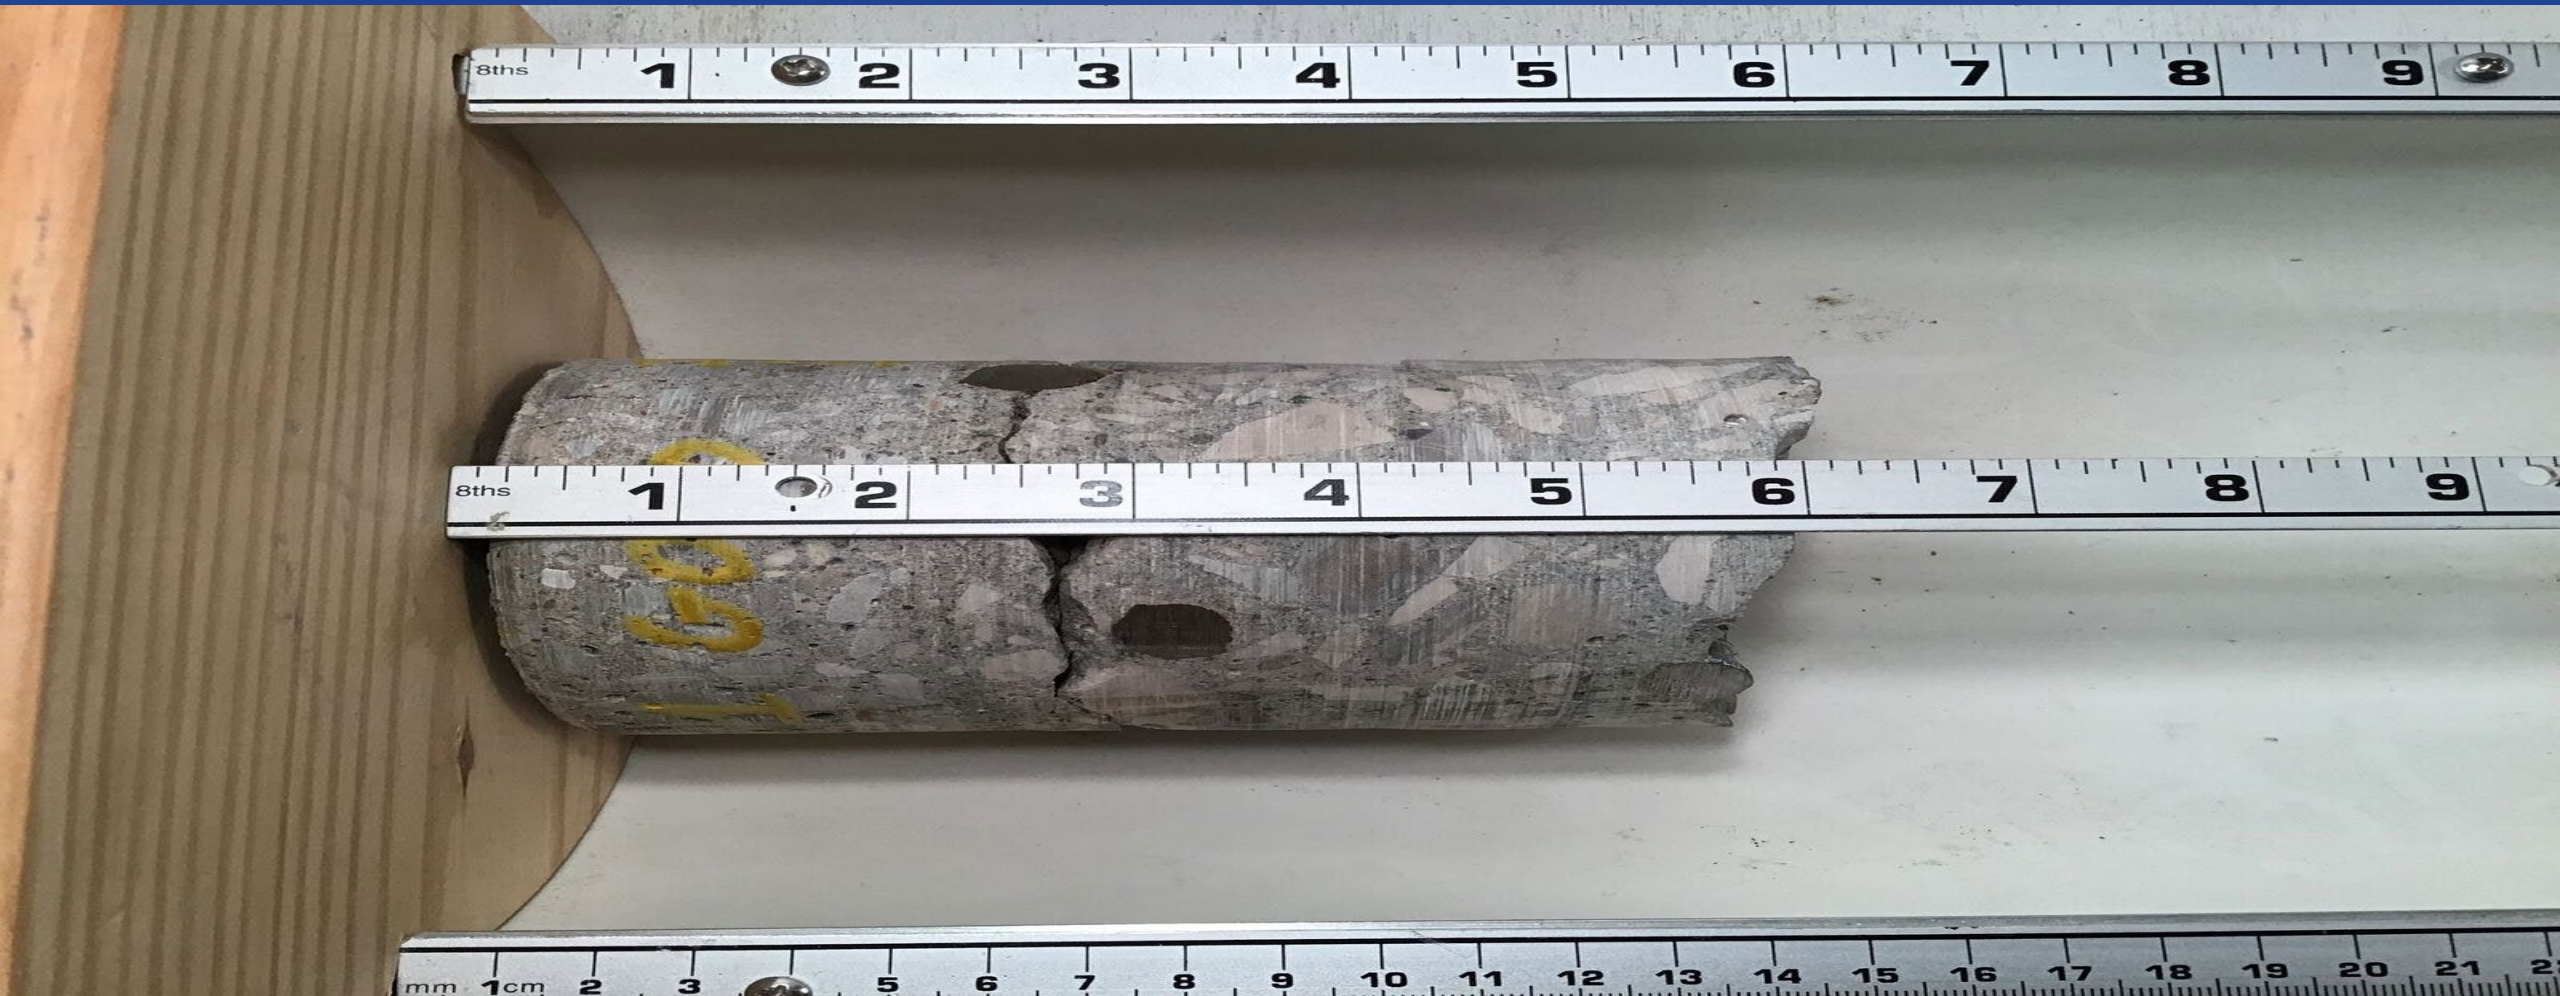
EB Core #1 (delaminated 2.5 inches)

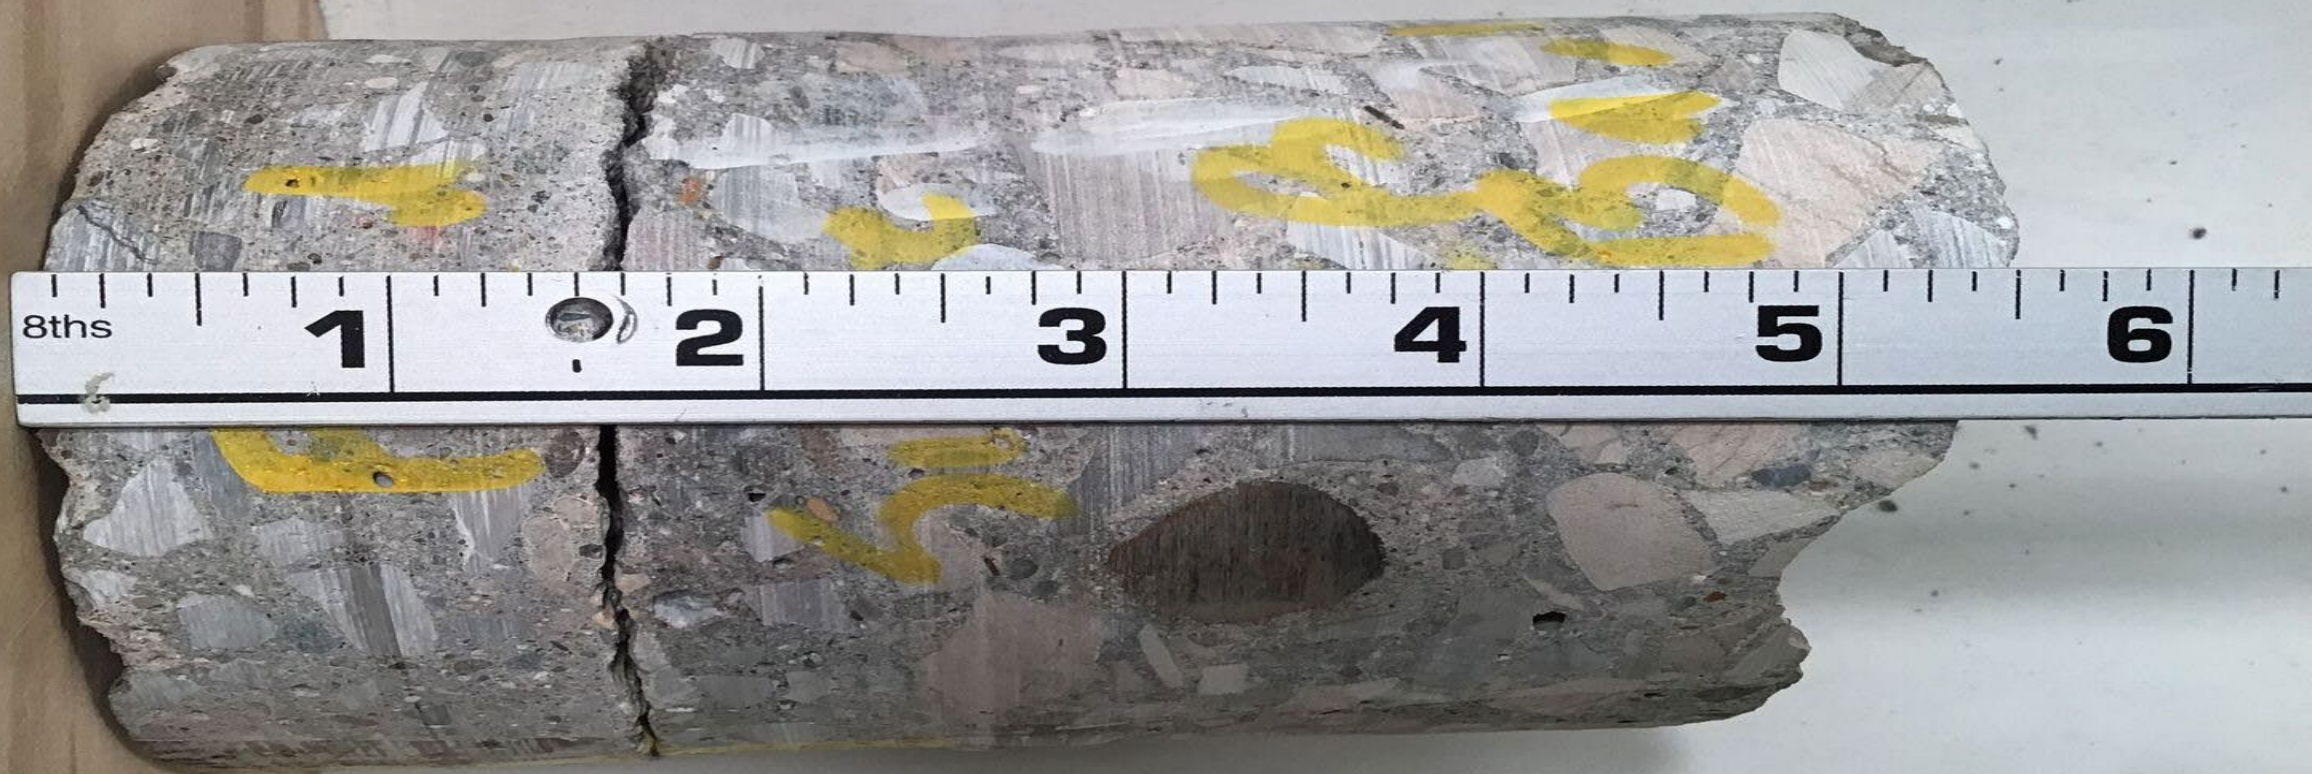
EB Core #2 "low amplitude" (delaminated 1.625 inches)

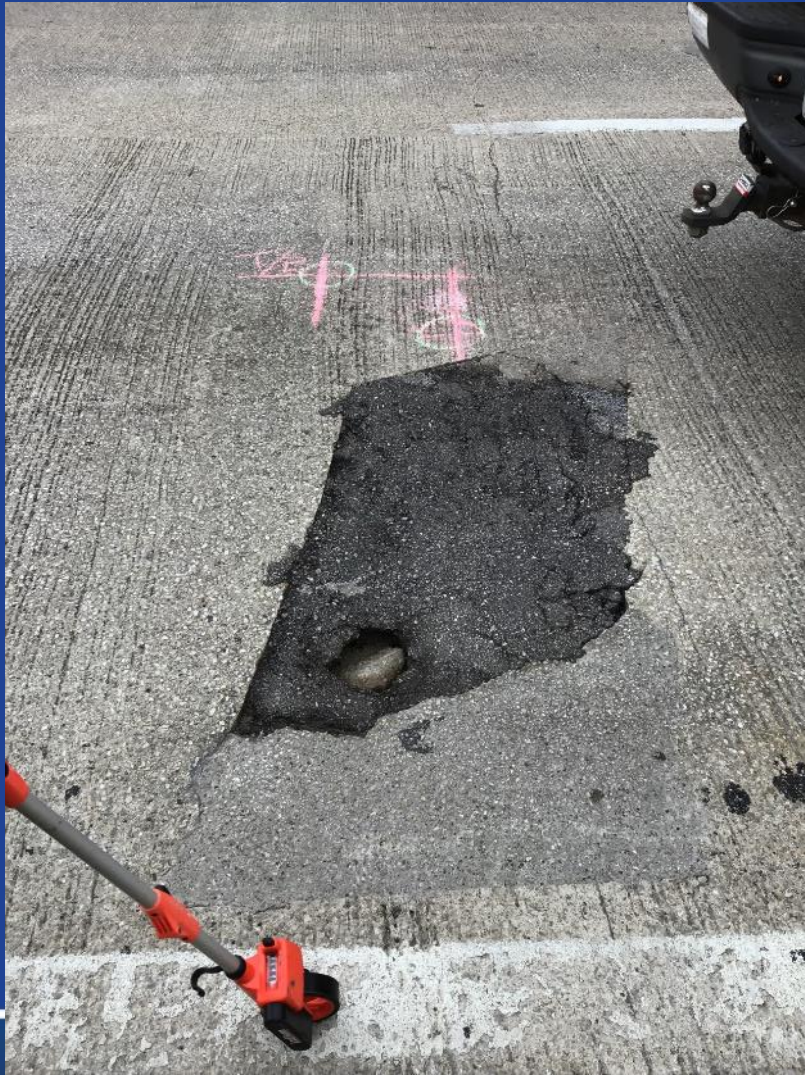
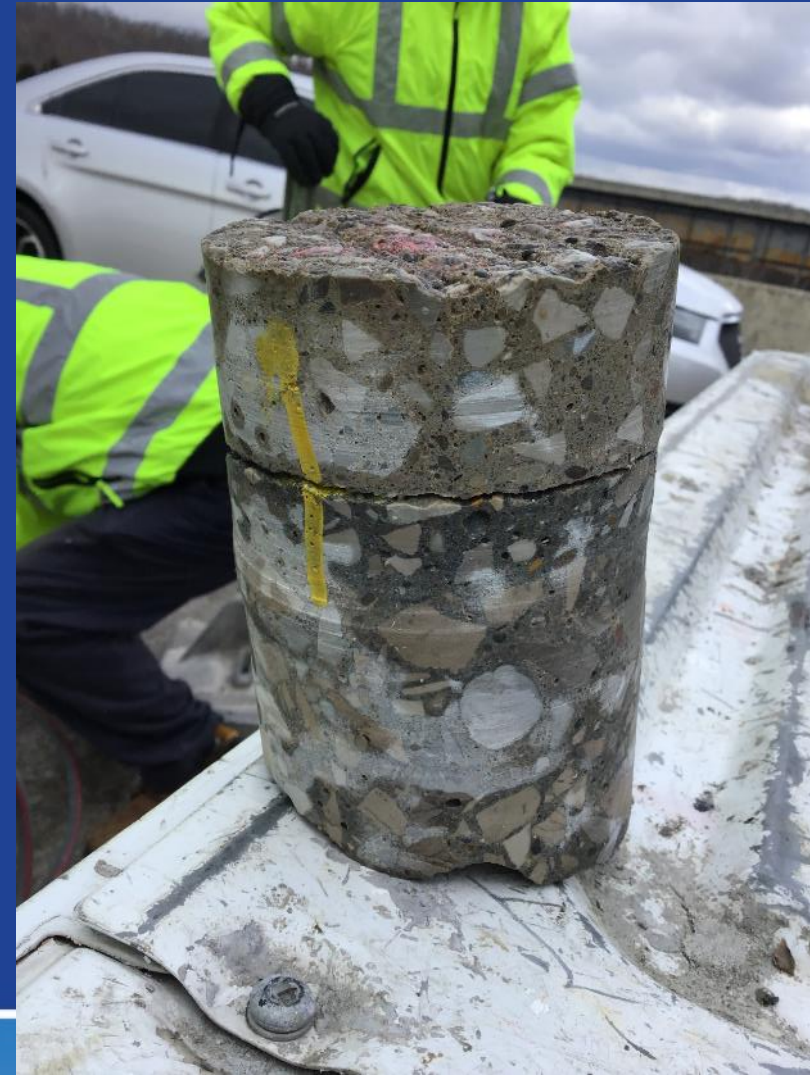
EB Core #2 “low amplitude” (delaminated 1.625 inches)

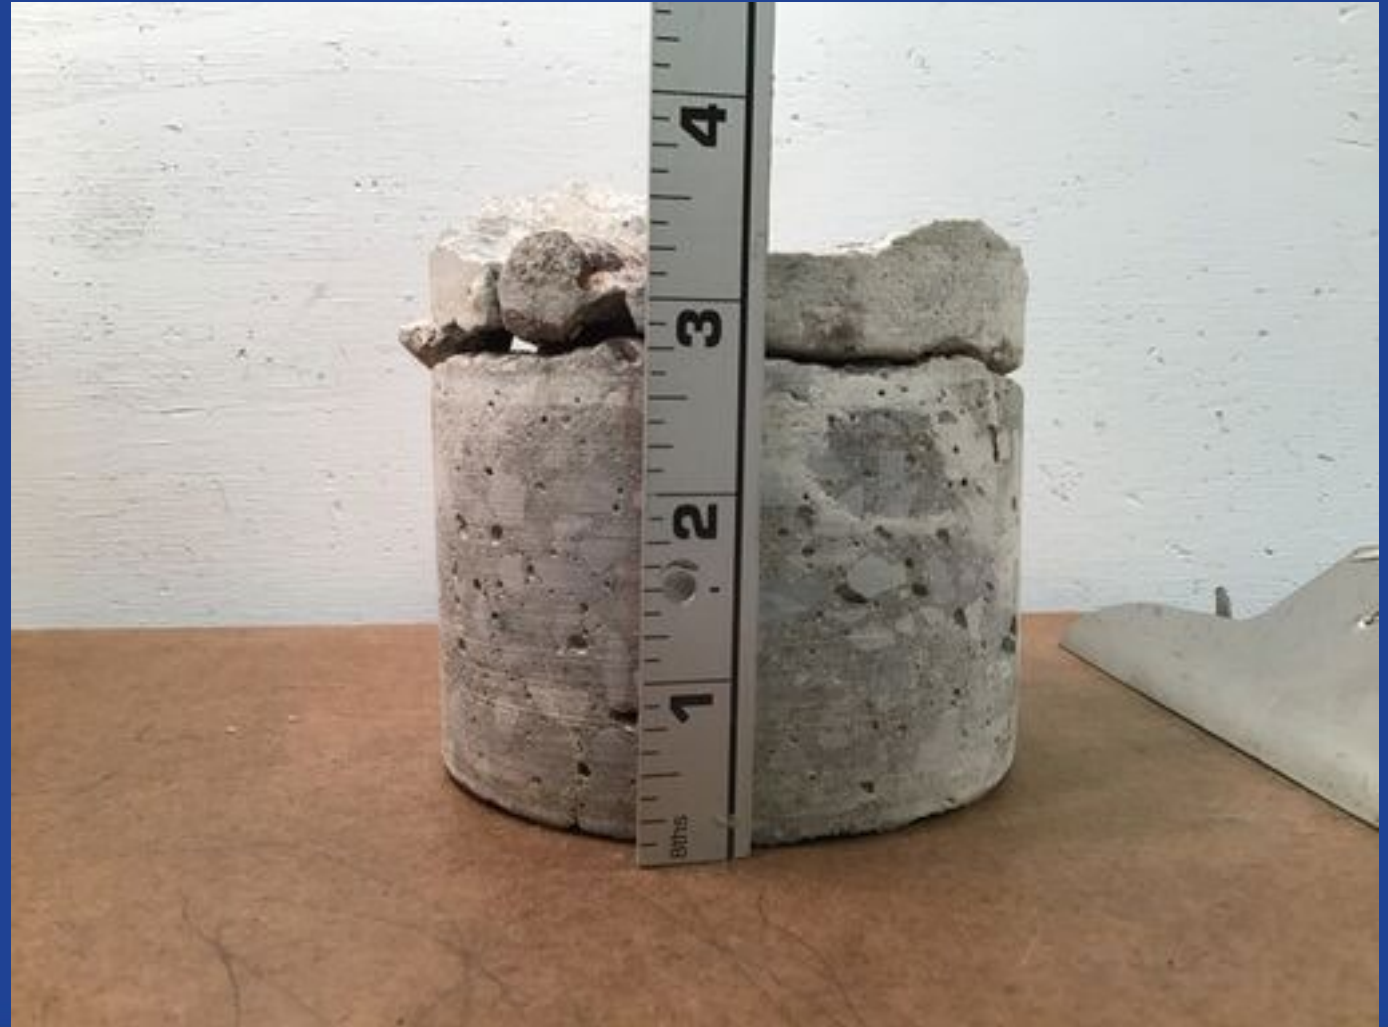
WB1 Core “low amplitude” (delaminated 3 inches)

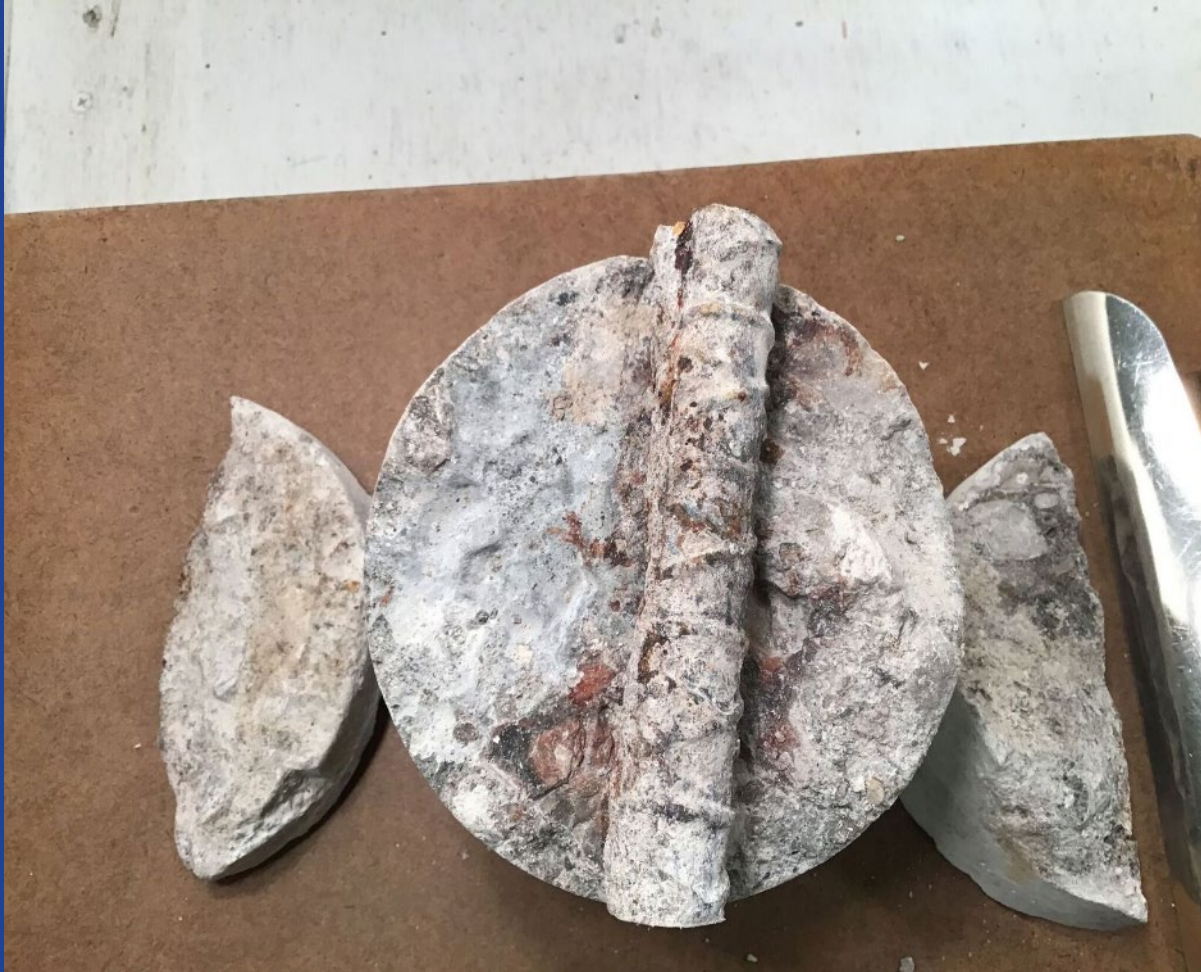
WB1 Core: #5 bar section loss 7 +/- 1 %

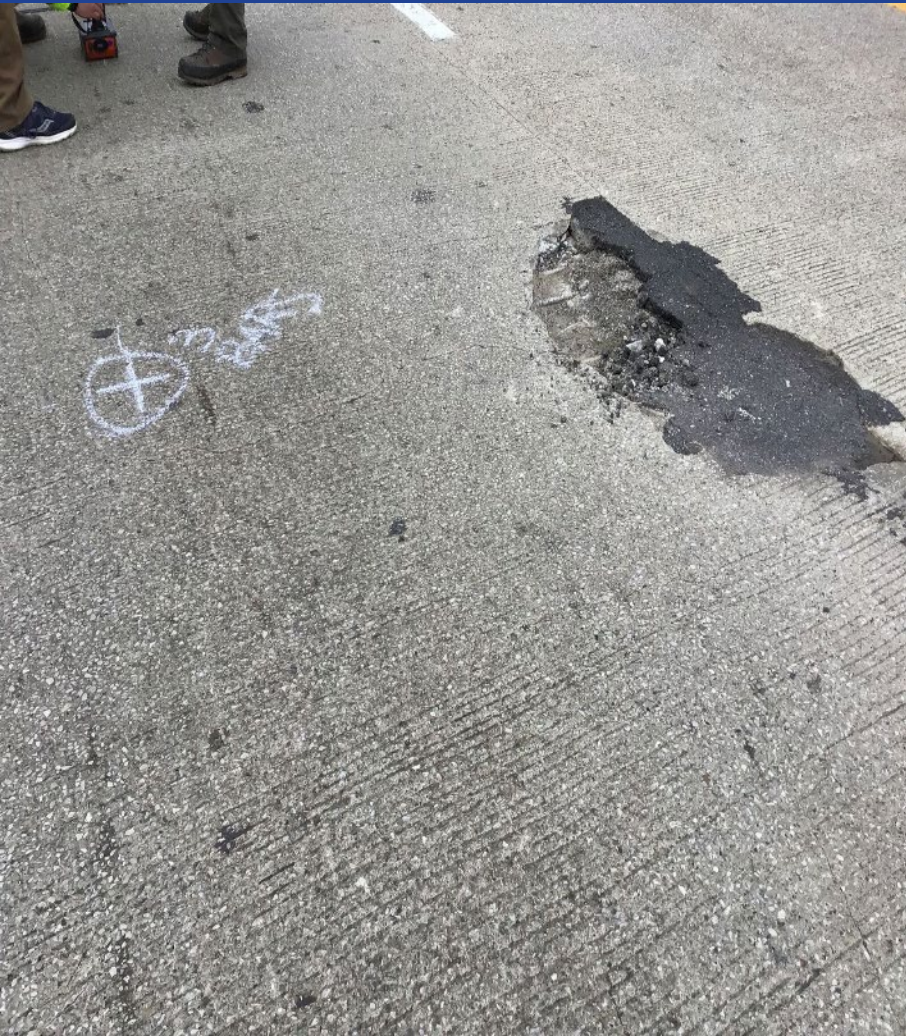
WB2 Core (4-bar) (delaminated 3 inches)

Transverse Steel

Longitudinal Steel
