Background on the TRB-SHRP2 Research and Current Deployment Overview for Nondestructive Testing for Tunnel Linings (R06G) Implementation

High-Speed Mapping of Defects In or Behind Tunnel Linings (R06G)

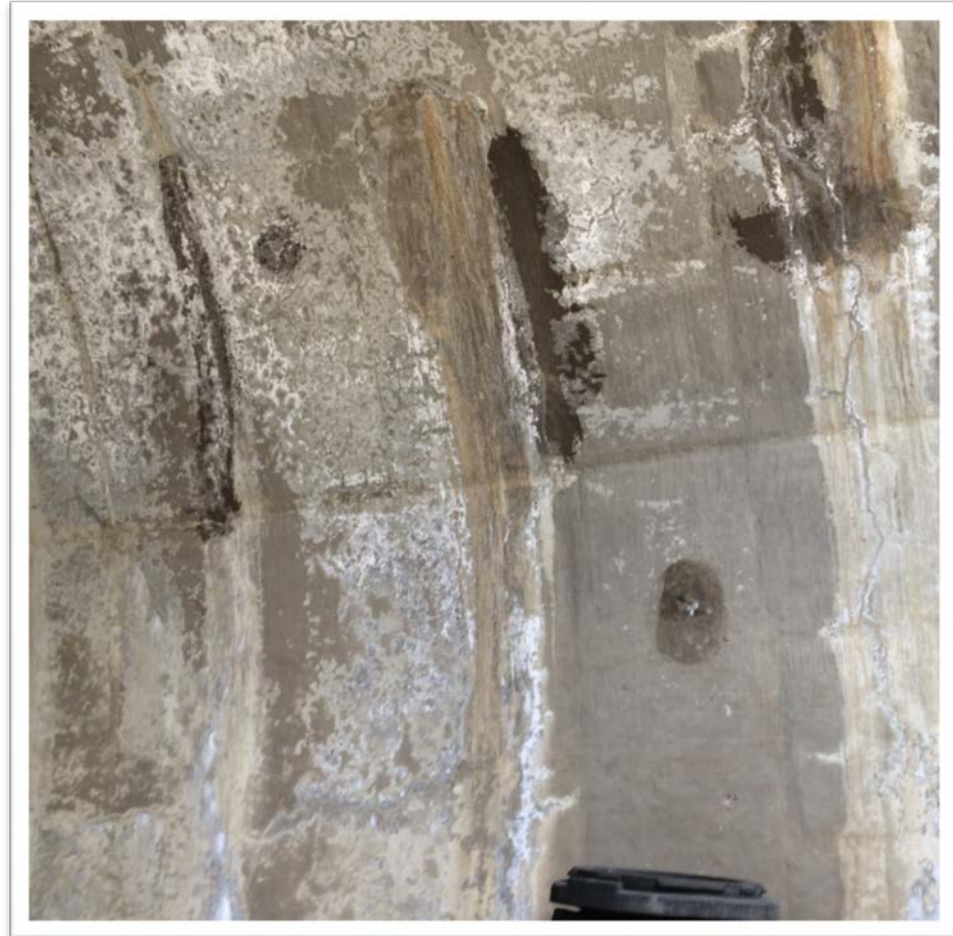
Efflorescence, Water Leakage (Mineral Deposits from Water Flow)

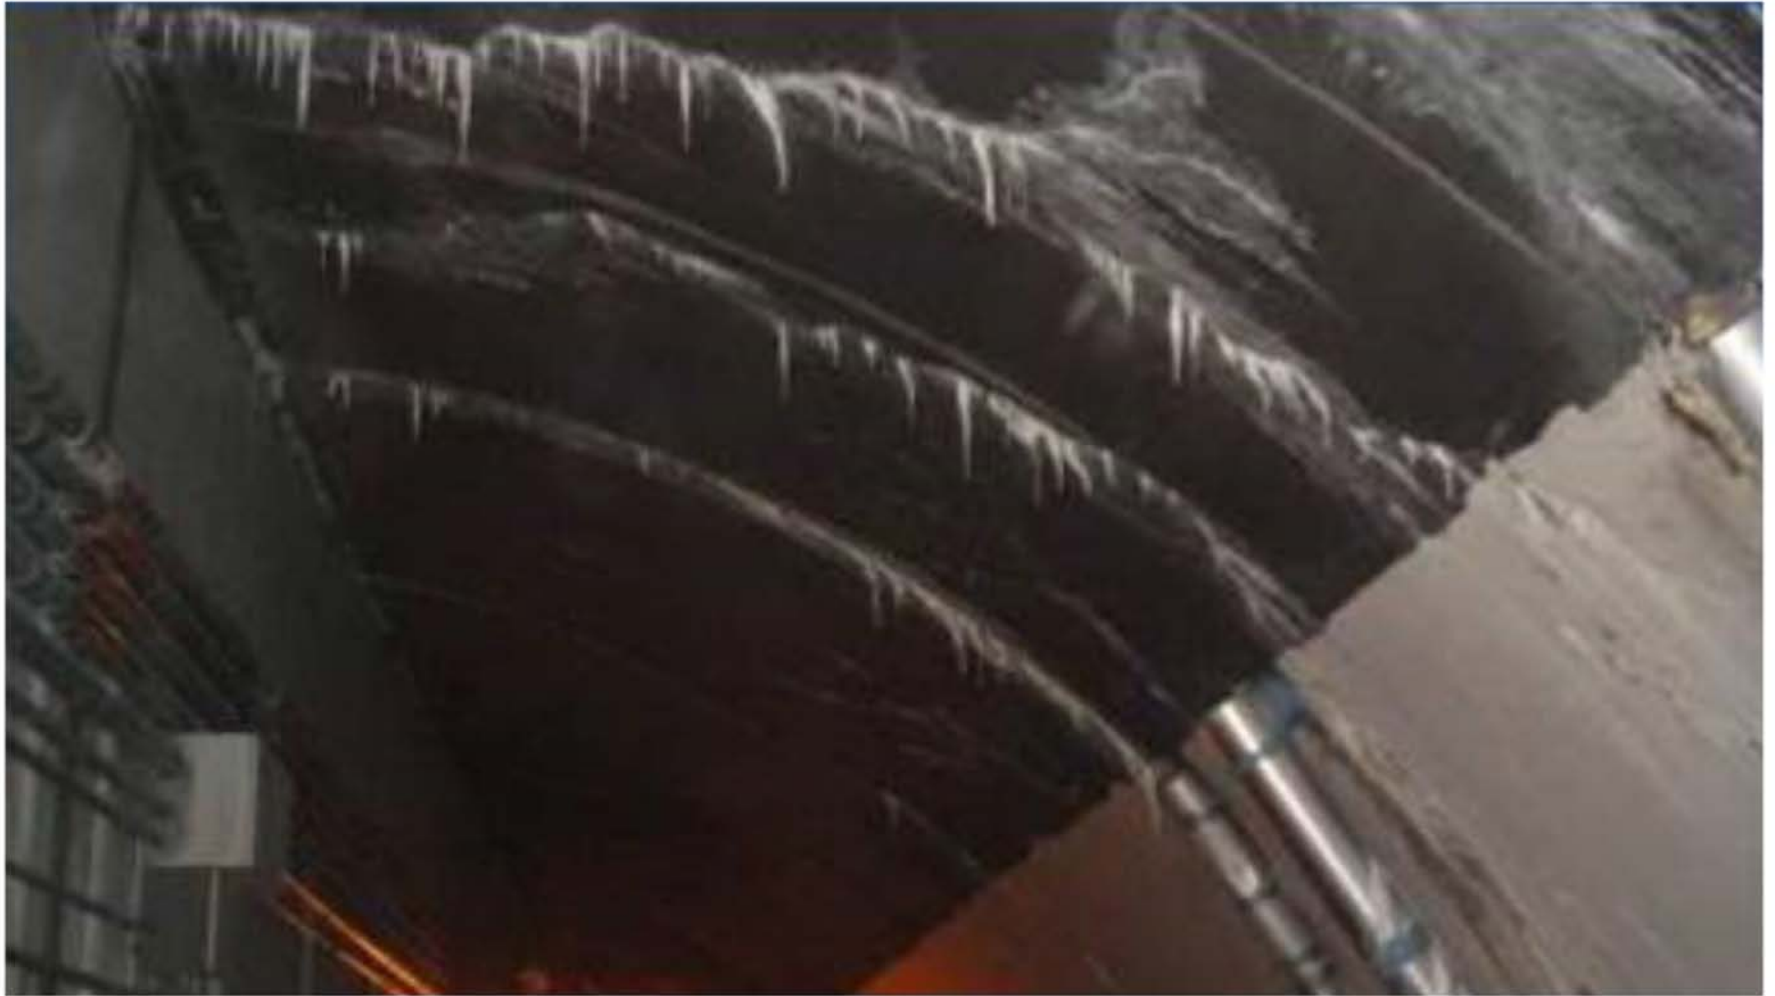
Efflorescence, Water Leakage with Cracking and Rust Staining (Rebar Corrosion)

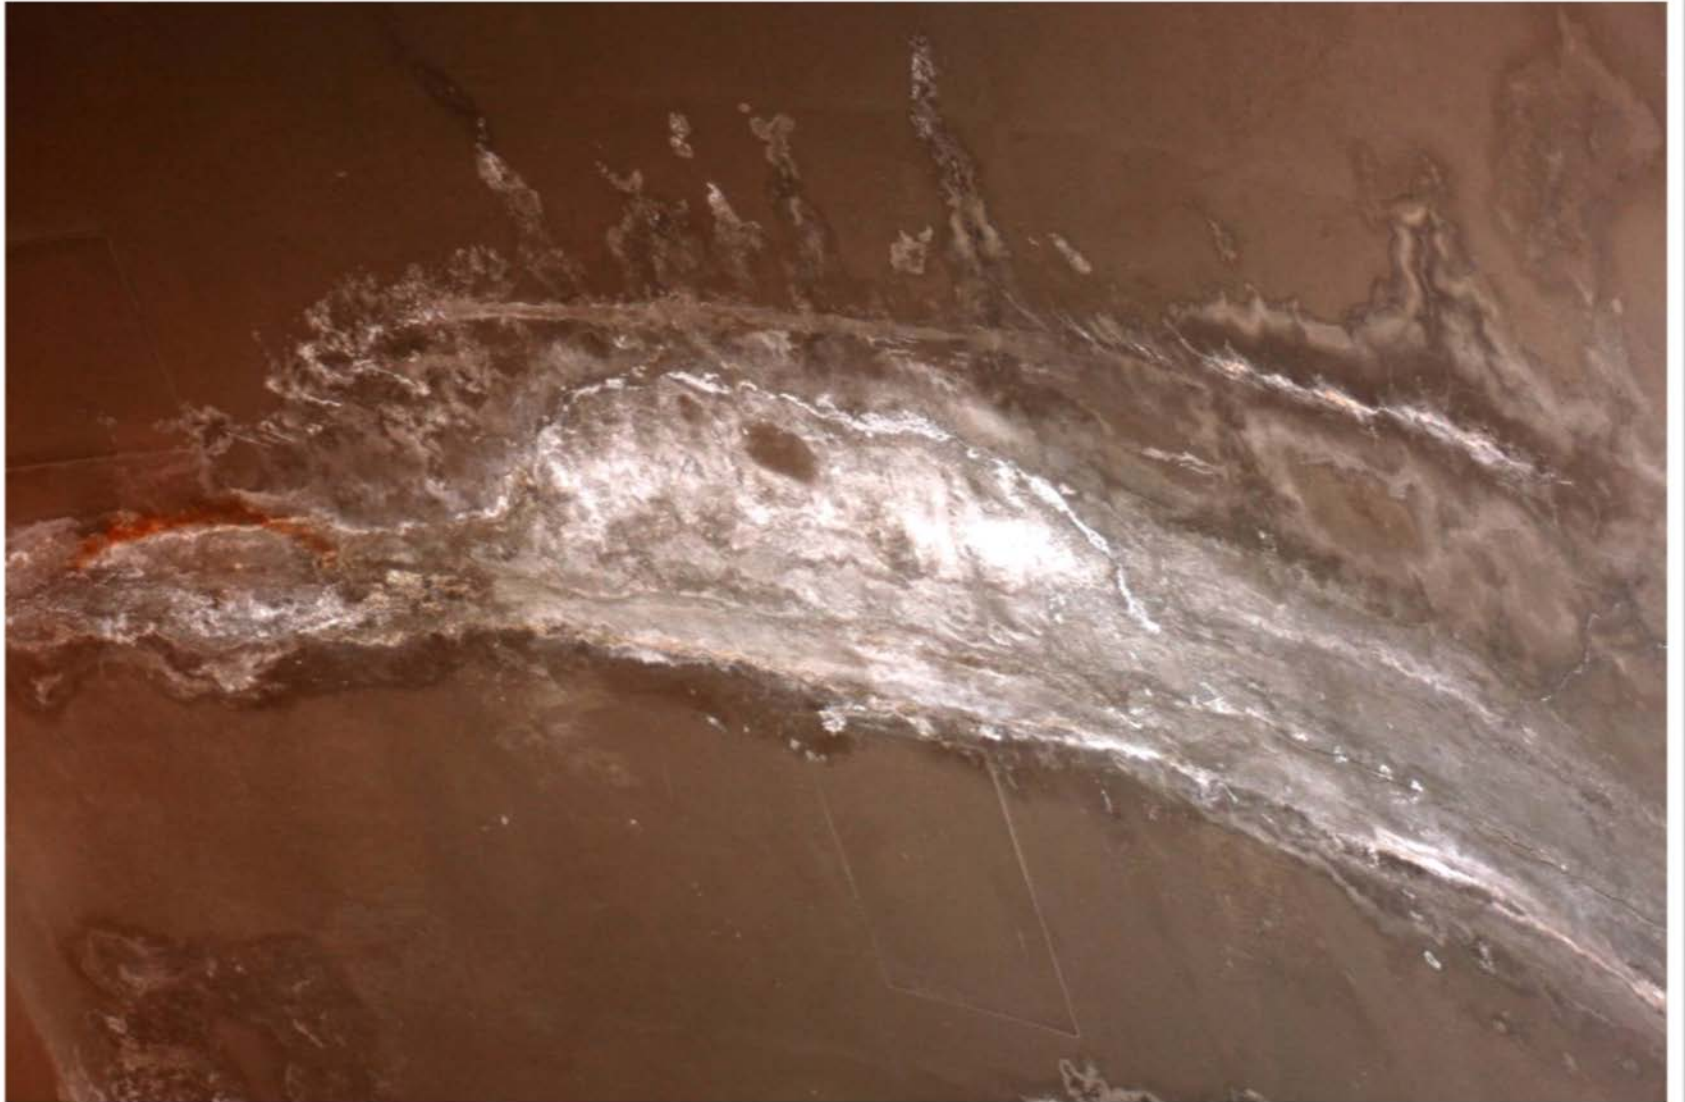
Efflorescence/Water Leakage with Cracking and Rust Staining (Rebar Corrosion)

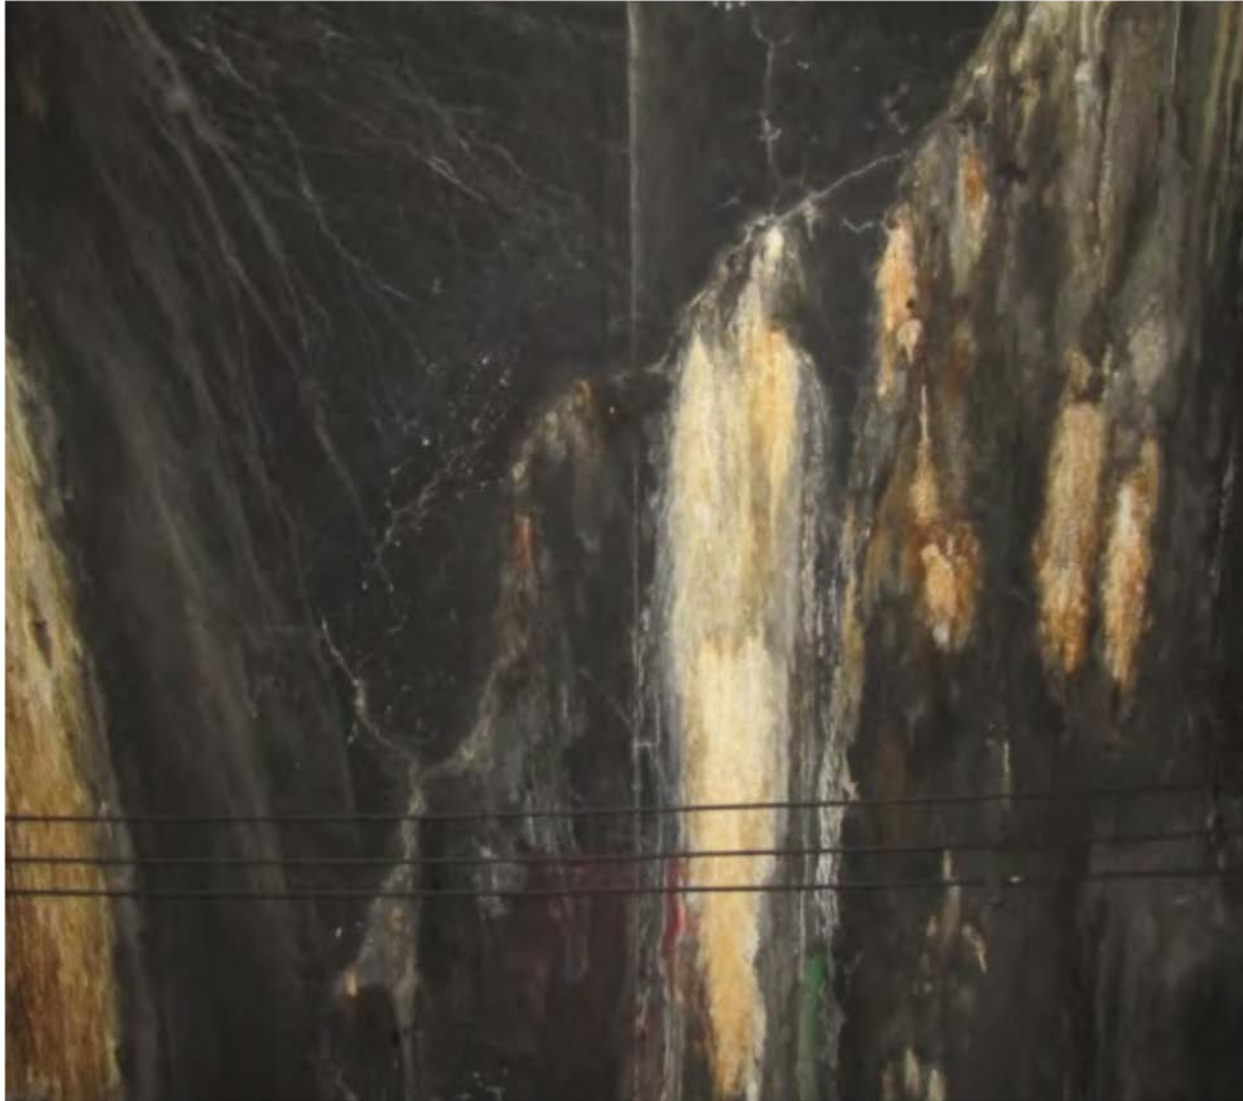
Cracking in Liner Concrete with Covered Void/Spall

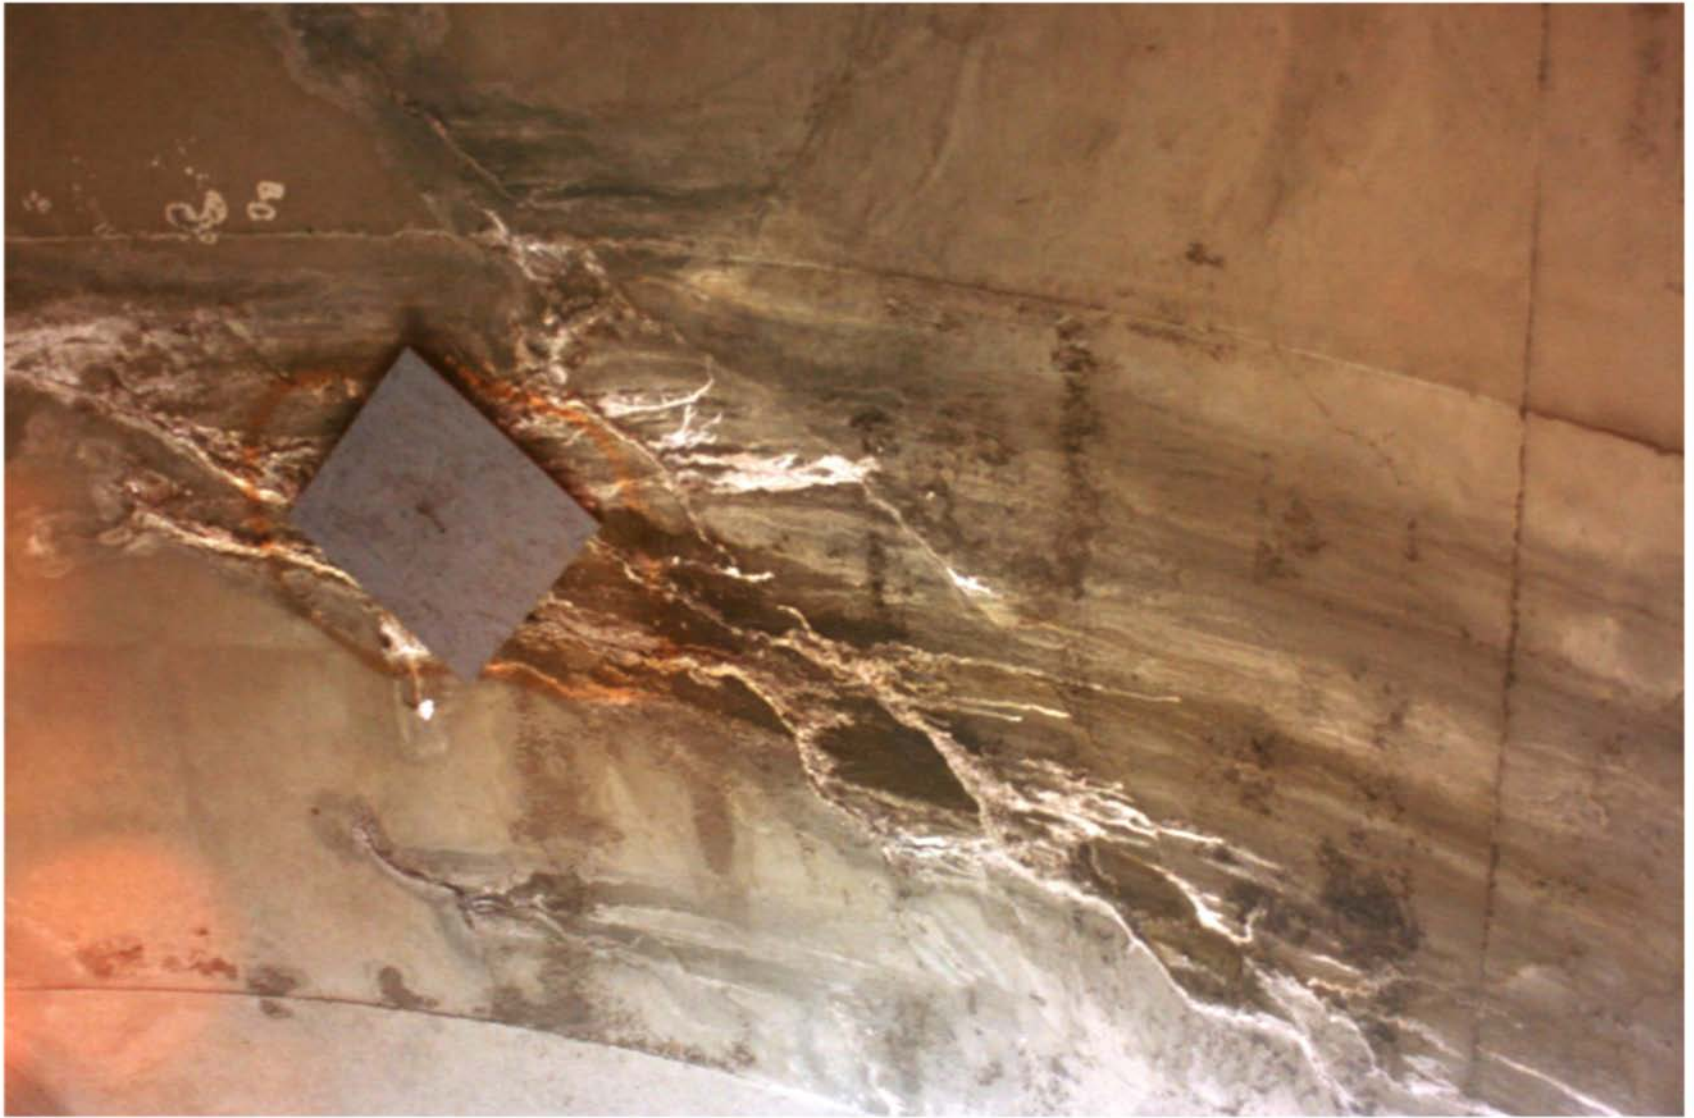
Concrete Liner Cracking

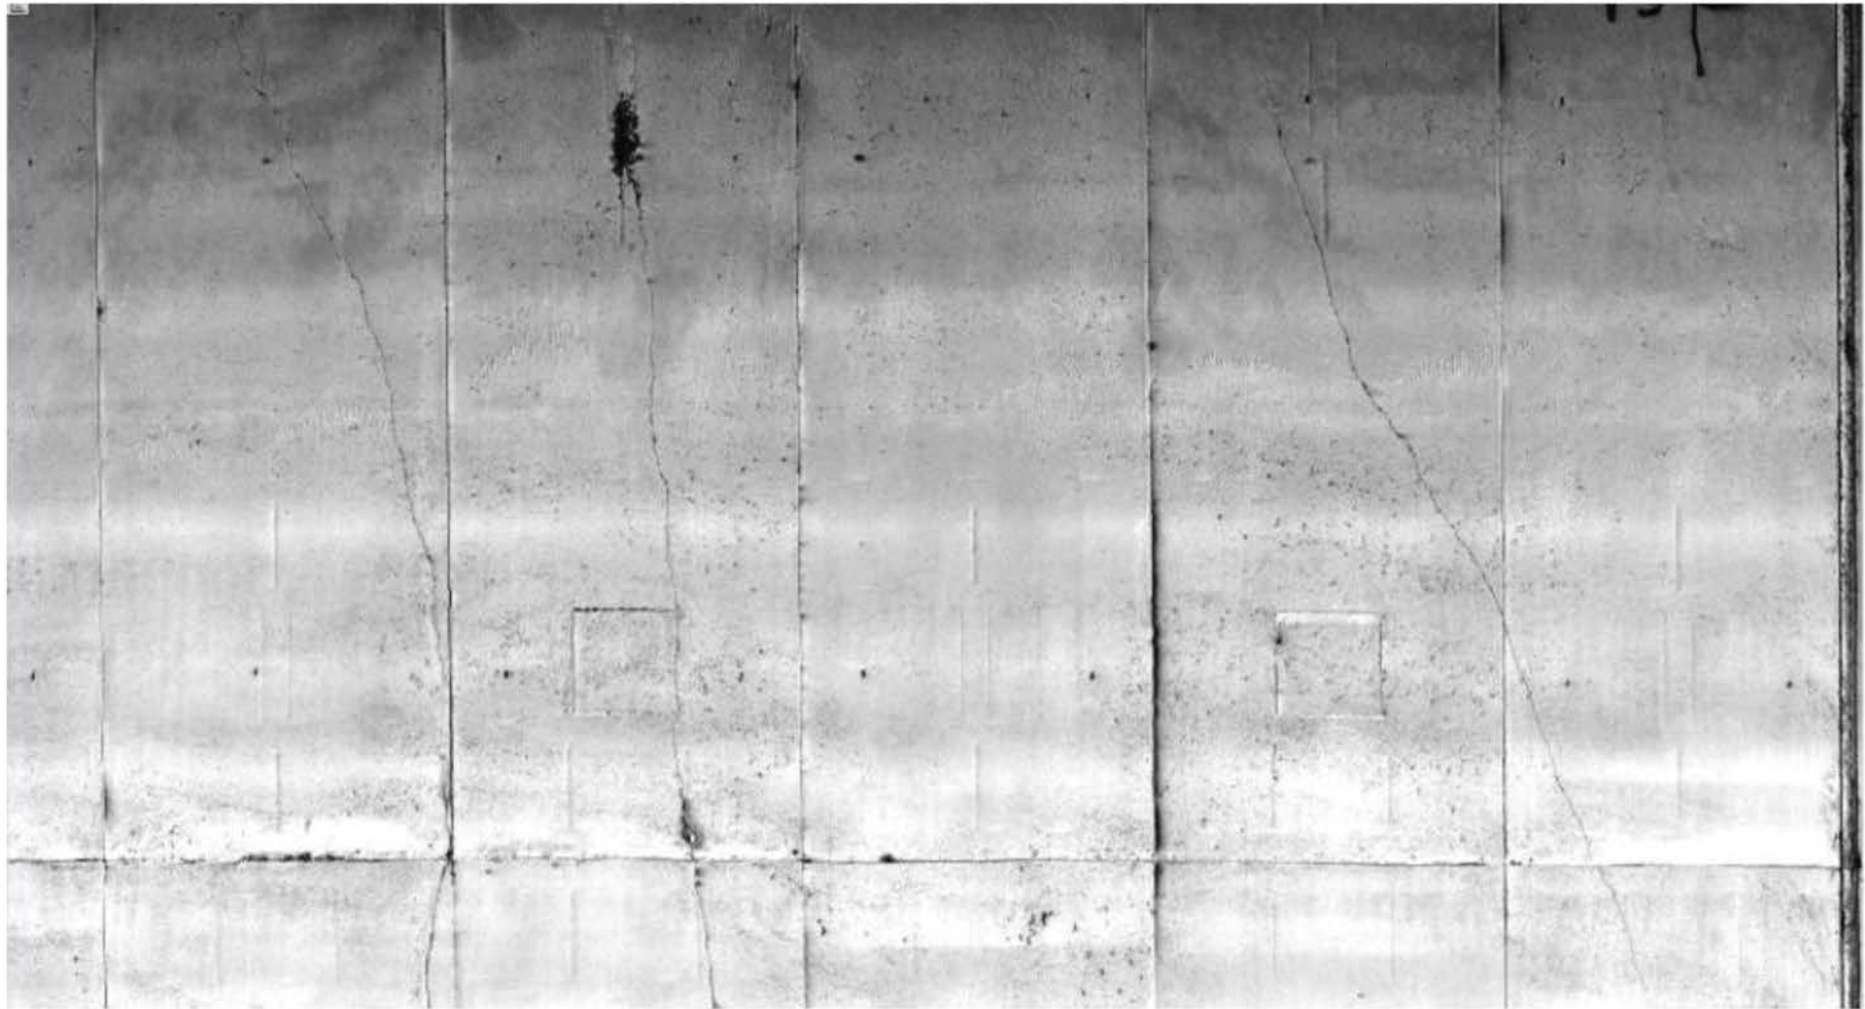
Minor Moisture Intrusion and Cracking

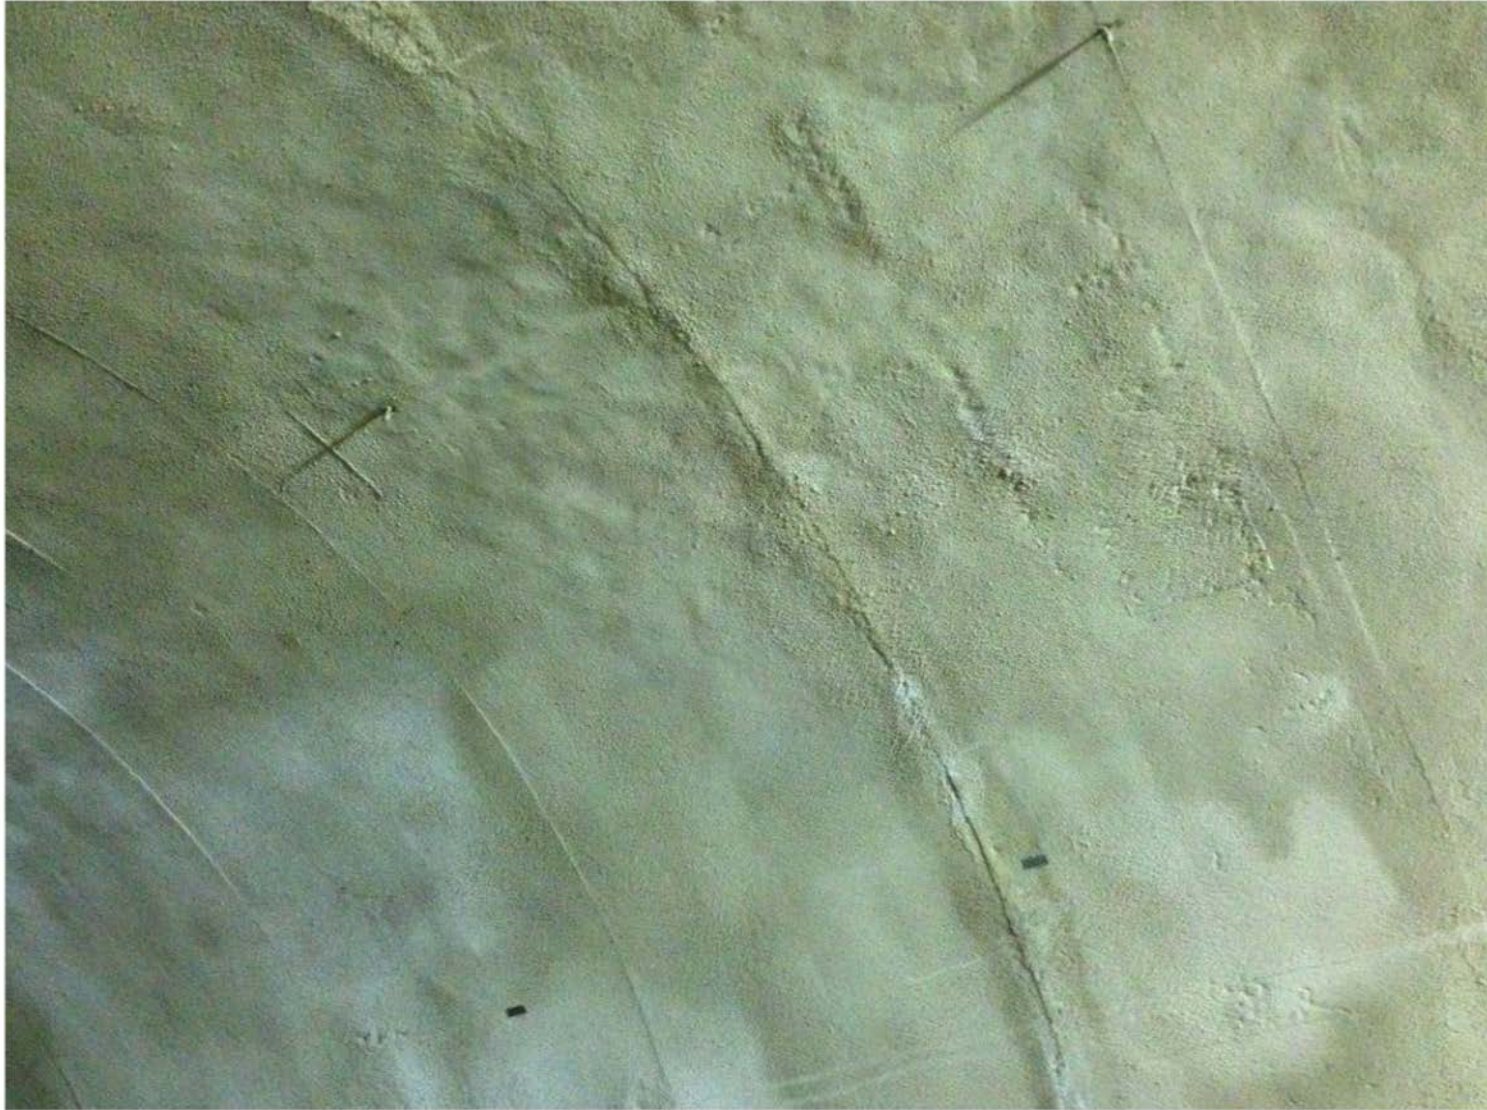
Concrete Delamination Seen in Corehole

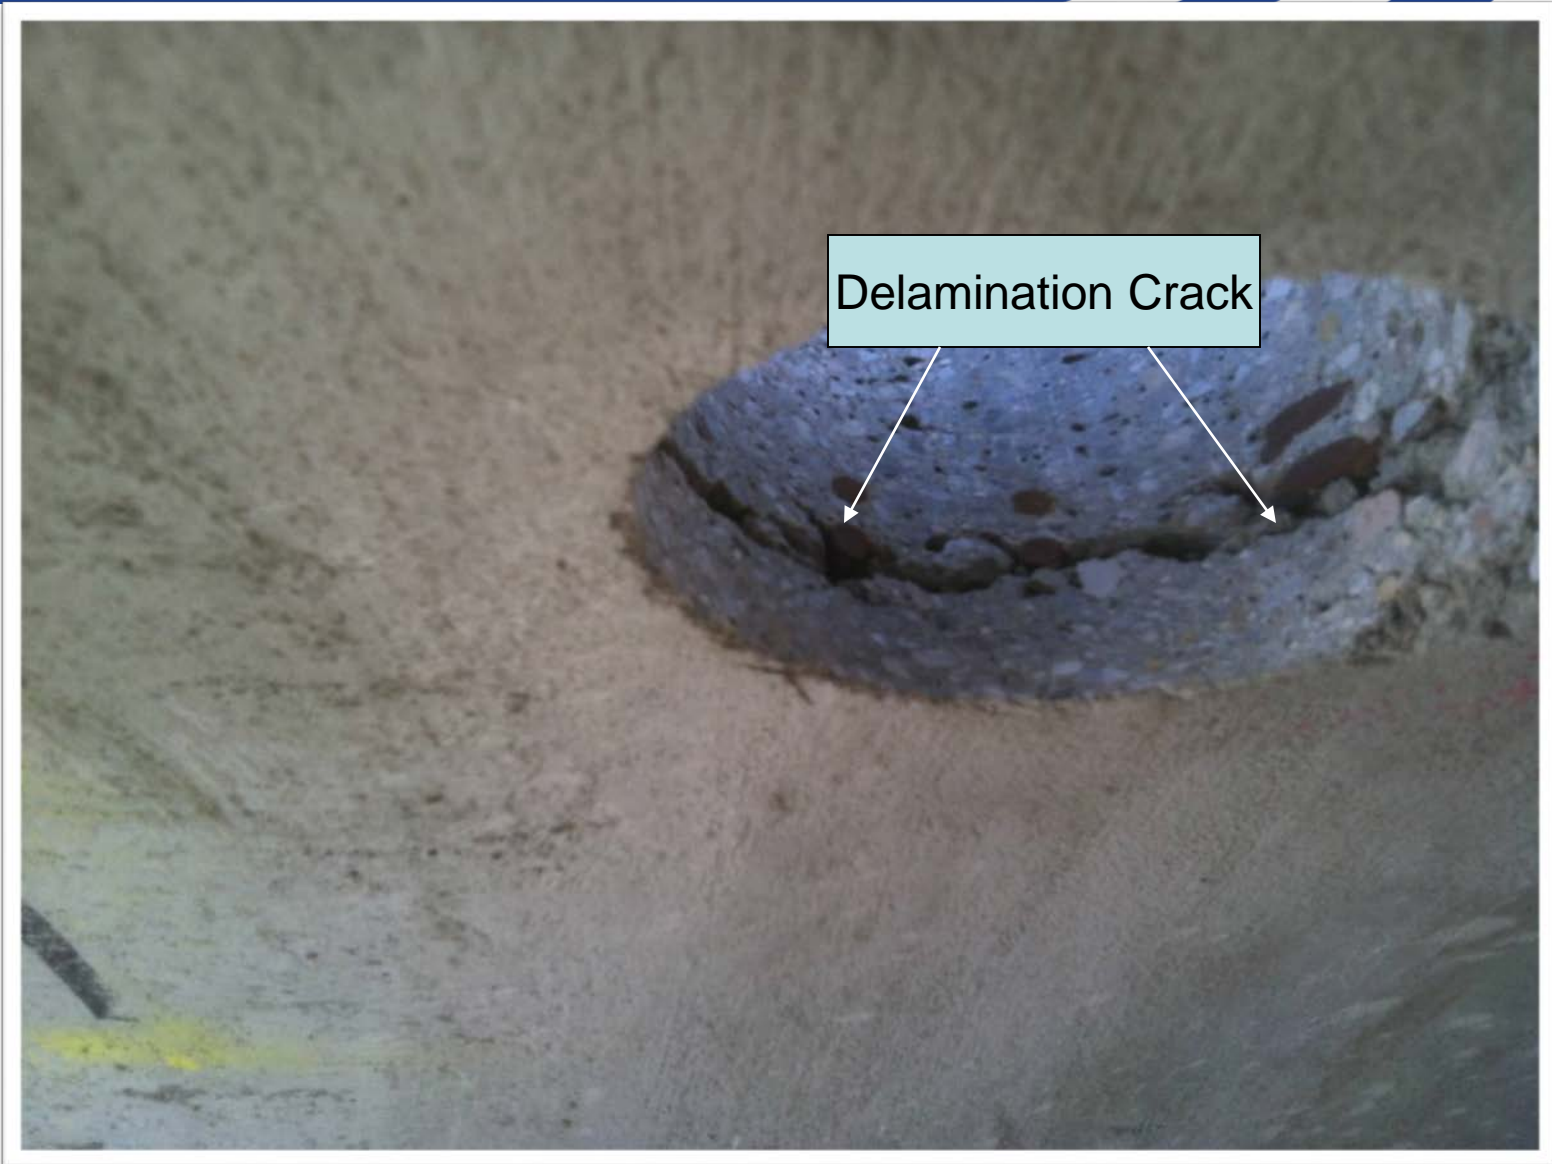
Photogrammetry Image of Severe Liner Rebar Corrosion and Spalling

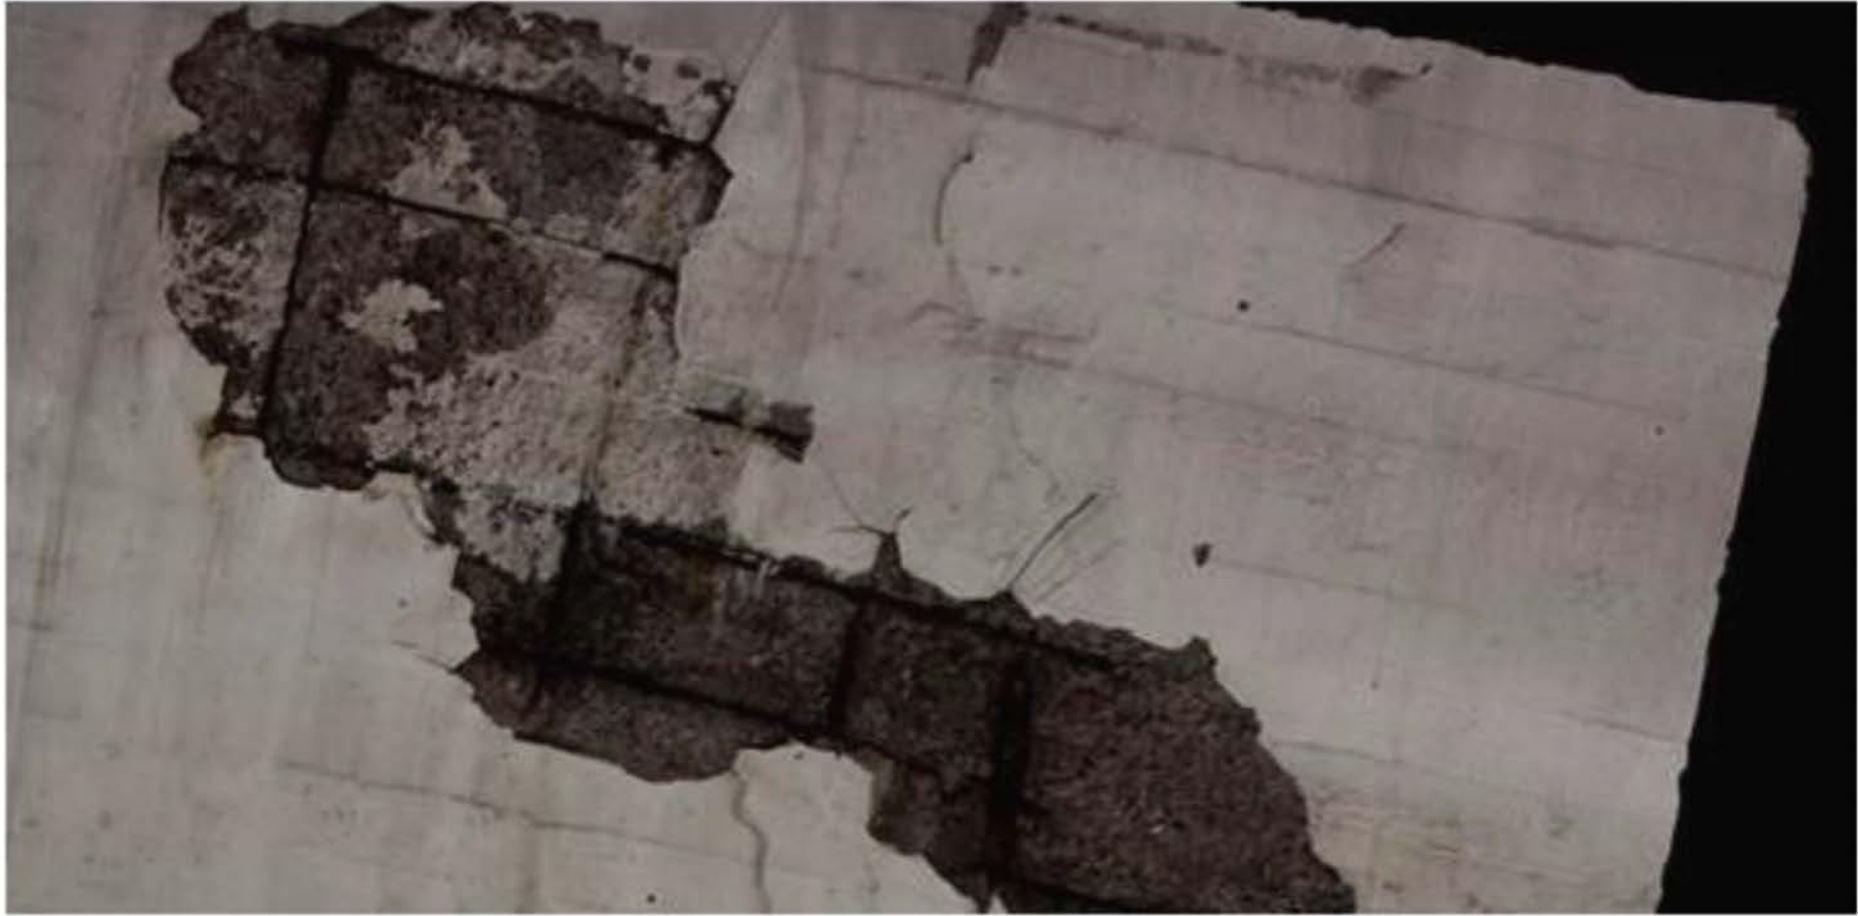
Wall Void from Embedded Timber

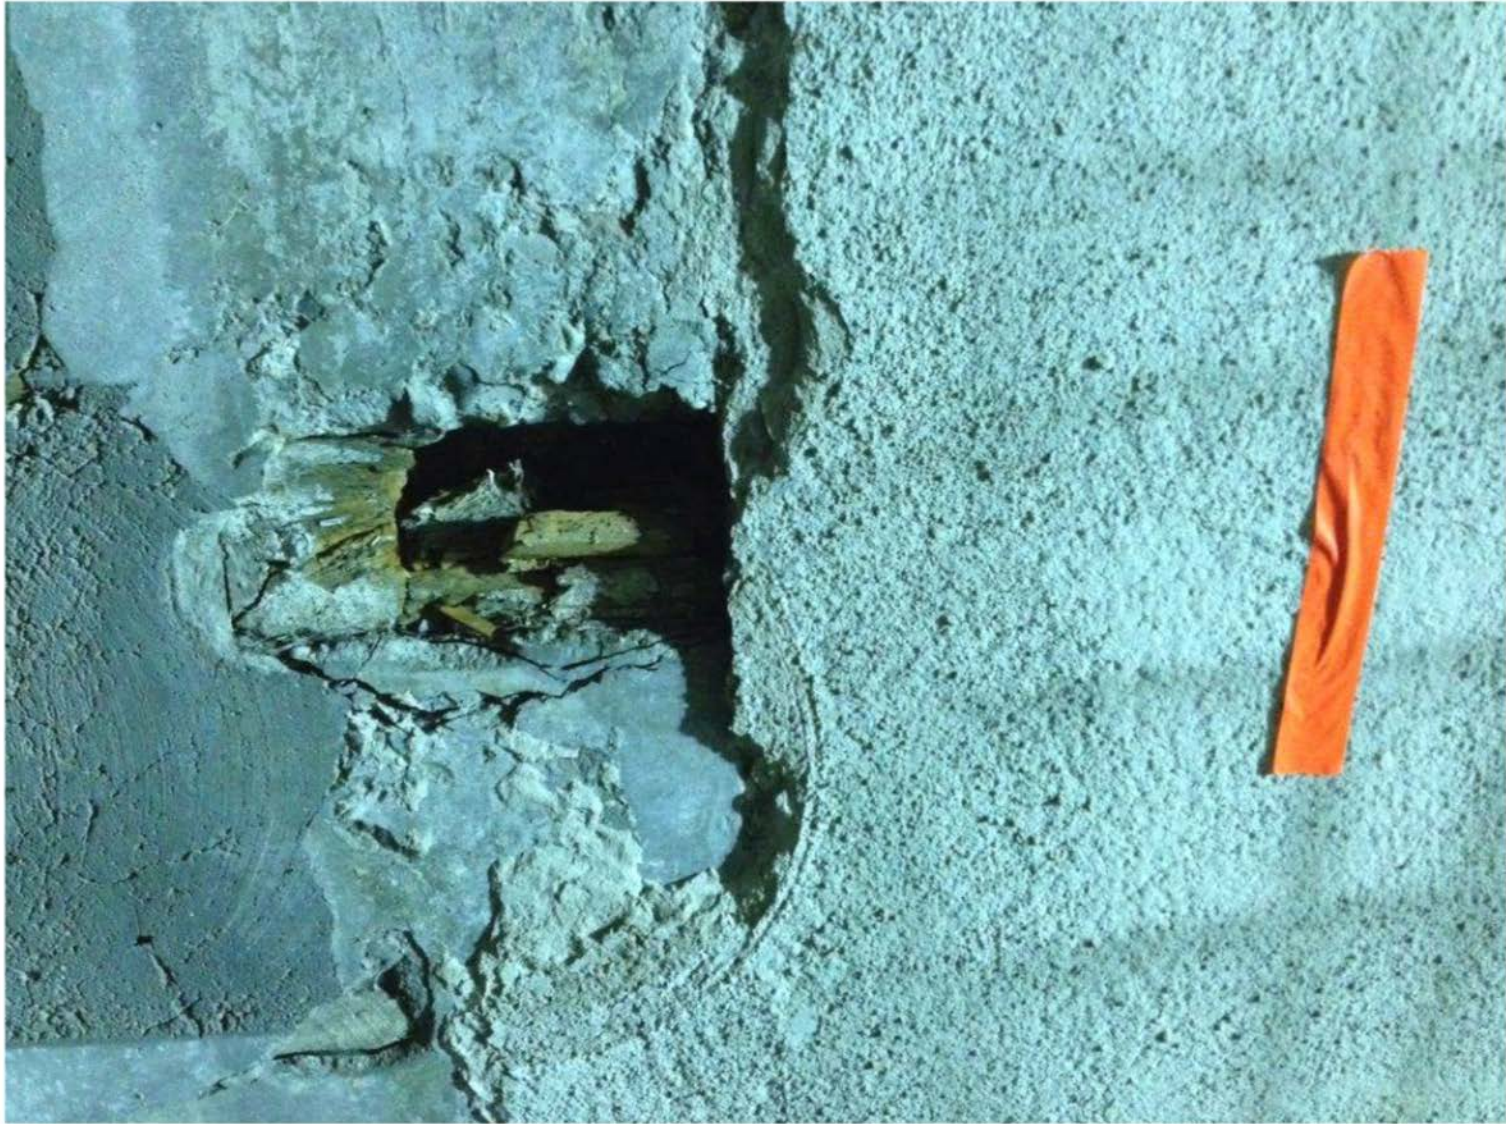
Geophones on Tunnel Crown for Void Detection Survey

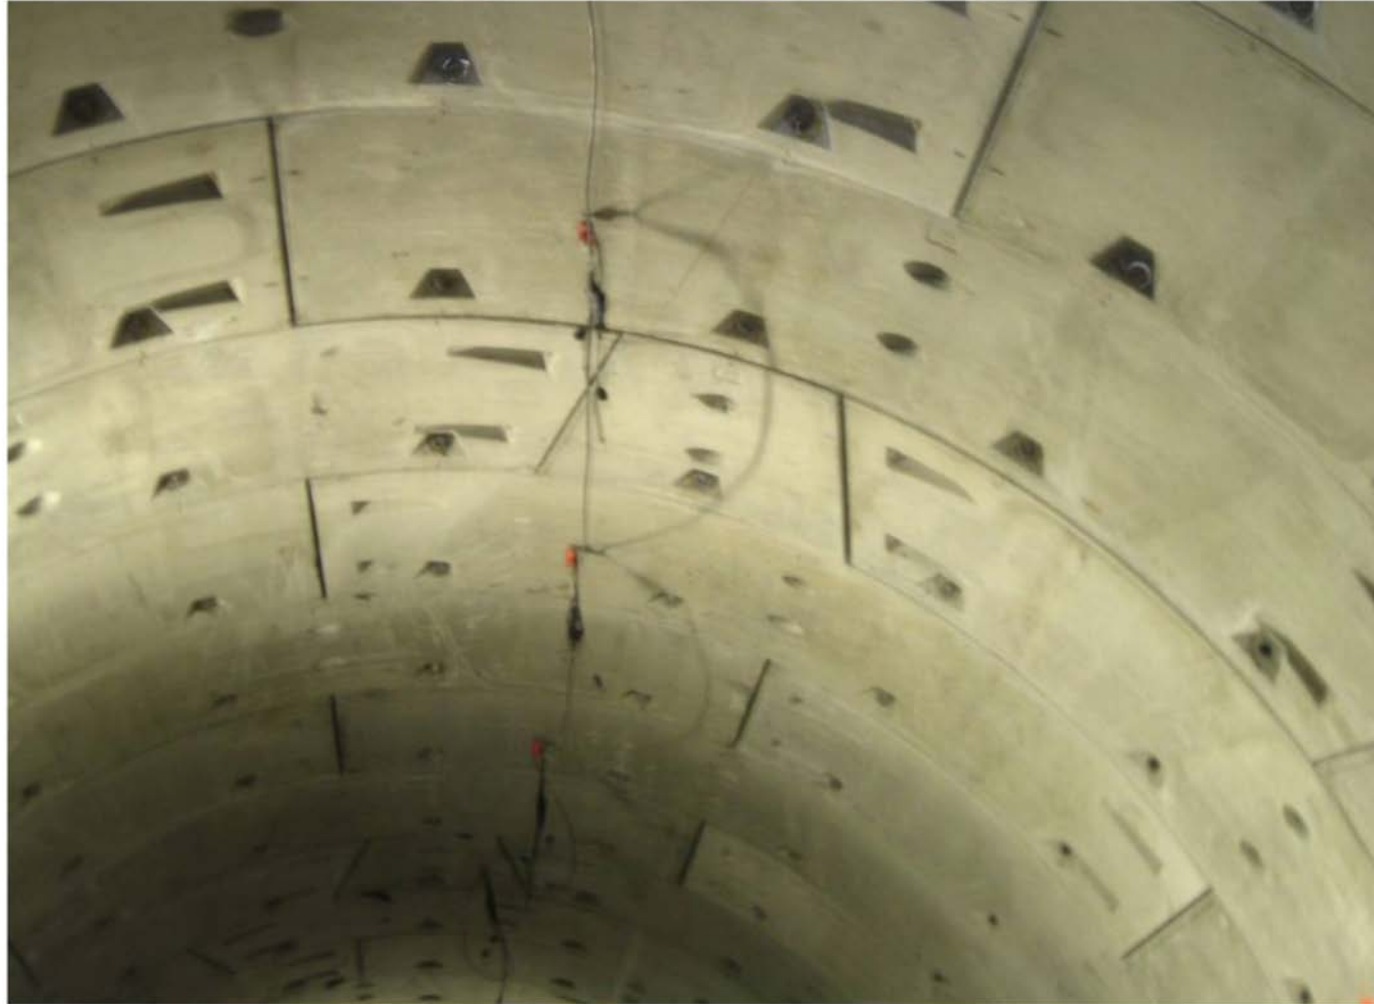
Geophones
Used for Shear
Wave Velocity
Survey to
Locate Voids
Above Liner

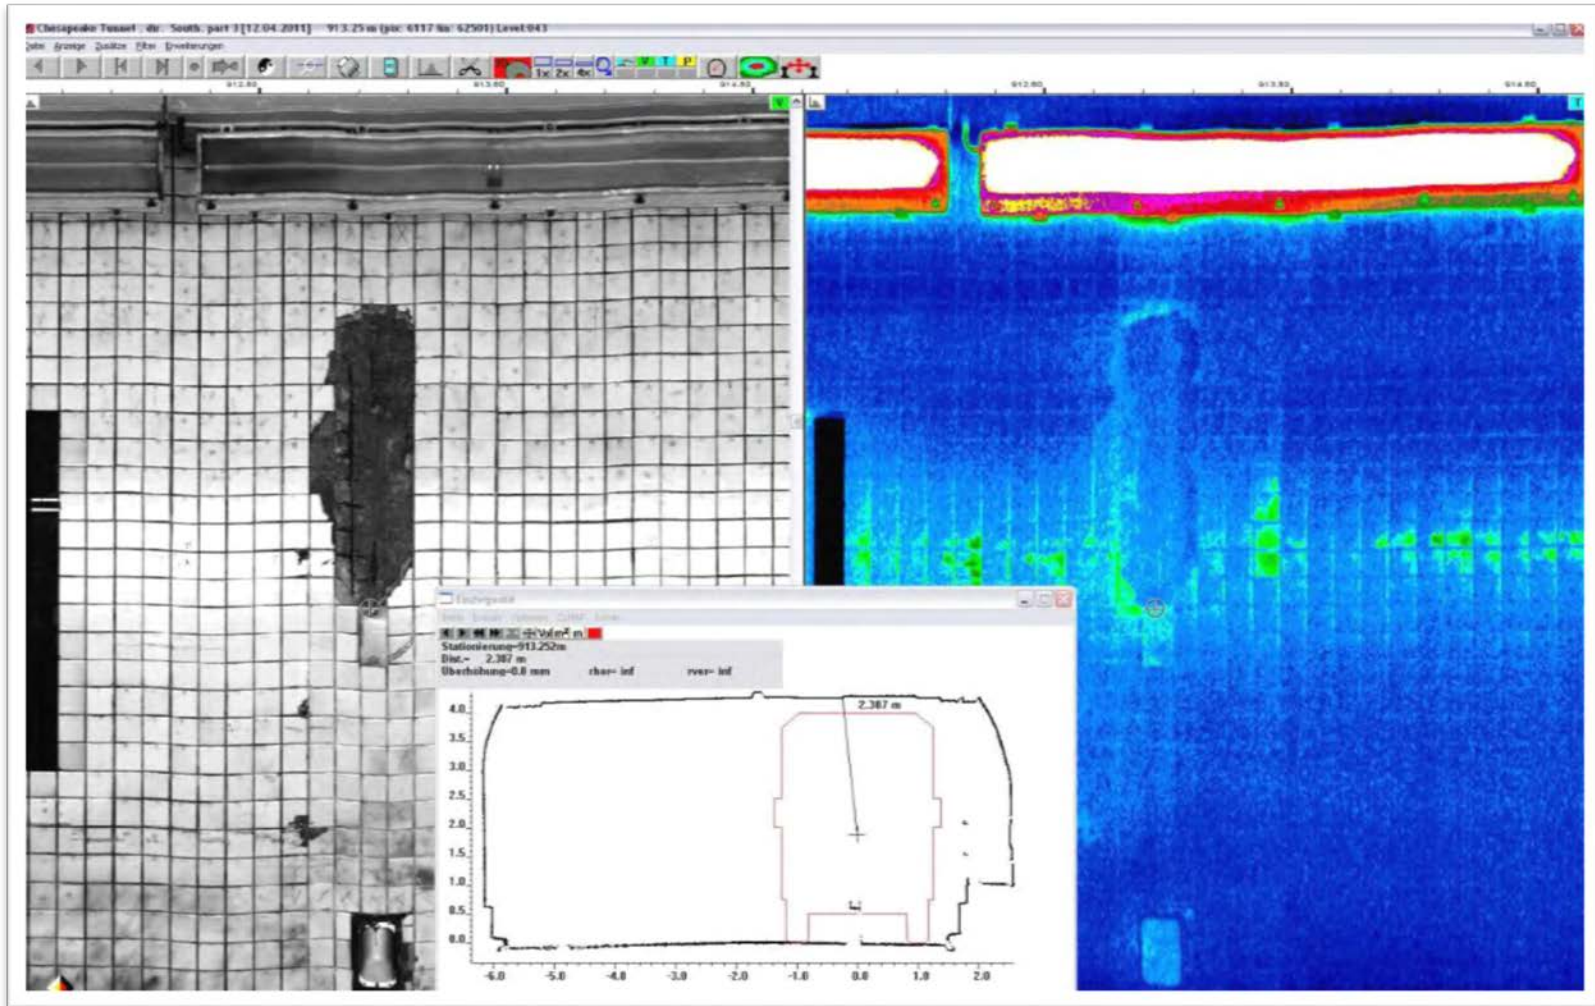
Missing Tiles (IR and Visual)

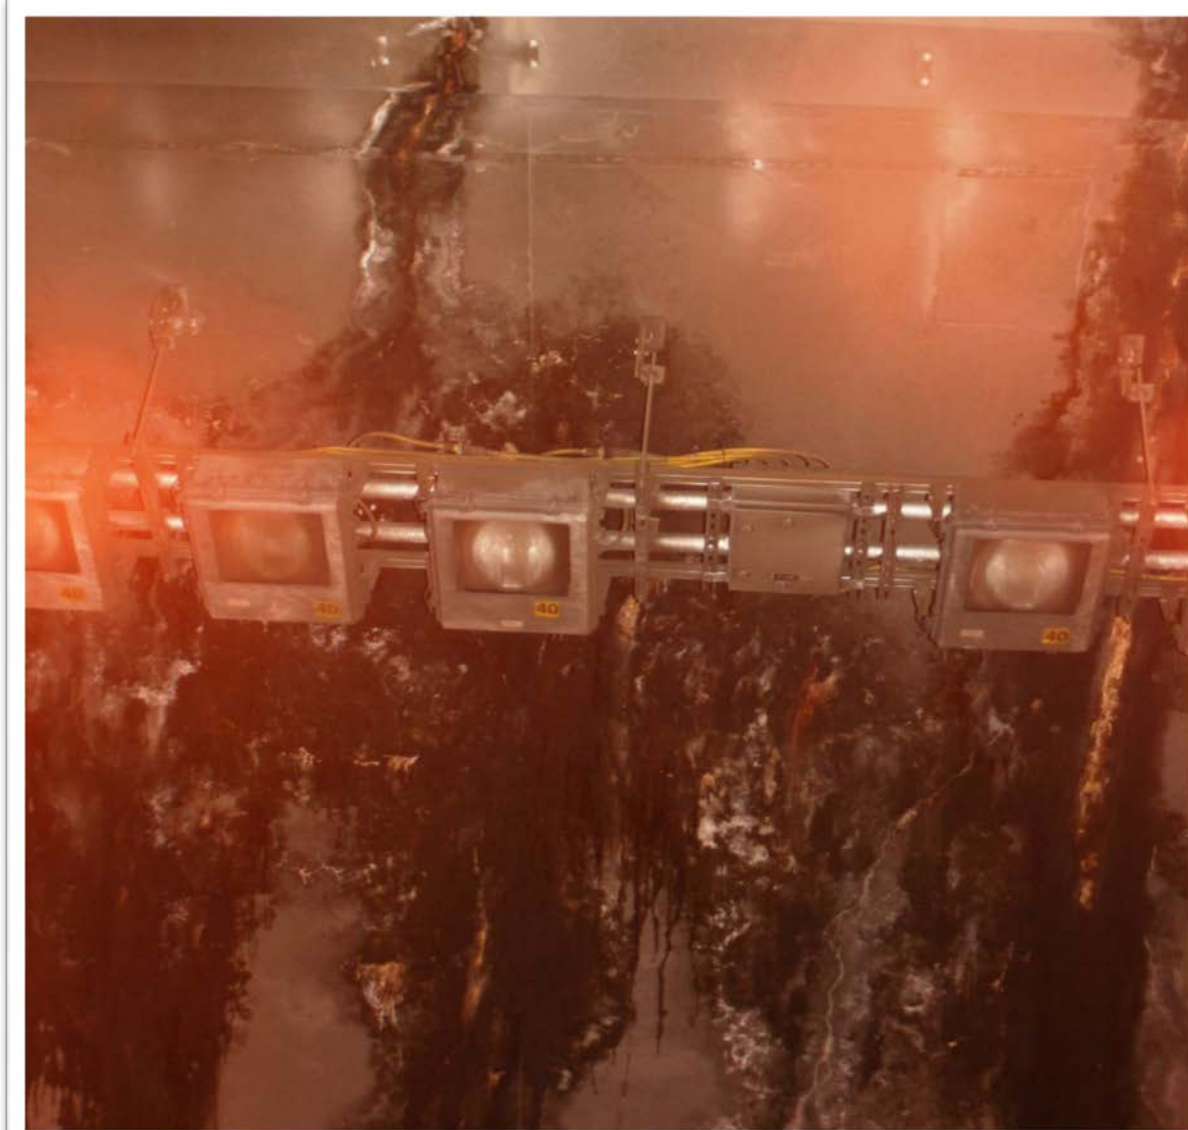
Cracking, Moisture Intrusion with Rust Staining – Possible Fixture Asset Threat As Well

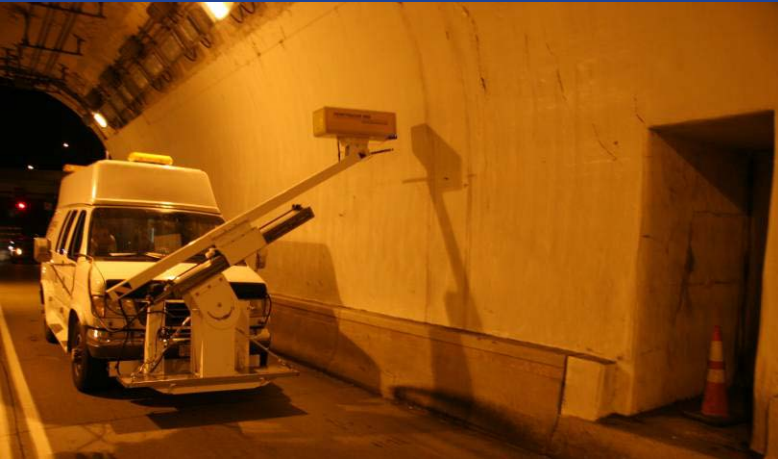
Penetradar GPR of PennDOT Tunnel

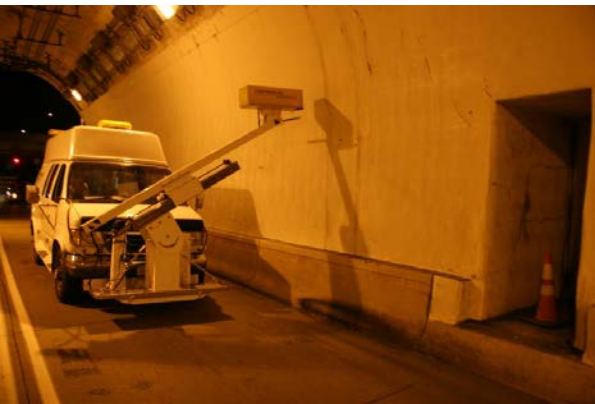
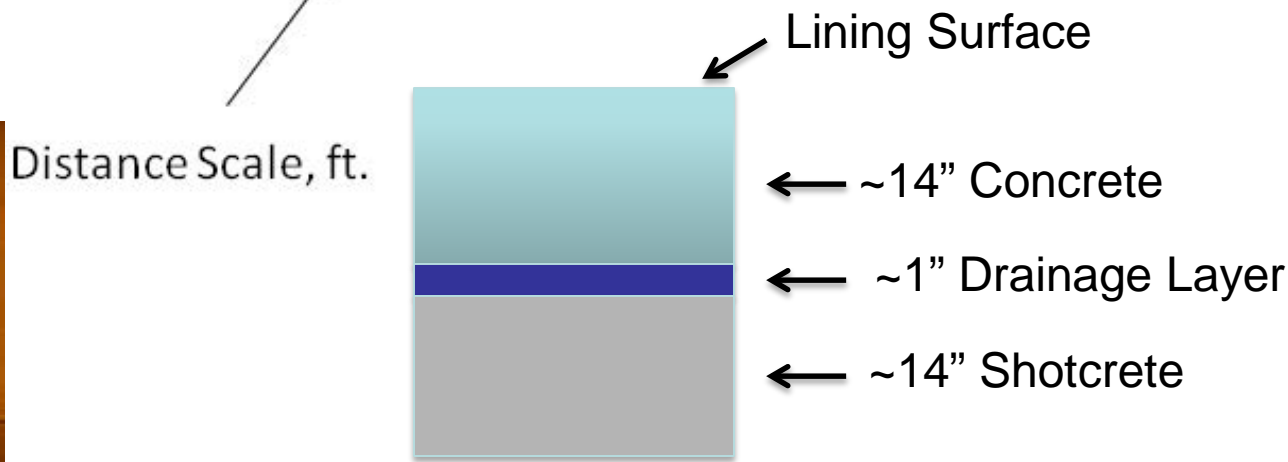
Air Coupled GPR Example

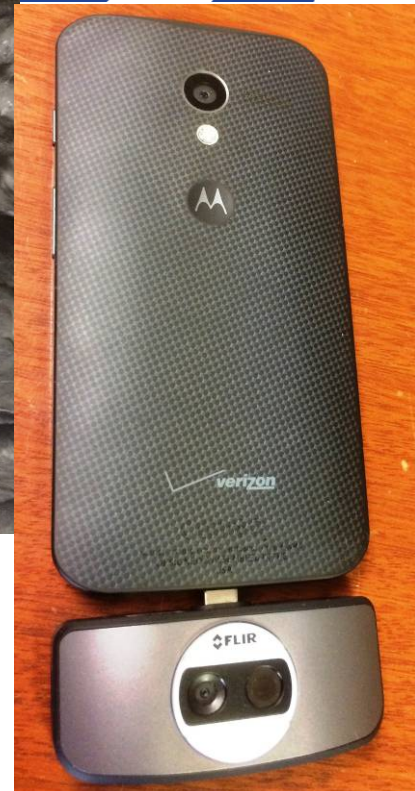
FLIR 1 IR
Camera
