# Nondestructive Tunnel Liner Evaluation

Using Ground Penetrating Radar, Infrared Thermography and High Resolution Imaging

Anthony Alongi, President – Penetradar Corporation

August 8, 2017

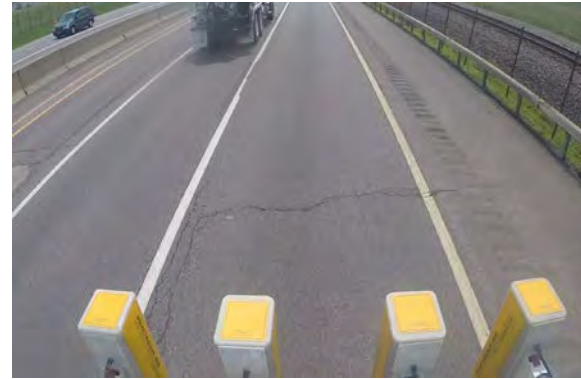
- **High Resolution Video Camera**
  - 4k optical resolution (3840 x 2160 pixel = 8.3M pixel)
  - 120Hz scan rate

- **High speed image recording (50MPH)**
  - Collected in forward-view
  - Converted to plan-view (top-view)

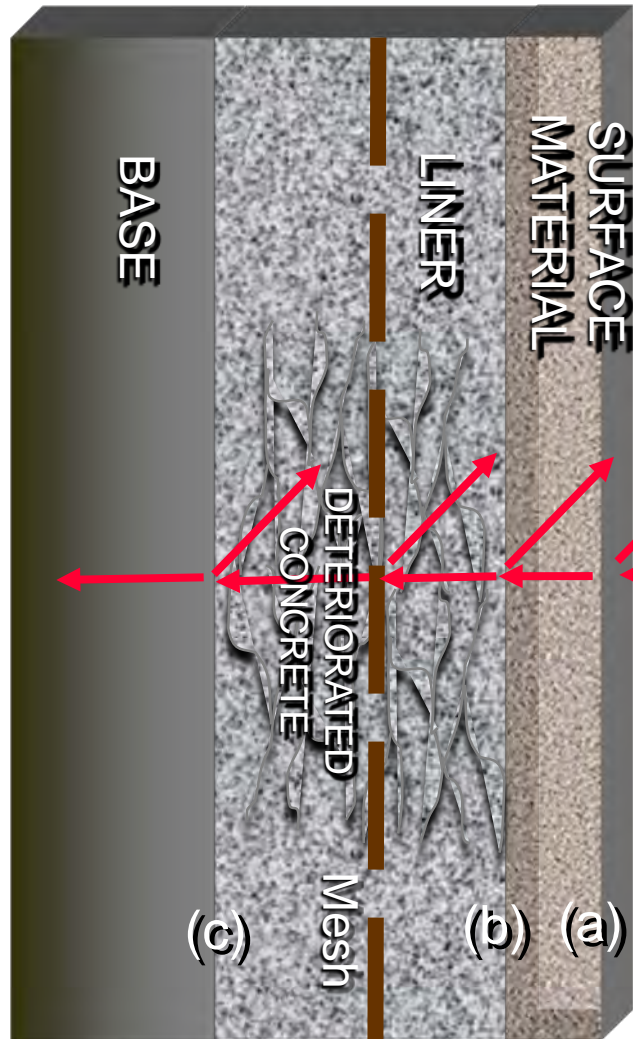
## CONCRETE DETERIORATION

- GPR Detection of Deteriorated Concrete is Based on Measurement of Signal Attenuation in the Material

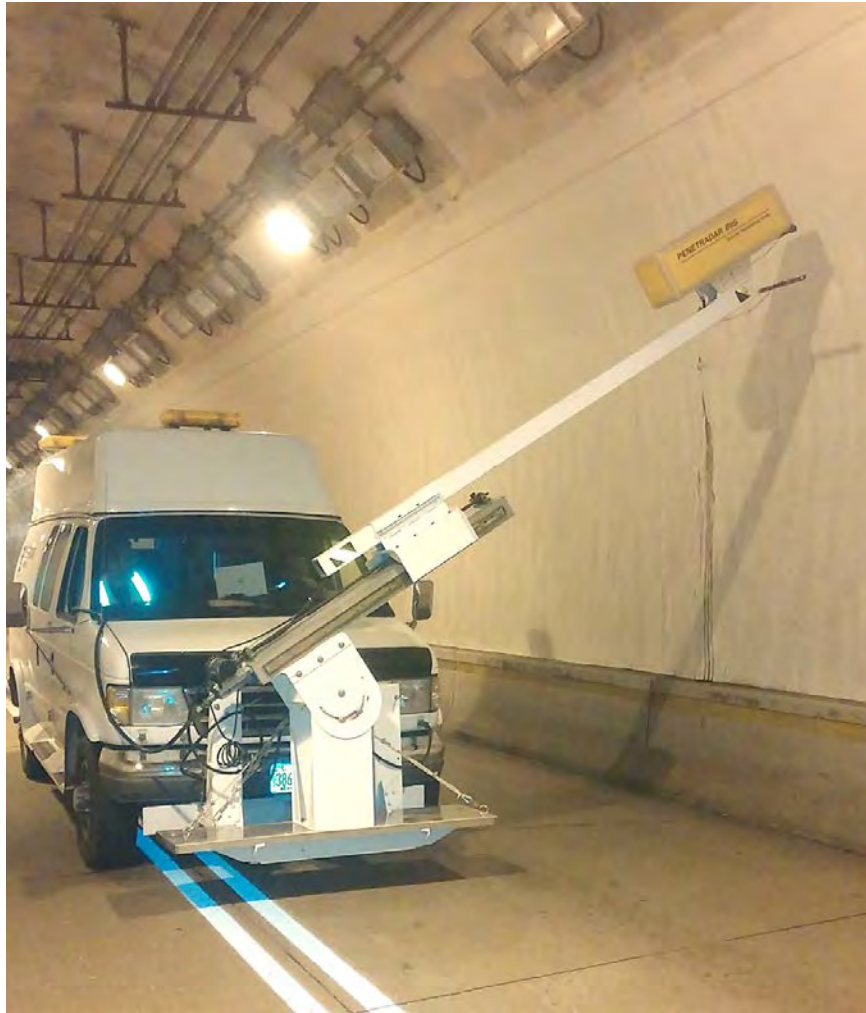
### GPR System used for Inspection of Roadway Tunnels

- Penetradar GPR Shown in Liberty Tunnel, Pittsburgh, PA

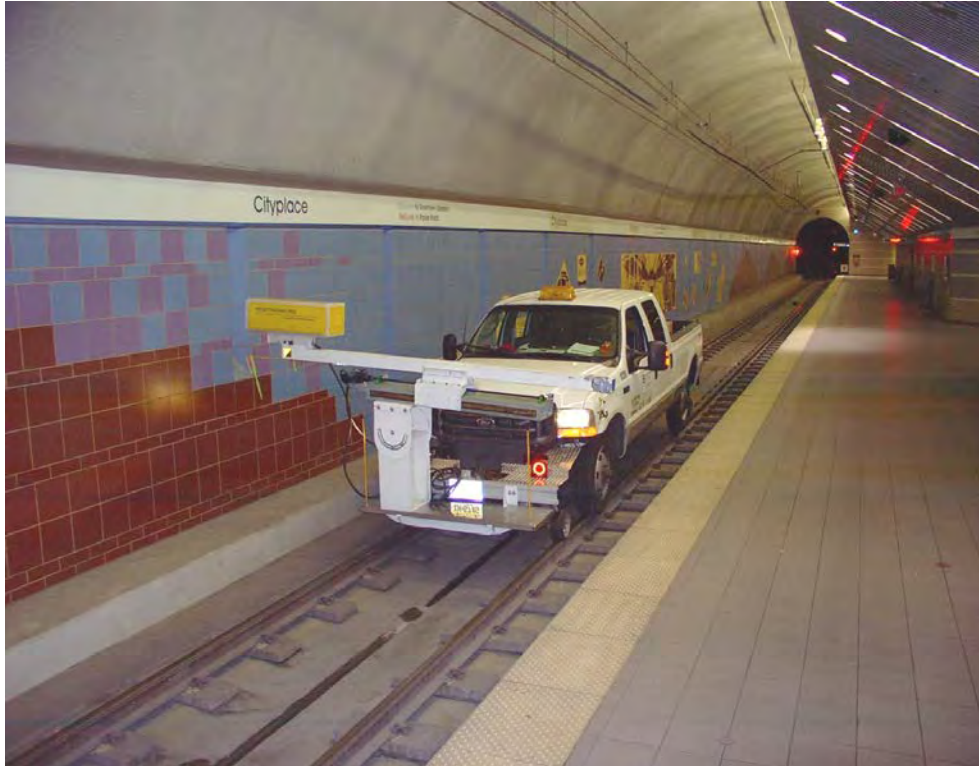
### Hyrail GPR System used for Inspection of Rail Tunnels

- Penetradar's GPR System Shown in DART Tunnel

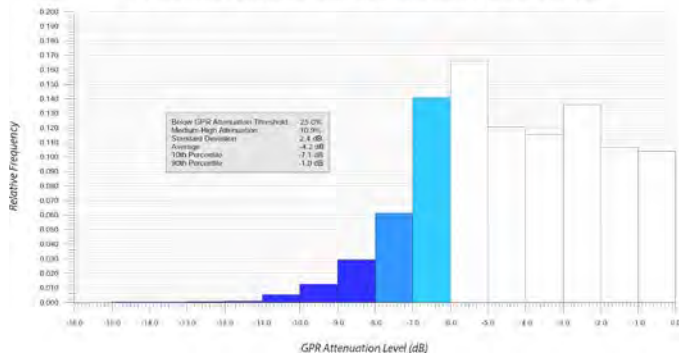
GPR Attenuation Distribution of Northbound Armstrong Tunnel (West Wall)

- West Wall Attenuation: 25.0% Total
- East Wall Attenuation : 25.5 % Total
- East Wall contained higher levels of attenuation
  - Suggest east wall to be in generally worse physical condition

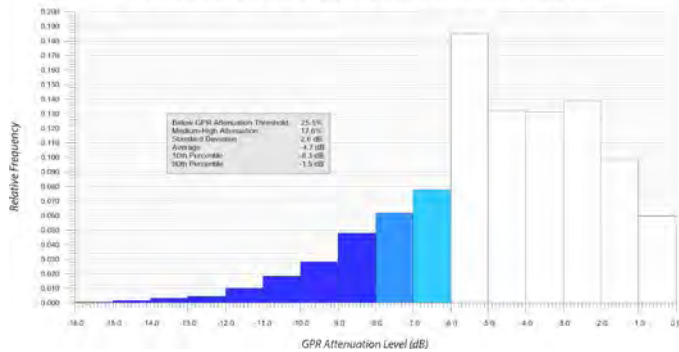
GPR Attenuation Distribution of Northbound Armstrong Tunnel (East Wall)

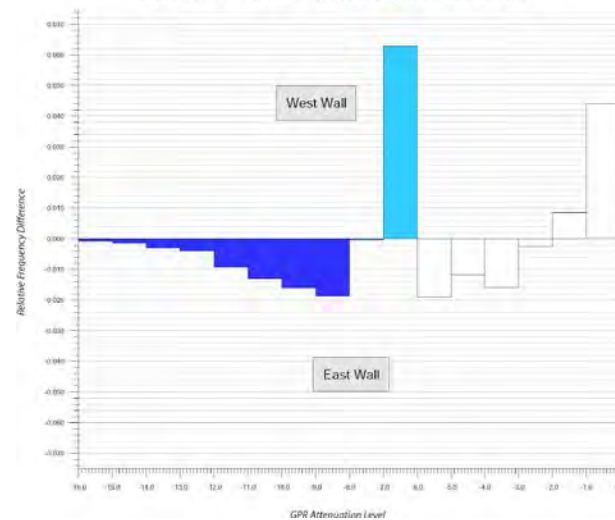
GPR Attenuation Distribution Comparison of the West and East Walls

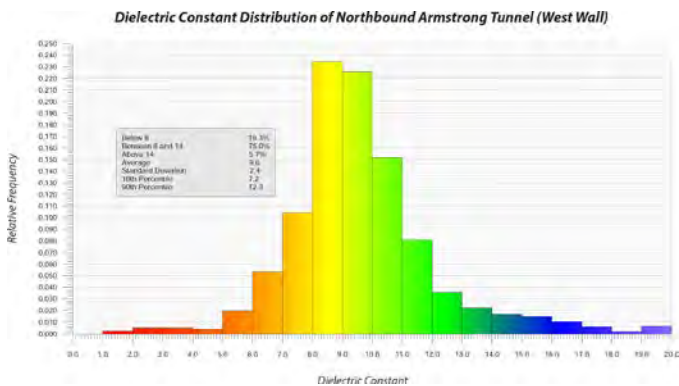
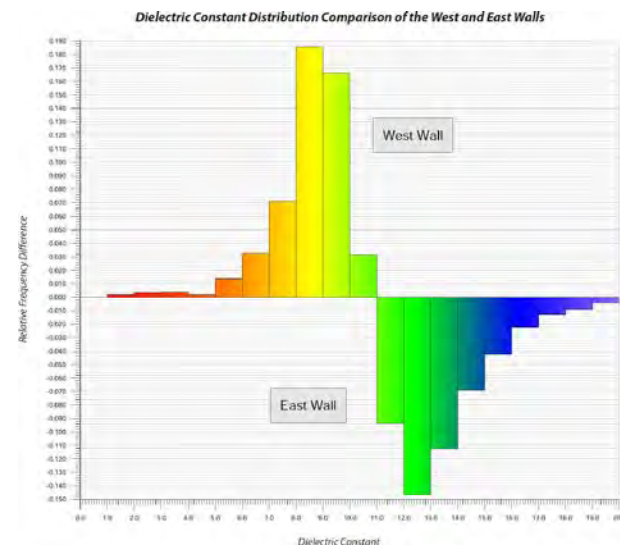
## Armstrong Tunnel Dielectric Constant ( $\epsilon_r$ ) Distribution

- West Wall Average  $\epsilon_r$ : 9.6 (~ 4% moisture content)
- East Wall Average  $\epsilon_r$ : 12.2 (~ 8% moisture content)
- East Wall was calculated to have almost twice the moisture content as the West Wall.

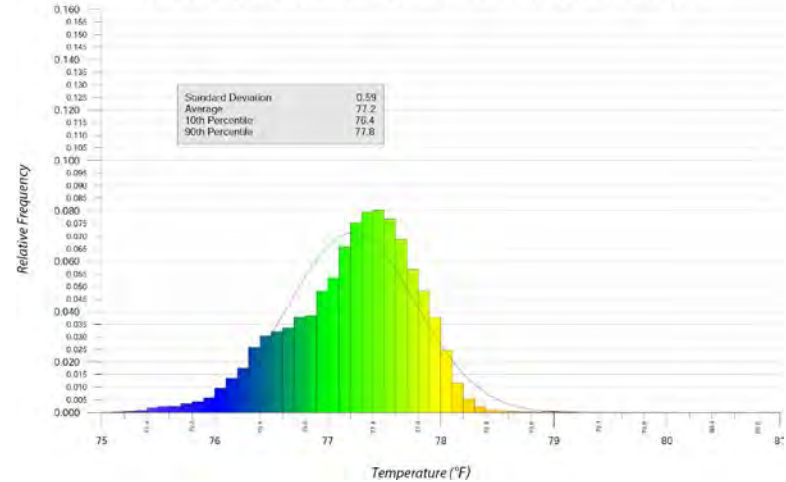
*Infrared Temperature Distribution of Northbound Armstrong Tunnel (East Wall)*

- West Wall Average Temperature: 78.1° F
- East Wall Average Temperature: 77.2° F
- Difference in temperature could be due to:
  - Construction of tunnel and area behind each wall
  - Result of higher moisture content conducting heat
