# PENNDOT Experience with NDT Testing on Tunnels in Pittsburgh

Jonathan Moses, P.E.  
District Geotechnical Engineer  
Pennsylvania Department of Transportation

# ▶ Liberty & Armstrong Tunnel NDT Testing

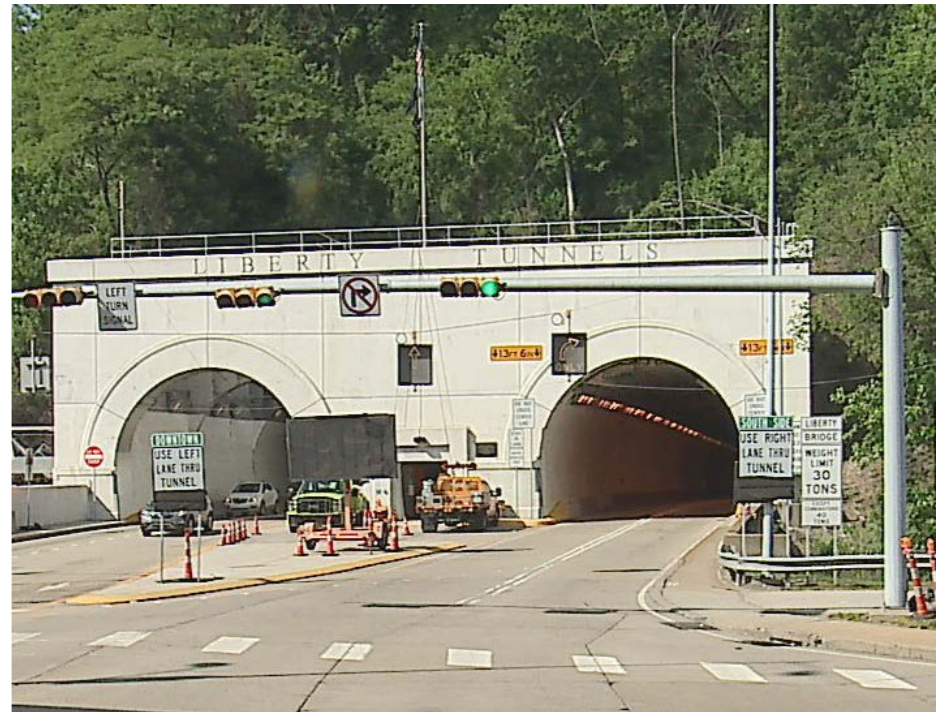
# Liberty Tunnels

- Cast-in-place (CIP) R/C arch built in 1926; rehabbed with synthetic fiber reinforced repairs and galvanized WWF (2011).
- 2 bores (NB & SB), 2 lanes per bore
- 5898' long, curb-to-curb width of 23'-0" and height of 20'-9 ¼" at the arch apex.
- ADT = 17,652 vehicles/day in NB bore

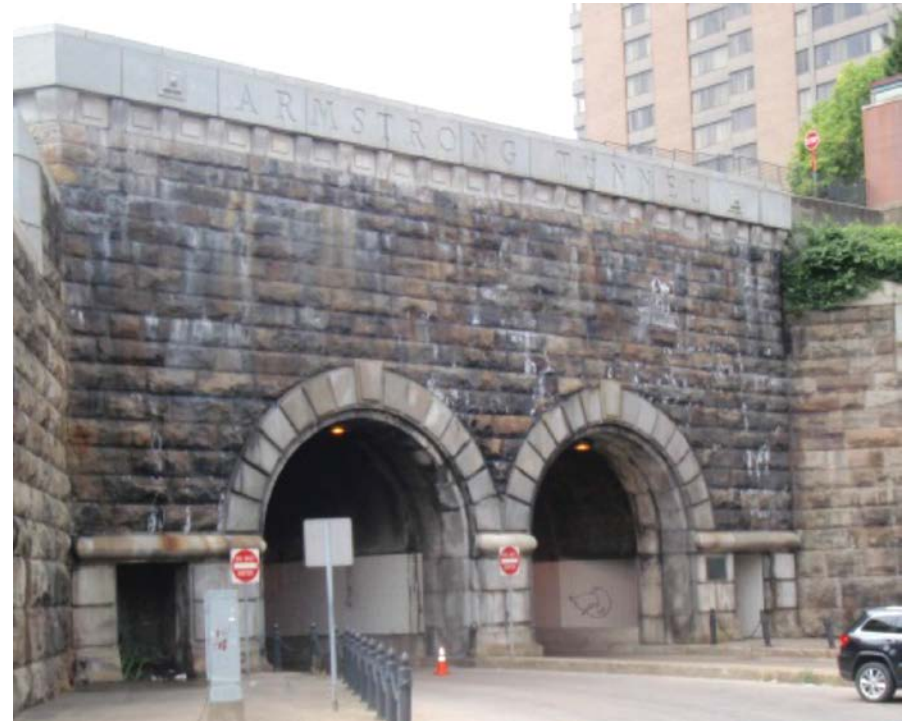
# ▶ Armstrong Tunnel

- Cast-in-place (CIP) R/C arch with tile-lined walls; built in 1927, rehabilitated in 1991.
- 2 bores (NB & SB), 2 lanes per bore
- 1300' long, curb-to-curb width of 20'-0" and height of 22'-0" at the arch apex.
- ADT = 9,230 vehicles/day in NB bore

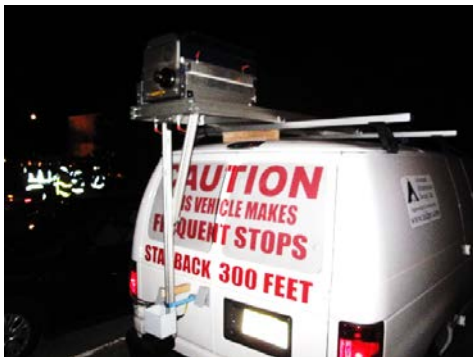
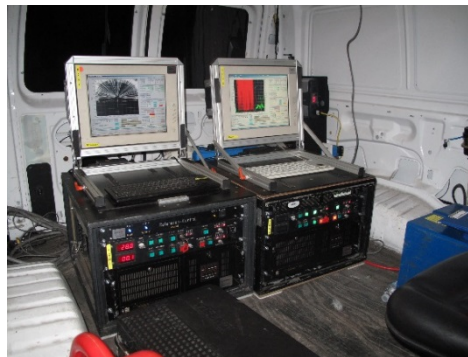
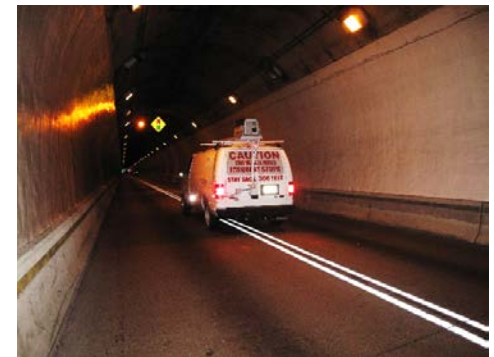
- Performed high-speed mobile scanning using IRT, 3-D laser scanning, and video recording
  - Detects delaminated and debonded areas, spalls, cracks, efflorescence, and water infiltration. Can also detect changes in shape, bulges, etc.

- SPACETEC's combination of 3-D laser scanning/IRT/Video was effective at detecting cracks, tile debonding, and moisture-related defects.
- SPACETEC's combination of NDT is not capable of detecting defects through liner thickness.
- PSPA testing is effective, but only practical over small, limited areas.
- "Delam2000" good for sounding large areas fast. But difficult to delineate areas with keel/paint that are not in arms-reach.

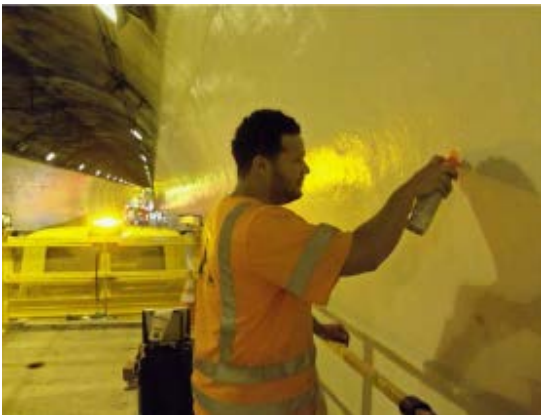
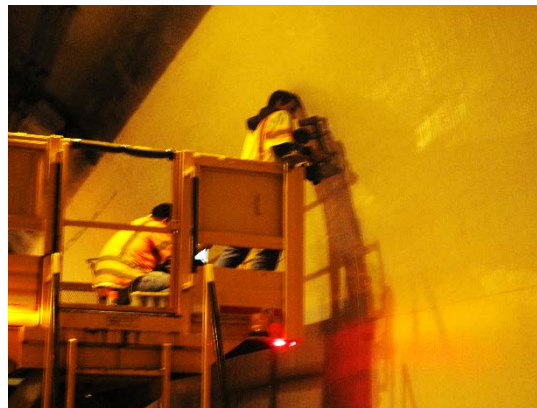
- PSPA used to perform Impact-Echo (IE) and Ultrasonic Surface Wave (USW) analysis at “test section”.
- Test grid established to conduct PSPA testing over 200LF (10’ spacing; 9 locations vertically).
- 189 total test points – 5 hours

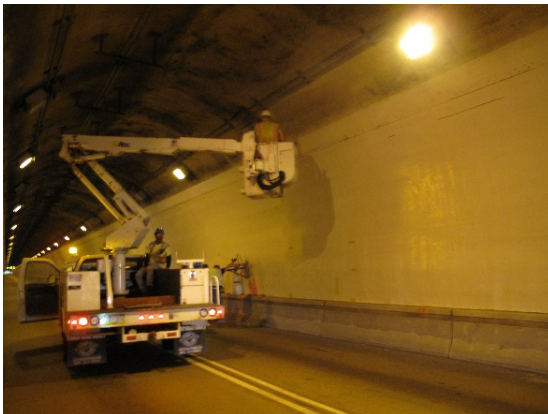
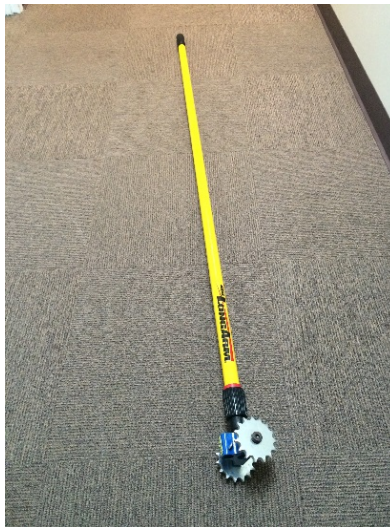
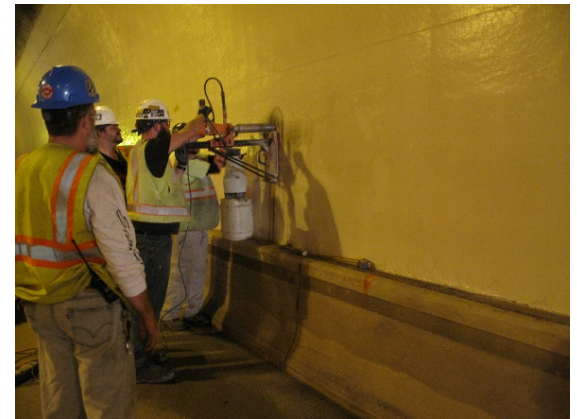
- Traditional hammer sounding was performed on the “test section” using 45-foot bucket truck
- Delam2000 – Rotary percussion tool also used to sound concrete
- Cores were taken at Station 3+475 (sound) and 3+321 (unsound)

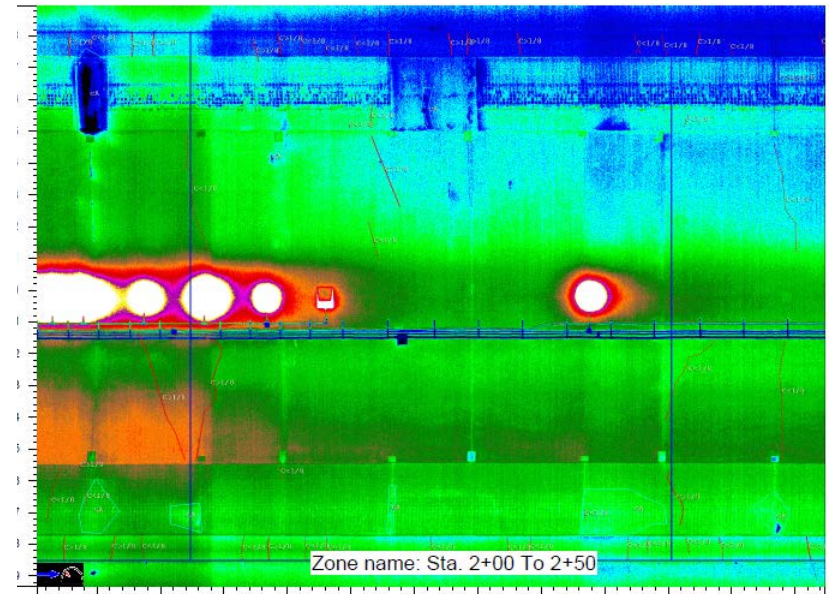
AID provided unfolded plan views of 3-D laser and thermal images for each tunnel (typical Armstrong scans shown below).

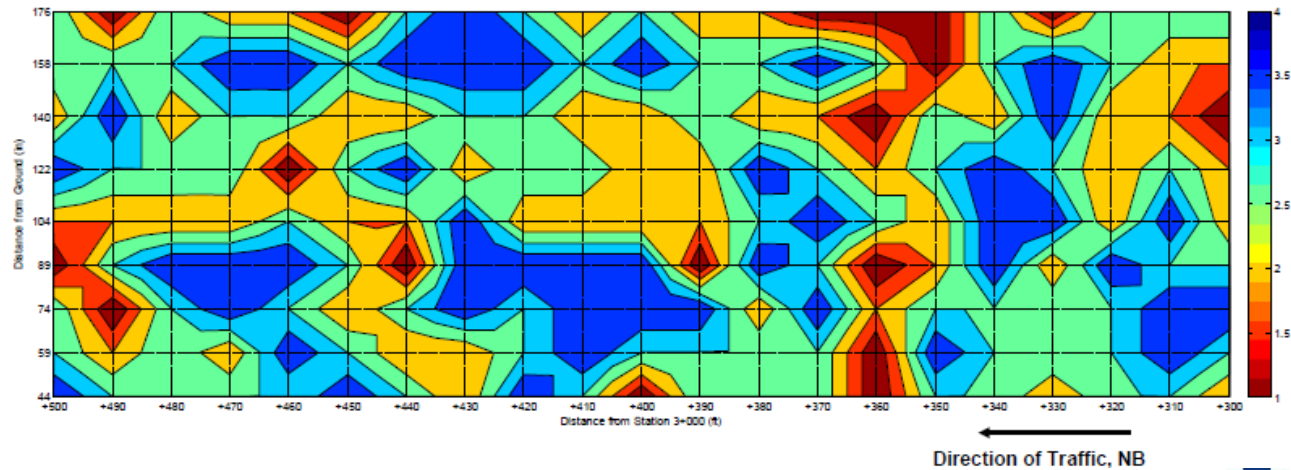
AID also developed contour maps of seismic moduli results from USW analysis and debonding condition from IE analysis.

- Based on correlations with hammer soundings during testing, AID concluded that seismic moduli lower than 2,750 ksi were suspected as being delaminated
