# SHRP2 Project R06G: High-Speed NDT Methods for Mapping Voids, Debonding, Delaminations, Moisture, and Other Defects Behind or Within Tunnel Linings

Liberty and Armstrong Tunnels, Pittsburgh, PA

Brad Miller, Mackin Engineering Company

- Condition Assessment of Liberty & Armstrong Tunnels in Pittsburgh, PA using High-Speed Mobile Scanning and Hand-held Non-Destructive (NDT) Technologies

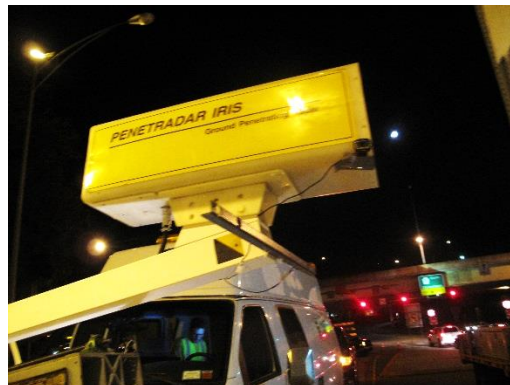
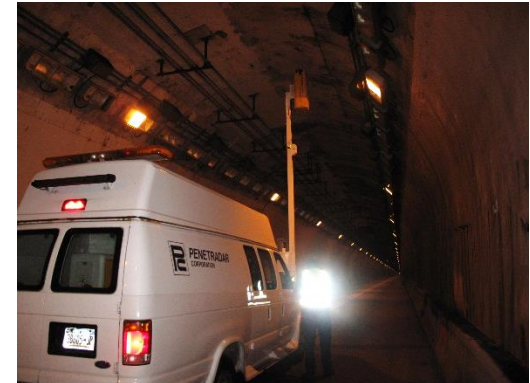
- Penetradar Corporation:
  - GPR/IRT/Video
  - Detects delaminations, voids behind liner, moisture within and behind liner, cracks, debonded tiles.

- Penetradar Corporation:
  - Multiple passes required for GPR (3-6 ft widths)
  - For IRT/Video, 3 passes required in each tunnel.

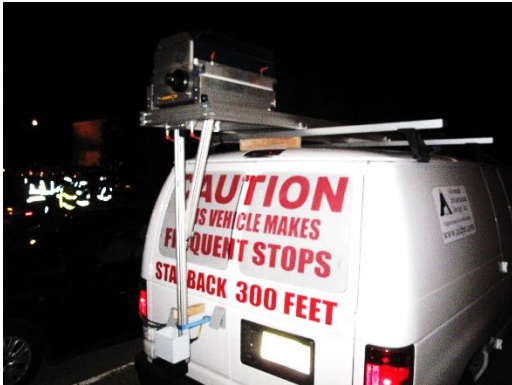
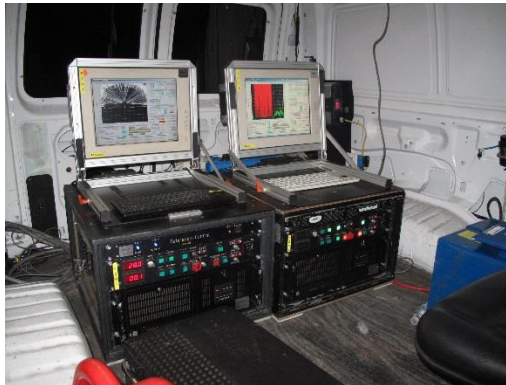
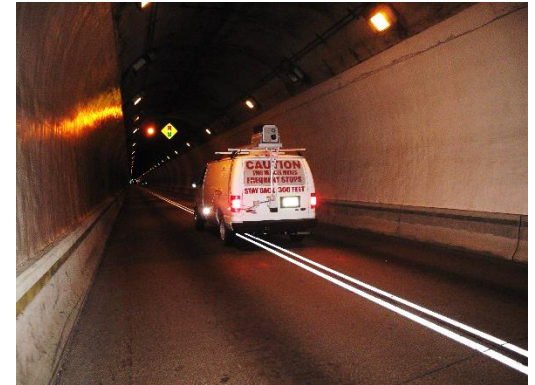
- SPACETEC:
  - 3-D Laser scanning/IRT/Video
  - Detects delaminated and debonded areas, spalls, cracks, efflorescence, and water infiltration. Can also detect changes in shape, bulges, etc.

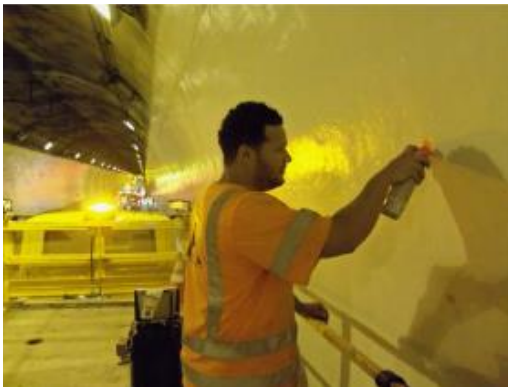
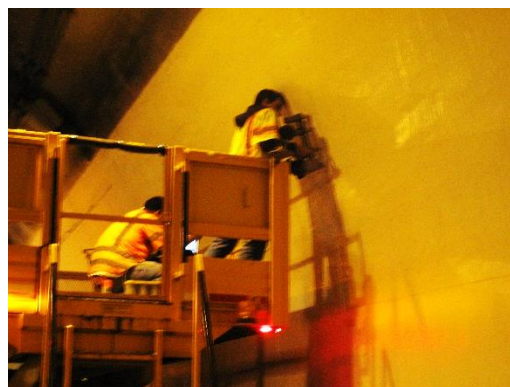
- PSPA Testing:
  - PSPA used to perform Impact-Echo (IE) and Ultrasonic Surface Wave (USW) analysis at “test section”.
  - Test grid established to conduct PSPA testing over 200LF (10’ spacing; 9 locations vertically).
  - 189 total test points – 5 hours

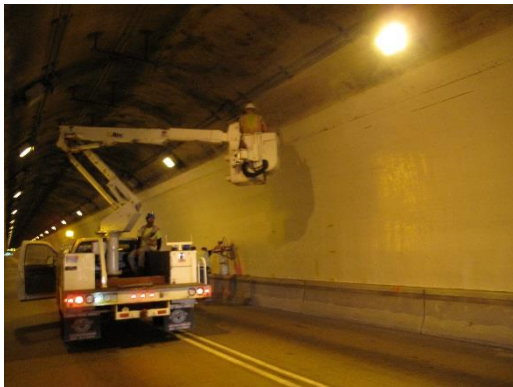
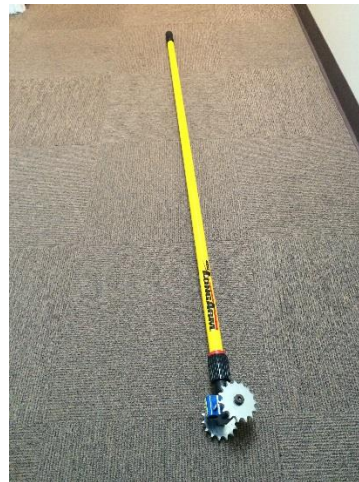
- Physical Testing:
  - Traditional hammer sounding was performed on the “test section” using 45-foot bucket truck.
  - Delam2000 – Rotary percussion tool also used to sound concrete.
  - Cores were taken at Station 3+475 (sound) and 3+321 (unsound).

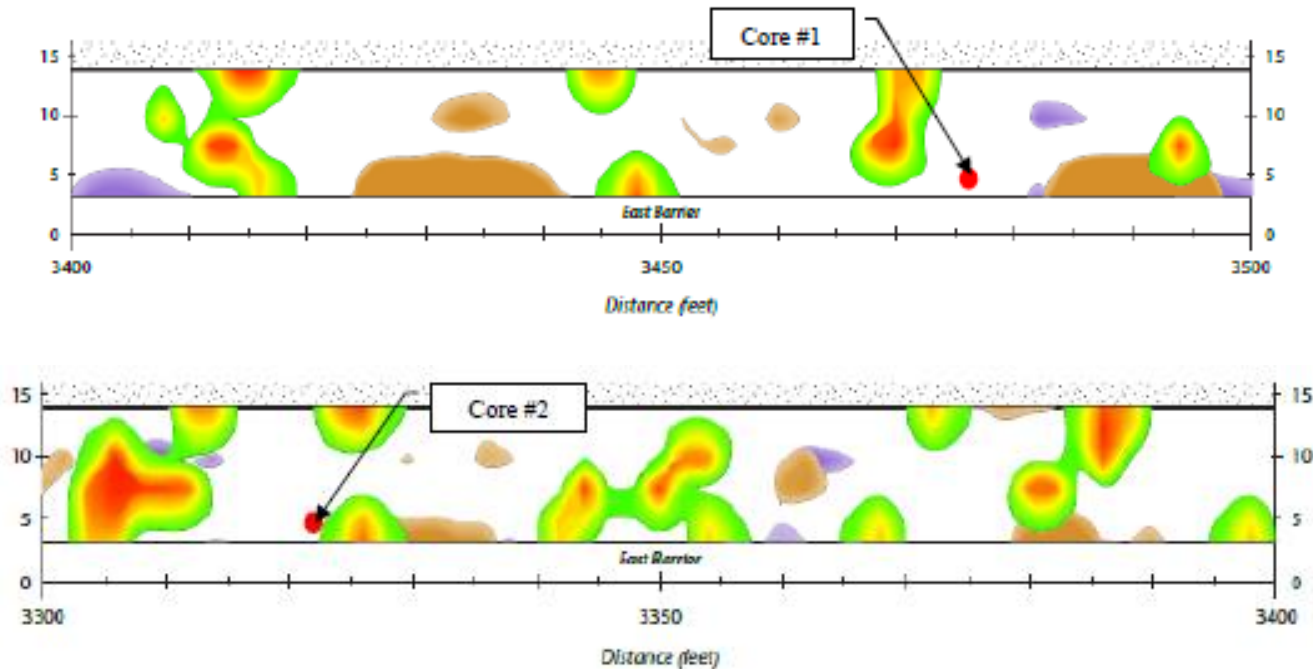
GPR consistent with location of concrete core samples.

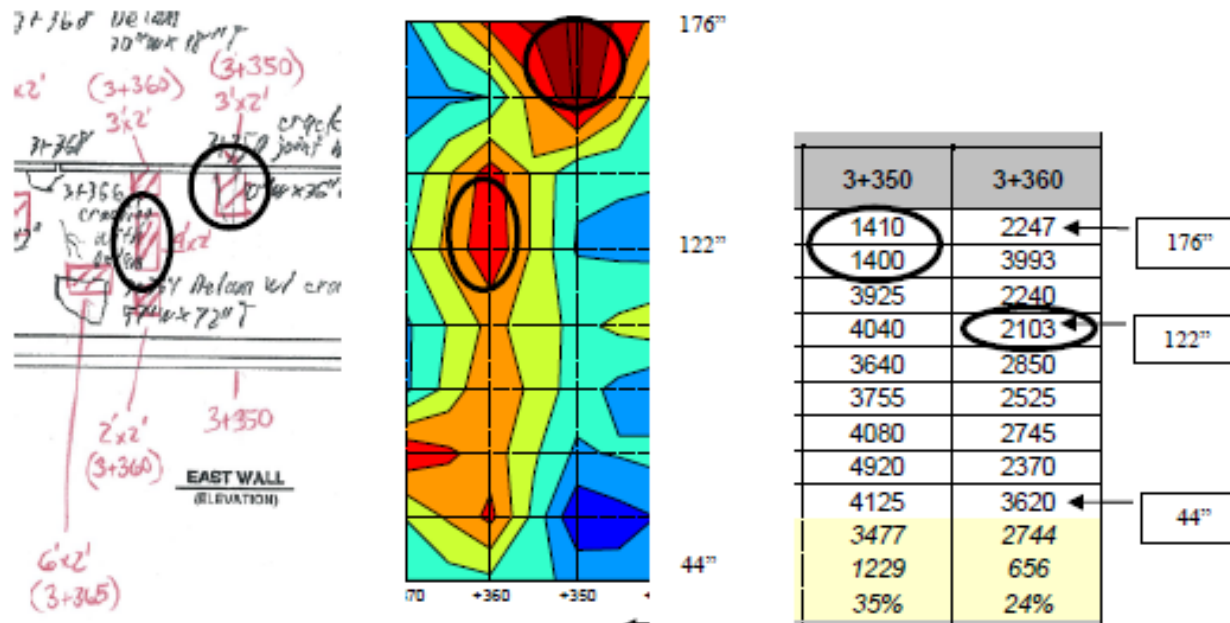
PSPA (USW) results matched well with hammer soundings.

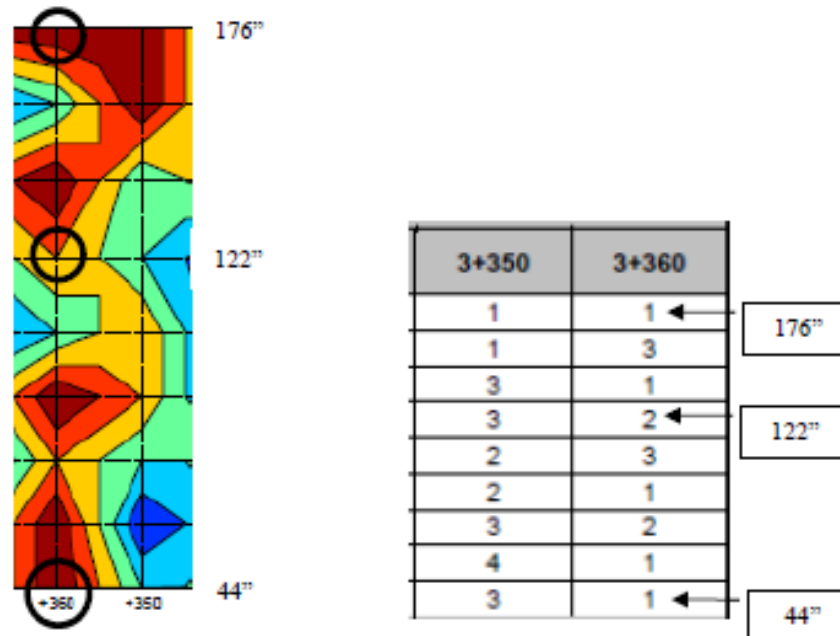
PSPA (IE) results matched well with hammer soundings.

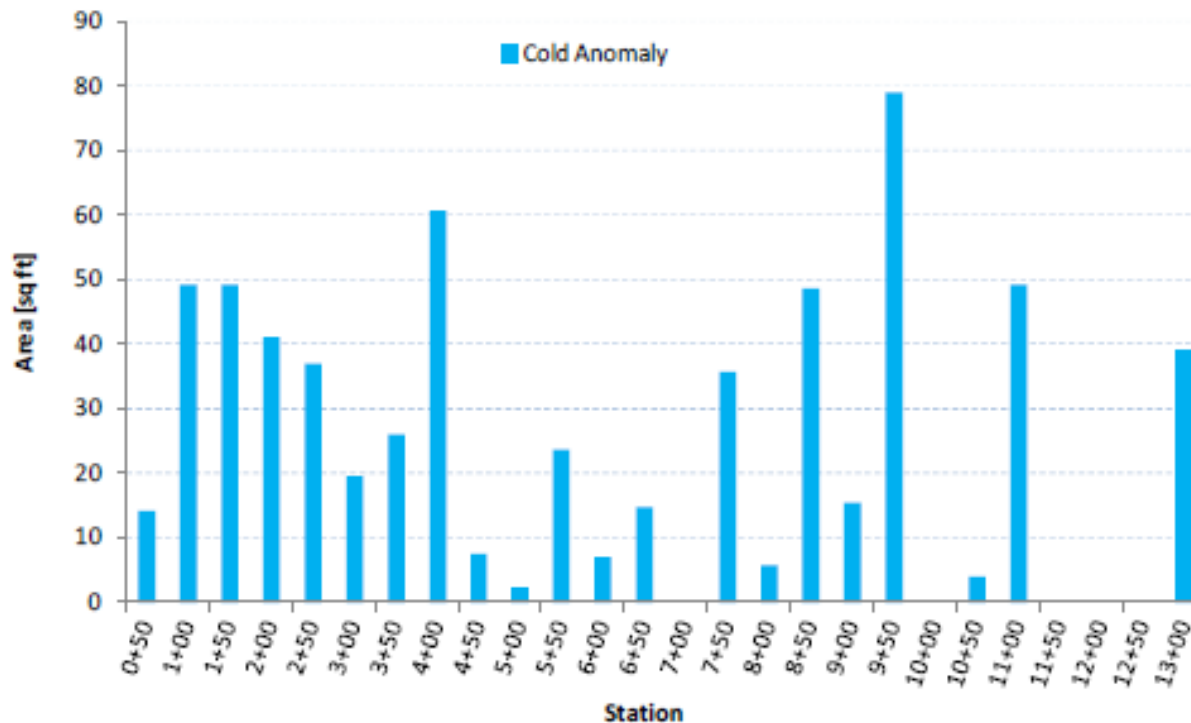
Cold Anomaly (example) - Armstrong
