SHRP2 Advancement in Nondestructive Testing for Concrete Bridge Decks

Yajai Tinkey, PhD, P.E., Olson Engineering, Wheat Ridge, Colorado

Nondestructive Testing - Concrete Bridge Deck

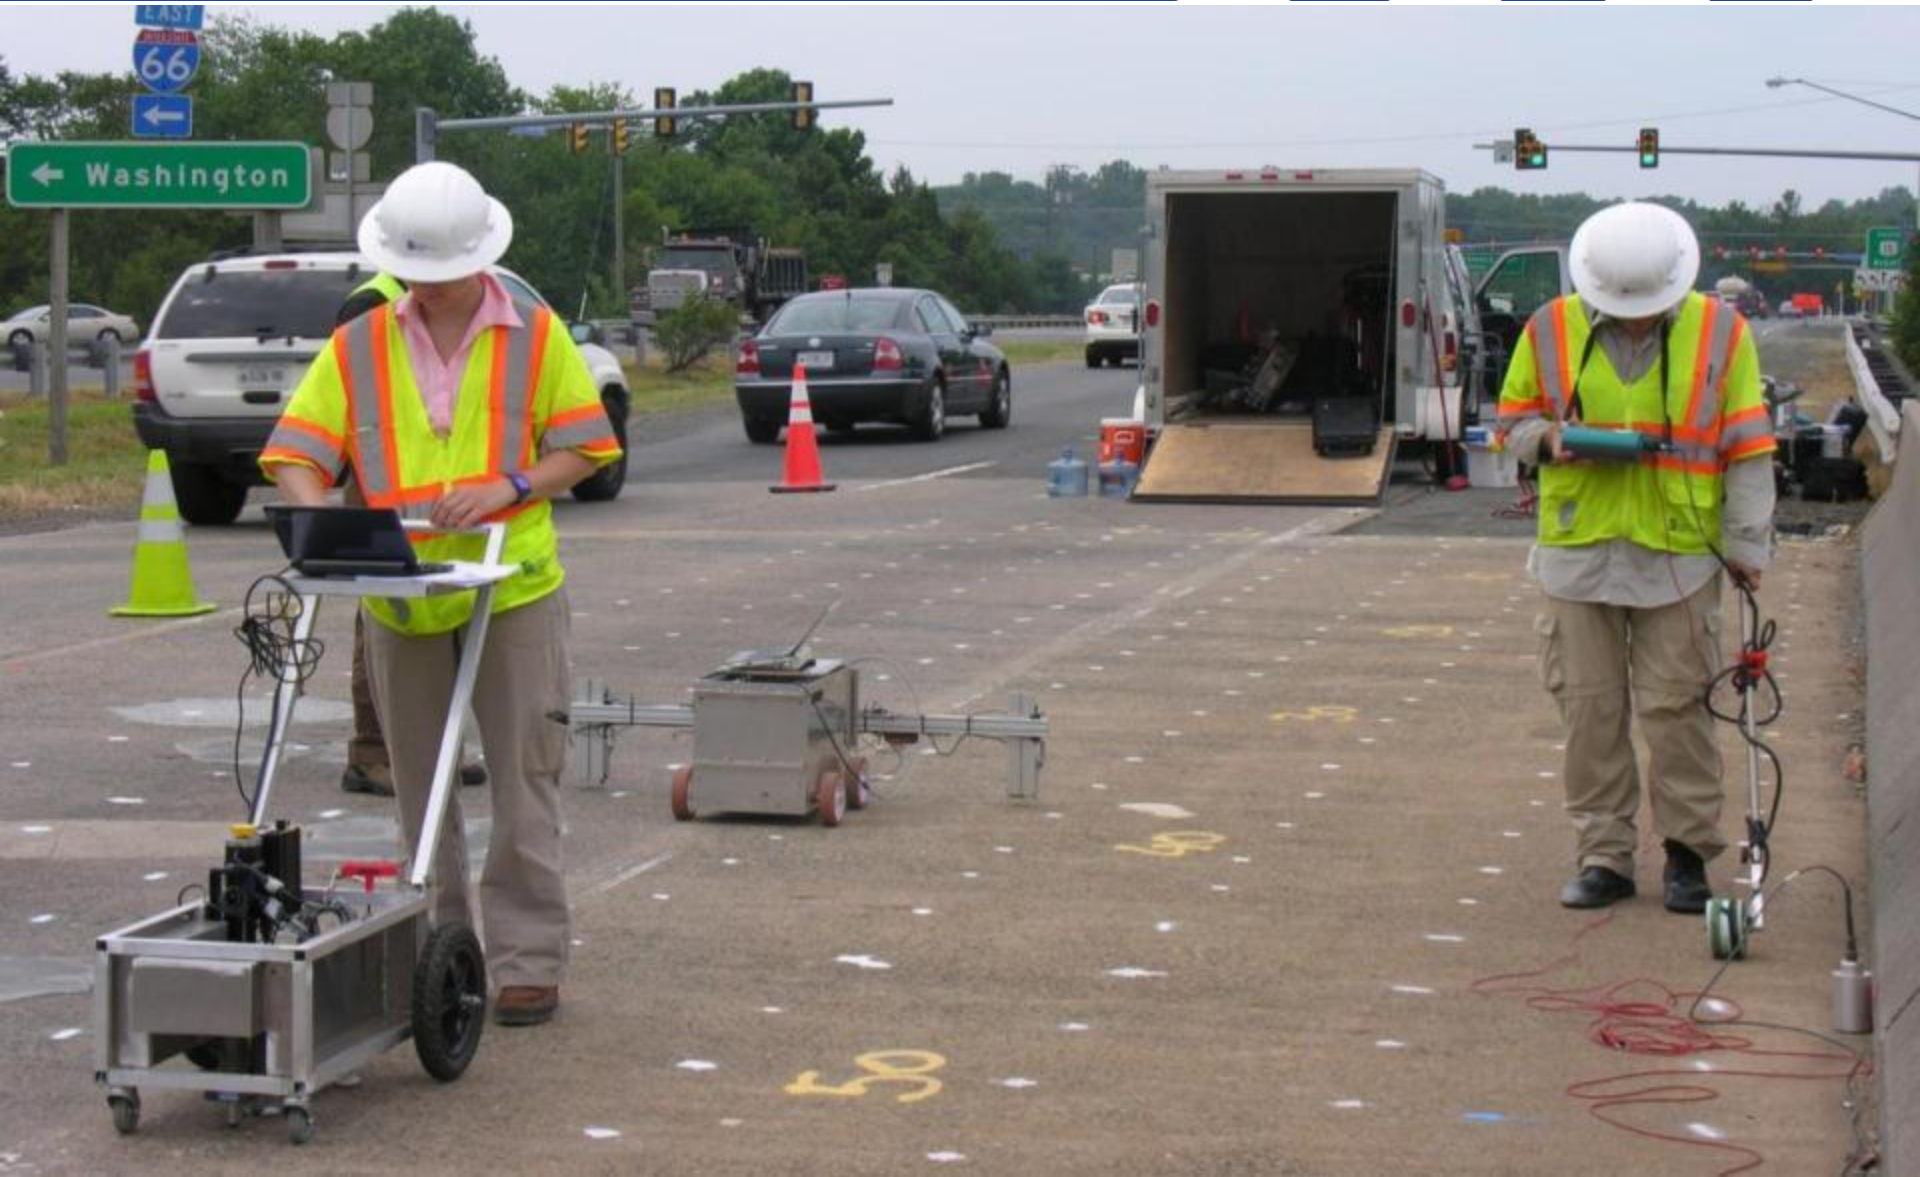
US Hwy 15 over I-66 in Haymarket, Virginia

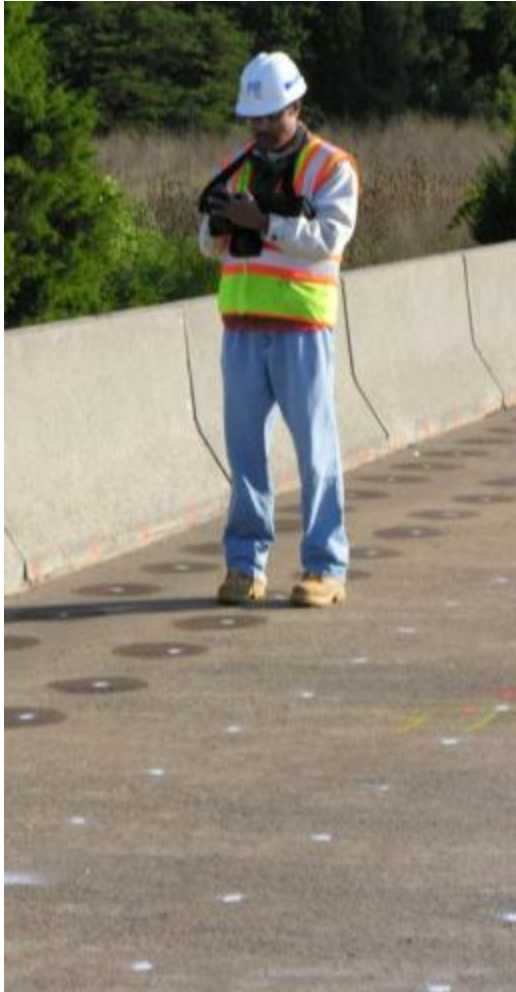
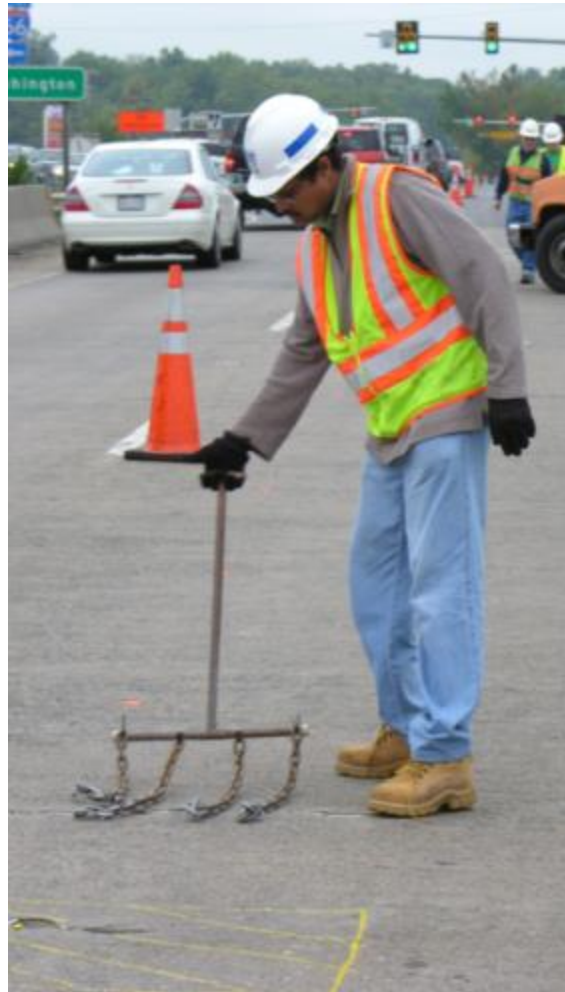
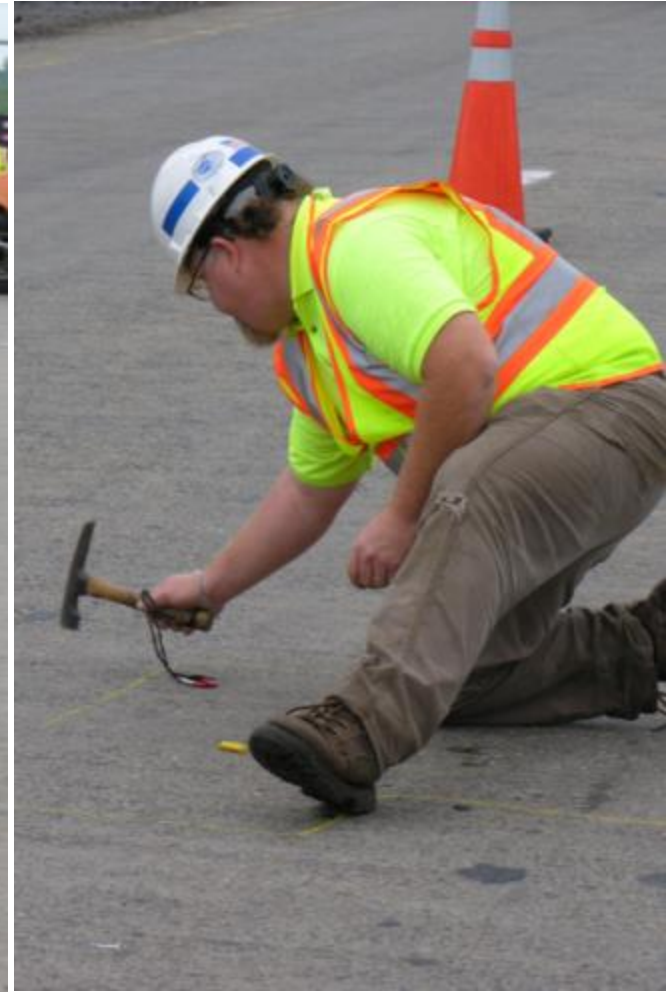
R06A Challenge: State of Practice – Acoustic Sounding and Half-Cell Potential
