SHRP2 Advancements in Rapid Tunnel Imaging and Nondestructive Testing

Dennis Sack, P.E.
Sr. Vice President
Olson Engineering

High-Speed Assessment Techniques for Tunnels

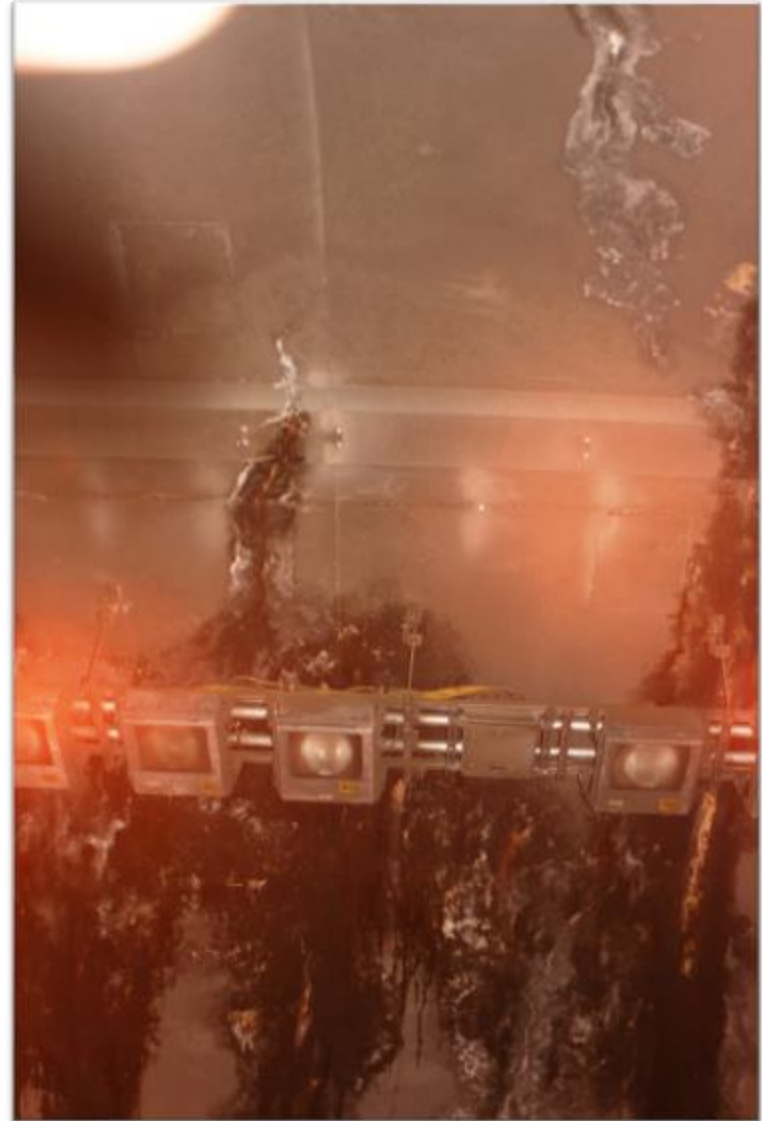
Efflorescence, Water Leakage (Mineral Deposits from Water Flow)

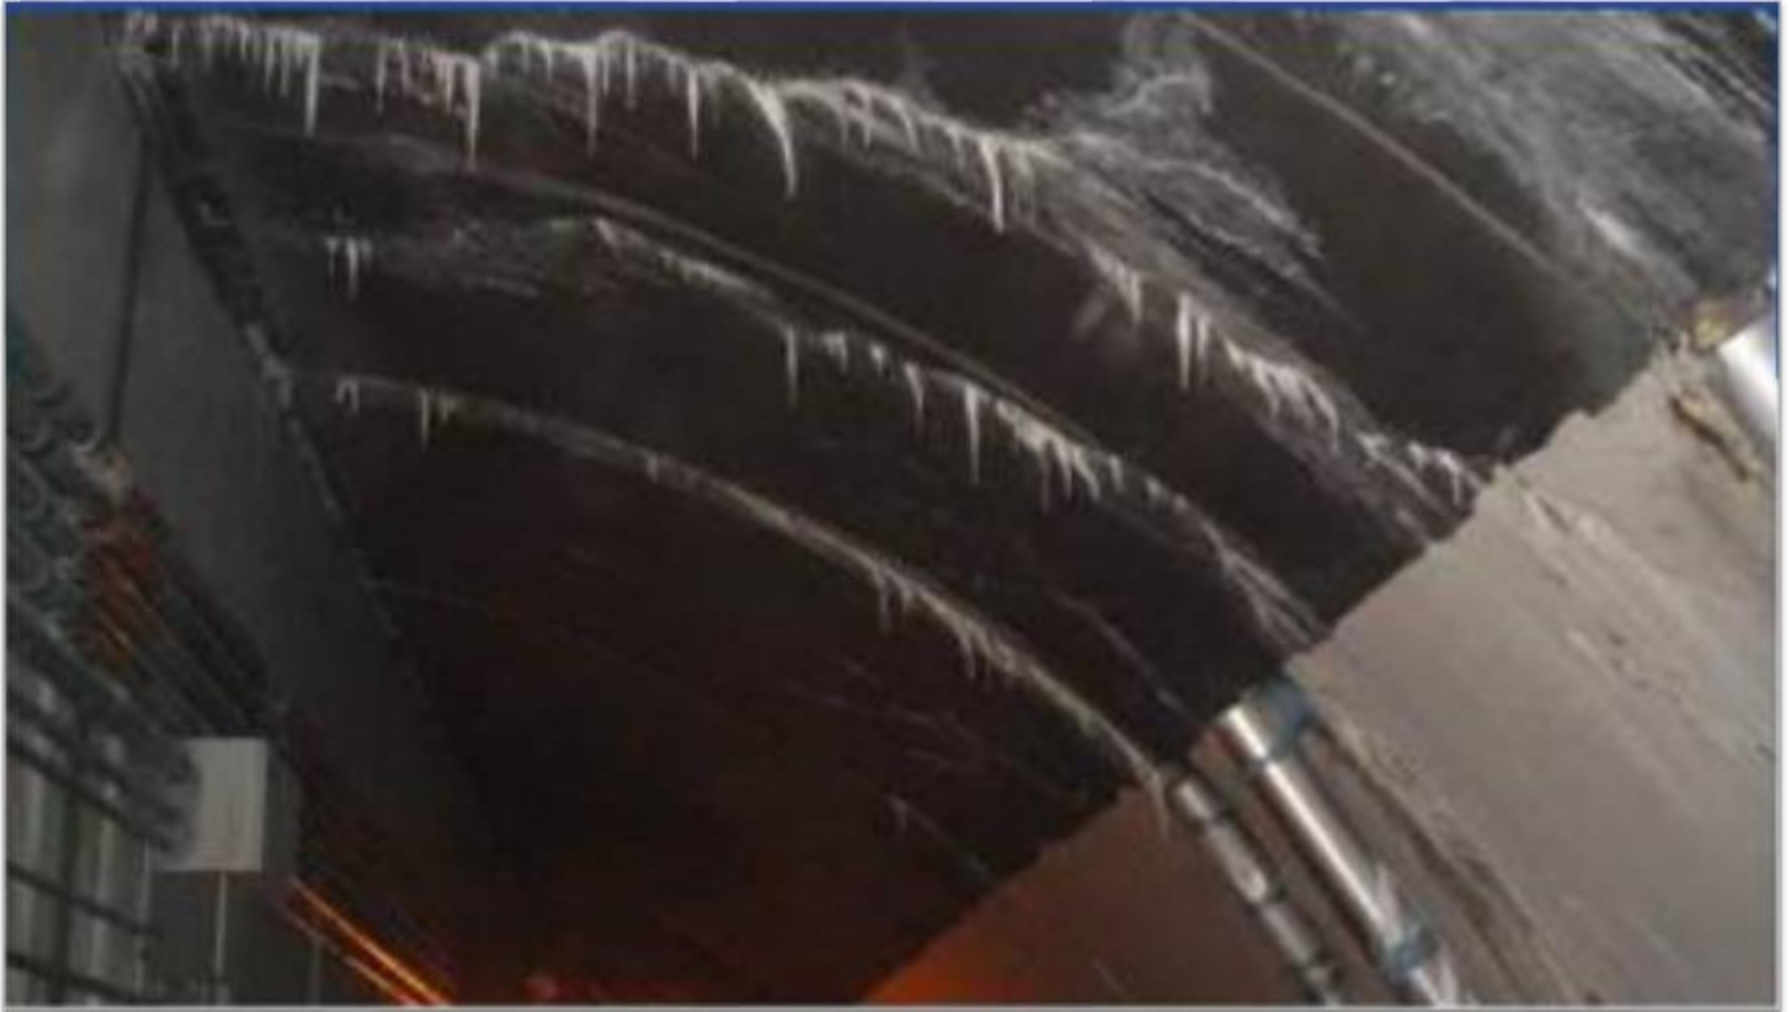
Cracking in Liner Concrete with Covered Void/Spall

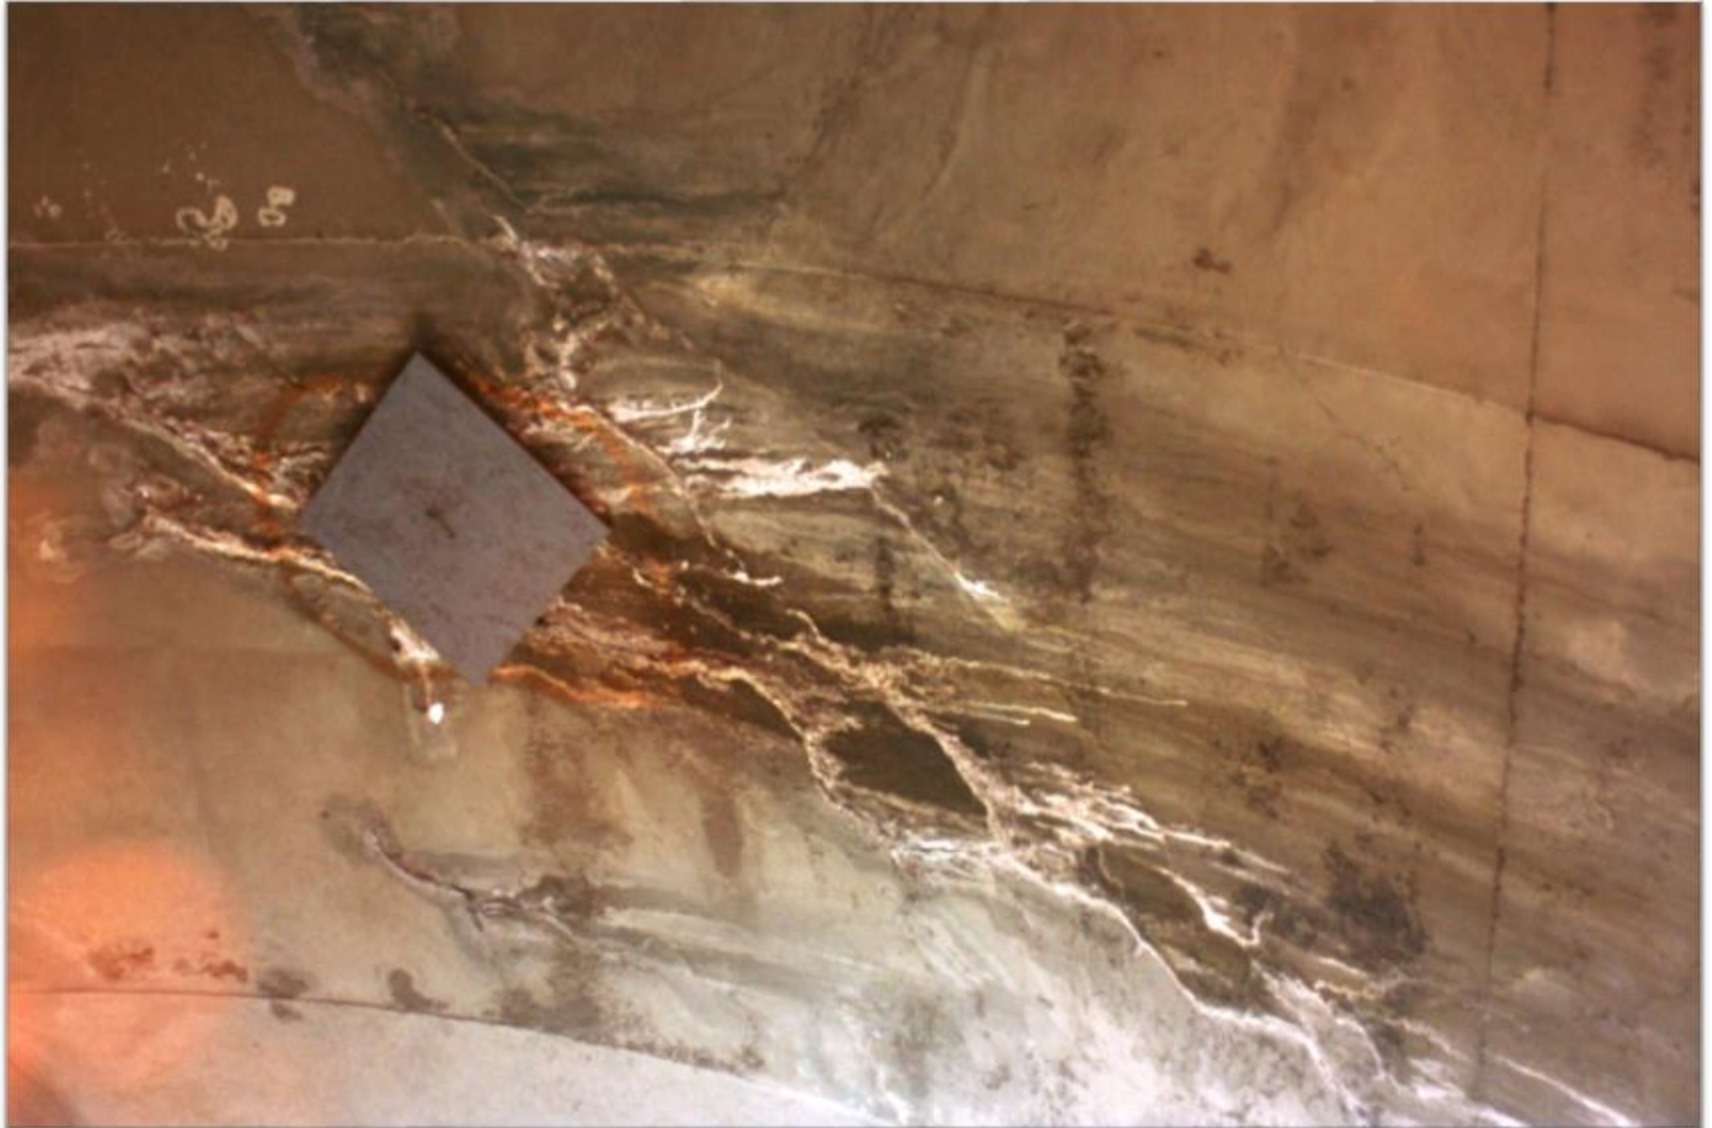
Concrete Liner Cracking

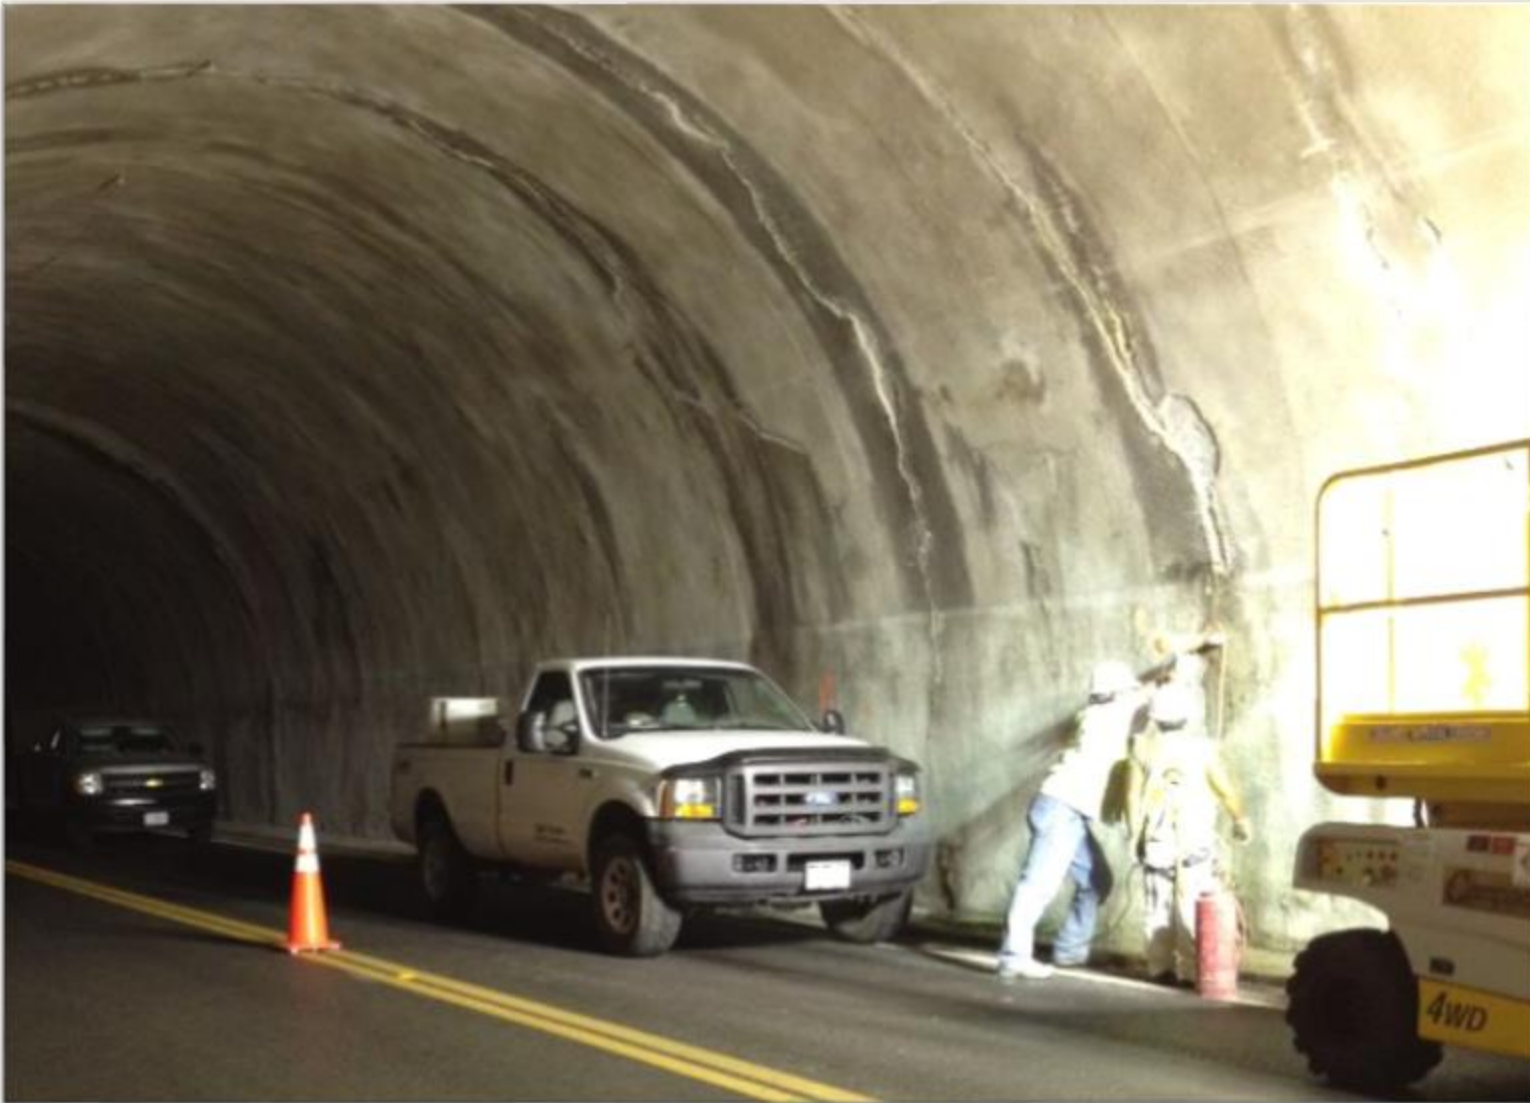
Tunnel Liner Deviations

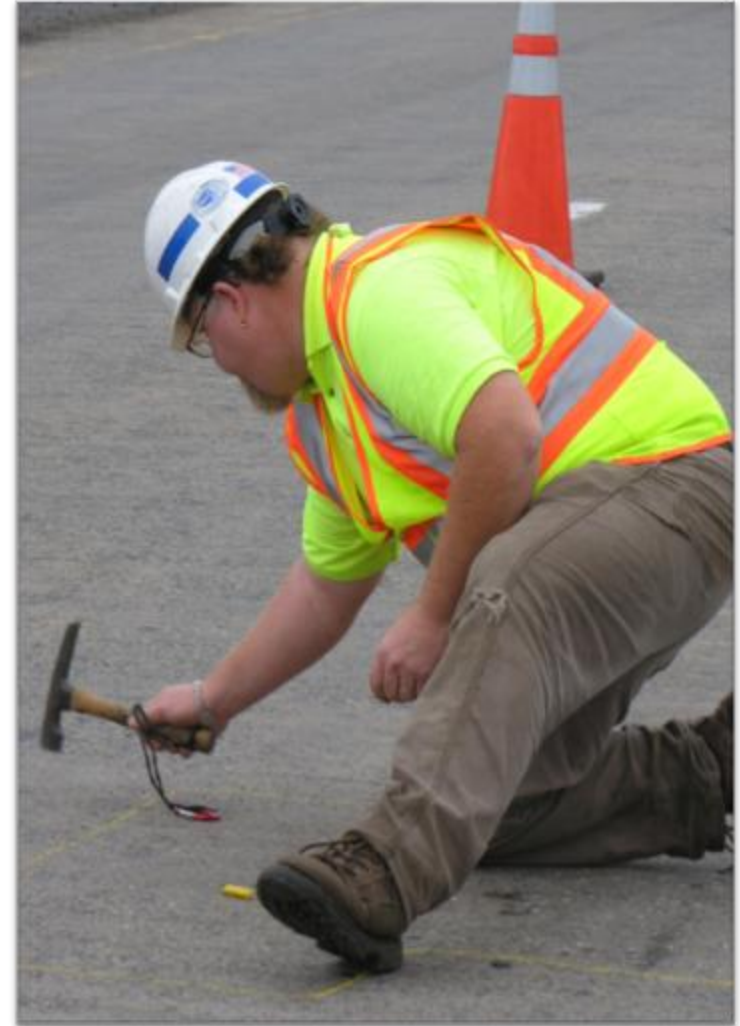
- The **most common** basic inspection methods used for detection of delamination in liner concrete, tile, shotcrete and other surface treatments.
- Used to detect regions **where the impact sound changes** from a clear ringing sound (well-bonded material) to a somewhat mute and hollow, drummy sound (delamination).
- **Easy to use** and requires **minimum training**.
- **Low-cost** equipment.
- Average speed of testing is about 800 ft²/hr.

- The **operator** impacts the wall or surface material while listening to the sound the impact makes.
- A **clear ringing sound** represents sound concrete or well bonded tiles/shotcrete while **a mute/hollow sound** represents a delaminated or debonded area.
- The hollow sound is a result of flexural vibrations of the delaminated area, creating a drum-like effect.

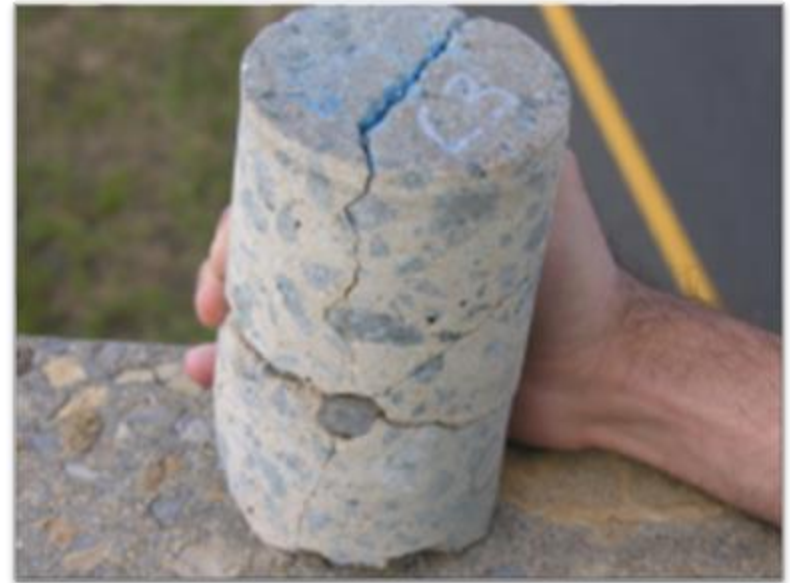
Core from bridge deck showing delamination due to corrosion of rebar at 3.5 inches – not detected by sounding

- Is highly dependent on the **operator's skill and hearing**, making the method subjective. The results may be significantly different if performed by 2 different persons.
- Initial (partial) delaminations often not detected.
- Only detects delaminations or debonds up to ~3 inches deep.
- Not easy to produce an accurate paper copy of the delamination map.
- Tunnel acoustics can make sounding more difficult.

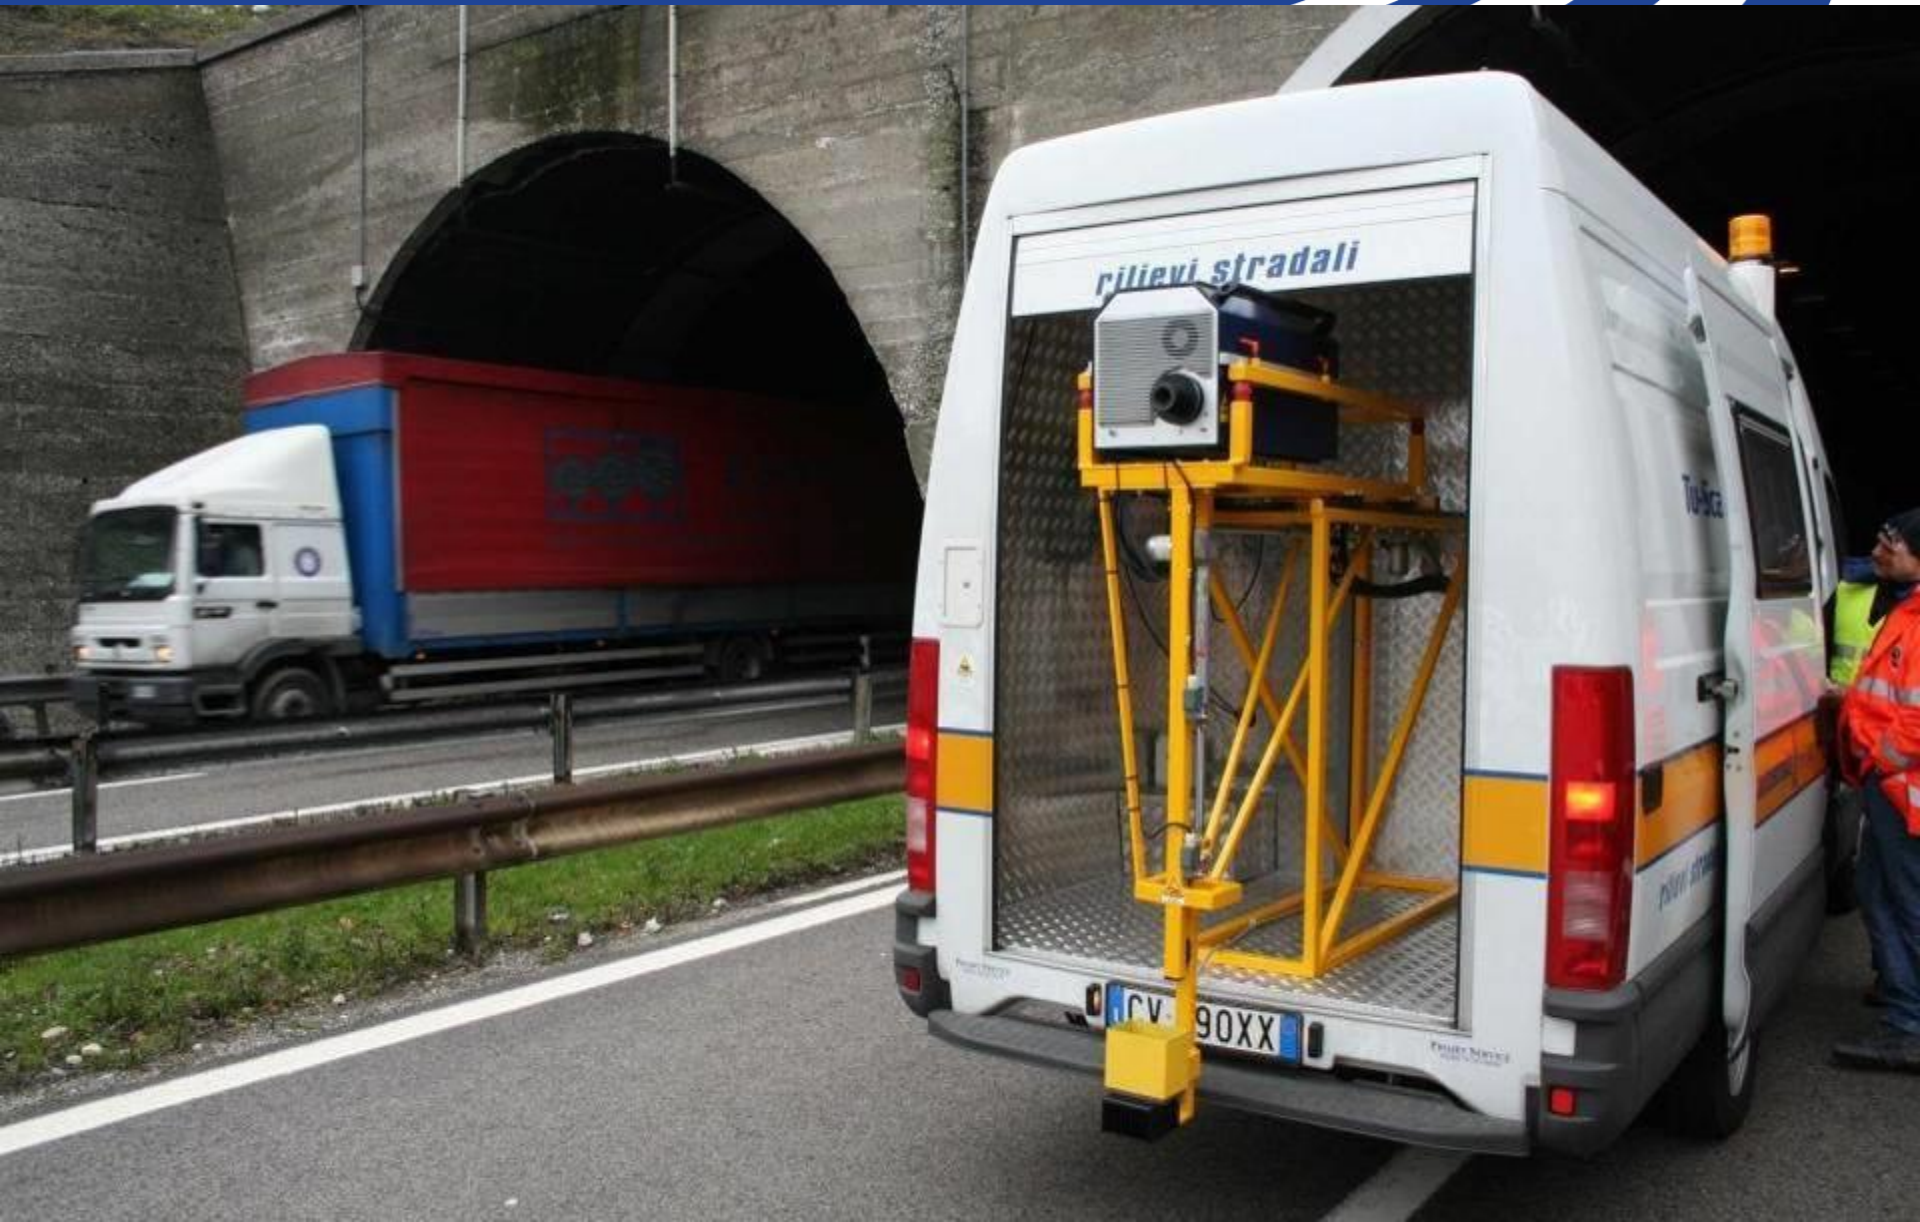
SPACETEC System – Visual vs IR Views with Areas of Concern in IR view

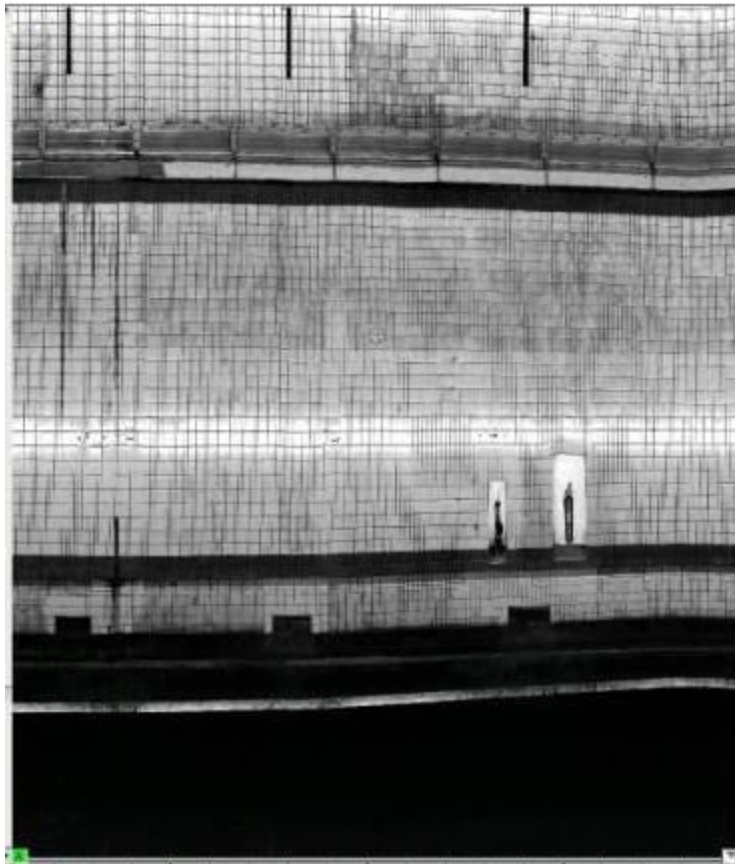
SPACETEC IR Data Showing Sound Tile

Chesapeake Tunnel IR and Visual Scans of Wall
