Nondestructive Testing Technologies for Concrete Bridge Decks (R06A)

Webinar

April 30, 2019

NDT Methods for Bridge Decks Summary and Discussion

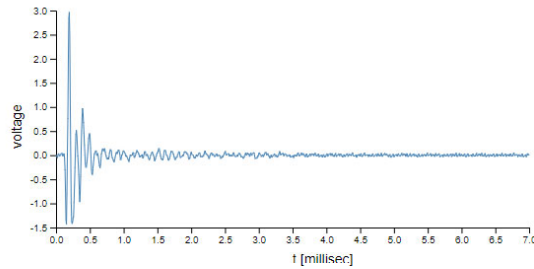
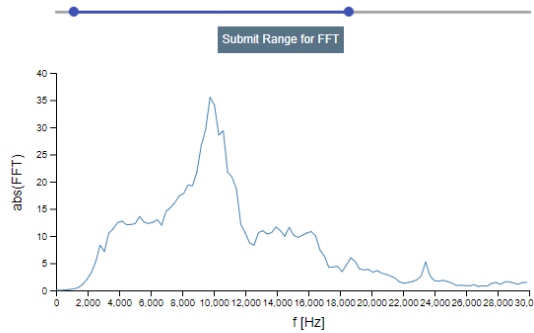
Experimental Results

The [impact-echo method](#) is based on monitoring the surface displacements associated with the arrival of the P-wave as it undergoes multiple reflections between the top and bottom surfaces

The measured voltage, proportional to the surface displacement, is plotted against the time as the waveform. Response spectrum is also presented by absolute Fast Fourier Transform based on the chosen range of waveform. The frequencies corresponding to the dominant amplitude peak for each spectrum are collected to form the contour map with colors, where

- blue colors indicate regions dominated by a low-frequency response referring to shallow delamination,
- red colors indicate regions dominated by a high-frequency response referring to intermediate delamination,
- orange indicates the regions of deep delamination,
- light blue, green and light yellow colors indicate the normal or non-defected solid regions.

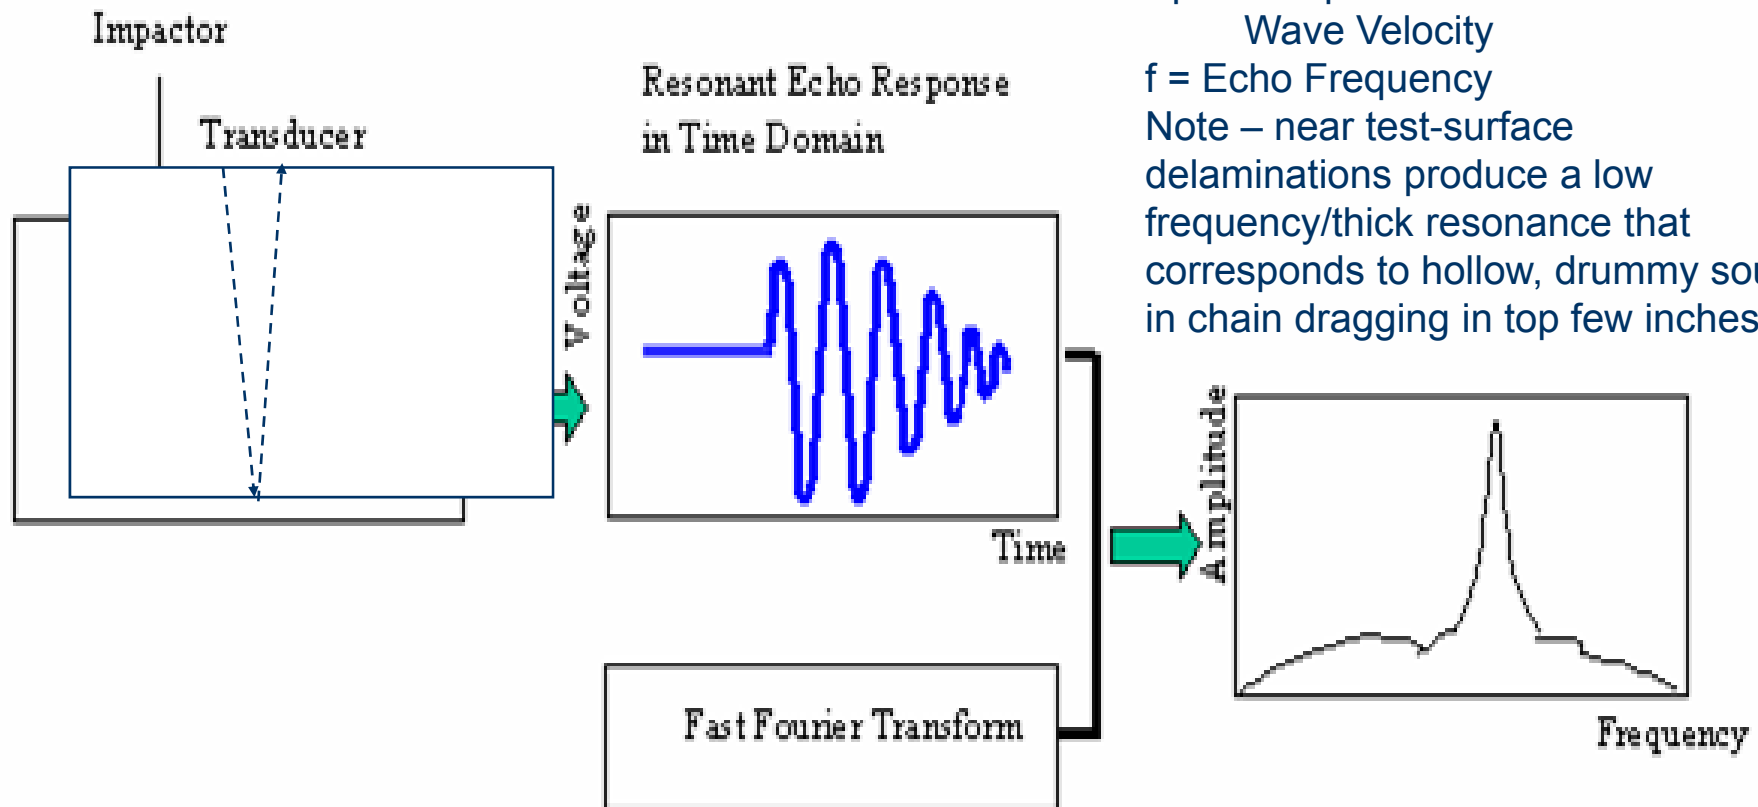
Impact Echo Test for Delamination/ Cracking/Thickness of Decks

$$D = bVp/(2*f)$$

b= Shape Factor (0.96 for slab)

D = Thickness

Vp = Compressional
Wave Velocity

f = Echo Frequency

Note – near test-surface delaminations produce a low frequency/thick resonance that corresponds to hollow, drummy sound in chain dragging in top few inches

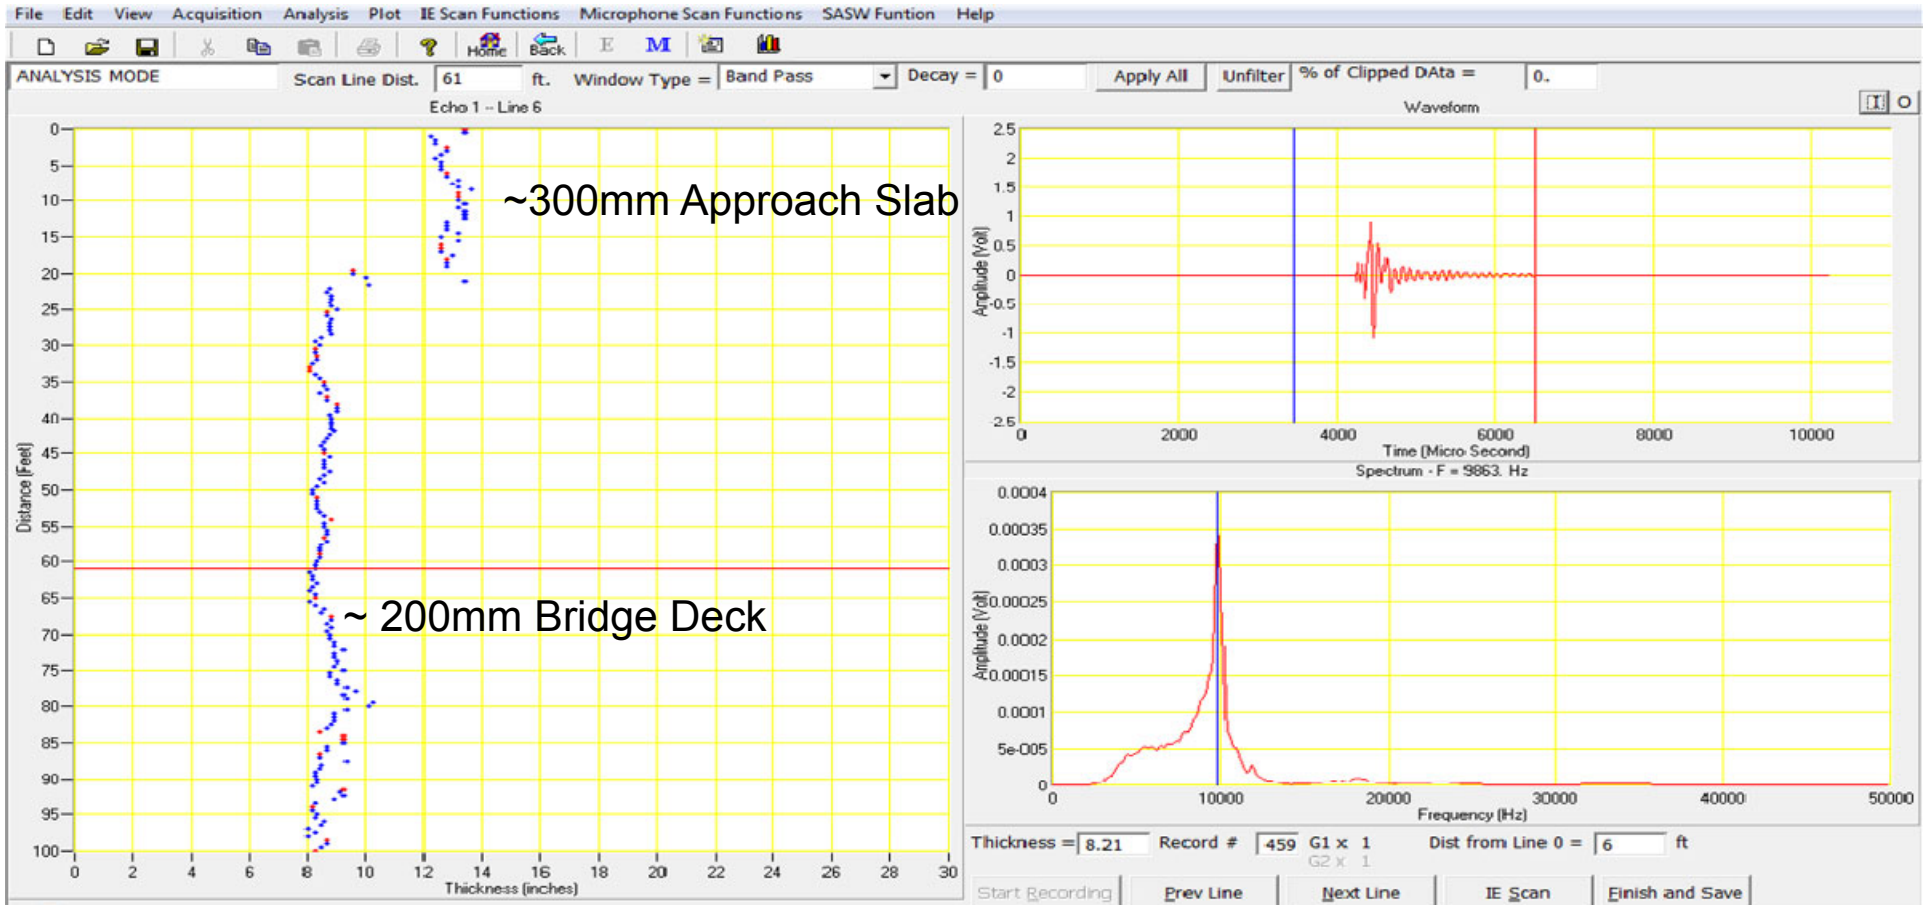
Sample Single IE Scanning Line Result

IE Thickness Plot vs. 100 ft Distance for a scan line on a bridge deck

Time Domain IE Signal at left cursor (Top Plot) and Frequency Domain Echo Depth Resonance=8.3 inches (Bottom Plot)

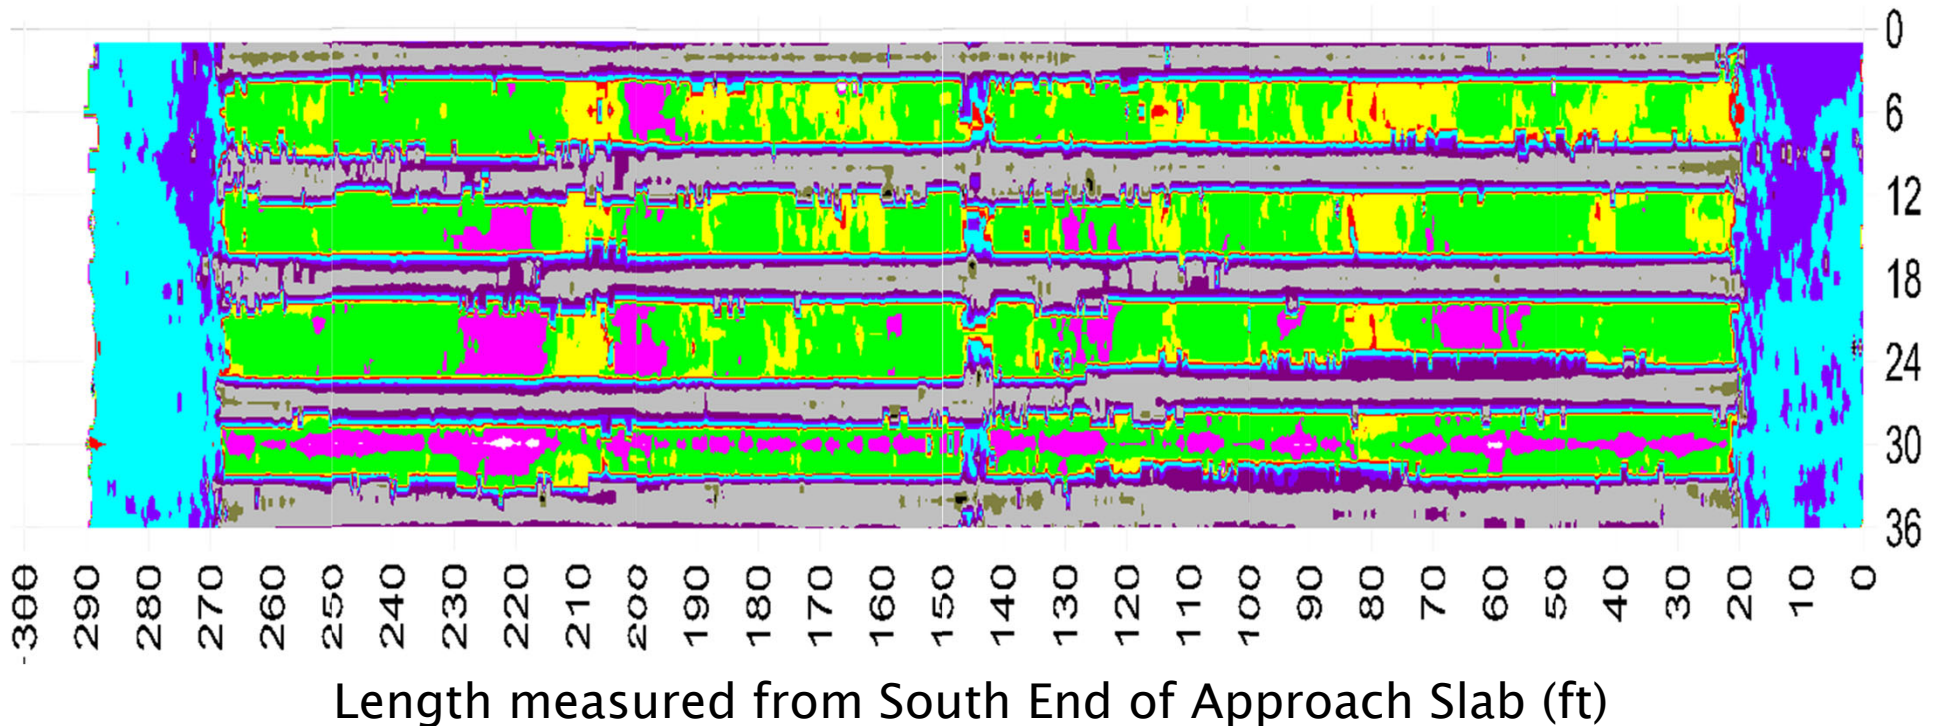
Overall IE Scanning Result Map from a Bridge Deck – Showing Beams and Deck Areas

Distance measured
from East End of Deck
(ft)

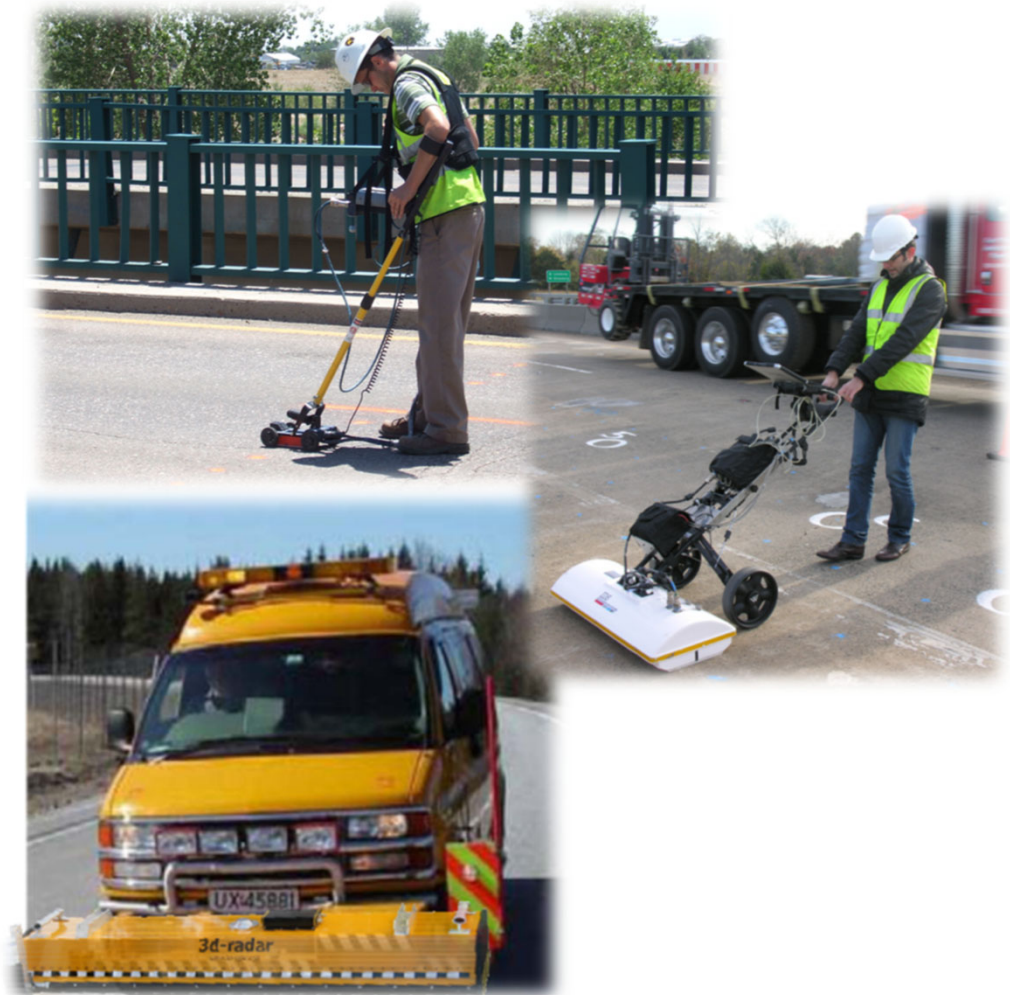
Description of the GPR Method

Reflection test

- Using electromagnetic waves
- Sending tiny pulse of energy through its antenna
- Reflecting back from different material or anomalies.

A rapid nondestructive testing method

- Ground Contact (single antenna and multiple antennas)
- Air Horn (multiple antennas)

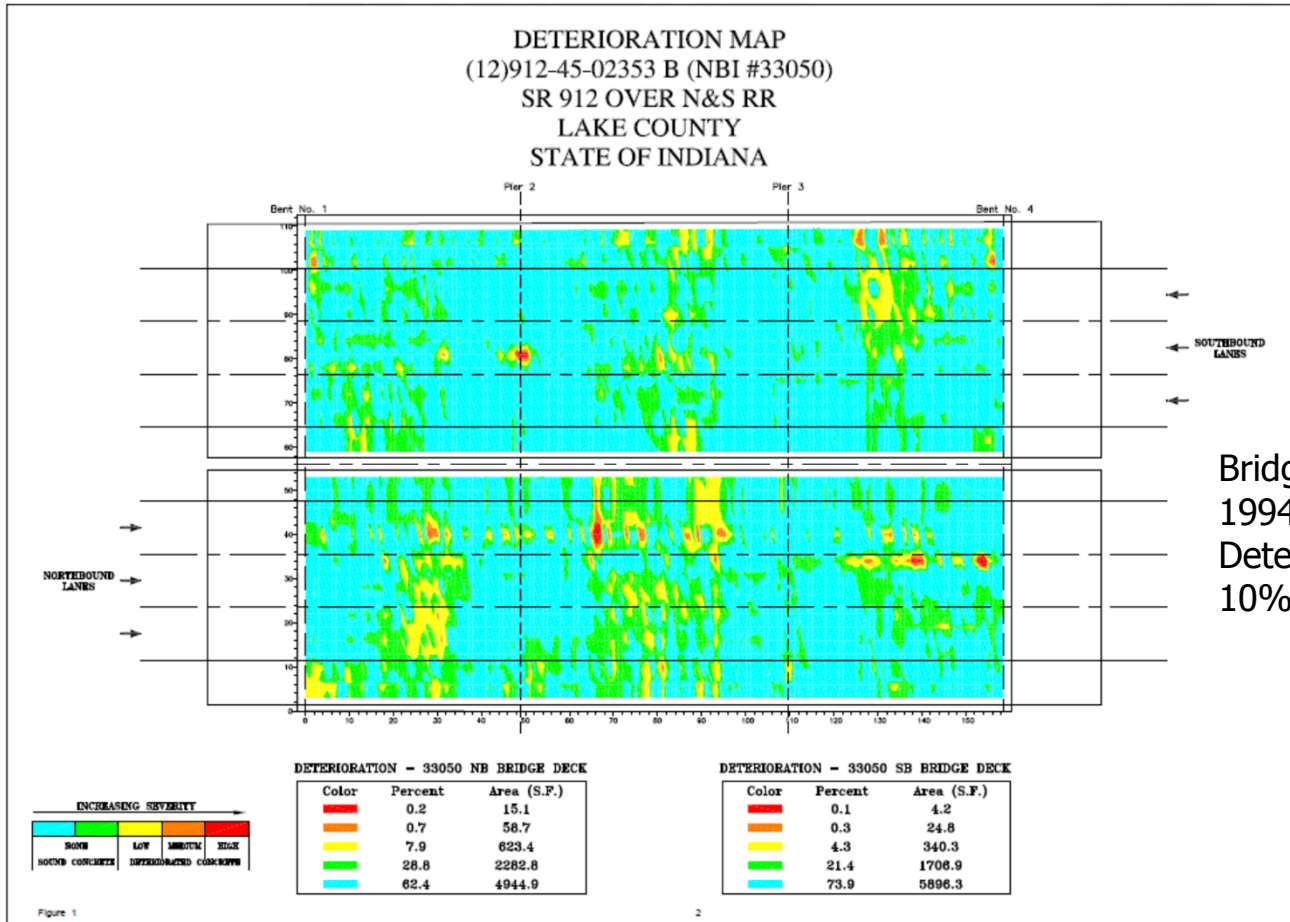
Bridge Deck constructed in 1994 25 year old deck
 Deterioration less than 10%

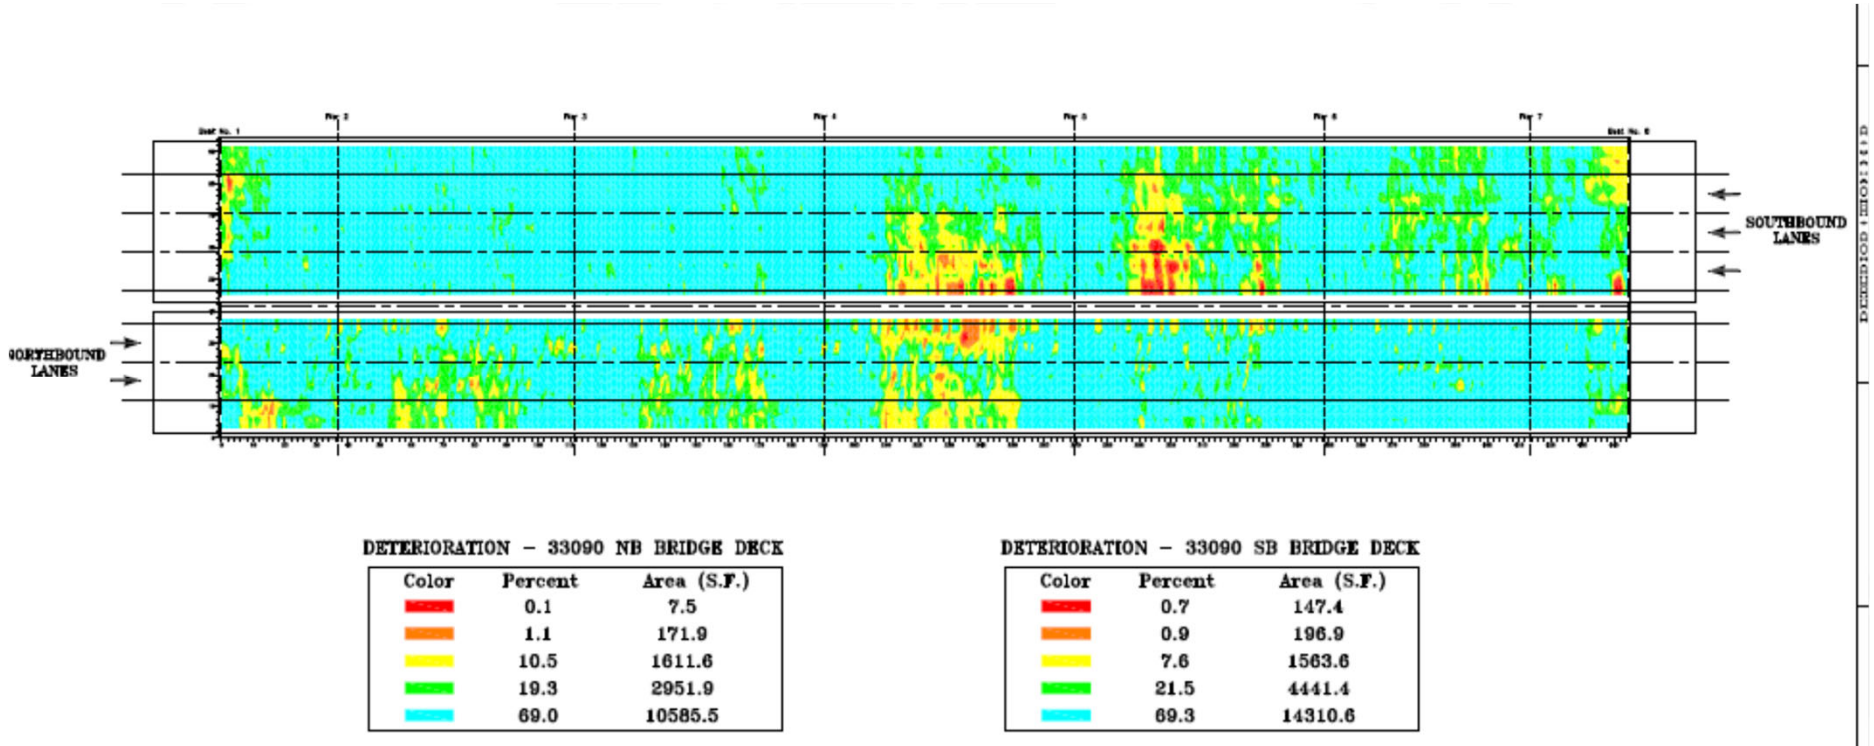
Bridge deck constructed in 1994 – 25 year old bridge deck
 Deterioration just over 10%

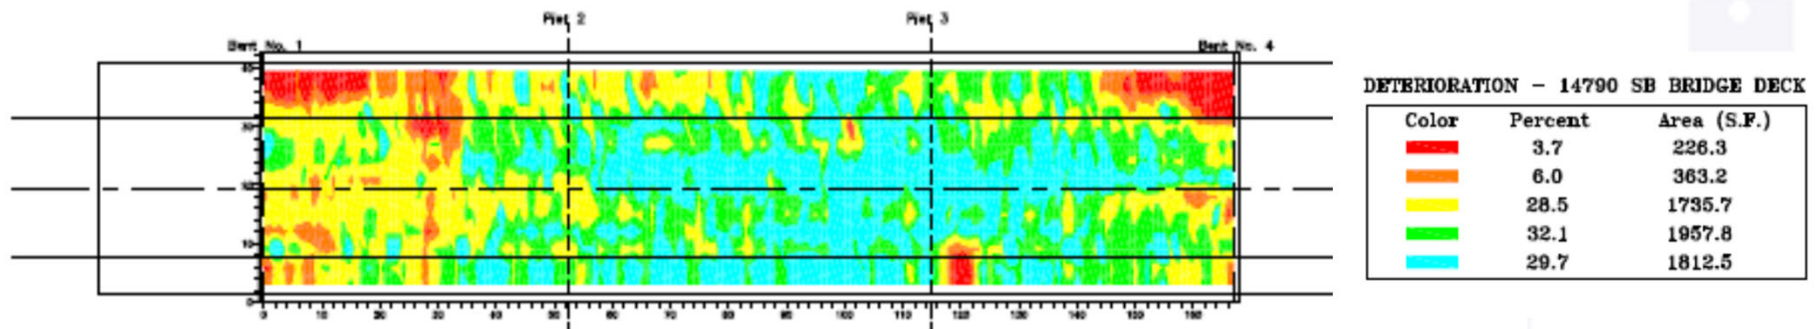
- 41-42-5935 BSBL

- 9.7% highly deteriorated
- 38.2% total deterioration
- 48 year old deck
- 24 year old 2nd overlay
- Structure is programmed to be rehabilitated in 2020. The inspector rated the deck a low 6 by notation and recommend the deck be replaced.

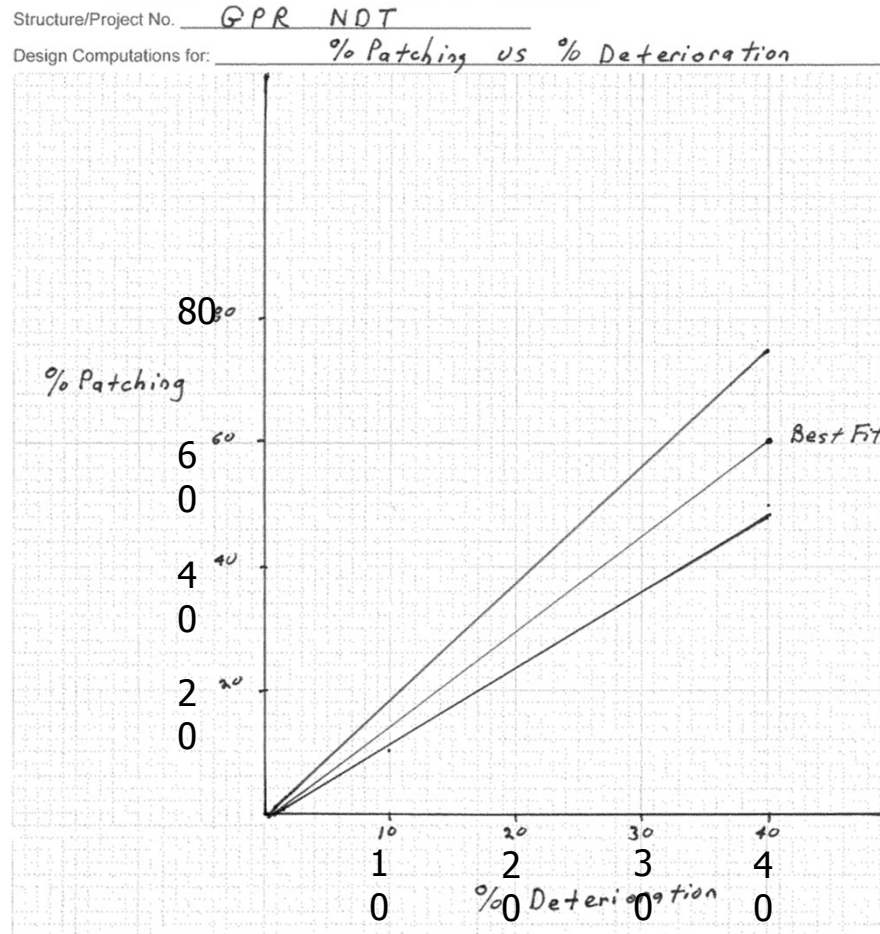
The relation between percent deterioration and percent patching is not a one to one correlation.

This graph is an approximation of the relationship.

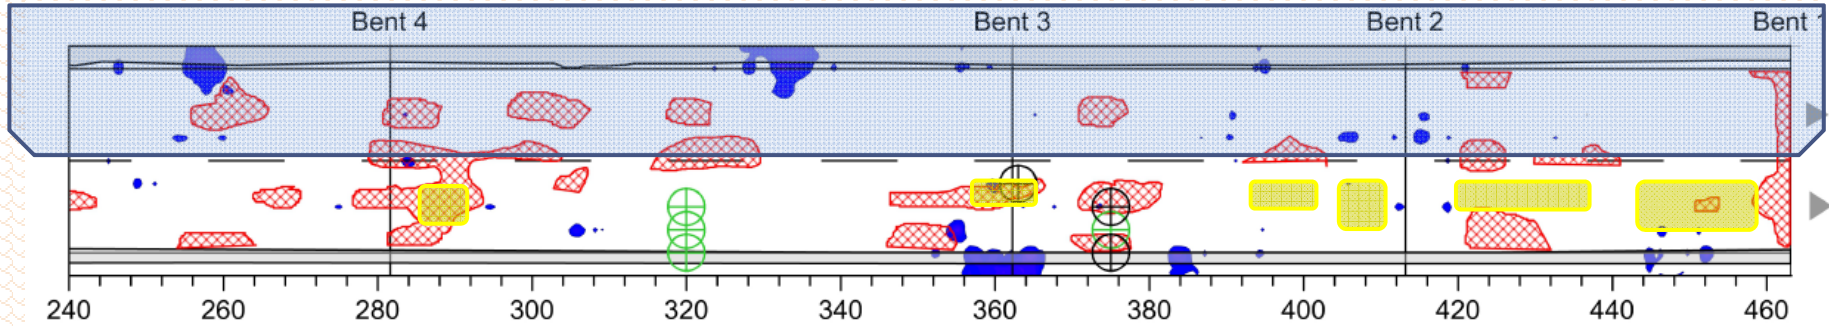
OR99, Tualatin River

Deterioration detected by GPR

⊕ IE (delam)

⊕ IE (no delam)

Delamination detected by IR

Patching

Not detectable by IR / GPR

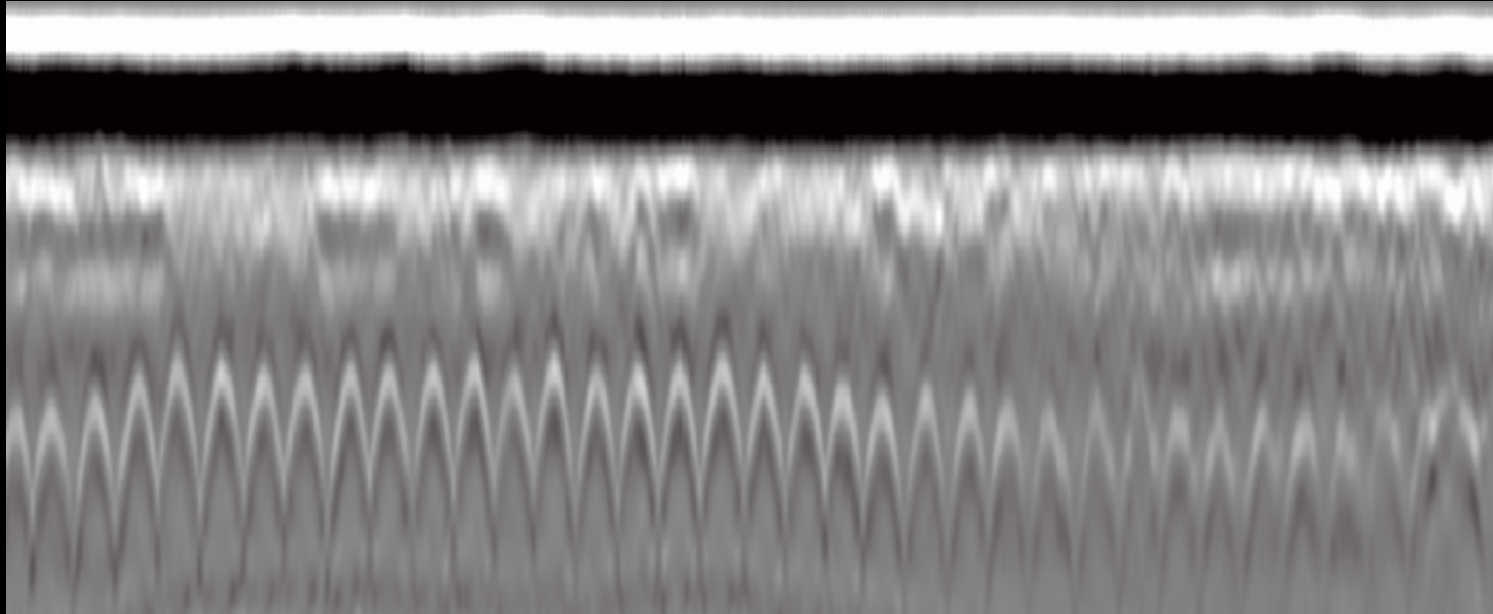
GPR Evaluation Results: Typical B Scan from Bridge 6840

- Reflection amplitudes picks, X and Y location coordinates, and two-way travel time are obtained using Radan 7

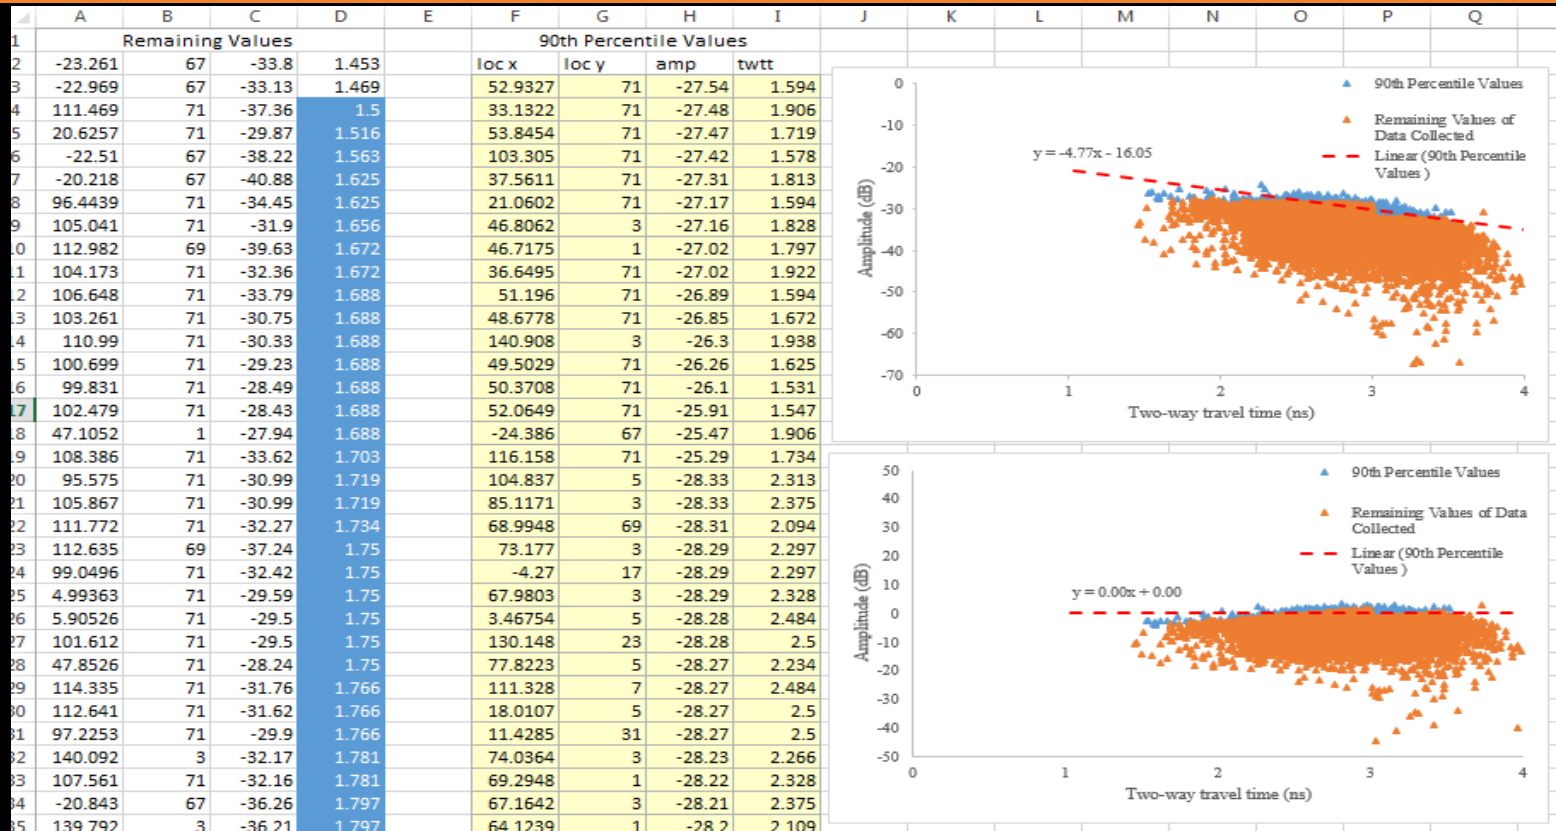
GPR Evaluation Results: Excel Processing Bridge 6840

– Information obtained from Radan 7 exported to Excel for further processing
