# SHRP2 Advancement in Nondestructive Testing for Tunnel Linings and Concrete Bridge Decks

# Mapping Defects In or Behind Tunnel Linings (R06G)

# Nondestructive Testing of Concrete Bridge Decks

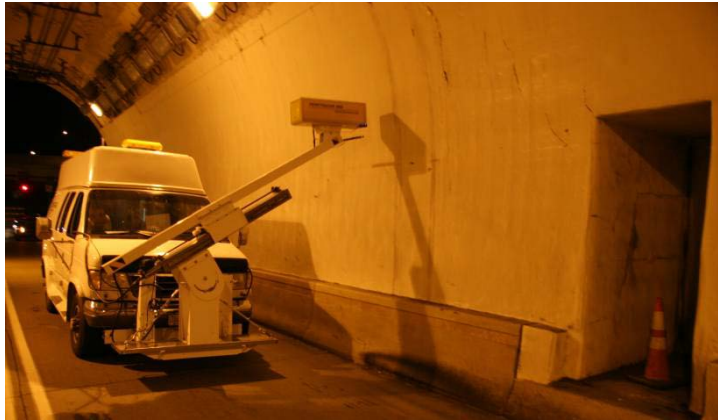
Penetrator GPR of PennDOT Tunnel

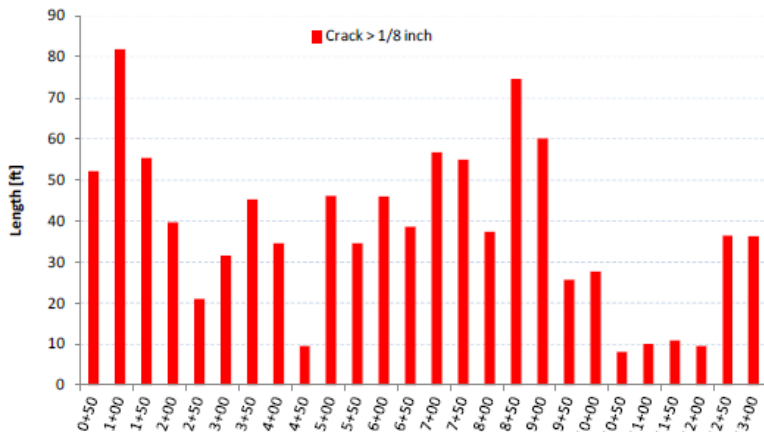
Distribution of Cracks Greater Than 1/8"  
Armstrong Tunnel

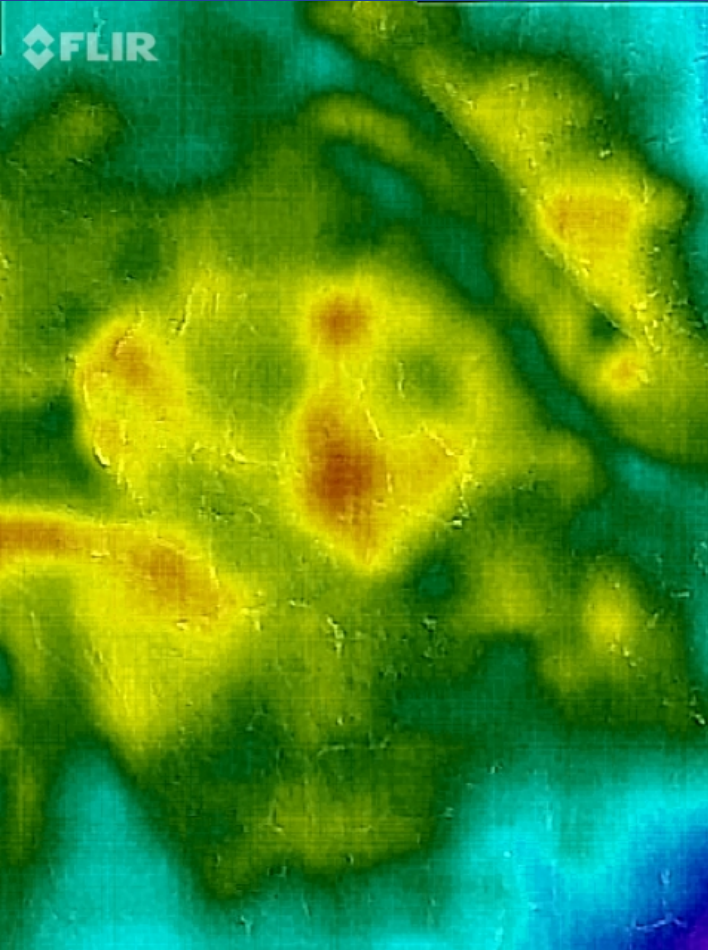
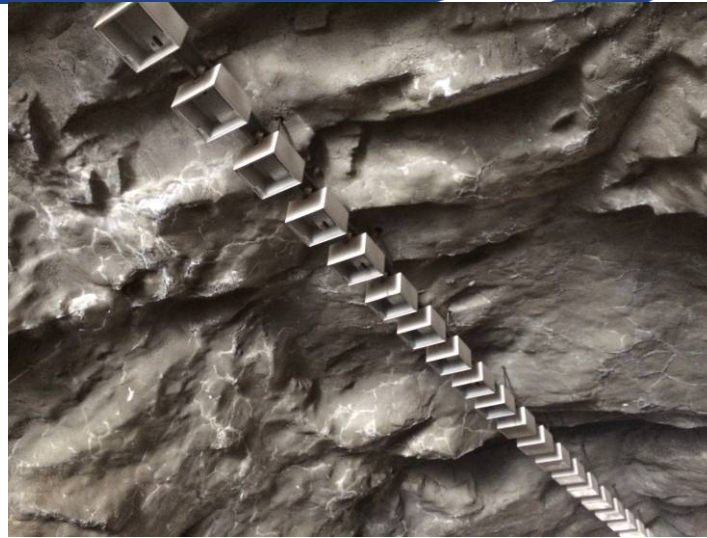
Shotcrete Lined Tunnel

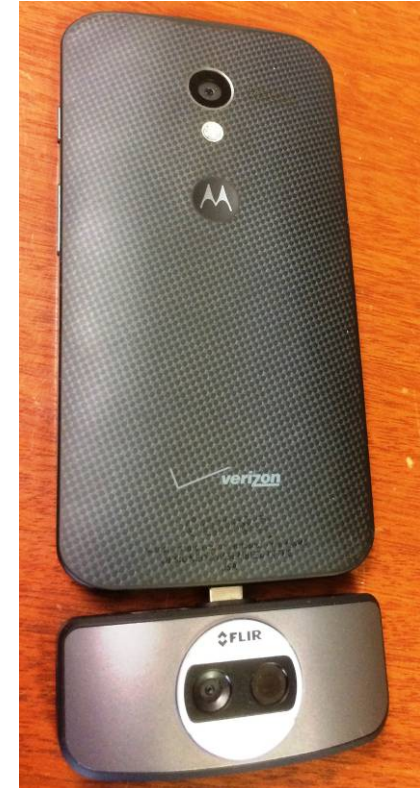
FLIR 1 IR  
Camera

IR Image of Debonded Shotcrete (debonds in red)

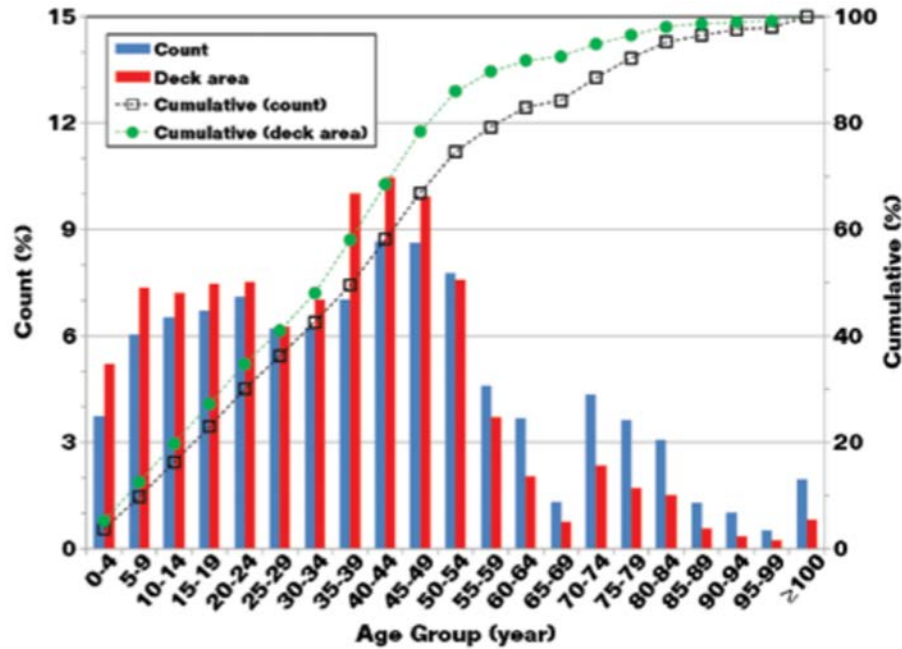
Distribution of the total bridges by age (2010 NBI data)

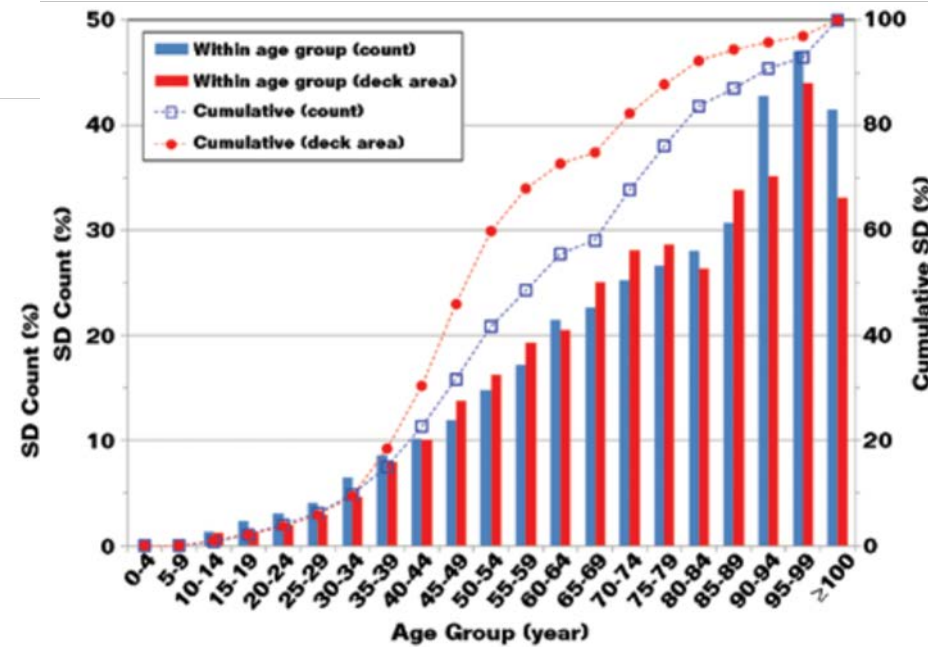
Structural deficient bridges by age (2010 NBI data)
