# Advanced Methods to Identify Asphalt Pavement Delamination (R06D)

## Minnesota DOT Evaluation: Calibration and Signal Analysis

Peer Exchange  
2018

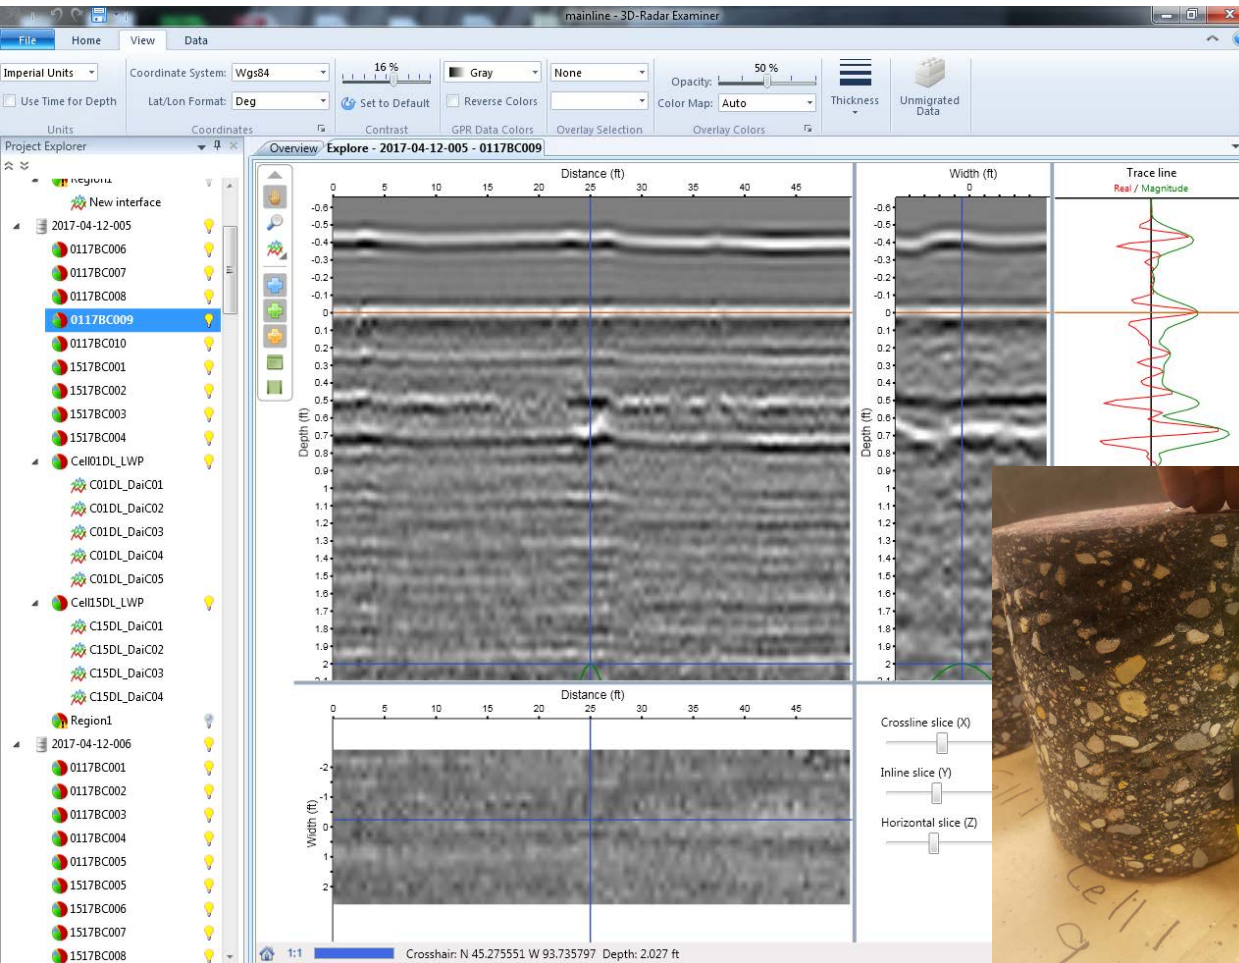
# Examiner Results: MnROAD Deteriorated Pavement, Unclear

9

slight deterioration/strip

direct reflection (deeper than distress)

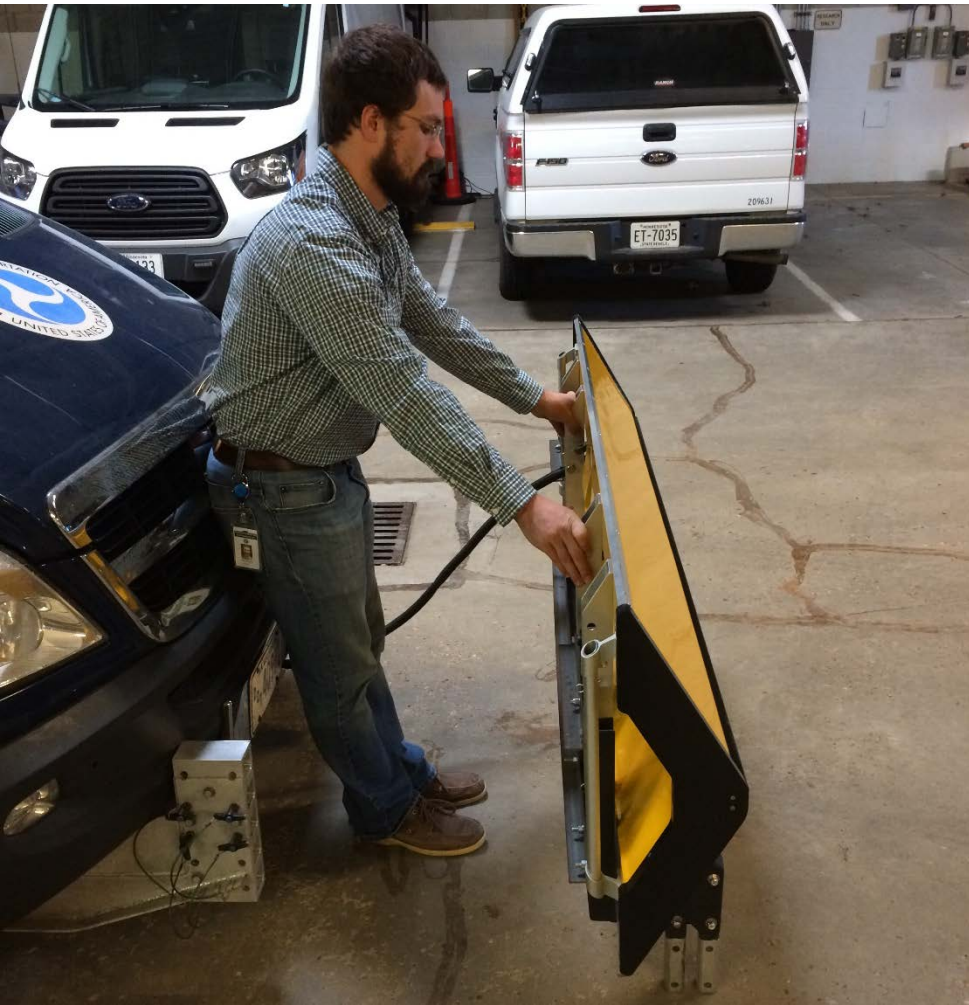
# Controlled Laboratory Tests: Air Calibration

## Extract “Air Wave”

- Face antenna away from the surface
- Eliminate portion of the signal that is only affected by the antenna

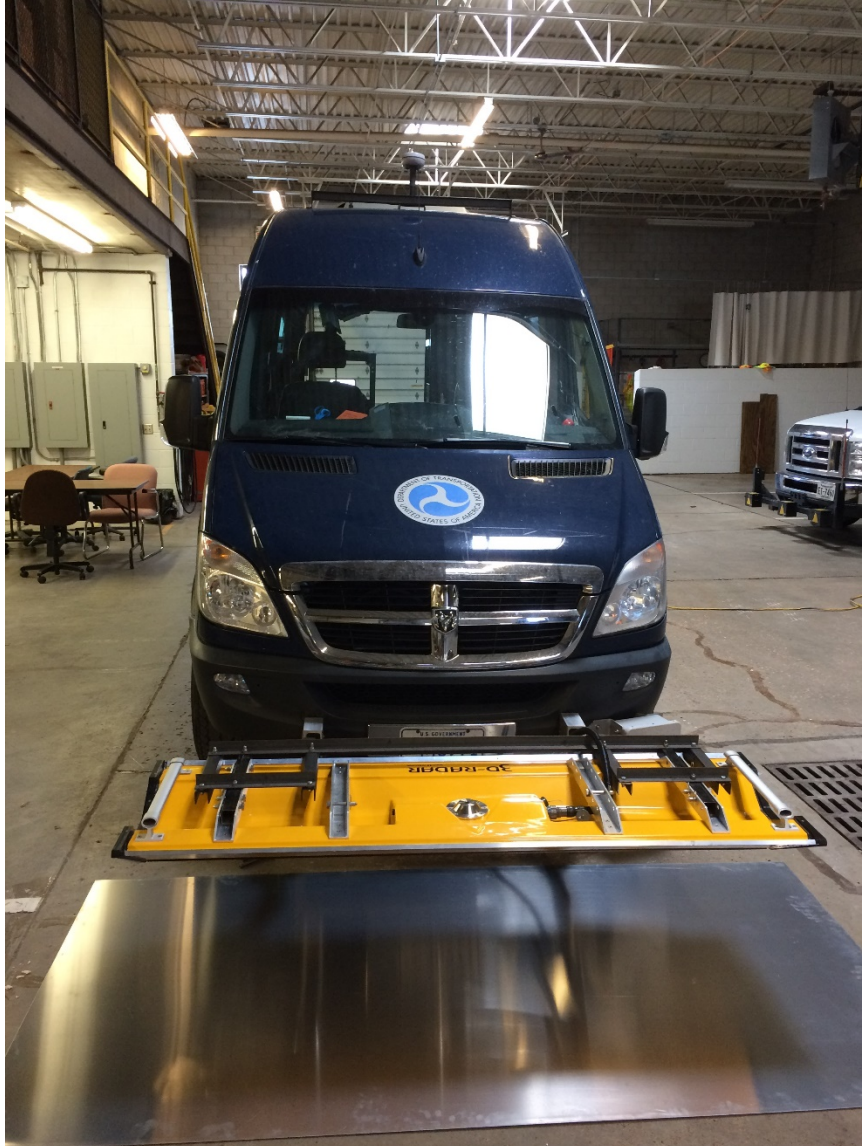
4'x8' Metal Surface Reflection Amplitude

- Placed in the center of the antenna array
- Use the amplitude of the surface reflection to characterize the signal magnitude

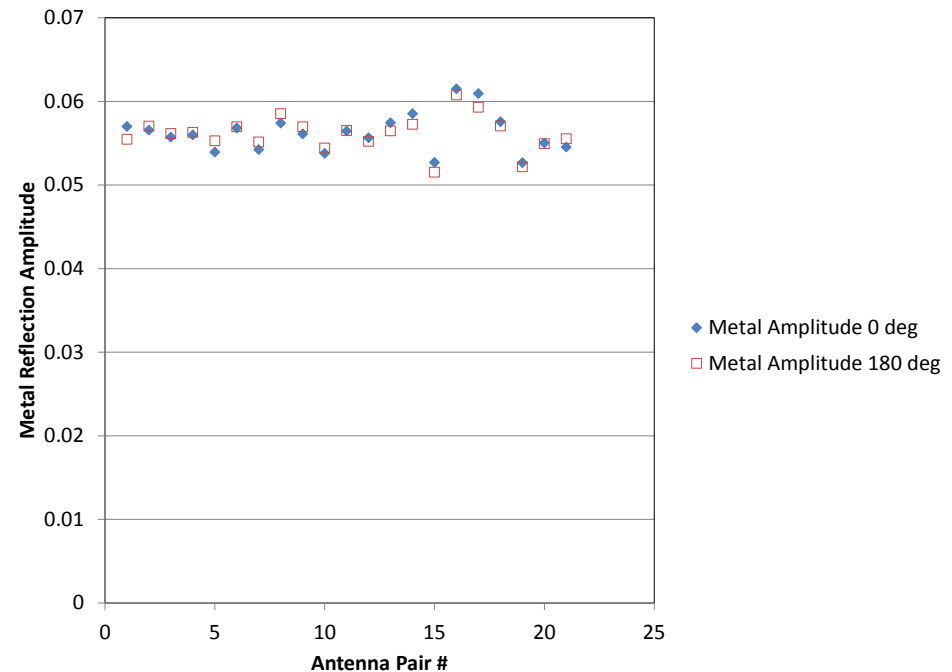
4'x8' Metal Surface Reflection Amplitude  
– Placed in the center of the antenna array  
– Rotated 180 degrees and placed in the center of the antenna array

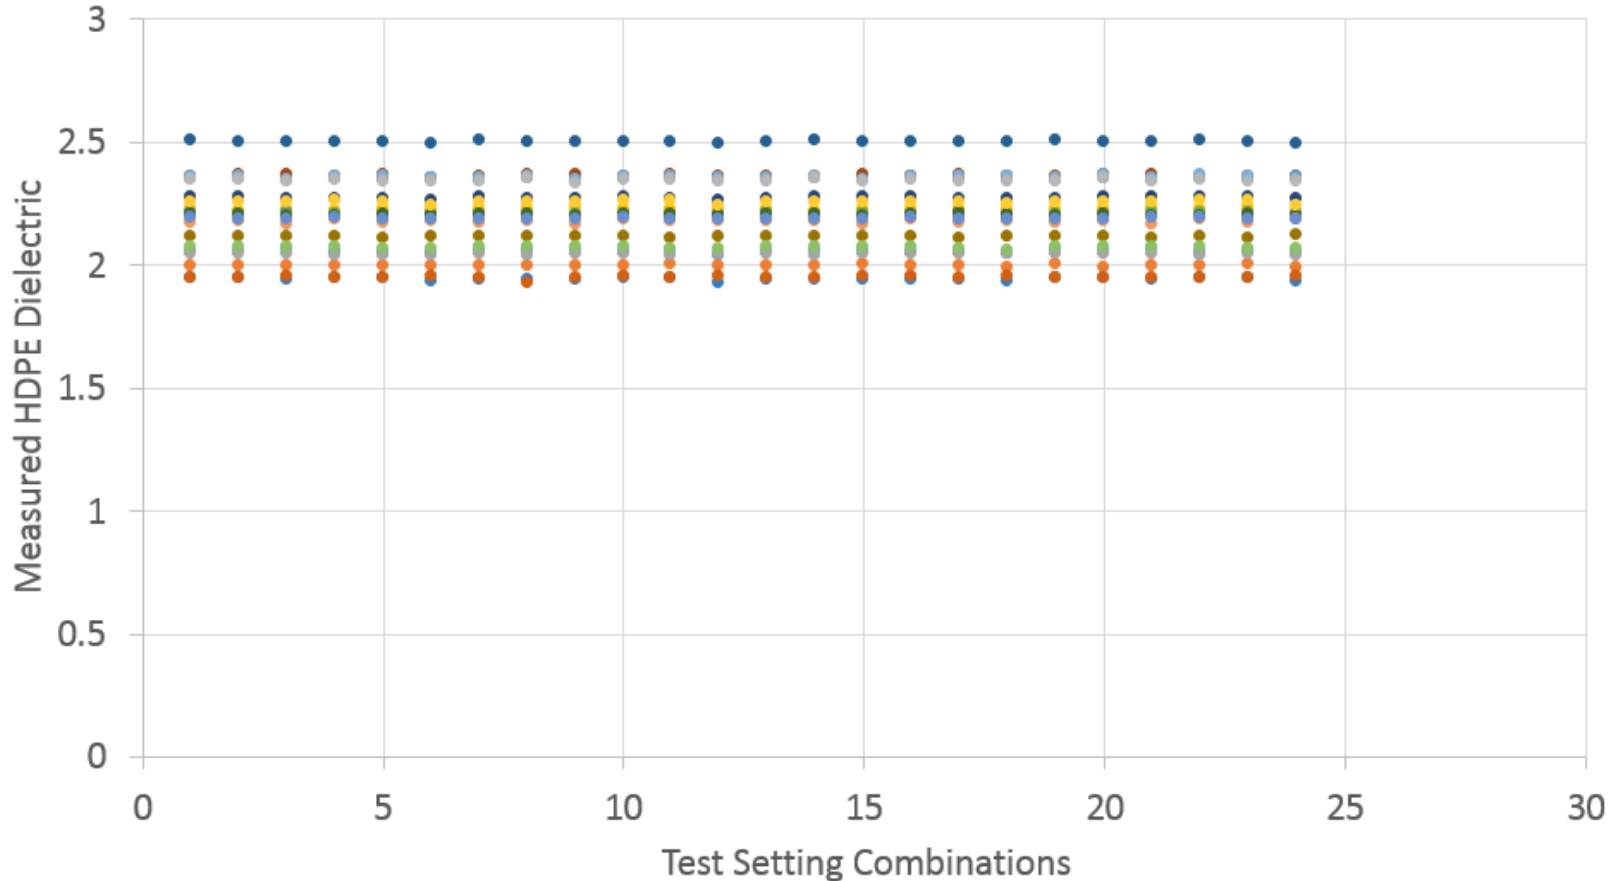
# Controlled Laboratory Tests: HDPE Plastic Dielectric Test

Prior to air calibration

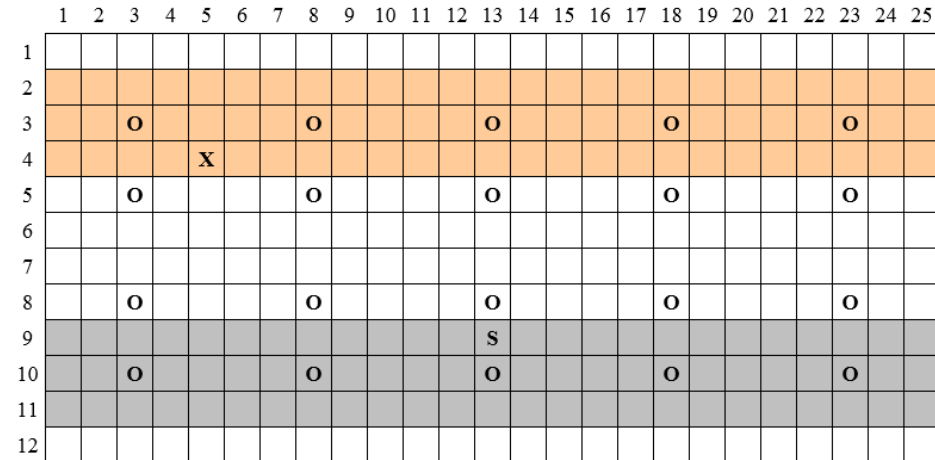
**FIGURE 19** Section 9: HMA Pavement, Wheel Path Delamination (STA 2+15 to 2+40).

## Debonding at 5" depth

Gray = bag house dust; tan = paper; delamination depth = ~ 5 in.; O = locations where point-load methods were conducted; X = verification core; S = standpipe.

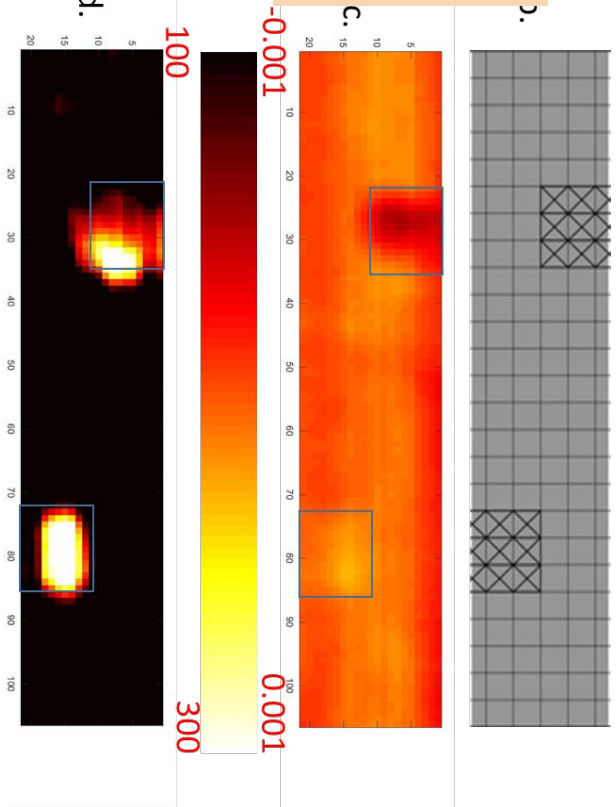
# Raw signal c-scan compared to the filtered data c-scan

C-scan of Energy-filtered Data

C-scan of Raw Data
