# Advanced Methods to Identify Asphalt Pavement Delamination (R06D) Ground Penetrating Radar (GPR) New Mexico DOT

Darlene Goehl, P.E.  
Research Specialist, TTI  
*Peer Exchange*  
*August 1-3, 2018*

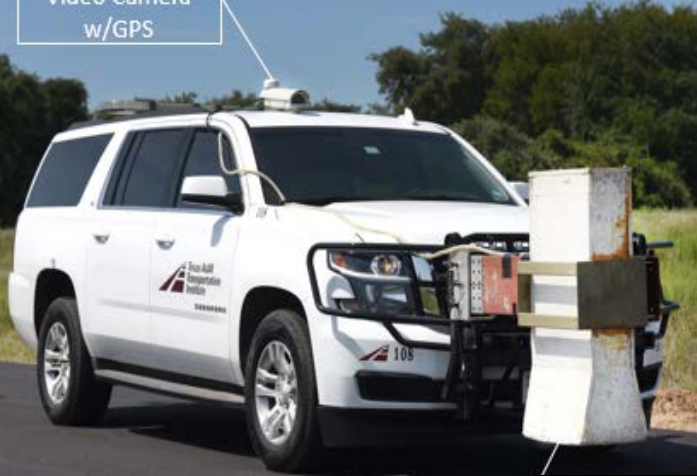
## TTI 1GHz System

GPR Antenna

TTI High  
Definition Video  
Camera w/GPS

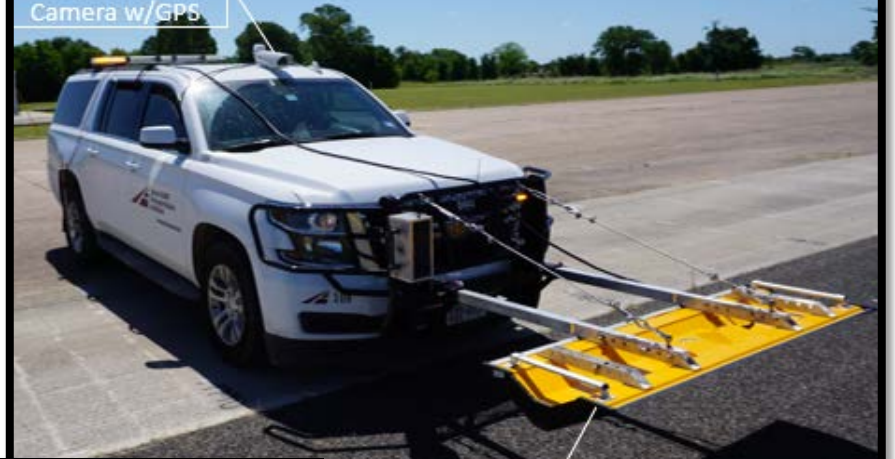
## 3D Radar System

GPR Antenna

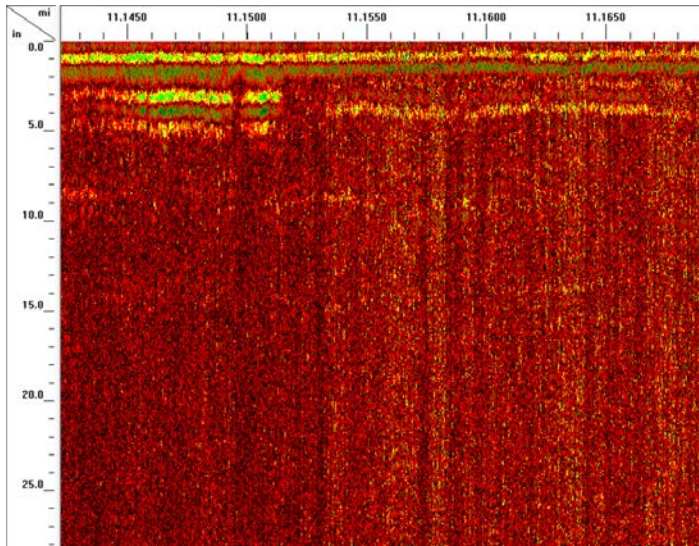
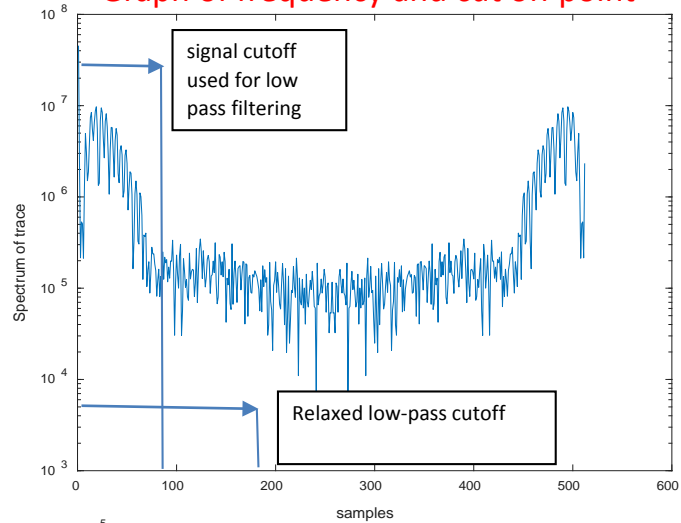
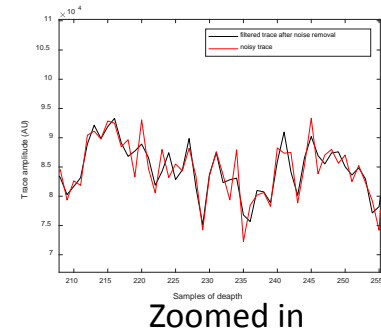
# Pre-processing Filtering

Graph of filtered vs. unfiltered wave from I-40

Graph of frequency and cut off point

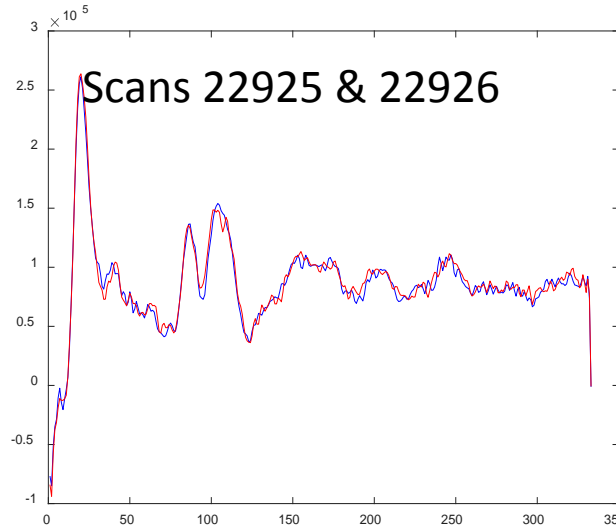
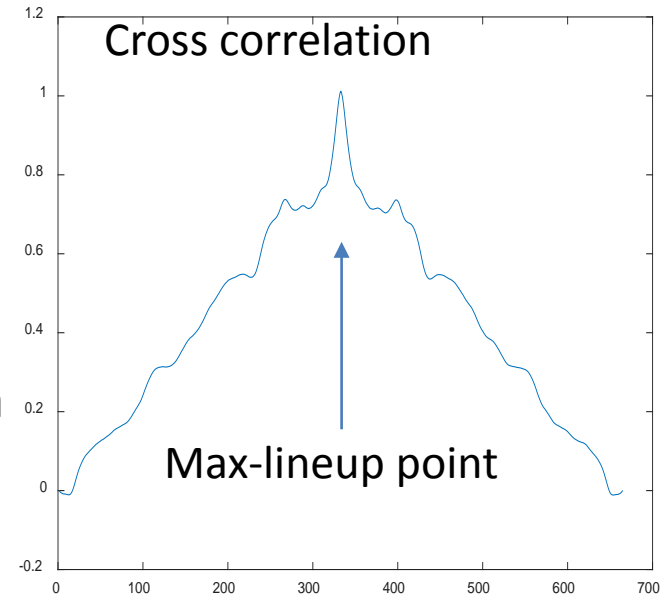
### Maximum cross correlation calculation:

- Every scan is shifted relative to the next scan, the two scans are multiplied, and integral is calculated
- Maximum area is obtained when maximum lineup is achieved
- This maximum integral is the cross correlation

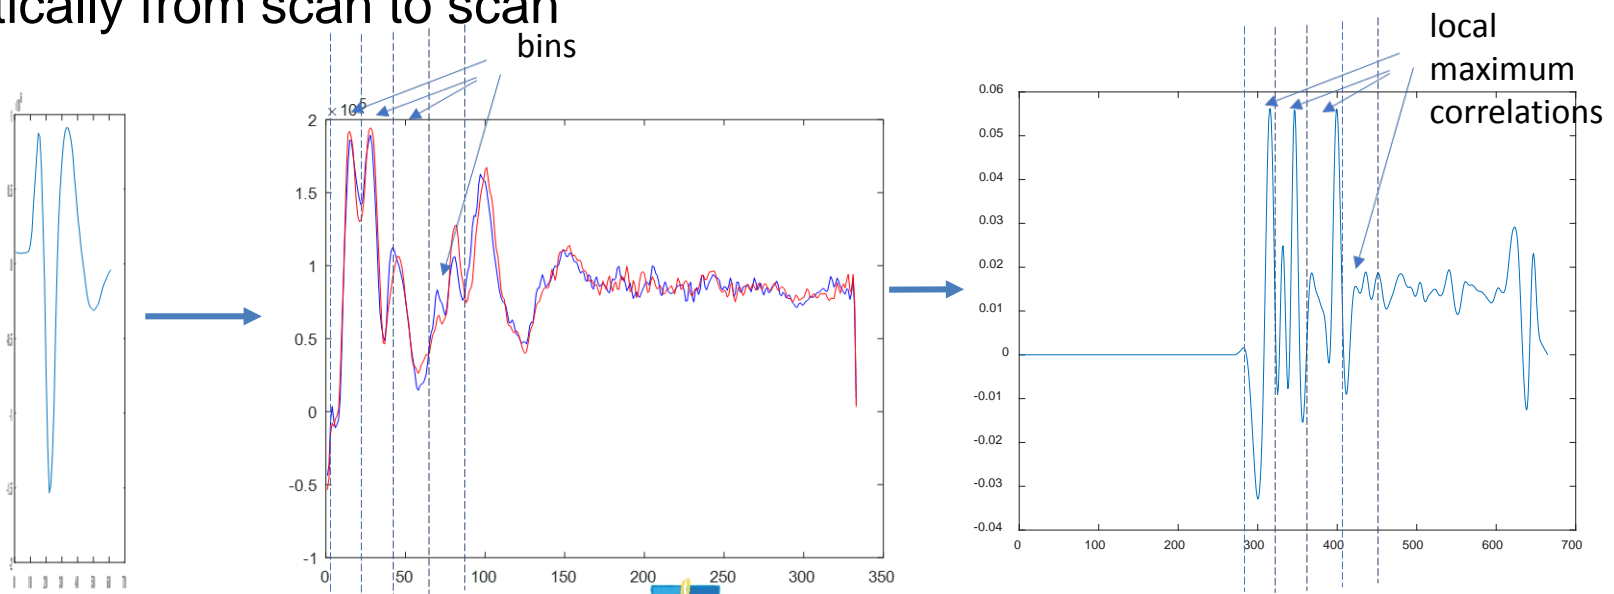
# Negative peak

- We divide each scan into bins of length 20 samples (see middle figure)
- We look for the presence of a negative peak (left figure) in each bin
  - This is done by cross correlating a pulse (left) with each trace (middle)
  - The peak of the cross correlation over each bin is indicative of the presence of a negative peak in that bin (right)
- We announce a negative-peak detection if *any* of the local maxima changes drastically from scan to scan

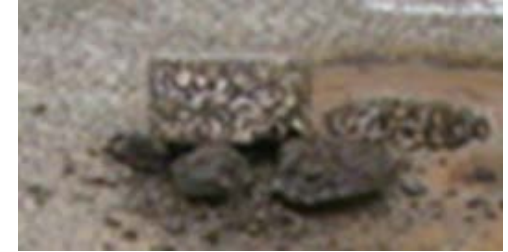
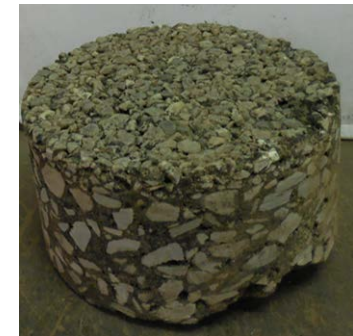
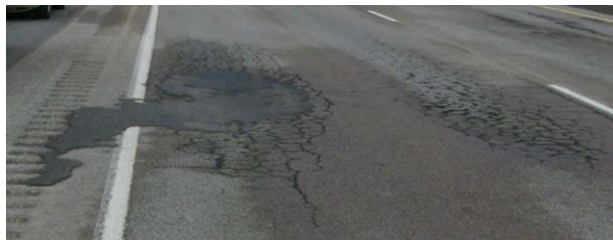
# Old NM264 example

Scan ~ 25,500

Scan ~ 25,800

Direction	MP	core	scan #	Trigger	correct?
EB	10.735	Failure/patch	22,900	Yes	yes
EB	10.745	Debonding	23,200	No	No-but debonding
EB	10.82	Fatigue failure	25,500	yes	Yes
EB	10.825	Stripping	25,800	yes	Yes
EB	11.32	Deteriorated completely	41,200	No	No-GPR limitation?
EB	12.67	Intact	83,700	No	yes

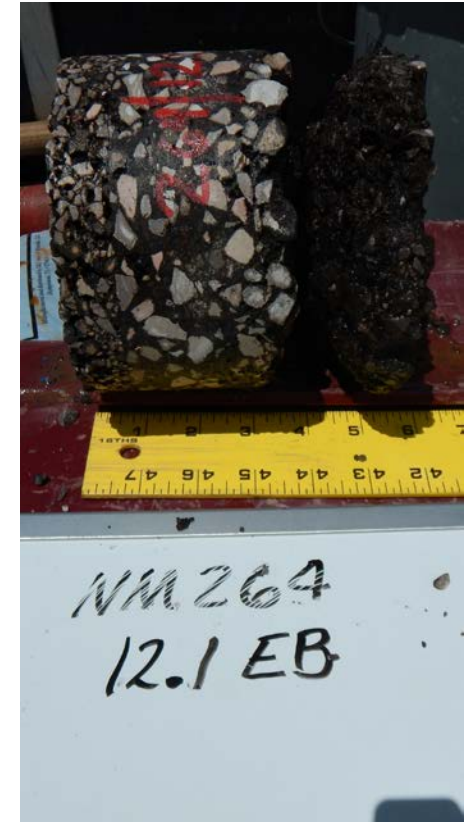
# New NM 264 Example

2017 scan

2015 scan

Scan ~ 11,600

Direction	MP	core	scan #	Trigger scan #	correct?
WB	11.7	intact	24200		yes
WB	12.976	intact	10850		yes
WB	12.1	patch area	20000	20035	yes
WB	11.9	high air voids	22100	22103	yes
WB	11.3	intact	28400		yes
WB	11.2	intact	29450		yes
EB	11.1	high air voids	1054	1100	yes
EB	12.1	stripping	11600	11647	yes

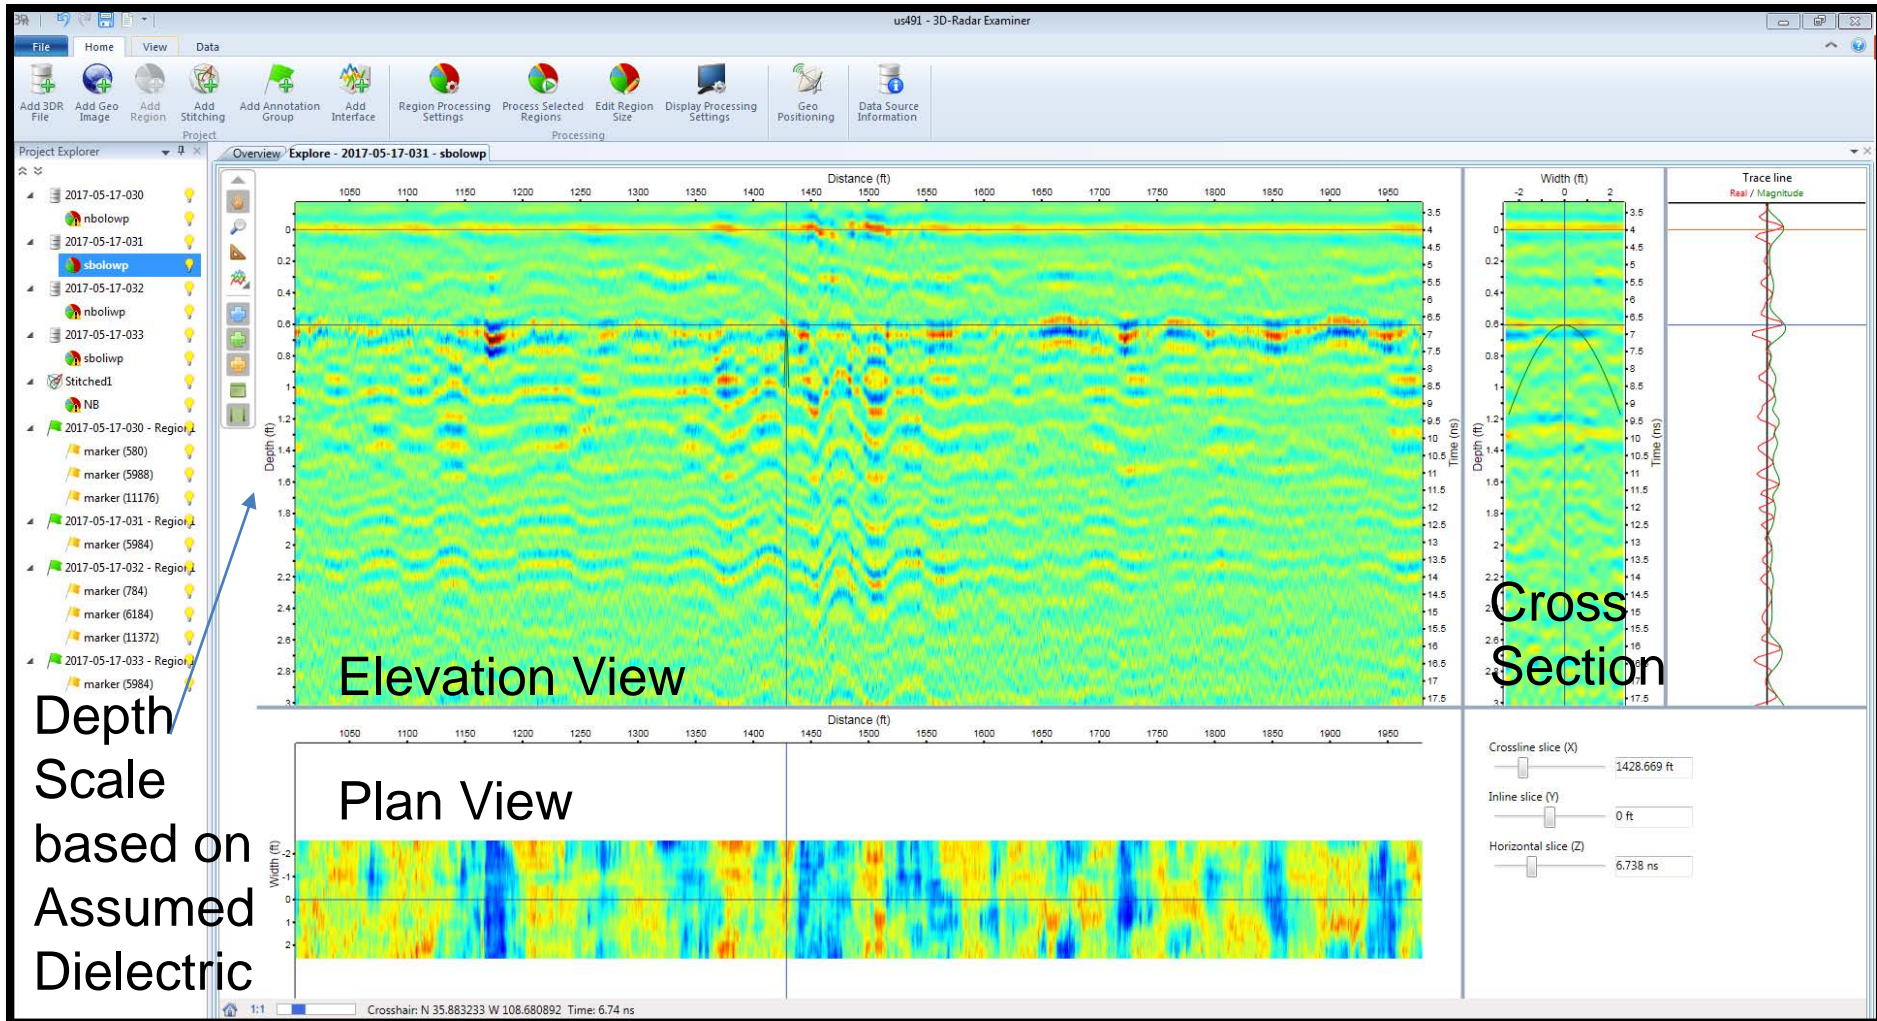
# 3D Radar Examiner Software

Depth Scale based on Assumed Dielectric

Elevation View

Plan View

Cross Section

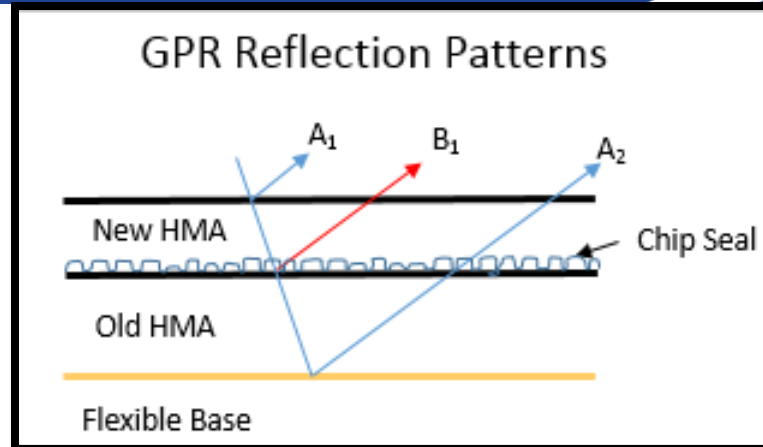
## Case-1: Normal

B<sub>1</sub> Positive, very small reflection  
Little dielectric contrast  
between new and old HMA

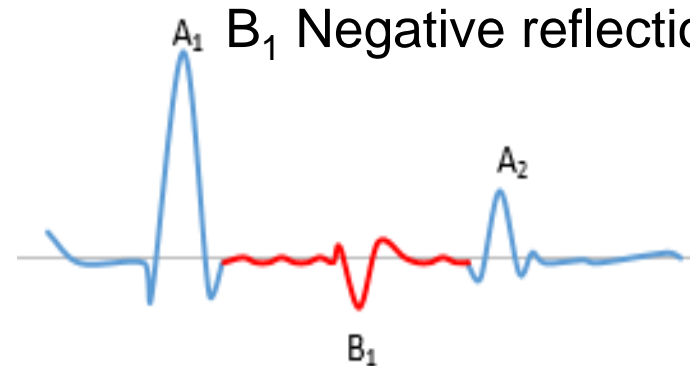
## Case-5: Lower HMA Severely Deteriorated-Stripping

Note: large negative reflections may be high void area, stripping or debonding

- In general the patterns follow the patterns we expect based on past experience.
  - The false patterns encountered, help justify the need to take verification cores.
- It is very difficult to distinguish between severity of deterioration/delamination.
  - While the patterns are similar, severe stripping tends to have much larger amplitude.
