# Advanced Methods to Identify Asphalt Pavement Delamination (R06D) Ground Penetrating Radar (GPR) Texas Department of Transportation

Darlene Goehl, P.E.  
Research Specialist, TTI  
*Peer Exchange*  
*August 1-3, 2018*

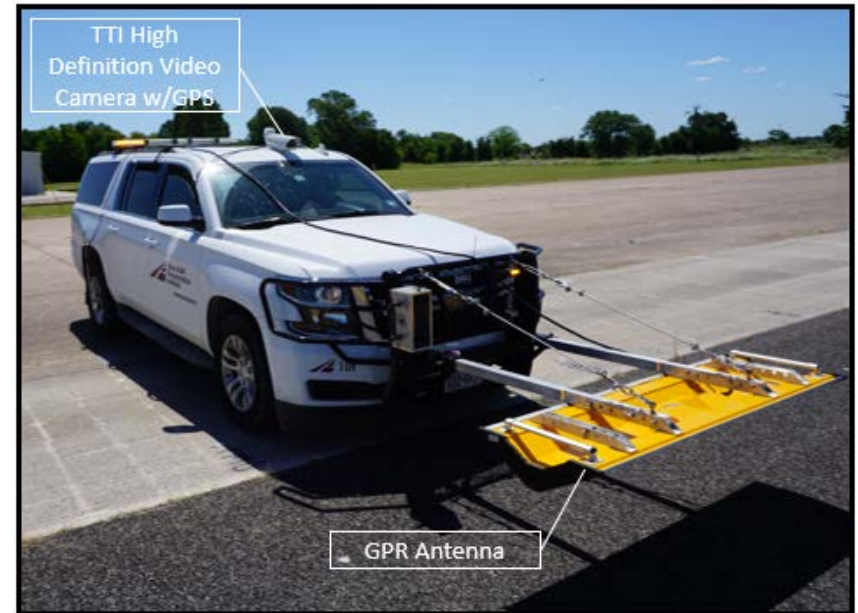
# Antenna Mounting Details

- Front of Vehicle
  - Consider this to be safer for operation
- 4 foot From Vehicle
  - Far enough away to minimize interference
- 18 inches from pavement to bottom of antenna
  - Ground clearance for safe operation

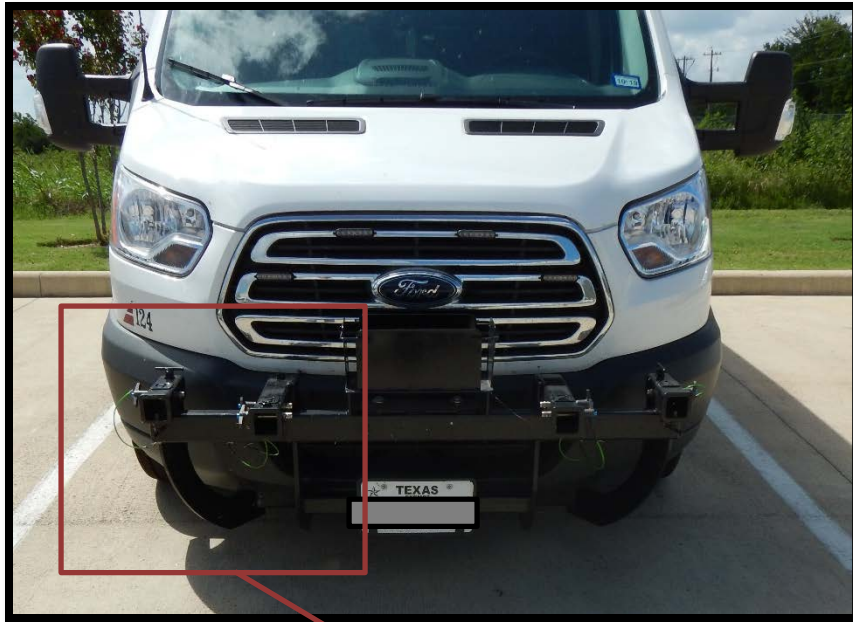
# Mounting System - Bumper

Aluminum Support Bars  
Use 4 connection locations on antenna

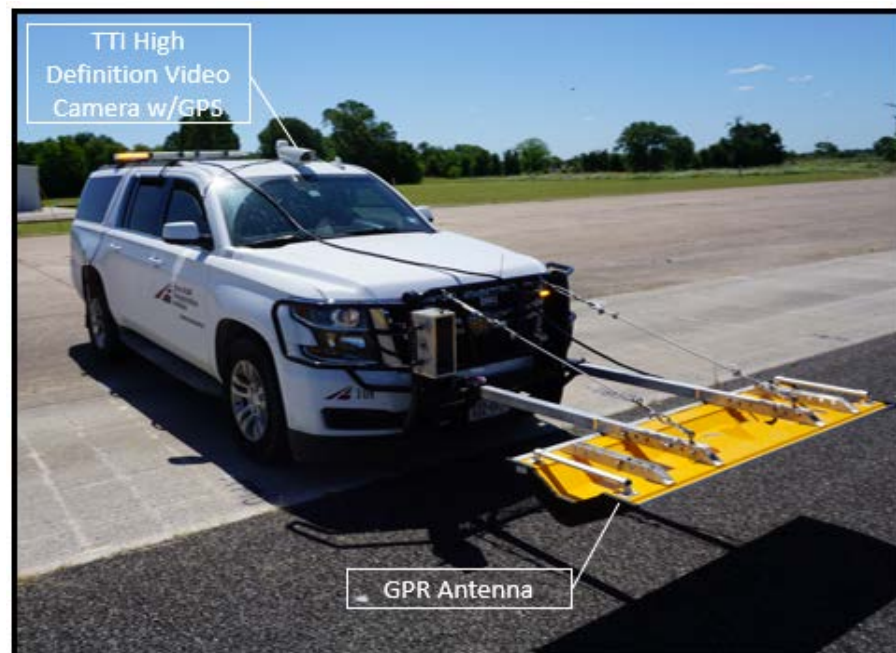
## 3D Radar System

- Flexible Pavement
  - Collect at Highway Speed
  - Collection interval 12”+
  - Significant Data Storage Required
    - US 59, 3.35 miles 1 run required 1,578,000 KB of storage

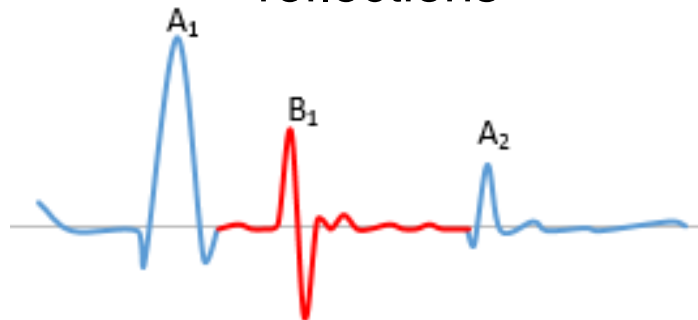
## Case-3:

Thin Layer of Moisture on Top of Seal  
B<sub>1</sub> Overlapping Positive and Negative reflections

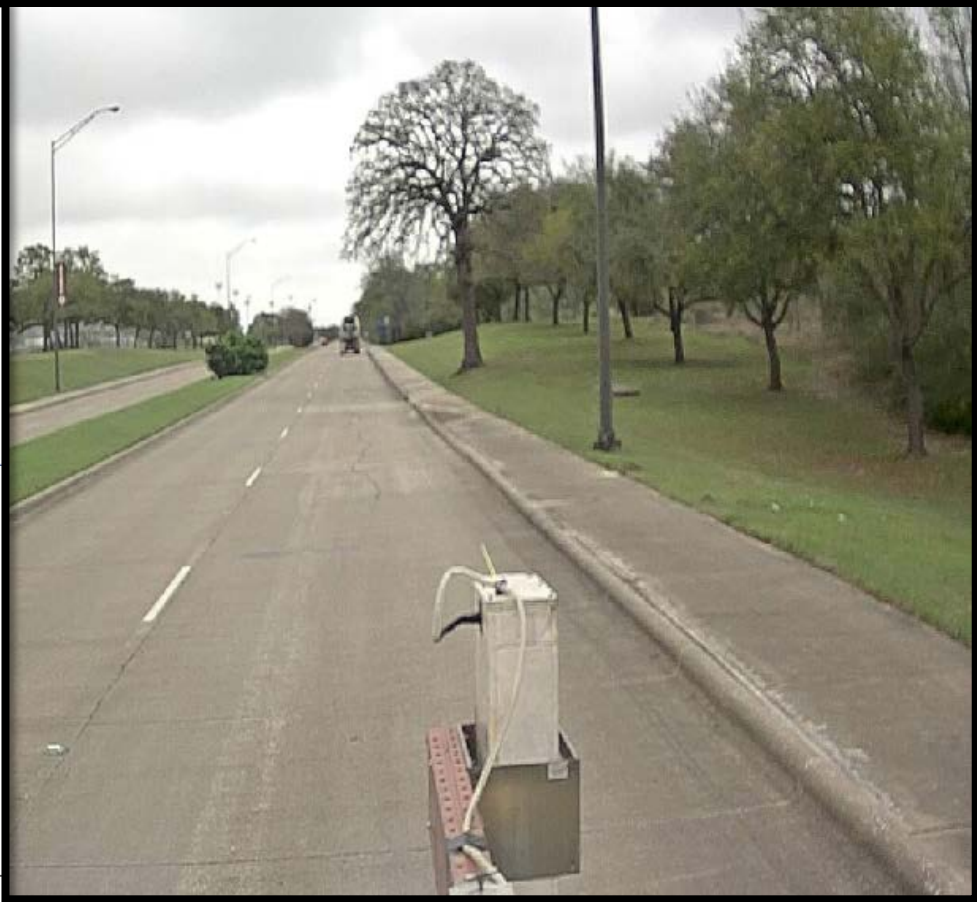
# Concrete Pavement FM 2347 Bryan District

3D Radar indicates skewed dowel baskets, sawed joints are not skewed.
