Case Study of Infrared Deployment

Technologies to Enhance Quality Control on Asphalt Pavements

Pave-IR Scan™

October 2017

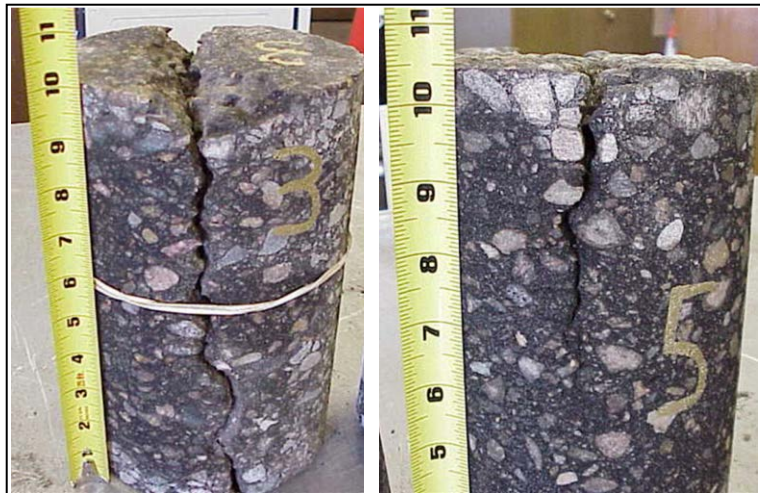
The core to the right in Figure 1 clearly shows a concentration of coarse aggregate at the surface. This concentration of coarse aggregate caused a “weak” spot where a longitudinal crack started at the surface and is propagating downward through the HMA. The core to the left is similar, but the crack has propagated through all of the HMA layers and the coarse aggregate have become dislodged by traffic and exhibits severe raveling along the longitudinal crack.

Figure 1. Longitudinal Aggregate Segregation and Top-Down Cracking.

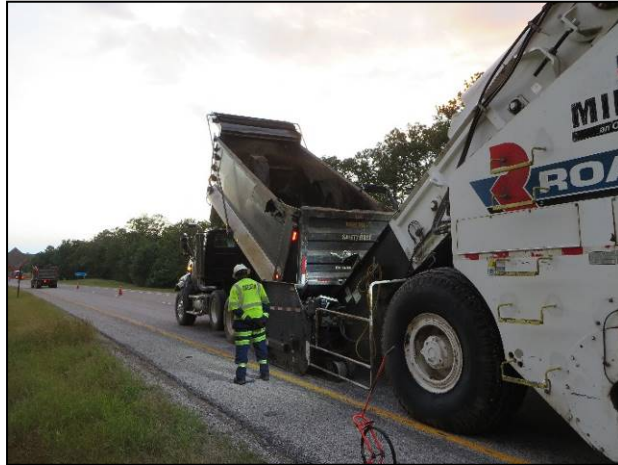
Figure 3. End-Dump Trucks Delivering Mixture to the Alabama Paving Site.

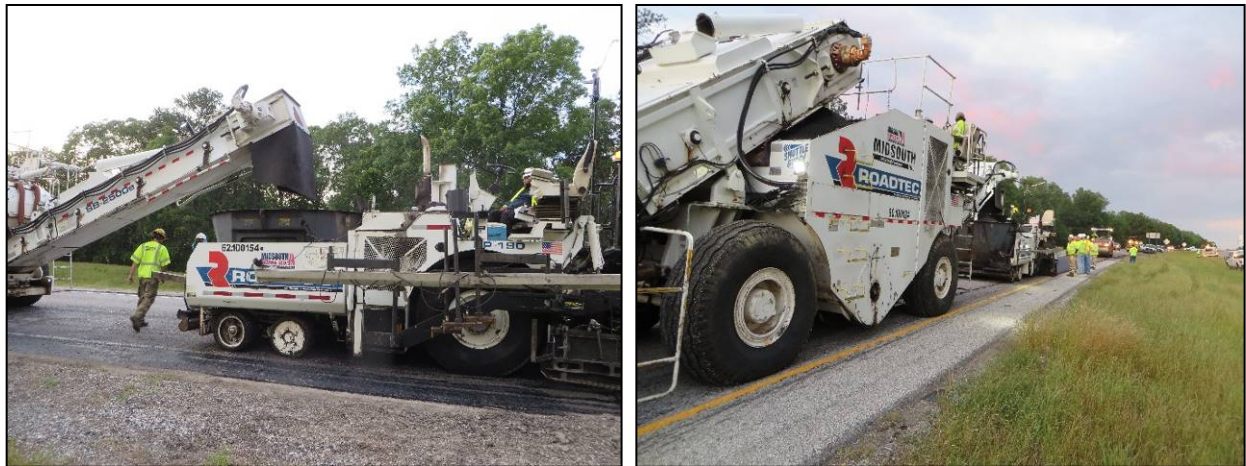
Figure 4. Roadtec Paver and Roadtec Material Transfer Vehicle Used to Place the Mixture.

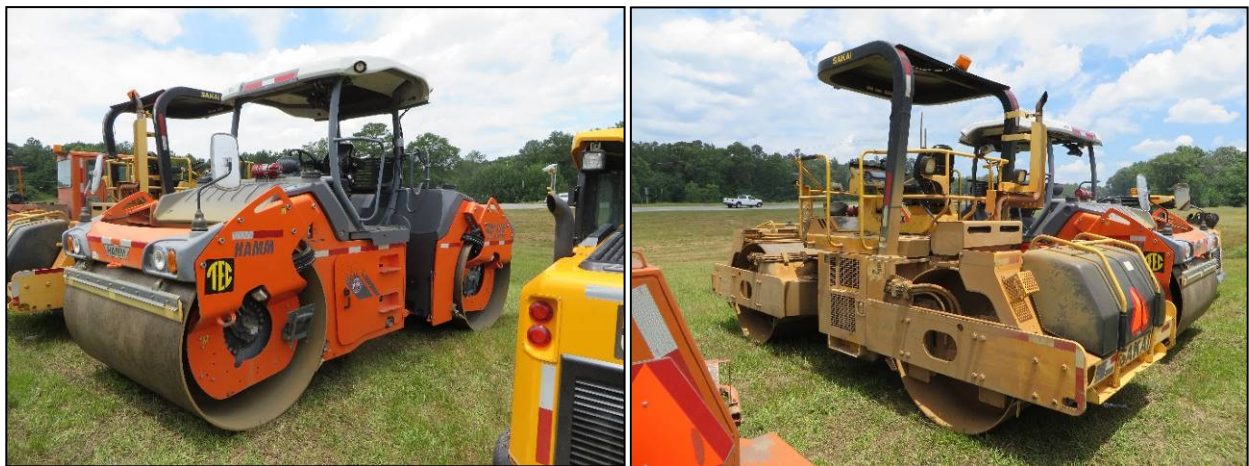
Figure 5. Hamm Roller Used in the Breakdown, and Sakai Roller Used in the Finish Rolling Position to Compact the Asphalt Concrete Mixture.

Compaction of the mix was achieved using one Hamm steel-drum roller in the breakdown position, with a Sakai steel-drum roller in the finish roller position. The breakdown roller was used in the vibratory and static settings, with the finish roller in the static setting. During the paving of the first control strip the rollers were having difficulty with the mix moving around during most rolling patterns and were creating a non-uniform surface visually. On the second night of paving the addition of the tack coat, the only paving variable changed that was observed, made it much easier for the roller crew to adjust the roller pattern to achieve density. Figure 5 shows the rollers used on the project. Cores were taken at random locations for acceptance of the mixture on the night of paving to determine if the control strip was acceptable. The results of this control strip on May 18 produced unsatisfactory results, with cracking and material loss evident the following day. The second night of control strip paving produced a satisfactory final surface.

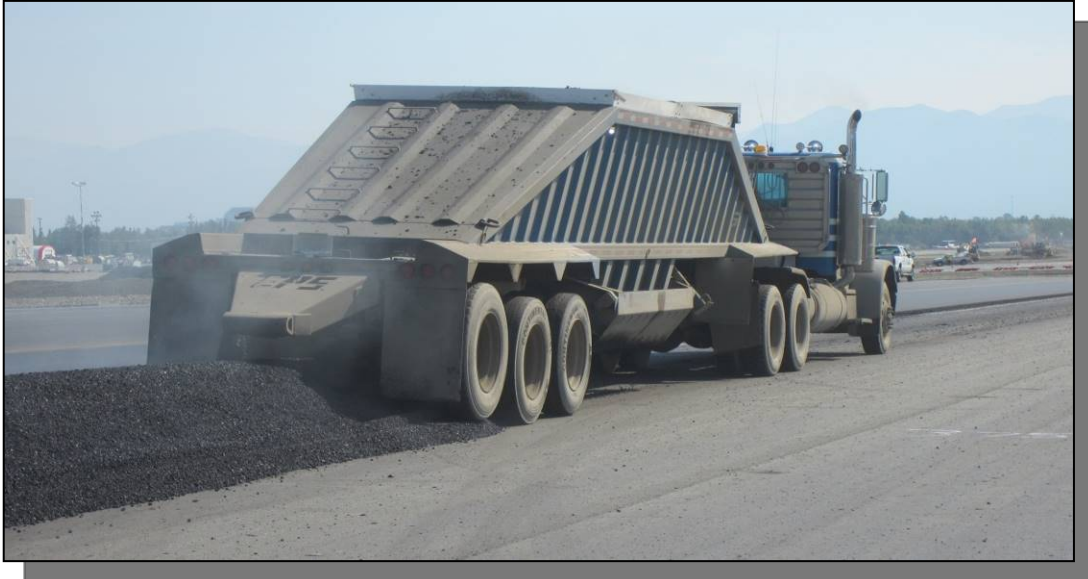
Figure 7. Bottom-Dump Truck Delivered Mix to Alaska Paving Site.

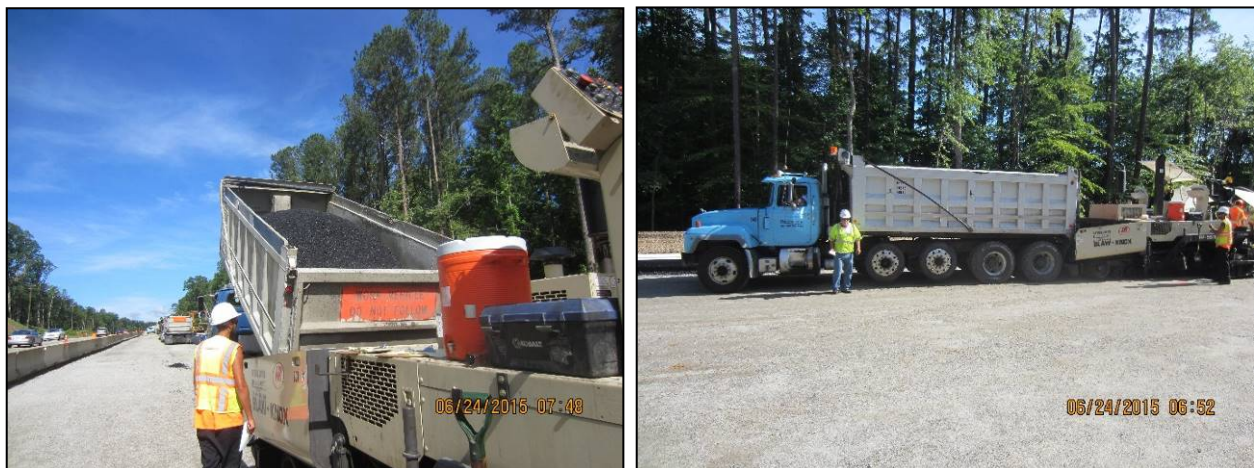
Figure 9. End-Dump Trucks Delivering Mixture to the EFL Paving Site

The asphalt concrete mixture was delivered to the project using end-dump discharge trucks, as shown in Figure 9. The haul time was between 45 minutes and two hours due to the location of the asphalt plant in Manassas, VA, and traffic conditions near the project site. This led to inconsistent delivery of material and frequent stops in paving shown in the data analysis presented in later sections. A Blaw Knox® rubber-tracked paver was used to place the mixture on the surface.

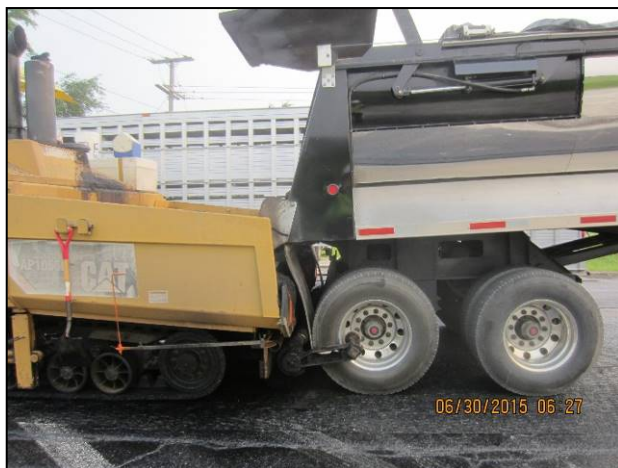
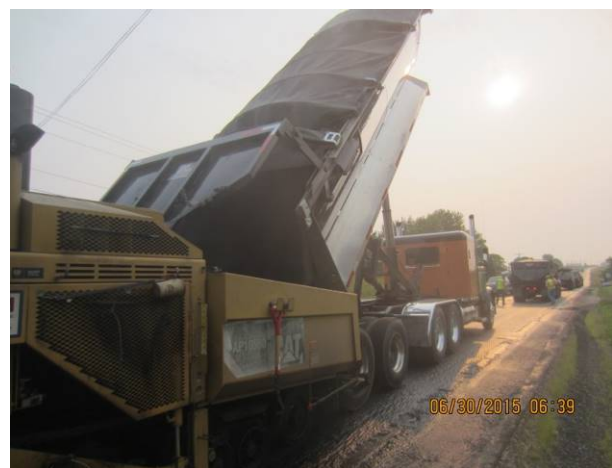
Figure 12. End-Dump Truck Delivering Mixture to Caterpillar Paver on the IL 116 Project

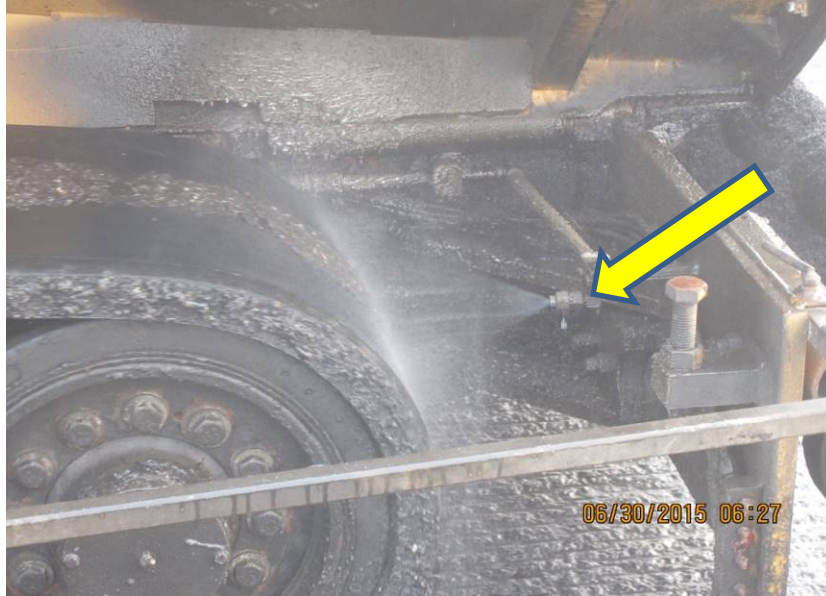
Figure 13. Water Nozzle Installed in Front of the Rubber-Track to Reduce Mix and Tack Coat Pick-Up along the IL 116 Project

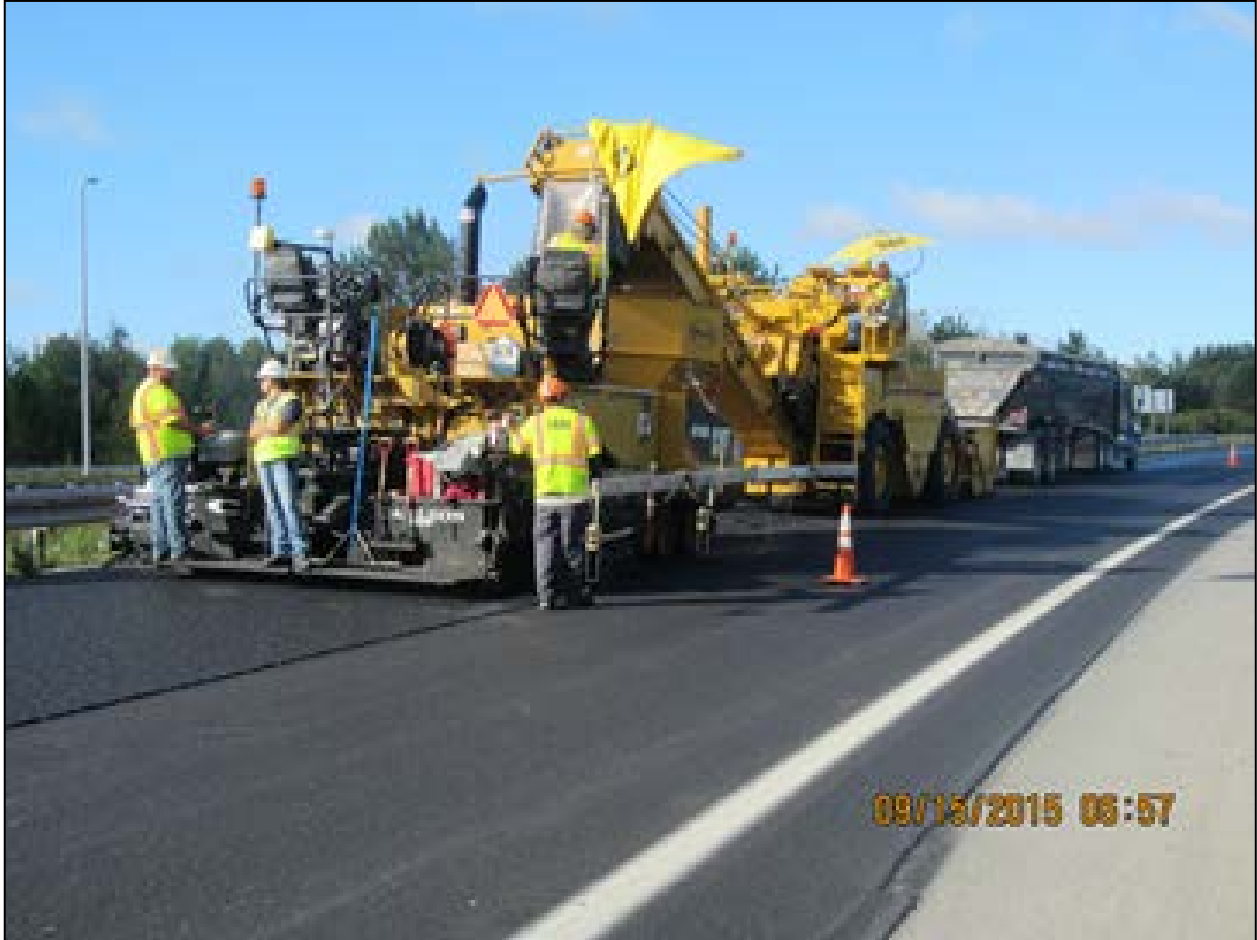
Figure 16. Paving Operation Used along the Maine I-95 Project

Five rollers were used to compact the mixture: a Caterpillar, Volvo, and Ingersoll-Rand steel wheel vibratory rollers, a Hamm steel wheel oscillatory roller, and a Caterpillar rubber tired roller. Two of the steel wheel rollers were used in the breakdown position in echelon, while the other two steel wheel rollers were used as finish rollers. The combination of breakdown and finish rollers changed during paving operations on different days. The Caterpillar rubber tired roller was used in the intermediate position.

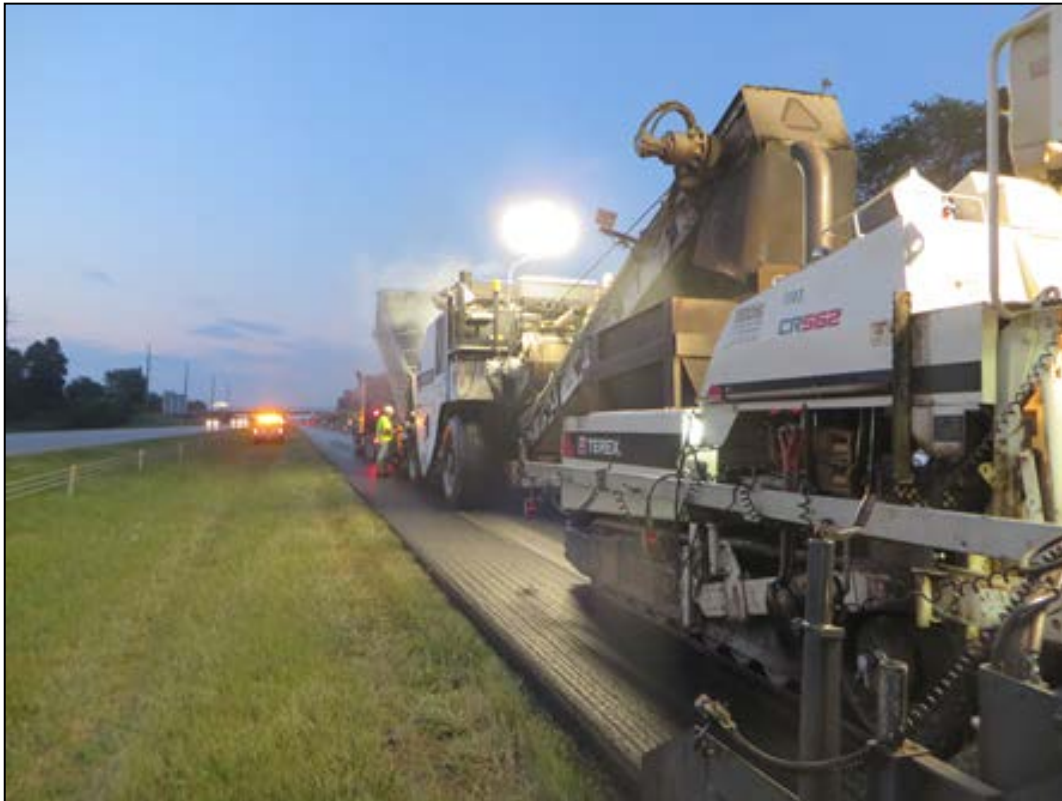
Figure 18. Paving Operation Used along the Missouri I-29 Project.

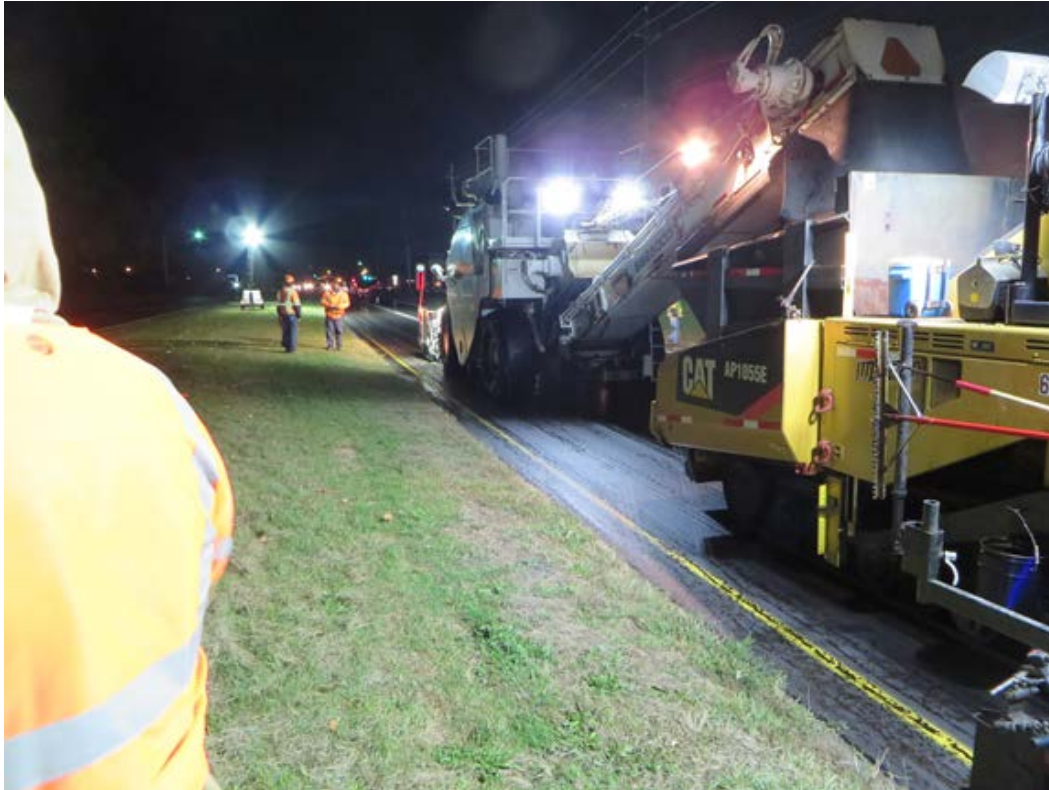
Figure 20. Paving Operation Used along the New Jersey US-130 Project Location.

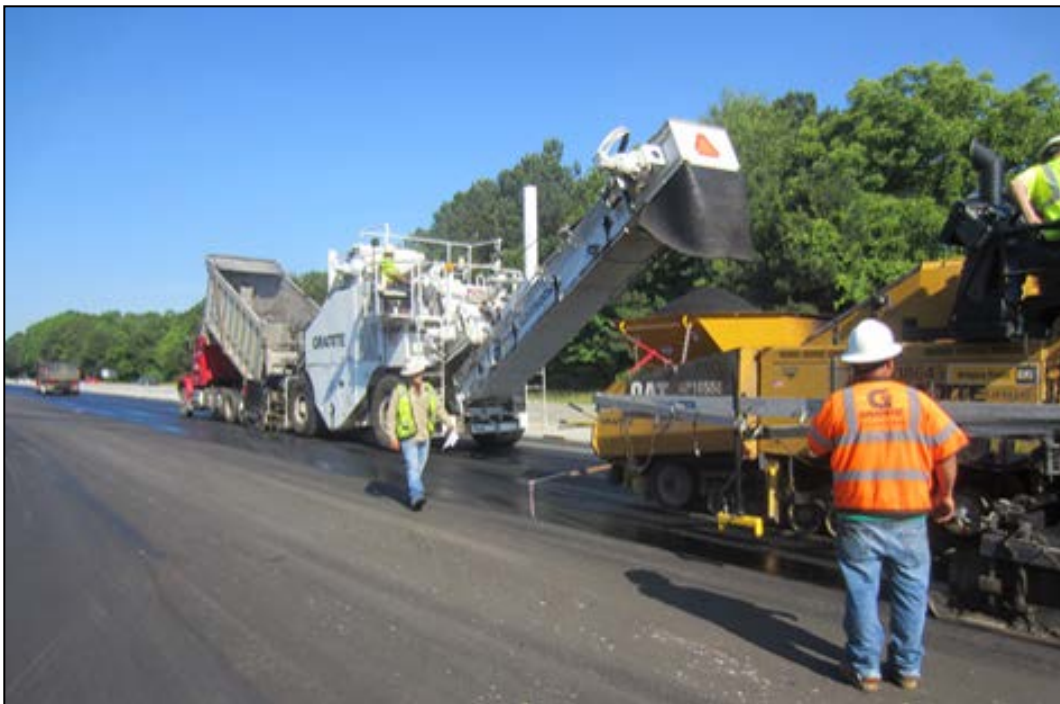
Figure 22. Paving Operation Used along the North Carolina I-40 Project.

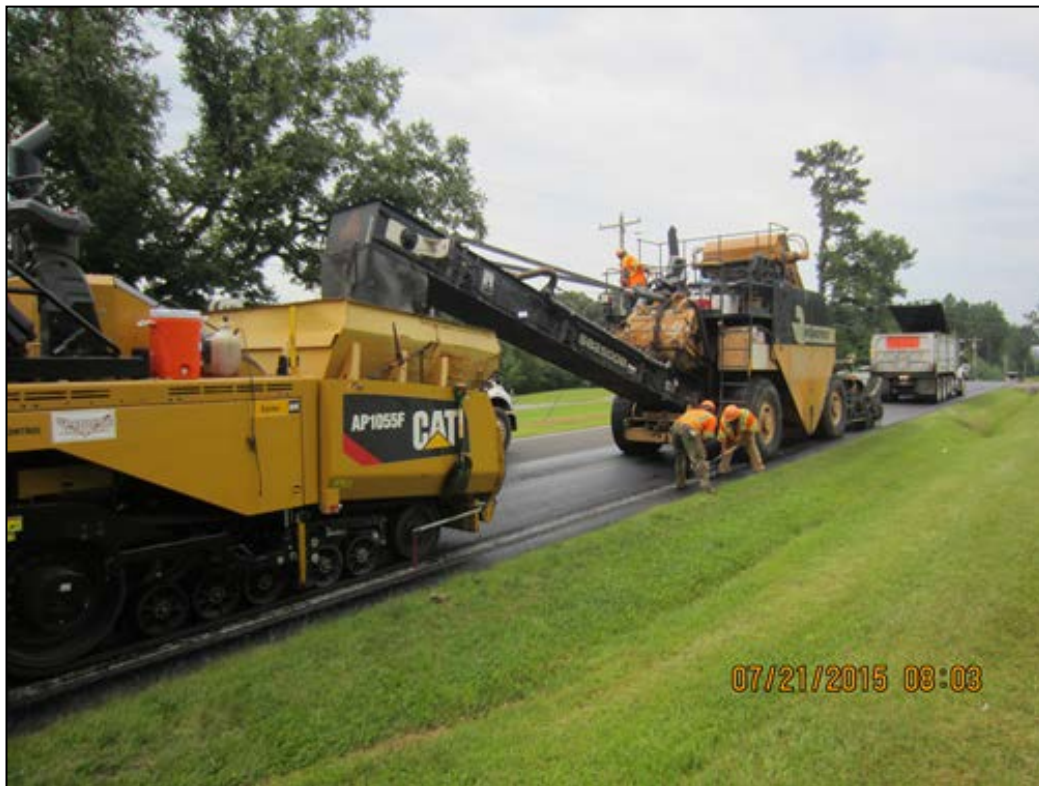
Figure 24. Delivery-Paving Operation Used along the Virginia US-15 Project.

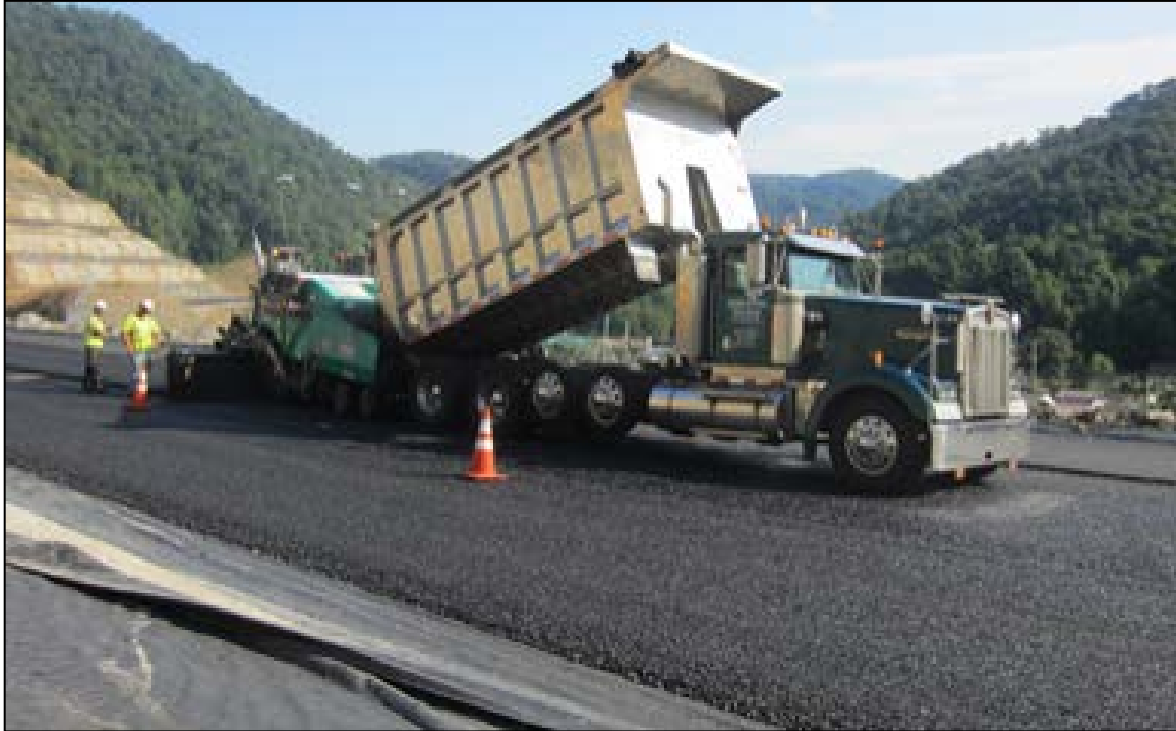
Figure 26. Mixture Delivery-Paving Operation used along the State Route 10 Project

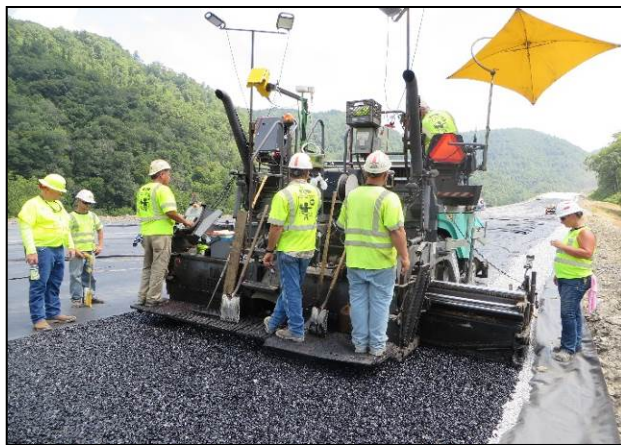
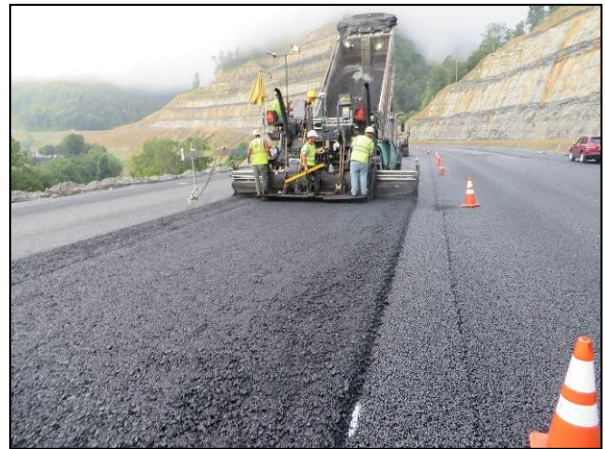
Figure 27. Placement of Drainage Base on the Geosynthetic Fabric along State Route 10

The construction strategy for the segment of SR 10 during the field demonstration project involved placing a 4-inch open graded drainage base on a geosynthetic filter fabric July 26. On July 27 and July 28, a 3-inch asphalt concrete base layer was paved over the drainage base without tack to preserve the properties of the drainage base. Figure 23 shows the placement of the drainage base on the geosynthetic, and the base paving on the drainage base layer.

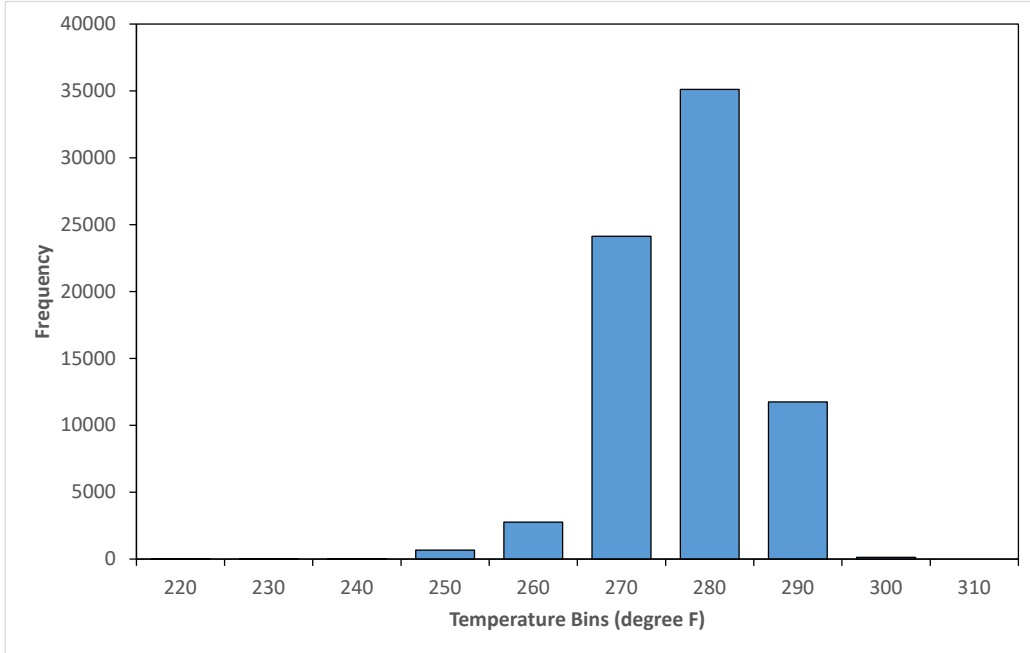
Figure 30. Processed Temperature Distribution for Path 1 on May 18, 2017; Alabama Field Demonstration Project.

Following the pre-screening procedure outlined above, a temperature contour plot was generated from the remaining data for further evaluation. To be consistent with Tex-244-F, the entire path was broken down into segments of 150 feet in length, and the segments were numbered from SG1 to SG24, with SG1 being the first 150-foot segment at the beginning (west end) of paving. Tex-244-F recommends that all paver stops greater than 1 minute in duration be removed from the processed temperature data for establishing the number of sections within the different temperature differential categories. Table 10 summarizes the analysis of the temperature differentials for excluding and including the paver stops. As shown, the use of the MTV and/or belly dump trucks significantly reduced the number of sections with temperature differentials exceeding 50 °F.

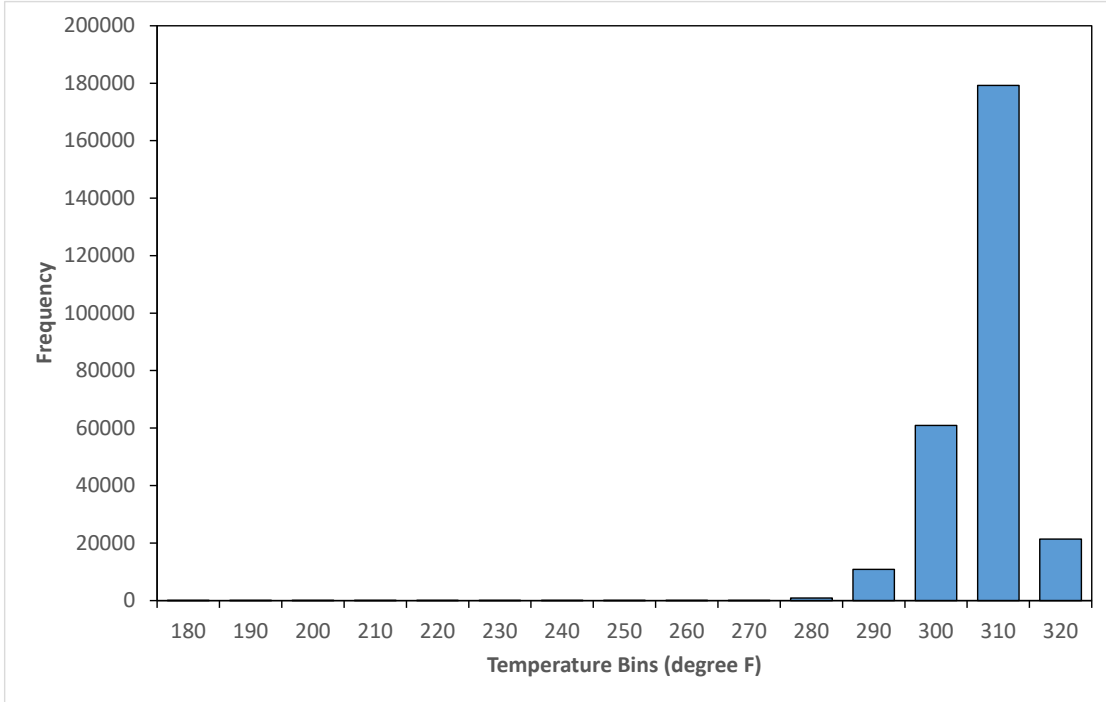
Figure 38. Processed Temperature Distribution, I-95; Maine Field Demonstration Project.
