SHRP2 Case Study
Infrared Thermal Profiler for Improving Mat
Uniformity and Long-Term Performance

Technologies to Enhance Quality Control on Asphalt Pavements, R06C

March 15, 2018

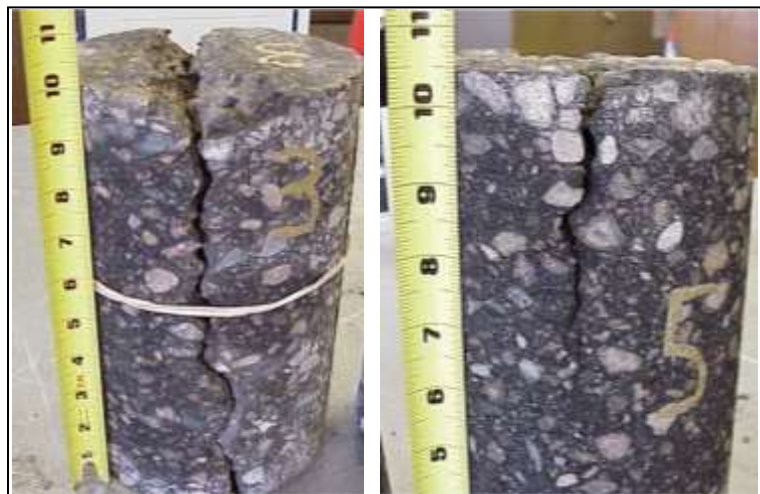
Figure 1. Longitudinal Aggregate Segregation and Top-Down Cracking

The core to the right in Figure 1 clearly shows a concentration of coarse aggregate at the surface. This concentration of coarse aggregate caused a “weak” spot where a longitudinal crack started at the surface and is propagating downward through the AC.

The core to the left in figure 1 is similar, but the crack has propagated through all of the AC layers. In addition, the coarse aggregate have become dislodged by traffic and exhibits severe raveling along the longitudinal crack. This condition can occur in a few years after construction and require premature maintenance or rehabilitation.

Segregation shows up as cold spots or areas on an IR scan or photograph, and the severity of segregation is quantified by the magnitude of the temperature differential in localized areas or thermal streaks down the roadway. Essentially, the cold spot results in low-density areas of the compacted AC mat, and the thermal streaks result in a weakened plane down the roadway. The cold spots can also exhibit a coarser gradation and lower asphalt cement content increasing the susceptibility for raveling and cracking. The thermal streaks or longitudinal segregation results in a crack initiator (see figure 1).

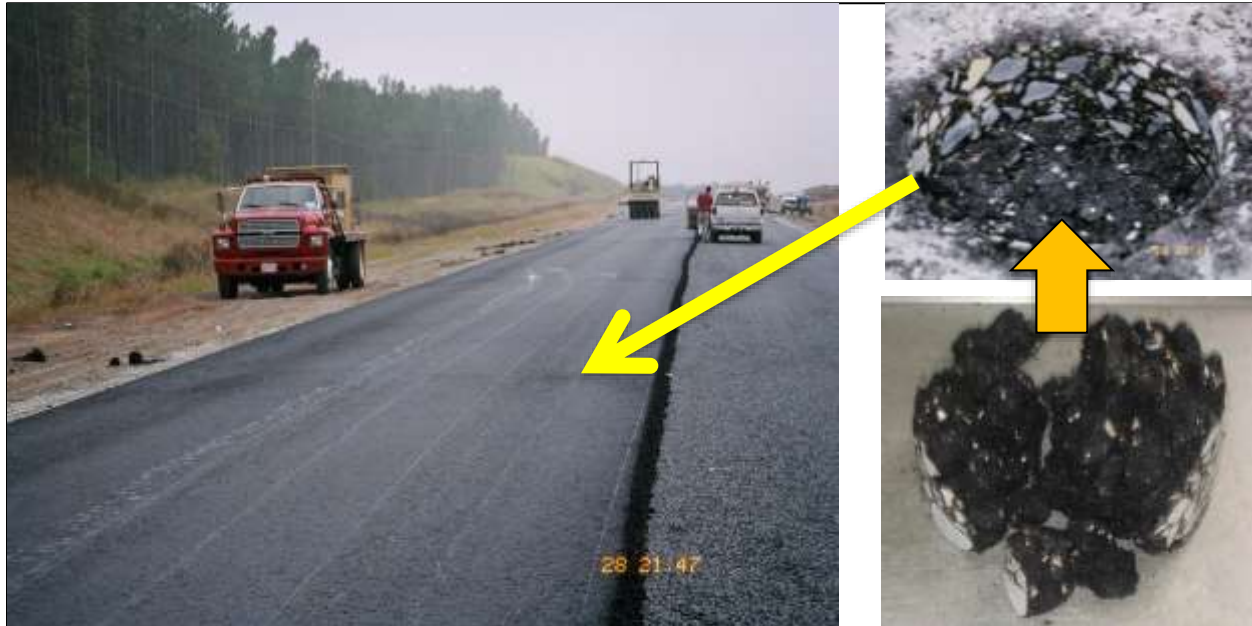
Figure 2. Truck to Truck and Longitudinal Segregation

The most common form of AC segregation is truck to truck segregation, also referred to as end of load segregation. Truck to truck segregation occurs at the start and/or end of the truckload, which can exhibit a higher amount of coarse aggregate depending on how the truck was loaded at the plant. These locations show up on the mat as regularly spaced defects and can vary from small areas on either side of the paver centerline to larger areas that extend across the width of the AC mat being placed.

Areas with segregation deteriorate rapidly because of their lower density, higher permeability, and higher air voids that allow the entry of water and air. These areas are susceptible to premature and accelerated raveling and fatigue cracking. Early distress results in poorer ride quality and requires agencies to use resources earlier than planned to maintain an acceptable level of ride quality. Michigan DOT reported that construction defects associated with deterioration of the centerline joint, longitudinal cracks at the center of the paver (center lane

cracks) and along the outside edges of the slat conveyor of the paver appeared on 100 percent of the flexible pavement and AC overlay projects exhibiting poor performance and requiring premature maintenance (Von Quintus and Perera, 2011).

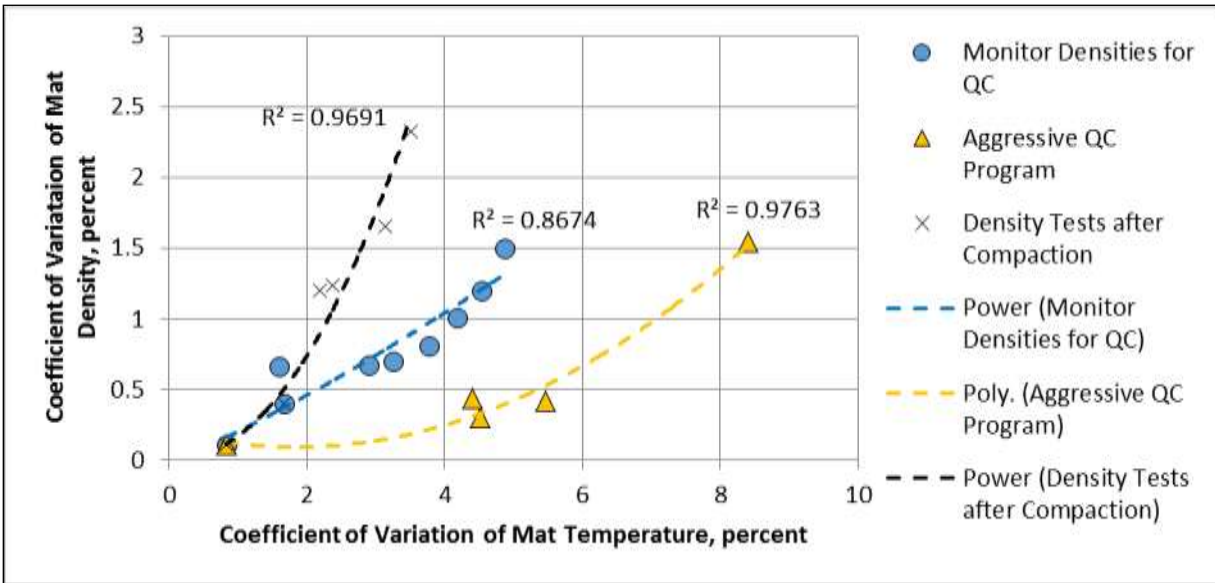
Figure 6. Coefficient of Variation of Mat Density as related to Coefficient of Variation of Mat Temperature

The relationship in figure 6 shows the importance of controlling density through the control of mat surface temperature. This relationship becomes important for a percent within limits (PWL) type specification, or in other words, controlling the risk of the contractor for being penalized based on mat density. Specifically, the greater variations in mat surface temperatures results in greater variations in mat density, which results in a higher probability that the contractor could

be penalized for insufficient mat density. This effect will be discussed in more detail in a latter next section of this chapter.

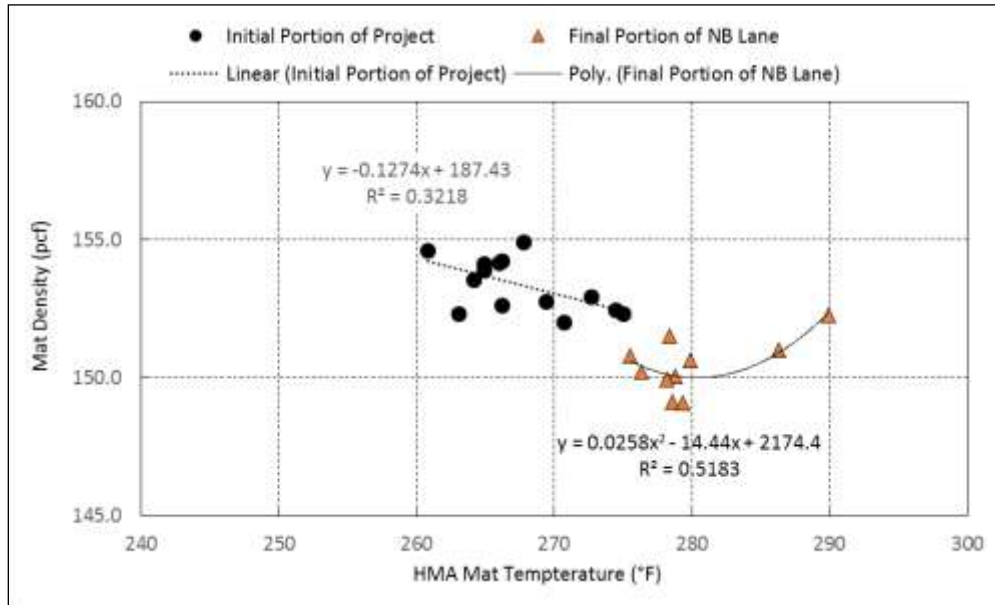
Figure 7. Illustration of the Mat Density for different Temperature Ranges

The densities measured from cores exceeded the density to receive 100 percent pay for a couple of the demonstration projects exhibiting a high percentage of severe temperature differentials. For example, 82 percent of the Eastern Federal Land segments contained severe temperature differentials. The densities measured on the cores exceeded the value for the contractor to receive 100 percent pay. Figure 9 shows the relationship between temperature and mat density,

as measured by the non-nuclear density gauge for the Eastern Federal Land project. As shown, the densities were found to vary significantly within the first lot. Cores were taken at random, but located in areas with the higher densities and/or lower temperature differentials. As such, these lots received 100 percent pay.

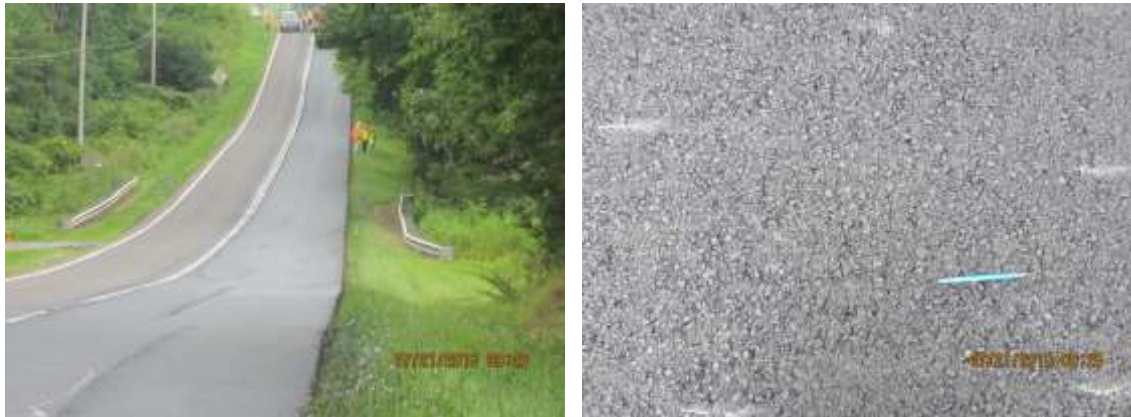
Figure 8. Roller Marks (photo on the left) and Checking (photo on the right) that Occurred in the Northbound Lane within the Temperature Sensitive Zone of the Mixture (see figure 7)

The contractor later started making sure the mat surface temperatures being monitored by the IR thermal profiler were higher and the finish roller was kept closer to the paving operation. This eliminated the roller marks and checking that was observed in the AC mat.

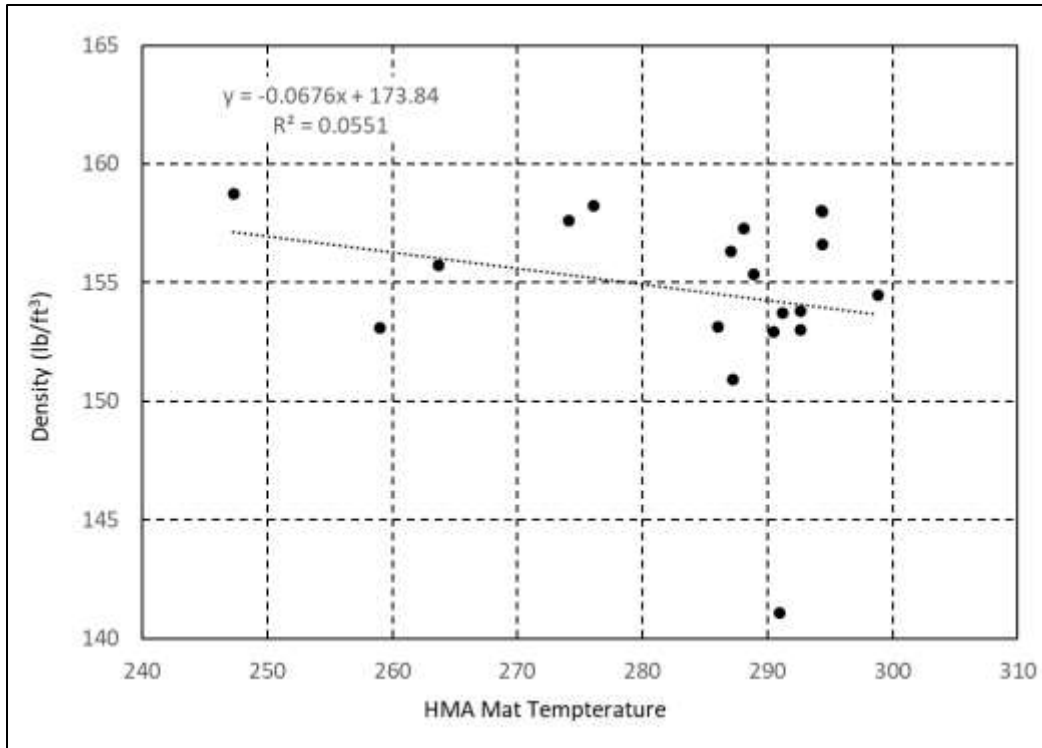
Figure 9. Comparison of Mat Density and Mat Surface Temperature observed for Lots within the Eastern Federal Land Demonstration Project

Even though 82 percent of the IR segments exhibited severe temperature differentials, the cold spots with or without segregation still represent a small portion of the mat. As such, the probability of drilling a core for acceptance in an area with minor temperature differential is higher than in areas with severe temperature differentials using random sampling methods.

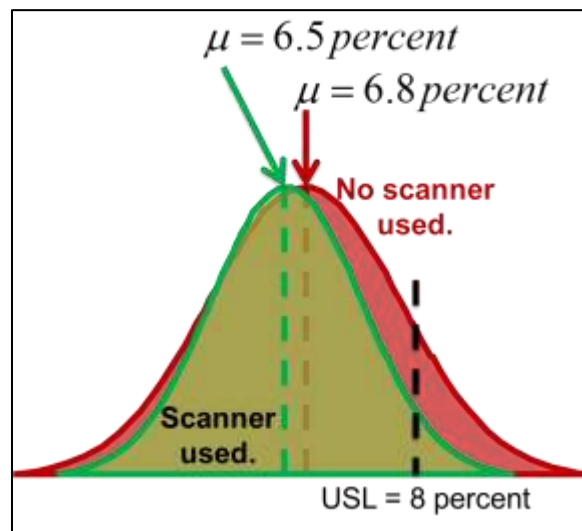
Figure 10. Example: Normal Distribution for Mat Air Voids with and without using the IR Thermal Profiler.

Figure 10 shows the two density distributions or frequency diagrams for this example. The “no scanner used” represents the average distribution at the beginning, while the “scanner used” represents the average distribution after adjustments were made to the paving process (i.e.; Maine, North Carolina, Virginia, and West Virginia demonstration projects). Using an upper limit of 8 percent air voids, the percent defective and PWL values were calculated for this example (see table 2). As shown, the PWL was 76 percent at the beginning of the lot, while a PWL of 95 percent was calculated after making adjustments based on the IR thermal profiler.

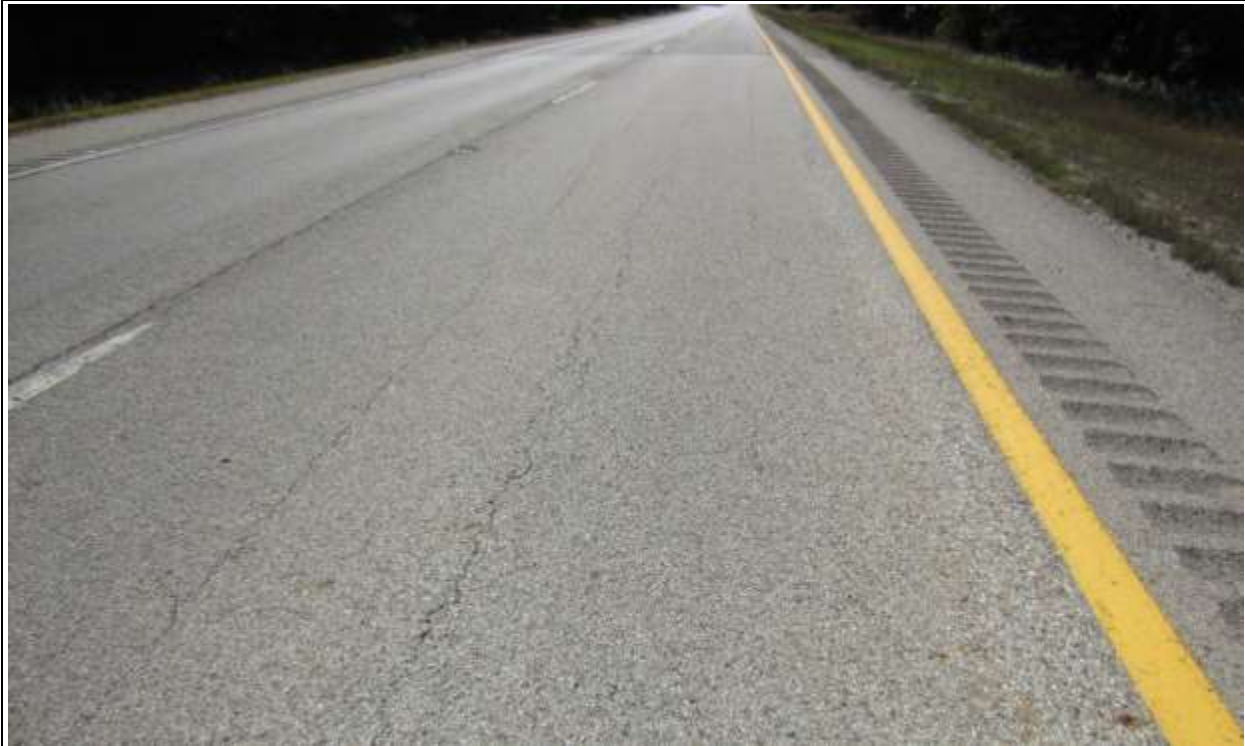
Figure 11. Longitudinal Cracks from Thermal Streaks during Construction.

Thermal streaks caused by a consistent temperature differential parallel to the paving direction with and without longitudinal segregation causes a weakened plane at which a crack initiates at the surface. If the consistent temperature differential down the mat is caused by segregation, accelerated crack deterioration will occur with the loss or dislodging of the coarse aggregate (see figure 1). If the thermal streak is not caused by longitudinal segregation, however, a crack will still appear but accelerated crack deterioration will not occur. It is the opinion of the authors that most thermal streaks are a result of longitudinal segregation.

Figure 11 shows longitudinal cracks in locations where thermal streaks were identified. It is important that the longitudinal cracks caused by longitudinal segregation be sealed as soon as possible to reduce or mitigate the loss of coarse aggregate along the crack.

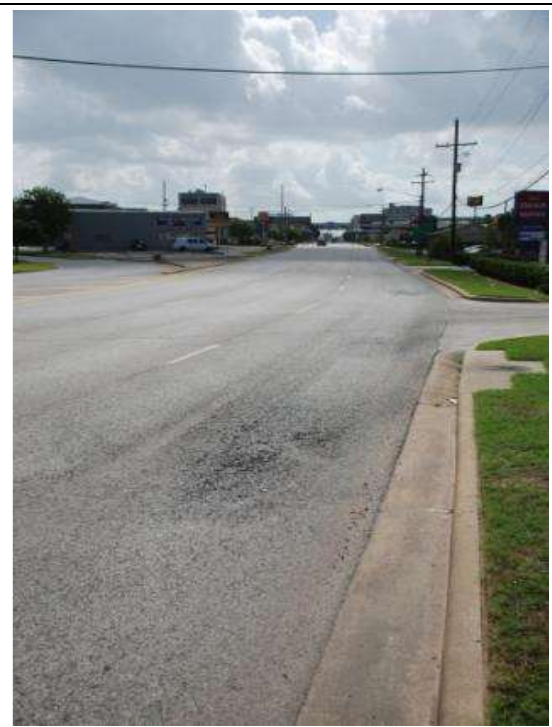
Figure 12. Raveling of the Wearing Surface from a Cold Spot during Construction.

The potential for raveling along a project with dense-graded wearing surfaces increases with an increase in air voids or reduction in density. Figure 12 shows raveling that has occurred in an area with a cold spot (probably from truck to truck segregation). The extent and severity of raveling depends on the extent of the segregation and magnitude of the air voids.

Raveling is difficult to estimate but is heavily dependent on air voids and asphalt content of dense-graded mixtures at the surface. As air voids increase and/or as asphalt content or asphalt film thickness decreases, the adhesion between the asphalt and aggregate decreases resulting in a higher severity of raveling. The potential for raveling in wearing surfaces for the demonstration

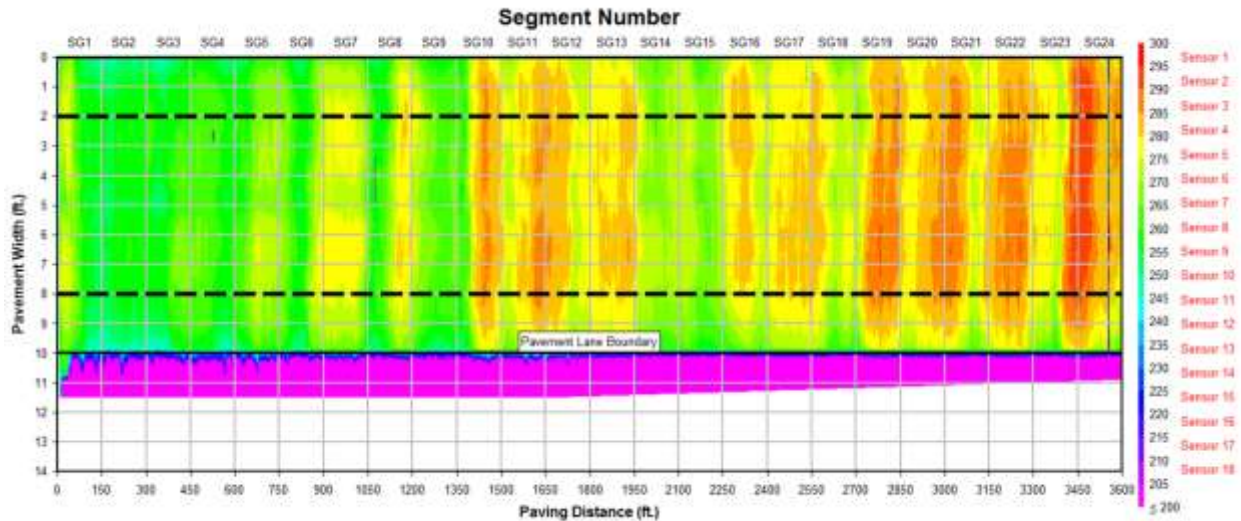
Temperature contour from one IR section of the Alabama demonstration project; end dump trucks and a MTV used to place the AC overlay (wearing surface).

| Temperature Differential Category | Percent of IR Segments, including Paver Stops, % | Percent of Total Mat Area, % |
|---|--|---|
| Cause of Severe Temperature Differentials | Most severe temperature differentials were in those areas where paver stopped and screed heater increased temperature of mat. As such, they are hot spots, rather than cold spots. Areas with moderate temperature differentials were a result of minor end of load segregation. | |

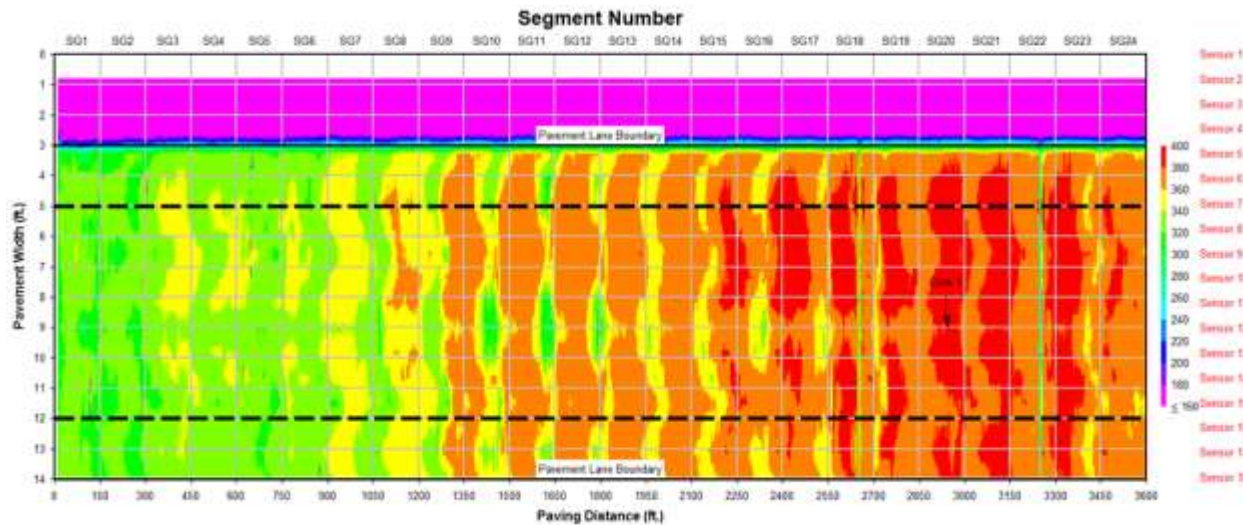
Temperature contour from one IR section of the Illinois demonstration project; end dump trucks used without an MTV to place the AC overlay (wearing surface) along Interstate 155.

| Temperature Differential Category | Percent of IR Segments, including Paver Stops, % | Percent of Total Mat Area, % |
|---|--|---|
| Cause of Severe Temperature Differentials | Most severe temperature differentials were in those areas where paver stopped and reflect the difference in mixture temperatures between trucks, rather than cold or hot spots. Mat temperatures were very high. | |

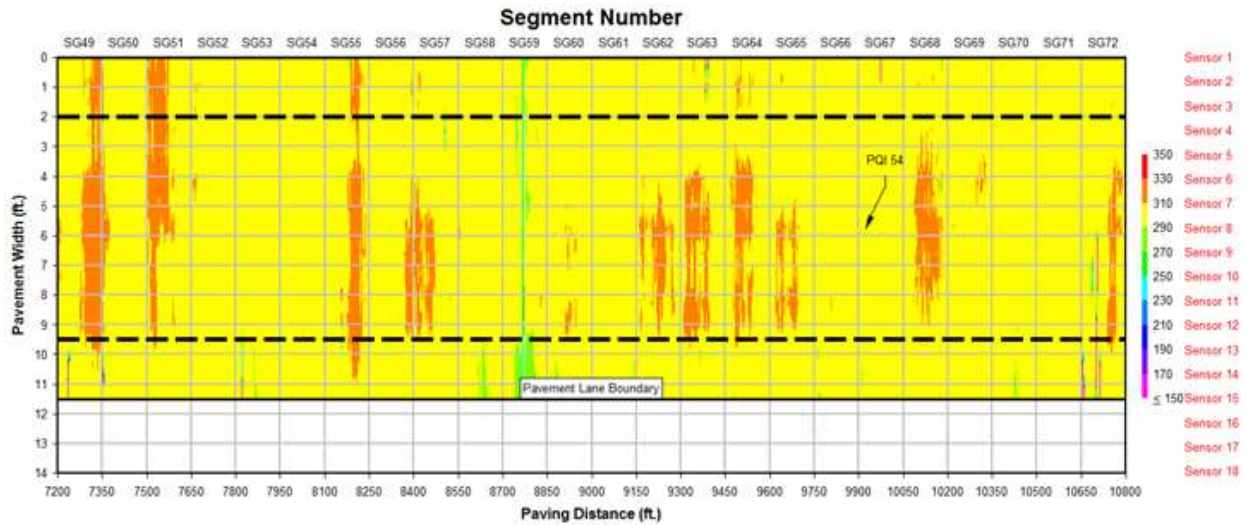
Temperature contour from one IR section of the Maine demonstration project; end dump trucks used with an MTV to place the AC overlay (wearing surface) along Interstate 95.

| Temperature Differential Category | Percent of IR Segments, including Paver Stops, % | Percent of Total Mat Area, % |
|---|---|---|
| Cause of Severe Temperature Differentials | Most severe temperature differentials were in those areas where paver stopped and/or temperature differences between truck loads. | |

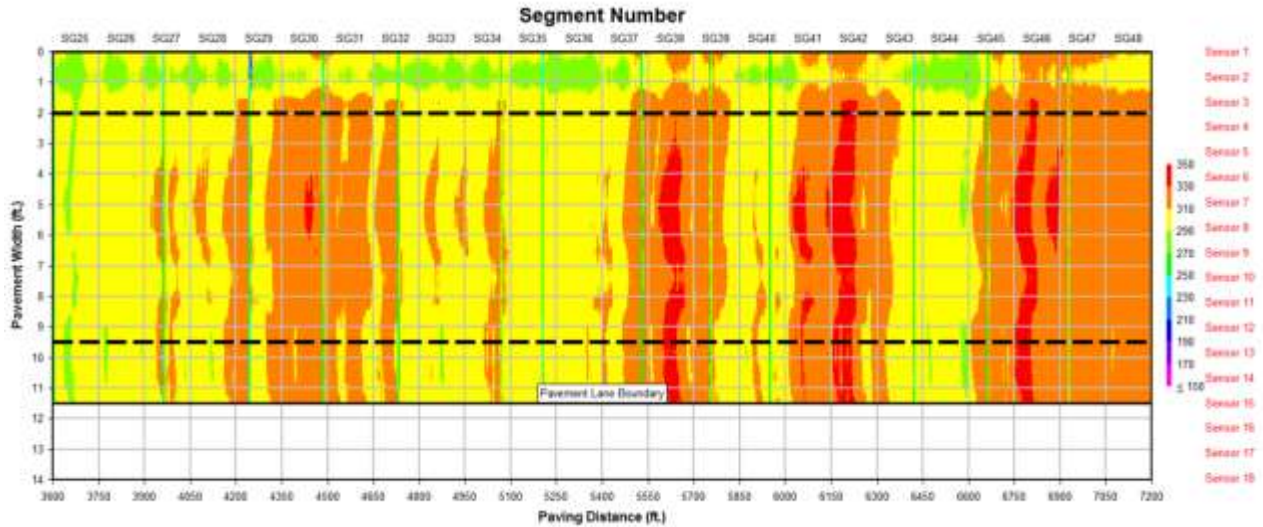
Temperature contour from one IR section of the Missouri demonstration project; end dump and flow boys or horizontal discharge trucks used with an MTV to place the AC overlay (wearing surface) along Interstate 29.

| Temperature Differential Category | Percent of IR Segments, including Paver Stops, % | Percent of Total Mat Area, % |
|---|---|---|
| Cause of Severe Temperature Differentials | Most severe temperature differentials were in those areas where paver stopped and/or temperature differences between truck loads, rather than cold spots. | |

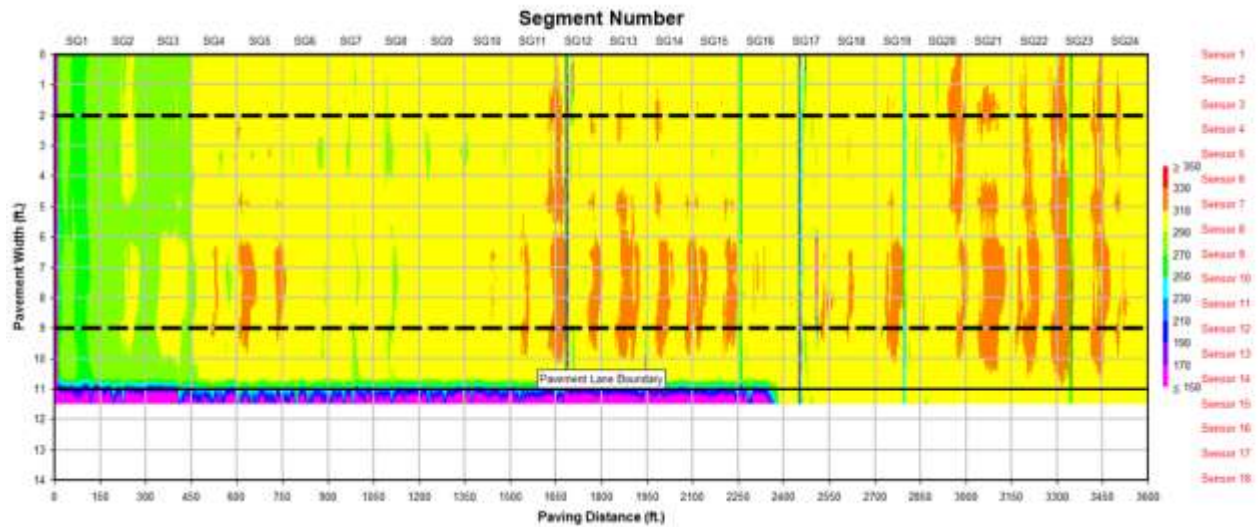
Temperature contour from one IR section of the New Jersey demonstration project; end dump trucks used with an MTV to place the AC overlay (wearing surface) along US 130.

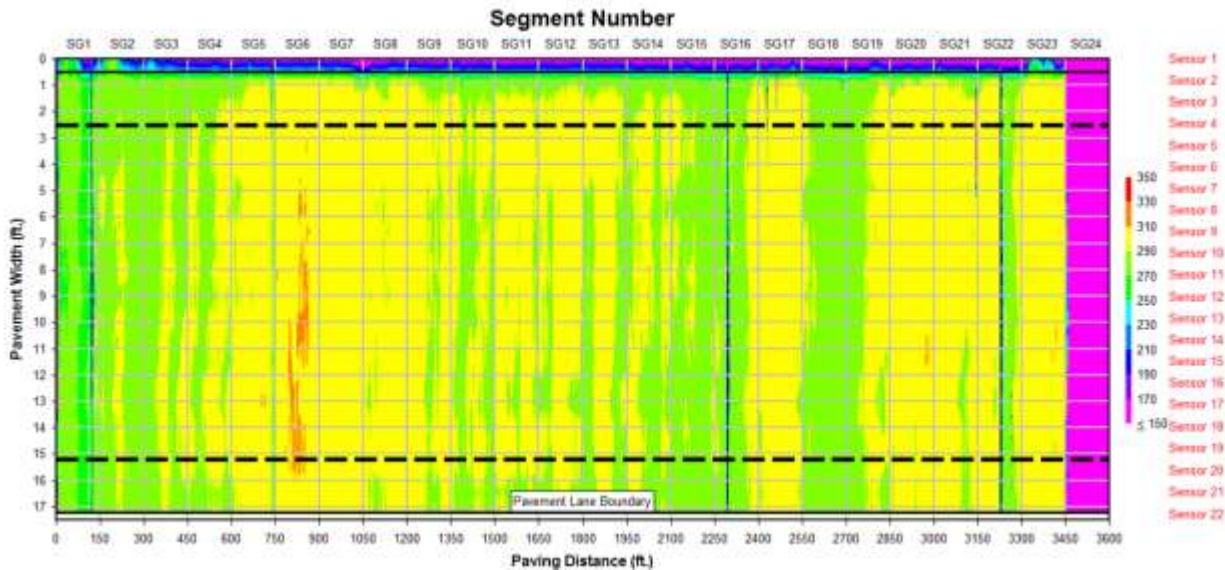
Temperature contour from one IR section of the North Carolina demonstration project; end dump trucks used with an MTV to place the AC wearing surface along Interstate 40.

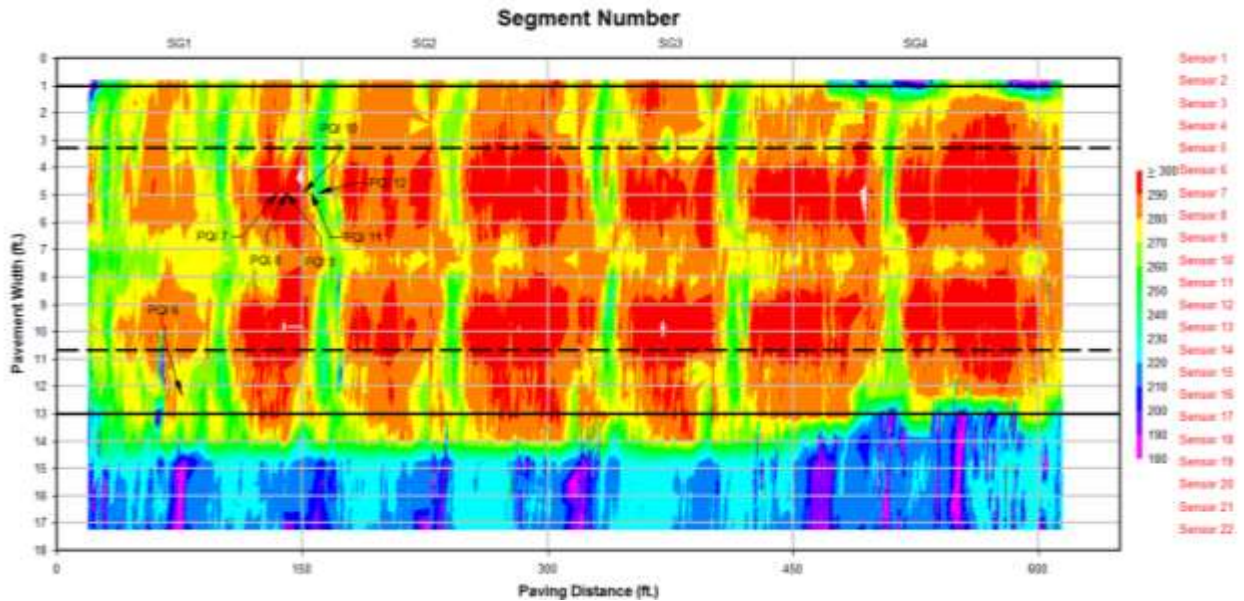
Temperature contour from one IR section of the Eastern Federal Lands demonstration project; end dump trucks used to place the AC base and binder layers along US 1 reconstruction.

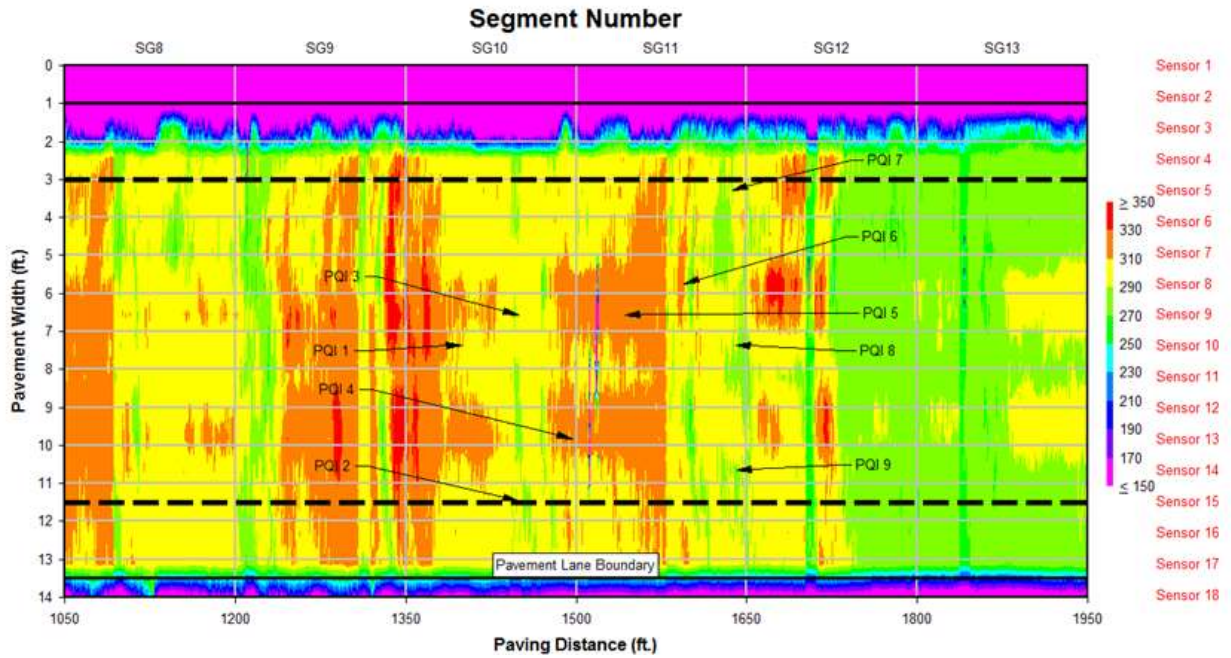
Temperature contour from one IR section of the West Virginia demonstration project; end dump trucks with an MTV used to place the AC base layers along US 1 reconstruction.
