Advanced Methods to Identify Asphalt Pavement Delamination (R06D) Spectral Analysis of Surface Waves (SASW) and Impact Echo (IE) AASHTO & FHWA Welcome

Kate Kurgan, AASHTO Monica Jurado, FHWA

Webinar June 26, 2018

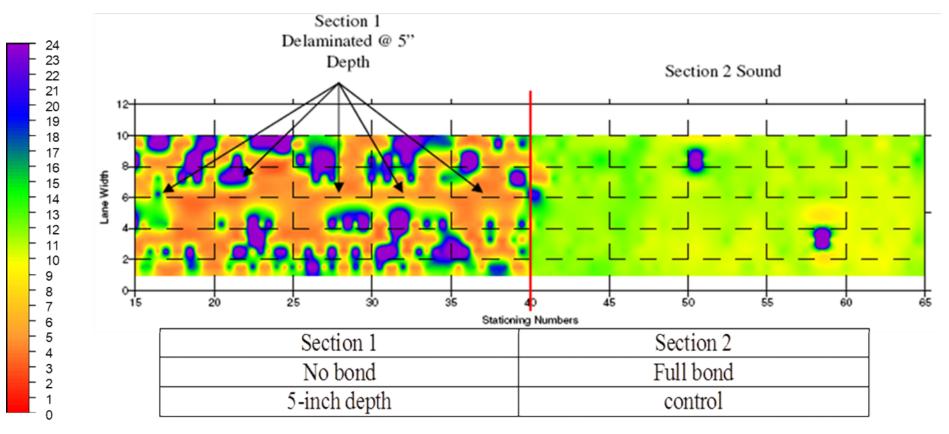
IE Data Display (NCAT test track section)

Thickness Color Scale (in)

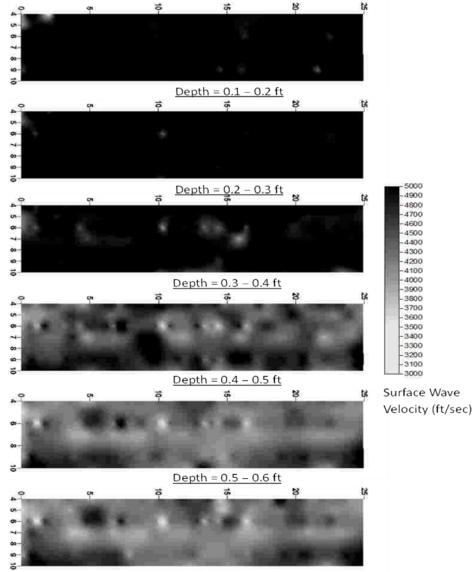
SASW Data Display (NCAT test track section)

<u>Depth = 0.6 – 0.7 ft</u>

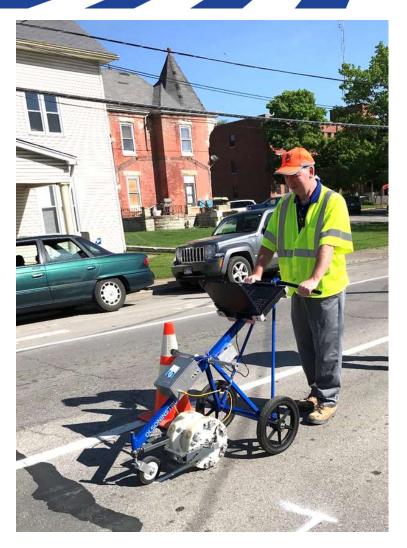
Sonic Surface Scanner (S³)

- Slow-rolling (1 mph) scanner for delamination mapping of asphalt pavements and bridge decks
- 6 Displacement transducers on two wheels lined up 6 to 9 inches apart
- Impacts surface every 6 inches for
 - Impact Echo (IE) test
 - Spectral Analyses of Surface Waves (SASW) test

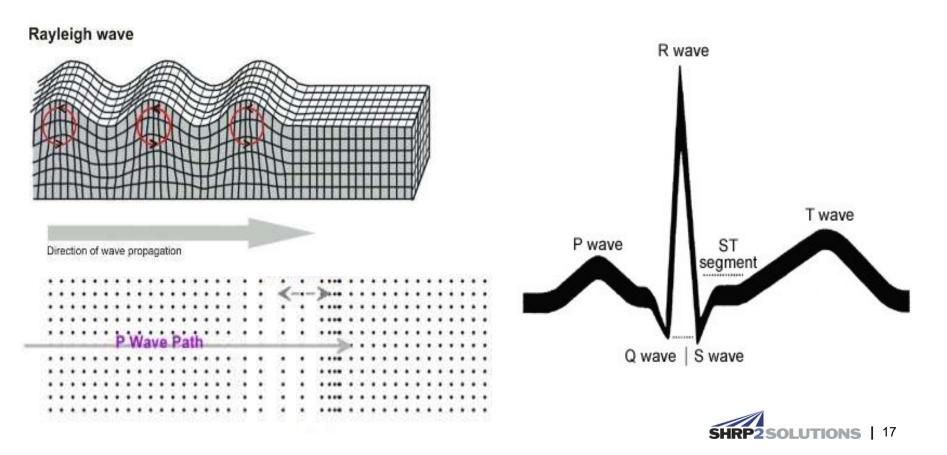
Types of stress waves

Principles of elastic wave theory

R-waves, surface waves – used by SASW to measure material stiffness

P-waves, body waves – used by Impact Echo (IE) to measure layer thickness

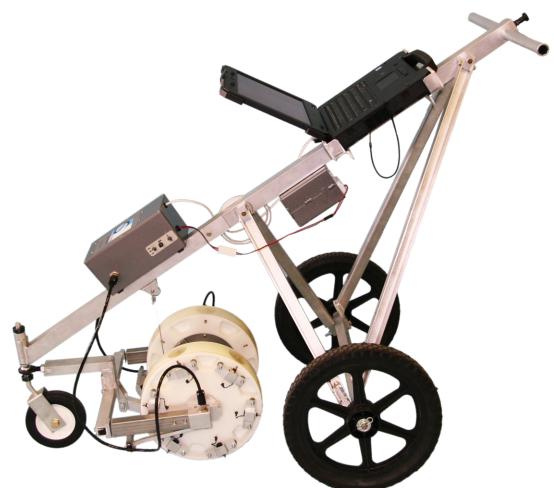
Sonic Surface Scanner – S3 Features

- Iowa DOT and Indiana DOT using IE on bare concrete decks for project level delamination mapping
- Dell Ruggedized Notebook with excellent sunlight viewable screen
- Shown with offset displacement transducers for IE tests on both wheels
- Rotate 30 degrees for IE test on left wheel and SASW test between wheels

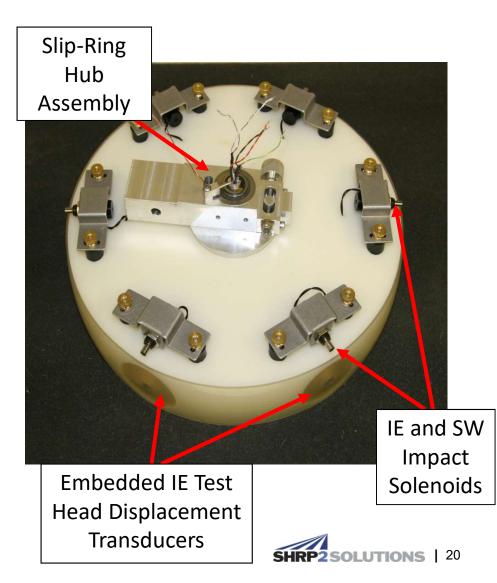
Scanning Impact Echo Testing

- Diameter of Wheel = 293 mm (11.5 inches)
- Six individual displacement transducers
- Six individual impactors
- Impacts spaced 150 mm (6 inches) apart along a scan line (around the wheel circumference)
- The 6 transducers were spring mounted with rubber isolators and captured with a thin urethane tire approximately 60 mm (2.5 inch) wide
- The thin urethane tire was added as a dust cover and to improve coupling

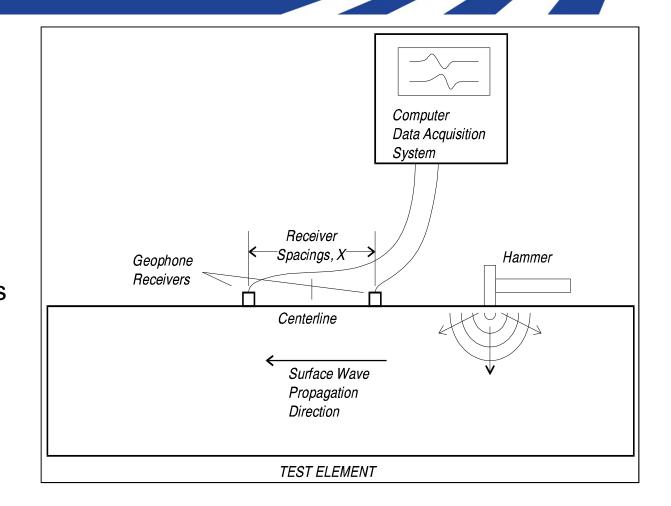
Spectral Analysis of Surface Waves Method (Stokoe and Nazarian)

- Acoustic method Short wavelength waves sample shallow, longer wavelengths sample deeper
- Allows the measurement of the velocity profile versus depth into the pavement, which provides Young's Moduli (E) versus deptha
- Based on Velocity = Frequency x Wavelength

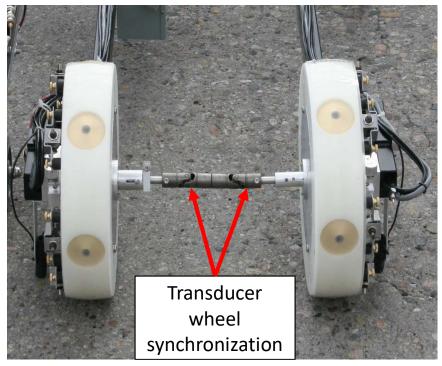
Scanning SASW

- Use 2 identical sensor/impactor wheels
- Only one wheel with the impactor turned on
- The spacing between the transducers is typically 6 or 9 inches for asphalt pavement SASW+IE and 12 or 24 inches for IE on concrete decks
- Can rotate the wheels 30 degrees out of phase to perform IE testing on both wheels simultaneously

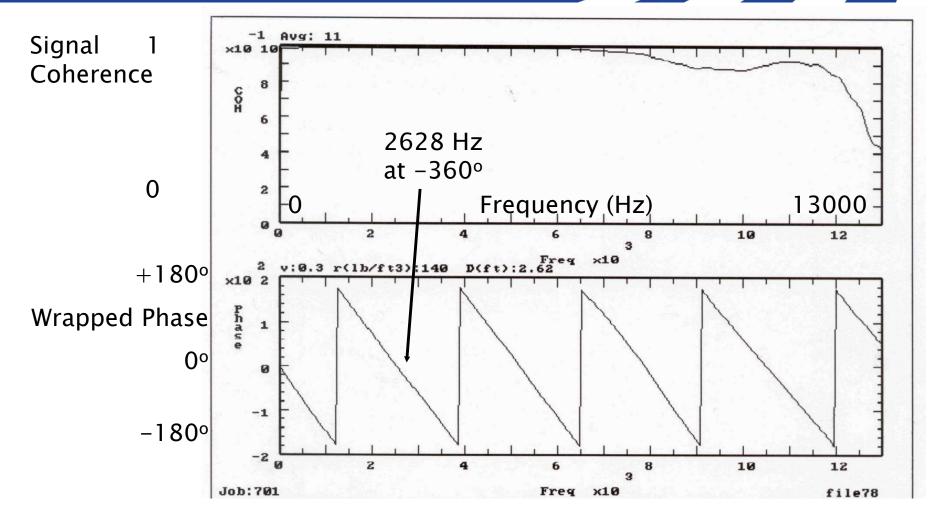
SASW Phase Plot from Sound Area (concrete)

for 2.62ft SASW Bar spacing = 1 wavelength (-360° phase), Velocity=frequency x wavelength= $2.62 \times 2628Hz=6900$ ft/s shifts solutions | 27

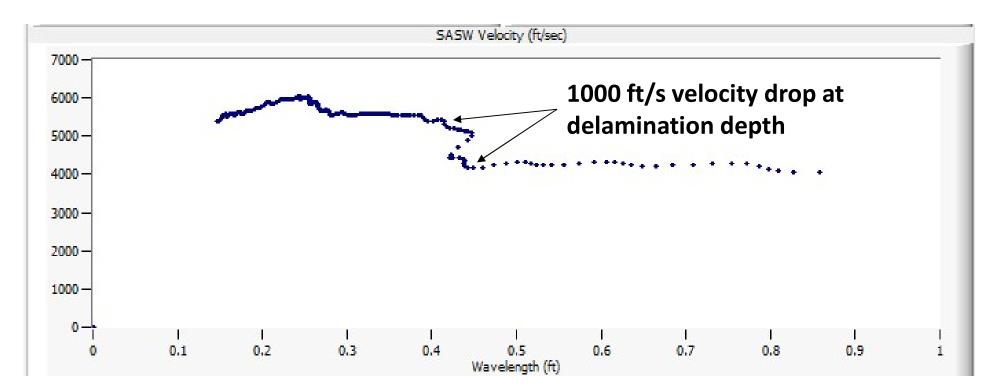
SASW Dispersion Curves from 5 Inch Deep Delamination Condition - NCAT

Delamination due to Thin Paper Delamination built at 12.5 cm (5 inches) deep – note surface wave velocity decrease from ~1590 m/s (~5300 ft/s on vertical scale) to ~1290 m/s (~4300 ft/s) at a wavelength of 12.5 cm (0.43 ft - ~ 5 inches)

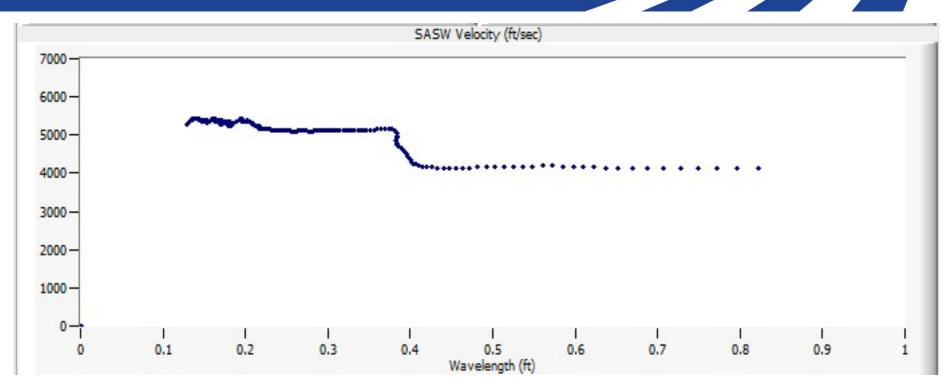
SASW Dispersion Curve from Baghouse Dust Delamination Conditions

Delamination due to Baghouse Dust built at 12.5 cm (5 inches) deep – note surface wave velocity decrease from ~1560 m/s (5200 ft/s on vertical scale) to ~1290 m/s (4300 ft/s) at a wavelength of 12.5 cm (0.4 ft on horizontal scale ~ 5 inches)

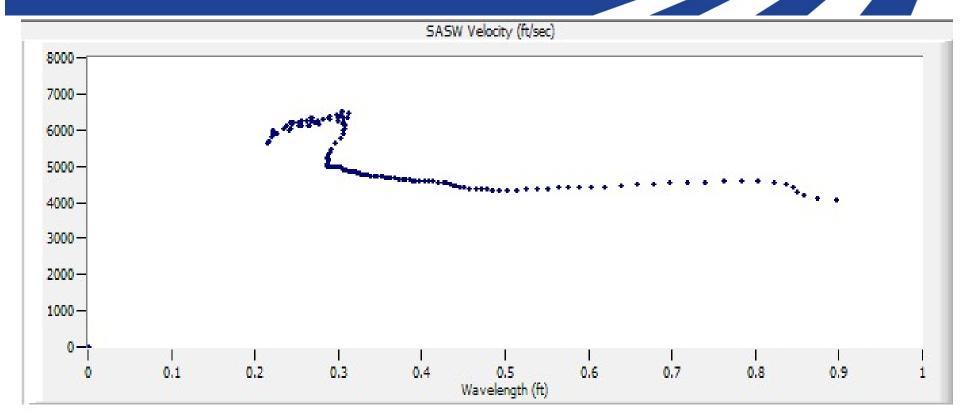
SASW Dispersion Curve 2 Inches Deep Delamination Conditions on Asphalt

Delamination 5 cm (2 inches) deep – note surface wave velocity decrease from ~1920 m/s (6400 ft/s on vertical scale) to ~1440 m/s (4800 ft/s) at a wavelength of 5 cm (0.27 ft on horizontal scale ~ 3.2 inches)

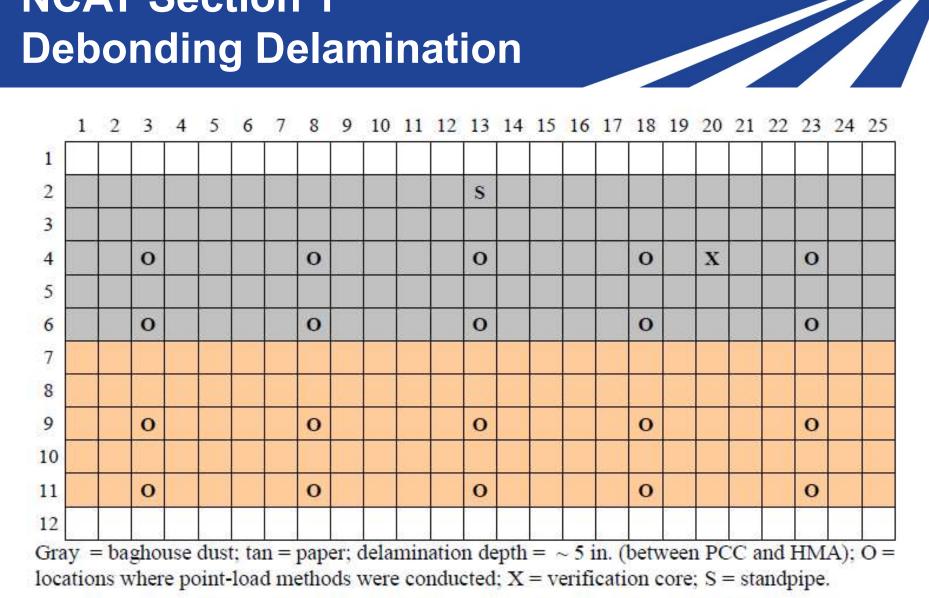
NCAT Section 1 Debonding Delamination

FIGURE 11 Section 1: HMA over PCC (STA 0+15 to 0+40).

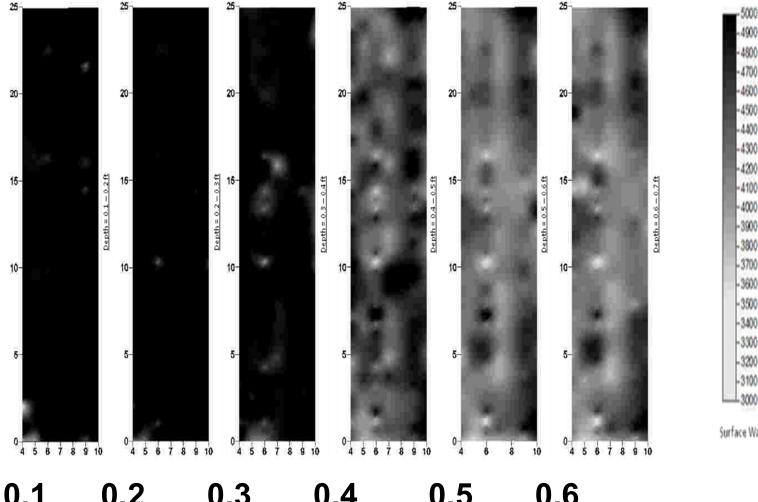
SASW Delamination Plot Velocity Results NCAT Section 1 Stations 15 to 40 ft

Surface Wave Velocity (ft/sec)

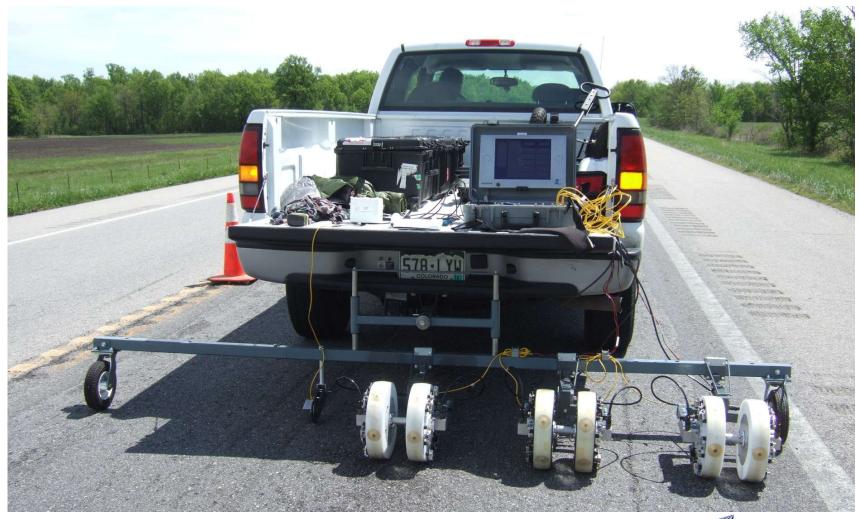
Prototype Pavement Scanner on Kansas DOT Asphalt Pavement test site with 3 pairs of wheels - Future full lane Scanner?

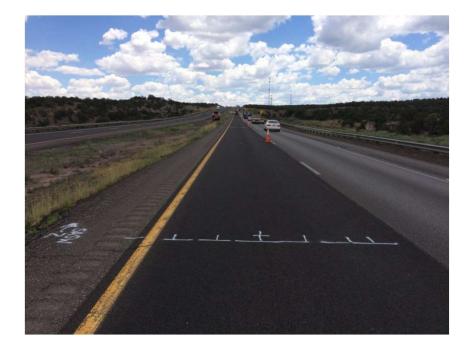
New Mexico Concerns

- Temperature
 sensitivity
- Surface Treatment
- Delamination
 Detection

- Good repeatability of trends were found for both similar temperatures and with different temperatures
- At high temperatures (130+ F) degradation of <2 inches existed, however, data was much better than expected
- Absolute velocity values changed with temperature, but percentage change in velocity with damage was similar

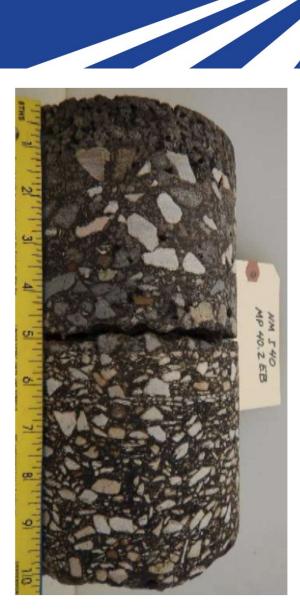
District 6 Sites

- 2 -1000ft. Sections tested
- In Mountains
- Basalt Mixes Top Mix
- Marshal Mix Bottom Mix
- Open graded friction course

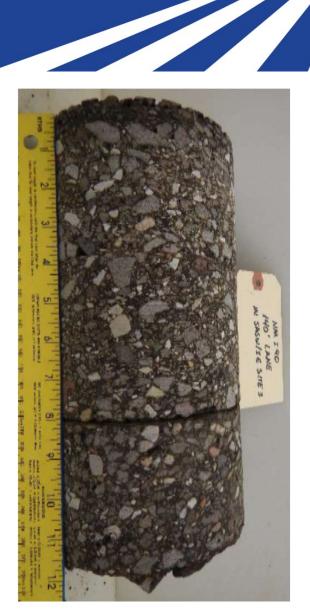
District 3 Site

- Temperature probes
- In "flat" area
- Same SPIII mix throughout
- Open graded friction course
- 1-500 ft. section tested multiple times

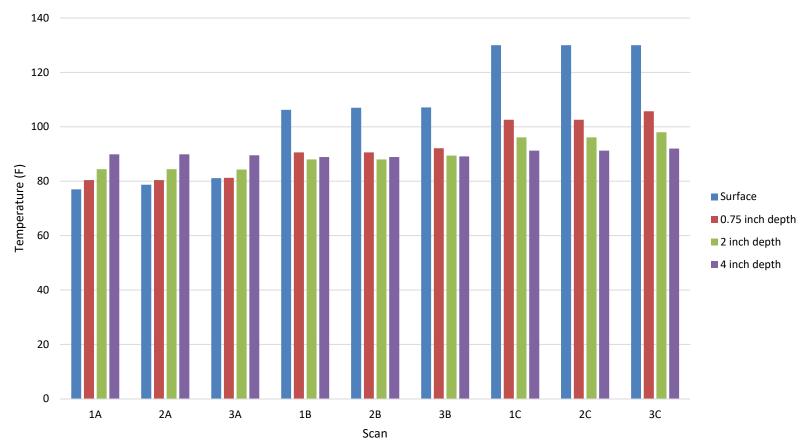
District 3 Full Scans Temperature

Temperature for 3 full scans

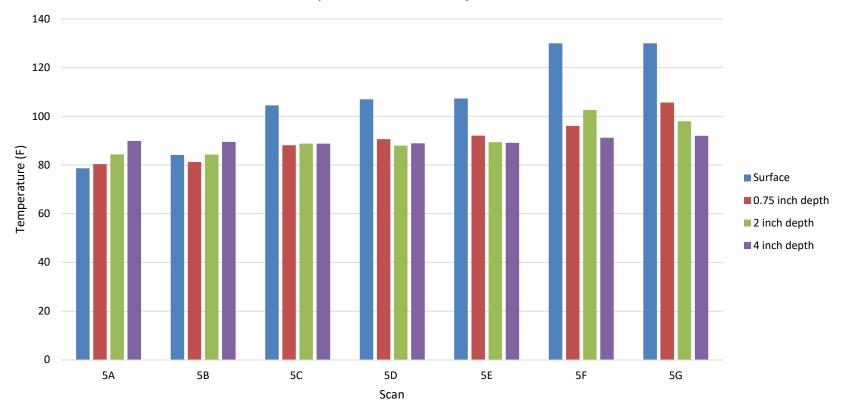
District 3 Repeat Scan Temperature

Temperature for Repeat Tests

- Repeatability was poor even with tests with similar temperatures
- General Trends are probably okay
- This test will probably need some form of temperature correction in the future for high temperature change areas

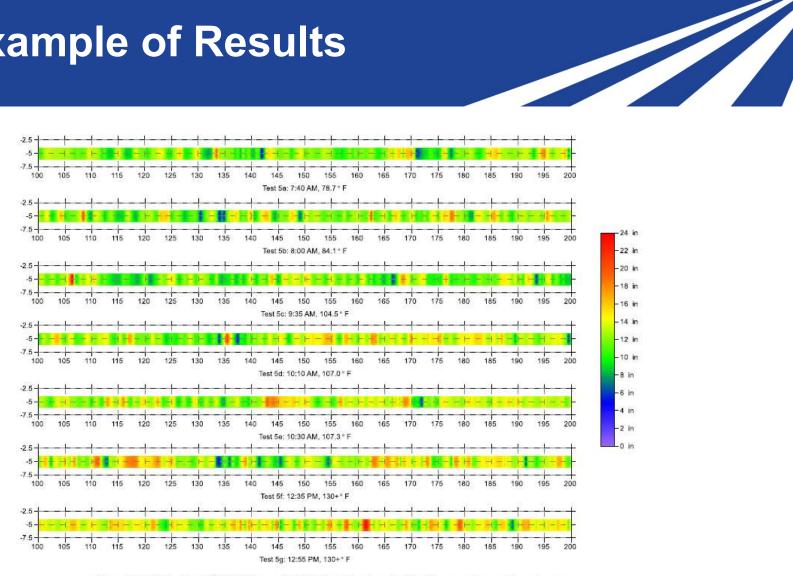
IE Example of Results

Figure B4: IE Results, 7/20/2017, Repeatability Study, 5 feet from left shoulder tested seven times (a - g). X = 0 @ start of section, Y = 0 at left shoulder. Distance 100 - 200 feet for all seven tests.

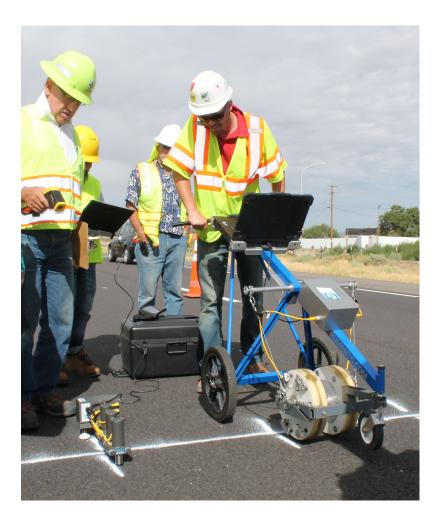
NMDOT Experience

- 1000 ft. line ~ 20 min.
- 1000 ft. segment ~ 2 hrs.
- Still much faster than PSPA!
- Analysis software in progress...

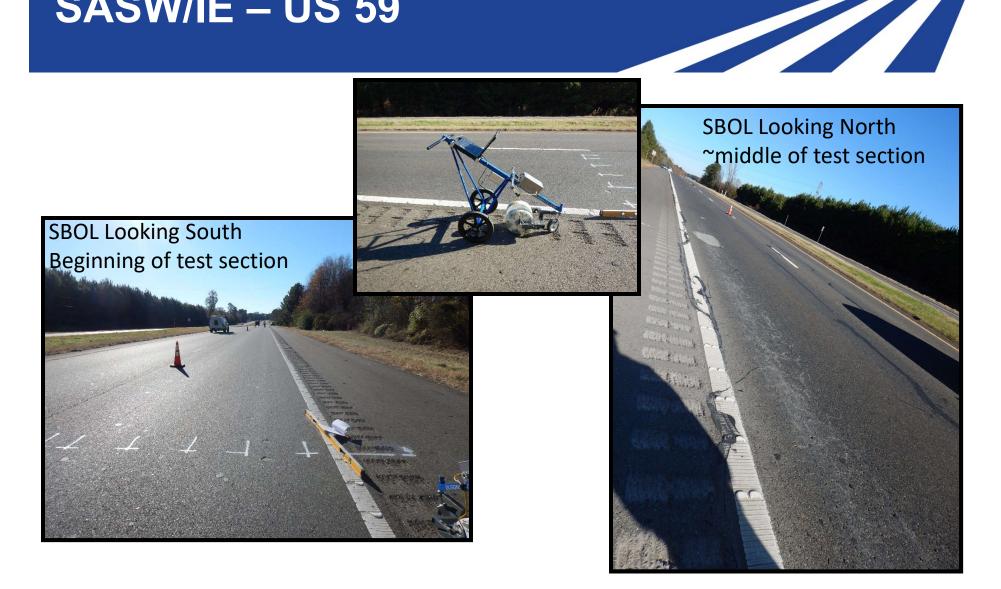
SASW/IE – US 59

- IE velocity of 8,000 ft/sec used for thickness values
- Yellow and red areas are potential deteriorated areas

- Test every 6 inches
 - ~12,000 tests for the 6000 LF tested
- Based on velocity profile with depth at each location.
 - Drop in velocity at depth of the degradation. Larger velocity drop indicates worse conditions.
- Velocity scale
- The SASW test results are presented 3 separate ways:
 - 1st as absolute velocity
 - 2nd as normalized velocity (percentage)
 - 3rd as changes in normalized velocity between depths.

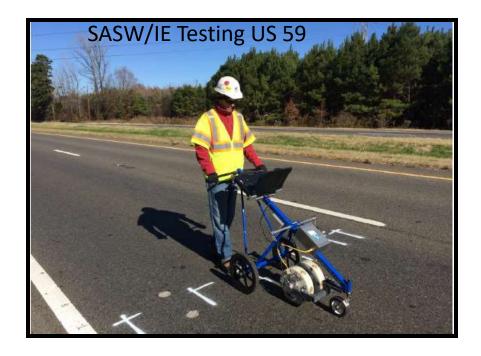
SASW/IE Testing US 59

- 1000' test Section
- 6 Scan Lines
 - At 1', 3', 5', 7' 9' and 10' measured from white edge line.
- Testing Time was ~2 hours.
- Pavement Surface temperature ~50°F

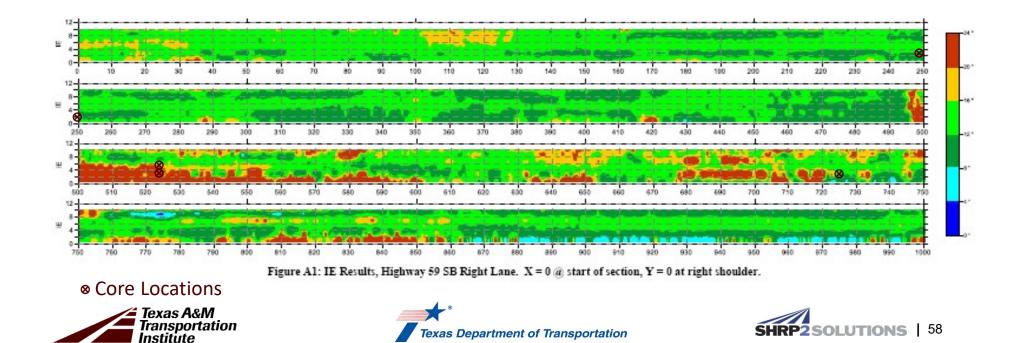
Impact Echo (IE) Test Results US 59

- Impact Echo (IE) Test Results
 - •Test every 6 inches resulting in ~12,000 tests for the 6000 LF tested (1000' test section with 6 locations)

- Information from Olson Engineering Report (IE)
 - The IE test method does not provide a measure of the level of degradation, <u>only an indication if degradation is present</u> or not in the form of a resonance echo outside the expected range.
 - The IE method is considered sub-optimal on asphalt surfaces due to the difficulty exciting the necessary frequency range.
 - There appears to be good correlation between the IE and SASW test results.

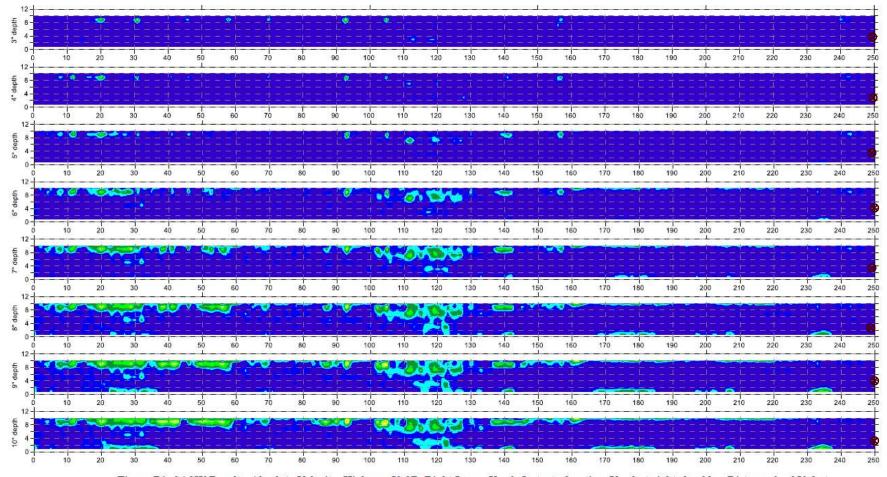
Figure B1: SASW Results, Absolute Velocity, Highway 59 SB, Right Lane. X = 0 @ start of section, Y = 0 at right shoulder. Distance 0 – 250 feet.

- Information from Olson Engineering Report (SASW)
 - There is extensive degradation of the tested area particularly between distances 495 – 850 feet.
 - All three presentation methods show the same general results.
 - It is likely that the normalized velocity method will allow users to become more comfortable with interpretation by removing the variable of temperature effects from the interpretation and allowing users to observe velocity changes on a percentage basis.
 - The difference maps help determine the depth range of deterioration.
 - Beyond the first significant poor layer (velocity drop) the SASW data becomes less definitive as the poor layer will affect the "appearance" of everything below it.

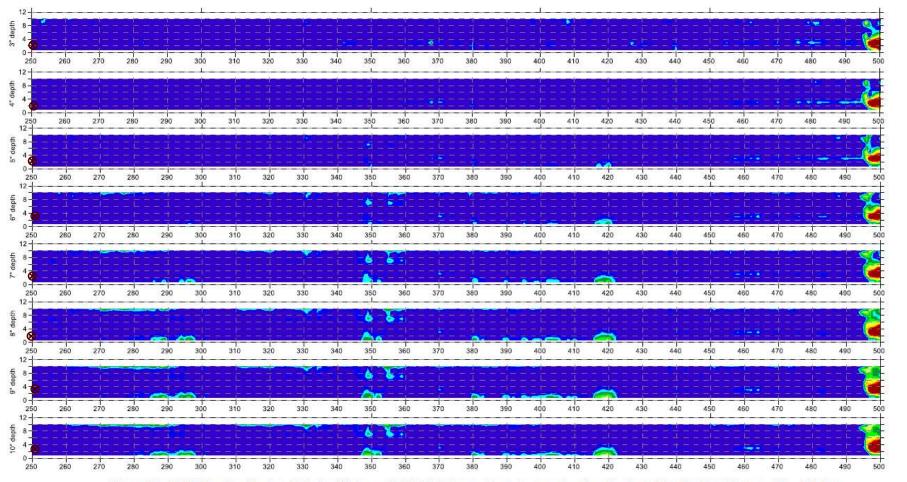
Figure B2: SASW Results, Absolute Velocity, Highway 59 SB, Right Lane. X = 0 @ start of section, Y = 0 at right shoulder. Distance 250 - 500 feet.

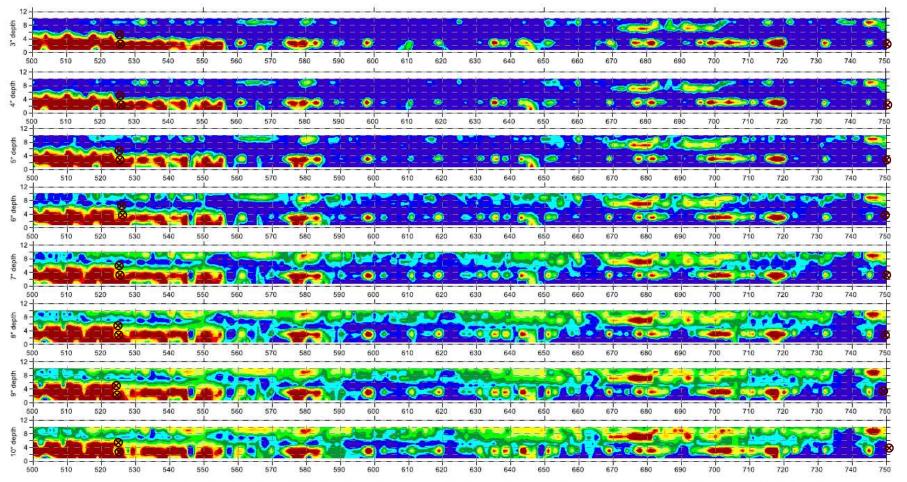
Figure B3: SASW Results, Absolute Velocity, Highway 59 SB, Right Lane. X = 0 @ start of section, Y = 0 at right shoulder. Distance 500 - 750 feet.

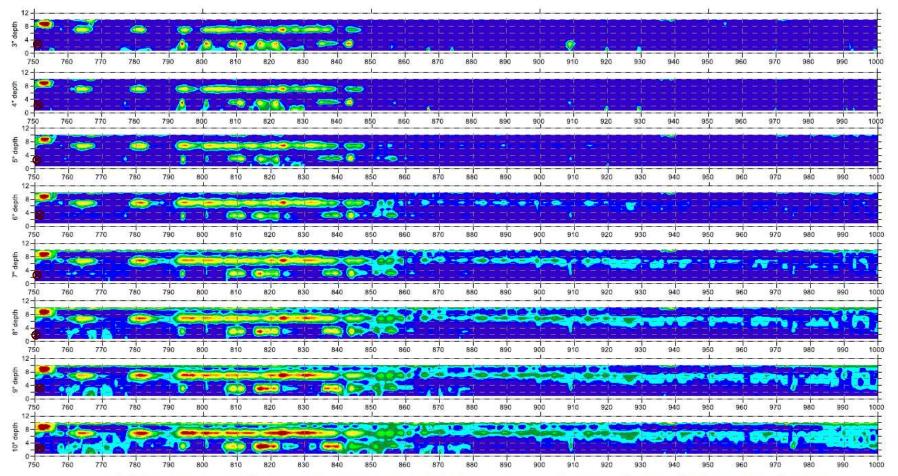
Figure B4: SASW Results, Absolute Velocity, Highway 59 SB, Right Lane. X = 0 @ start of section, Y = 0 at right shoulder. Distance 750 - 1000 feet.

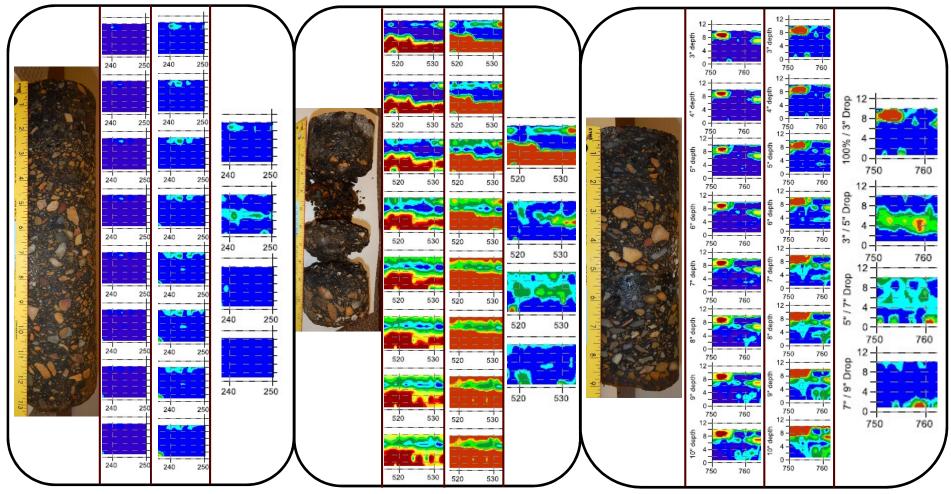
SASW Analysis at Cores US 59

Analysis - Left is Absolute Velocity, Middle is Normalized Velocity and Right is Normalized Depth-Difference

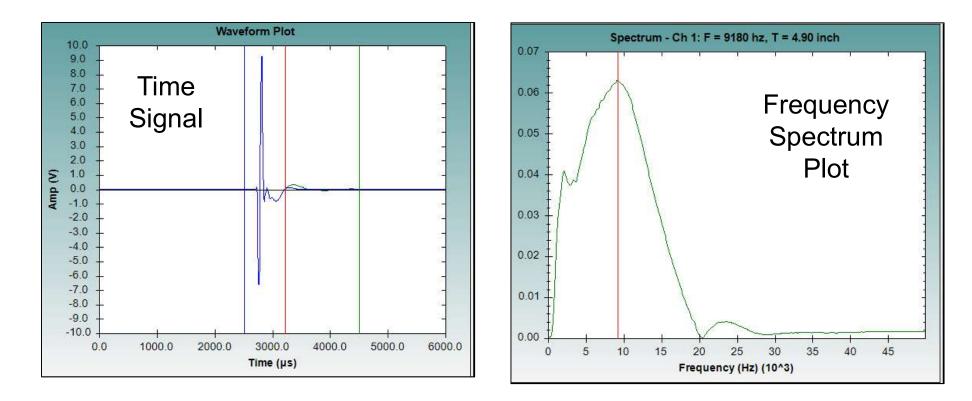
Automated IE Analysis

IE NCAT Results Image

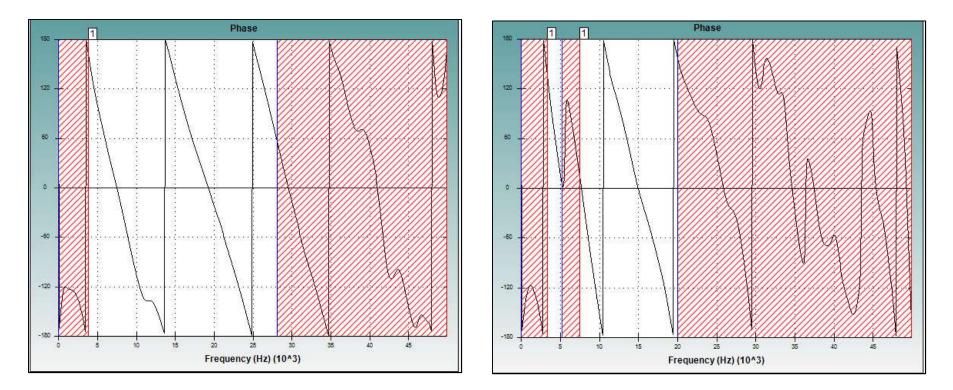
Automated SASW Phase Masking

Automated Phase Analysis Works Well

Additional Phase Mask added Manually

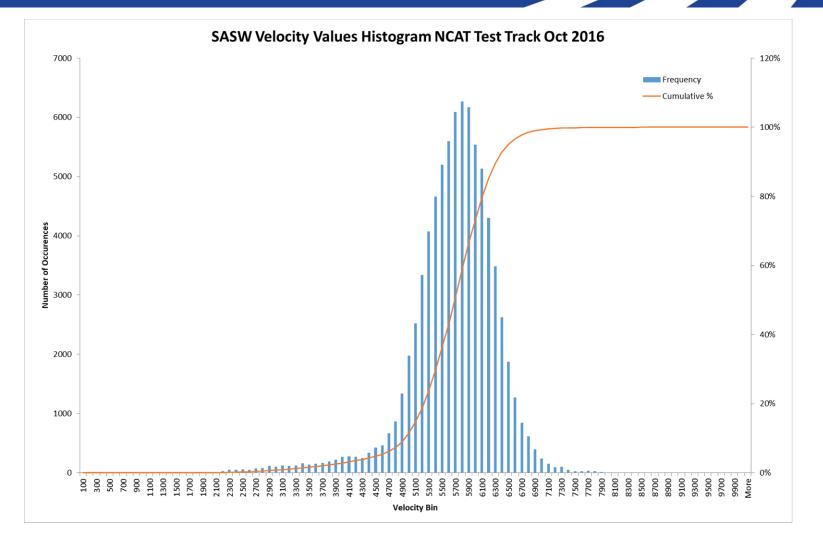
Normalized Velocity Method

Most common value between 5700 – 5800 ft/sec
