SHRP2 Solution:

Technologies to Enhance Quality Control on Asphalt Pavements

Pave-IR Scan™ Primer

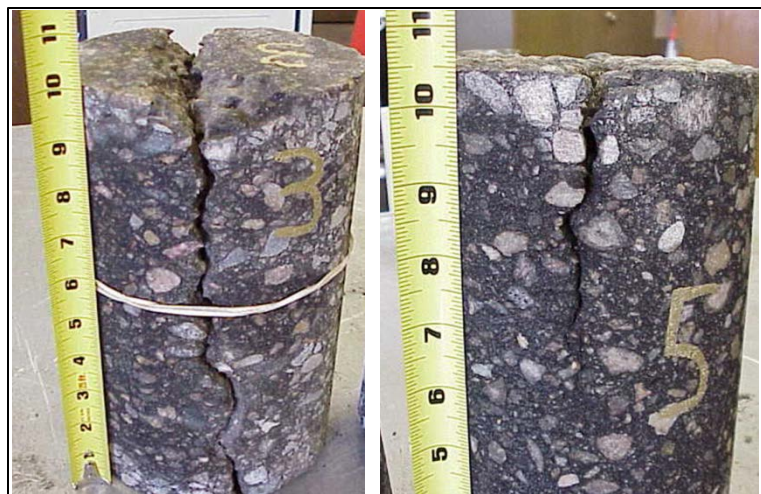
The core to the right in Figure 1 clearly shows a concentration of coarse aggregate at the surface. This concentration of coarse aggregate caused a “weak” spot where a longitudinal crack started at the surface and is propagating downward through the HMA. The core to the left is similar, but the crack has propagated through all of the HMA layers and the coarse aggregate have become dislodged by traffic and exhibits severe

raveling along the longitudinal crack. This condition can occur in a few years after construction and require premature maintenance or rehabilitation. The infrared scanner technology is being used to ensure these conditions are identified on a real time basis during the paving operation.

In-place density is a critical factor in determining pavement durability in hot mix asphalt (HMA) mixtures. Localized non-uniform zones of mix, often defined as segregation, are low-density areas in the HMA mat. Although very localized, segregation is a major construction-related problem with an adverse impact on pavement service life. For example, Figure 1 includes a photograph of two cores that exhibit longitudinal aggregate segregation at the surface of a mat.

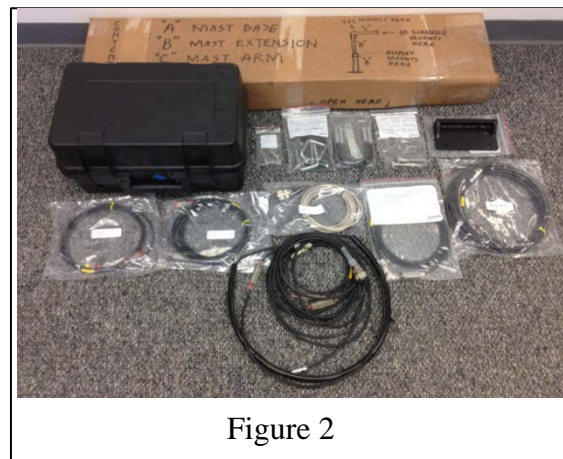
Figure 2

The equipment and materials that are used to continuously monitor the surface temperatures is simple to use and install. The product or system being used on multiple demonstration projects is called Pave-IR Scan™, developed by MOBA Mobile Automation. The pieces of equipment within this system include: an IR mast base, mast extension, and mast arm; the IR scanner itself; the monitor; a distance measuring instrument (DMI); a combined wireless communication and GPS unit; wiring; and various connection bolts and materials. All of the pieces of equipment, except for the mast base, extension and arm, fit into an easily transported case as shown in Figure 2. The case can be handled by one person.

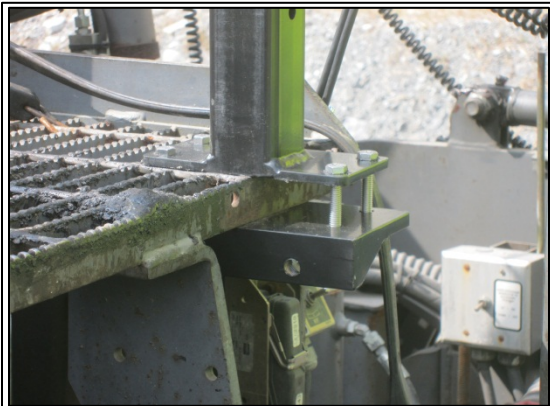
does not interfere or restrict movement of paving personnel working on or around the screed. The installation procedure takes less than 2 hours to complete for most pavers. Figure 3 shows the IR scanner mast base plate mounted with four bolts. In some cases, the IR mast is attached to the hand rail using a “U-bolt” for stability. Figure 4 shows the Pave-IR Scan™ unit installed which is not restricting any of the paving personnel from doing their job.

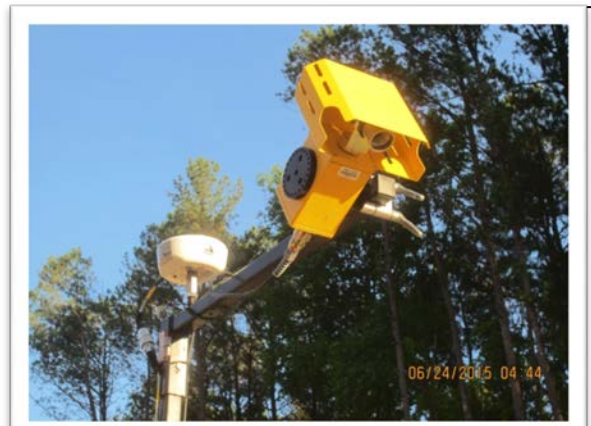
The GPS unit and IR scanner are placed on the mast arm. The scanner includes an IR sensor mounted to a step motor which sweeps the paving surface to measure the surface temperature. Figure 5 shows the GPS unit and IR scanner in place. The Pave-IR Scan™ unit is powered by the onboard generator or is connected directly to machine power, which is typical of a more permanent installation.

The IR scanner (see Figure 5) measures the surface temperature of the material within the line scan on a continuous basis as the paver is moving forward. The sensor rotates or cycles from side to side at a specified width as the paver moves down the paving lane. It is recommended that the line scan takes readings at a sufficient distance behind the screed (typically 6 feet) to reduce the interference of paver personnel being in the line scan as they walk on and off on the screed, but not so far behind the screed that the sensor range is exceeded.

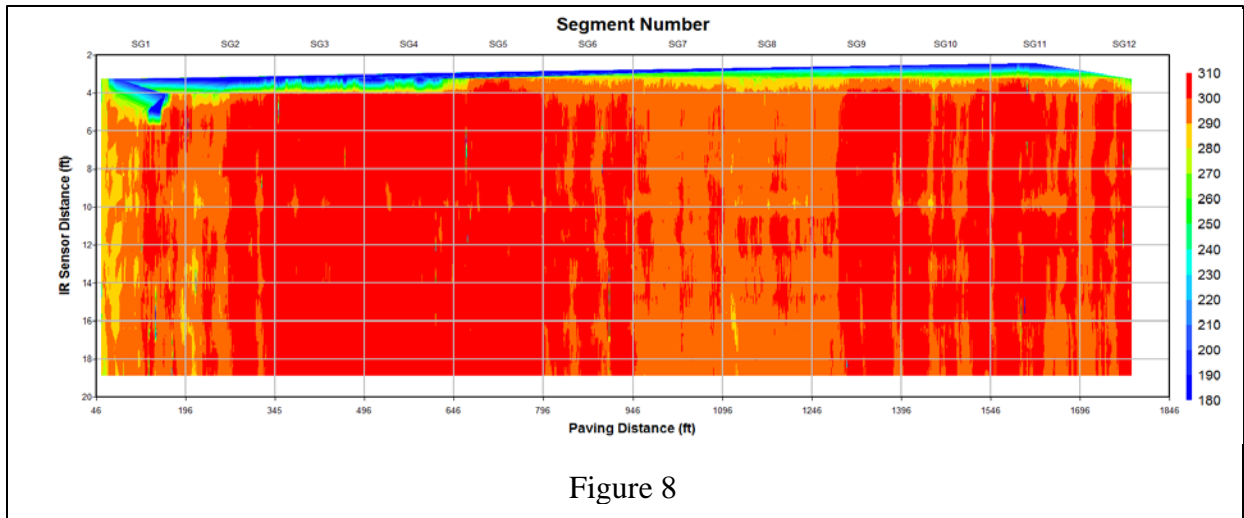
The IR line scanner images the entire scan width and provides adequate data-collection and data processing features for uniformity measurements. The scan width is normally set up to make sure the edges of the HMA mat are within the scan. A two-dimensional contour plot is provided on the monitor as the output in both real time and post-processing without the need to merge any IR images together. Figure 8 is an example of the two dimensional contours presented in a color diagram for the temperatures collected by the scanner. As shown, all temperature data are presented on the image including surface temperatures just outside the edge of mat along one side of paving.

Although it is difficult to explain the reason behind such temperature measurements in the data, the low temperatures can be caused by: (1) the temperatures measured towards the paving edge (see Figure 8); (2) temperature recorded during extended paver stops; and/or (3) human interference (i.e., the system measuring the temperature of a person in between the IR scanner and the mat). The data pre-screening criteria are discussed in the next section to ensure non-mat temperatures get removed from the analysis to evaluate mat temperature uniformity.

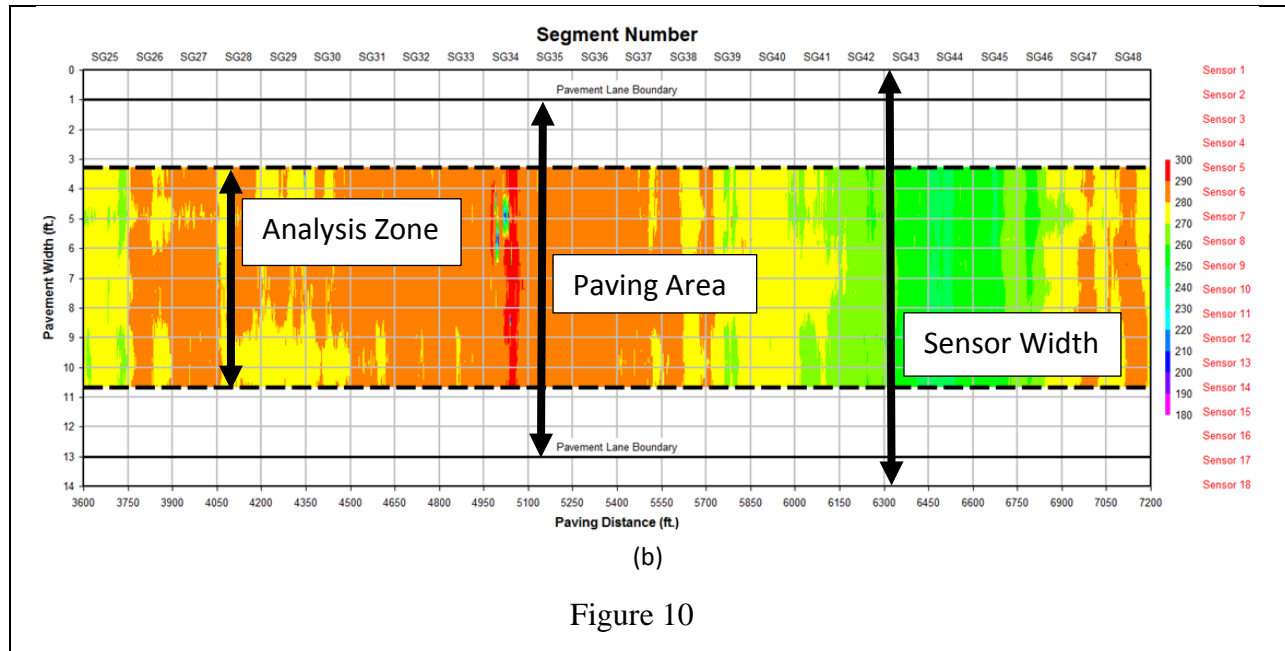
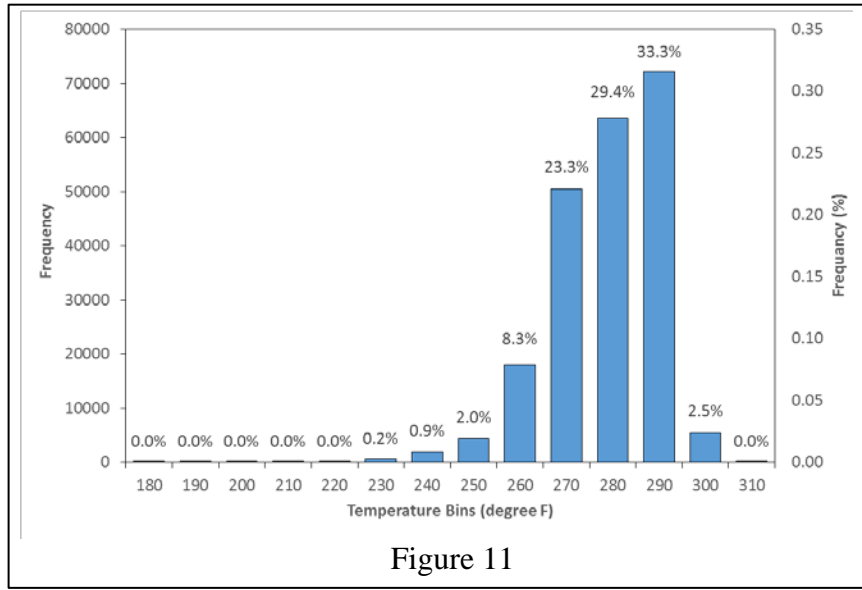
The software automatically completes the pre-screening of the temperature data. The user, however, can override the criteria because the raw temperature data remain in the files that are stored. Thus, changes can be made to the interpretation of the data post-construction. Figure 11 shows an example of the histogram of mat temperatures after pre-screening the data where all low, non-mat temperatures have been excluded or removed.

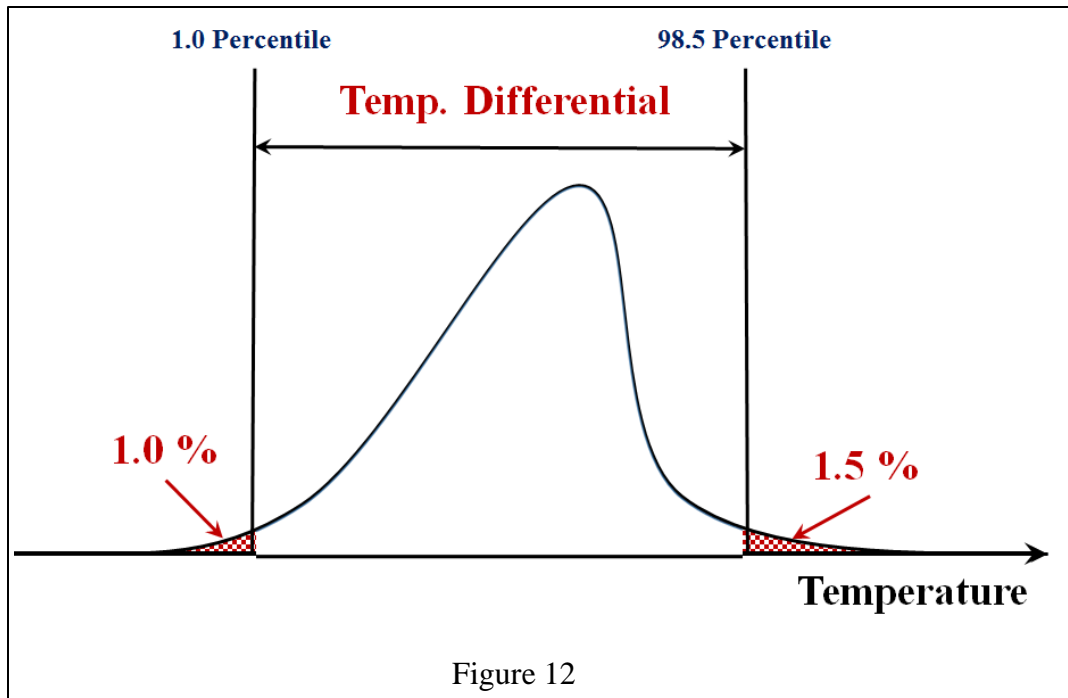
$$T_{diff} = T_{98.5} - T_{1.0} \quad (1)$$

Where $T_{98.5}$ and $T_{1.0}$ are the 98.5 and 1.0 percentiles obtained from the distribution of the temperature data, respectively.

A graphical schematic of the temperature differential is provided in Figure 12. Tex-244-F requires that temperature differential, T_{diff} , be calculated in 150 ft. segments. According to the proposed specification for Pave-IR from the American Association of State Highway and Transportation Officials (AASHTO), the presence and severity of temperature differential (referred to as thermal segregation in the AASHTO specification) is defined as the following:

- $T_{diff} \leq 25$ degree Fahrenheit (°F): No to minor temperature differential (or segregation)
- $25 \text{ °F} < T_{diff} \leq 50 \text{ °F}$: Moderate temperature differential (or segregation)
- $50 \text{ °F} < T_{diff}$: Severe temperature differential (or segregation)
