Rapid Technologies to Enhance Quality Control on Asphalt Pavements Infrared (IR) Scanner Workshop

Hosted by Maine DOT April 28, 2016

Data Analyses and Findings: I-95 Rehabilitation; Houlton, ME

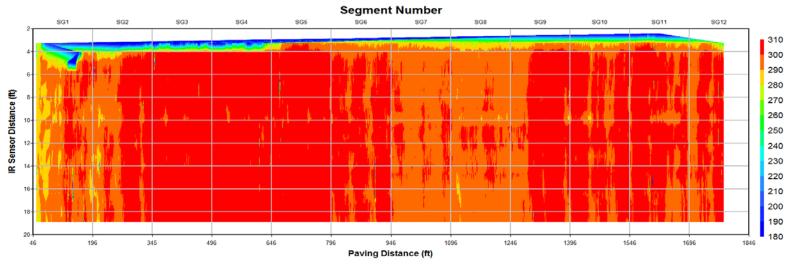
Infrared Thermography:

- The mapping of temperature contours (equal temperature) over the surface of a material.
- Contours are used to evaluate materials by measurement of their surface temperature and its variation.

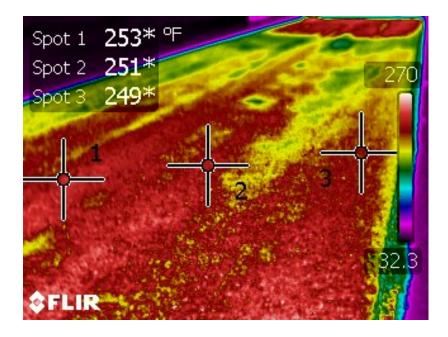
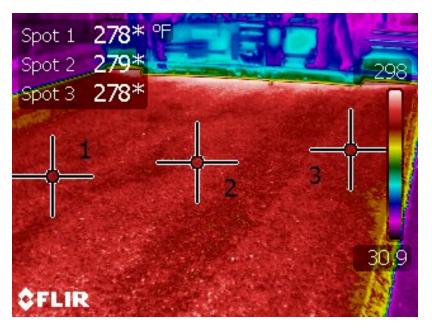
Temperature segregation (differential):

More than 25 °F difference in mat temperature behind screed.

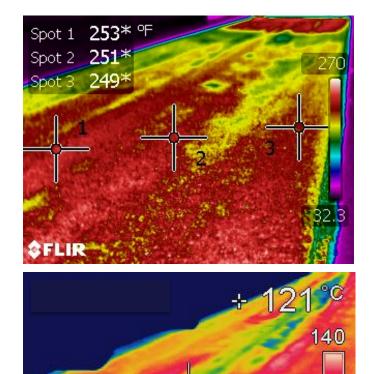
16/08/06 09:13:43 e=0.97

- Cold spots
 - Temperature difference of mat between truck exchanges – common.
 - Areas with higher air voids
- Focused testing have validated higher air voids
 - Coring
 - Radar (full coverage)
 - Nuclear gauge

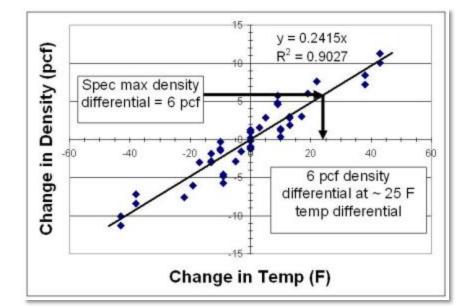
Temperature profile criteria based on desired density uniformity.

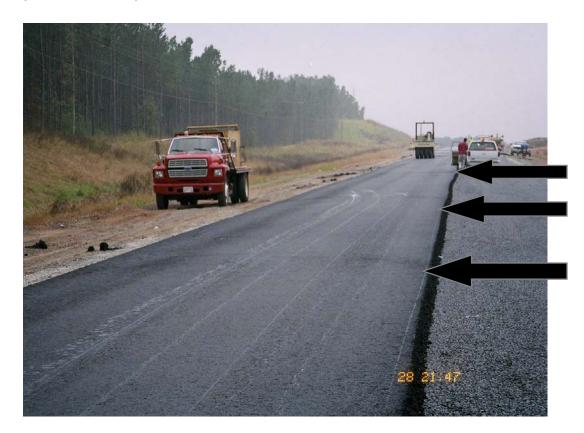
• Truck to truck segregation results in cold spots; IR can accurately identify these areas.

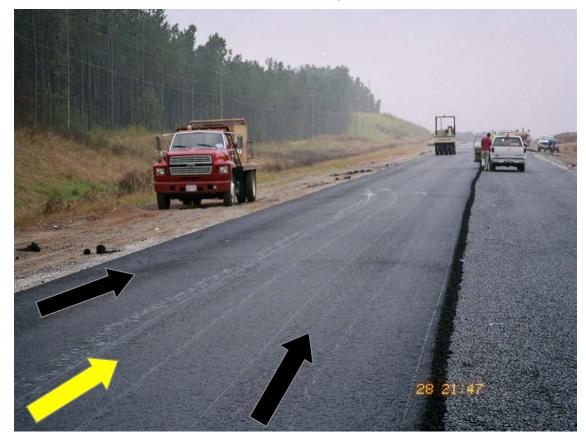
• Both sided longitudinal and centerline segregation result in thermal streaks; IR can identify these areas.

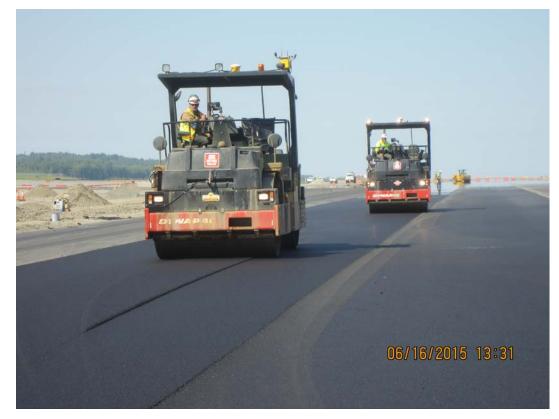
- Effect of cold spots, low mat temperatures on percent compaction; densities are:
 - Lower
 - More variable

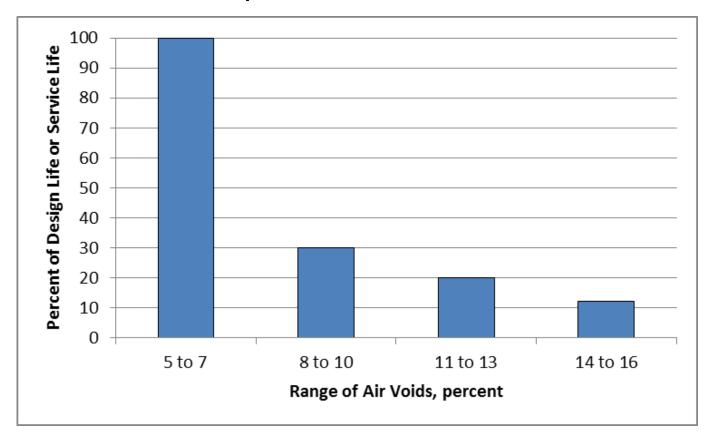
• Effect of reduced compaction or higher air voids because of lower mat temperatures.

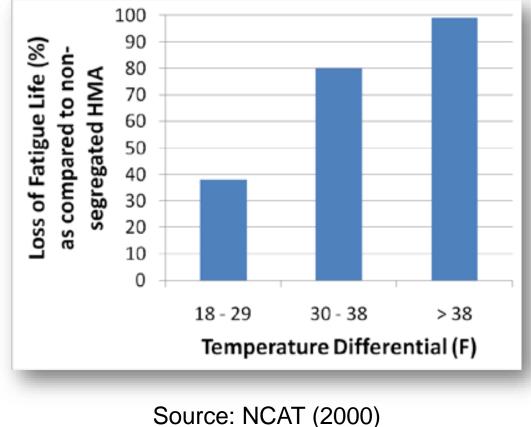
Fatigue life can be substantially reduced, as a result of lower densities because of lower mat temperatures.

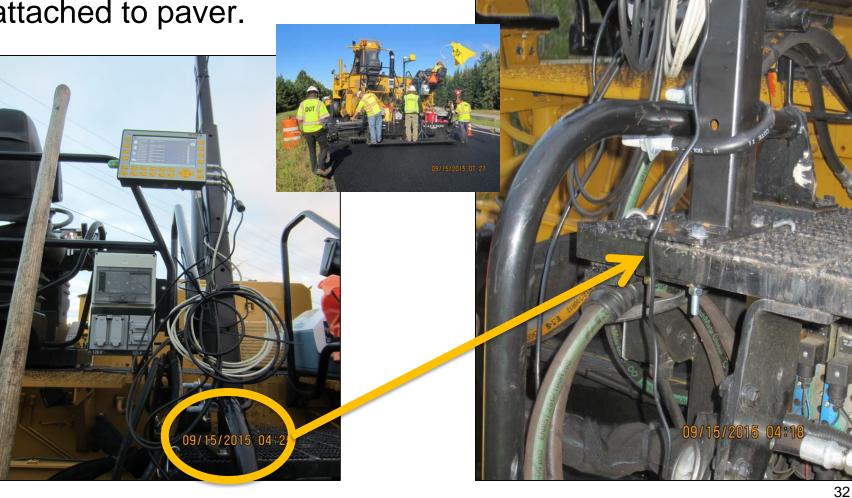
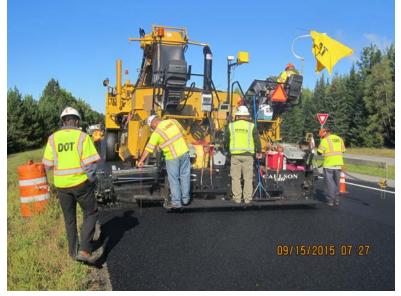
IR mast base and extension attached to paver.

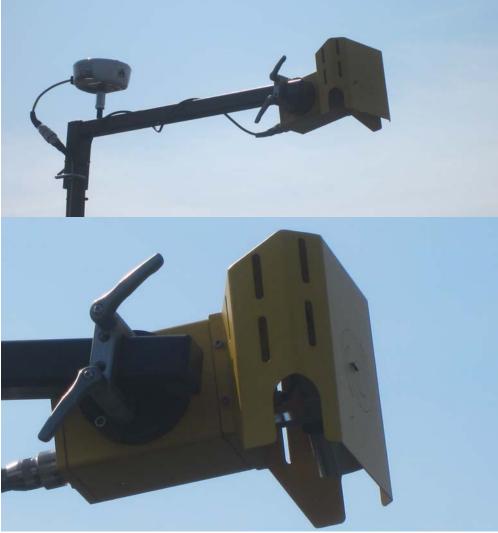
- IR Scanner attached to paver; scans mat behind screed in one direction.
- GPS attached to the mast arm.

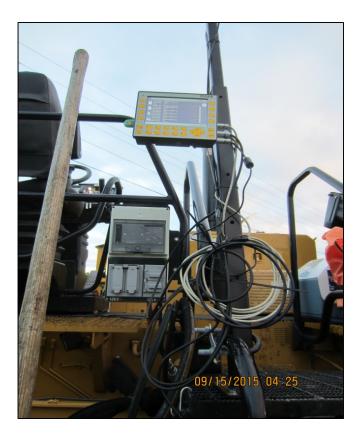
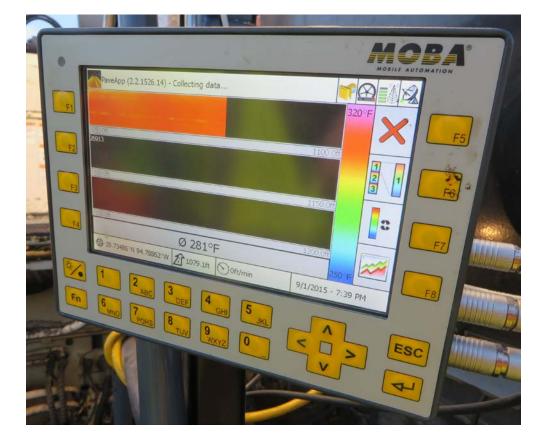
IR scan screen used to see/monitor mat temperatures in real time; attached to the mast post or extension.

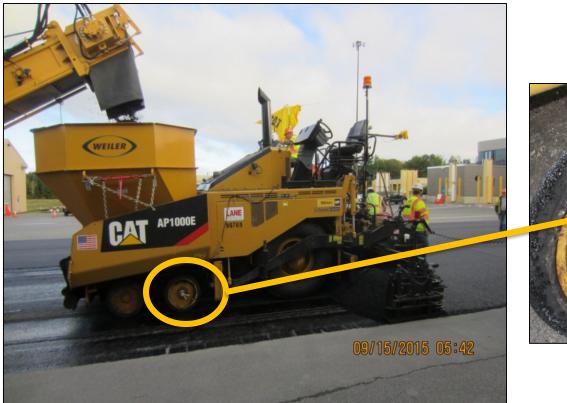
DMI placed on wheel hub to measure distance during paving operation.

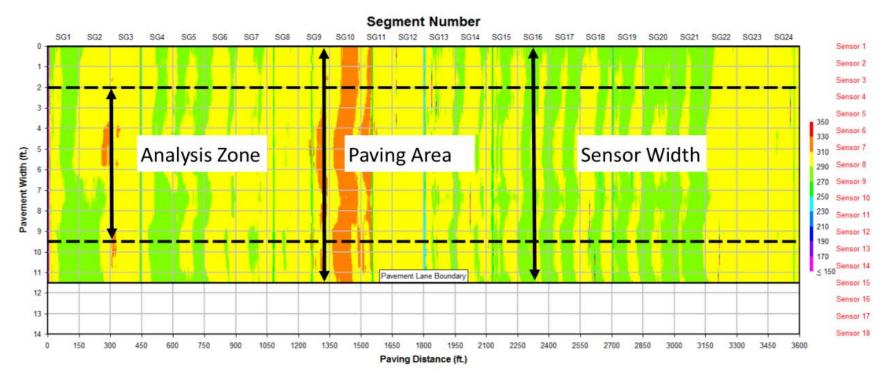
Raw Temperature Profile for first part of the southbound lane.

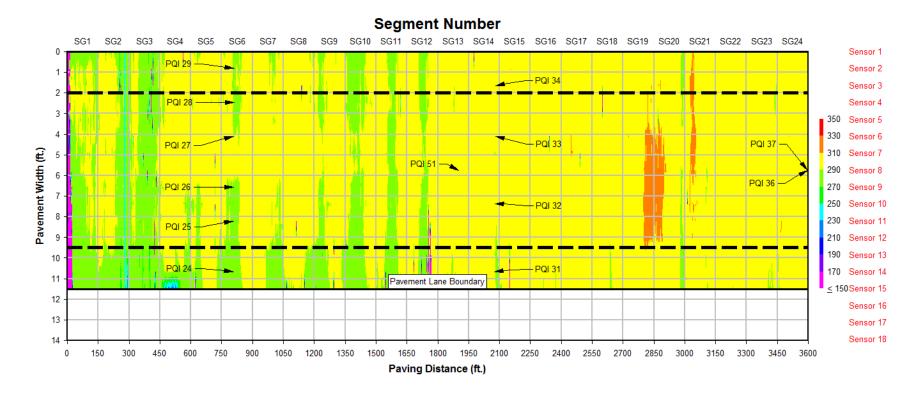
Raw Temperature Profile for center part of the southbound lane.

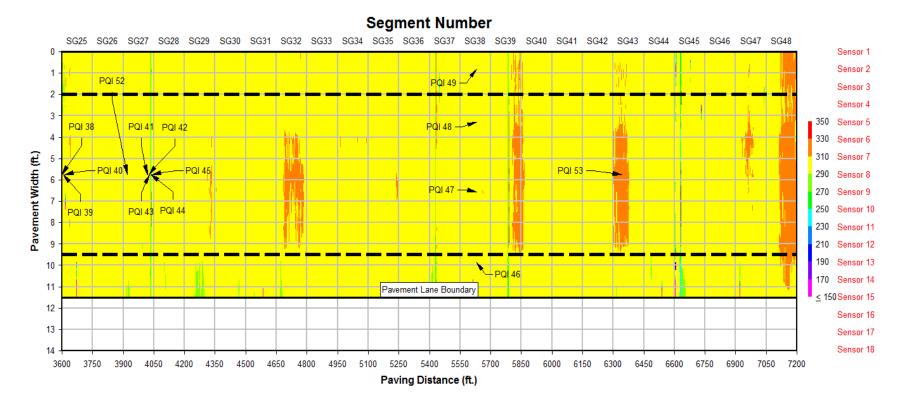
Raw Temperature Profile for latter path of the southbound lane.

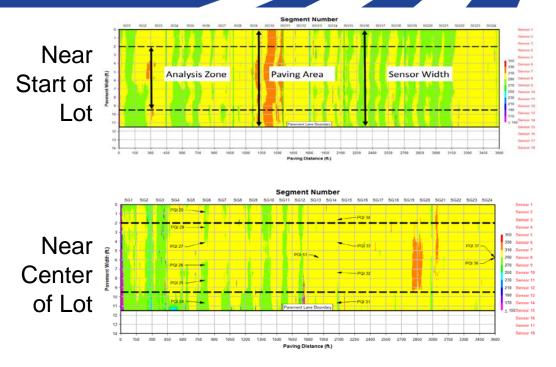
Raw Temperature Profile showing continuous improvement or more uniform mat temperatures along the southbound lane.

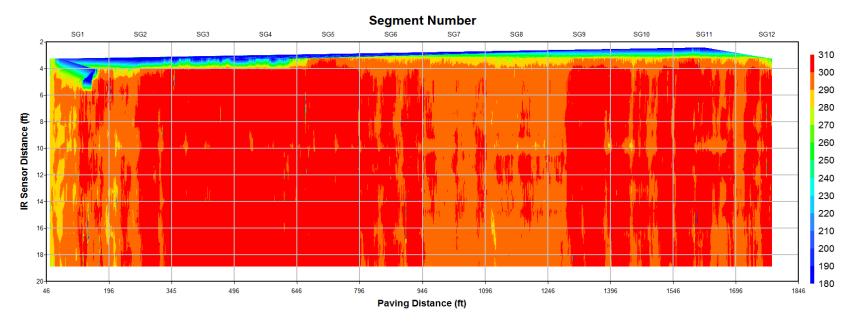
Data Processing—eliminate invalid temperature measurements:

1. Eliminate measurement locations within 2 feet of the mat's edge.

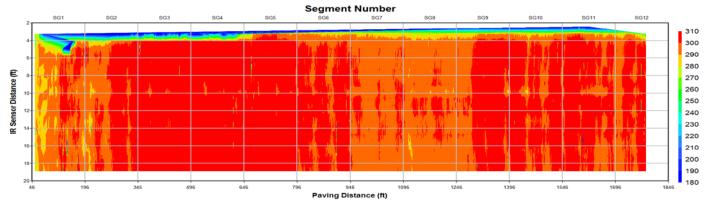
Data Processing—eliminate invalid temperature measurements:

- 2. Eliminate data with paver stops greater than 10 seconds, between locations:
 - 2 feet behind measurement location of stop
 - 8 feet in front of measurement location of stop
- 3. Eliminate temperature readings < 170 $^{\circ}$ F and > 400 $^{\circ}$ F.

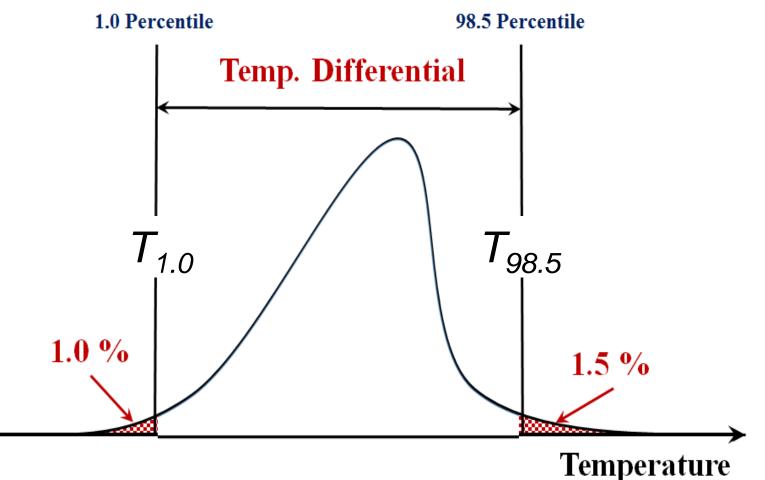
• Temperature Differential, each 150 foot segment

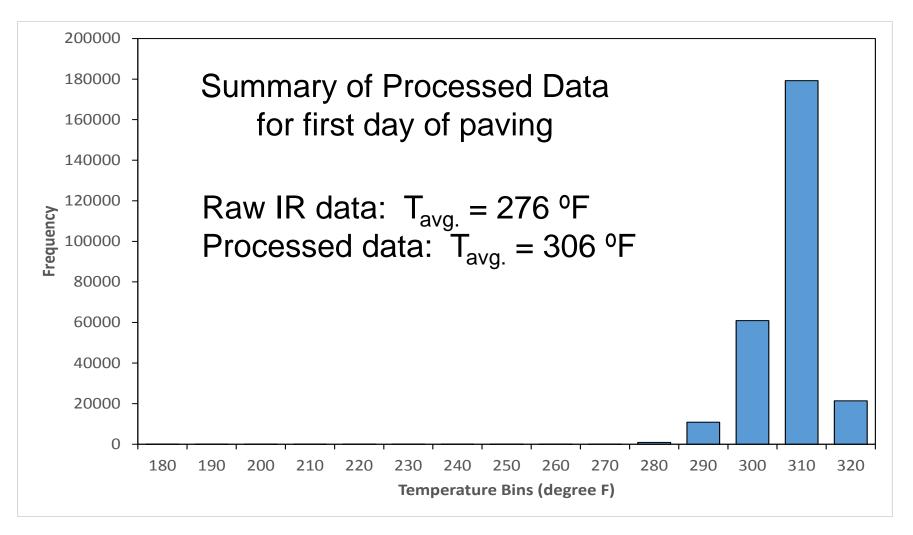
Temperature Differential Criteria, each 150 foot segment:

$$T_{Diff} = T_{98.5} - T_{1.0}$$

- T_{diff} ≤ 25 °F
- $25 \,{}^{\circ}\text{F} < \text{T}_{\text{diff}} \le 50 \,{}^{\circ}\text{F}$
- T_{diff} > 50 °F

No temperature difference

Moderate temperature difference

Severe temperature difference

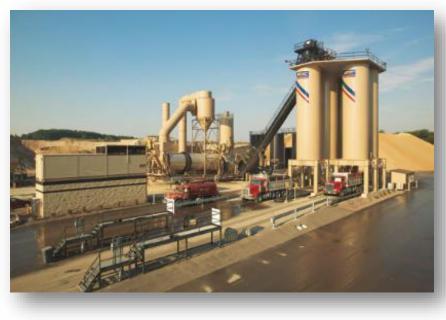
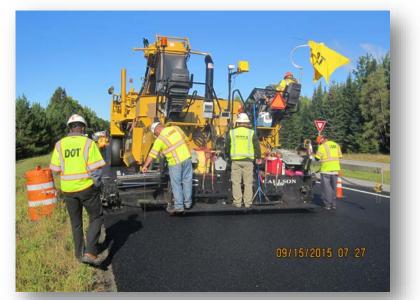
- 1. Missouri demonstration project
 - Communication between plant and paver; monitoring production/placement operations to minimize temperature differentials of mat.

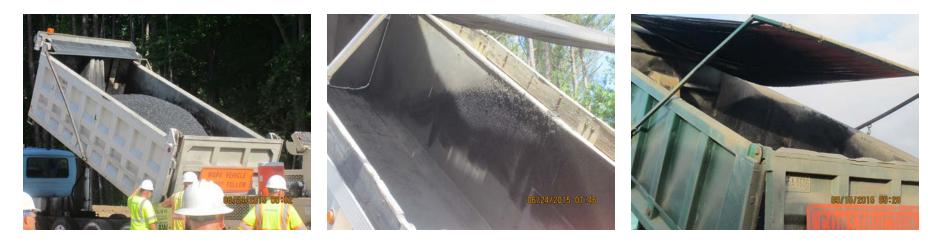
- 3. Federal Lands demonstration project
 - Identify reason for severe temperature differentials and take action; loading of trucks.
 - One dump of mix in truck bed severe temp. differential
 - Two dump, no stockpile reduced temp. differential.
