The Barton Corner Bridge No. 518

Kyle P. Gagnon, P.E. – RIDOT Project Manager Gary I. Hall, P.E. – Parsons Transportation Group

Advancing Women in Transportation (WTS) Rhode Island November 19th Luncheon

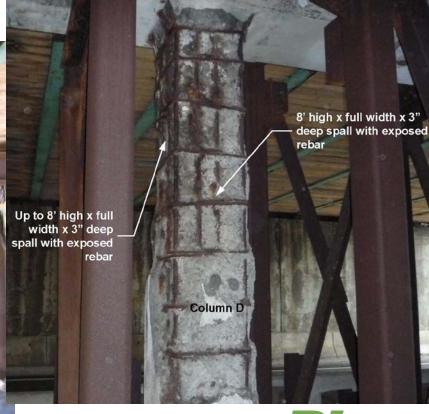
Project Overview

Built in 1958, the Barton Corner Bridge had surpassed its design life and was showing signs of aggressive deterioration. To avoid reducing its carrying capacity, a steel shoring system was installed in 2010 to support the bridge.

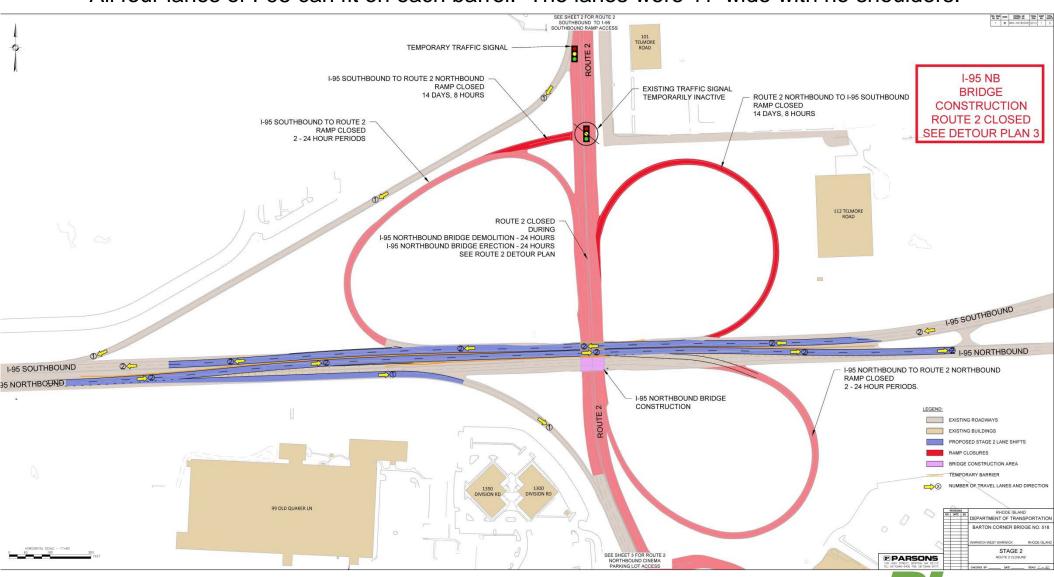
Lane Shifts – I-95 Northbound Bridge Construction

All four lanes of I-95 can fit on each barrel. The lanes were 11' wide with no shoulders.

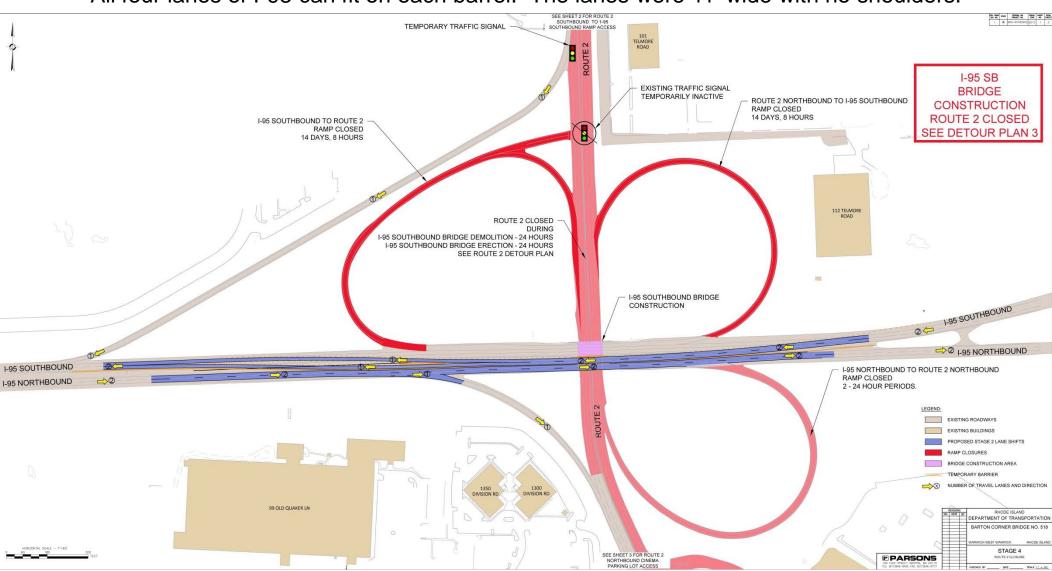
Lane Shifts – I-95 Southbound Bridge Construction

All four lanes of I-95 can fit on each barrel. The lanes were 11' wide with no shoulders.

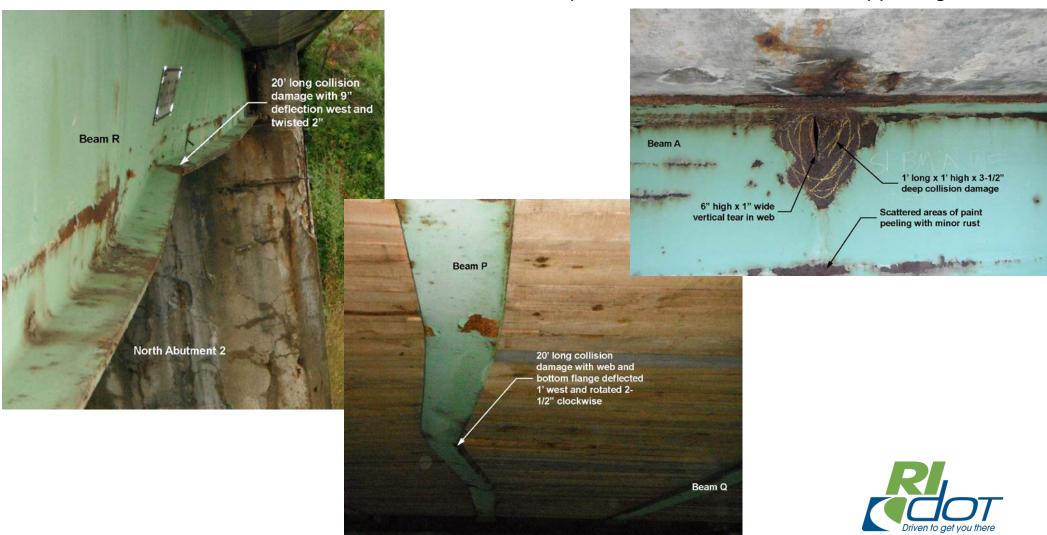
Vertical Clearance

The previous bridge structure had a vertical clearance of **14'-2"** and the new structure has a vertical clearance of **15'-1"**. This increase of 11" was achieved by using a shallower beam of W21X147 versus the original W27x84 for a savings of 5". Also, I-95 profile was raised 6".

The new vertical clearance dimension should help eliminate the below from happening....

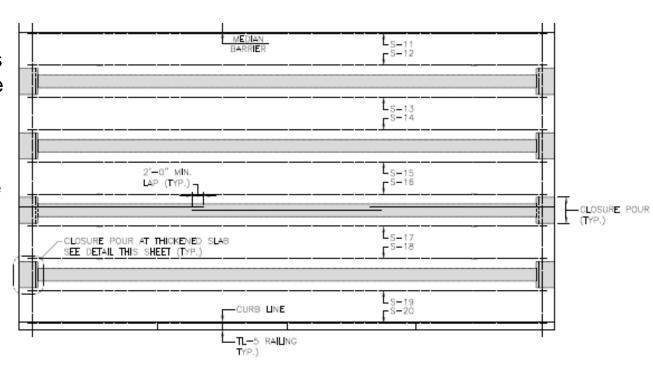
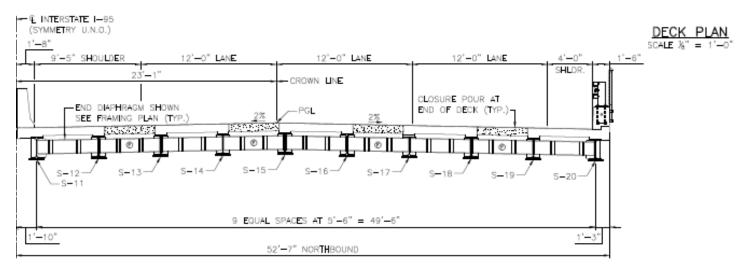
Prefabricated Bridge Units (PBUs)

This contract was originally advertised as prefabricated bridge units being placed with closure pours.

The PBUs consisted of two steel stringers with an integrally cast concrete deck. The 5 PBUs per bridge bound would then be erected onsite and then threaded with galvanized bars to connect the pieces. Once the rebar was tied a closure pour with a high early strength concrete would be placed.

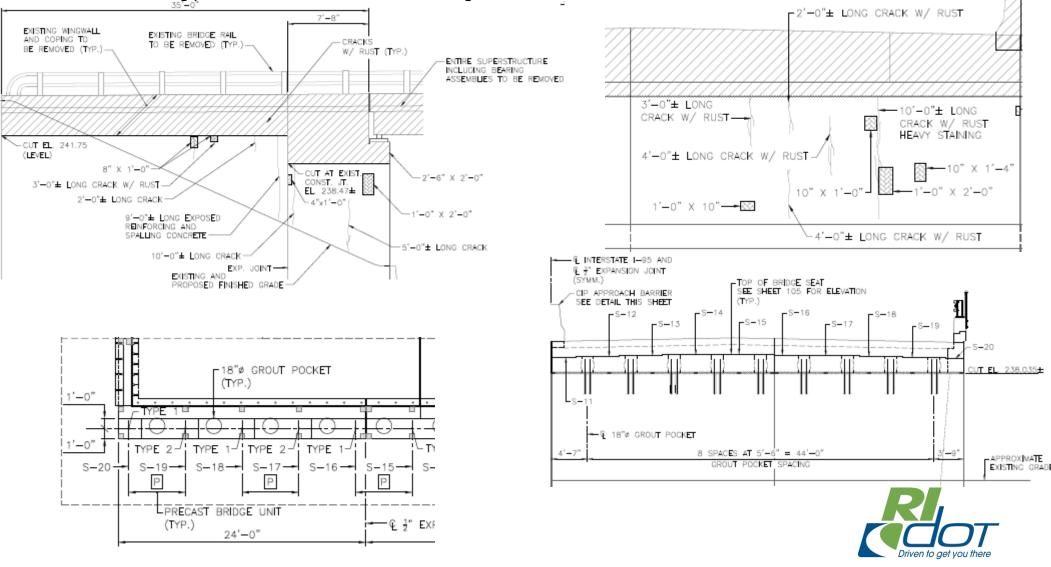
Precast Abutment and Wingwall Caps

The abutment and wingwalls were in fairly good condition. A complete replacement was not needed.

The bridge beam seats had their fair share of water and chlorides leaking through the joints for many years and had to be replaced. The abutment was cut about 3' below the beam seat and new precast beam seats installed. Patch repairs were

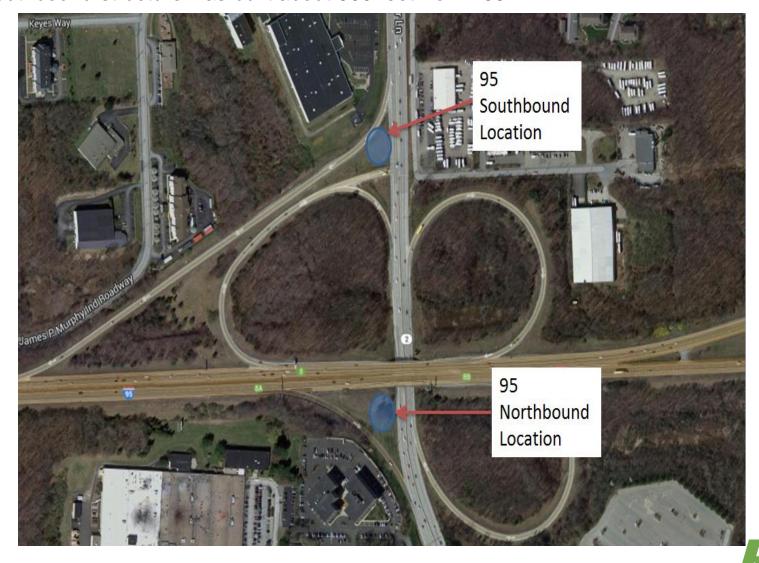
Northbound and Southbound Construction Sites

- The I-95 Northbound structure was built adjacent to I-95.
- The I-95 Southbound structure was built about 900 feet from I-95.

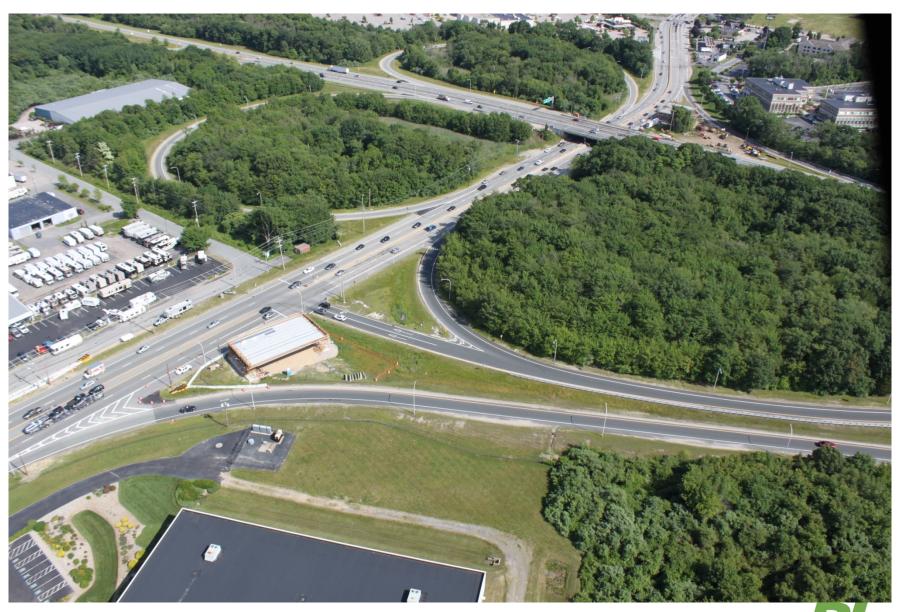
D'Ambra used EFCO Shoring Towers to support the superstructure.

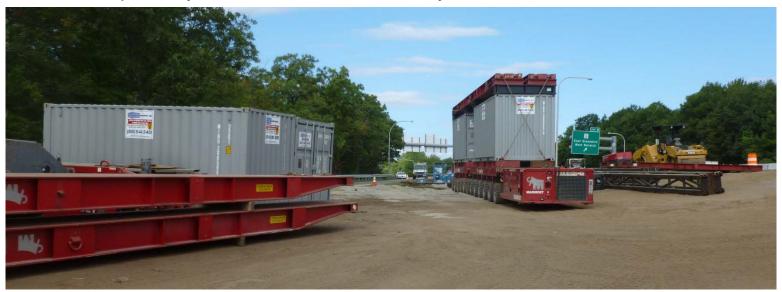
Self-Propelled Modular Transporters (SPMTs)

FHWA Definition - A Self-Propelled Modular Transporter is a combination of multi-axle platforms operated through a state-of-the-art computer-controlled system that is capable of pivoting 360 degrees as needed to lift, carry, and set very large and heavy loads of many types.

SPMTs are motorized vehicles that move at walking speed and are capable of carrying large structures, such as bridges, from offsite locations, positioning them precisely into final position. The SPMT then exits the site, opening the area to traffic possibly within minutes or certainly within a few hours.

Each Bridge Weighed 440 Tons

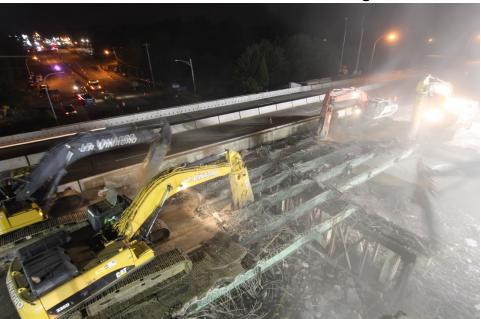
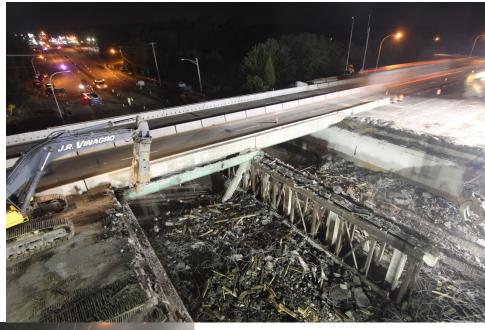
First Bridge Demolition – I-95 North

The I-95 Northbound structure was the first to be demoed and took place on Tuesday night August 19, 2014. Route 2 was shutdown at 10 PM and was opened at 5:45 AM (less than 8 hours of closure).

The deck and beams were all on the ground in under an hour and a half.

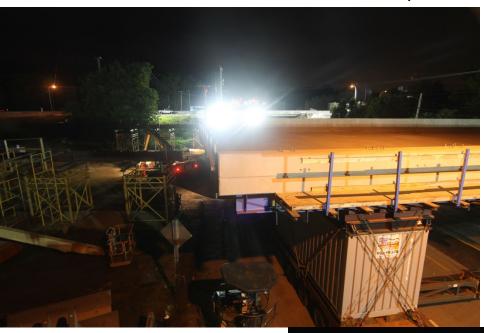
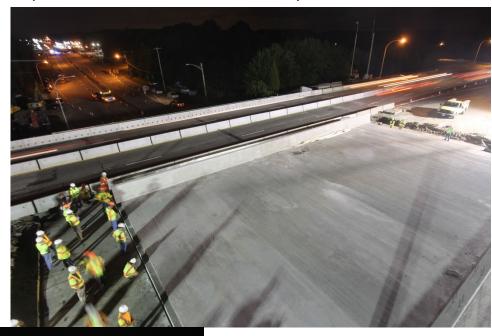
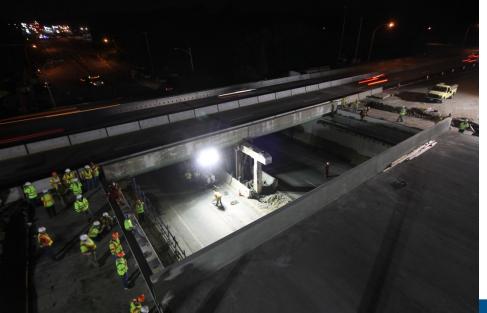
First Bridge Move – I-95 North

The I-95 Northbound structure was the first to be moved and took place on Thursday night August 21,2014. Route 2 was shutdown at 9 PM and was opened at 12:50 AM (less than 4 hours of closure).

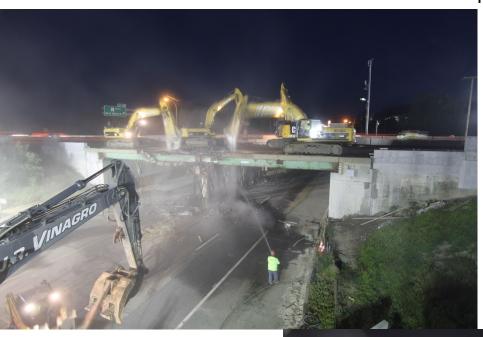
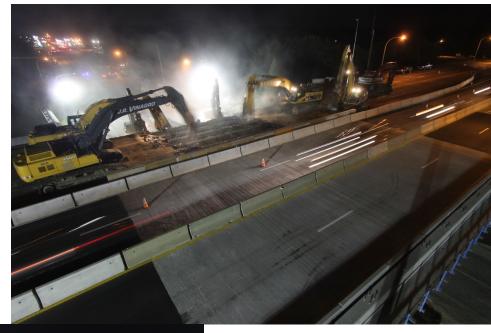
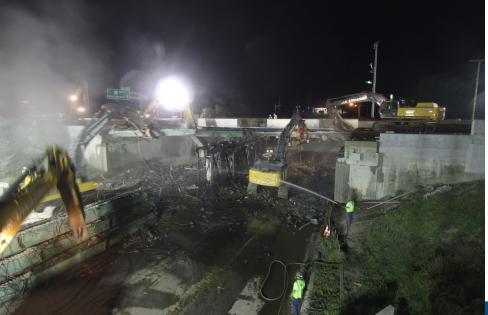
Second Bridge Demolition – I-95 South

The I-95 Southbound structure was the second to be demoed and took place on Monday night August 25, 2014. Route 2 was shutdown at 8 PM and was opened at 2:30 AM (less than 7 hours of closure).

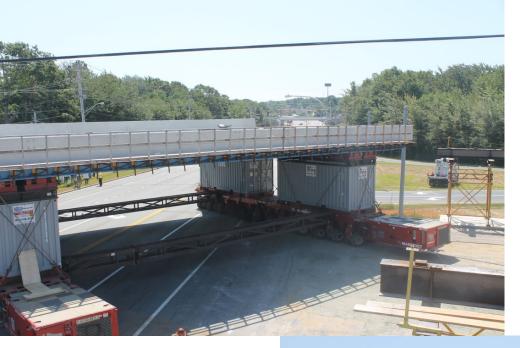
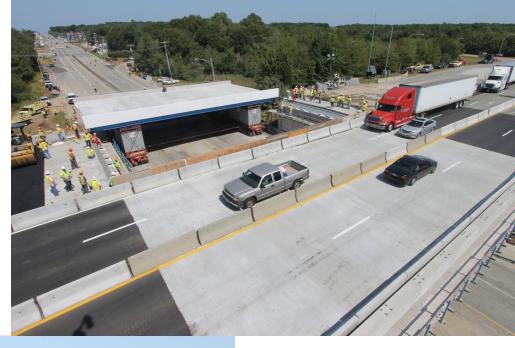
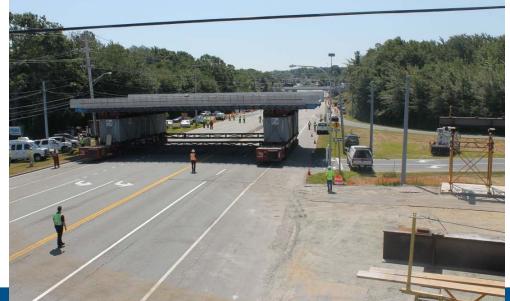
Second Bridge Move – I-95 South

The I-95 Southbound structure was the second to be moved and took place on Wednesday afternoon on August 27,2014. Route 2 was shutdown at 12:00 PM and opened at 3:50 PM (less than 4 hours of closure).

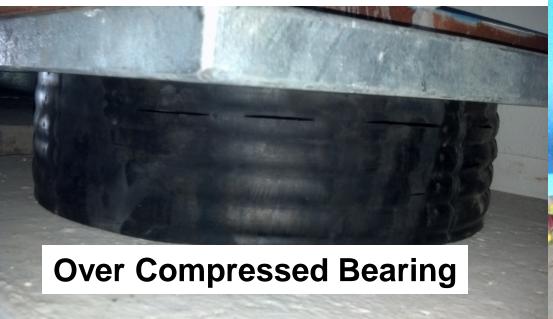
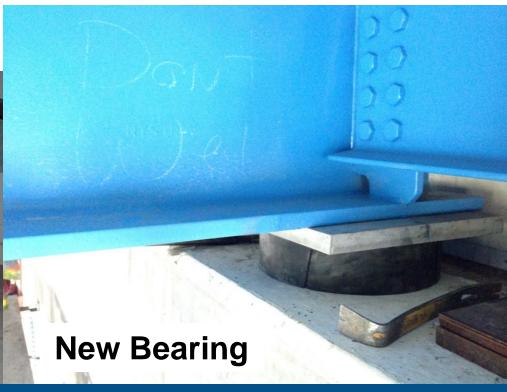
Lessons Learned

- Don't use exposed concrete deck!
 - Very small margin of error to achieve correct deck grades
 - Had to have multiple surveys to check elevations
 - Had to revise I-95 pavement leveling course many times

- Watch the bridge bearings!
 - An elastomeric bearing was overloaded when being placed on beam seat
 - The beam seat was not completely level in that bearing location
 - Luckily D'Ambra ordered two extra bearings
 - New thinner sole plate was ordered
 - Bearing was replaced on October 24, 2014

Recommend asphalt overlay

Recommend ordering extra bearings
