### Final Report on the Non-Destructive Inspection of the Tooth Rock & Vista Ridge Tunnels

Oregon Department of Transportation Contract B35752 R06G Tunnel Liner Investigation Project

October 16, 2018

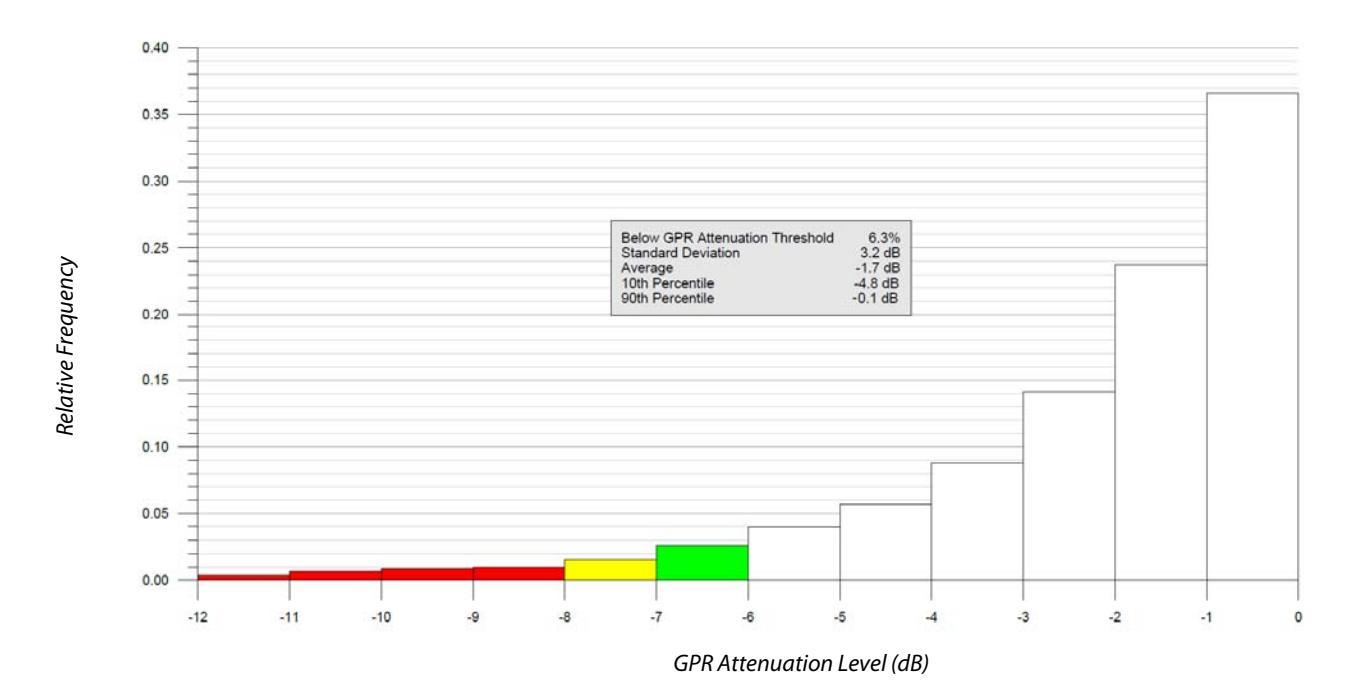
**GPR Attenuation Distribution of Tooth Rock Tunnel**

The GPR inspection of the Tooth Rock Tunnel detected varying levels of signal attenuation. Higher levels of attenuation typically correspond to greater incidence of delamination or deterioration in the concrete liner. This was found in 6.3% or 3317 square feet of the concrete liner, with 4.5% of the attenuation detections being classified as "medium or high" suggesting higher probabilities of deterioration/delamination in the liner at these locations. Detailed plan-view mappings showing probable areas of deterioration are provided later in this report.

*Figure 13.* The histogram shows the distribution of attenuation in the GPR signal. The attenuation level is the ratio of the measured GPR signal versus the maximum signal amplitude from the GPR scan. The relative frequency shows the percentage of attenuation values of all measured values on a 1 dB interval.

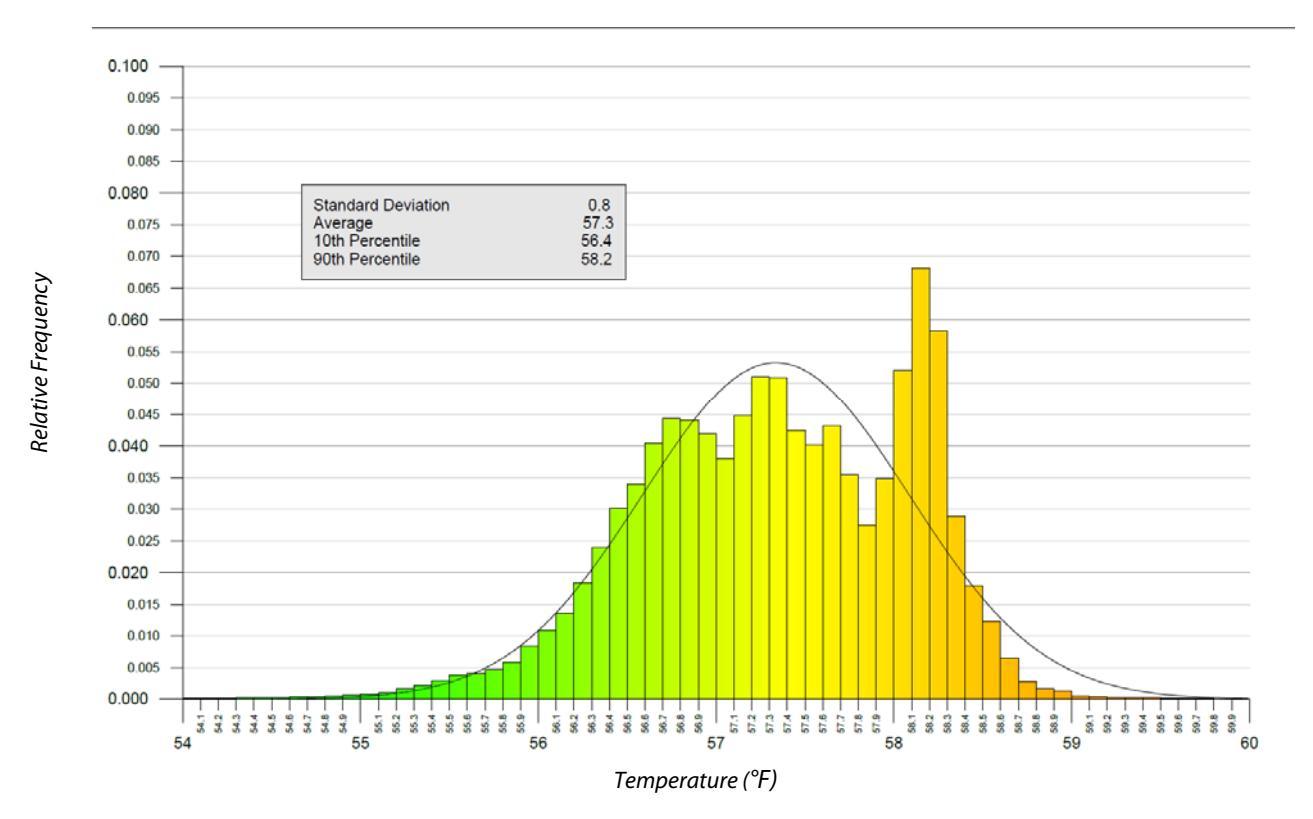
Infrared Temperature Distribution of Tooth Rock Tunnel (Left Lane Wall)

**Figure 16.** The histogram showing the distribution of temperature values recorded during the Infrared Thermography scan of the Tooth Rock Tunnel – Left Lane Wall.

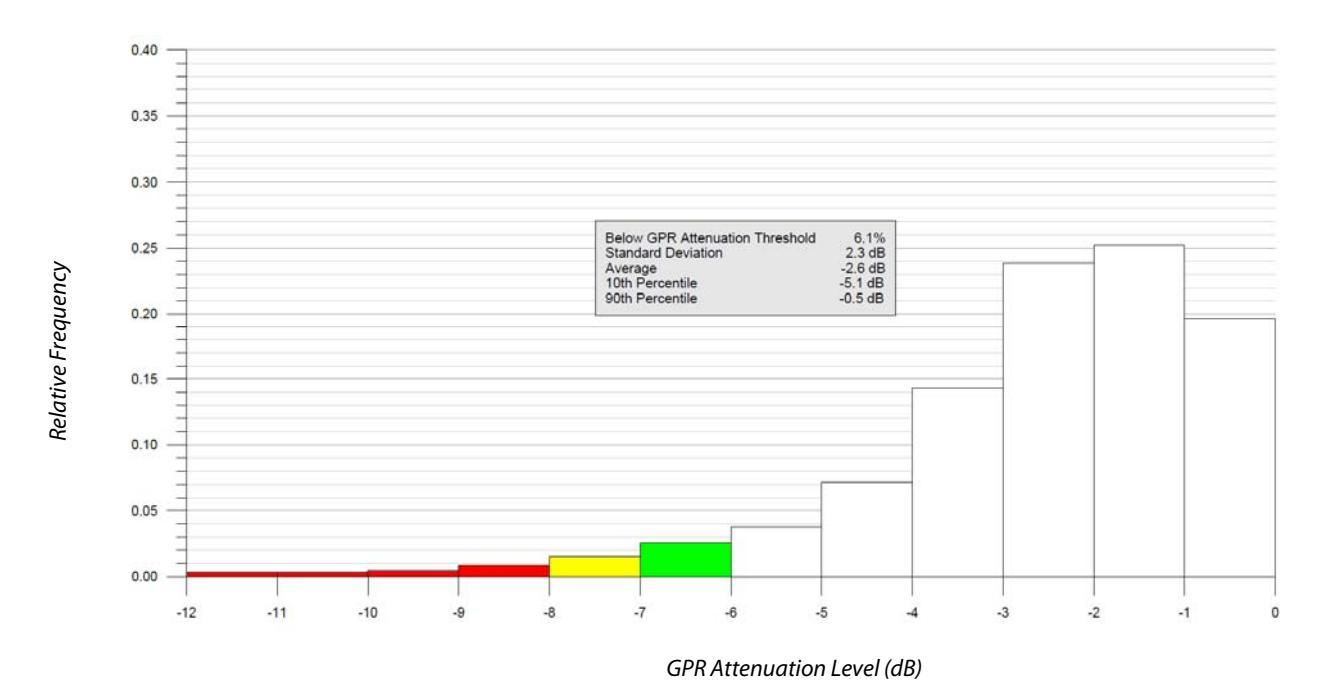
GPR Attenuation Distribution of Vista Ridge Eastbound (Right Lane)

Our inspection for liner deterioration based on measurement of GPR attenuation found similar quantities in the right and left walls of roughly 5 to 6 percent. These are the quantities that exceeded the -6 dB threshold, which is the threshold for possible concrete deterioration. However, while overall quantities were similar, the right lane wall of the Vista Ridge Eastbound Tunnel was found to contain

greater levels of attenuation than the left lane wall suggesting it to be in a worse physical condition. The percent and total area (in square feet) exceeding each threshold are shown in Table 2.

**Figure 17.** The histogram shows the distribution of attenuation in the GPR signal. The attenuation level is the ratio of the measured GPR signal versus the maximum signal amplitude from the GPR scan. The relative frequency shows the percentage of attenuation values of all measured values on a 1 dB interval.

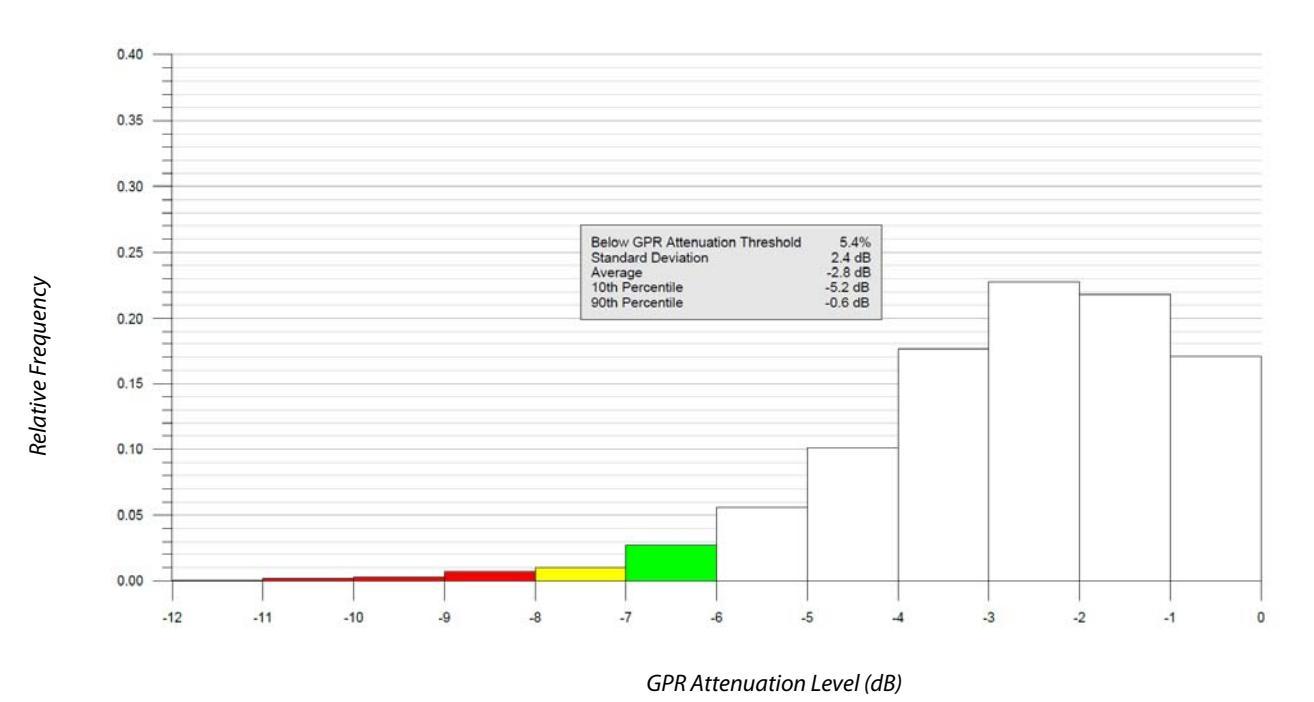
GPR Attenuation Distribution of Vista Ridge Eastbound (Left Lane)

**Figure 18.** The histogram shows the distribution of attenuation in the GPR signal. The attenuation level is the ratio of the measured GPR signal versus the maximum signal amplitude from the GPR scan. The relative frequency shows the percentage of attenuation values of all measured

values on a 1 dB interval.

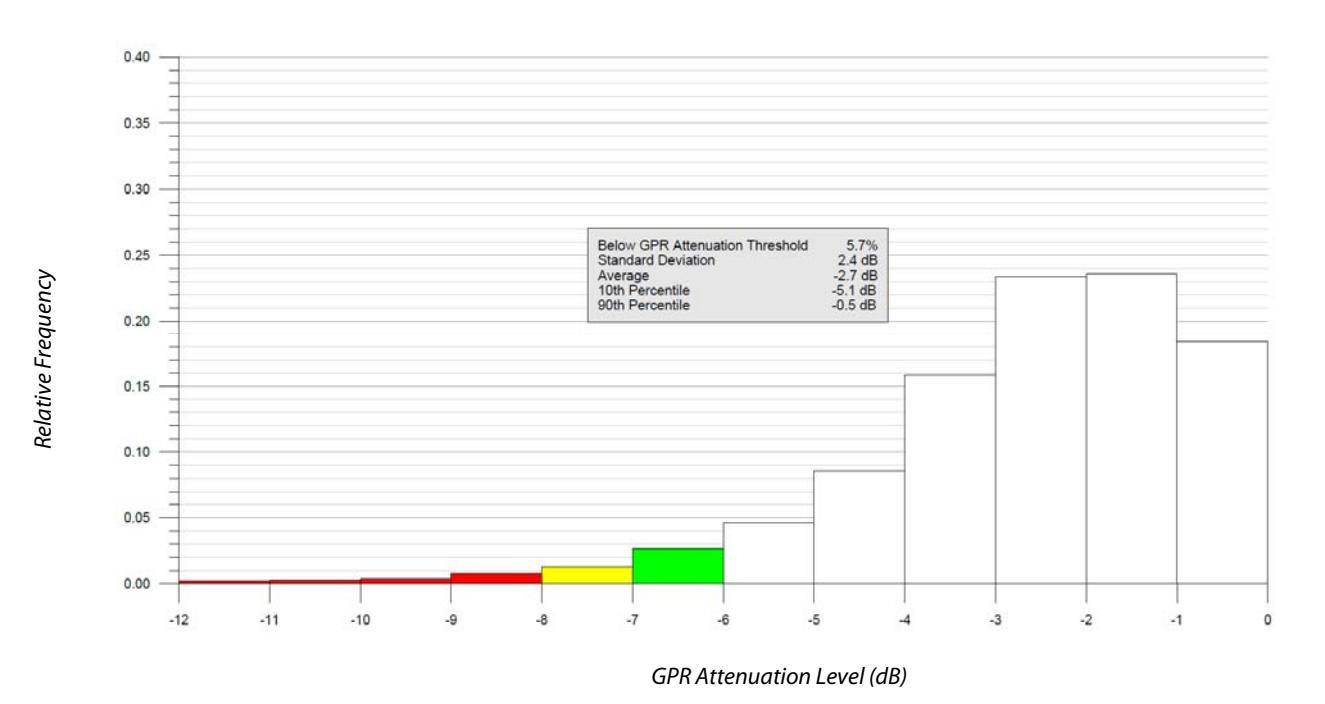
GPR Attenuation Distribution of Vista Ridge Eastbound (Total)

**Figure 19.** The histogram shows the distribution of attenuation in the GPR signal. The attenuation level is the ratio of the measured GPR signal versus the maximum signal amplitude from the GPR scan. The relative frequency shows the percentage of attenuation values of all measured values on a 1 dB interval.

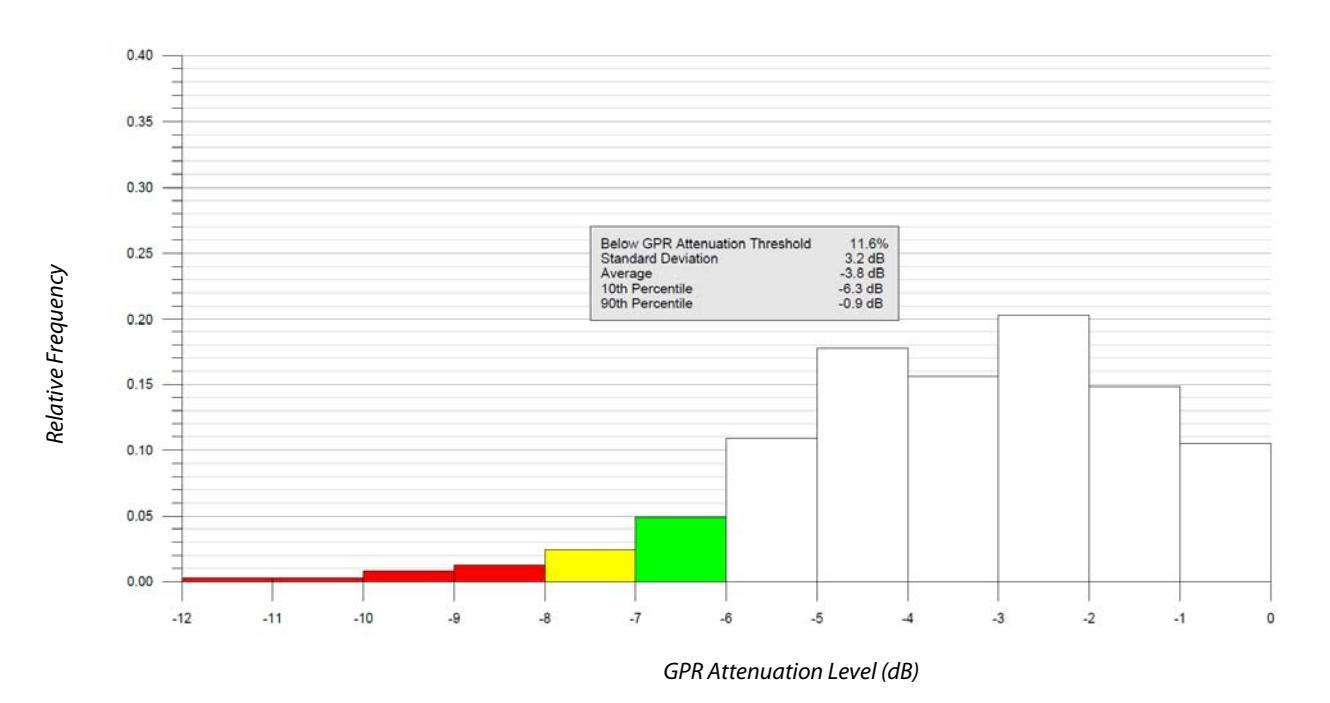
GPR Attenuation Distribution of Vista Ridge Westbound (Right Lane)

**Figure 20.** The histogram shows the distribution of attenuation in the GPR signal. The attenuation level is the ratio of the measured GPR signal versus the maximum signal amplitude from the GPR scan. The relative frequency shows the percentage of attenuation values of all measured values on a 1 dB interval.

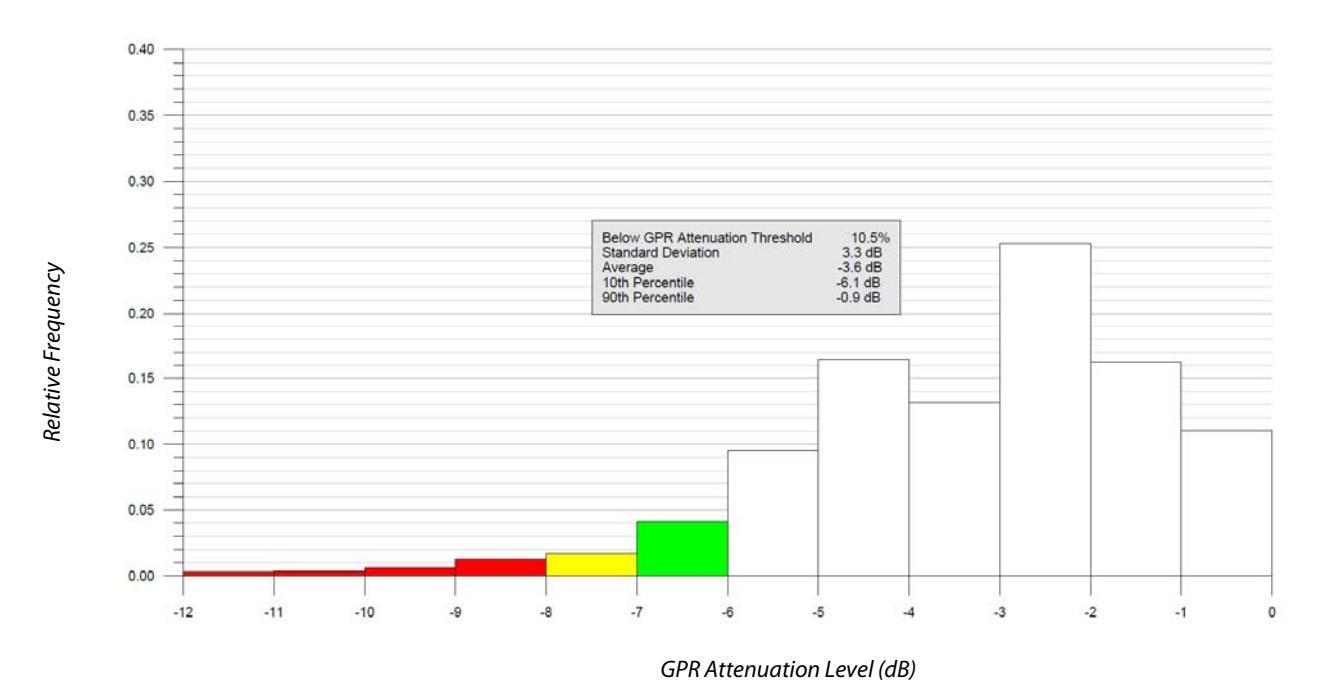
GPR Attenuation Distribution of Vista Ridge Westbound (Left Lane)

**Figure 21.** The histogram shows the distribution of attenuation in the GPR signal. The attenuation level is the ratio of the measured GPR signal versus the maximum signal amplitude from the GPR scan. The relative frequency shows the percentage of attenuation values of all measured values on a 1 dB interval.

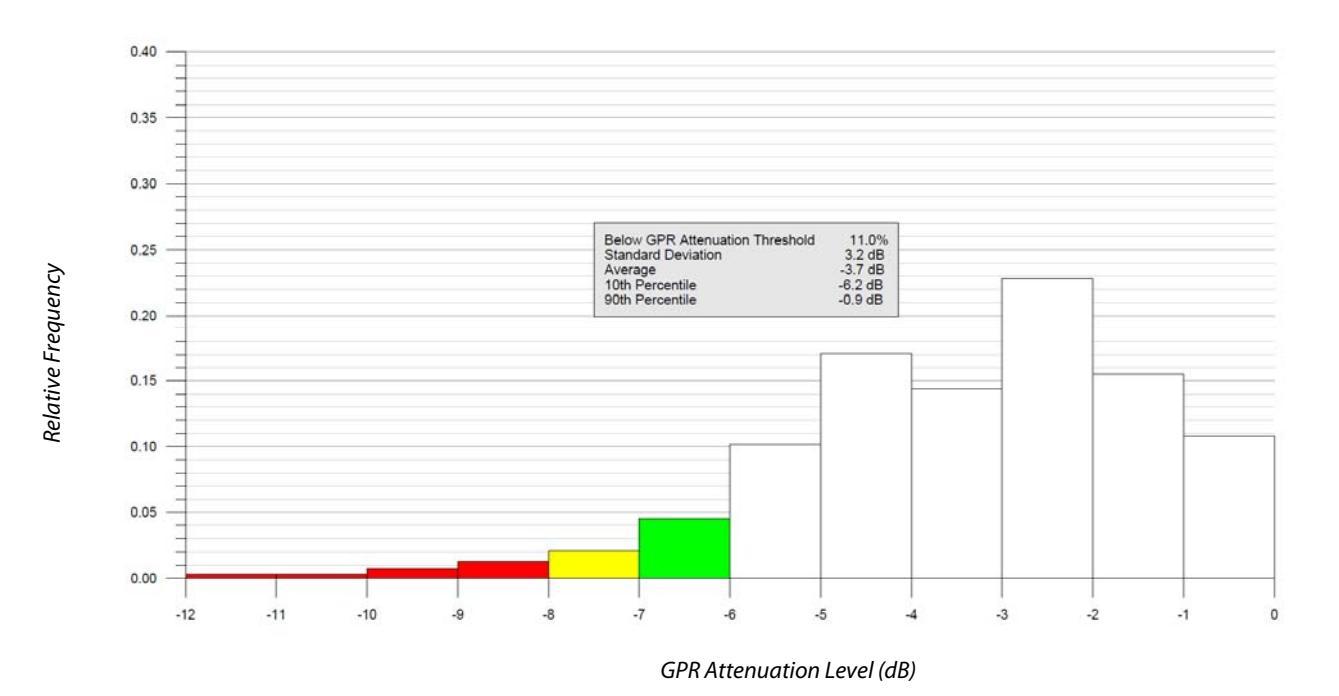
GPR Attenuation Distribution of Vista Ridge Westbound (Total)

*Figure 22.* The histogram shows the distribution of attenuation in the GPR signal. The attenuation level is the ratio of the measured GPR signal versus the maximum signal amplitude from the GPR scan. The relative frequency shows the percentage of attenuation values of all measured values on a 1 dB interval.

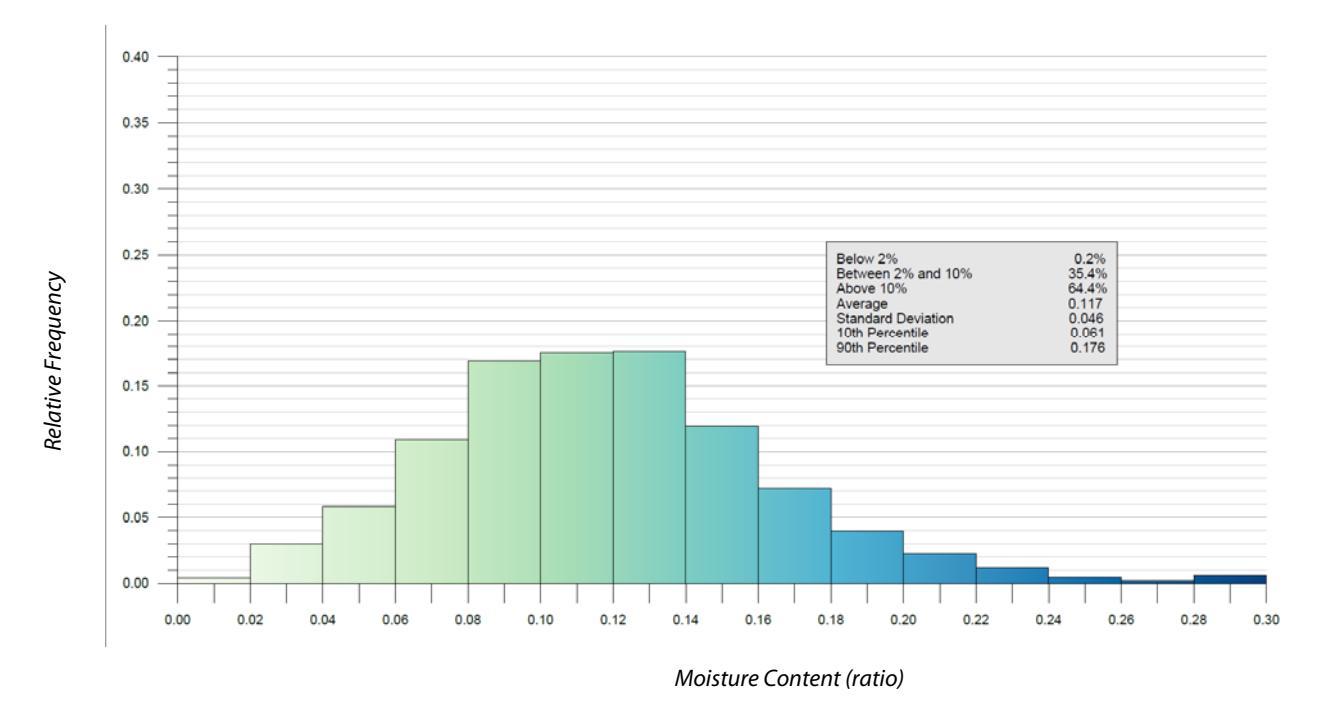
Moisture Content Distribution of Vista Ridge Eastbound (Right Lane)

*Figure 24.* Histogram showing the distribution of calculated moisture content based on relative dielectric content of concrete in the Vista Ridge Eastbound Tunnel – Right Lane.

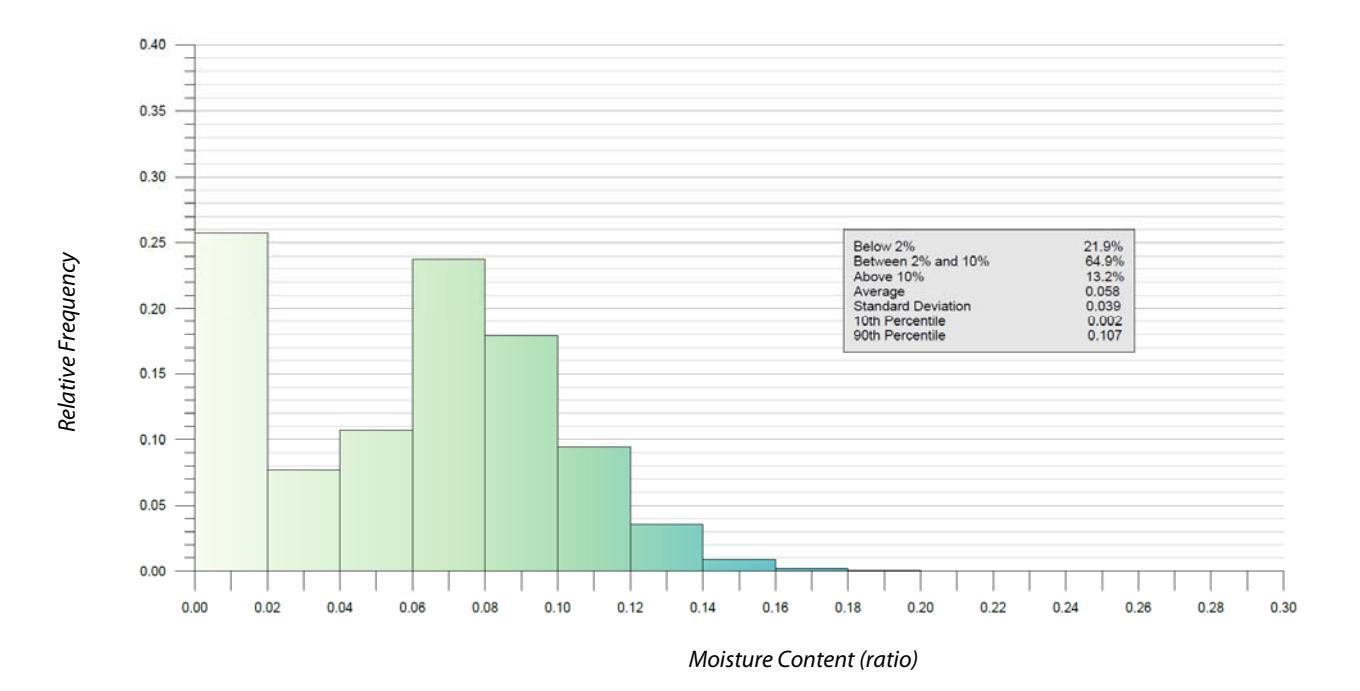
Moisture Content Distribution of Vista Ridge Eastbound (Left Lane)

*Figure 25.* Histogram showing the distribution of calculated moisture content based on relative dielectric content of concrete in the Vista Ridge Eastbound Tunnel – Left Lane.

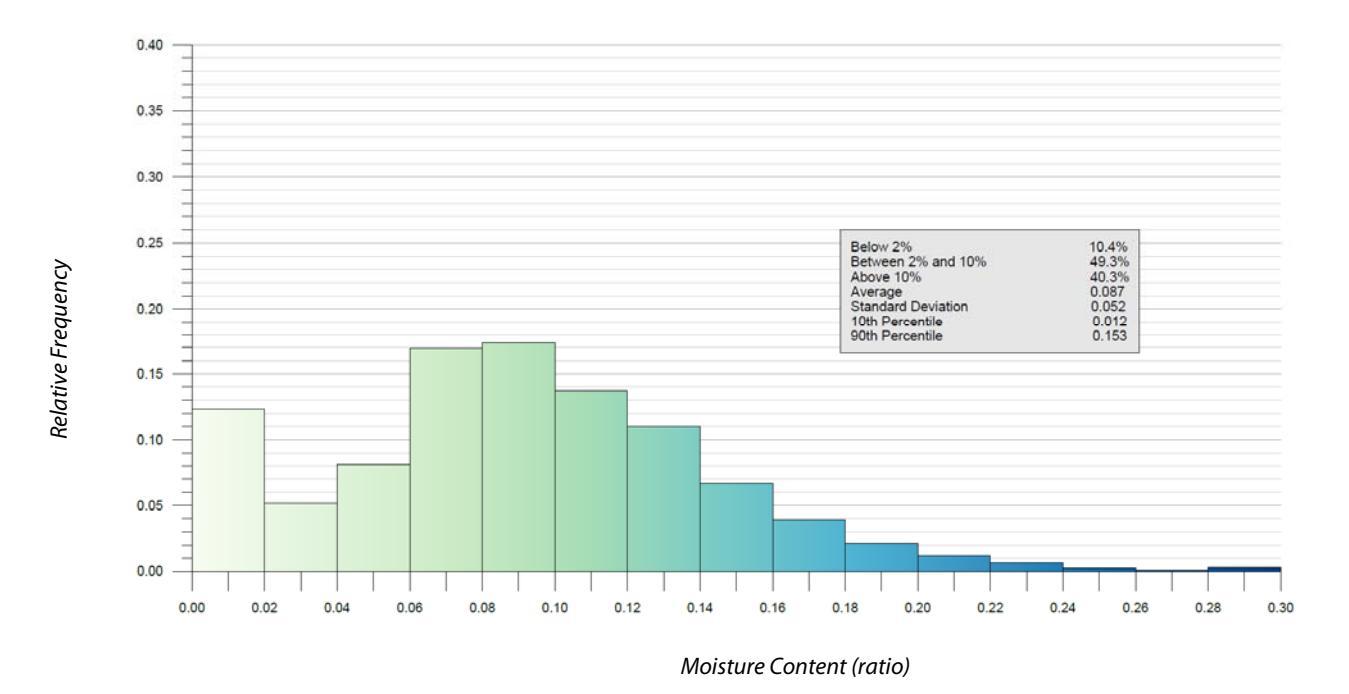
Moisture Content Distribution of Vista Ridge Eastbound (Total)

*Figure 26.* Histogram showing the distribution of calculated moisture content based on relative dielectric content of concrete in the Vista Ridge Eastbound Tunnel – Both Walls.

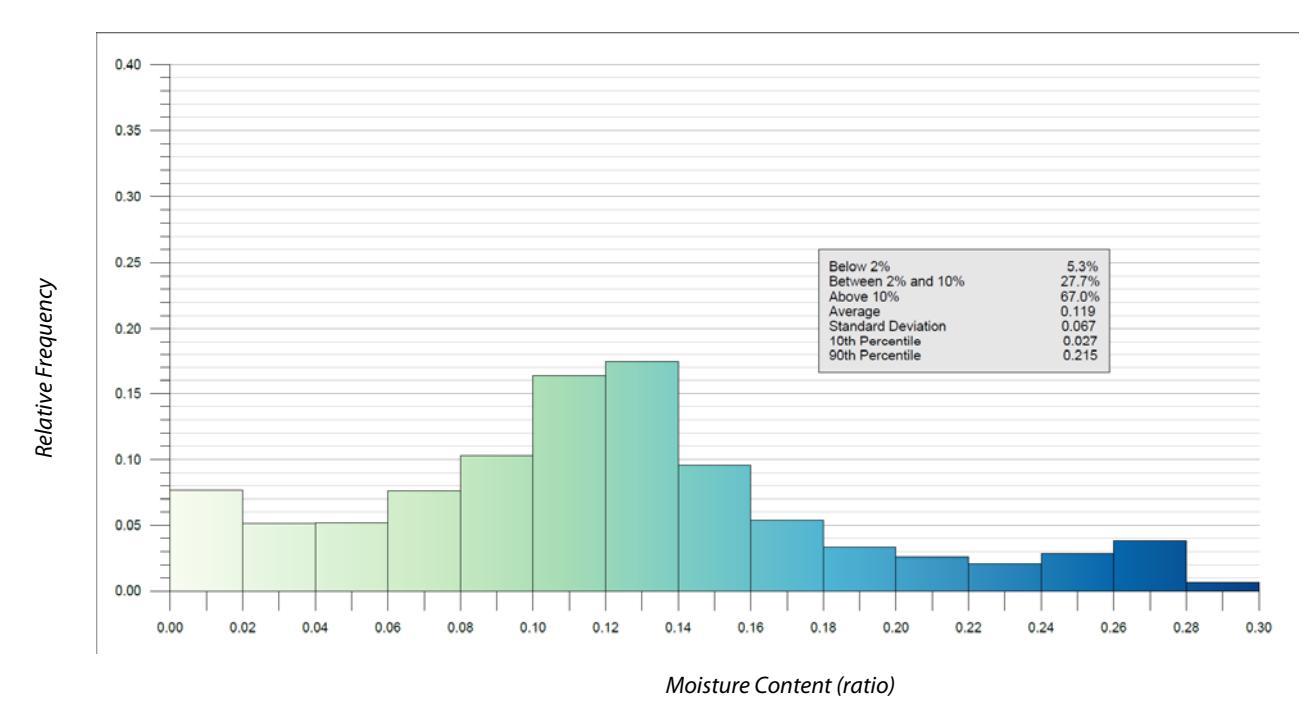
Moisture Content Distribution of Vista Ridge Westbound (Right Lane)

This resulted in total values for the Westbound Tunnel of 6.4% (3,249 ft<sup>2</sup>) below 2% moisture by volume, 41.4% (21,089 ft<sup>2</sup>) between 2% and 10% moisture by volume and 52.2% (26,590 ft<sup>2</sup>) above 10% moisture by volume.

*Figure 27.* Histogram showing the distribution of calculated moisture content based on relative dielectric content of concrete in the Vista Ridge Westbound Tunnel – Right Lane.

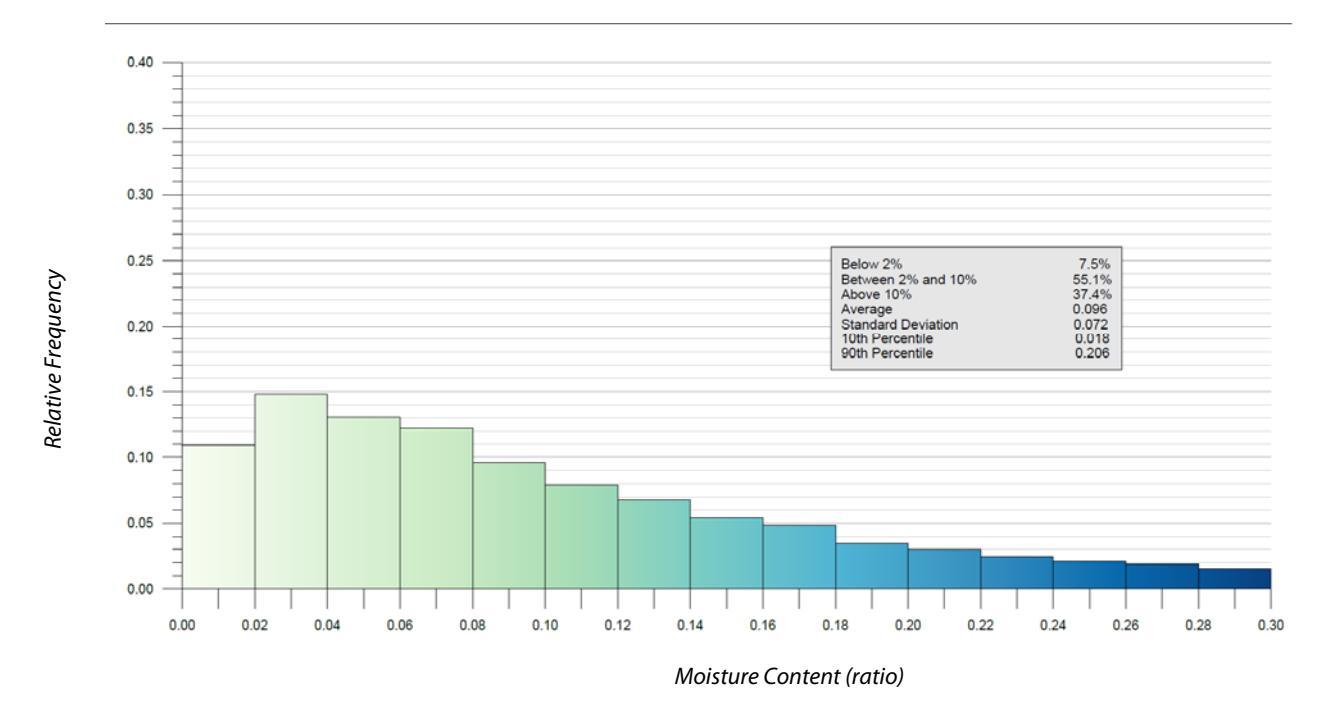
Moisture Content Distribution of Vista Ridge Westbound (Left Lane)

*Figure 28.* Histogram showing the distribution of calculated moisture content based on relative dielectric content of concrete in the Vista Ridge Westbound Tunnel – Left Lane.

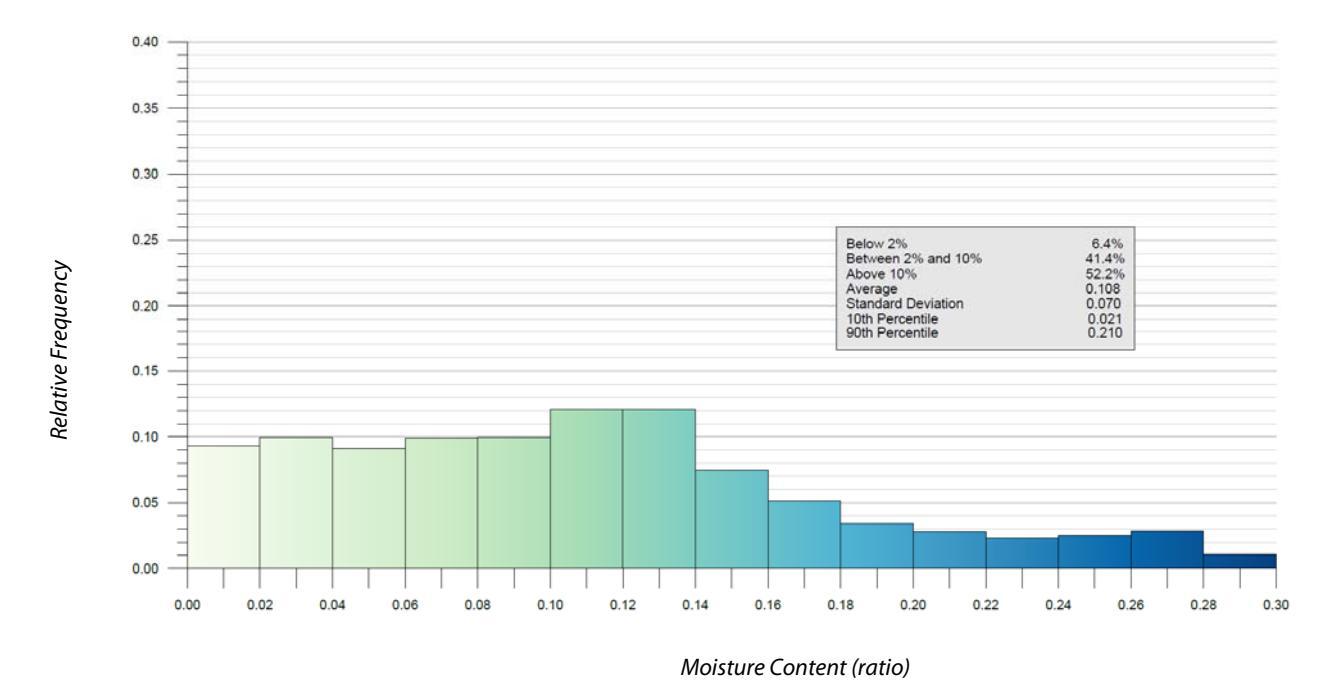
Moisture Content Distribution of Vista Ridge Westbound (Total)

*Figure 29.* Histogram showing the distribution of calculated moisture content based on relative dielectric content of concrete in the Vista Ridge Westbound Tunnel – Both Walls.

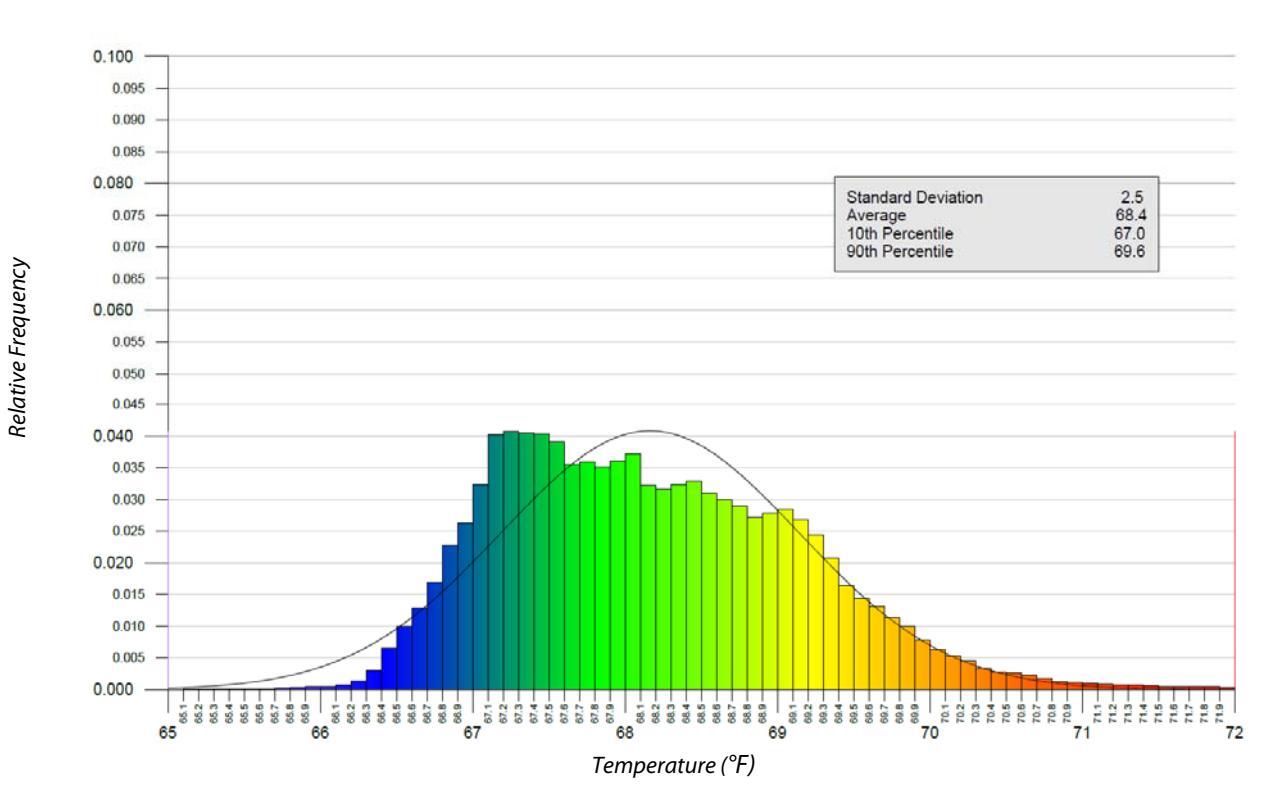
Infrared Temperature Distribution of Vista Ridge Westbound (Right Lane Wall)

**Figure 33.** The histogram showing the distribution of temperature values recorded during the Infrared Thermography scan of the Vista Ridge Westbound Tunnel – Right Lane Wall.

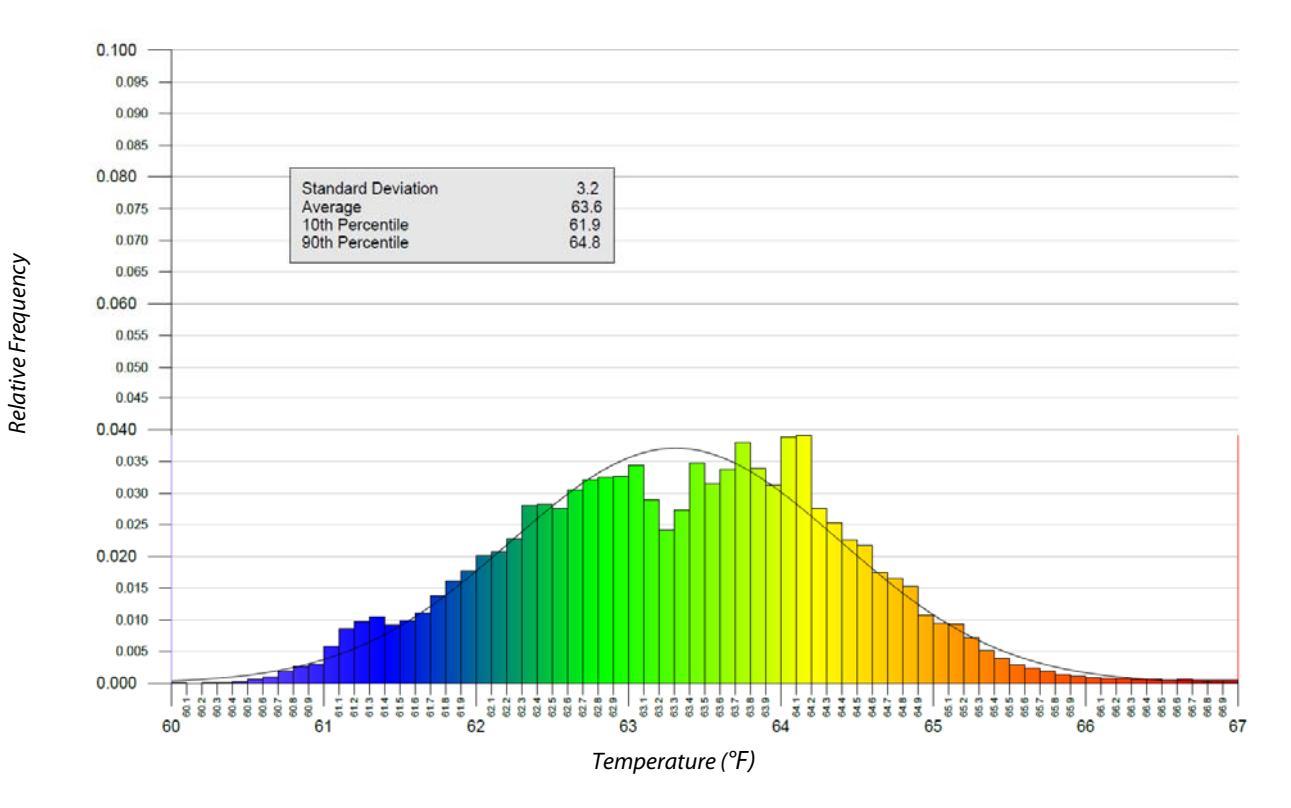
Infrared Temperature Distribution of Vista Ridge Westbound (Left Lane Wall)

**Figure 34.** The histogram showing the distribution of temperature values recorded during the Infrared Thermography scan of the Vista Ridge Westbound Tunnel – Left Lane Wall.
