# Testing and Evaluation of Existing Bridge Decks for Chloride Concentration

SHRP2 Service Life Design Workshop (R19A)

Andrew S. Blower, P.E.

ODOT

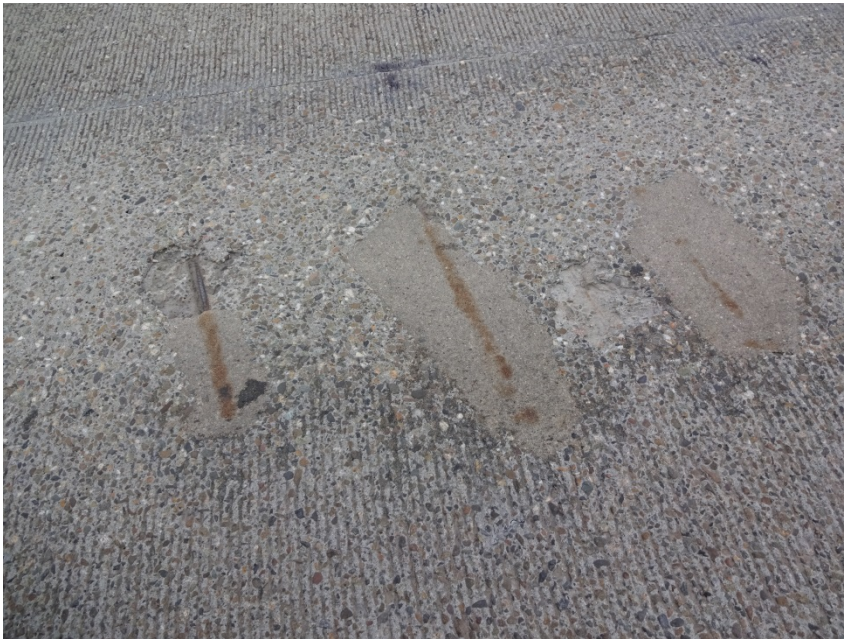
- This deck was replaced during a widening project that completed in 2001.
- At only 15 years old, this bridge deck is already showing signs of severe corrosion activity and damage.
- This damage is caused by a combination of heavy deicer usage and shallow reinforcement where the transverse bars are tied together which also corresponds to a wheel track.

These issues can be avoided by:

- Additional third party QA testing of reinforcement clearances via GPR prior to acceptance.
- Application of a water impenetrable wearing surface after 3 months of aging.

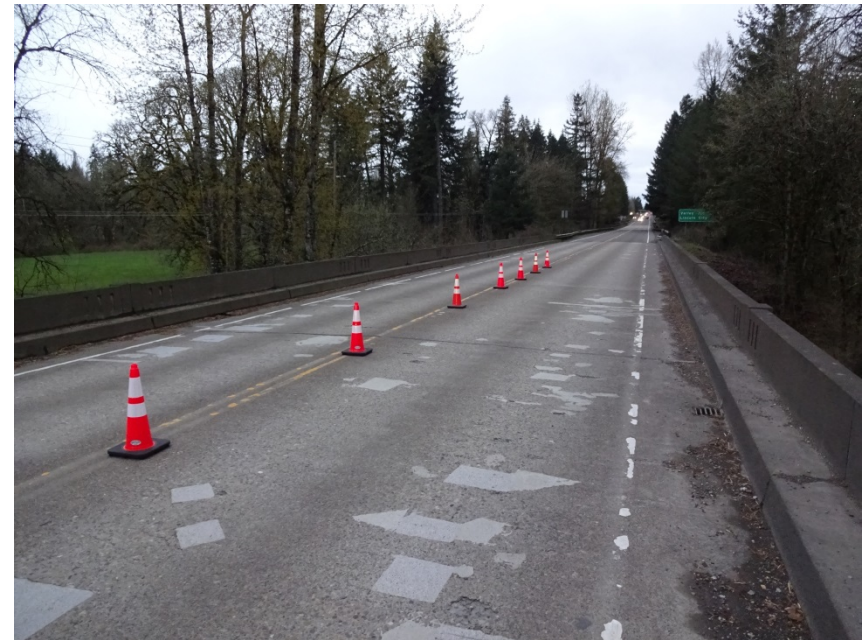
# Yamhill River Overflow BR #08492

- Constructed 1963
- RCDG w/precast beams on timber bents.
- Deck is 6" thick with 1" of (design) cover at the wearing surface.
- "2 inch wearing surface by others" was never installed as recommended by engineers in 1979...

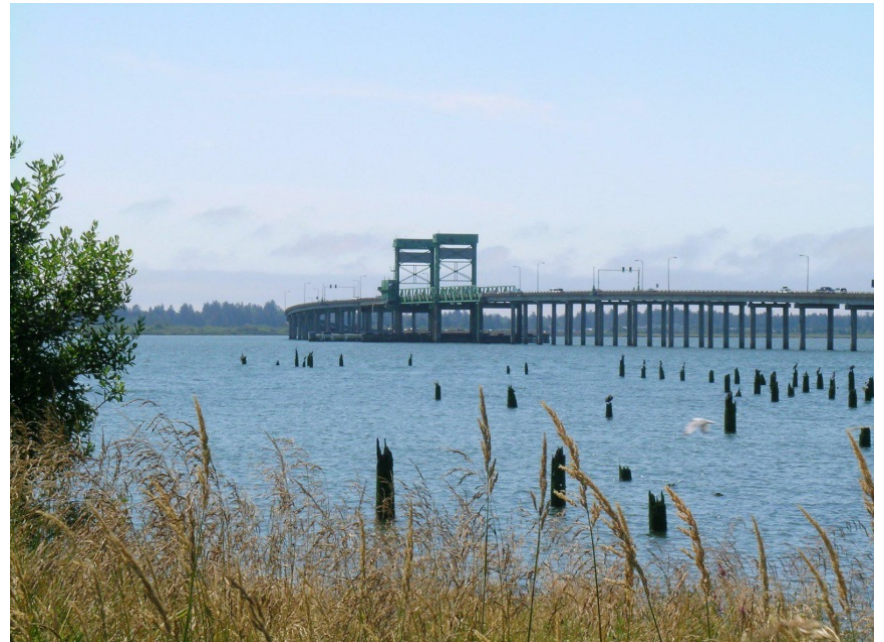
# Youngs Bay Bridge #08306

- Constructed 1964
- Pre-stressed girders with a pony truss vertical lift span and adjacent fixed pony truss.
- Deck is 7" thick with 1.5" of (design) cover at the wearing surface.
- Exposed rebar on the surface was first reported in 1996.

- Programmed to receive a PPC overlay.
- Visual examination reveals multiple bars exposed at the wearing surface.
- However, there are few spalls and spalls are shallow.

- Deck is above chloride threshold to about 0.75" below the surface.
- The rebar was not placed with 1.5" of cover in many locations and rutting has further reduced cover.
- Any rebar within 0.75" of the surface likely has corrosion initiated.

- A PPC wearing surface is not recommended. It is unclear how much cover exists and corrosion has likely initiated on rebar that are within 0.75" of the surface. PPC will not have an opportunity to reach its intended service life of 25 years.
- A structural overlay is recommended with at least 1" of contaminated concrete removal via hydro-demolition due to shallow reinforcement.
- Class 2 prep should be performed on all spalled or patched areas and where hydro-demo reveals cracking over rebar.

- 0.75" additional cover will provide a 30 year service life for the overlay, but 1.5" is recommended to account for rutting, and construction tolerances.

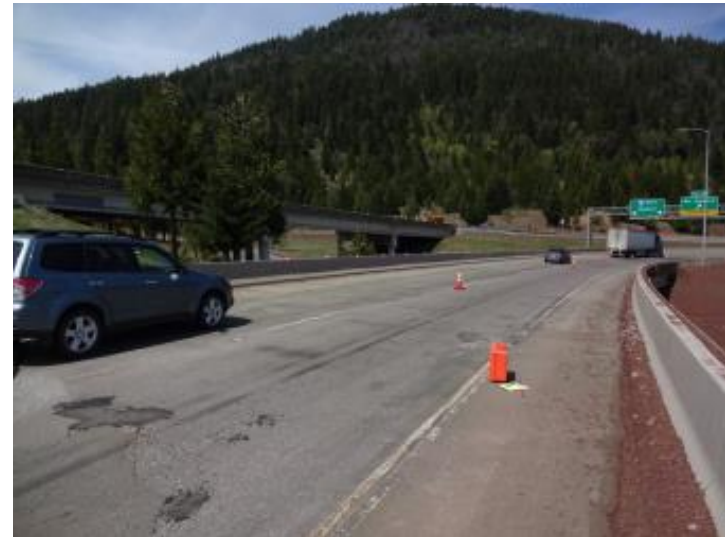
# Hwy 1 Over Hwy 273 BR #09259 & #09259A

- Constructed 1965
- Pre-stressed girder design.
- Deck is presumed to be 7.5" with 2" cover.
- A repair called the "Iowa Method" was performed sometime between 1976 and 1978 due to rock salt induced corrosion damage.

- Programmed for a PPC Overlay
- Visual examination reveals there are numerous spall repairs with a high concentration at the impact panel joints due to steel dowels used to hold grade.
- Cores reveal that the overlay has a thickness variation from 2" to 4".

- A PPC wearing surface is not recommended. The overlay shows chloride contamination approaching the chloride threshold at the depth of reinforcement.
- There is significant chloride contamination in the original construction material and hydro-demolition would need to remove material to a depth of 4" to ensure further delamination does not occur and chlorides don't migrate toward the bottom mat.
- The Iowa method utilized an extremely dense, low slump mix. The dense material in conjunction with variable thickness makes partial hydro demolition difficult and likely much of the deck will be removed to full depth with this quantity being unknown.

- The history and salt content of this structure suggests that reinforcement condition will vary and repairs will be difficult to quantify.
- Many of the dowels holding impact panels at grade have been removed as spalls have been repaired, but the remaining dowels will have to be removed and should be replaced with a corrosion resistant material.
- It is recommend that, due to these constructability issues, that the decks and impact panels be replaced.
- Alternative construction materials should be explored to increase corrosion resistance of any new construction on these structures.

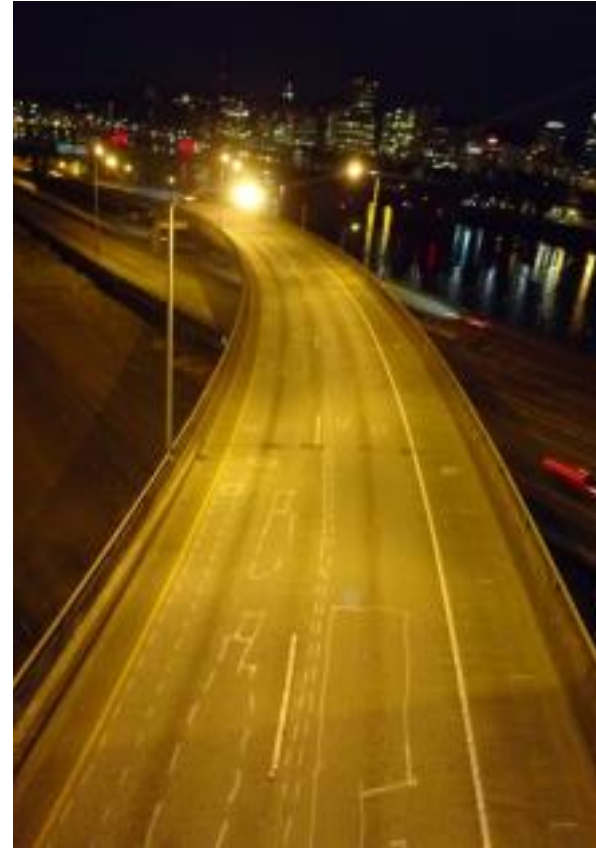
# Banfield Interchange BR #08588A, 08588B, & 08588C

- Constructed 1963
- Plate Girder and RCDG mixed construction.
- Deck is 6" thick with a 1.5" (design) cover.
- A 1.5" concrete wearing surface, planned for in design was added in 1985.

- Programmed to receive a PPC overlay.
- Visual examination and chain drag reveals numerous delaminations and cracks throughout the overlay.
- Some joints have severe impact damage at header details with numerous patch materials.

- The overlay has reached the end of it's service life due to normal wear from impact. There may be small amounts of freeze/thaw forces at work, but degradation is not caused by widespread chloride induced corrosion.
- Due to the amount of delamination, the overlay should be removed and replaced by a new wearing surface.
- Soffit cracking and efflorescence indicate that the thin deck is flexing and may benefit from a structural concrete overlay. Care should be taken when deciding on a wearing surface material.
