# **SHRP2 R06A NDT Bridge Decks = primarily GRP**

Kathy Crowell, NMDOT  
Dr. Brad Weldon, NMSU  
Daniel Diaz, NMSU

# Nine Bridges

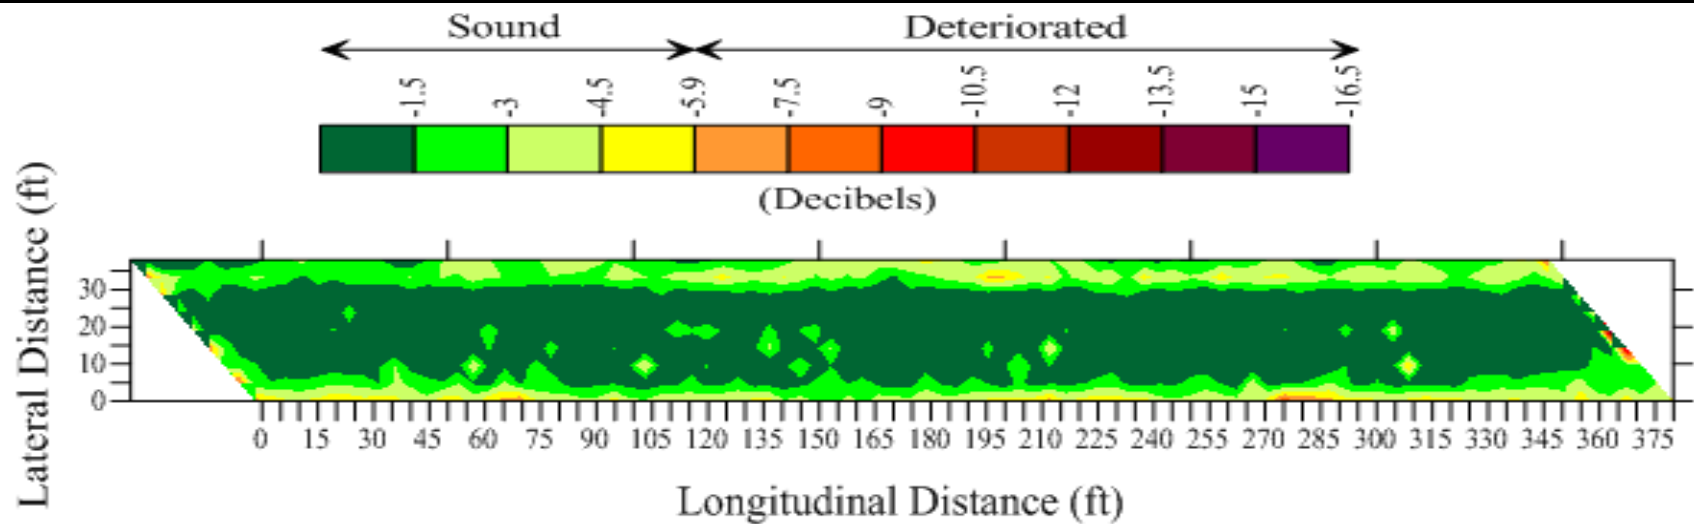
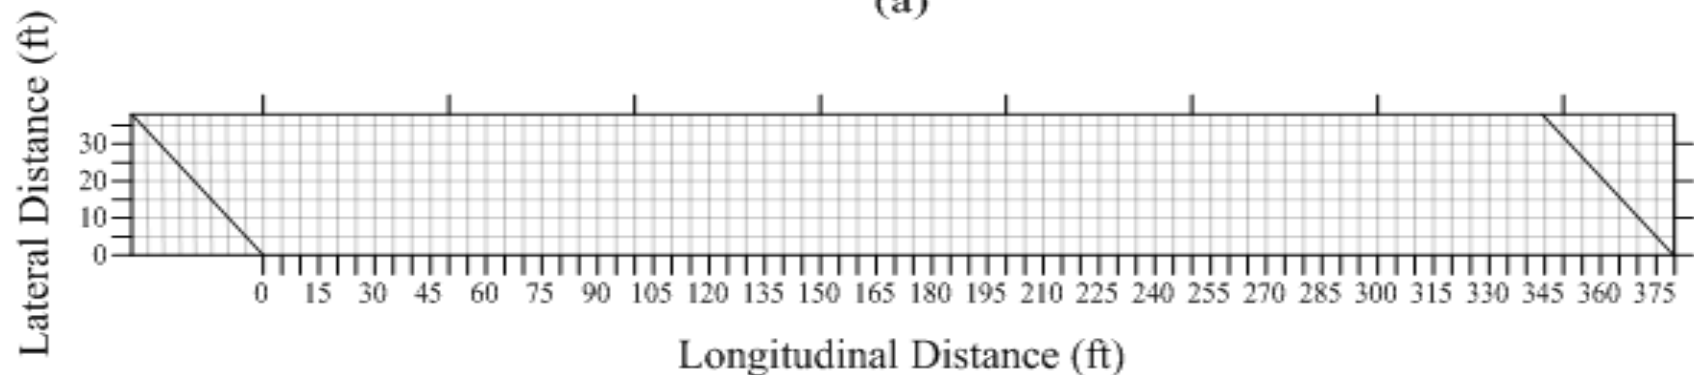
# GPR Evaluation Results: Bridge 8845

- AASHTO Girder
- From most current inspection report:
  - Deck: 7
  - Superstructure: 7
  - Substructure: 7
- Deck inspection reports:
  - Isolated transverse and longitudinal cracks up to 1/32" with light leaching (Underside)
  - Transverse and vertical cracks up to 1/16" with light leaching (Deck edges)

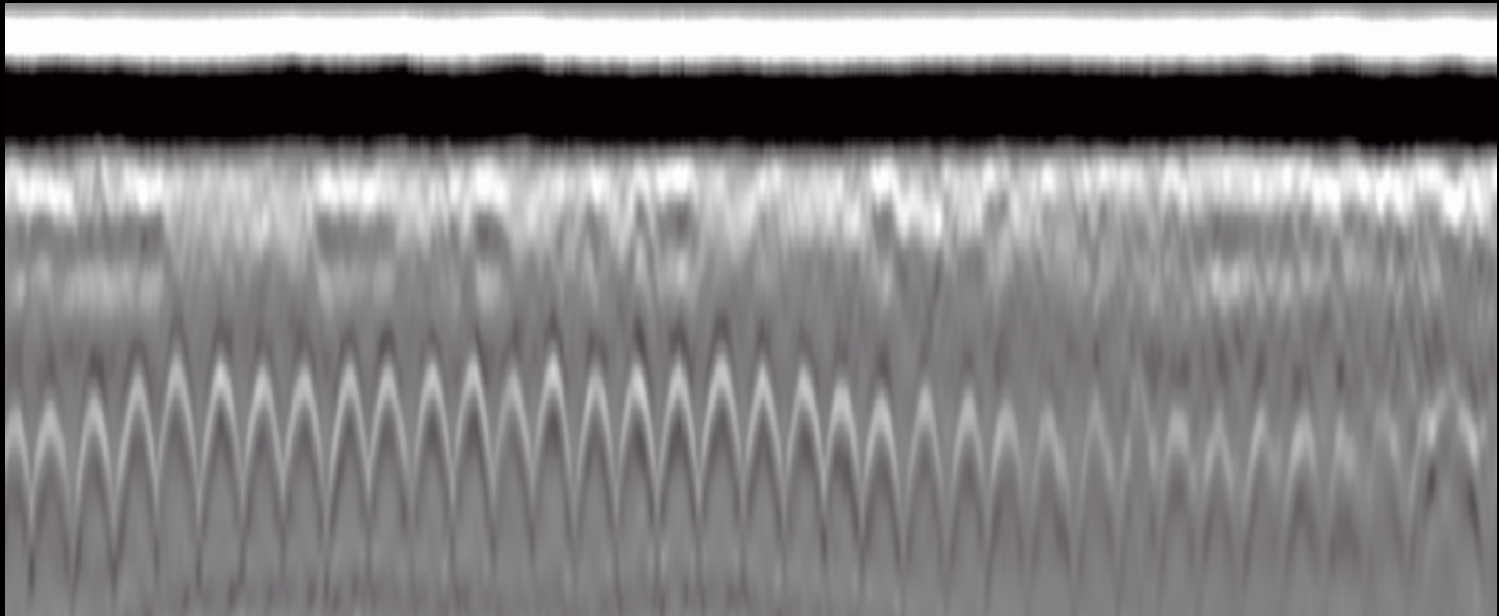
## GPR Evaluation Results: Typical B Scan from Bridge 6840

- Reflection amplitudes picks, X and Y location coordinates, and two-way travel time are obtained using Radan 7

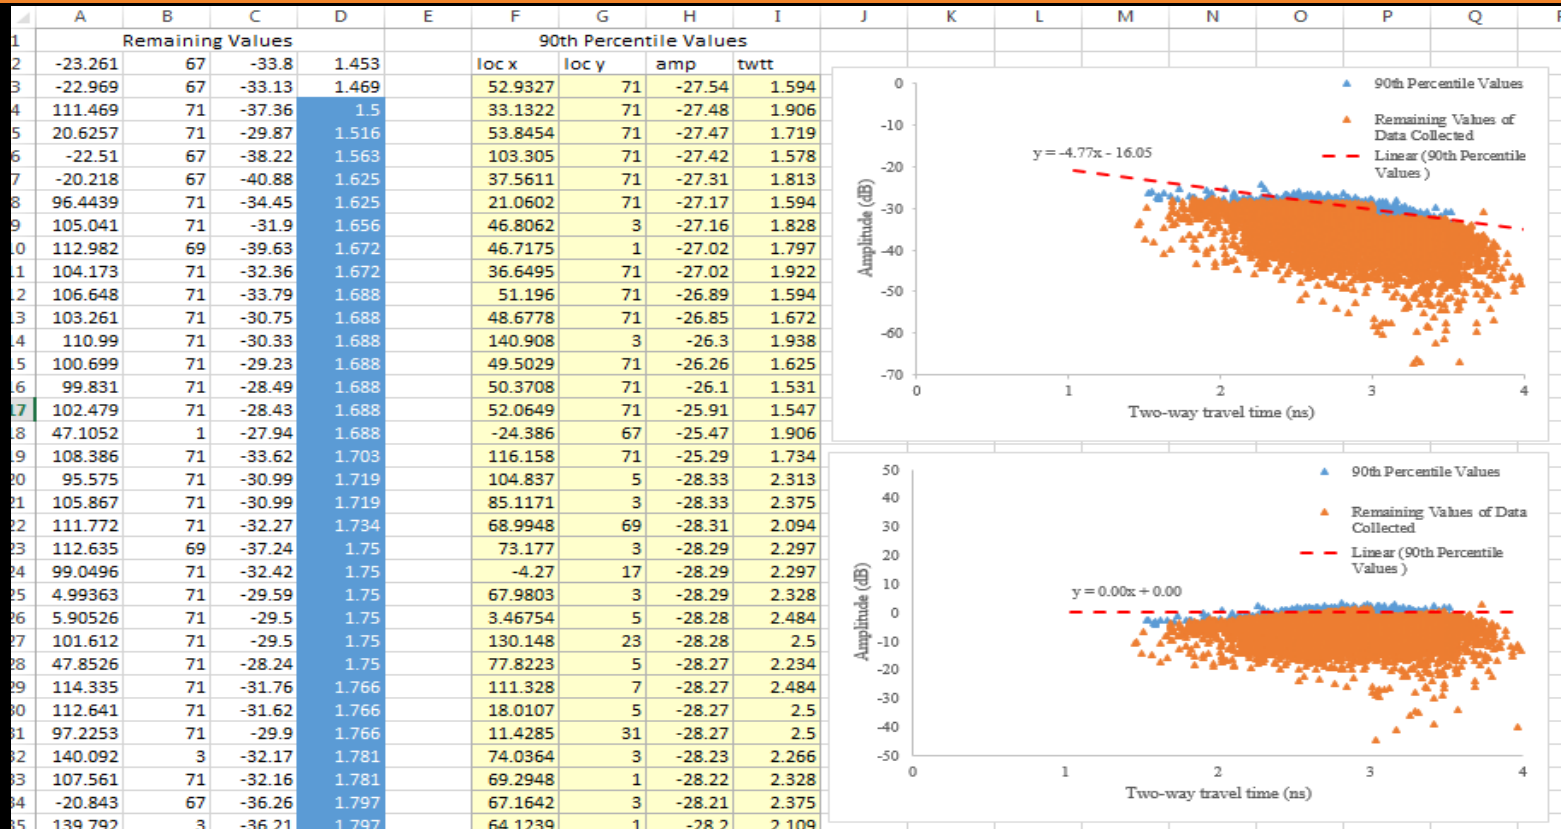
# GPR Evaluation Results: Excel Processing Bridge 6840

– Information obtained from Radan 7 exported to Excel for further processing

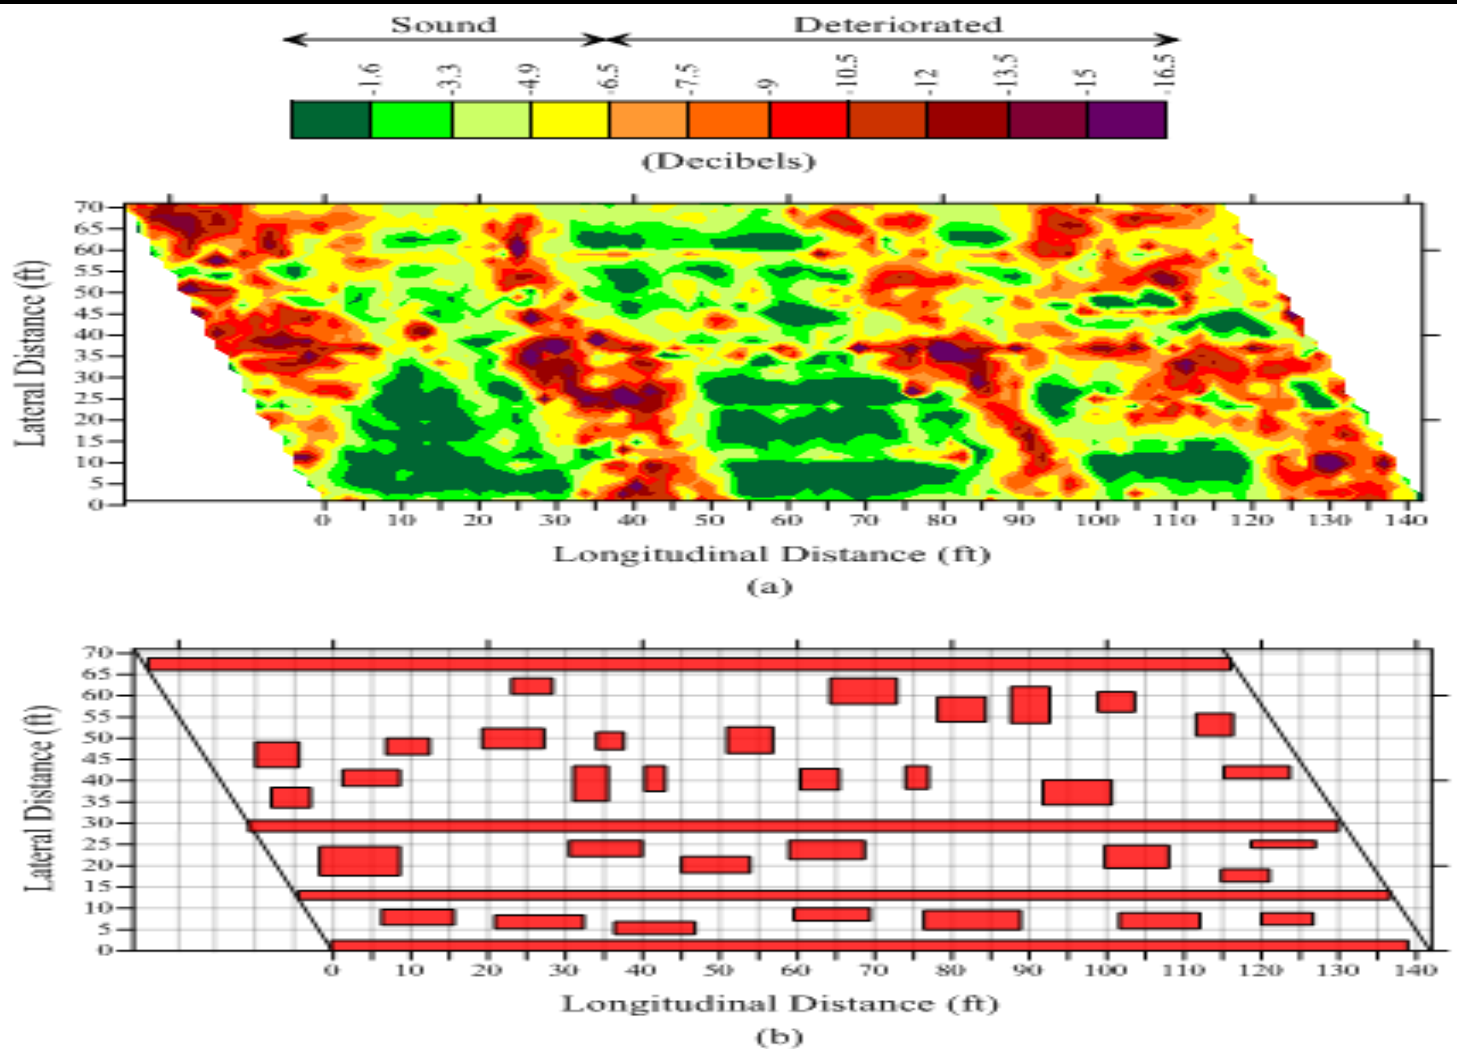
# GPR Evaluation Results: Bridge 6840

- AASHTO Prestressed Girder
- From most current inspection report:
  - Deck: 4
  - Superstructure: 5
  - Substructure: 6
- Deck inspection reports:
  - Transverse and longitudinal cracks up to 1/8" with heavy leaching (deck edges); transverse and longitudinal cracks up to 1/16" with heavy leaching and rust stains near joints

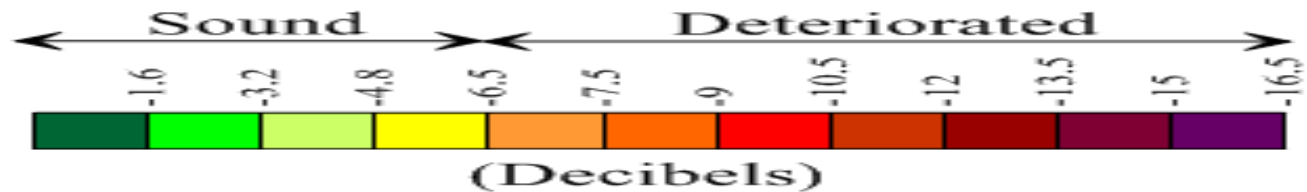
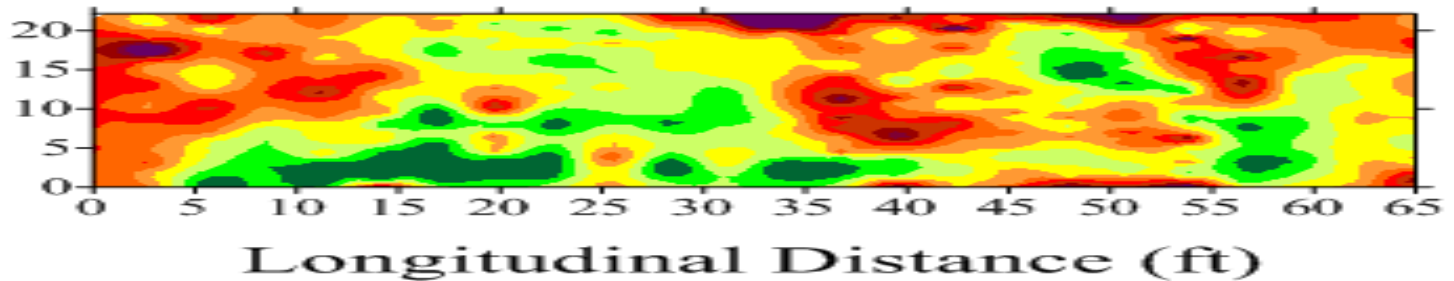
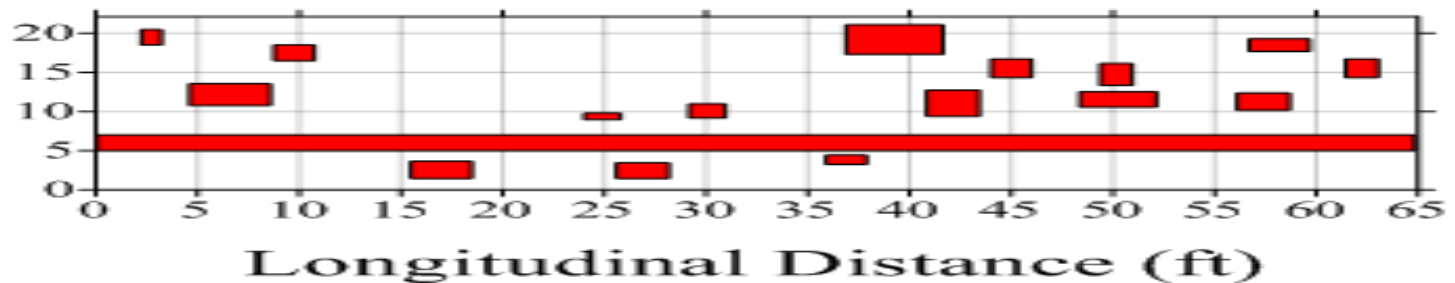
# GPR Evaluation Results: Bridge 6932 (Northbound Lanes)

- Concrete Slab Bridge – Asphalt Overlay
- From most current inspection report:
  - Deck: 5
  - Superstructure: 5
  - Substructure: 6
- Deck inspection reports:
  - Vertical, horizontal, transverse and map cracks up to 1/4" (deck edges); transverse and map cracks up to 1/16", areas of moderate leaching, and spalls up to 6" by 5" (Underside)

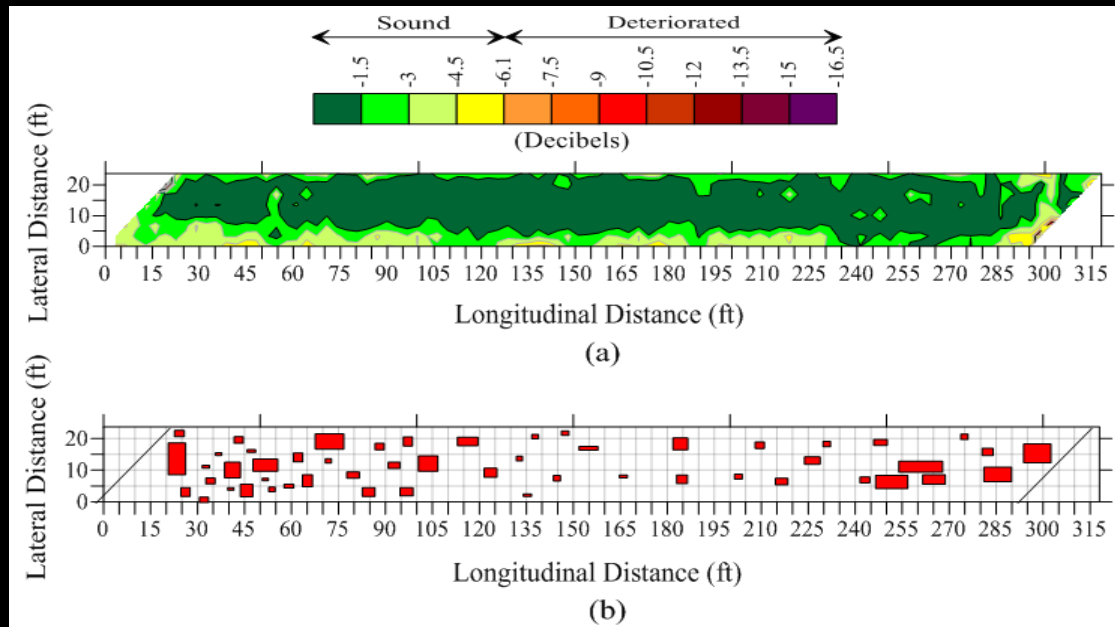
# GPR Evaluation Results: Bridge 7032 (East Bound)

- **THIS BRIDGE HAS A COMPLETELY DELAMINATE LATEX MODIFIED CONCRETE DECK OVERLAY**
- From most current inspection report:
  - Deck: 5
  - Superstructure: 5
  - Substructure: 5
- Deck inspection reports:
  - Vertical, transverse, longitudinal cracks up to 1/4"; exposed rebar up to 22', spalls up to 8'x6", apparent delaminations up to 28', and minor leaching and water stains (Deck edges)

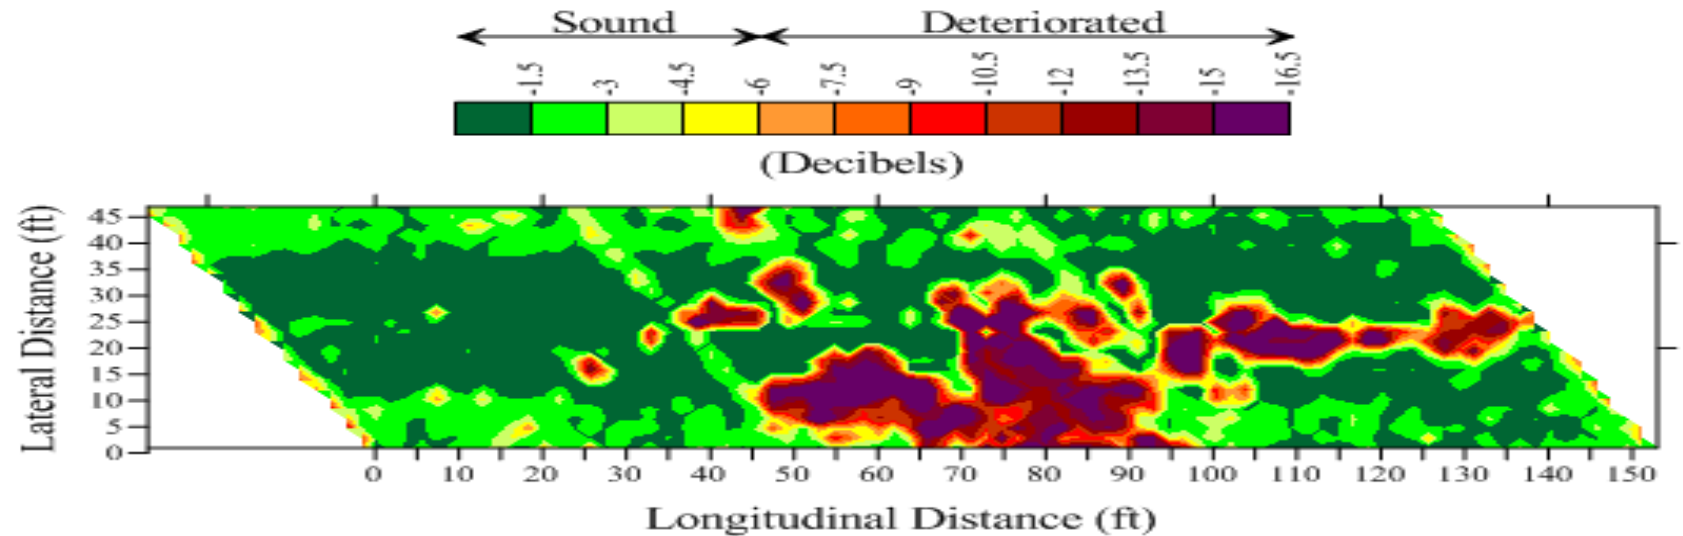
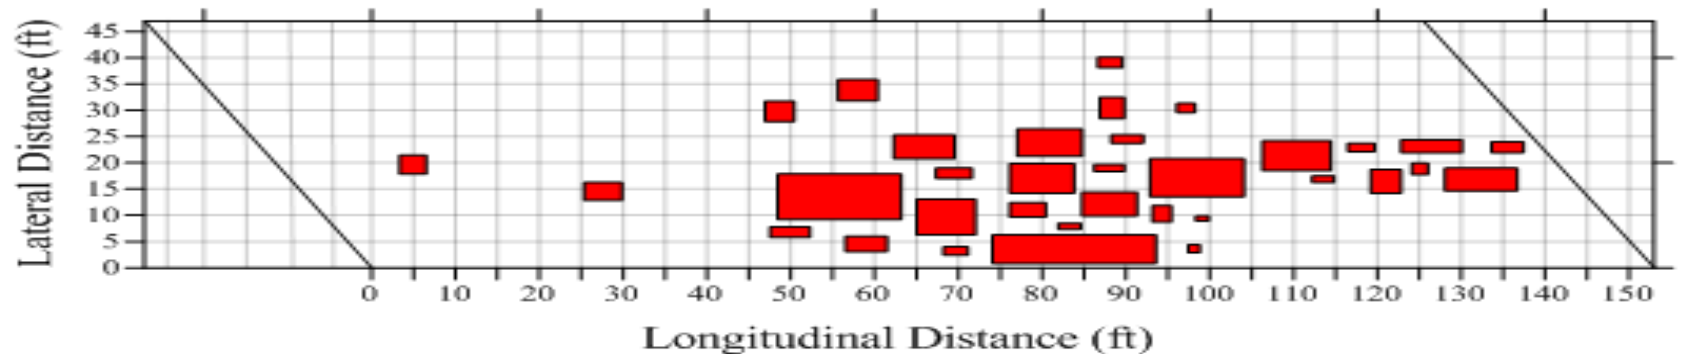
# GPR Evaluation Results: Bridge 7113

- AASHTO Girder – construction defect (cover)
- From most current inspection report:
  - Deck: 5
  - Superstructure: 7
  - Substructure: 7
- Deck inspection reports:
  - Transverse cracks up to 1/16" and minor leaching (Deck edges); transverse and map cracks up to 1/16", exposed rebar, and spalls (Top of Deck); Rust stains at the joint locations (Underside)

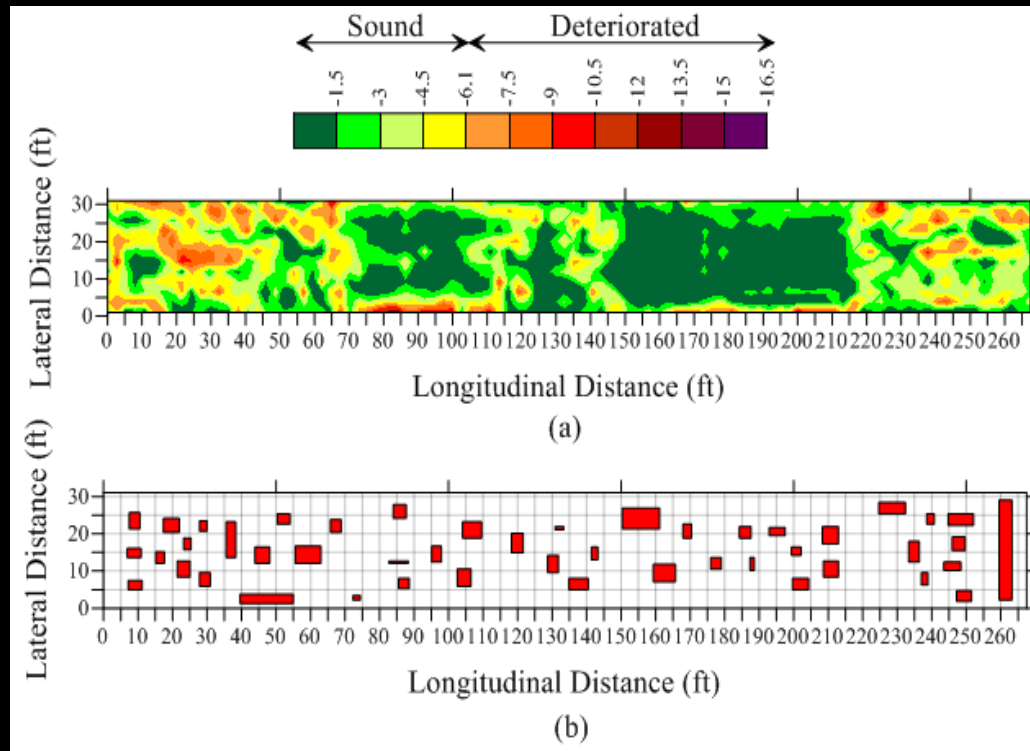
# GPR Evaluation Results: Bridge 7299

- Grant Application
- From most current inspection report:
  - Deck: 5
  - Superstructure: 5
  - Substructure: 5
- Deck inspection reports:
  - Transverse and vertical cracks up to 1/8" with heavy leaching (Deck edges); transverse and longitudinal cracks up to 1/8" with heavy leaching (Underside)
