SHRP2 R06A - Nebraska Experience

Jason Volz

Assistant Construction Engineer
Nebraska Department of Transportation

STRUCTURE 006 30574

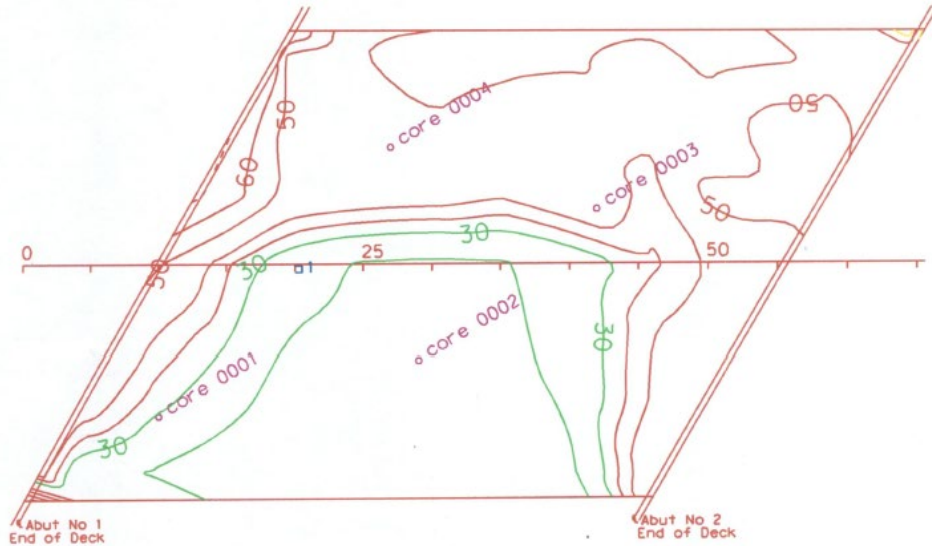
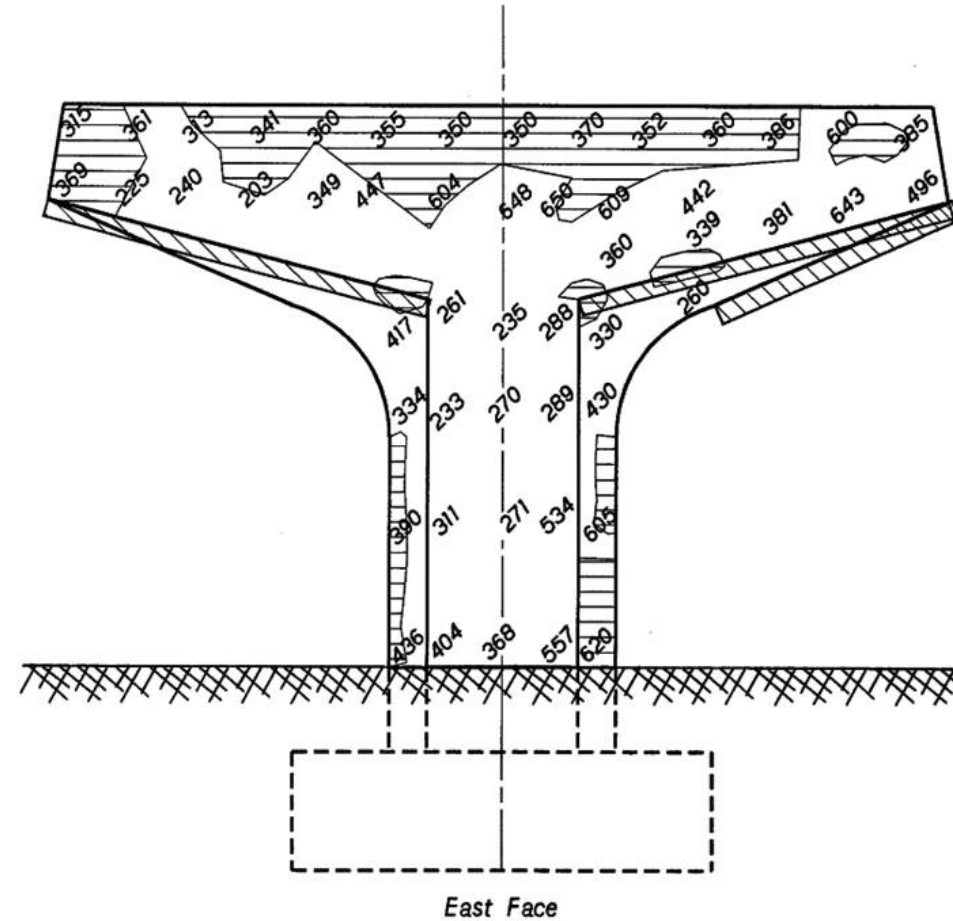
BRIDGE DECK SURVEY

Project No= 35-4(111) Hwy No= N-35 Ref Post= 21.19
 Location= Winside North
 Spans= One Date Tested= 8/1/00 Roadway Width= 34 FT
 Reamrks= Cast-in-Place Concrete Girders

0.25 SQ FT OF 1562.64 SQ FT = 0 PERCENT

CORE	DEPTH (IN.)	REINFORCING CHLORIDES (LB./CU.YD.)
0001	2.50	0.13
0002	2.50	0.27
0003	2.50	0.27
0004	2.50	0.40
AVERAGE	2.50	0.27

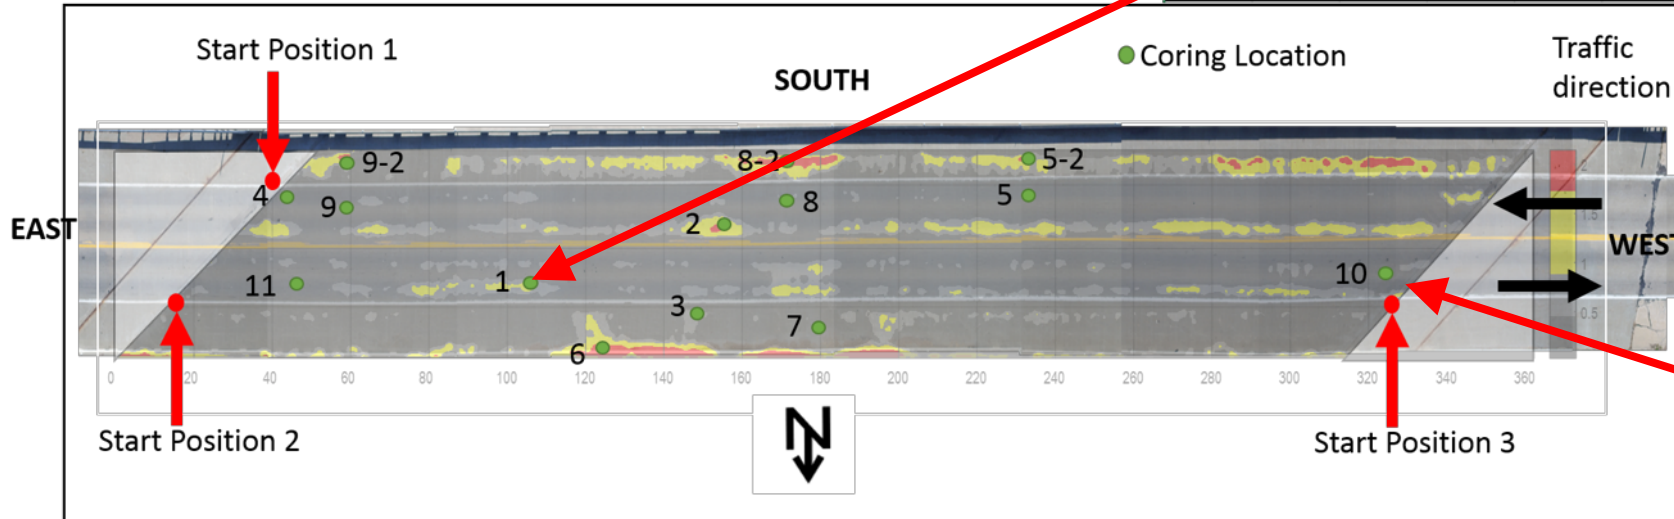
Bridge S006 30574 US 6 OVER BNSF RR

Chlorides:
3.11 lb/cuyd

Chlorides:
4.12 lb/cuyd
