Nondestructive Condition Evaluation of 14 Bridge Decks – Florida DOT, District 2

FINAL REPORT

RS&H
10748 Deerwood Park Blvd South
Jacksonville, FL 32256

Infrasense, Inc
21-G Olympia Avenue, Suite 45
Woburn, MA 01801

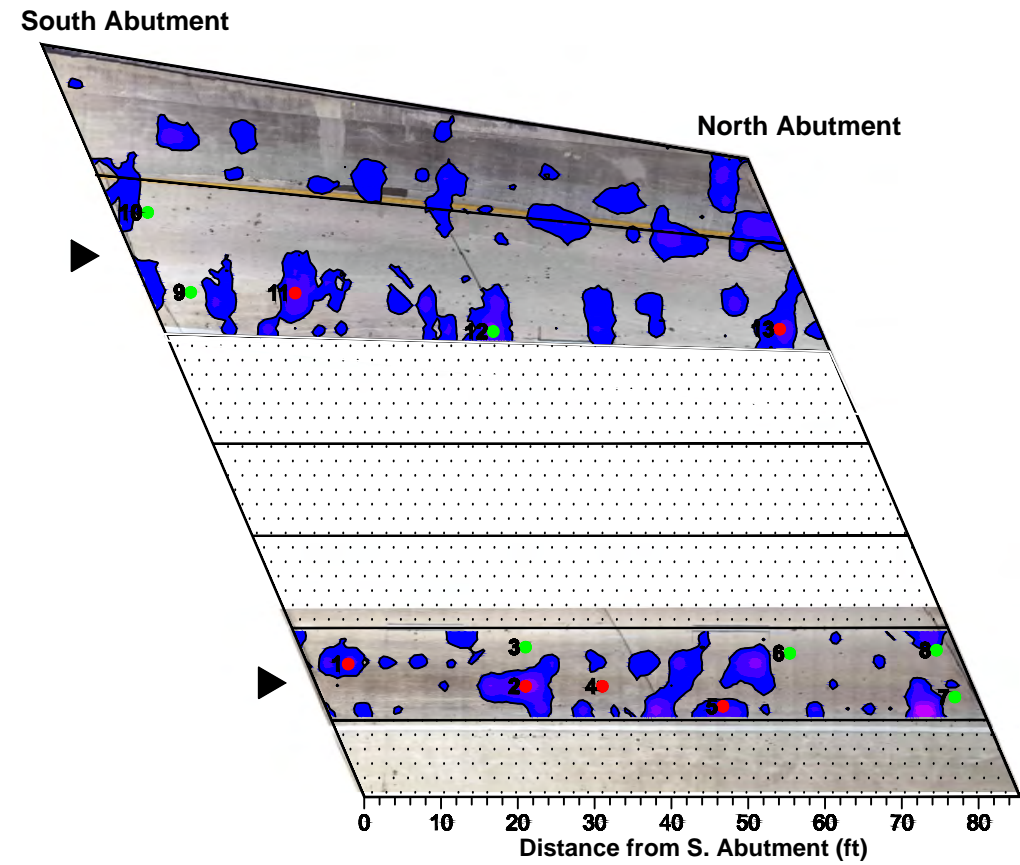
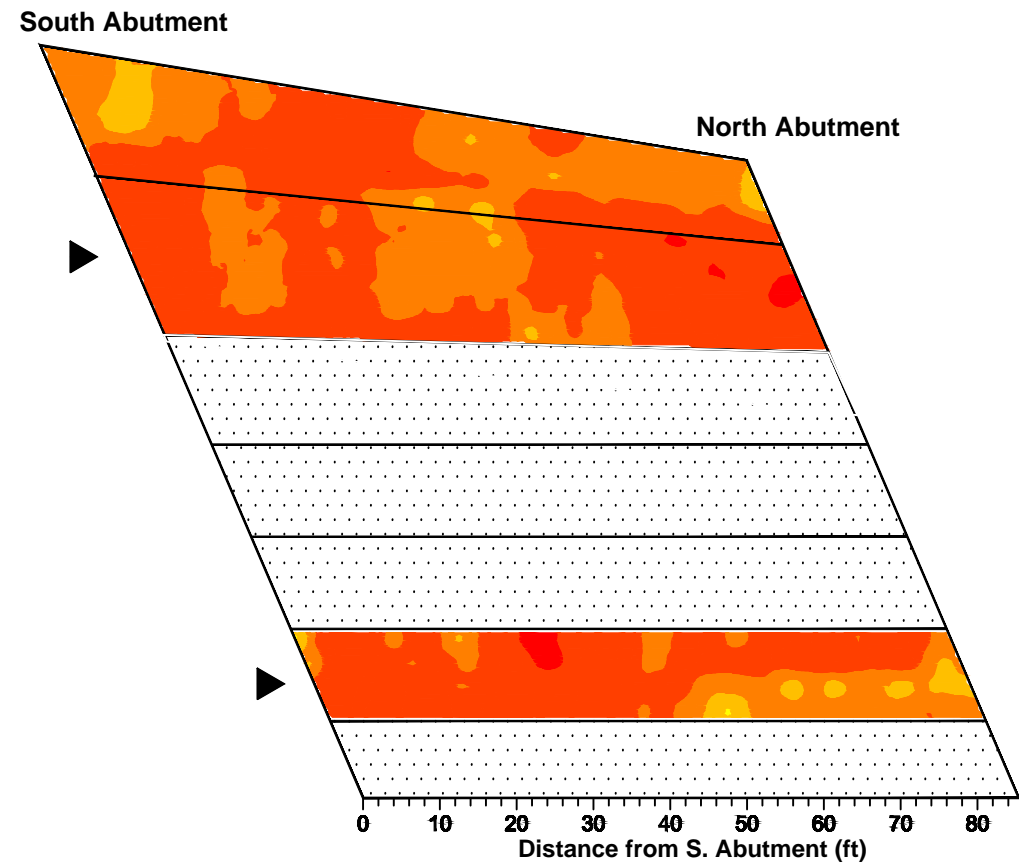
Deck Condition Evaluation	
I-95 Northbound	
Bridge ID: 720297	
RS&H Florida Scanning Project, Project No. 101-3098-012	
Analyzed by: KJS	Infrasense, Inc.
Reviewed by: AJC	21-G Olympia Avenue,
Completed: 06/6/2016	Suite 45, Woburn, Massachusetts 01801
Sheet 1 of 1

720079	SR-10A	Palmetto St.	9786	ALL	N/A	5.4%	N/A	N/A	N/A
720323	I-10 EB (SR-8)	CSX RR	19190	ALL	Inside Lane Only	3.6%	18.30%	3.1	12 of 14
720297	I-95 NB	Church St.	7250	N/A	Outside NB Lane and Inside Ramp	N/A	28.00%	2.1	11 of 13
720300	I-95 NB	Union St.	9660	N/A	NB Exit Ramp	N/A	12.20%	2.3	6 of 10
720174	I-95 NB	8th St.	14646	N/A	Outside NB Lane and Shoulder	N/A	3.70%	1.9	5 of 10
