NCDOT SHRP2 R06A Feasibility Study for Nondestructive Evaluation of Bridge Decks

FINAL REPORT

FEBRUARY 5, 2018

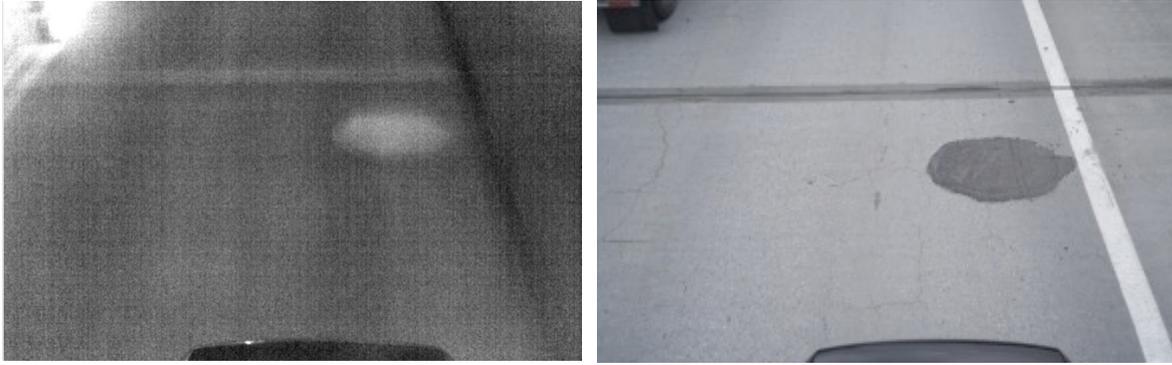
Figure 7 - Sample Infrared and Visual images

Figure 7 presents an example of a patched area as it appears in a single image of infrared data and in the corresponding visual data. For analyzing this data, proprietary software automates the process of taking horizontal slice from each infrared and visual image and calibrates the image so that an area of 1 foot is captured in the direction of travel. Sequential slices are then automatically stitched together to create a single strip image for each pass of both the infrared and visual data. The strip images for each pass are placed next to those of adjacent passes to produce composite visual and thermal images of the entire deck as presented in Figure 8. While Figure 8 is a compressed example, the final deliverable provided to NCDOT will be of 4K resolution, allowing for the identification and mapping of 1 mm size cracks. Finally, composite images such as those presented in Figure 3 are analyzed to identify delaminations, which are outlined with a cursor. These outlined areas are then quantified and used to create final plan area maps (Figure 9).

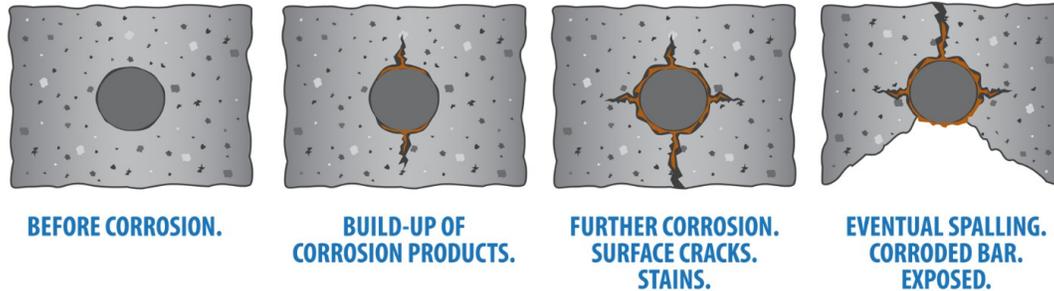
Figure 12 – Corrosion in Structural Concrete Leads to Cracks and Eventual Spalling.

As the corrosion continues and the reinforcing steel loses cross section, an air void forms between the concrete and the steel (i.e. the bond between the reinforcing steel and the concrete is lost). As this happens, the remaining steel also begins to expand and induces tensile forces into the concrete matrix. Because concrete has a relatively low tensile strength, this causes the concrete to crack. At first, with small levels of steel corrosion and expansion, the cracks are in the form of microcracks within the concrete matrix itself. However, as the corrosion process continues and the reinforcing steel loses more cross section, these cracks coalesce and eventually form horizontal cracks that are parallel to the concrete surface (delaminations). Eventually these delaminations will grow to the surface and cause concrete spalls. Essentially, the rust product formed during the corrosion process occupies a much greater volume than the original steel member, tensile stresses are exerted into the surrounding concrete, and the concrete cracks, delaminates, and given enough time spalls (Figure 12).

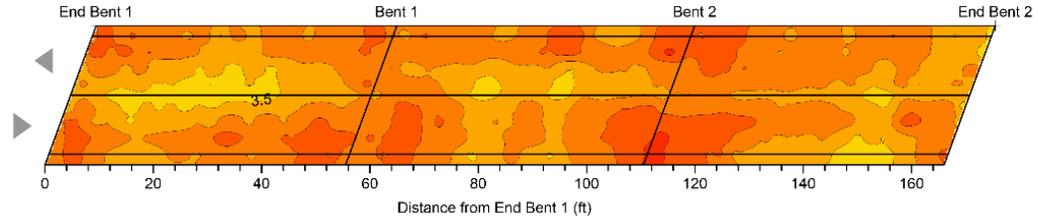
► Direction of traffic	Condition	sq. ft.	%	Bridge ID: 290007 SR 1147 over Hunting Creek
*combined quantity accounting for overlap				Delamination (IR)	225	5.2	Analyzed by: SB Reviewed by: AC Completed: 12/14/17
			Deterioration (GPR)	749	17.4	Sheet 1 of 1	
			Patching	134	3.1		
			Spalling	0	0.0		
			Combined Defects*	947	22.0

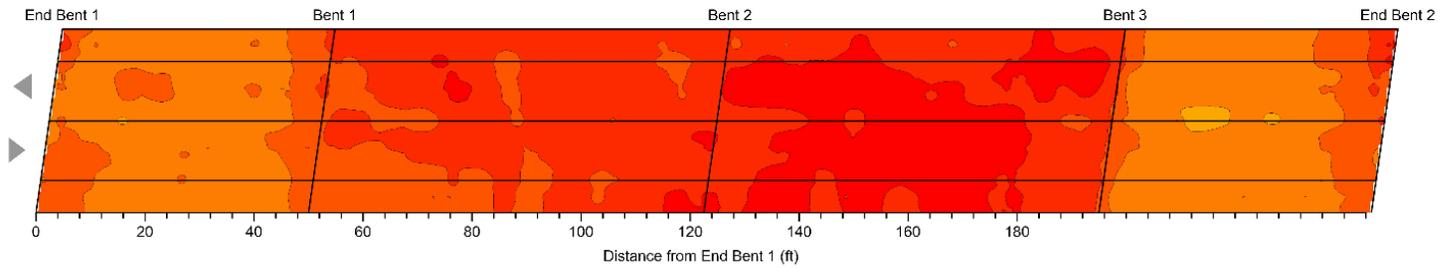
Direction of traffic	Condition	sq. ft.	%	Bridge ID: 290014
*combined quantity accounting for overlap				Delamination (IR)	396	4.8	SR 1147 over I-40
			Deterioration (GPR)	1196	14.4	Analyzed by: SB	
			Patching	87	1.0	Reviewed by: AC	
			Spalling	0	0.0	Completed: 12/14/17	
			Combined Defects*	1371	16.5	Sheet 1 of 1

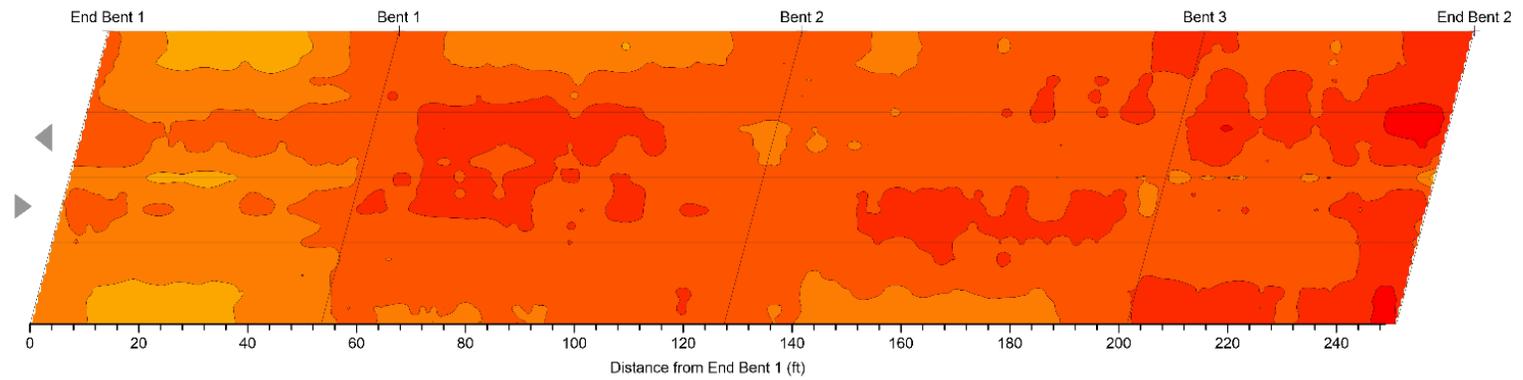
Concrete Condition Legend		Orientation	Quantity Summary		General Information	
Deterioration detected by GPR severity → *combined quantity accounting for overlap	Delamination detected by IR Patching Spalling Thermal Obstruction	 Direction of traffic	Condition	sq. ft.	%	Bridge ID: 290018 SUS 64 over I-40 Analyzed by: SB Reviewed by: AC Completed: 12/14/17
	Delamination (IR) 269 2.0		Deterioration (GPR) 489 3.6	Patching 142 1.0	Spalling 0 0.0	
			Combined Defects*	758	5.6
