Advanced Methods to Identify Asphalt Pavement Delamination--R06D New Mexico Department of Transportation

IE/SASW

Pavement Management and Design

August 2, 2018

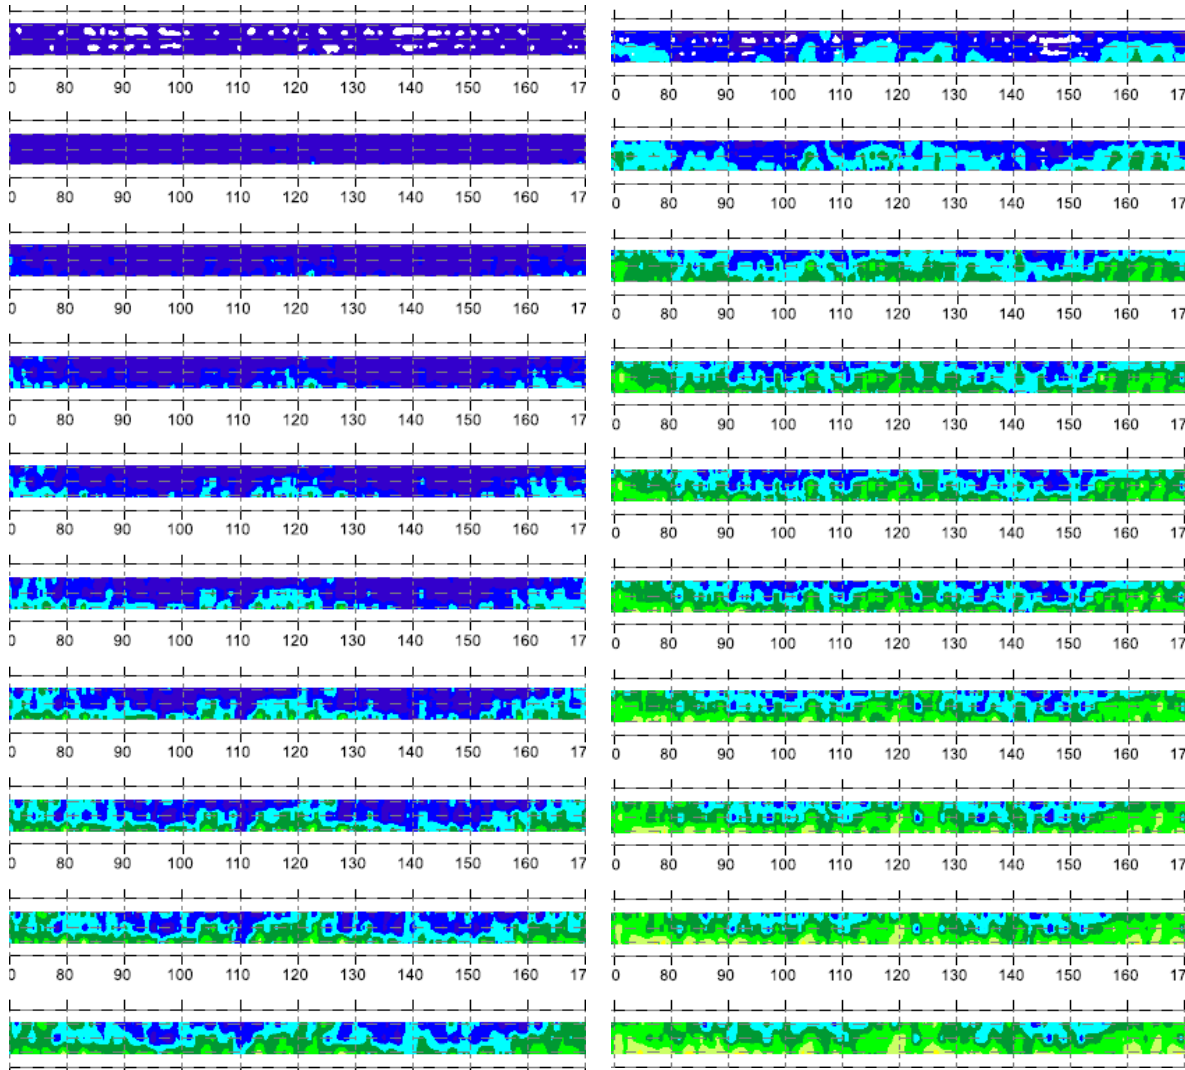
Test A

Test B

- Good repeatability between pairs of scans performed at similar temperatures
- Trends across the scan area considered quite similar and would lead to virtually the same overall pavement assessment
- Small differences in the data sets are likely due to scans not being at the exact location
- At high surface temperatures (130+ F) degradation of data that was 2 inches or less in depth was noticed
- Absolute velocity values changed with temperature
