Advanced Methods to Identify Asphalt Pavement Delamination (R06D) Spectral Analysis of Surface Waves (SASW) and Impact Echo (IE)

Texas Department of Transportation

Darlene Goehl, P.E.
Research Specialist, TTI
Webinar
August 1-3, 2018

US 59
From Marion/Harrison County line
to FM 1997

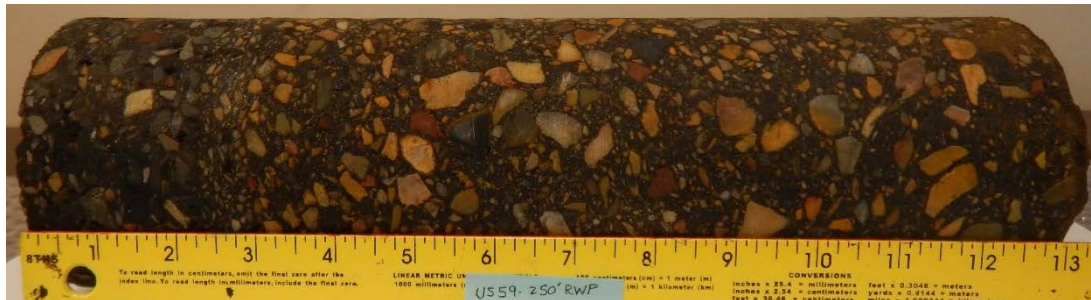
IE Test Results – 250'

Figure A1: IE Results, Highway 59 SB Right Lane. X = 0 @ start of section, Y = 0 at right shoulder.

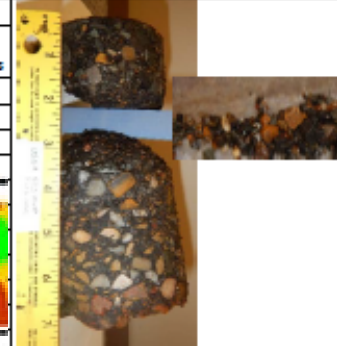
2nd Core – POOR CONDITION

Description of Layers & Notes:	Depth Below Surface (inches)		Layer thickness
	From	To	
Dense Graded HMA; cracked	0	2	2
Dense Graded HMA; stripping	2	3 1/2	1 1/2
Dense graded HMA; gravel	3 1/2	7	3 1/2

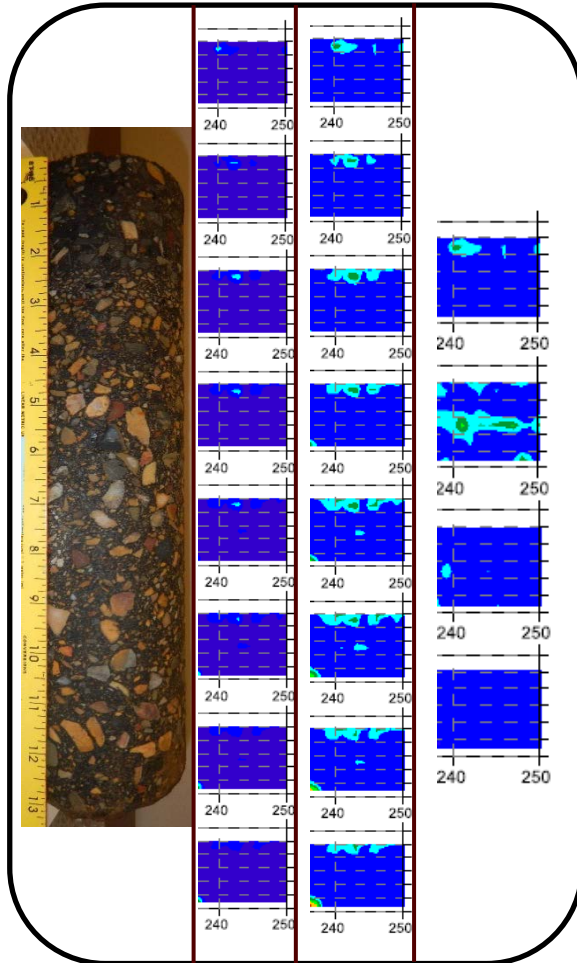
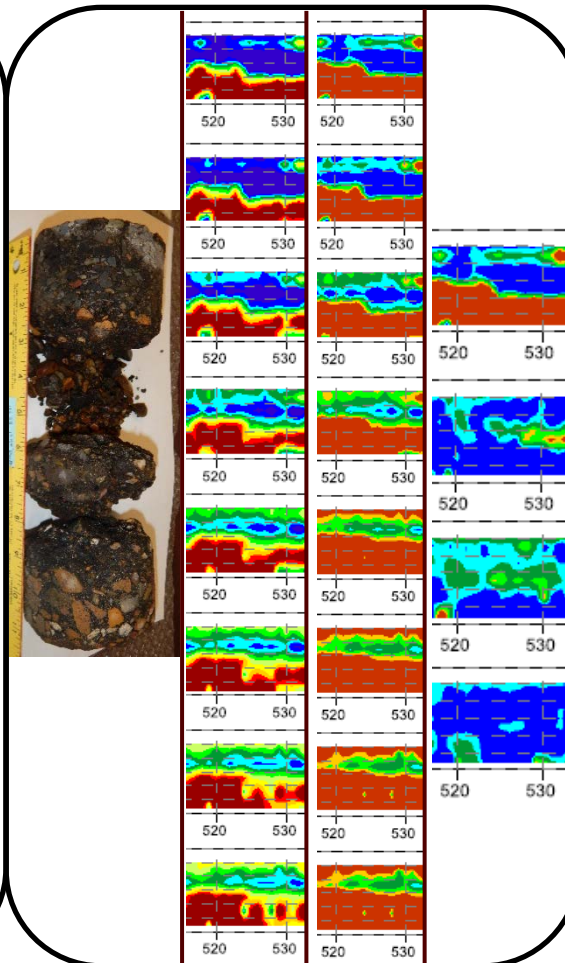
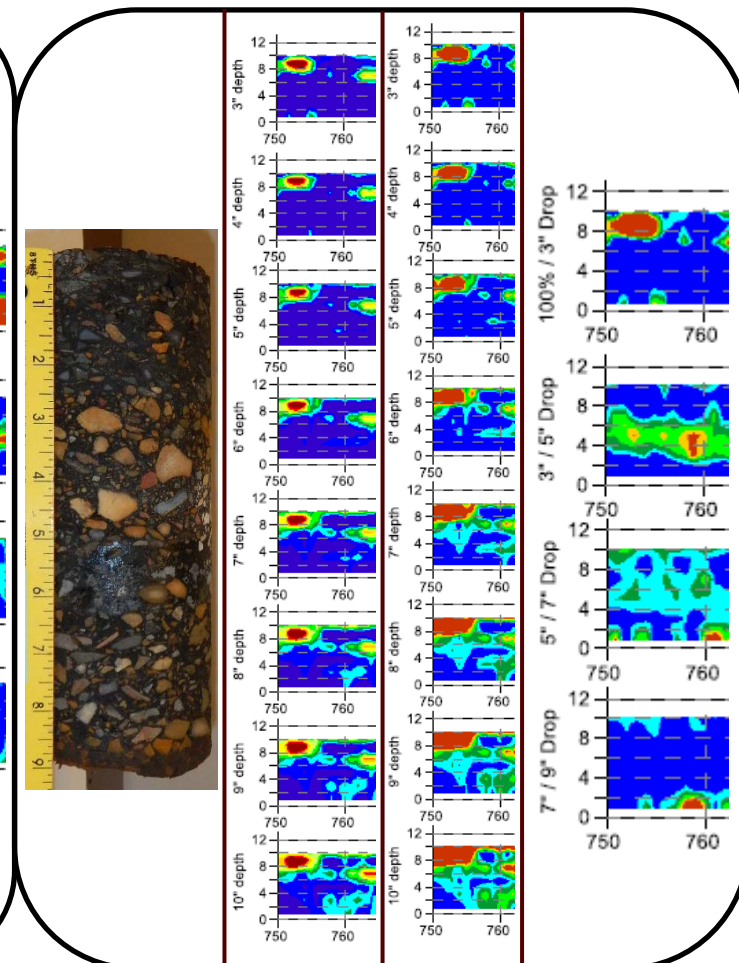
SASW Analysis at Cores

- Information from Olson Engineering Report (SASW)
 - “There is extensive degradation of the tested area particularly between distances 495 – 850 feet.”
 - “All three presentation methods show the same general results.”
 - “It is likely that the normalized velocity method will allow users to become more comfortable with interpretation by removing the variable of temperature effects from the interpretation and allowing users to observe velocity changes on a percentage basis.”
 - “The difference maps help determine the depth range of deterioration.”
 - “Beyond the first significant poor layer (velocity drop) the SASW data becomes less definitive as the poor layer will affect the “appearance” of everything below it.”
