One Site Swerve Correction

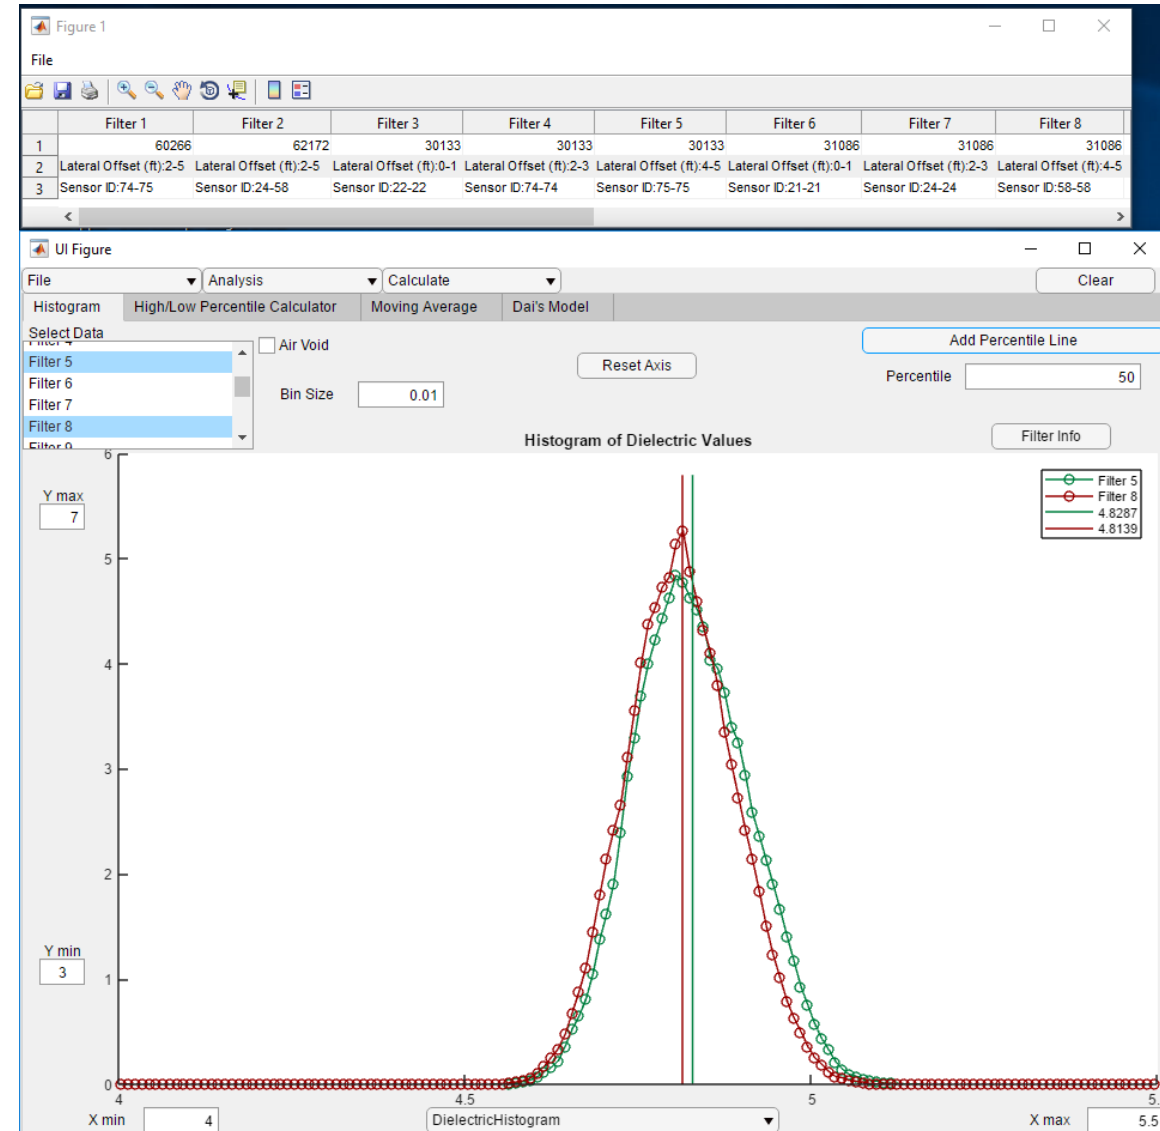
Before and after Swerve Correction
