SHRP2 R06A Implementation Assistance Program Update on Nondestructive Testing for Concrete Bridge Decks

Larry D. Olson, PE, Olson Engineering, Rockville, Maryland

SHRP2 R06A IAP Project of FHWA/AASHTO/CH2M

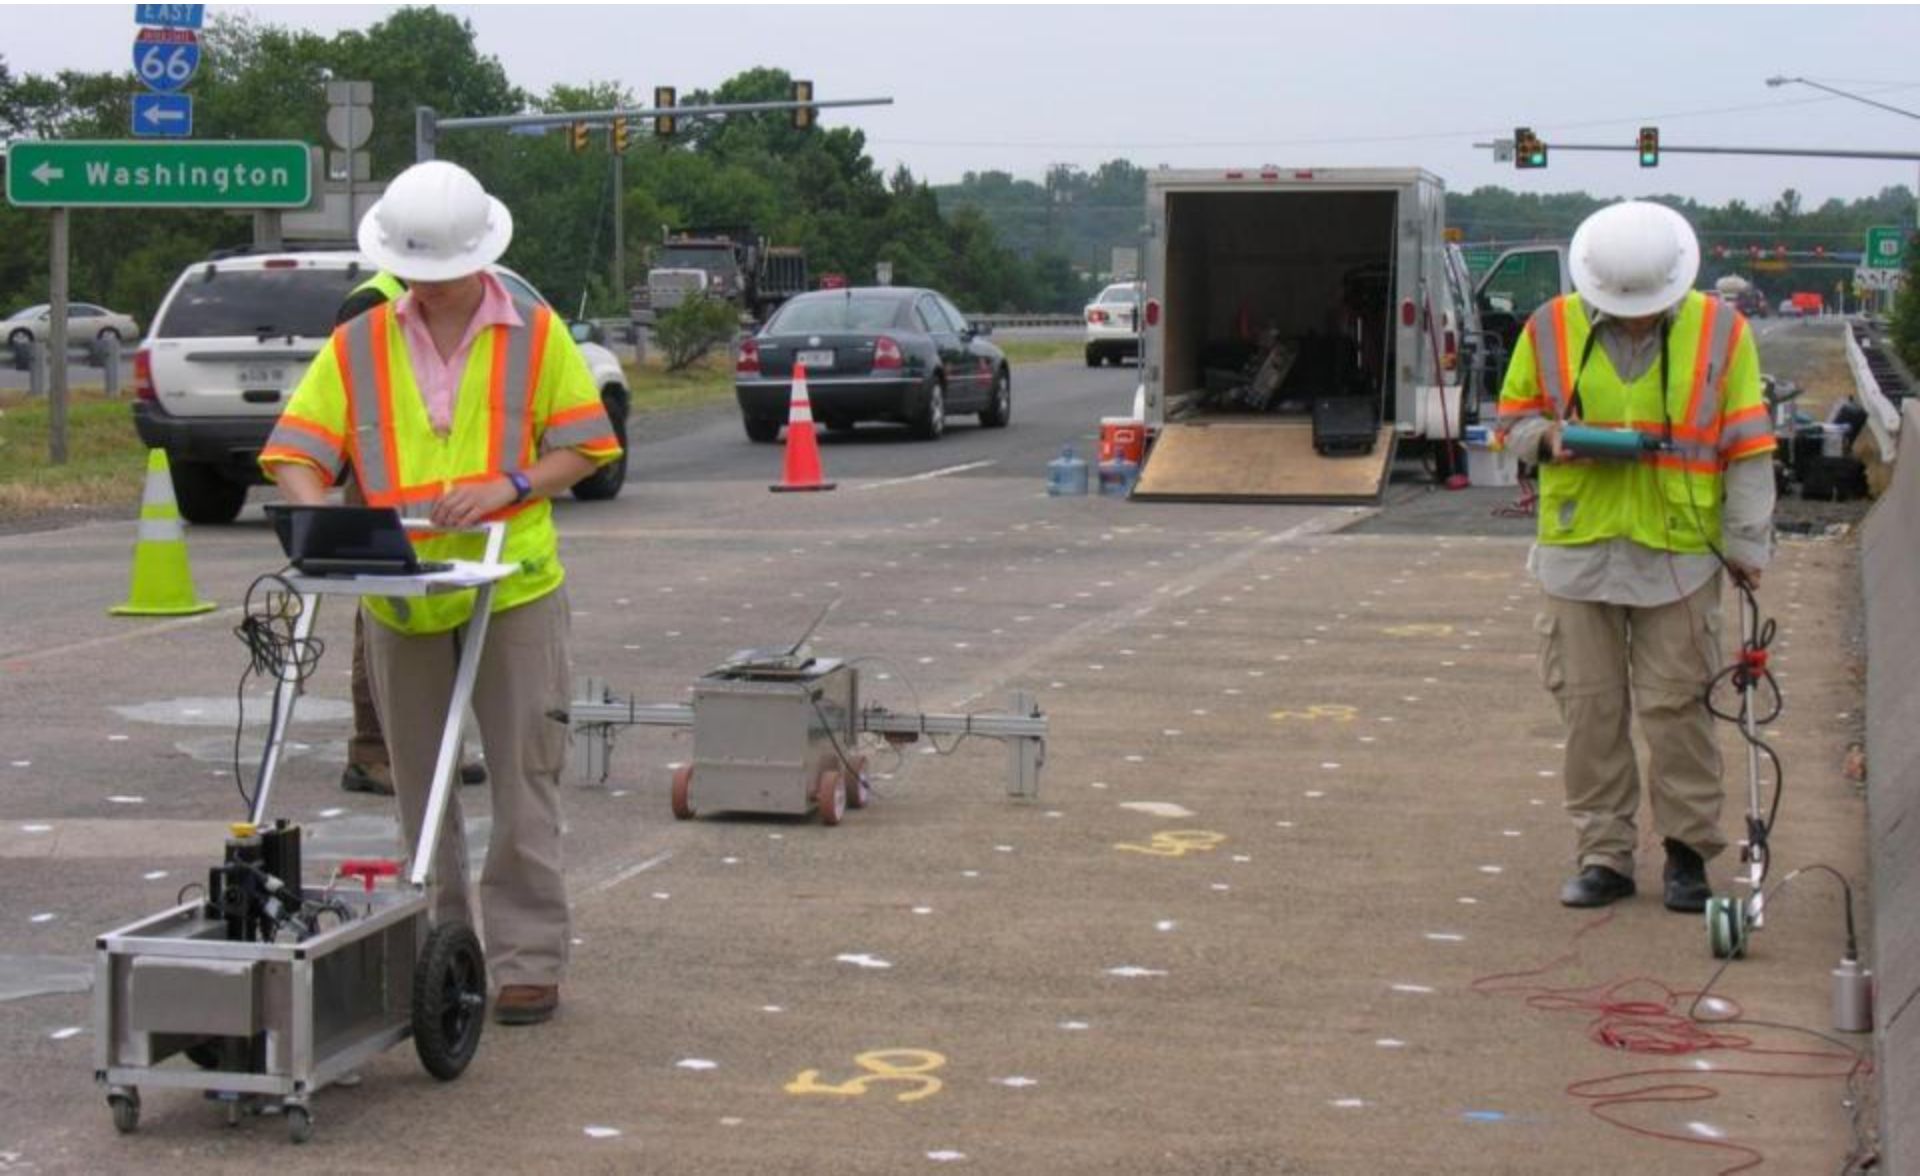
Nondestructive Testing - Concrete Bridge Deck US Hwy 15 over I-66 in Haymarket, VA Rutgers University SHRP2 R06A Project

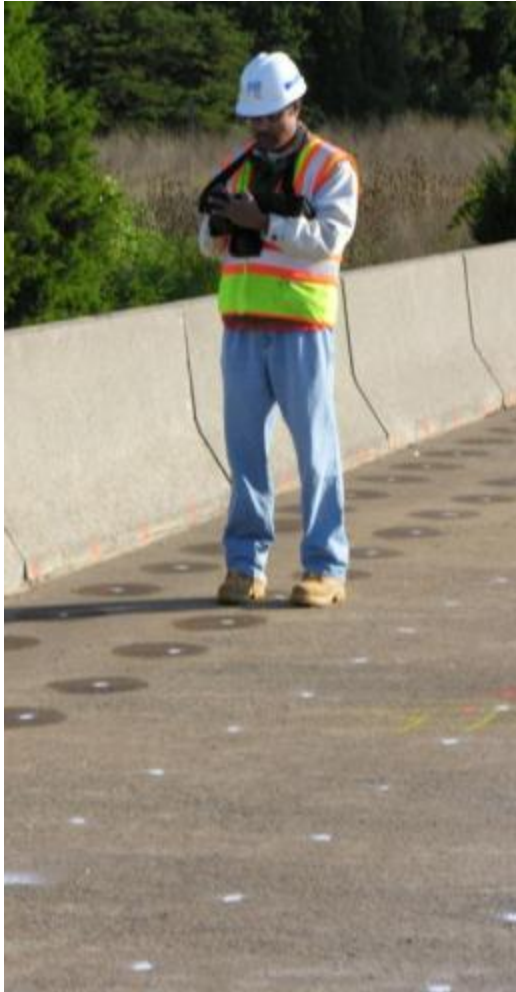
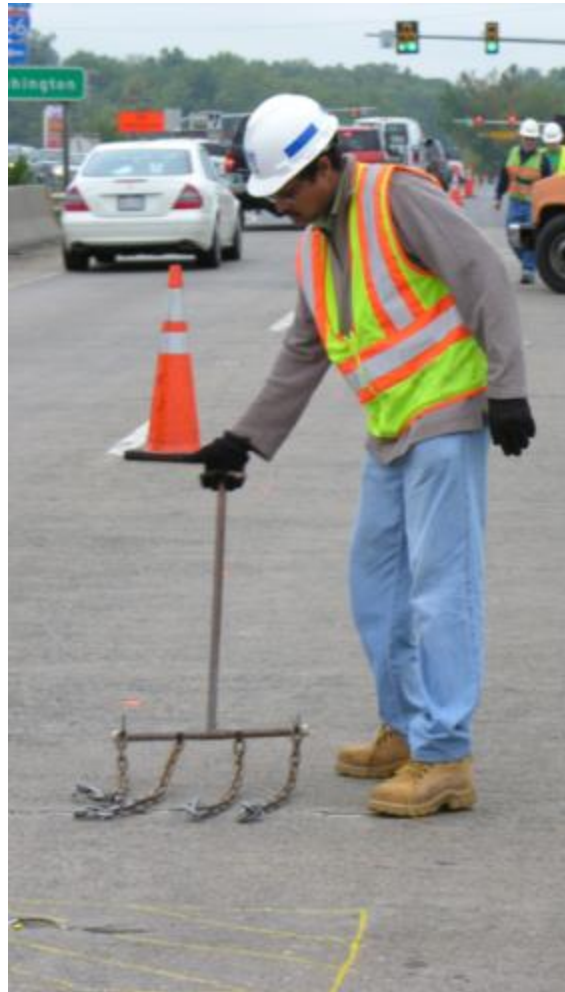
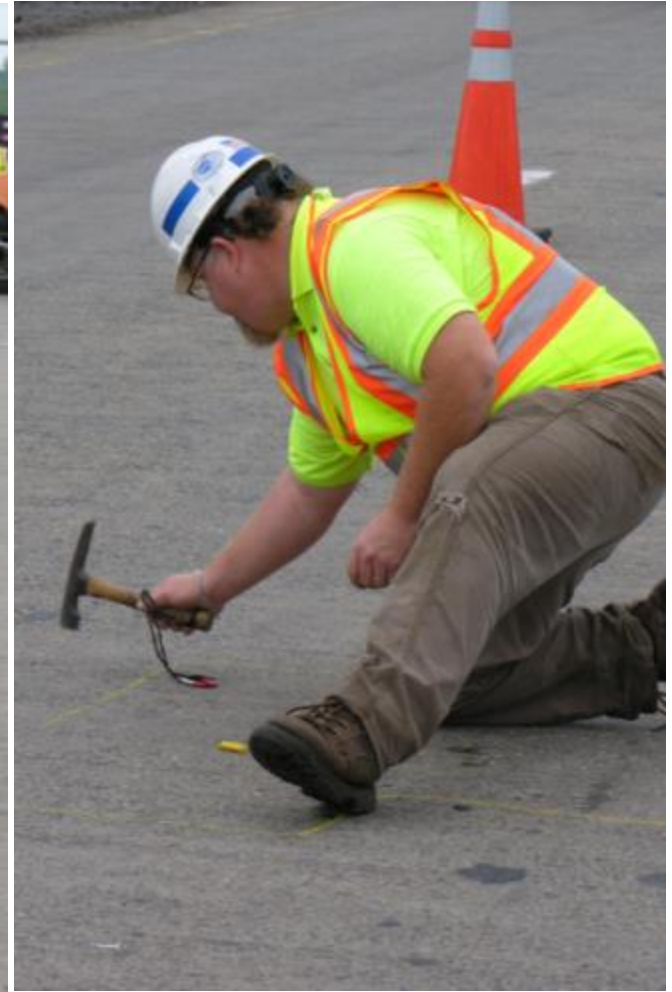
R06A Challenge: State of Practice – Acoustic Sounding and Half-Cell Potential
